# Shake Table Response of Unreinforced Masonry and Reinforced Concrete Elements of Special Moment Resisting Frame

Half-scaled reinforced concrete frame of two storeys and two bays with unreinforced masonry (URM) infill walls was subjected to base excitation on a shake table for seismic performance evaluation. Considering the high seismic hazard Zone IV of Pakistan, reinforcement detailing in the RC frame is provided according to special moment resisting frames (SMFRs) requirement of Building Code of Pakistan Seismic-Provisions (BCP SP-2007). The reinforced concrete frame was infilled with in-plane solid masonry walls in its interior frame, in-plane masonry walls with door and window openings in the exterior frame, out-of-plane solid masonry wall, and masonry wall with door and window openings in its interior frame. For seismic capacity qualification test, the structure was subjected to three runs of unidirectional base excitation with increasing intensity. For system identification, ambient-free vibration tests were performed at different stages of experiment. Seismic performance of brick masonry infill walls in reinforced concrete frame structures was evaluated. During the shake

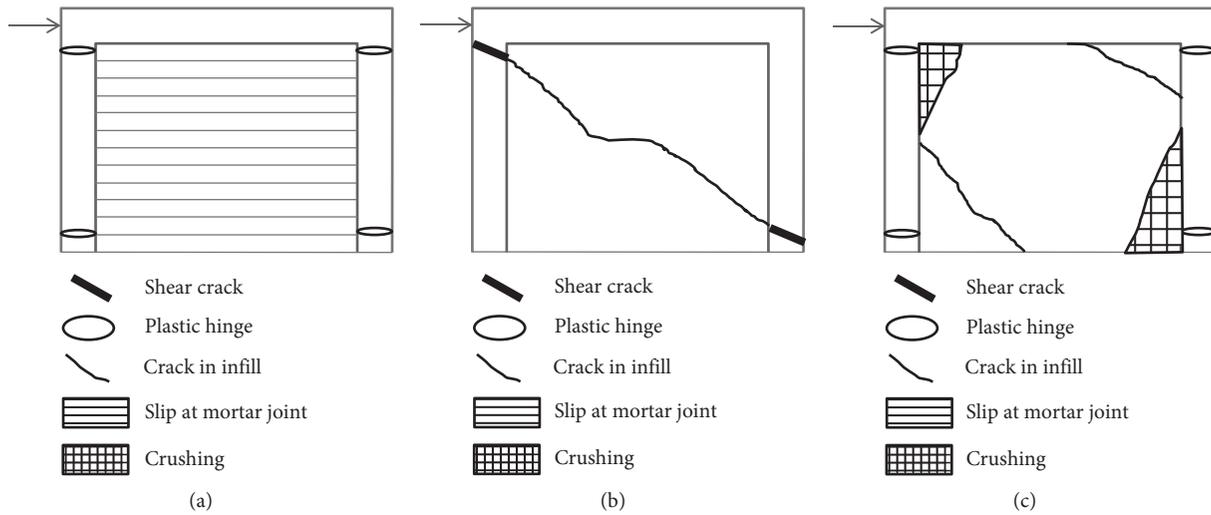
FIGURE 1: Three distinct failure mechanisms of masonry infills. (a) Horizontal sliding. (b) Diagonal cracking. (c) Panel or corner crushing.

Different failure modes of masonry infilled structures have been witnessed by the past earthquakes and experimental studies. Severe damage has been demonstrated to these types of structures by previous earthquakes (including 1999 Kocaeli, Turkey earthquake [6]; the 2008 Sichuan, China earthquake; and the 1999 Chi-Chi, Taiwan Earthquake). The damage mechanism comprises of partial or full masonry panel failure, shear failure of columns, plastic hinges at columns ends, soft-storey mechanism, and short column effect [23, 24]. Mehrabi et al. [25] experimentally investigated fourteen half-scale masonry infilled RC frame test specimens and categorized 24 distinct failure modes. Later on Stavridis [22] narrowed down these mechanisms into three main failure modes which includes diagonal cracking (occurs in nonductile frames with strong infill), horizontal shear sliding (occurs in weak frames and weak infill), and corner crushing (occurs in strong frames and strong infill) as shown in Figure 1.

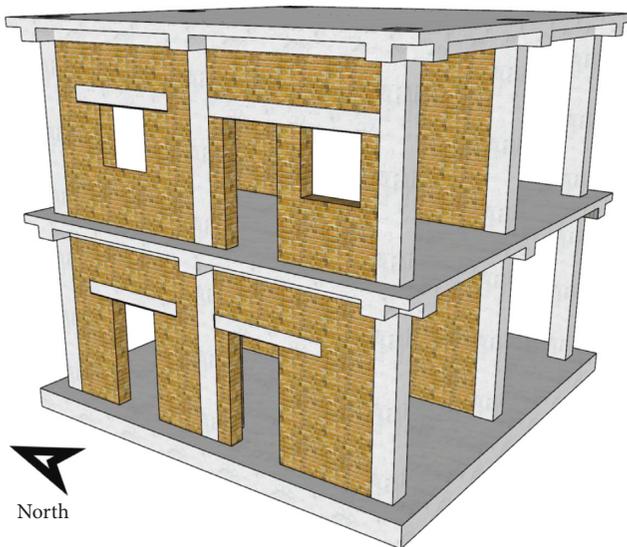
FIGURE 2: Three-dimensional view of prototype.

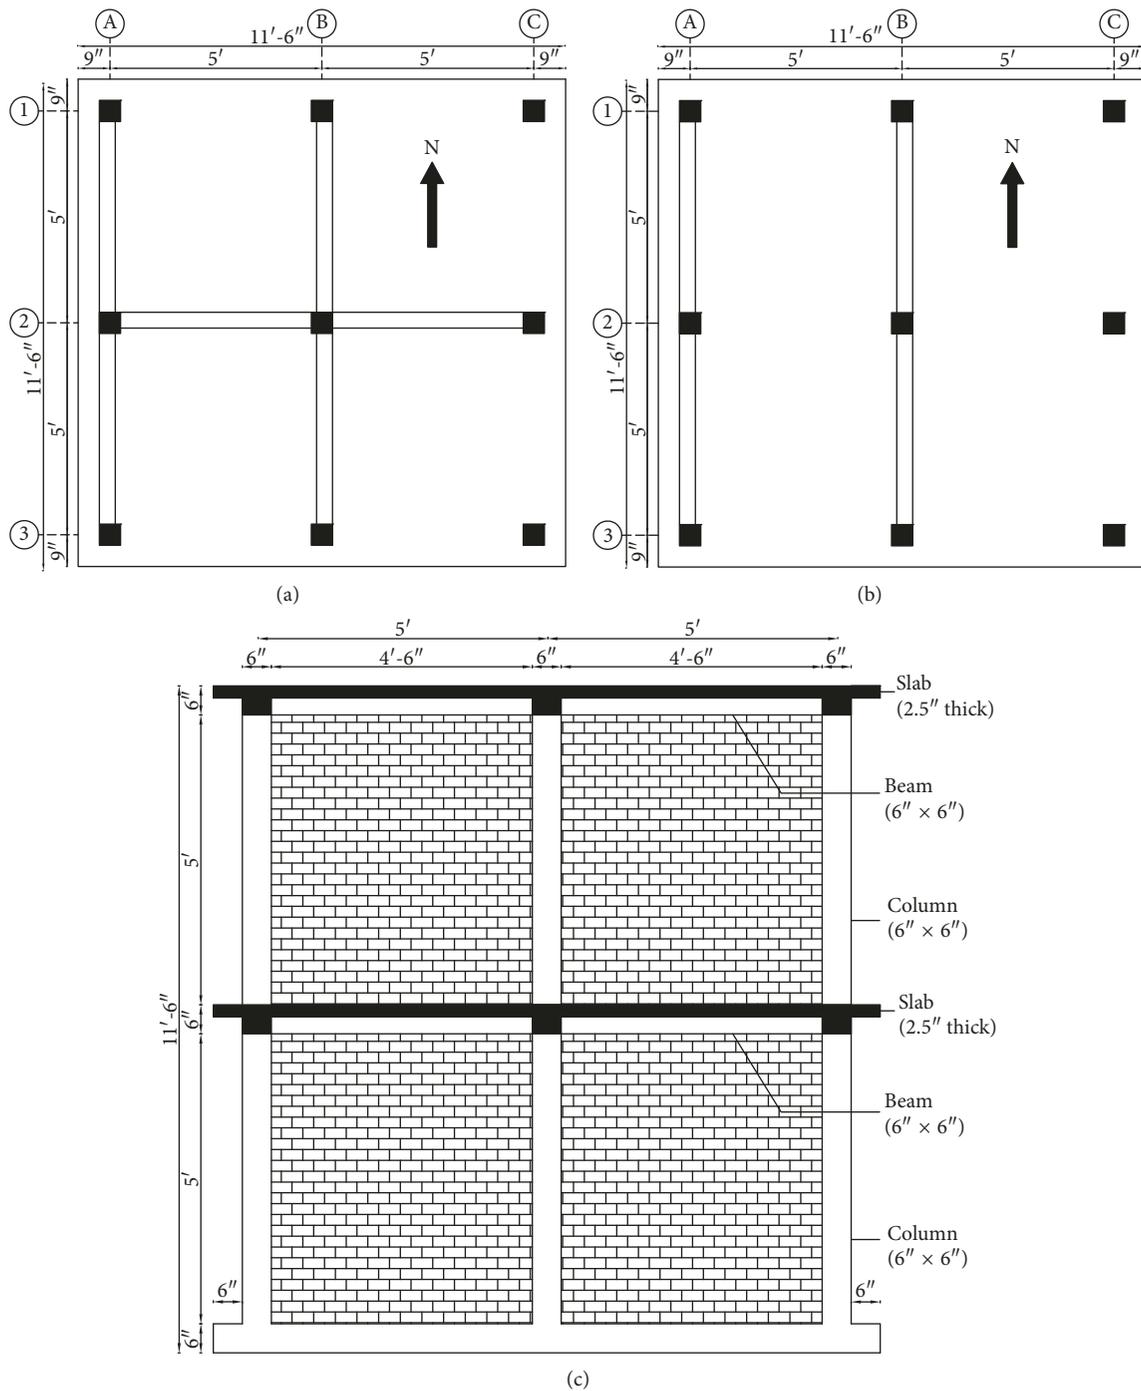
FIGURE 3: Plan and elevation view of the test specimen. (a) First-storey wall layout plan. (b) Second-storey wall layout plan. (c) Elevation view of the interior frame.

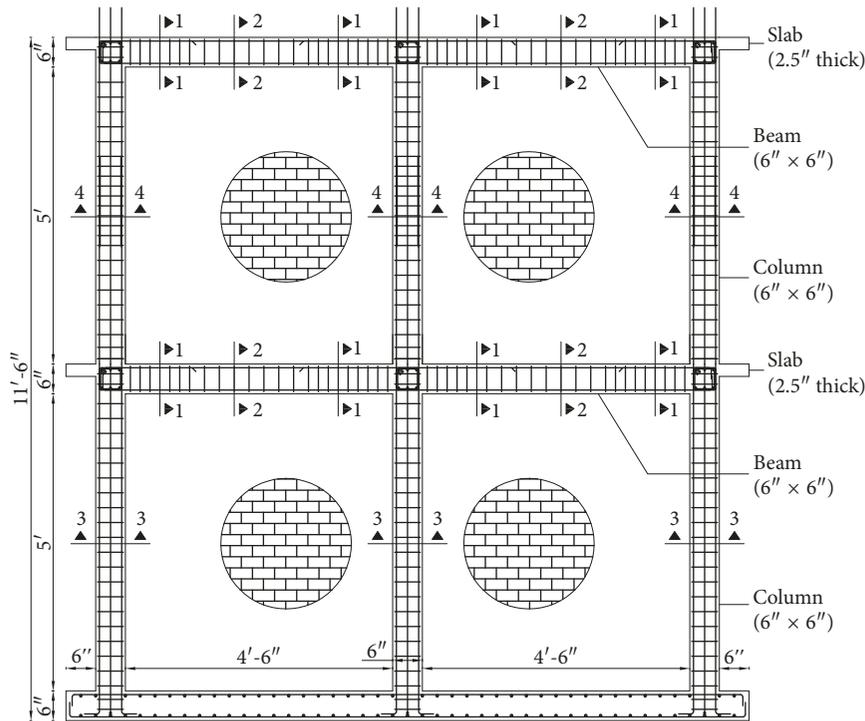
FIGURE 4: Design of the two-storey specimen (dimensions in inches).

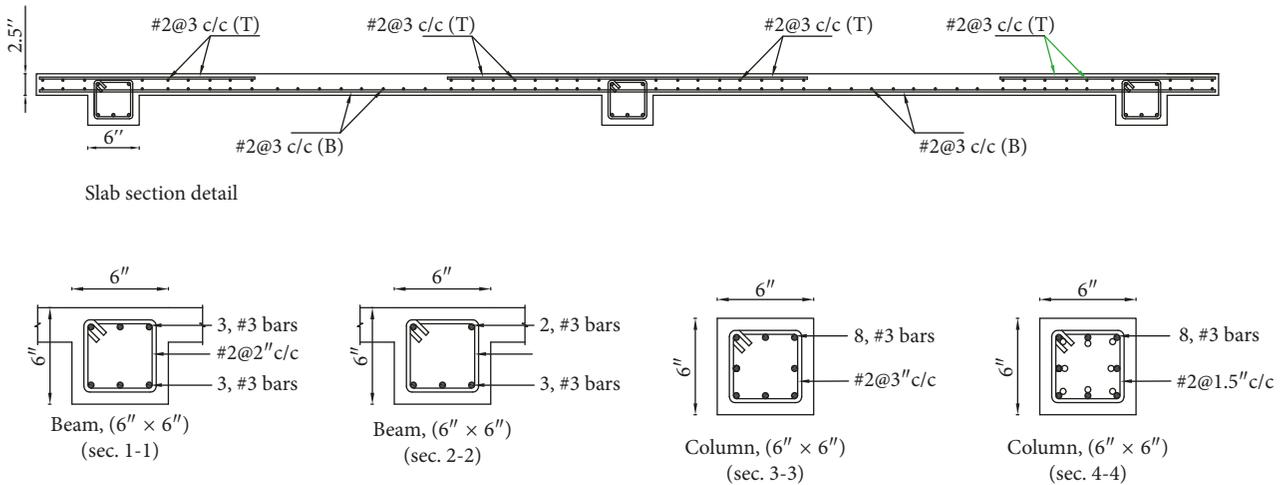
FIGURE 5: Cross-sectional detail of the RC frame (dimensions in inches).

The RC frame was designed with the lateral static force-based method of seismic design procedures which is based on Uniform Building Code (UBC) 97 and detailed as per SMRF requirements of American Concrete Institute (ACI) Committee 318 Building Code Requirement for Structural Concrete. Beams, columns, and beam-column joints in SMRFs structure is detailed such that it can resist axial, flexural, and shearing actions produced by structure during strong earthquake motion. High seismic hazard region is specified by Zone IV where PGA is greater than 0.32g (BCP SP-2007). Seismic hazard of Zone IV with a design PGA of 0.40g and soil type B was considered. Loads on structure includes the self-weight for structural beam-column elements and slabs, while superimposed dead load for partition URM infill walls, floor finishing, and live load of 40 psf (Pounds per square foot) (0.0019 MPa) was assigned to the structure. The concrete compressive strength of 3,000 psi (Pounds per square inch) (21 MPa) and reinforcing steel of 50,000 psi (344 MPa) which is typically used was considered in the design. The dimensions of the RC frame and reinforcement bars layout are given in Figure 4. Using 6-inch square of beams and columns, two types of reinforcement were provided at different locations as shown in Figure 5. In section 1-1 of beam, the longitudinal reinforcement of 6 #3 (9.52 mm) diameter bars and transverse reinforcement of #2 (6.35 mm) diameter bars at 2 inches (50.8 mm) center-to-center were provided. Section 2-2 of beam is having longitudinal reinforcement of 5 #3 (9.52 mm) bars and transverse reinforcement of #2 (6.35 mm) bars at 3 inches (76.2 mm) center-to-center.

Longitudinal reinforcement provided in the column section 3-3 is 8 #3 (9.52 mm) bars and transverse reinforcement of #2 (6.35 mm) bars at 2 inches (50.8 mm) center-to-center. Column cross section 4-4 is having 8 #3 (9.52 mm) bars of longitudinal reinforcement and #2 (6.35 mm) bars at 1.5 inches (38.1 mm) center-to-center. The transverse reinforcement in the beam and column was provided with 135° hook. The reinforcements in the slabs of

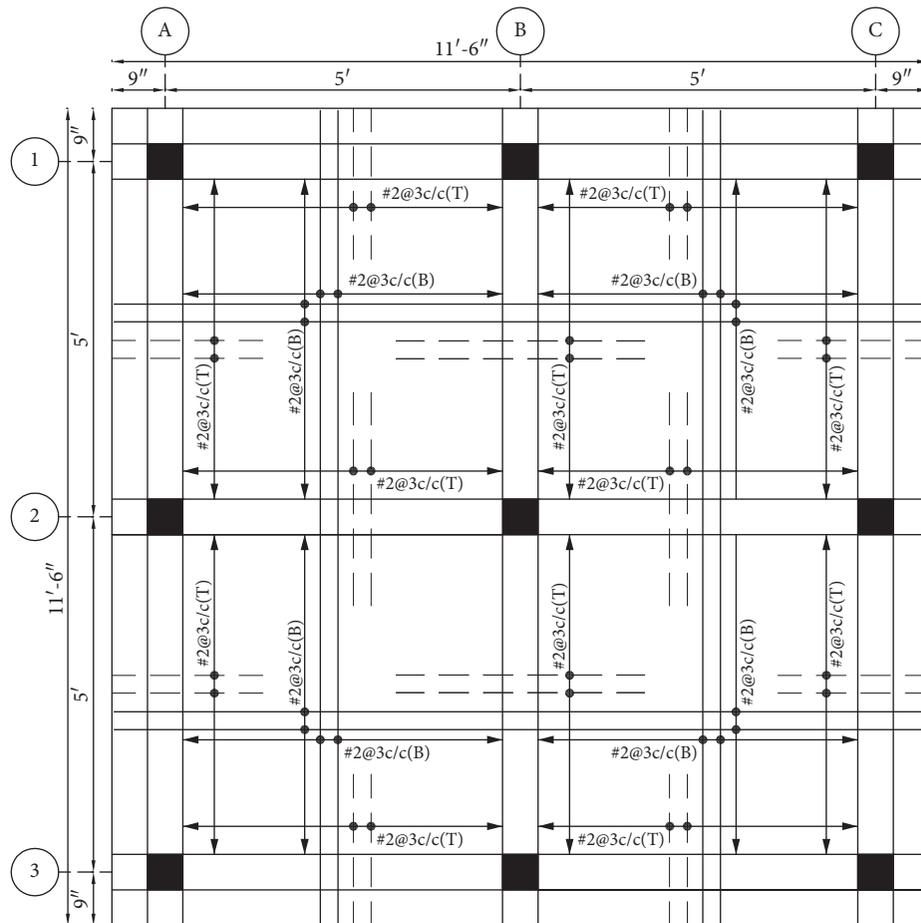
FIGURE 6: Plan view of first- and second-storey specimens with slab reinforcement details.

both the storeys were same, and the steel reinforcement detail of slabs is shown in Figure 6.

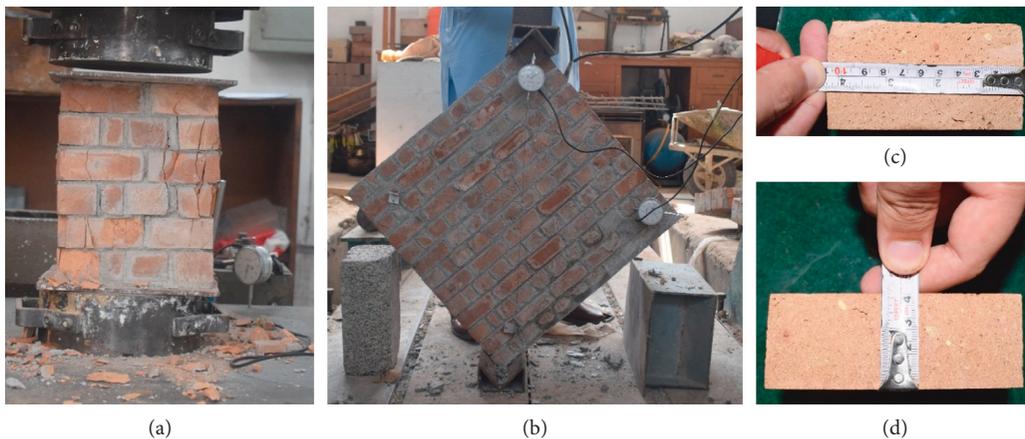
FIGURE 7: (a) Compressive and (b) diagonal tests of brick prism and (c) length and (d) width of brick specimens.

of URM walls, three samples of a masonry prism for compressive strength and three samples of a diagonal prism for tensile strength were constructed and tested after 28 days. Results of material properties are summarized in Table 2.

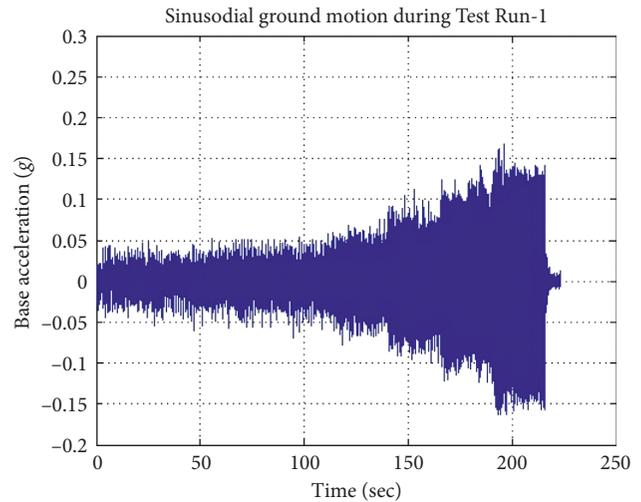
FIGURE 8: Acceleration recorded at the base during Test Run-1.

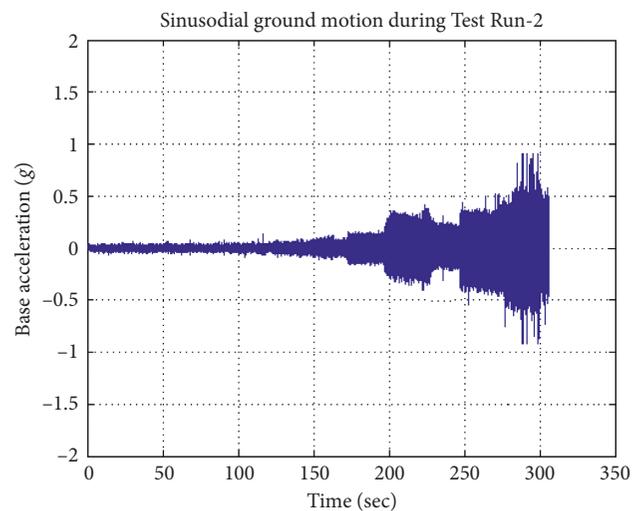
FIGURE 9: Acceleration recorded at the base during Test Run-2.

0.60g with frequency between 0.50 and 7.50 Hz at the second stage of experiment shown in Figure 9. In order to observe response of structure at resonance and to cause major collapse in the nonstructural URM walls, the test specimen was subjected to a strong sinusoidal base excitation of PGA 0.05 to 1.24g with frequency varying between 0.50 and 8.00 Hz as shown in Figure 10. It was decided to conclude the base excitation after the collapse of nonstructural URM walls as the masonry walls of the specimen will be strengthened and retrofitted in the future.

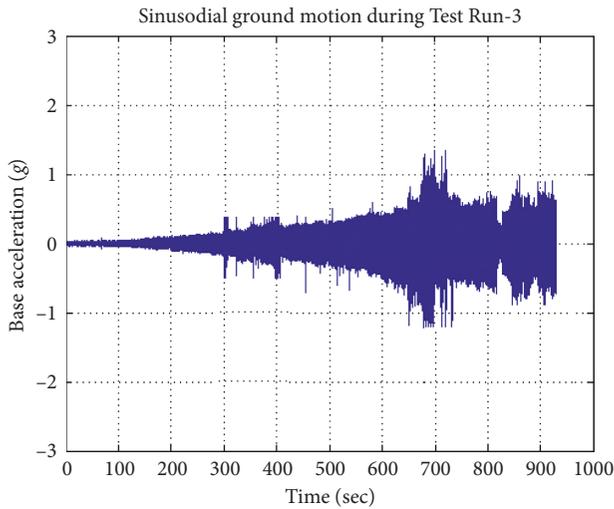
FIGURE 10: Acceleration recorded at the base during Test Run-3.

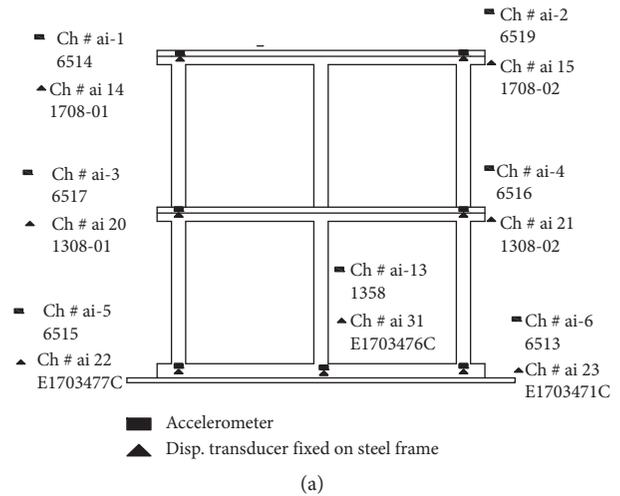
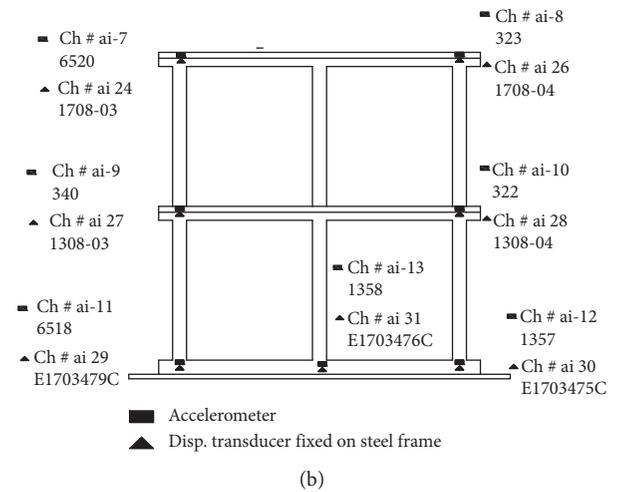
FIGURE 11: Instrumentation setup. (a) North face instrumentation. (b) West face instrumentation.

**2.5. Instrumentation.** To measure the displacement and acceleration response histories, the test specimen was instrumented with a total sum of thirteen displacement transducers (DT's) and thirteen uniaxial accelerometers. Prior to the instrumentation, two steel frames were fixed along North and West face of the test specimen. Four accelerometers and four displacement transducers were installed at each floor level and at the base to record the response history in both directions. Instrumentation detail of North and West face is given in Table 4 and Figure 11. All the sensors were calibrated before installation of sensors on steel reference frame and test specimen. The sensors were cross checked to see if all connections are whether functional or not.

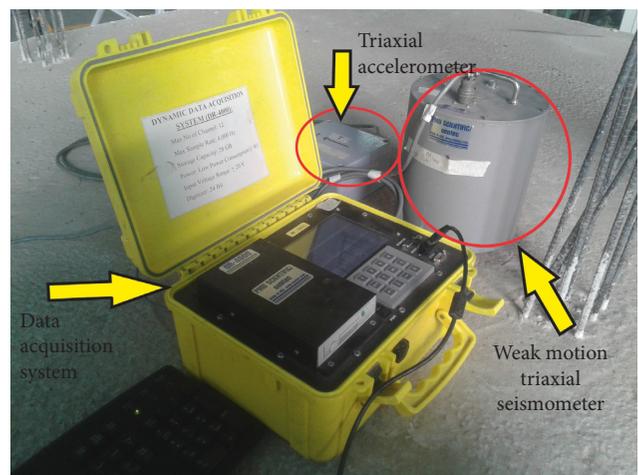
FIGURE 12: Test setup for the free vibration test.

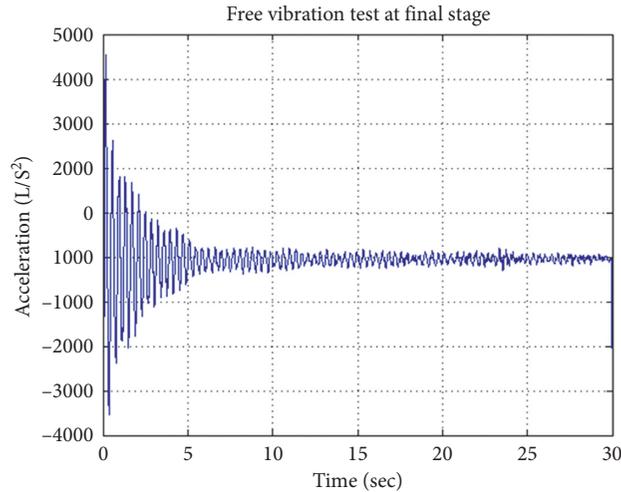
FIGURE 13: Sample of free vibration-time history recorded with the triaxial accelerometer after Test Run-3.

Ambient-free vibration tests were performed at different stages of experiment to determine the natural frequency and damping ratio of the structural system. These tests were conducted to determine dynamic characteristics of structure in both in-plane North–South direction and out-of-plane East–West direction. The test setup for the ambient-free vibration test is shown in Figure 12. A triaxial accelerometer and weak motion seismometer is connected to data acquisition system of a 24-bit recorder (DR-4,000) and facing toward North. The sampling rate was kept 200 Hz, and sample of free vibration-time history recorded after Test Run-3 is given in Figure 13.

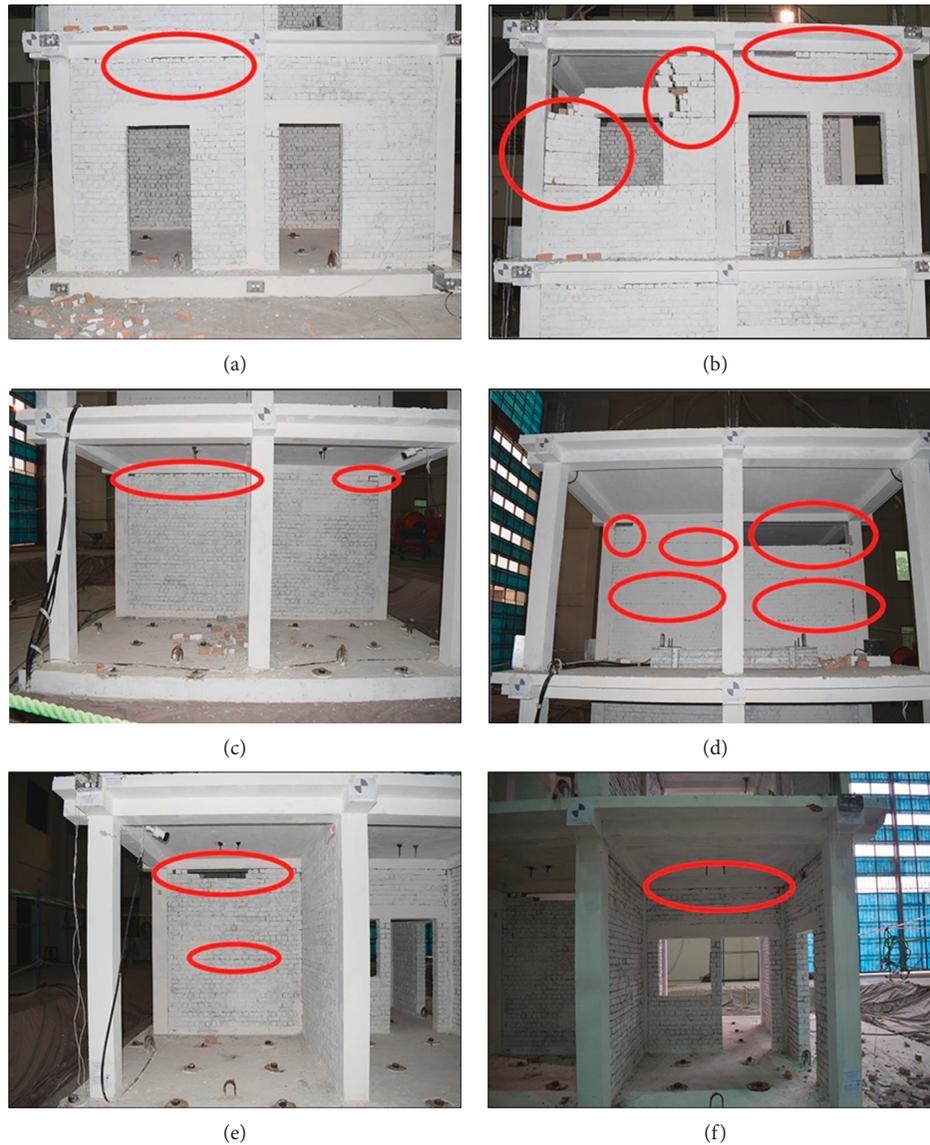
FIGURE 14: Damage observations of URM walls after Test Run-2. (a) Exterior infilled frame of first storey. (b) Exterior infilled frame of second storey. (c) Interior infilled frame of first storey. (d) Interior infilled frame of second storey. (e) Out-of-plane solid infilled frame. (f) Out-of-plane with openings infilled frame.

frame were clearly observed. First-storey exterior URM walls (Figure 14(a)) on both north and south side panels went through vertical frame infill separation, and horizontal shear cracking particularly at the interface of beam infill. Excessive damage (relative to the remaining infill panels) occurred in infill panels of exterior second storey (Figure 14(b)), and the top course of the masonry panels collapsed due to

inadequate binding of panels with beam, while infill walls of exterior second storey (Figure 14(b)) started separating from the bounding RC frame and a clear horizontal shear crack was observed at the 5<sup>th</sup> row of infill wall with window opening. Similarly, the frame infill separation at the top interface followed by corner crushing behavior was observed in the interior first-storey (Figure 14(c)) URM walls. At the location of holdfast (mild steel plates for anchorage of masonry wall with adjacent columns), horizontal shear cracks along mortar layer extended throughout the interior masonry panels. Second-storey interior (Figure 14(d)) URM walls received horizontal and vertical separation and cracking and corner crushing. Few bricks in the top course slid outward in the solid out-of-plane (Figure 14(e)) wall.

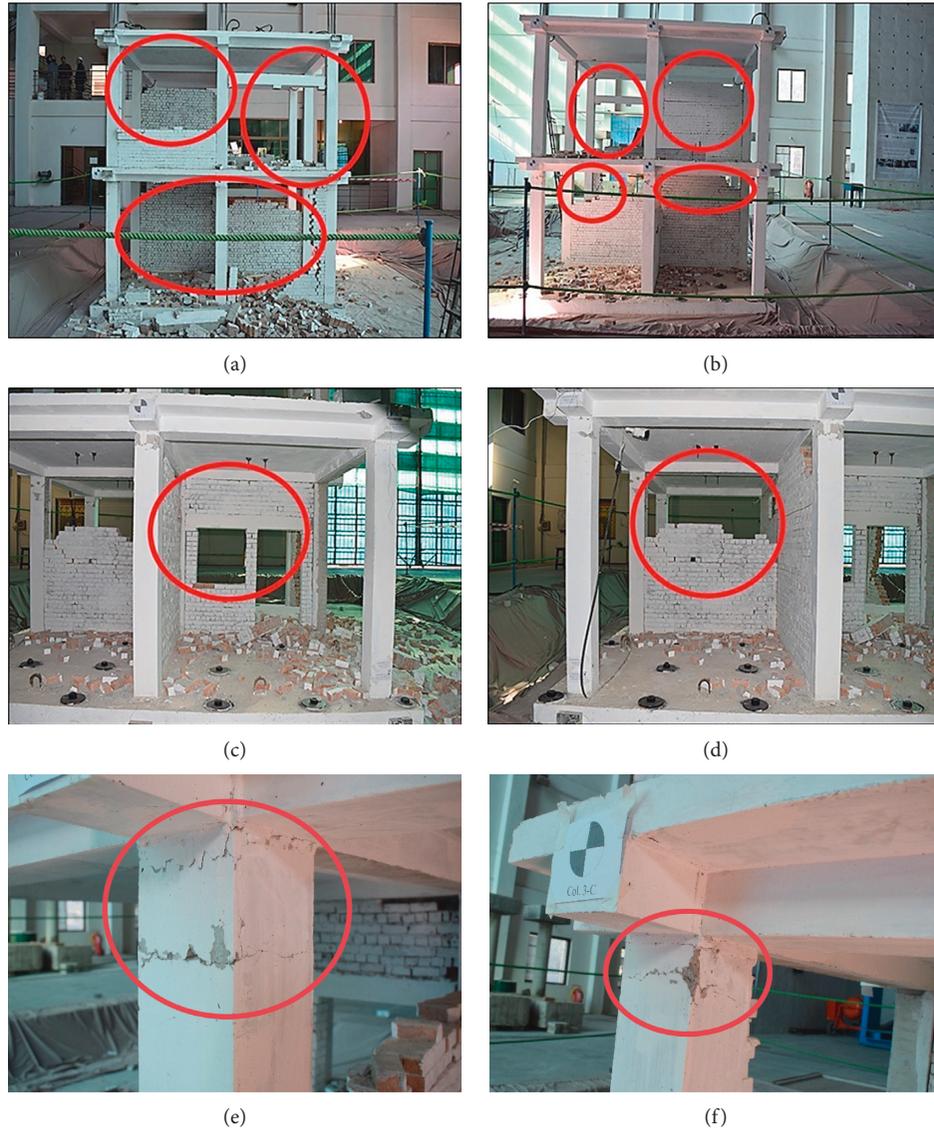
FIGURE 15: Damage observations of URM walls after Test Run-3. (a) West face of the test specimen. (b) East face of the test specimen. (c) South face west-side infilled frame. (d) South face east-side infilled frame. (e) Crack at the top of the exterior column. (f) Crack at the top of the exterior column.

Exterior URM wall of second storey with window opening only, which was already separated from the RC frame up to window height during Test Run-2 (Figure 15(b)), dropped in shear sliding on the table when frequency reached to 3.16 Hz. Also, few rows of interior solid URM walls of both storeys collapsed in shear sliding when frequency was 3.69 Hz.

beneath the lintel beam of exterior URM walls. Out-of-plane infilled wall up to lintel beam height slid horizontally outwards. The performance of the out-of-plane URM wall with window and door opening was significantly better than the out-of-plane solid masonry wall due to horizontal stiffener provided in the form lintel beam throughout the masonry panel. Damage observations in URM walls after Test Run-3 are shown in Figure 15.

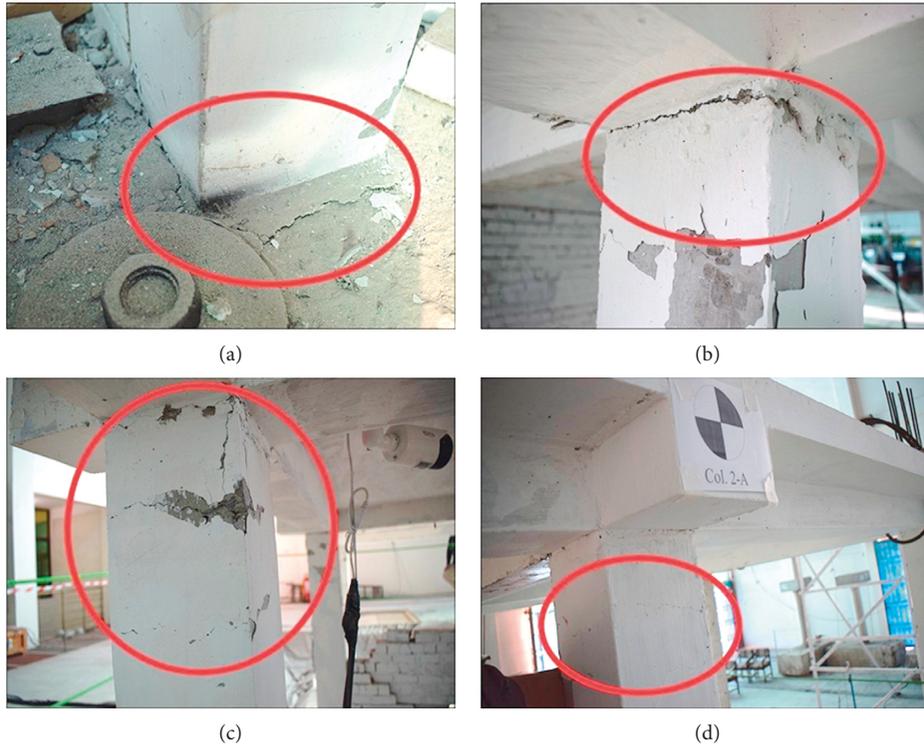
FIGURE 16: Damage observations of URM walls after Test Run-3. (a) Pulling out of column from foundation. (b) Flexural cracking at top end of first storey. (c) Level of cracking and spalling (1st storey). (d) Level of cracking (2nd storey).

$8 \times 10^{-4}$  to  $1.5 \times 10^{-3}$  in. (0.02–0.04 mm.). The damages observed in RC frame after Test Run-3 is shown in Figure 16. A free vibration test was conducted after Test Run-3, natural frequency in loading direction drops down to 2.67 Hz, and the damping ratio decreases to 4.01%, while in the out-of-plane East–West direction, the natural frequency decreases to 1.93 Hz and damping ratio to 2.19%. The decrease in natural frequency is the indication of damage in the structure, while loss of URM walls causes drop of damping ratio.

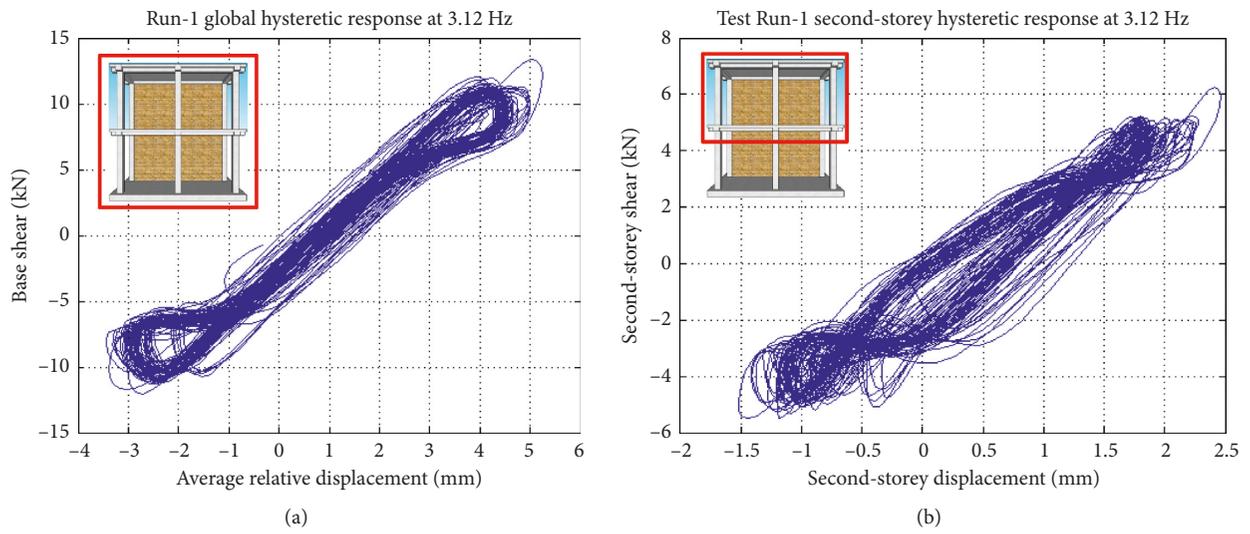
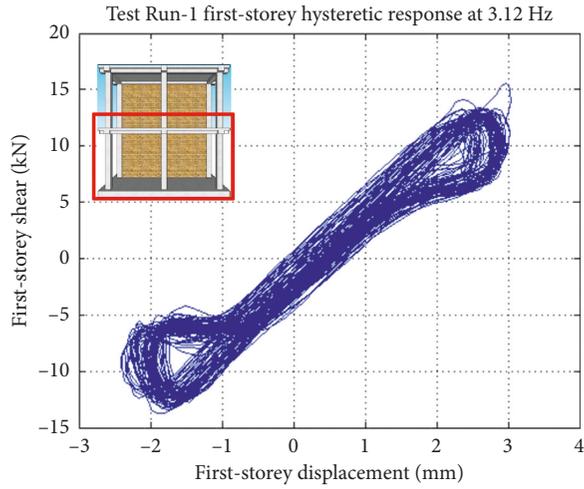
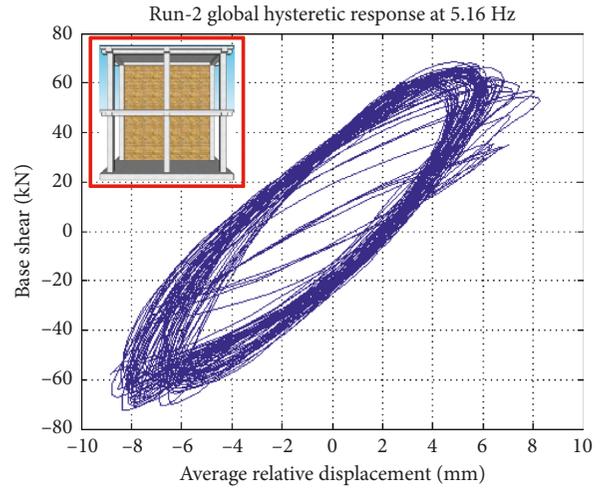
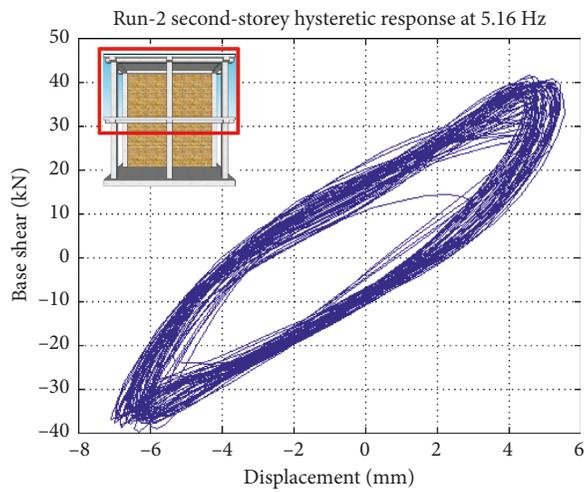
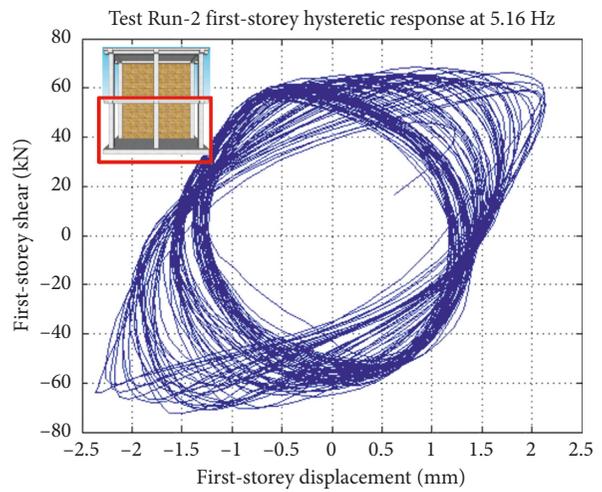
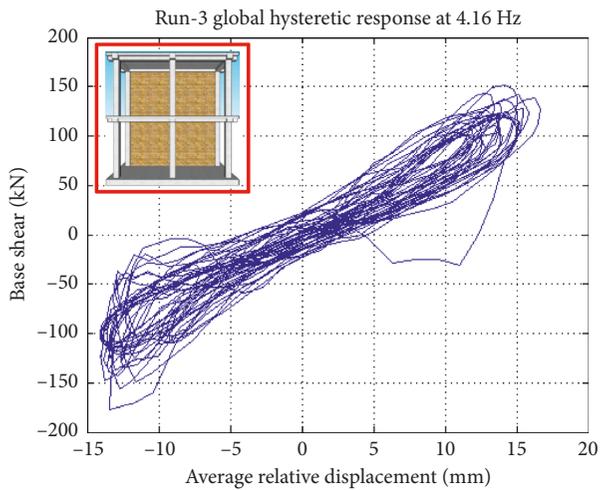
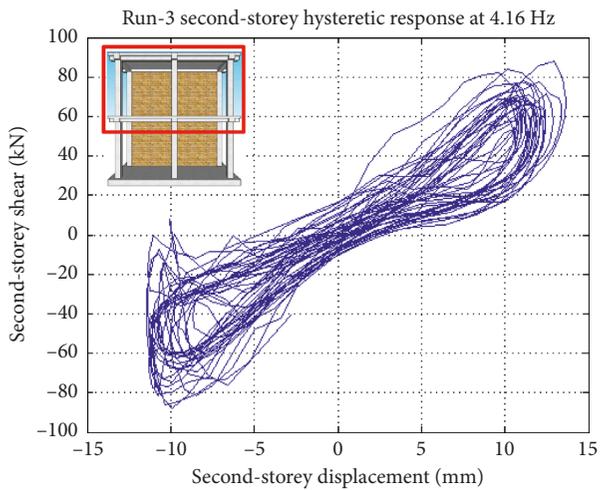
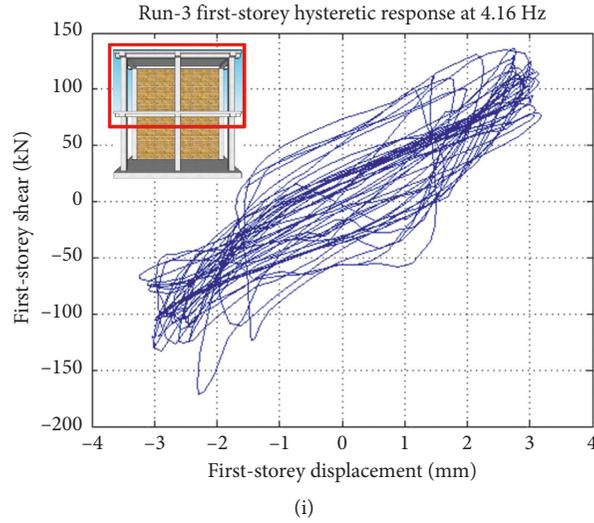
FIGURE 17: Hysteretic behavior of structure at each test run. (a) Run-1 global hysteretic response at 3.12 Hz. (b) Test Run-1 second-storey hysteretic response at 3.12 Hz. (c) Test Run-1 first-storey hysteretic response at 3.12 Hz. (d) Global hysteretic response at 5.16 Hz. (e) Run-2 second-storey hysteretic response at 5.16 Hz. (f) Test Run-2 first-storey hysteretic response at 5.16 Hz. (g) Run-3 Global hysteretic response at 4.16 Hz. (h) Run-3 second-storey hysteretic response at 4.16 Hz. (i) Test Run-3 first-storey hysteretic response at 4.16 Hz.

The hysteretic behavior of structure is obtained at global and first and second-storey levels as shown in Figure 17. For global hysteretic behavior, the base shear is plotted with average relative displacement. In order to know whether the distribution of displacement over the RC frame is uniform or concentrated in one of the storey, hysteretic

curves are plotted for individual storey: first-storey hysteretic curves are obtained by plotting first-storey drift (displacement at first storey top relative to base) with first-storey shear. second-storey shear is plotted with second-storey drift (roof displacement relative to the top of the first-storey displacement). The hysteretic curve reported here are only for selected frequencies (peak response) of shake table test runs. The peak response takes place at 3.12, 5.16, and 4.16 Hz during Test Run-1, Run-2, and Run-3. The test specimen response at different levels of excitation is summarized in Table 6.
