Research Article

Shield Equipment Optimization and Construction Control Technology in Water-Rich and Sandy Cobble Stratum: A Case Study of the First Yellow River Metro Tunnel Undercrossing

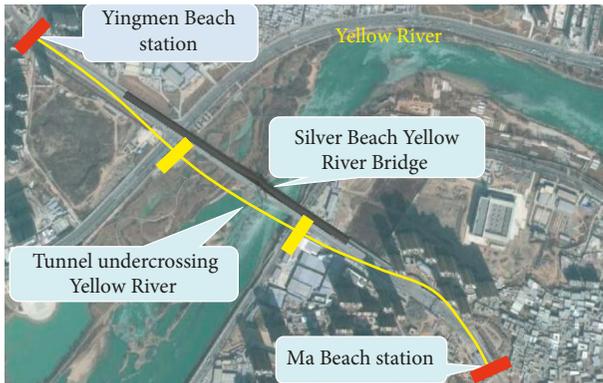
FIGURE 1: Plane layout of the Lanzhou No.1 Metro Line.

The left-hand track of the section between Yingmen Beach and Ma Beach (hereinafter referred to as Ying Ma) of Lanzhou No. 1 Metro Line is 1908.029 m in length, and the right-hand track is 1906.567 m in length. The entire section was constructed using the shield method, and the inner and outer diameters of the tunnel are 5500 mm and 6200 mm, respectively. The shield tunnel passes through the Yellow

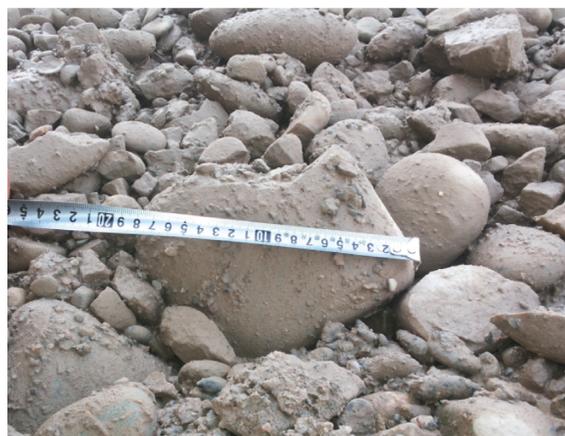
FIGURE 4: Representative photograph of the cobble stratum.

2.2.1. High Percentage of Large Grain Size Cobbles. Grains with sizes ranging from 40 to 60 mm accounted for 32.73% by volume of the sandy cobble stratum (Q_1^{al}) through which the tunnel passed, while the grains with sizes larger than 60 mm accounted for 6.44% by volume (Table 1). The sampling in the stratum was as shown in Figure 4. The stratum was unstable and it was therefore difficult to control the tunnel face, which increased the likelihood of a collapse and the subsequent blockage of the circulation system for the shield tunnelling machine.
