## Research Article

# Fire Behavior of the Assembled Monolithic Hollow-Ribbed Slabs

This paper presents the results from the furnace tests conducted on two assembled monolithic hollow-ribbed (AMH) slabs consisting of the open box and the covered box, respectively. Detailed experimental data in the form of describing slab cracking or spalling, furnace temperatures, temperature distributions, and vertical deflections are presented. Comparison of the results from the two fire tests indicates that the covered box shows better fire resistance compared to the open box; thus, the covered box is recommended to adopt in structural fire-resistant design. However, they are both prone to cracking or spalling at their bottom surfaces during the fire tests, so the AMH slab still needs further optimum design to meet its requirements of fire resistance and service function. In addition, the sealing quality of congruent boxes also has a great influence on the fire resistance of the AMH slab.

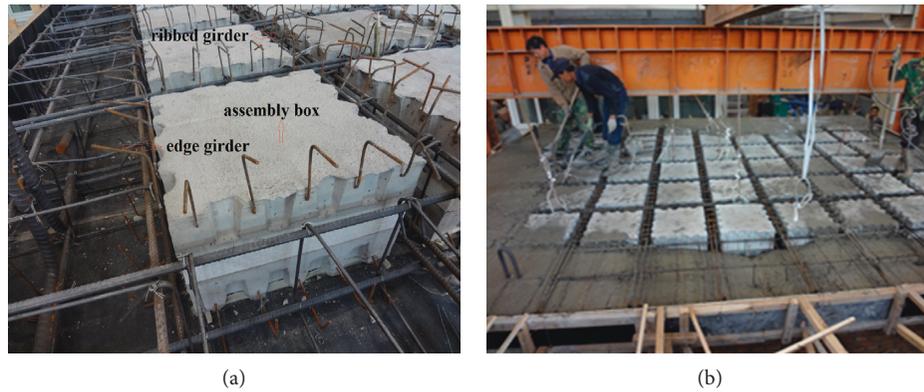
FIGURE 1: View of the AMH floor. (a) Before pouring concrete. (b) Pouring concrete.

The AMH slab floor is developed from the traditional ribbed floor and the cast-in-situ concrete hollow floor. As shown in Figure 1, it consists of prefabricated congruent boxes, cast-in-place concrete ribbed girders, and edge girders. As an important innovation of the slab structure field, it combines many advantages of two traditional floor structure systems and at the same time has solved many problems of the traditional floor. Furthermore, the AMH slab has the characteristics of light weight, little material, good integrity, and spatial performance and so on; thus, it can be used widely in large span, big space, or high-load buildings [1, 2].

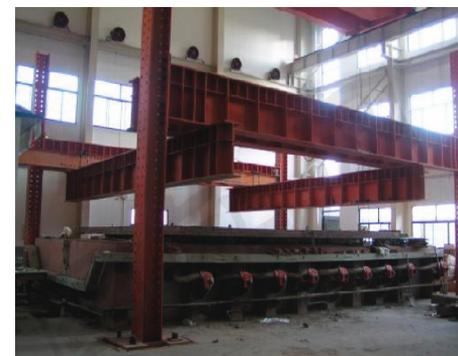
FIGURE 2: Picture of the furnace. (a) Complete picture. (b) Construction details.

**2.1. Furnace Construction and Loading.** Two tests were conducted on a specially designed furnace at Shandong Jianzhu University, China. As shown in Figure 2, the furnace was located underneath the test panels, and the heated slabs served as the upper cover of the furnace. The underside of the slab was heated by six oil-fired burner nozzles, which was located in the furnace walls symmetrically, and each nozzle was controlled independently from each other. Four Type S thermocouples were installed (two in each side shown in Figure 2(b)) to measure the temperatures of the gas inside the furnace.

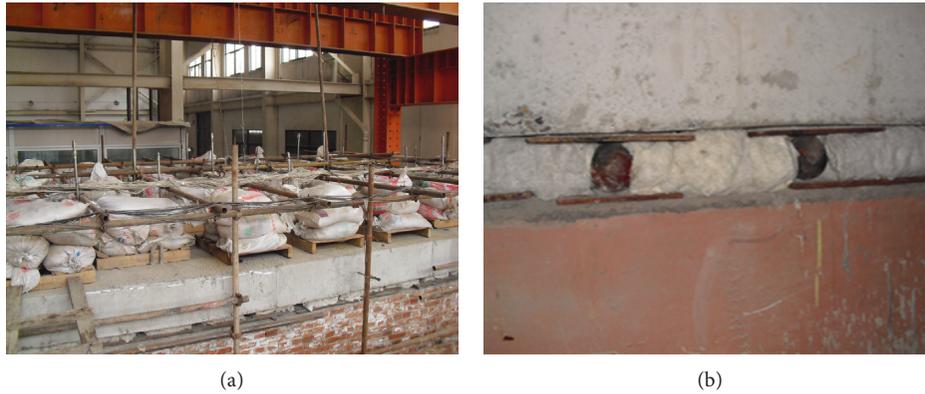
FIGURE 3: View of the loading. (a) Sandbags. (b) Supports.

During the fire tests, sandbags were placed on the slabs to simulate the uniformly distributed load of  $2.0 \text{ KN/m}^2$  in addition to the self-weight [17], and the slabs were loaded at least two hours before each fire test, as shown in Figure 3(a). These sandbags were insulated from the upper surface of the test slab with wooden supports to avoid being damaged by high temperatures.

According to the standard of concrete testing methods of China, the two slabs were both simply supported at all four sides above the furnace, as shown in Figure 3(b). The diameters of both steel balls and steel rollers of the simple edge supports were all 100 mm. There were 120 mm wide and 12 mm thick steel strips continuously between concrete slabs and steel balls or rollers, and the same steel strips were also arranged between steel balls or rollers and four reinforced concrete walls.
