Failure and Remediation of an Embankment on Rigid Column-Improved Soft Soil: Case Study

The south extension line was constructed as a new part of the Xintai Expressway in Guangdong Province, China. The project required the construction of an embankment over soft soil with a thickness of up to approximately 14.0 m, and prestressed pipe pile was selected for reinforcing the soft soil foundation to increase bearing capacity and reduce settlement. Embankment sliding with a length of approximately 110 m and cracking with a length that exceeded 300 m occurred before the construction of the pavement structure. Field investigation and theoretical analysis results indicate that the safety factor of the overall stability calculated by the existing code methods is overly large, thereby resulting in large design pile spacing, low design bearing capacity provided by single pile, and excessive load shared by subsoil between piles. These results all cause the flow sliding of soft soil between the piles and the bending fracture of some piles. The revised density method can be used to check the stability of flow sliding, and the bending moment of piles should also be checked during the embankment

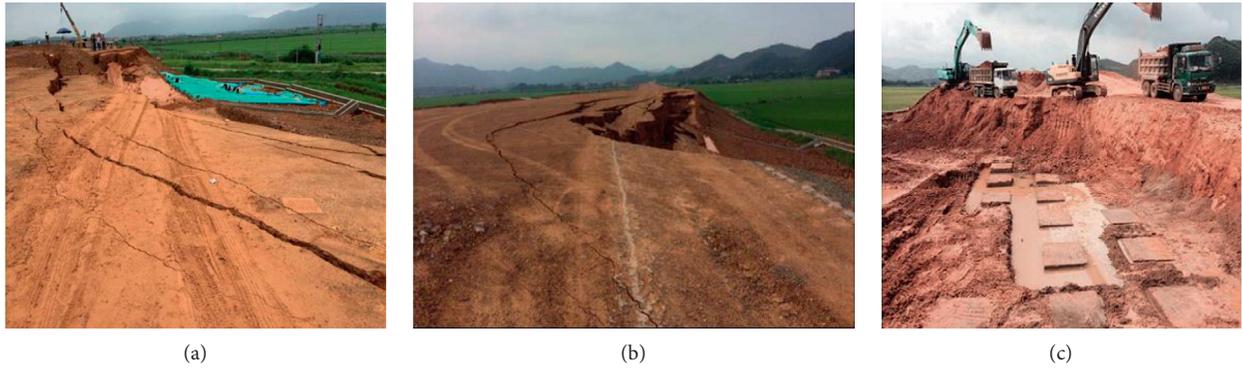
The sliding section is located in the bridge approach, and the embankment is surrounded by farmland. After the embankment construction was completed, the right and left embankments slid successively (Figure 2). The length, width, fill height, maximum ground-lifting height, and ground-lifting width of the right sliding embankment are approximately 110 m, 10 m, 6.9 m, 2.177 m, and 17.3 m, respectively, whereas those of the left sliding embankment are 110 m, 8 m, 6.9 m, 2.021 m, and 26.2 m, respectively (Figure 3).

FIGURE 2: Sliding failure of the embankment. (a) Sliding of the left embankment. (b) Sliding of the right embankment. (c) Excavation investigation.

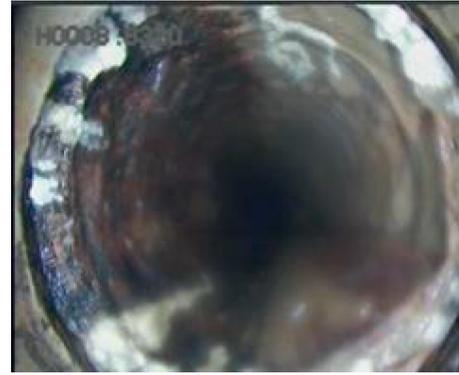
3.3. Influence of Poor Joint on Pipe Pile. The depth of soft soil bottom at the sliding section is approximately 14 m, and the length of the pile is 18-19 m. Each pile consists of two identical prefabricated piles. Thus, the joint of the two piles is located in the middle of the soft soil layer, in which the maximum positive moment of piles is located. In detecting the integrity of piles on the diseased section, the defect locations of piles usually occur near the joint. Figure 10 shows the interior pipe-pile monitoring result obtained by hole camera technology. Dislocation and water leakage have occurred at the joints of some pipe piles.

FIGURE 10: Pipe-pile joint monitored by camera technology in the hole.
