# The Role of Water and Lithology on the Deformation and Failure of an Anaclinal Rock Slope in a Hydropower Reservoir

A series of settlement, cracking, and collapse of the Zhengjiaping slope has been increasingly developing since October 2015 during impoundment at the Dagangshan Hydropower Station. It is a dangerous signal, which means that landslide potential will be existed for the Zhengjiaping slope and poses great threat to the operation of hydropower station and traffic safety. Related slope protection measures and research studies have been implemented accordingly in the Zhengjiaping slope to prevent and control adverse influences on property security and human life in the reservoir area. In order to understand the geological and hydrological settings of the Zhengjiaping slope and its surroundings, a field investigation was carried out to determine the lithological composition and toppling/sliding deformation characteristics using exploratory adit and site boreholes. The large deformation process in the apparently deformed area was analyzed using borehole inclinometers and global navigation satellite systems (GNSS). It was found that the apparently deformed area zone was cha

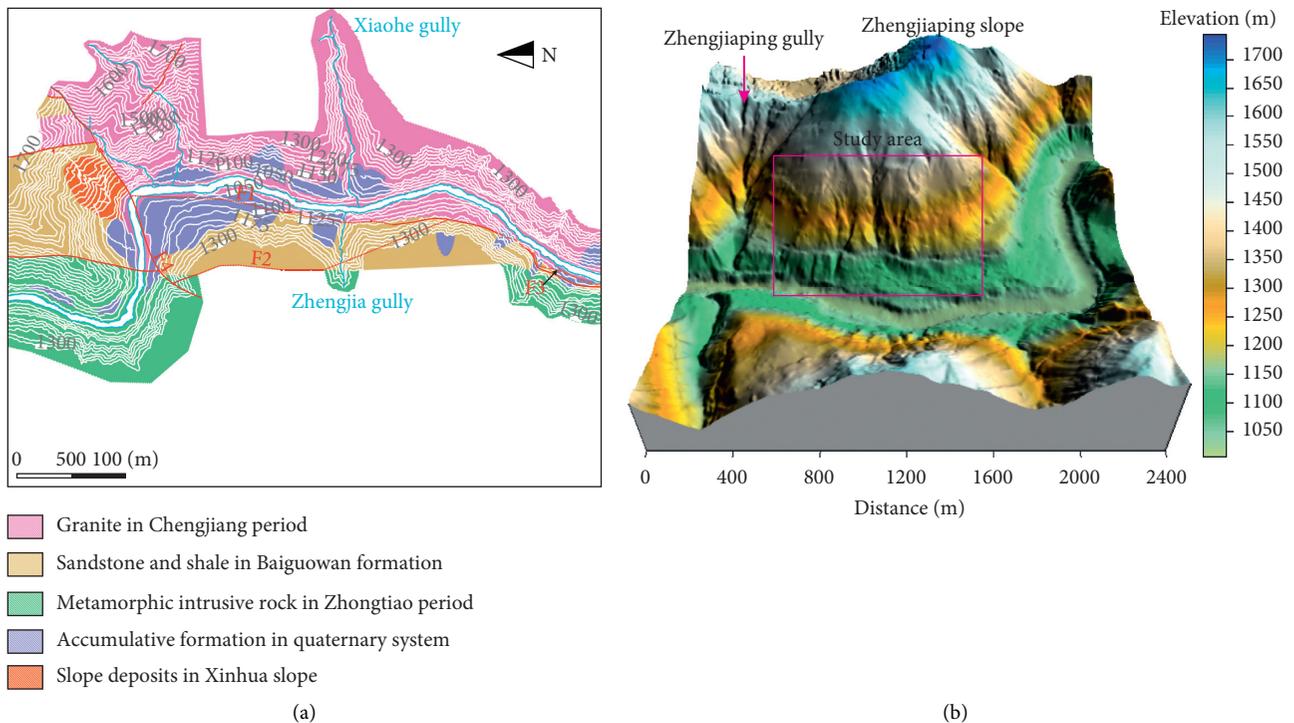
FIGURE 2: Geological conditions and topographic characteristics of the Zhengjiaping slope: (a) geological map of the Zhengjiaping slope and (b) three-dimensional visualization of the study area.

Figure 3(a) shows the lithology of the Zhengjiaping slope and the surrounding area. The evident deformation zone in the Zhengjiaping slope was developed in the stratified sandstone and shale of the Baiguowan Formation. The Baiguowan Group is distributed between the East Branch Fault (F1) and the West Branch Fault (F2) of the Dadu River Fracture Zone. The lithology of the Baiguowan Group is mostly siltstone mudstone, with gray sandstone and gray-black carbonaceous shale in the interlayer. The Chengjiang stage, characterized by granite, is distributed on the left bank of the Dadu River and the footwall of the East Branch Fault of the Dadu River Fracture Zone on the right bank. The Zhongdian period is characterized by tonalite gneiss and diorite gneiss, which are distributed in the footwall of the West Branch Fault (F2) of the Dadu River Fracture Zone. The area below 1130 m elevation of the Zhengjiaping slope is locally covered by the accumulation of quaternary system. As shown in Figure 4, this study investigated the deformation quality of the Zhengjiaping slope by exploratory holes and eight site boreholes. The horizontal length of one exploratory borehole was 100 m and the investigation depth of the site borehole was 80 m. The Zhengjiaping slope has strong and weak weathering zones, as well as non-corresponding strong and weak unloading zones, with intact fresh rock at depth. Figure 5 shows the attitude of slope surface, bedding plane, and major joints. Table 1 shows the volume content of the different lithologies, and Figure 6 shows the degree of weathering and unloading of the rock masses at different depths.

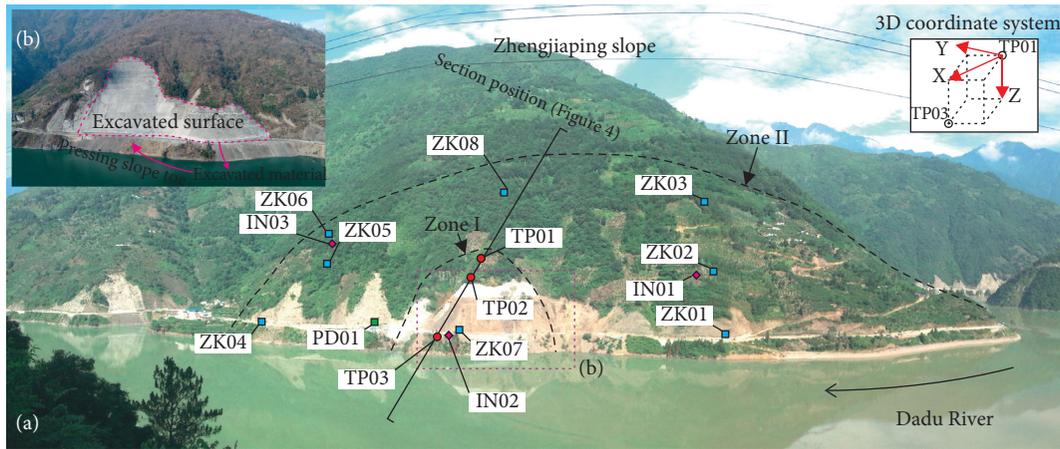
FIGURE 3: Overall view of the Zhengjiaping slope: (a) layout of exploratory adit, site boreholes, borehole inclinometers, and GNSS monitoring points and (b) postexcavation morphology and support measures. PD represents exploratory adit; ZK represents site boreholes; IN represents borehole inclinometers; and TP represents GNSS monitoring points.

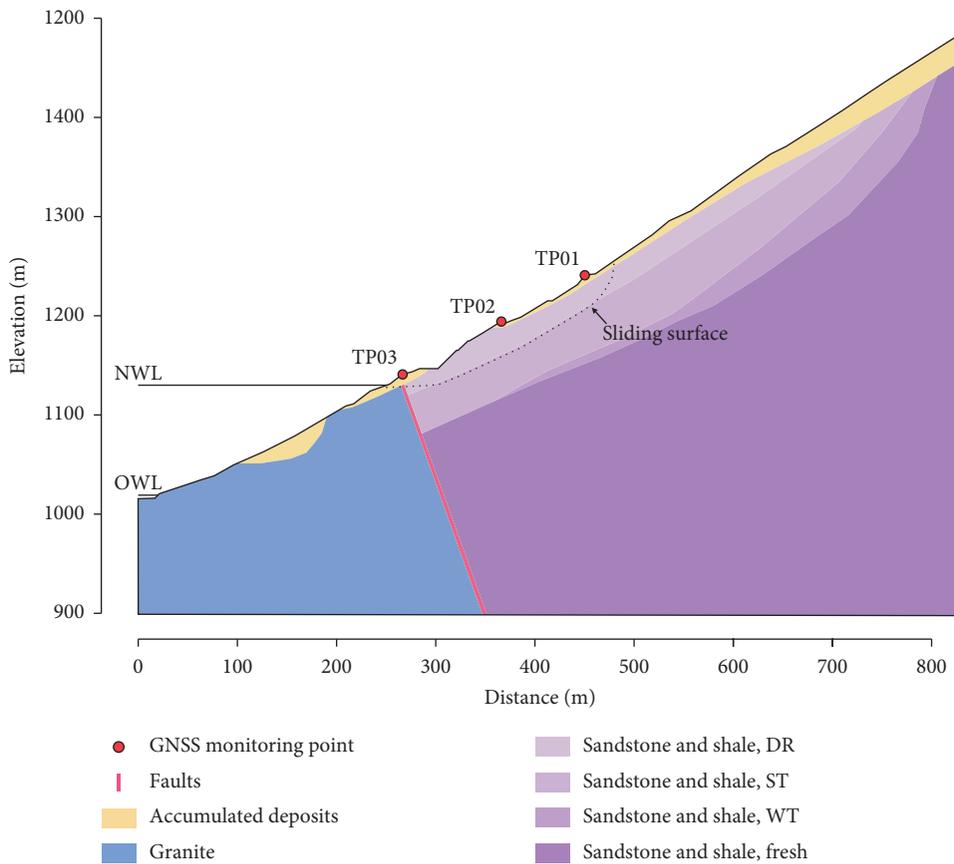
FIGURE 4: Geological profile of the selected location of the Zhengjiaping slope. NWL represents normal water level; OWL represents original water level; DR represents disintegration and relaxing deformation zone; ST represents strong toppling deformation zone; and WT represents weak toppling deformation zone.

and several deformation monitoring points. For better analysis of the monitoring data, a three-dimensional coordinate system was used, as shown in Figure 4.

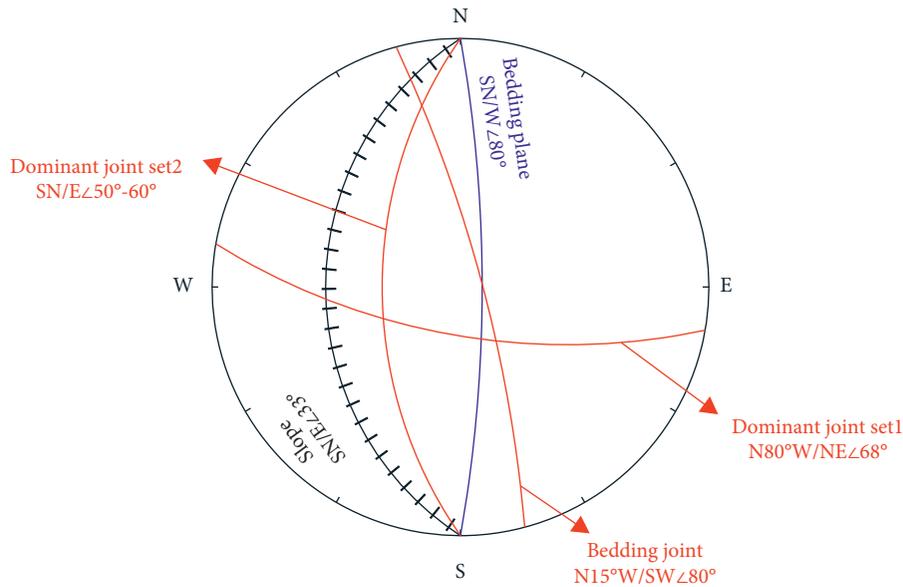
FIGURE 5: Stereonet with projections of the slope surface, bedding plane, bedding joint, and dominant joint sets.

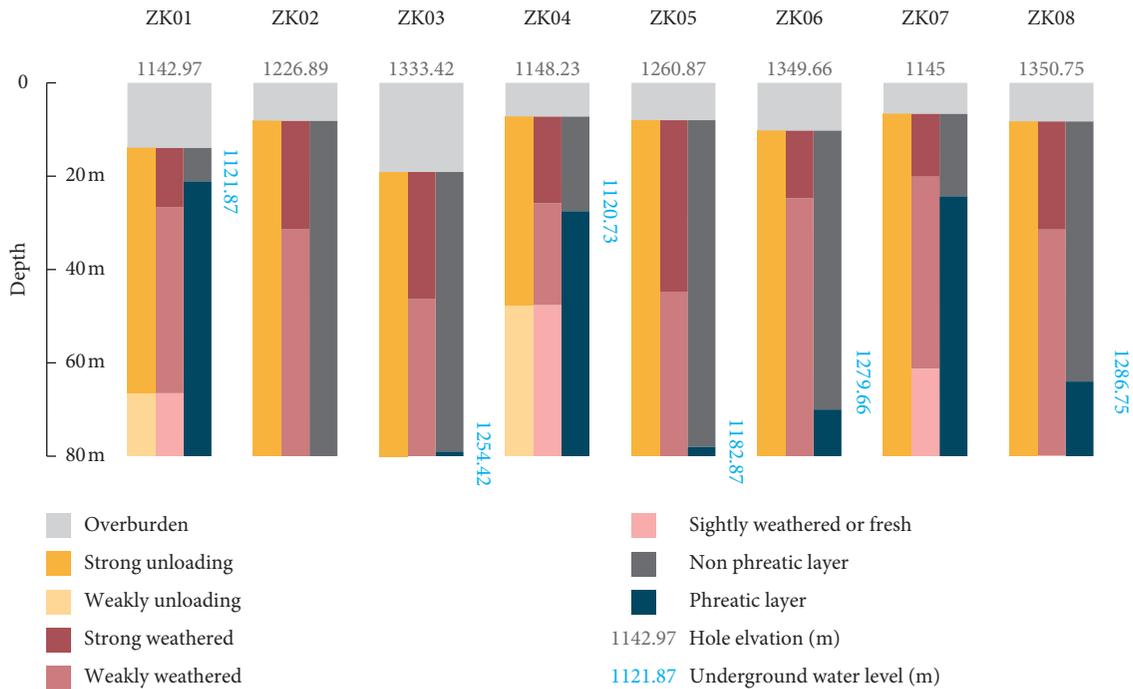
FIGURE 6: Vertical sequence of the unloading level and the weathered level, and the distribution of the underground water level in site boreholes.

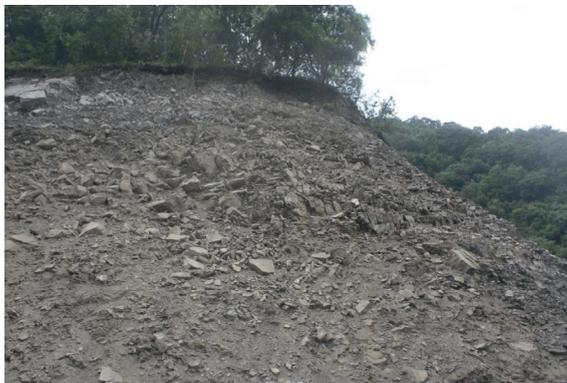
Disintegration and the relaxing deformation zone are mainly distributed in the shallow part of the Zhengjiaping slope at a depth of 6.6–46.25 m. As shown in Figure 7, rock stratum has a dip angle  $0^{\circ}$ – $20^{\circ}$ , partly gently slope out. The deformation is characterized by strong tensile fracture. The

fragmented relaxed rock mass has evidently internal hollow parts, which are filled with large pieces of block broken stones and breccia rock cuttings.

FIGURE 7: Photograph of the toppling deformation characteristics in the disintegration and relaxation of the deformation zone.

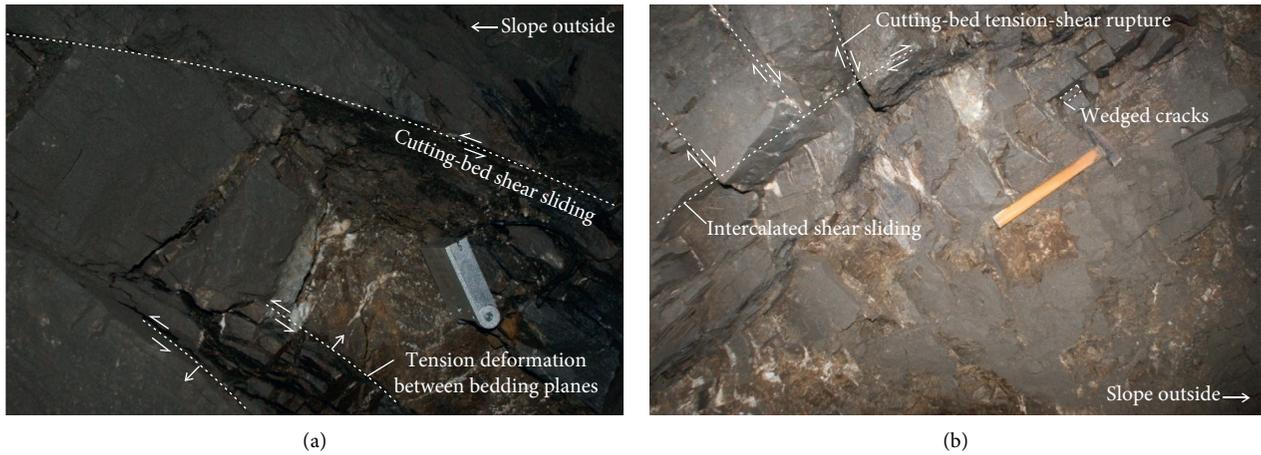
The distribution depths of the strong toppling deformation zone range from 6.6–46.25 m. As shown in Figure 8(a), the stratified rock mass is characterized by strong tensile deformation between the bedding planes, and the extension-shear fracture surfaces of the cutting beds are commonly developed. The deformation behavior of the rocks in the strong toppling deformation zone is complex and can be summarized into three basic failure modes: intercalated shear sliding, discontinuous tensile fracture, and cut-bed tensile sliding (Figure 9). Intercalated shear sliding is a common phenomenon in schistosity planes and weak rock belts. Stratified rock masses with large dip angles have a tendency to dip out of the slope under bending moments from ground stresses, similar to cantilever beams. The flexural toppling deformations have a process of gradual development from the shallow part to the deep part, and the higher elevation causes the more intense deformation. In the local stratigraphy, tensile deformation occurs between the bedding planes under the high flexural toppling

deformation. As flexural toppling deformation develops, the level of toppling of the stratified rock mass is increasingly enhanced and the tensile stresses applied to the stratified rock mass are increasingly expanded. If the increased tensile stress reaches or exceeds the tensile strength, tensile fractures occur in the stratified rock mass accompanied by intercalated shear dislocations, resulting in discontinuous tensile fractures. When the development of toppling deformation is sufficient, the inclination of the deformed section changes considerably, the ground stress bending moment increases greatly, and the shear effect is greatly amplified. Under the joint action of shear and tension, cutting-bed tension sliding occurred on the deformed section.

FIGURE 8: Photographs of the toppling deformation characteristics in the strong toppling deformation zone: (a) view of the cutting-bed shearing sliding and tension deformation between bedding planes and (b) view of intercalated shearing sliding.

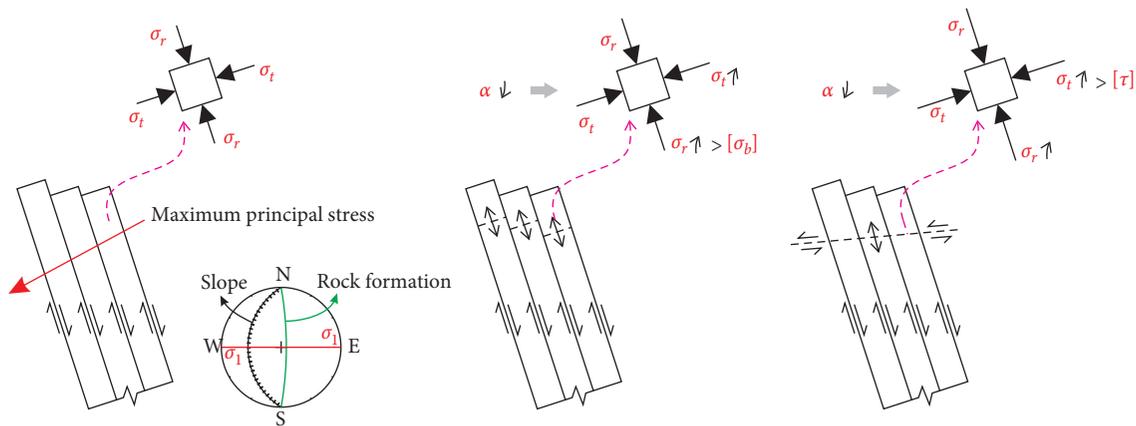
FIGURE 9: Schematic diagram of evolution process of the toppling deformation in the Zhengjiaping slope.

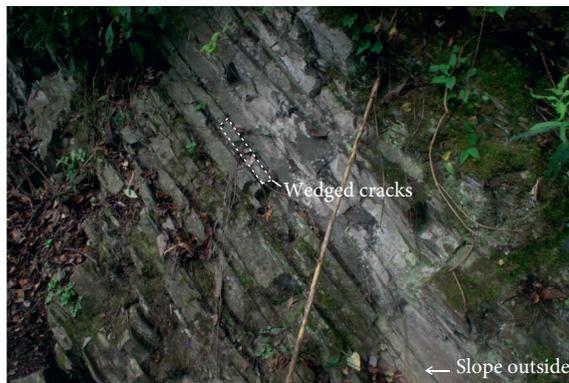
FIGURE 10: Photograph of the toppling deformation characteristics in the weak toppling deformation zone.

Figures 8(b) and 10, the existence of intercalated shear sliding and discontinuous tensile rupture rebuild the morphology of the original intact bedrock and form wedged

distributed in the deep part of the Zhengjiaping slope, with a depth more than 38.4 m. This zone is characterized by the weak toppled level and slightly intercalated shear sliding with a dip direction of 40°–60°. Because of the weak extension between bedding planes and the rare development of extension-shear fracture surfaces cutting the rock stratum, the stratified rock mass has a few tensile ruptures in the weak toppling deformation zone.

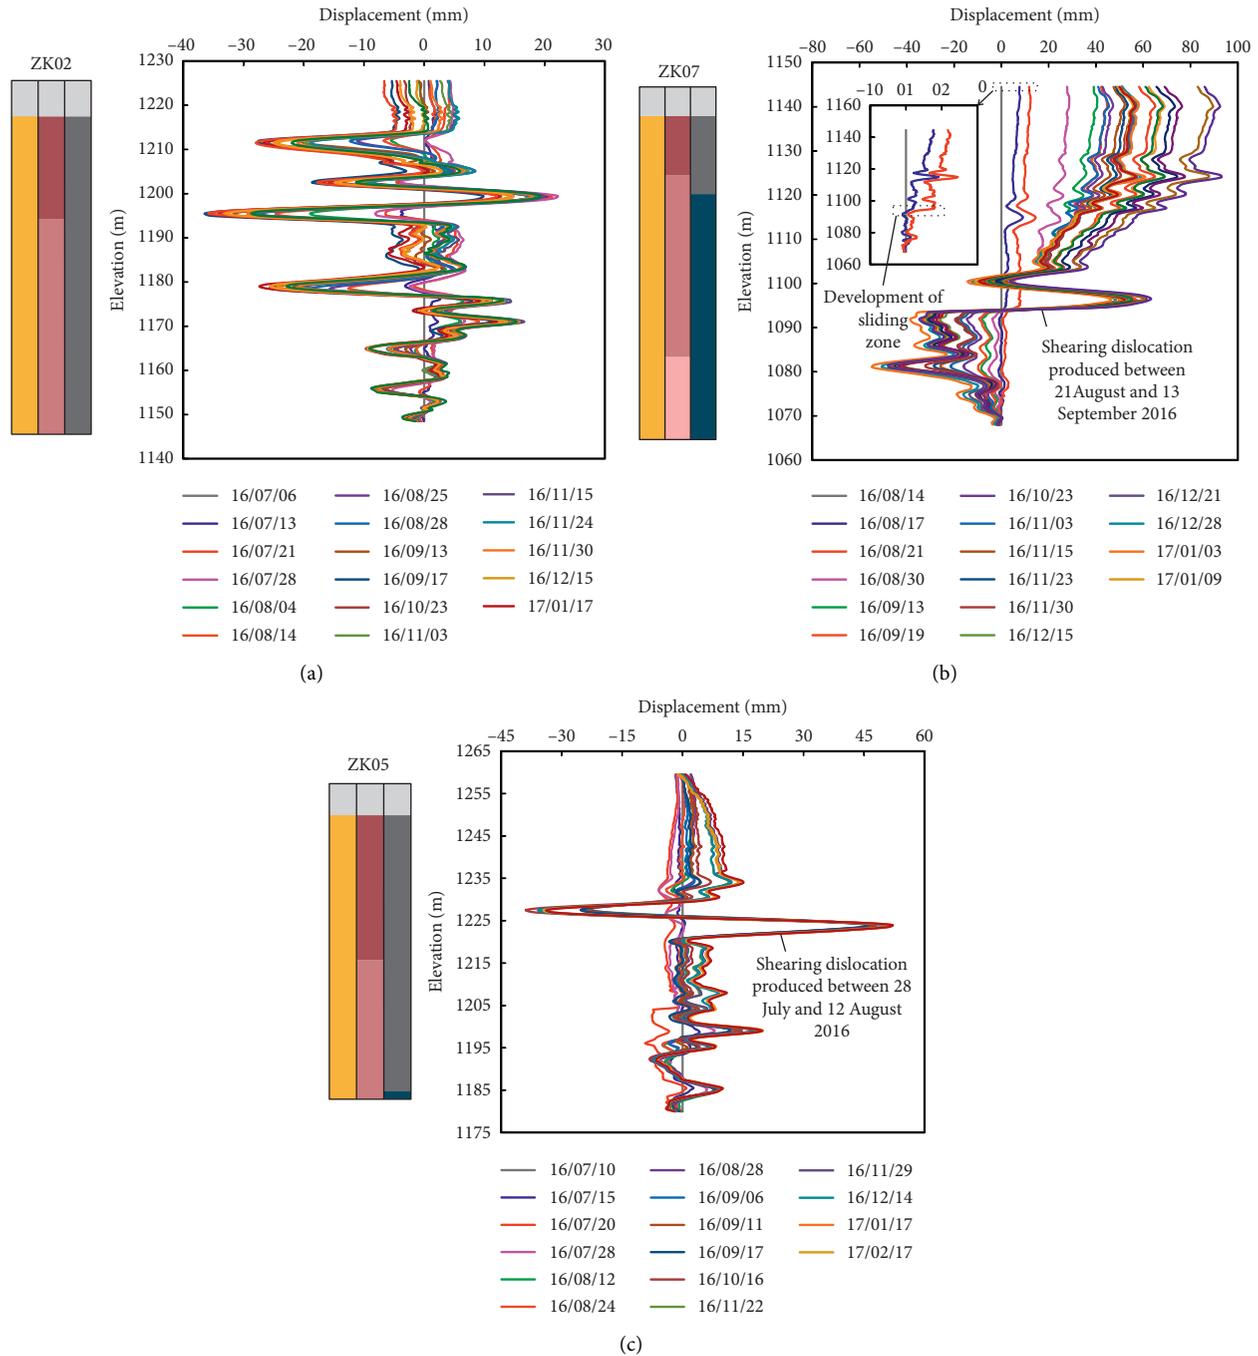
4.2. Deep Deformation. As shown in Figure 11, the data obtained by borehole inclinometers show lateral displacements of monitoring points for approximately half a year. As shown in Figure 4, the borehole inclinometers IN01 and IN03 were installed in Zone II, and IN02 was installed in Zone I. The evident deformation zone has a sliding surface of development with a depth of approximately 50 m on IN02 and several shearing dislocation zones of development on both borehole inclinometers. There are differences in the timing, number, and development of shear deformation

FIGURE 11: Time evolution of the lateral displacements for different monitoring points of the borehole inclinometer: (a) IN01; (b) IN02; and (c) IN03.

zones at the three borehole locations. The records of the borehole inclinometers indicate that the rock mass of Zone I actually participates in the sliding deformation. However, as can be seen in Table 3, the rock mass below 80 m depth is identified as a weak toppling deformation zone or a normal rock stratum zone, which makes it difficult to produce a sliding surface zone. Therefore, it is certain that the displacement of Zone I is characterized by a combination of sliding and toppling deformation processes that need to be focused on.

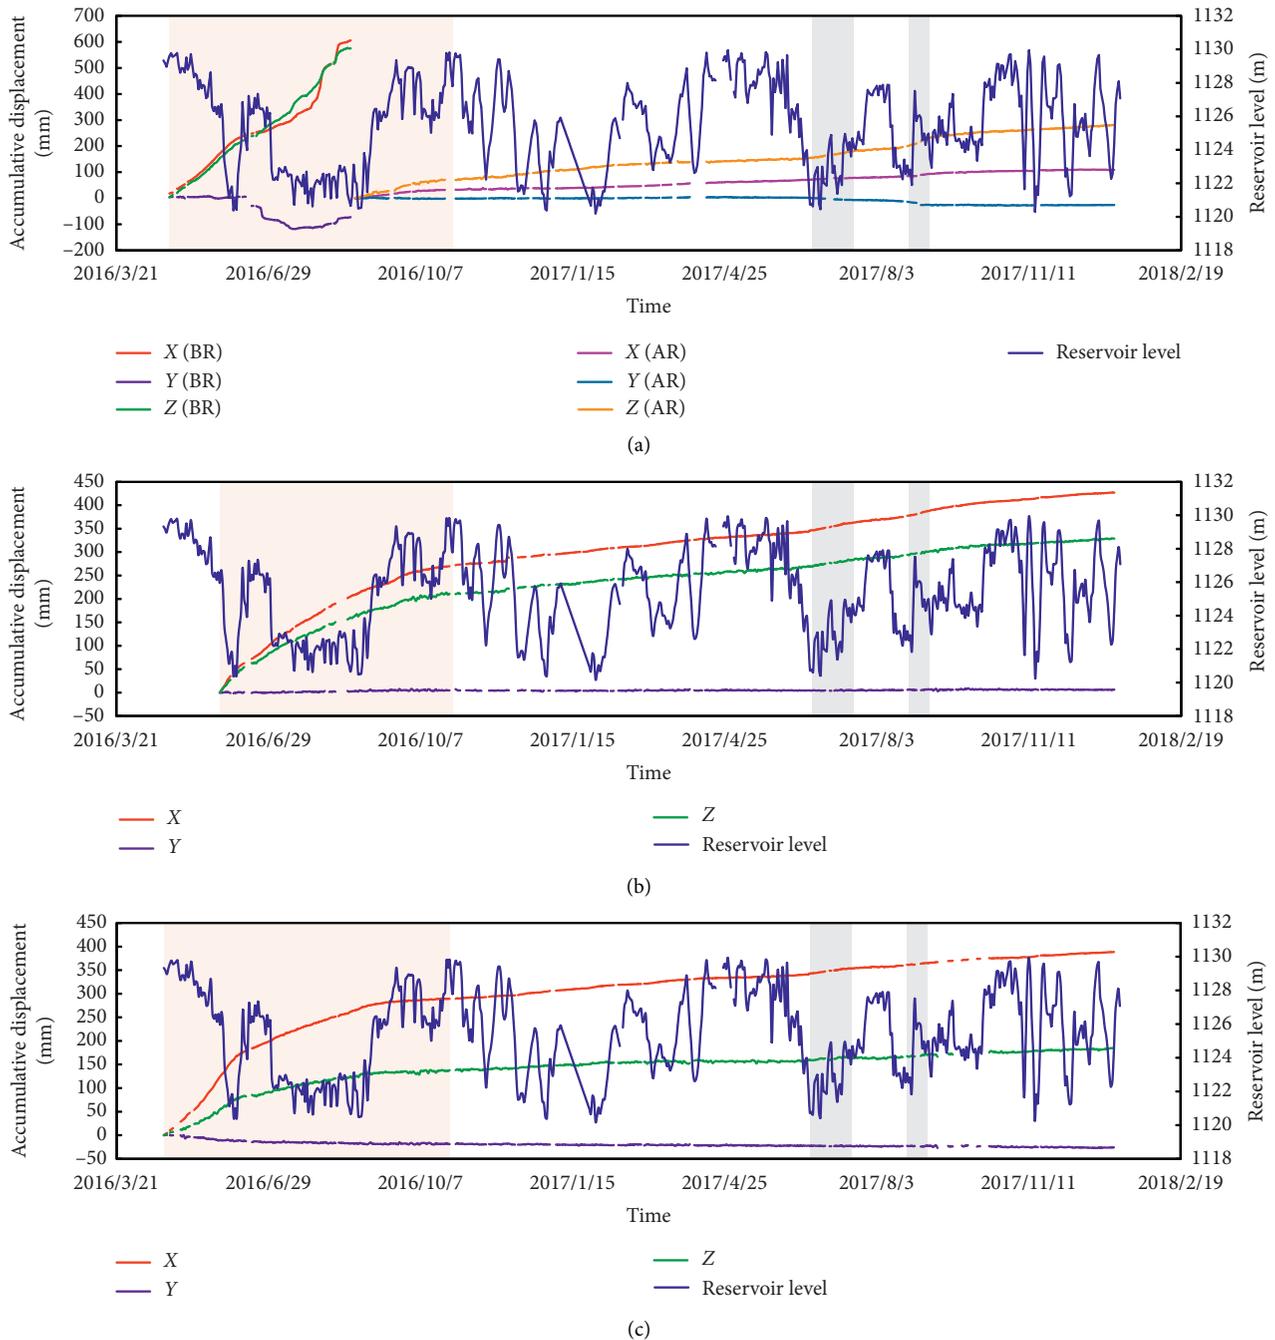
**4.3. Slope Deformation.** As shown in Figure 12, the monitoring data obtained by the GNSS have a record of accumulative displacements of monitoring points for approximately one and a half years. The preconstruction geological survey overlooked the potential of reservoir landslides in the Zhengjiaping slope. When the monitoring displacement began on 21 April 2016, it was approximately one year from the beginning of impoundment, and creep/sliding deformations had already been occurring in the Zhengjiaping slope. Due to the late recording of the initial

FIGURE 12: Time evolution of accumulative displacements in different directions for different monitoring points of GNSS in Zone I: (a) TP01; (b) TP02; and (c) TP03.

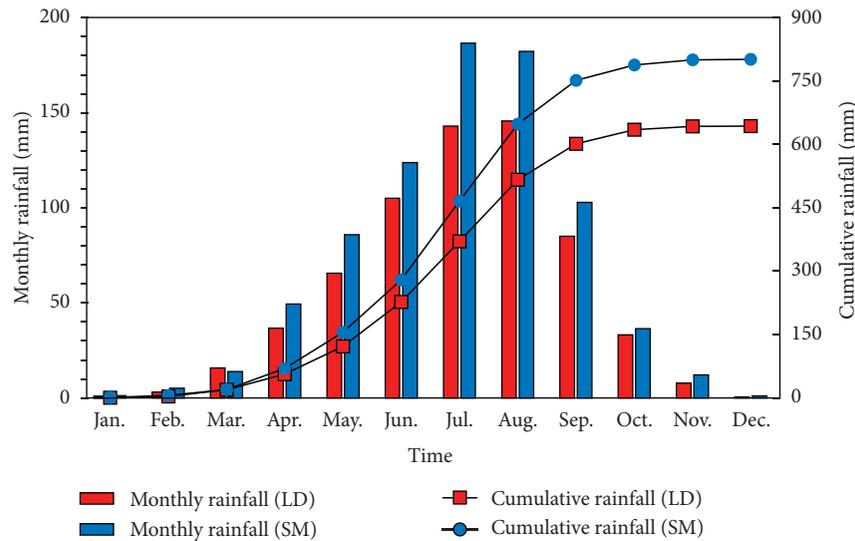
FIGURE 13: Precipitation records from two meteorological stations near the Dagangshan Hydropower Station (the data are mean annual values).

meteorological stations near the Dagangshan Hydropower Station. The Luding Meteorological Station has a distance of approximately 72 km from the upstream of the dam site and the Shimian Meteorological Station has a distance of approximately 40 km from the downstream of the dam site. As shown in Figure 13, the rainfall is mainly focused on a period from June to September, which accounts for 70–80% of the year's precipitation. It can be used as a reference for the rainfall characters for this case. The two mutations of displacement growths both happened in the flood season, that is, from June to September.

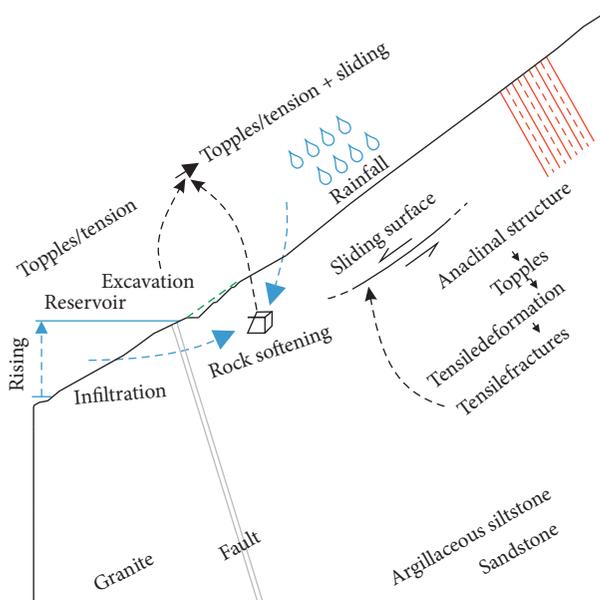
FIGURE 14: Mechanism of deformation development in the Zhengjiaping slope.

As shown in Figure 14, the sliding deformation on the Zhengjiaping slope is an integration of many adverse factors. The hydrological activities, lithology, tectonic activities, and artificial disturbances, etc., make great contributions to the formation of the sliding mass and the sliding surface zone, for which a major performance assists in generating fragmented rock mass in the shallow part. The Zhengjiaping slope has geological settings that are prone to toppling deformation under long-term maximum principal stress parallel to the slope surface. The main contents of the lithology in the sliding mass are sandstone and shale, which have low strength and lamellar structures with a large density of bedding surfaces, which aggravates the development of toppling deformation. Lithology is not the direct reason for the observed deformation after impoundment but has a specific lithologic distribution that ignores the potential for reservoir landslides in the early investigation. As shown in Figure 3(a), the region over the F1 Fault is characterized by argillaceous siltstone with intercalations of sandstone and carbonaceous shale, and the region below the F1 Fault is characterized by granite. The argillaceous siltstone, sandstone, and carbonaceous shale are different types of cementitious sedimentary rock. As shown in Table 4, the argillaceous siltstone and sandstone undergo a decrease in strength when they are saturated. When the water level rises significantly, the large volume of rock is immersed in the

reservoir water, which in turn leads to a decrease in the shear capacity of the slope and a faster increase in displacement.
