## Research Article

# Experimental Study and Numerical Simulation on Mechanical Properties of the Bottom Plate in the Assembled Composite Slab with Additional Steel Trusses

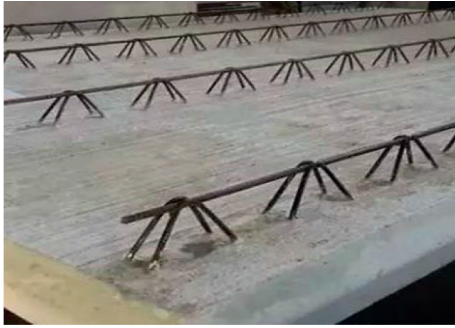
The precast bottom plate is produced in the factory, transported to the construction site for installation, and then used as the formwork for casting the upper concrete so that the composite slab is formed, as shown in Figure 1.

FIGURE 1: The composite slab with steel trusses.

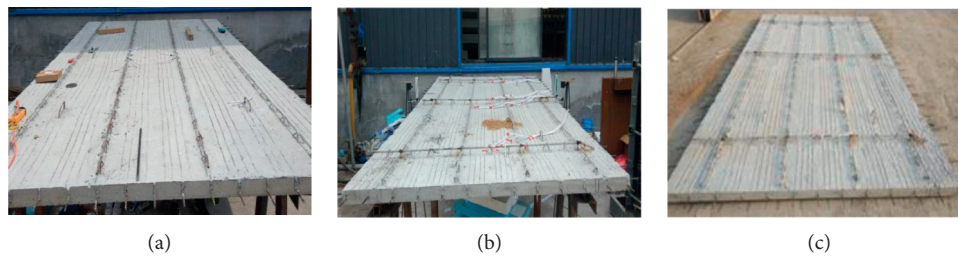
**2.1. Test Preparation and Process.** Three bottom plates with different forms were made by experiment to study the mechanical properties and cracking characteristics contrastively, which serial numbers are DHB1, DHB2, and DHB3. The first plate, DHB1, is the bottom plate of B90 composite slab with one-way steel trusses, which is commonly used in the design atlas “reinforced concrete composite slab with steel trusses” (15G366-1). On the basis of DHB1, the second plate DHB2 is added with three additional transverse steel trusses to form a new type of plate with two-way steel trusses. The thickness of the third plate DHB3 is reduced by 20 mm on the basis of DHB2. The dimensions of the three plates are all 4200 mm × 2400 mm, the thickness of DHB1 and DHB2 is 60 mm, and the thickness of DHB3 is 40 mm. The longitudinal and transverse reinforcement in the bottom plate are HRB400 with 8 mm diameter per 200 mm, the upper chord member of the longitudinal trusses is HRB400 with 10 mm diameter, the lower chord member is HRB400 with 8 mm diameter, and the web member is HPB235 with 6 mm diameter. The length of the additional transverse steel trusses is 2300 mm, the upper chord member is HRB400, with 10 mm diameter, and the web member is HPB235 with 6 mm diameter, with no lower chord. C25 concrete is used in the plates, and the thickness of the concrete cover is 15 mm. The specific sizes of the three plates, DHB1, DHB2, and DHB3, are shown in Table 1, and the test plates are shown in Figure 3.

FIGURE 3: The test plates. (a) DHB1. (b) DHB2. (c) DHB3.

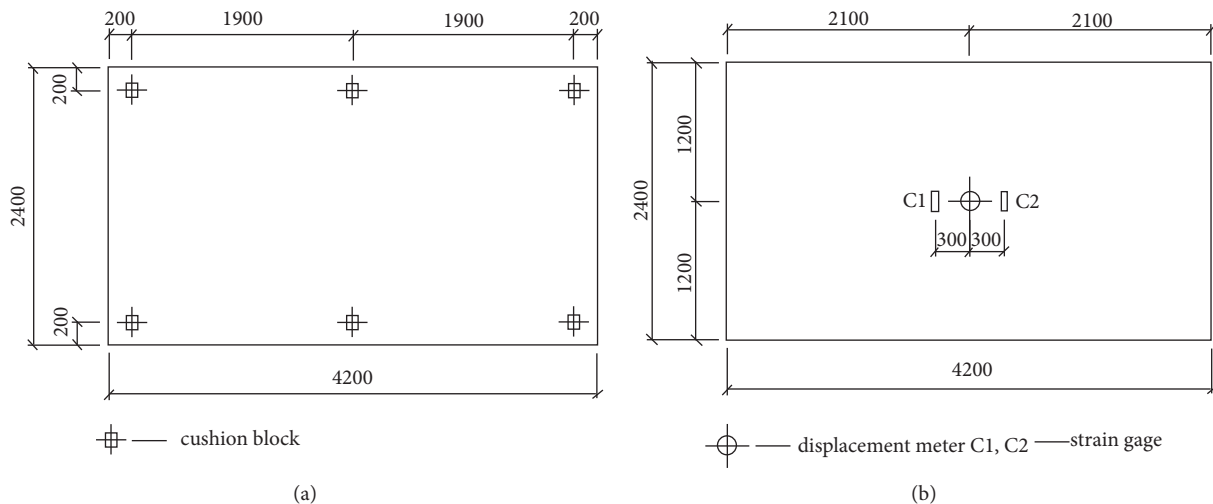
To be consistent with the actual engineering, the bottom of each plate is supported by 6 points. A wooden cushion block is placed at each point. The block size is 200 mm × 100 mm × 100 mm. The distance between the block and the edge of the plate is 200 mm, and the spacing of the blocks is 1900 mm, as shown in Figure 4. The positions of the displacement meter and strain gauge are also shown in Figure 4.

FIGURE 4: The positions of (a) cushion block position (mm) and (b) displacement meter and strain gage position (mm).

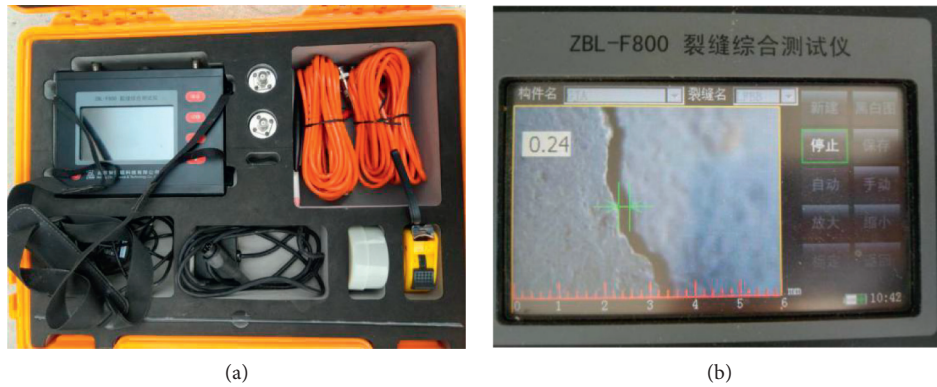
The load was applied step by step with an increment of 0.12 kN/m<sup>2</sup>, and a load holding time of 5 min for each level. The midspan deflection was recorded with the load increasing, and the development of cracks in the bottom of the plates was observed and marked. The ZBL-F800 comprehensive crack tester was used for observing cracks, with a range of 0–6 mm and an accuracy of ±0.01 mm, as shown in Figure 5.

FIGURE 5: Comprehensive crack tester. (a) Tester. (b) Testing process.

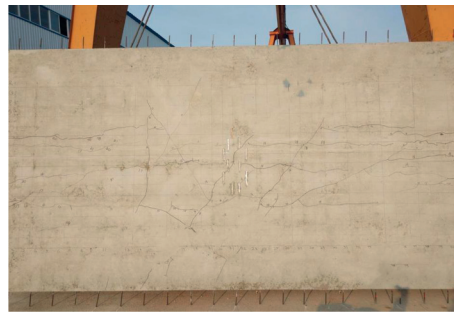
For plate DHB1, when loading to level 5 (0.6 kN/m<sup>2</sup>), tiny cracks began to appear in the bottom of the plate, with the length of about 600 mm and the width of 0.02 mm. When loading up to level 12 (1.44 kN/m<sup>2</sup>), the cracks on the edge of the bottom were connected with the midspan cracks to form continuous cracks. When loading to level 15 (1.8 kN/m<sup>2</sup>), a 0.2 mm crack appeared in midspan; it is considered to reach the serviceability limit state, and the plate cracks of DHB1 are shown in Figure 6.

FIGURE 6: The plate cracks of DHB1.

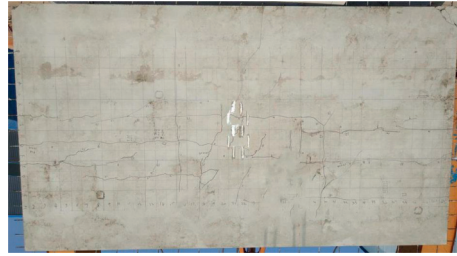
For plate DHB2, when loading to level 12 (1.44 kN/m<sup>2</sup>), tiny cracks began to appear in the bottom of the plate, with the length of about 500 mm and the width of 0.02 mm. When loading up to level 15 (1.8 kN/m<sup>2</sup>), cracks appeared on both left and right sides of the plate. When loading to level 17 (2.04 kN/m<sup>2</sup>), long cracks appeared in midspan, with about 1100 mm in length. When loading to level 20 (2.4 kN/m<sup>2</sup>), a 0.2 mm crack appeared in midspan; it is considered to reach the serviceability limit state, and the plate cracks of DHB2 are shown in Figure 7.

FIGURE 7: The plate cracks of DHB2.

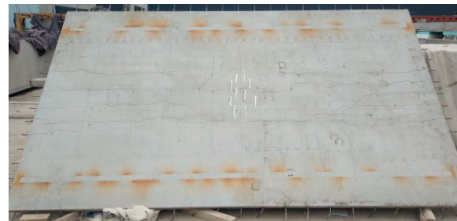
For plate DHB3, when loading to level 5 (0.6 kN/m<sup>2</sup>), tiny cracks began to appear in the bottom of the plate, with the length of about 300 mm and the width of 0.01 mm. When loading up to level 7 (0.84 kN/m<sup>2</sup>), long cracks appeared in midspan. When loading up to level 12 (1.44 kN/m<sup>2</sup>), the cracks on the edge of the bottom were connected with the midspan cracks to form continuous cracks. When loading to level 14 (1.68 kN/m<sup>2</sup>), a 0.2 mm crack appeared in midspan; it is considered to reach the serviceability limit state, and the plate cracks of DHB3 are shown in Figure 8.

FIGURE 8: The plate cracks of DHB3.

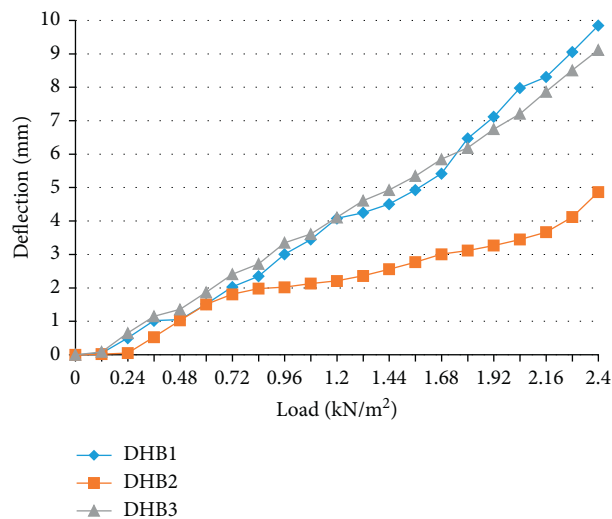
Figure 9 shows the load-deflection contrastive curves of DHB1, DHB2, and DHB3.

It can be seen from the curves in Figure 9 that the development trend of midspan deflection is consistent in the three plates.

At the initial stage of loading, the deflection varied with the load slightly; then, with further increasing of the load, the deflection increased significantly. As shown in Figure 9, under the same load, the deflection values of DHB3 with two-way steel trusses 40 mm thickness are very similar to those of DHB1 with one-way steel trusses 60 mm thickness, while those of DHB2 with two-way steel trusses 60 mm thickness is significantly smaller. The deflection value of DHB2 is about 50% of that of the other two plates in its serviceability limit state. It is further indicated that the setting of the additional transverse steel trusses can significantly improve the stiffness of the plate.

FIGURE 9: The load-deflection contrastive curves of DHB1, DHB2, and DHB3.

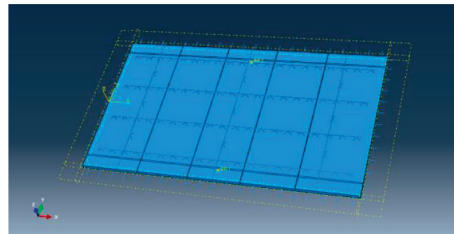
The bottom plate model is established and meshing is carried out. The mesh size has a certain influence on the calculation accuracy, so the mesh division of the plate is as dense as possible to maintain high calculation accuracy. The entire floor is divided into 14,000 units; the finite element model of the two-way steel trusses plate is shown in Figure 10 (the one-way steel trusses' plate has only longitudinal steel trusses).

FIGURE 10: Finite element model of the two-way steel trusses' plate.

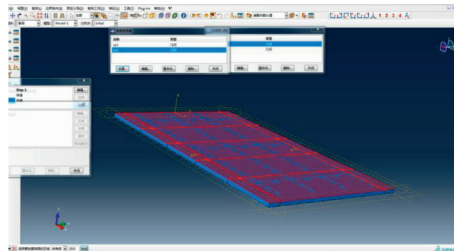
The six points of support were set according to the test conditions, and the finite element model after loading is shown in Figure 11.

FIGURE 11: Loading model.

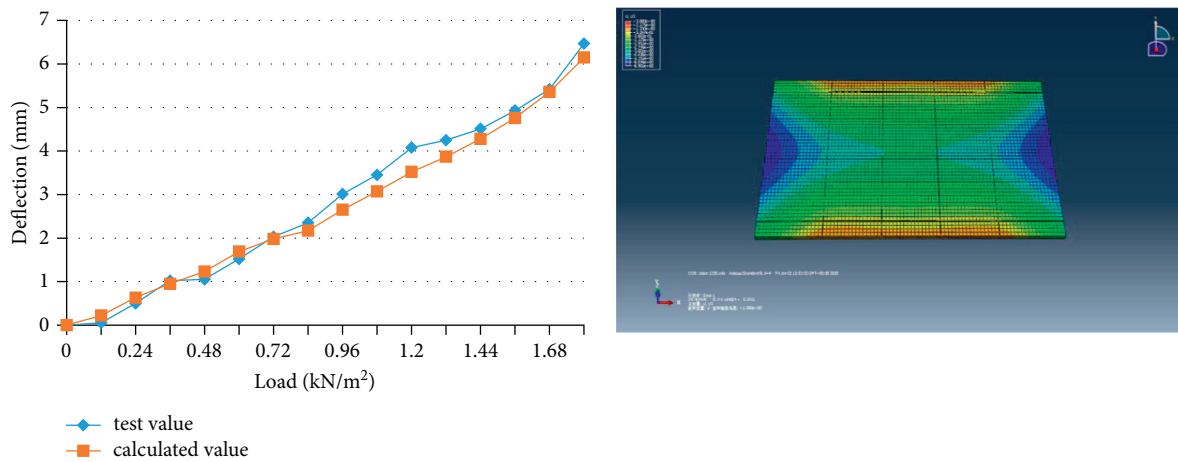
Load is applied step by step, the load-deflection curves comparing the calculated values with the test values and the cloud chart of the three plates DHB1, DHB2, and DHB3 are shown in Figures 12–14, respectively.

By comparing the three plates with different trusses forms and thicknesses, it can be found that the calculated values of the deflection have the same development trend with the experimental values, and the two results are in good agreement.

FIGURE 12: The deflection of DHB1. (a) Load-deflection curves. (b) Cloud chart.

Under the same load, the calculated value of deflection is relatively small because there is a slip phenomenon of reinforcement in the test, which is not considered in the process of calculation so that the calculated value is smaller than the experimental value.

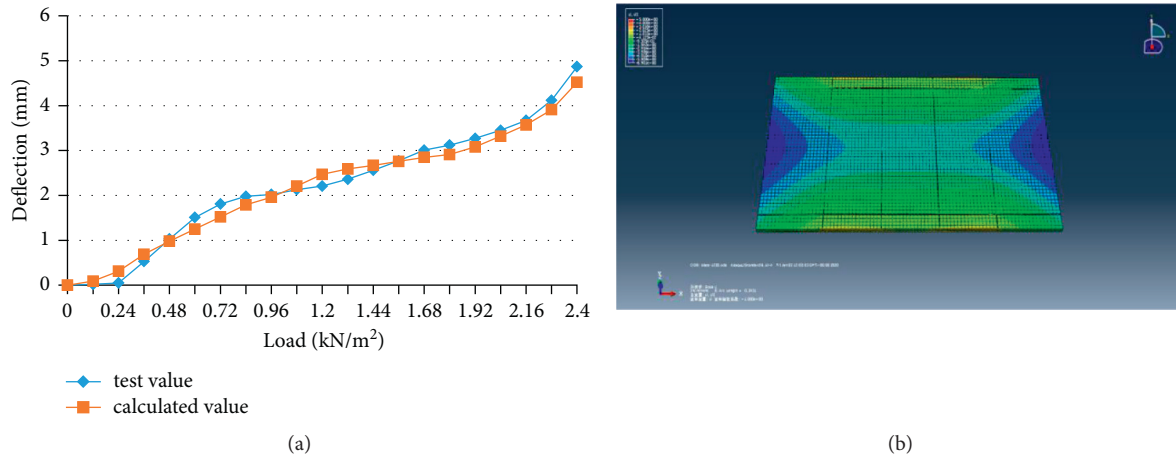
FIGURE 13: The deflection of DHB2. (a) Load-deflection curves. (b) Cloud chart.

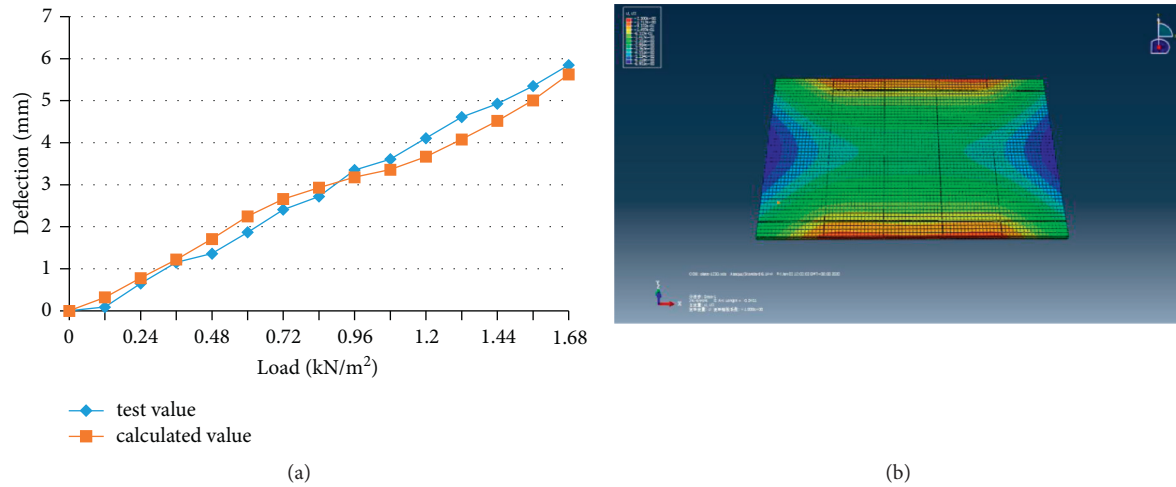
FIGURE 14: The deflection of DHB3. (a) Load-deflection curves. (b) Cloud chart.
