## Research Article

# An Experimental Study of the Impact Mechanical Properties of RC Beams following Replacements of Stainless Steel Reinforcements of Equal Strength

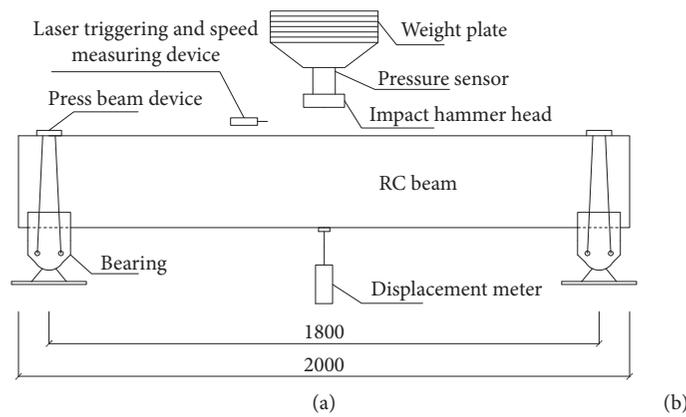
FIGURE 2: Drop hammer impact test device (mm).

**2.2. Experimental Devices and Data Collection.** The loading device which was used in this study's experiment was an ultrahigh heavy drop hammer impact test machine, as detailed in Figure 2. The beams were placed on fixed hinge supports, and the drop hammer impacted the beams along the vertical guide rail with an approximated free fall motion. The mass of the drop hammer could be adjusted using a counterweight steel plate. The drop hammer head was a cylindrical flat hammer head with a diameter of 200 mm. A force sensor was built into the hammer head for the purpose of measuring

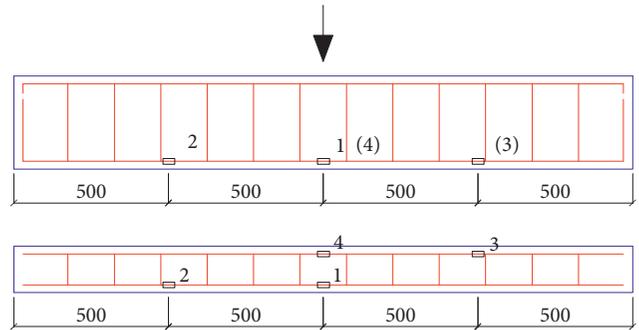
FIGURE 7: Distribution of the steel strain gauge.

In this experimental study, in order to analyze the deformations of the tensioned reinforcements in the beams under impact conditions, a resistance strain gauge was used to measure the strain of the reinforcements. The distribution of the measuring points is shown in Figure 7. The strain gauge which was utilized in this study's test processes was produced by the Zhejiang Huangyan Testing Apparatus Factory. Also, the type of steel strain gauge used in the tests was BX120-3AA, which had a grid length of  $3 \times 2$  mm, a resistance value of  $119.9 \pm 0.1 \Omega$ , and a sensitivity coefficient

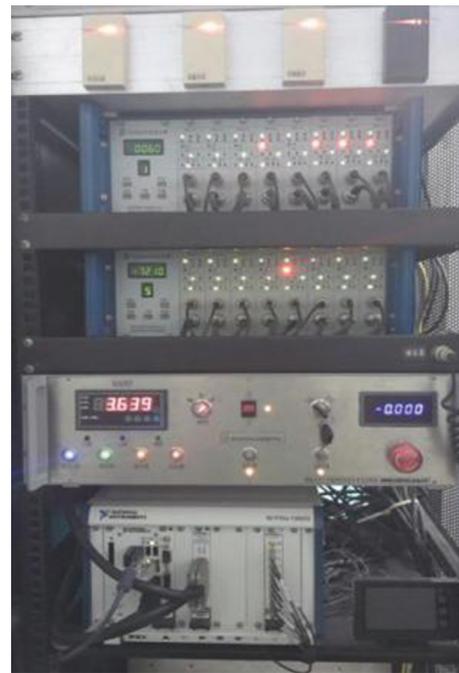
FIGURE 8: Data collection system.

had been produced by the National Instruments Co. Ltd. As can be seen in Figure 8, all of the data signals obtained from the various devices, such as the resistance strain gauge, pull rod-type displacement gauge, and pressure sensor, were voltage signals during the tests. These were collected into LabVIEW SignalExpress graphic interactive software using the aforementioned NIPXIe-1006Q dynamic acquisition

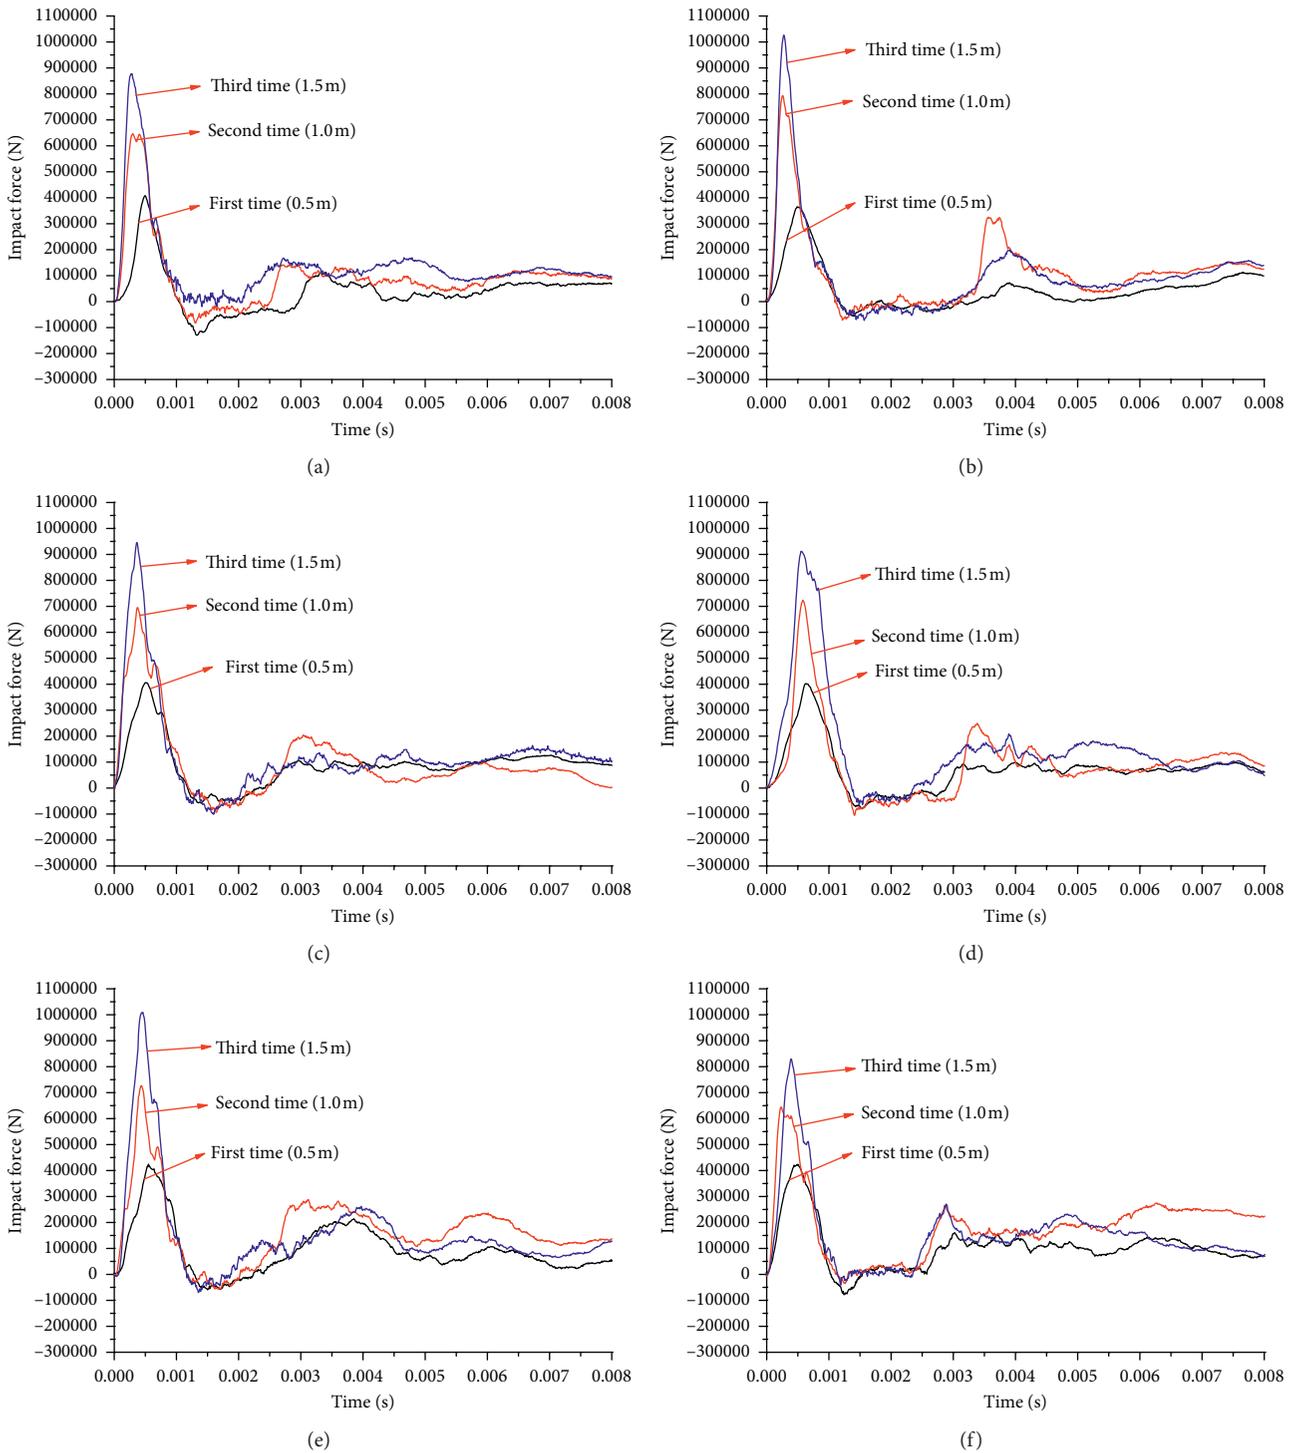
As can be seen in Figure 9, the impact force time history curves of the ordinary reinforced beams and stainless steel-reinforced beams had displayed consistent changing trend during each impact. That is to say, the drop hammer had collided with the beams and had then undergone postpeak oscillations which tended toward the horizontal. The durations of the subsequent wave crest formations were observed to be approximately the same (approximately 1 ms).

FIGURE 9: Time history curves of the impact forces. Group A: (a) L18 and (b) S12. Group B: (c) L20 and (d) S16. Group C: (e) L25 and (f) S20.

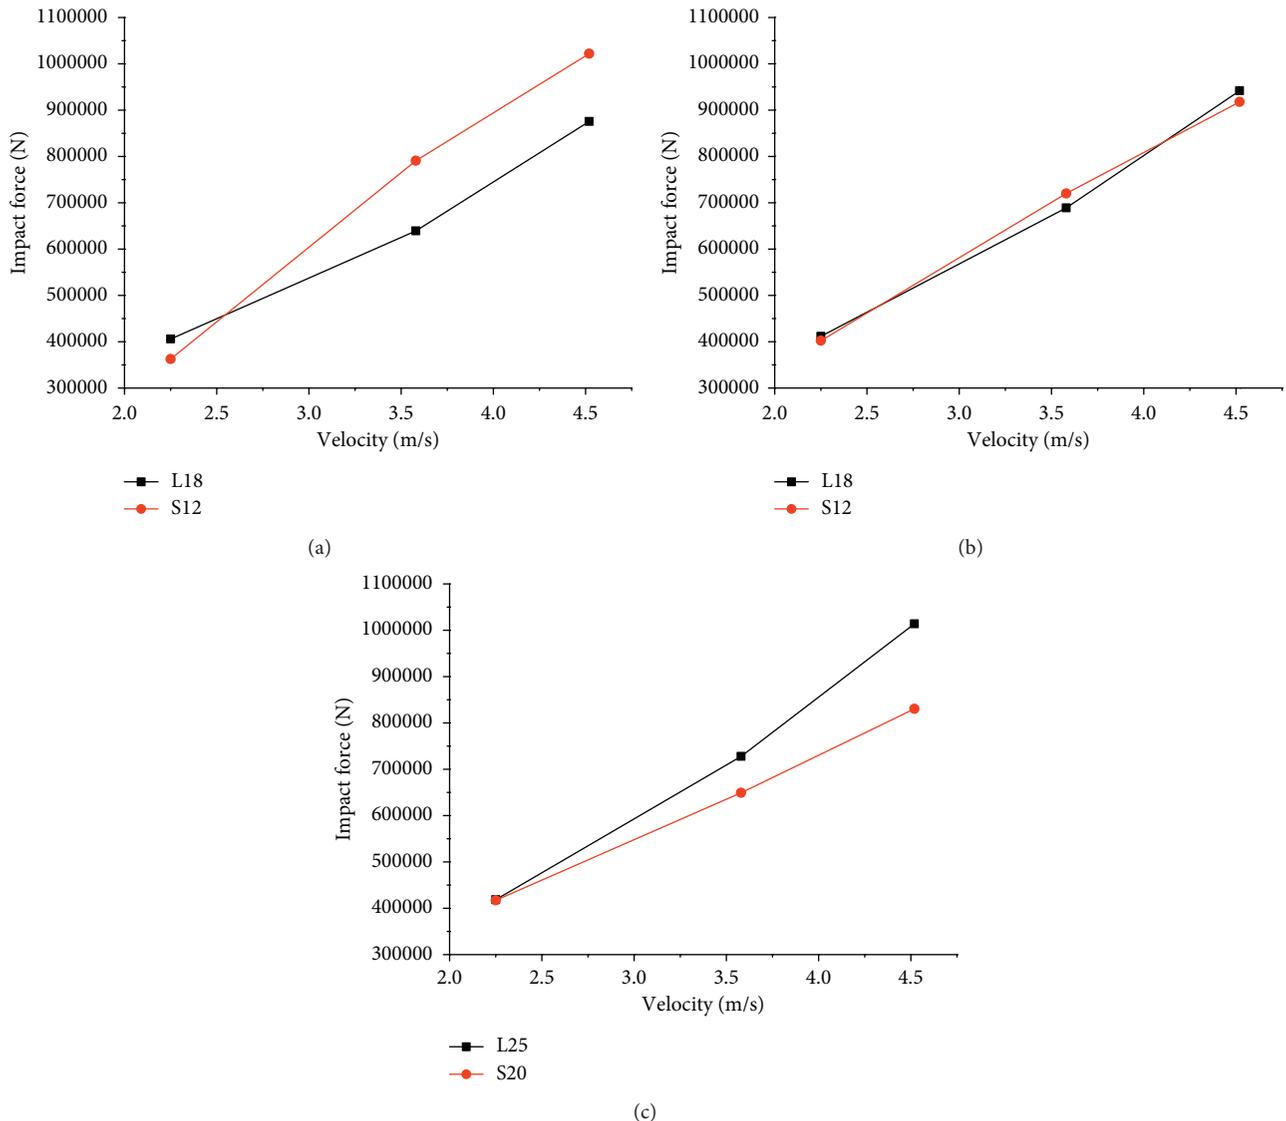
As shown in Figure 10, the peak impact forces had increased with the increases in the impact energy for each of the beam specimens. For example, in regard to Group A, the peak impact forces of the two beams were observed to be similar to each other at the first impact, with a difference of 10.75%. This was determined to be due to the fact that before the beams had become damaged, the concrete had played a major role and the participation of the steel bars was not high. However, during the second and third impacts, the concrete had undergone cracking, and the reinforced bars had played a major role. During the second and third impacts, the peak impact forces of the S12 beam were 16.70% and 23.64% higher than those of the L18 beam, respectively, which indicated that the overall stiffness of the S12 beam was relatively large.

For Group B, the differences in the peak impact forces between the ordinary reinforced concrete beams and the stainless steel-reinforced concrete beams following the equal strength replacements were found to be less than 5%. These results indicated that the equal strength replacements of the stainless steel reinforcements had less influence on the overall stiffnesses of the beams.

For Group C, the peak impact forces of the two beams were observed to be similar at the first impact. The peak impact forces of the L25 beam were 5.83% and 18.10% higher than those of the S20 beam at the second and third impact, respectively. These results showed that with the increases in the impact velocities, the stiffness losses of the stainless steel-reinforced concrete beams of equal strength replacements had been faster.

FIGURE 10: Peak impact forces and velocity curves. (a) Group A. (b) Group B. (c) Group C.

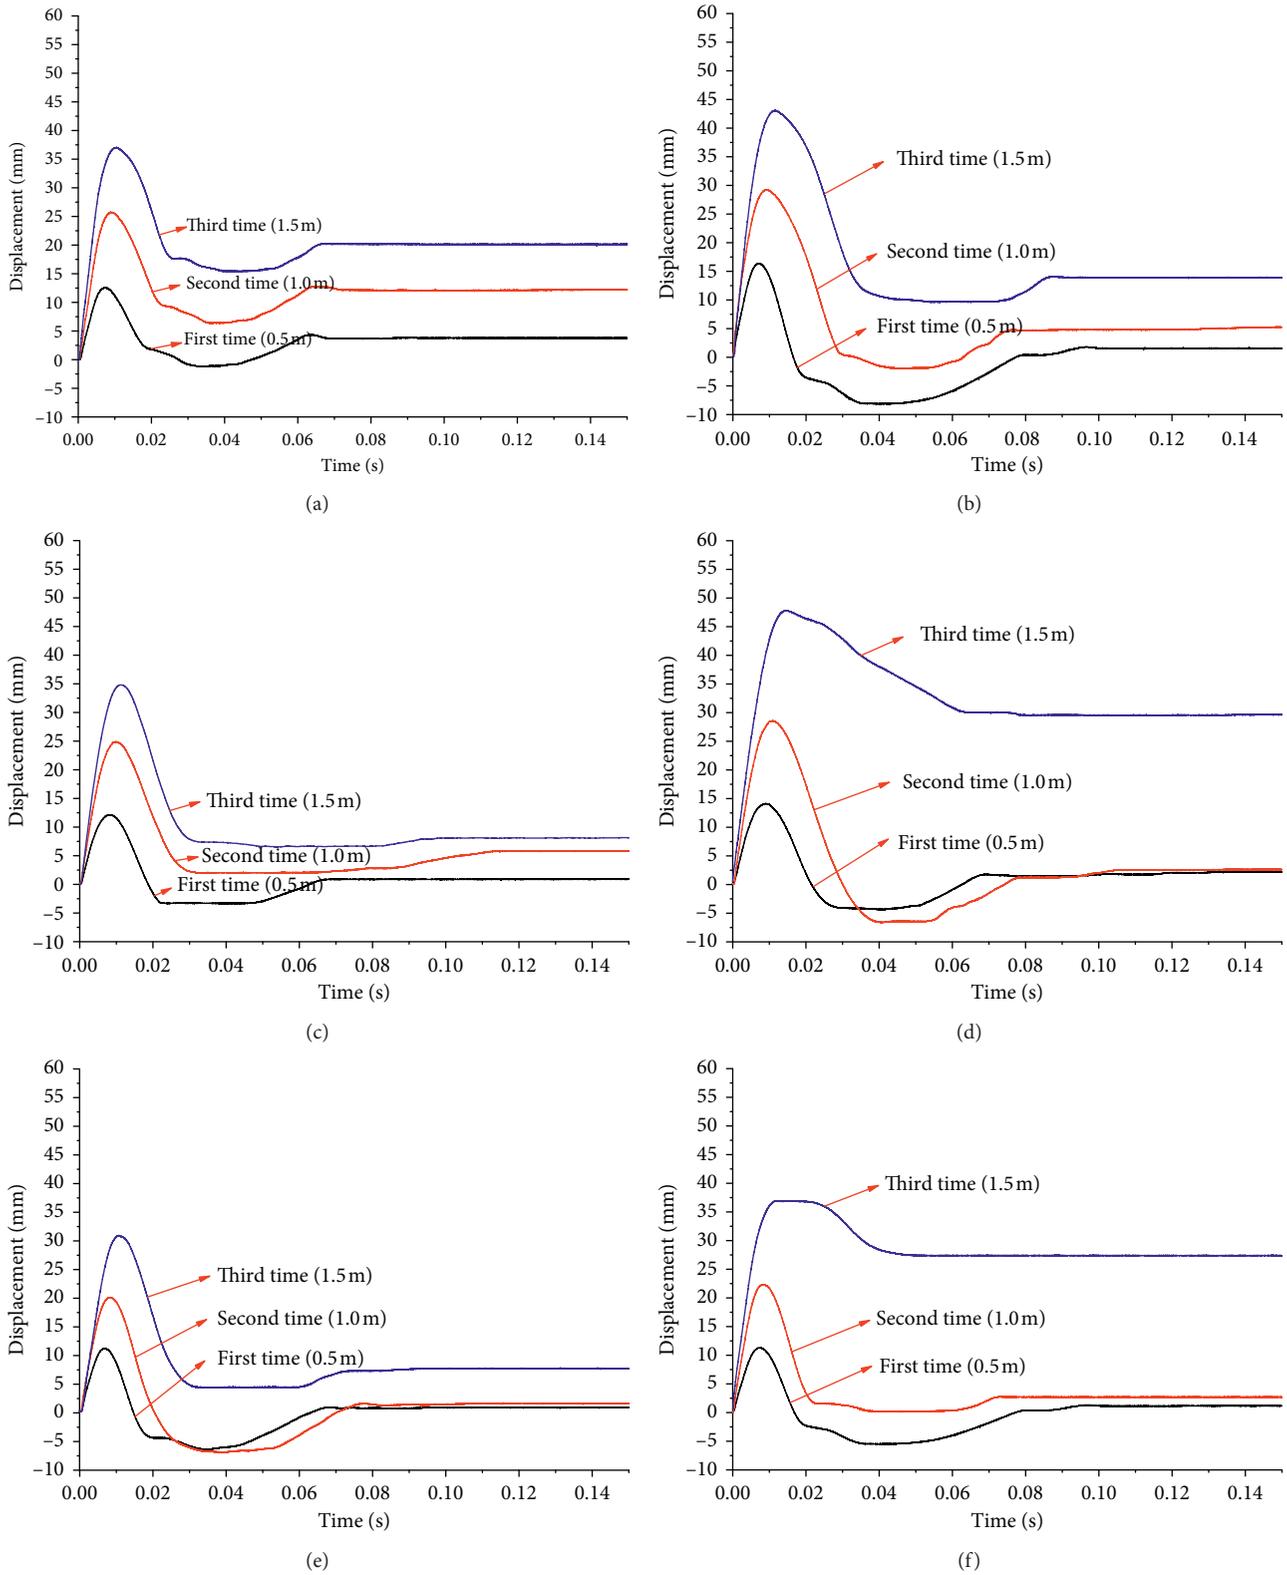
As detailed in Figure 11, the change trends of the displacement time history curves of the ordinary steel bar beams and stainless steel-reinforced beams were consistent during each of the impacts. In other words, the drop hammer had collided with the beam; the midspan displacements had increased and then had dropped after reaching the peak values resulting in main wave crest formations. Then, the displacements had continued to decrease (some of which had reached negative values) and had risen again after reaching the minimum values, resulting in wave trough formations. It was observed that when the displacements had risen to a certain value, the curves had tended to be horizontal, characterized in part by residual deformations. The durations of the main wave crests were approximately 15 ms to 30 ms, which were much longer than the duration of 1 ms observed for the wave crests of the impact forces. These findings suggested that the overall deformations of the beams were just beginning after the impacts. At those times, the beams were in stages of overall responses, and the stress had been transferred along the entire lengths of the beams. Therefore, the impact energy had been consumed by the entire beams through deformations. The durations of the main peak crests were determined to be related to the impact energy. It was observed that for the same beam, the higher the impact energy was, the larger the displacement would be, and the longer the durations of the main wave peaks would be.

In regard to Group A, the peak durations of the displacement time history curves of beams L18 and S12 were observed to be similar. The residual deformations of the two beams after each impact had increased with the increases in the impact energy. The residual deformations of the stainless steel-reinforced S12 beam of equal strength replacements were determined to be 43.12% lower than those of the L18 beam. Therefore, the results indicated that replacement of ordinary steel reinforcements with stainless steel reinforcements of equal strength could effectively improve the elastic resilience of the beams, as well as reduce the residual deformations.

For Group B, the residual deformations of beam L20 were observed to gradually increase with the increases in the impact energy, which approximately ranged from 1 to 10 mm. It was found that for the S16 beam, the elastic

resilience abilities were better and the displacements had basically recovered after the first and second impacts. However, the residual deformations had suddenly increased after the third impact, which was approximately 33 mm.

It was observed that for Group C, the elastic resilience abilities of the L25 and S20 beams were better, and the displacements had basically been restored following the first and second impacts. However, after the third impact, the

residual deformations of the L25 beam were observed to be approximately 7.5 mm, while those of the S20 beam had suddenly increased to 27.5 mm.

FIGURE 11: Time history curve of the displacements. Group A (a) L18 and (b) S12. Group B: (c) L20 and (d) S16. Group C: (e) L25 and (f) S20.

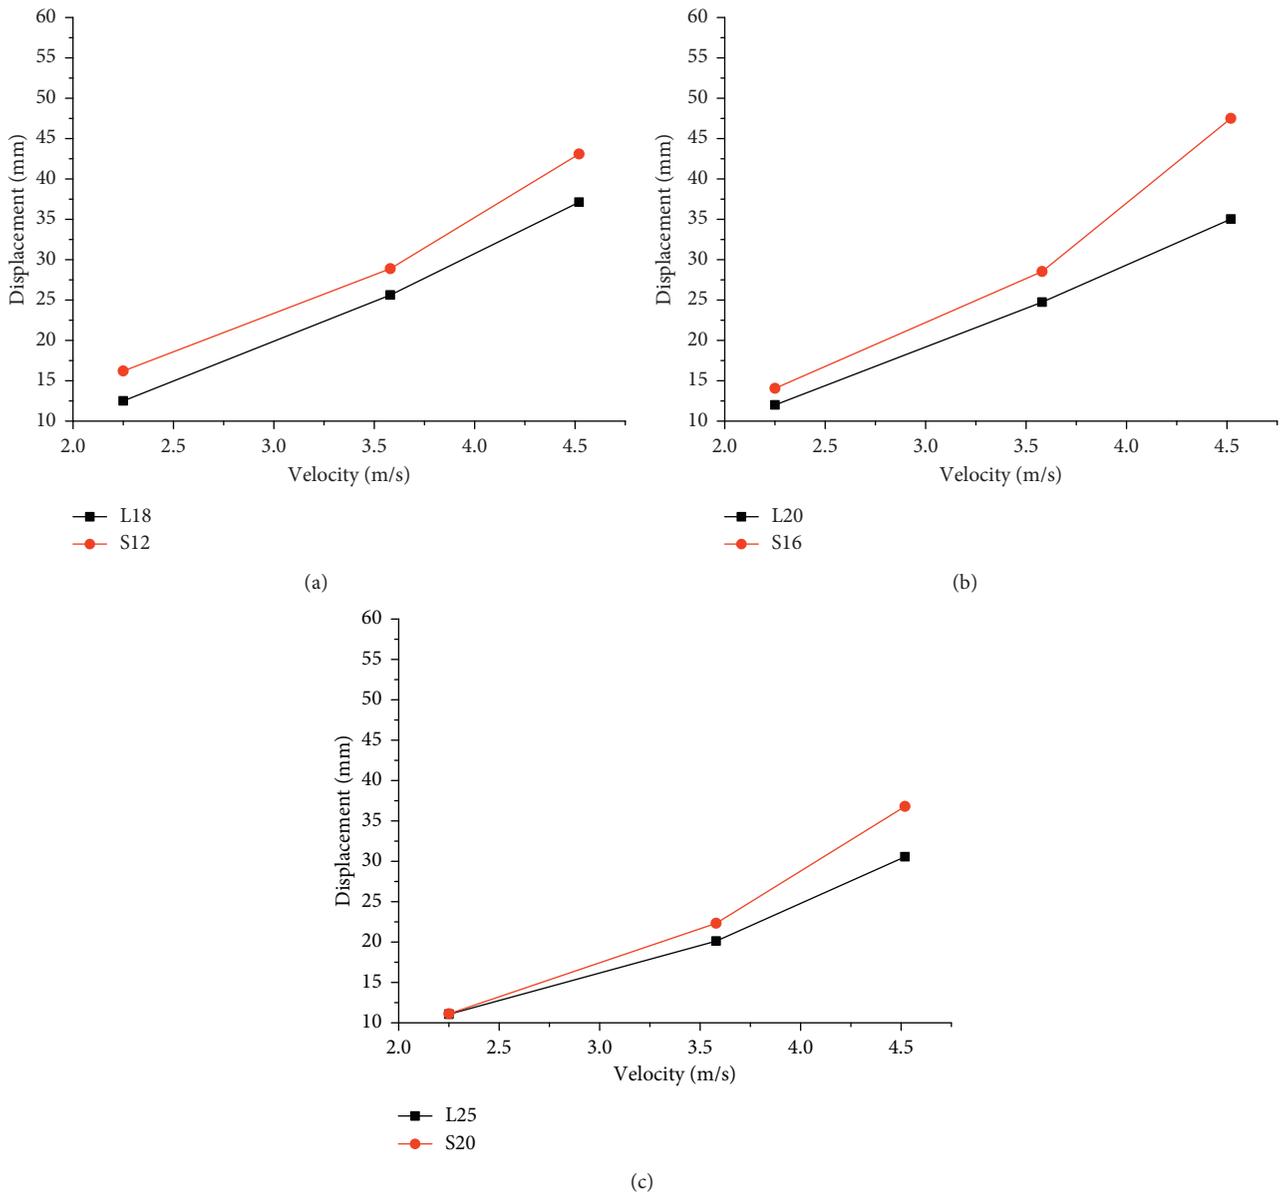
FIGURE 12: Peak displacements and velocity curves. (a) Group A. (b) Group B. (c) Group C.

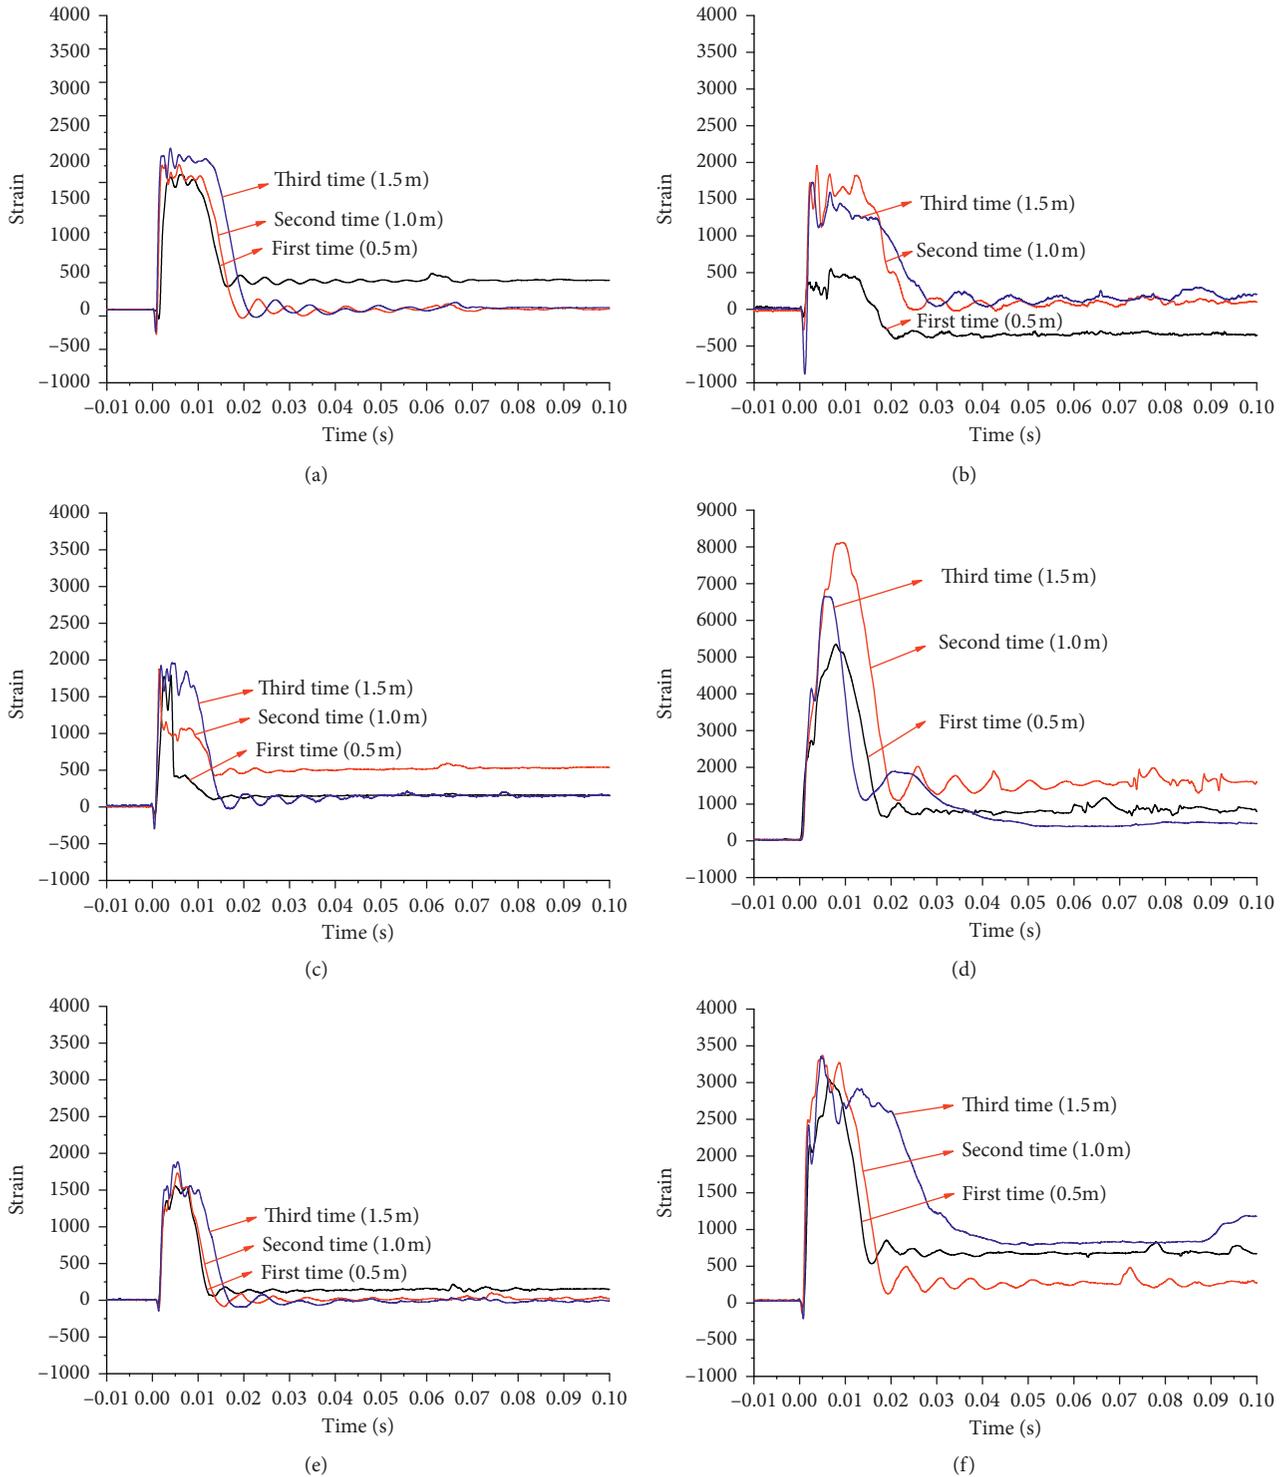
**3.3. Time History Curves of the Strain.** During this study's experimental testing processes, the strain levels of the longitudinal reinforcements of the beams at the measuring points were obtained using a steel strain gauge. Due to the different failure modes of the beams and the different locations of the measuring points, it was found that the strain levels of the reinforcements had varied greatly. In the current study, the strain data ( $\mu\epsilon$ ) of the #3 reinforcement were selected for analysis purposes. The strain time history curves of the #3 reinforcement during each of the impact processes of the three groups of beams are shown in Figure 13.

As detailed in Figure 13, the steel strain time history curves of the ordinary and stainless steel-reinforced beams had displayed similar changing trends. That is to say, the drop hammer had collided with the beams. The steel strain had first increased and then decreased after reaching the peak values, resulting in main wave crest formations. At that point, the curves had tended to be horizontal. The steel strain time history curves were observed to be relatively simple. The durations of the main wave crests had ranged between 15 ms and 30 ms, which were found to be similar to the durations of main wave crests of the displacement time history curves.

FIGURE 13: Time history curves of the steel strain. Group A: (a) L18-3# and (b) S12-3#. Group B: (c) L20-3# and (d) S16-3#. Group C: (e) L25-3# and (f) S20-3#.

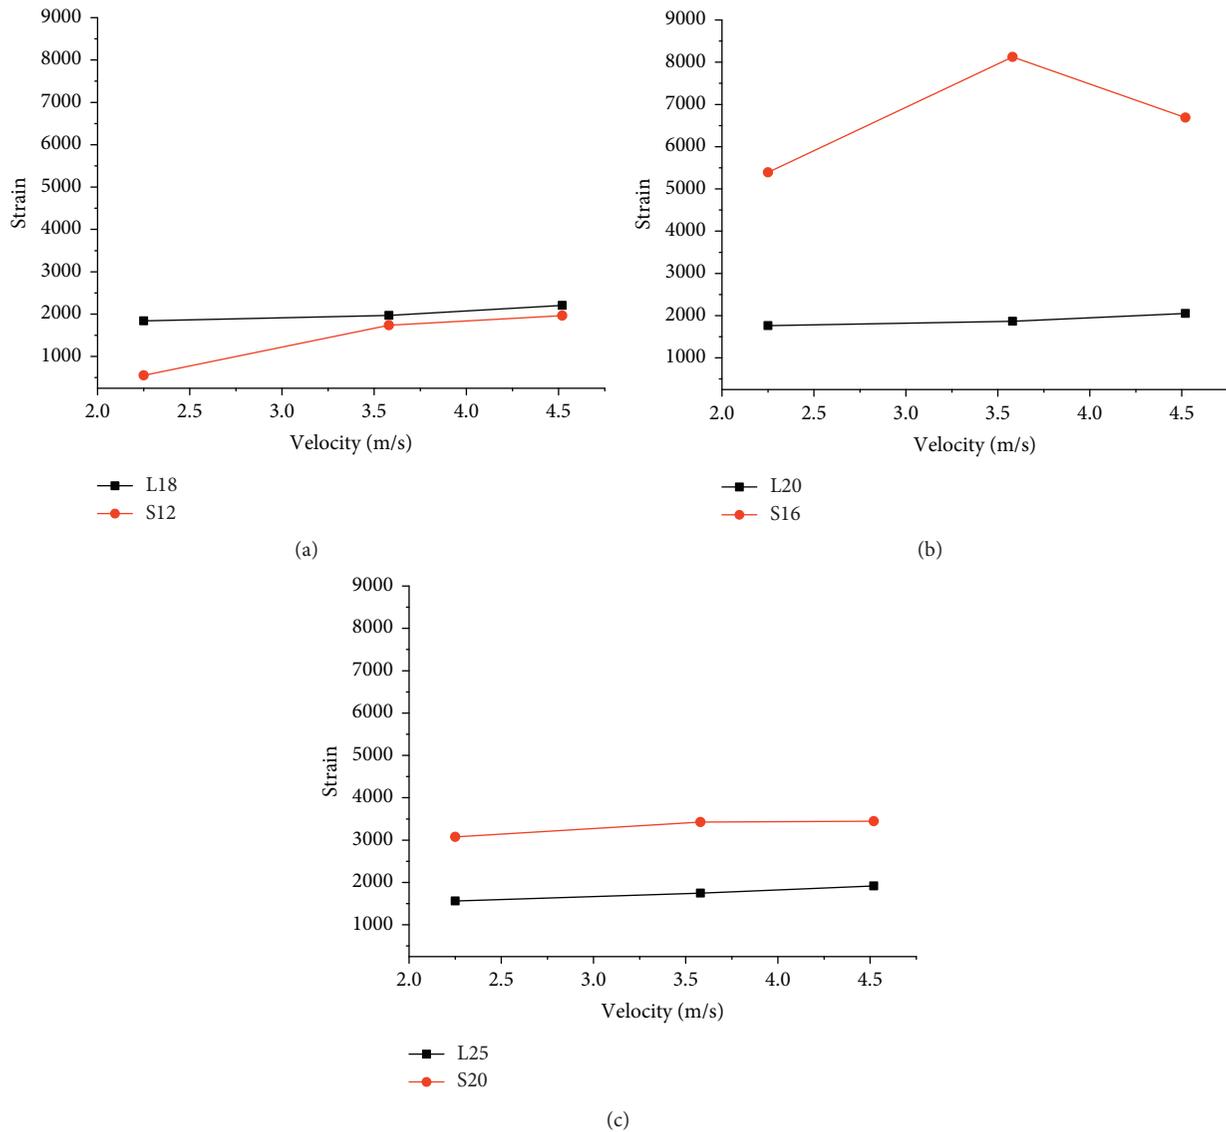
In the current study, for the convenience of comparing the peak strains of the reinforcements, the peak strain-velocity curves of each group of beams were plotted, as illustrated in Figure 14.

As shown in Figure 14, for Group A, the peak strains of the L18 reinforcement were 69.93%, 11.85%, and 11.11%

higher than those of the S12 during the three impacts, respectively. Also, the strain levels of stainless steel reinforcements had obviously been reduced following the equal strength replacements. For Group B, the peak strains of the reinforcements in the S16 beam were observed to be much larger than those in the L16 beam, which may have

been caused by the fact that the #3 measuring point situated at the shear failure location of the beam. For Group C, the peak strains of the reinforcement in the S20 beam during the three impacts were determined to be 96.67%, 96.26%, and 79.90% higher than those of the L25 beam, respectively. In summary, it was determined that the steel strain levels could

FIGURE 14: Strain peaks and velocity curves of each specimen group. (a) Group A. (b) Group B. (c) Group C.

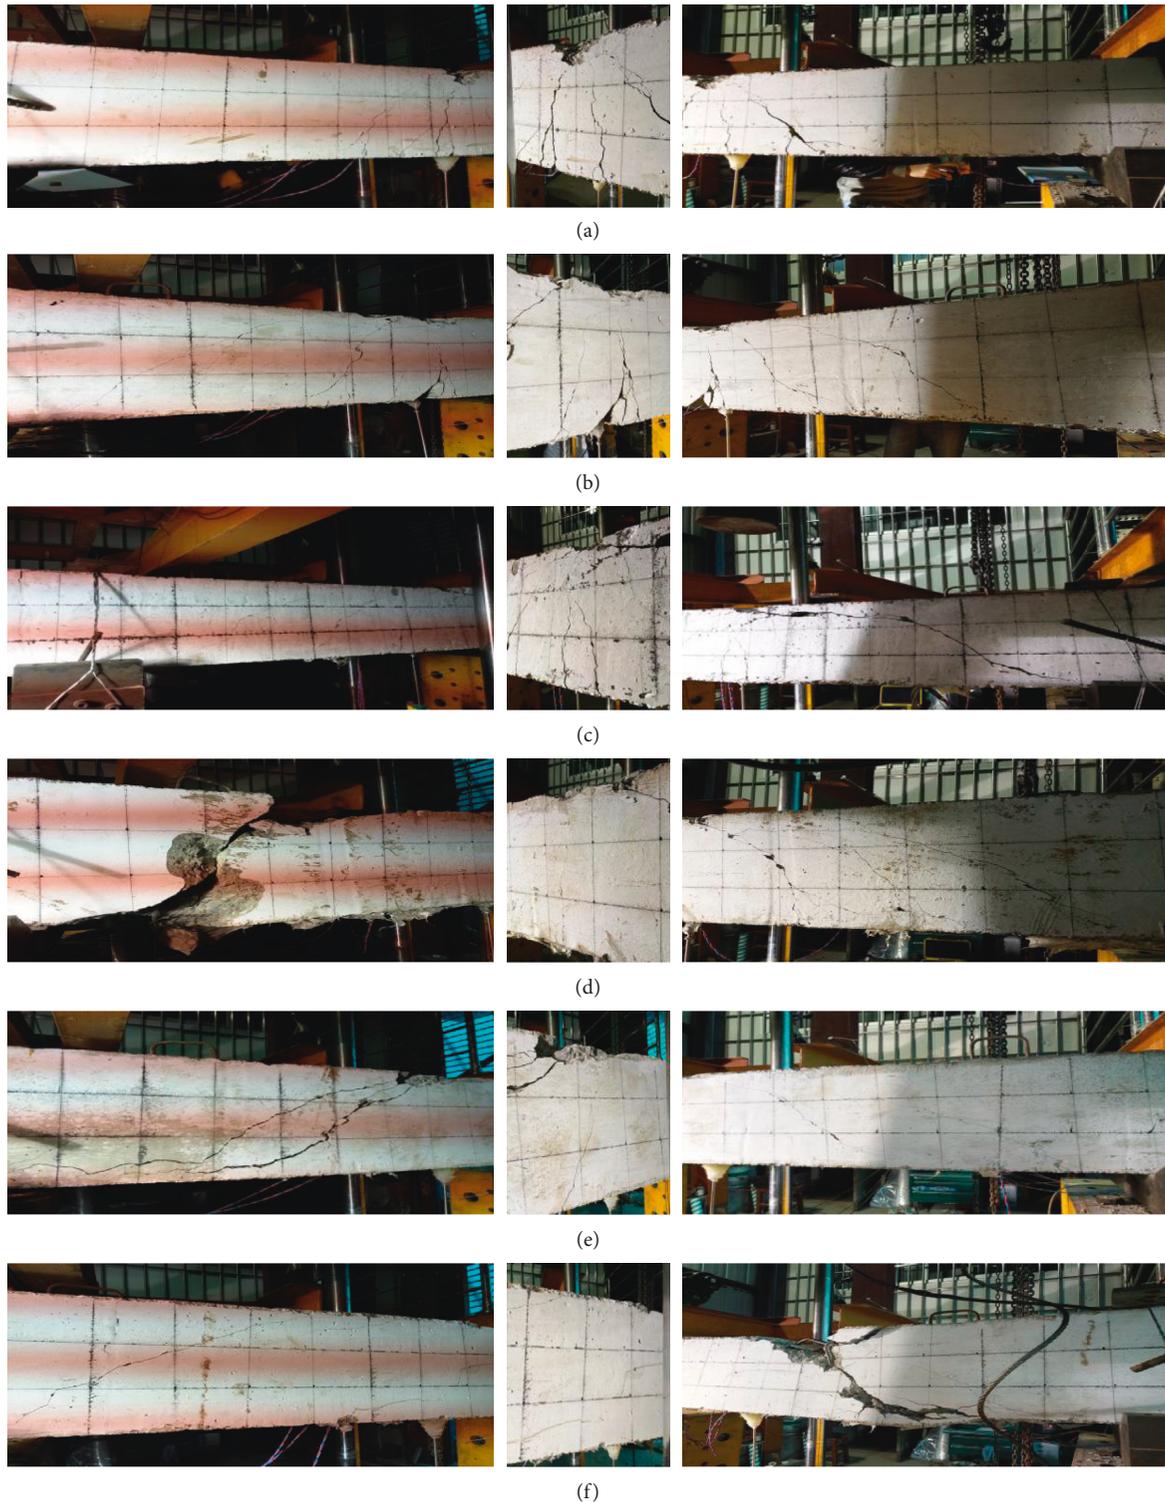
**3.4. Crack Propagations and Failure Modes.** The crack propagations of the three groups of beams after each impact were recorded, as detailed in Table 5. The final failure pattern of the beam is shown in Figure 15.

It was observed that for Group A, the cracks in the L18 beam had appeared in the midspan area at the beginning and had then propagated from bottom to top. The majority of those cracks were vertical cracks. It was found that with the

FIGURE 15: Beam failure form. (a) L18. (b) S12. (c) L20. (d) S16. (e) L25. (f) S20.

increases in the impact energy, the cracks in the midspan area had continued to expand and extend upward until they had penetrated the beam body. At the same time, multiple cracks at the bottom of the beam had extended to the top of the midspan area, and those cracks were observed to be evenly distributed. The cracks in the S12 beam had first

appeared at 1/4 position of the beam body and had then propagated from the bottom to the top of the beam midspan area to form 45° oblique cracks. It was observed that with the increases in the impact energy, some smaller cracks had successively appeared in the beam midspan area and its vicinity. Also, a small number of cracks had propagated to

For Group B, the L20 beam cracks had appeared at the 1/4 position of the beam body at the beginning of the impact process and had propagated from the bottom to the top of the midspan area of the beam to form 45° oblique cracks. It was observed that with the increases in the impact energy, some small cracks had appeared in the midspan area of the beam and its vicinity. However, those cracks had propagated slowly, while the cracks at the 1/4 position of the beam body had propagated more quickly to become the main cracks. The cracks of the S16 beam had begun to distribute evenly from the midspan area of the beam to the 1/4 position location of the beam body and were mainly small oblique cracks. It was found that with the increases in the impact energy, the cracks near the midspan area of the beam had slowly propagated. Meanwhile, 60° oblique cracks had appeared at the 1/4 position location of the beam body and had rapidly propagated to become the main cracks. These cracks had subsequently penetrated the beam body, which then led to beam failure.

In regard to Group C, the crack propagation of the L25 beam was observed to be similar to that of the L20 beam. However, the cracks were found to be relatively narrow. The crack propagation of the S20 beam was determined to be similar to that of the S16 beam. The cracks began to be evenly distributed from the midspan area of the beam to the 1/4 location of the beam body and had the characteristics of small oblique cracks. It was found that with the increases in the impact energy, the cracks near the midspan area of the beam had propagated slowly and remained small. Meanwhile, 60° oblique cracks had occurred at the 2/3 position of the beam body and had rapidly propagated to become main cracks. Those cracked then penetrated the beam body, which subsequently led to beam failure.

In summary, for the L18 and S12 beams in Group A, bending failures were evident, and the crack propagation characteristics were observed to be similar. However, according to the number and widths of the cracks, the damage degree of the S12 beam was smaller, which indicated that stainless steel-reinforced concrete beams after equal strength replacements could effectively reduce beam damages and had displayed better impact resistance performances. For Group B, it was found that the L20 and S16 beams had mainly experienced shear failures. However, the main locations of the shear cracks were slightly different. It was determined that in accordance with the number and widths of the cracks, the damages to the S16 beam were less severe during the first impact. However, with the increases in the impact energy, the cracks had quickly propagated until the bearing capacity had been lost. It was determined that this was due to the fact that when the impact energy was larger, the strength of stainless steel reinforcements was higher; the deformations were smaller; and the energy absorption abilities were poor. Therefore, when the beams had impacted, the internal forces of the beams could not be released in time, and serious shear failures mainly occurred due to the concrete being subjected to impact forces.
