Research Article

Analysis of Changes in the Micromorphology of Sandstone Joint Surface under Dry-Wet Cycling

Key Laboratory of Geological Hazards on Three Gorges Reservoir Area (China Three Gorges University), Ministry of Education, Yichang, Hubei 443002, China

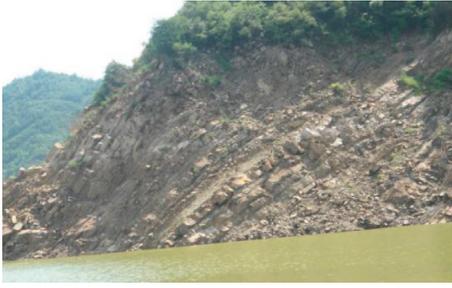
As shown in Figure 1, after the completion of the Three Gorges project, reservoir water levels fluctuate within a belt up to 30 m wide, which represents the range between the flood control level (145 m) and the power plant level (175 m). Under conditions of frequent water level fluctuation, the rock masses in the fluctuating belt periodically undergo dewatering and saturation, resulting in a “fatigue effect.” The effect of a single cycle may not necessarily be significant, but after repeated cycles, progressive damage can occur [4, 5]. As can be seen from Figure 1, in the area of water fluctuation (145 m to 175 m), there is almost no vegetation. Instead, we clearly see well-developed rock joints and fissures. At the same time, previous studies [5] have shown that under large fluctuations in the reservoir water level, the damaging effect

FIGURE 1: Diagram of the destruction of rock masses in a typical slope bank.

2.2. Dry-Wet Cycling Test Scheme. As can be seen in Figure 1, the rock body collapse phenomenon in the fluctuating zone of the bank slope is obvious. Therefore, in the experiment, the dry-wet cycling process of the hydrofluctuation belt is simulated. A dry-wet cycle test program was designed. First, the joint rock samples were dried at 105°C for 24 hours, then cooled to room temperature, force-saturated for 4 hours under a vacuum, and finally soaked in water for 24 hours [5]. The process is designed to undergo 20 dry-wet cycles. The block diagram of the dry-wet cycling test scheme is shown in Figure 3.

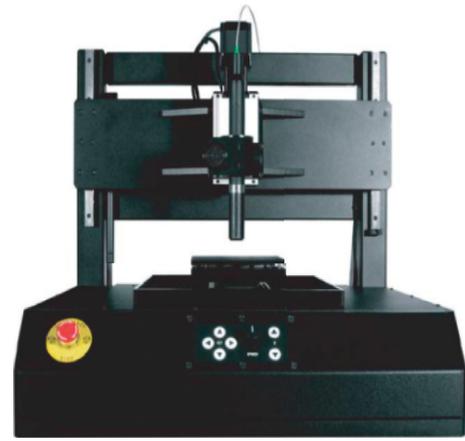
2.3. Joint Microscopic Scanning Analysis. To facilitate analysis of the influence of dry-wet cycling on the topological characteristics of the joint surface, an ST500 three-dimensional noncontact surface profiler was used to scan the joint surface at the start and end of the dry-wet cycles 1, 3, 5, 8, 12, 16, and 20. As shown in Figure 4, the device uses a front-end laser scanning confocal microscope to test and analyze the sample surface. Three-dimensional image analysis software can then be used to obtain the microtopographic parameters of the sample surface.

FIGURE 4: ST500 three-dimensional noncontact surface profiler.
