## Research Article

# Study on the Life-Cycle Health Monitoring Technology of Water-Rich Loess Tunnel

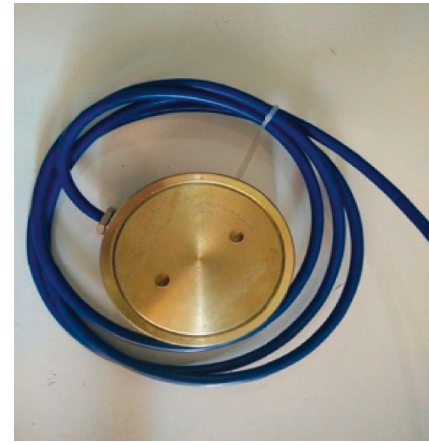
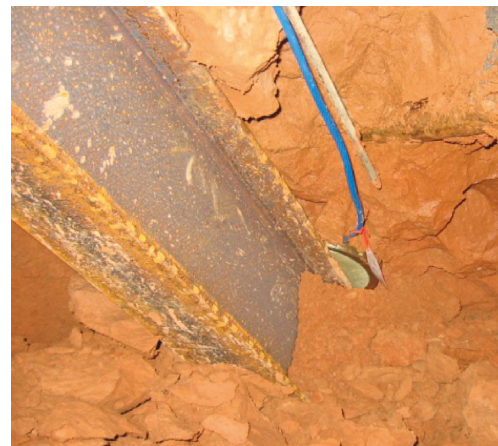
FIGURE 1: The pressure cell and its conditions: (a) double capsule pressure cell and (b) field installation of pressure cell.

**2.1.1. Soil Pressure Cell.** As shown in Figure 1, the contact pressure between the surrounding rock and primary support was monitored by the double capsule soil pressure cell. Based on the theory of vibrating wire tension, for the pressure cell, the frequency was used as the output signal to enhance its anti-interference capability. The built-in temperature sensor could modify the effect of the external temperature fluctuations and improve the monitoring accuracy as well. Moreover, the pressure cell has two stress capsules and cushion in a smart structure. The cushion transfers the pressure from the outer capsule to the inner capsule evenly. The specific conditions and pressure cell (JMZX-5020ATm) were used in the field. In addition, the measurement ranged from 0 MPa to 2 MPa and the resolution is 0.01 MPa. In the process of the field installation, the pressure-bearing capsule was buried toward the surrounding rock. In order to guarantee good contacting results, the clearances among the pressure cell, surrounding rock, and primary support should be filled by fine-grained soil.

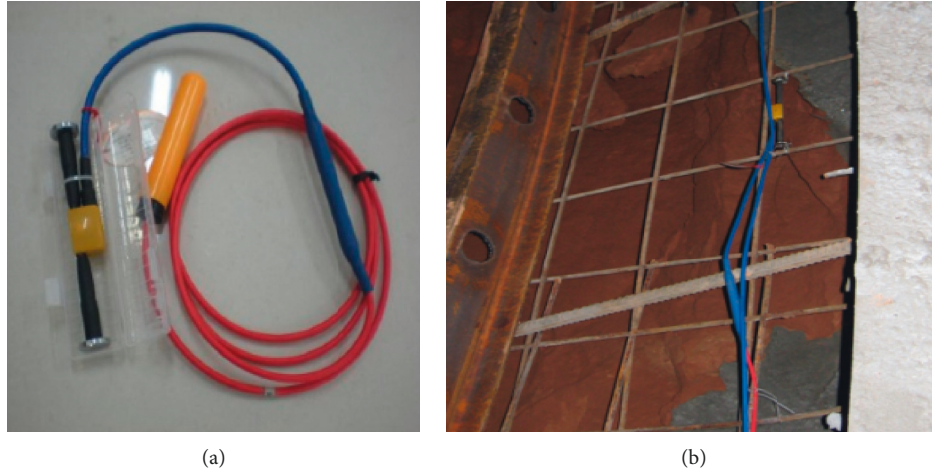
FIGURE 2: The equipment of concrete strain gauge: (a) concrete strain gauge and (b) field installation of concrete strain gauge.

**2.1.2. Concrete Strain Gauge.** As shown in Figure 2, the internal force state of the concrete structure was monitored by the concrete strain gauge. Based on the theory of vibrating wire tension, the gauge has a  $-2,000$  to  $+2,000 \mu\epsilon$  measurement range and accuracy to 0.5% of full scale. In field installation, the concrete strain gauge was tied up to the structural steel with the iron ribbons firmly. The installation position should be protected from construction disturbance as much as possible. Then, the conducting wire was laid out

along with the bars, which was fastened with the iron ribbons at 0.5 m intervening distance.

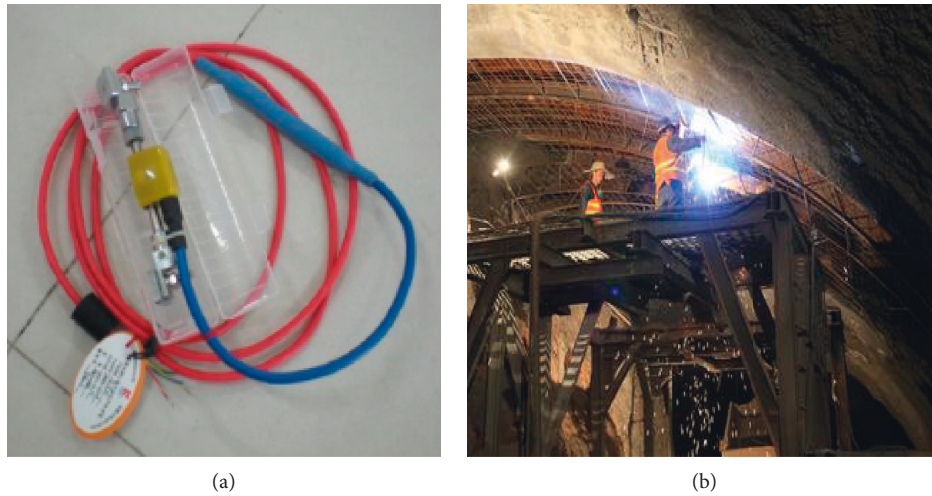
FIGURE 3: The equipment of surface strain gauge: (a) surface strain gauge and (b) field installation of surface strain gauge.

**2.1.3. Surface Strain Gauge.** As shown in Figure 3, the internal force of the support steel arch was monitored accurately using surface strain gauges, owing to the axial surface deformation of the steel arch. The surface strain gauge measurement ranged from  $-3,000$  to  $+3,000 \mu\epsilon$ , and the full-scale precision is 0.5%.

Field installation procedures are shown as the following: Firstly, the special bracket was welded on the inside flange plate of the steel arch. Secondly, the surface strain gauge was welded on the middle of the bracket, which should be coated with a wet towel to avoid frequency drift in the process of the high temperature welding. For the purpose of avoiding the construction disturbance, the gauge was protected by iron-sheet box. Finally, the corresponding frequency value was set as the initial value when the strain value was  $0 \mu\epsilon$ .

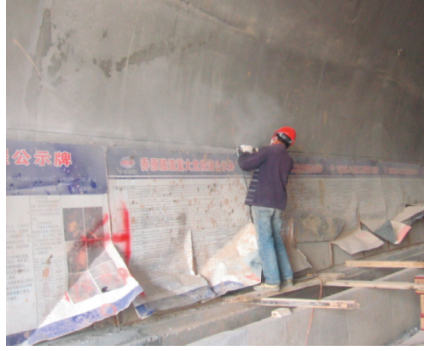
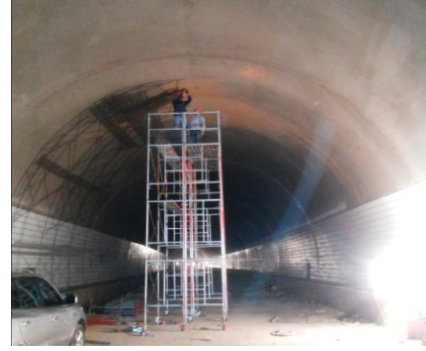
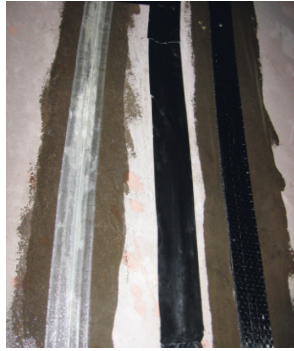
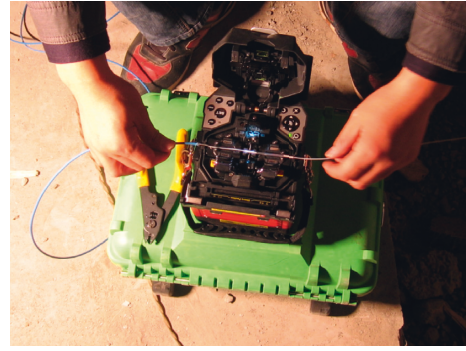
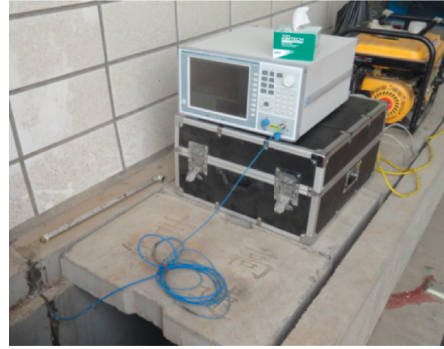
FIGURE 4: The distributed optical fiber installation flowchart: (a) carving slot and routing on the sidewall, (b) carving slot and routing on the crown, (c) laying of protection layer, (d) fiber splicing, and (e) debugging the light circuit.

Figure 4 shows the construction process of the distributed optical fiber. Specifically, the following steps were involved:

- (1) Carving slot: to ensure the installation properly of the sensing cable, the ink line was served as a guide. Then, the slot was carved on the concrete structure with a width of 3 mm and a depth of 5 mm.
- (2) Layout of the sensing cable: the cable was placed in the slot and fixed by the epoxy resin glue. To ensure the coordination deformation between the cable and

the concrete structure, the curing shrinkage ratio of the epoxy resin glue must be less than 2%.

- (3) Sticking protective layer: to avoid the exuding of epoxy resin glue, the adhesive tape was stuck on the surface of the slot.
- (4) Field debugging: all the sensing cables were connected to be a monitoring network using a fusion splicer. Finally, the complete optical fiber path was debugged by the BOTDR.

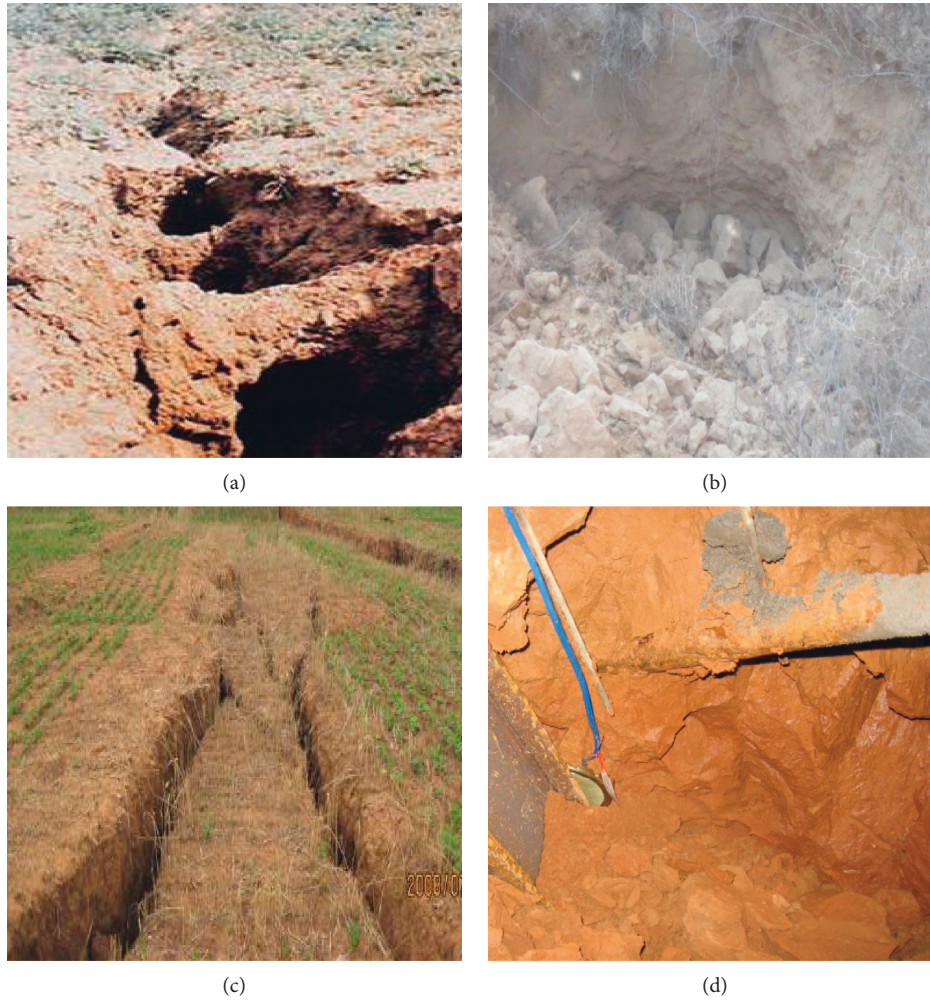
FIGURE 6: The geological hazard of the water-rich loess tunnel: (a) water sinkhole in ground surface, (b) loess settlement cave, (c) surface crack, and (d) surrounding rock argillization.

As shown in Figure 6, the Qiaoyuan tunnel was influenced by the negative factors of farmland irrigation, transient rainfall, and excavation unloading. There are many geological hazards in the loess strata, from water sinkhole, settlement cave, to ground surface crack, which intensified the deterioration degree of loess surrounding rock. Besides, a vicious circle of the geological hazard is performed. The groundwater sank into the loess strata constantly. The phenomenon of argillization will act on in the surrounding rock of the loess tunnel.

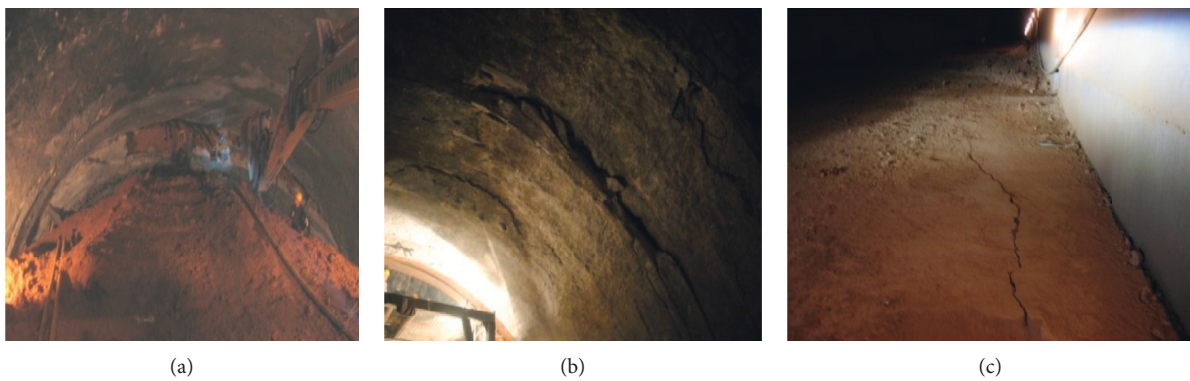
FIGURE 7: The damage of the water-rich loess tunnel during construction. (a) Collapse of the tunnel face, (b) primary support cracking, and (c) inverted arch cracking.

As shown in Figure 7, many sections have undergone collapse of the tunnel face, primary support cracking, and inverted arch cracking as well as the serious deterioration of the surrounding rock evoking the extension of time for completion and increment of the construction cost.

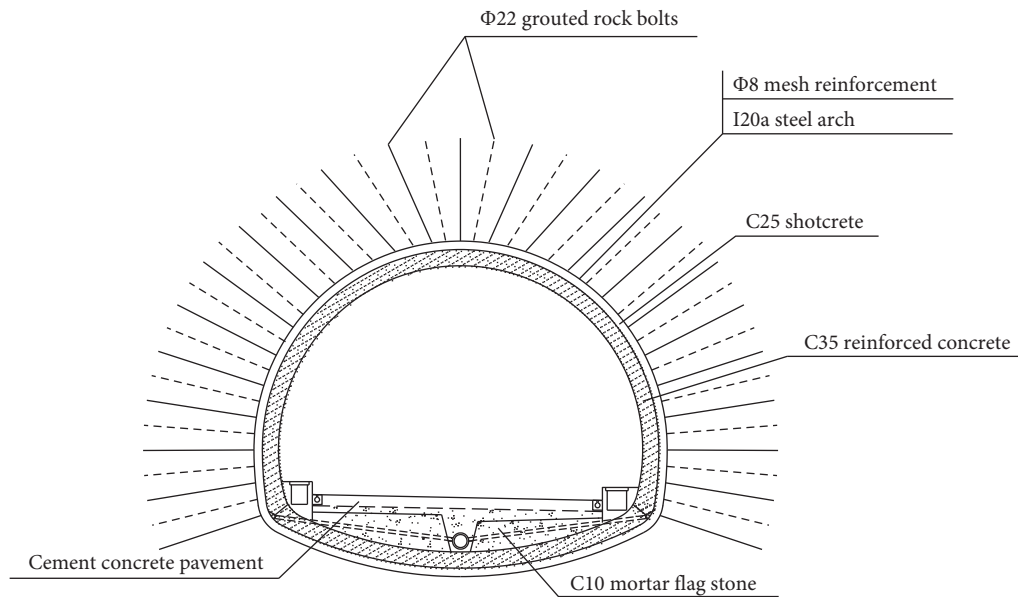
FIGURE 9: Schematic diagram of the tunnel support structure.

As shown in Figure 9, the tunnel support structure presented the primary support including  $\Phi 22$  grouted rock bolts,  $\Phi 8$  mesh reinforcements, I20a steel arch, and 26 cm

C25 shotcrete. The secondary lining was made of the reinforced C35 concrete.

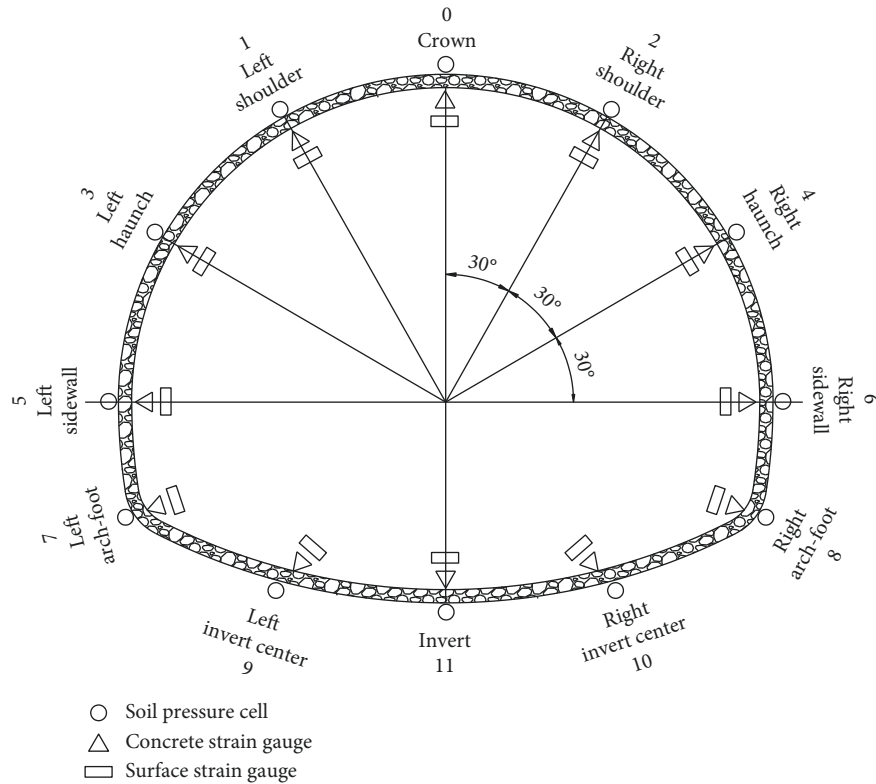
FIGURE 10: Arrangement of the key monitoring points on the primary support.

As shown in Figure 10, the high risk segment YK9 + 660-YK9 + 710 was selected to be the support engineering. The three sections (YK9 + 675, YK9 + 690, and YK9 + 705) were monitored by the vibrating wire sensors, which were arranged in the key position of each tunnel section, such as a crown, shoulder, arch-foot, and invert. The arrangement of the key monitoring points on the primary support is illustrated.

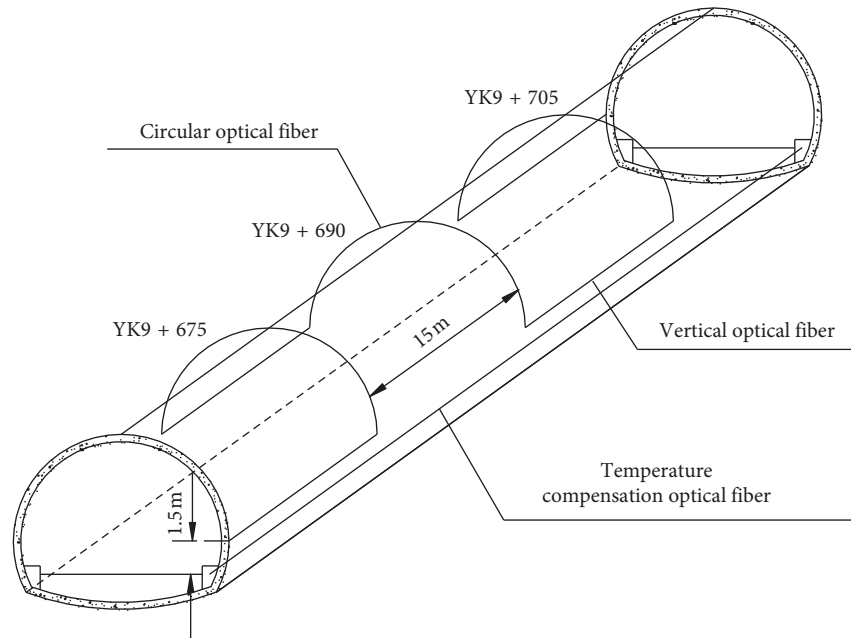
FIGURE 11: Arrangement of the distributed optical fiber.

As shown in Figure 11, the distributed optical fiber monitoring system was composed of the circular optical fiber, vertical optical fiber, and temperature compensation optical fiber. The distance of the longitudinal interval of two circular optical fibers is 15 m. The vertical optical fiber is arranged on the sidewall, and the distance is 1.5 m from the floor to the arrangement position. The temperature compensation optical fiber is arranged in the cable trench. In this tunnel, the complete lengths of the strain-sensing fiber and temperature compensation fiber are 104 m and 50 m, respectively.

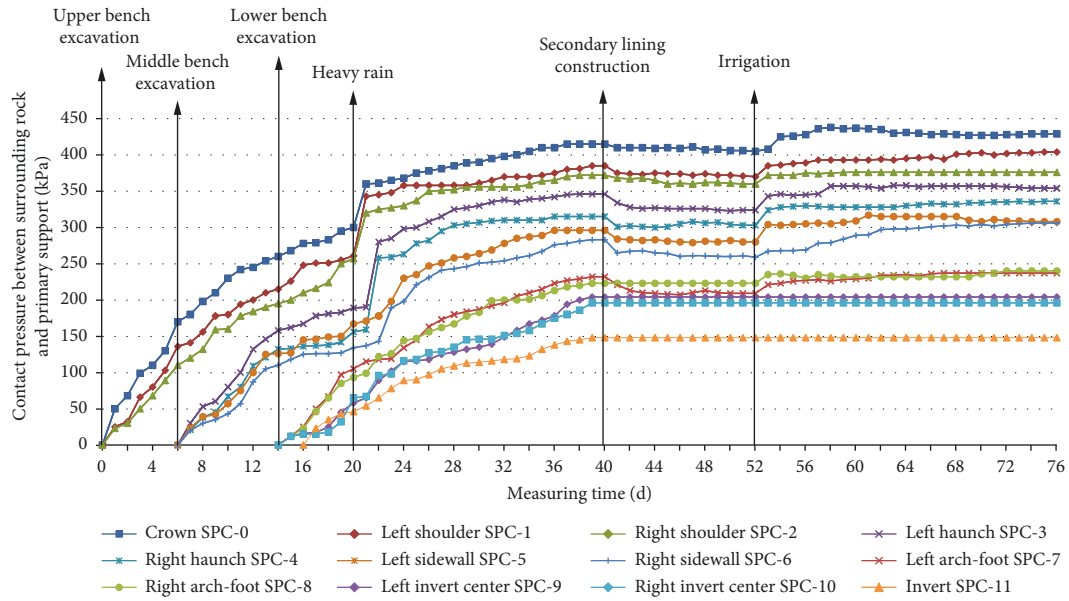
FIGURE 12: Monitoring results of the contact pressure.

**3.1. Contact Pressure.** As shown in Figure 12, the contact pressure located between the surrounding rock and the primary support structure for section YK9 + 685 was plotted.

The construction procedure and heavy rainfall had a substantial influence on the contact pressure with the effect of excavation unloading. In the early stage, values of measuring point SPC-0 to SPC-6 had increased greatly. Actually, the surrounding rock of loess tunnel has a weak overall stability.

The plumb joints, fissures, and excavation-free face lead to the rock stress release. Nonetheless, after completion of the tunnel invert, the support structure was constructed in the form of a closed loop and the growth trend of the contact pressure had been relaxed.

There was a heavy rainfall on the tunnel location in the 20<sup>th</sup> monitoring day, giving rise to the rain runoff infiltration and the increasing of surrounding rock water content. Contract pressure had been increasing drastically on the crown and shoulder with the influence of the water content with a maximum increasing rate of 62%. After completion of tunnel secondary liner, the contract pressure decreased in a small range, which is attributed to that the liner bore the partial load and the load-sharing ratio has changed. In the 52<sup>nd</sup> monitoring day, the irrigation led to the increase in surrounding rock water content. Therefore, under the interaction of water and soil pressure, the contract pressure increased in a small range.

In the whole monitoring process, all the monitoring points had the changing similar trend upon observation. The arch crown bore the contact pressure at the maximum of 437 kPa, which inflicted negative effect on the overall stability of the support structure.

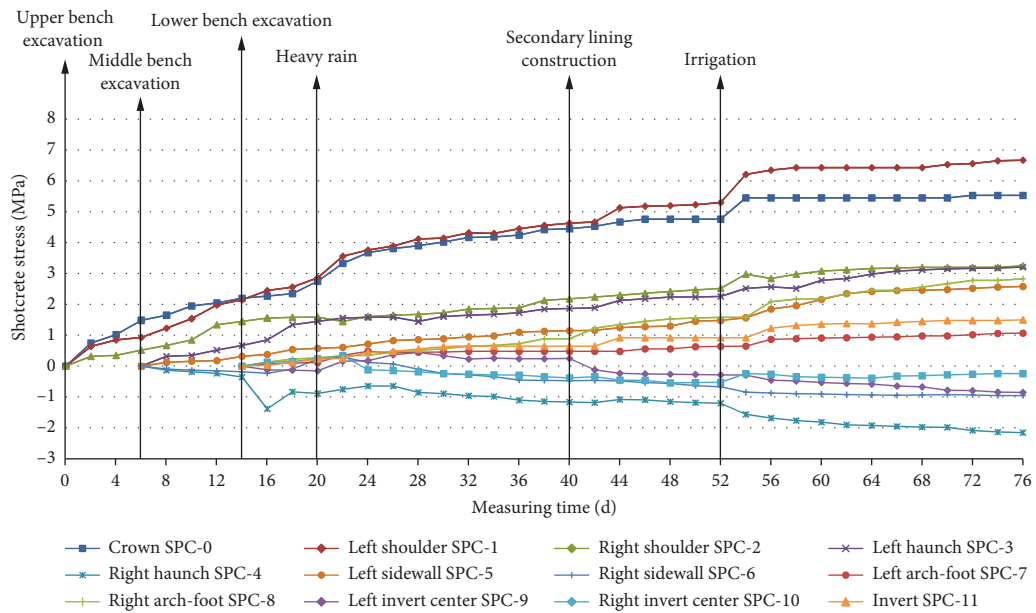
FIGURE 13: Monitoring results of shotcrete stress (Color figure online).

**3.2. Shotcrete Stress.** As shown in Figure 13, the shotcrete stress was changed with the construction procedure, irrigation, and heavy rainfall at section YK9 + 685. It can be seen that the shotcrete stress had an obvious variation in the construction process. After completion of the tunnel secondary liner, the change trend of shotcrete stress was slow. However, there was an irrigation on the ground surface, leading to the remarkable increment of shotcrete stress in the 52<sup>nd</sup> monitoring day. In particular, shotcrete stress of the left shoulder had risen to 6.21 MPa from 5.30 MPa and the growth rate surpassed 17.2 percent.

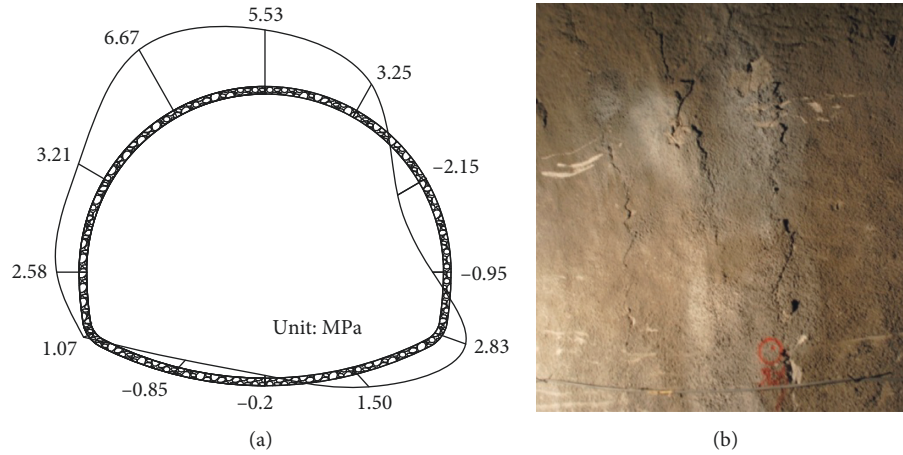
FIGURE 14: (a) Finally stress distribution of shotcrete and (b) cracking of the primary support.

Figure 14(a) shows the final stress distribution. The left shoulder of shotcrete bore the compression stress with the maximum of 6.67 MPa, which was smaller than the shotcrete ultimate compressive strength 13.5 MPa. Nevertheless, the right haunch of shotcrete bore the tensile stress with the maximum of 2.15 MPa, exceeding the ultimate tensile strength 1.3 MPa. Apart from that, the tensile stress caused the cracking of the primary support structure in right haunch with a crack width of 3 mm to 8 mm (Figure 14(b)).

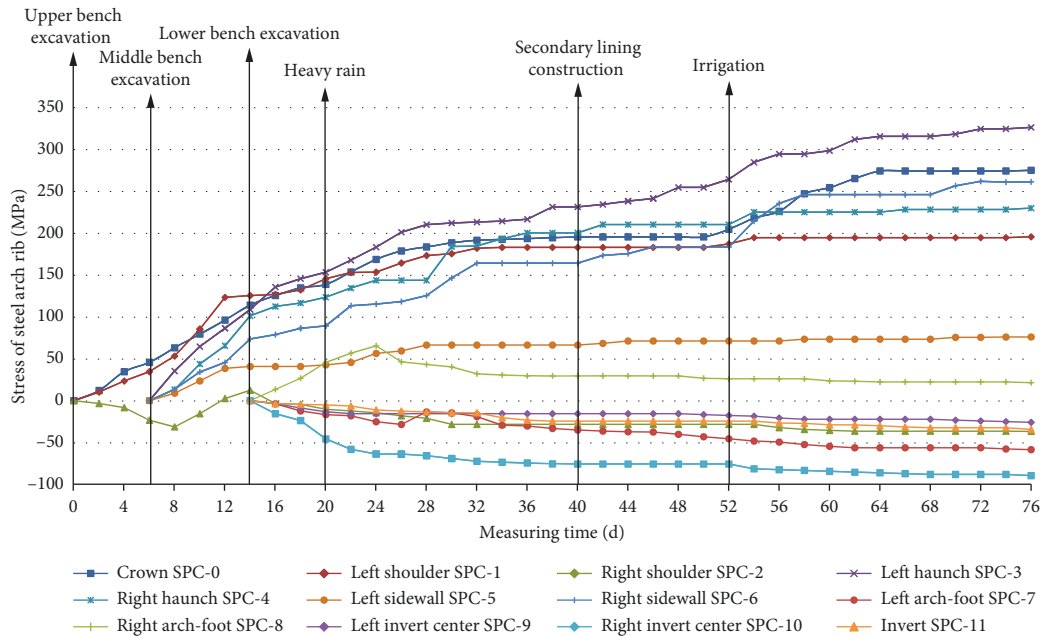
FIGURE 15: Monitoring results of the stress of steel arch rib.

**3.3. Stress of Steel Arch Rib.** As shown in Figure 15, the stress variation of steel arch rib was similar to the shotcrete stress, which was affected by the construction procedure, irrigation, and heavy rainfall obviously. The stress of the left haunch had risen to 135.7 MPa after heavy rainfall. Stress had risen

to 298.7 MPa after irrigation. The growth rates of stress were 24.6% and 12.9%, respectively.

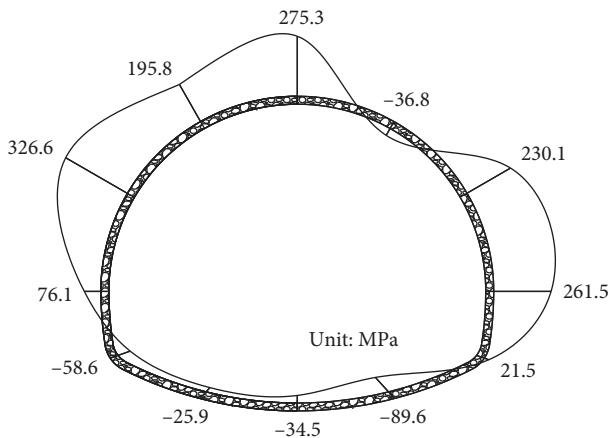
FIGURE 16: Final stress distribution of the steel arch rib.

As shown in Figure 16, the stress of steel arch rib was unbalanced in terms of the overall distribution. The majority of steel arch rib bore compressive stress and only the

invert and right shoulder bore tensile stress. There was a tendency of basement uplift. The basic reason was that the ground surface water flowed into back of both sidewalls resulting in that both ends of the basement bore the greater stress, as in “carrying-pole” shape. For the whole steel arch, the maximum compressive stress appeared in the left haunch with the value of 326.6 MPa. The maximum tensile stress appeared in the right shoulder with the value of 89.6 MPa, which did not exceed the ultimate compressive and tensile strengths of the steel arch. It was indicated that the steel arch bore the majority the external load, which played an important role of load-bearing on the whole support structure.

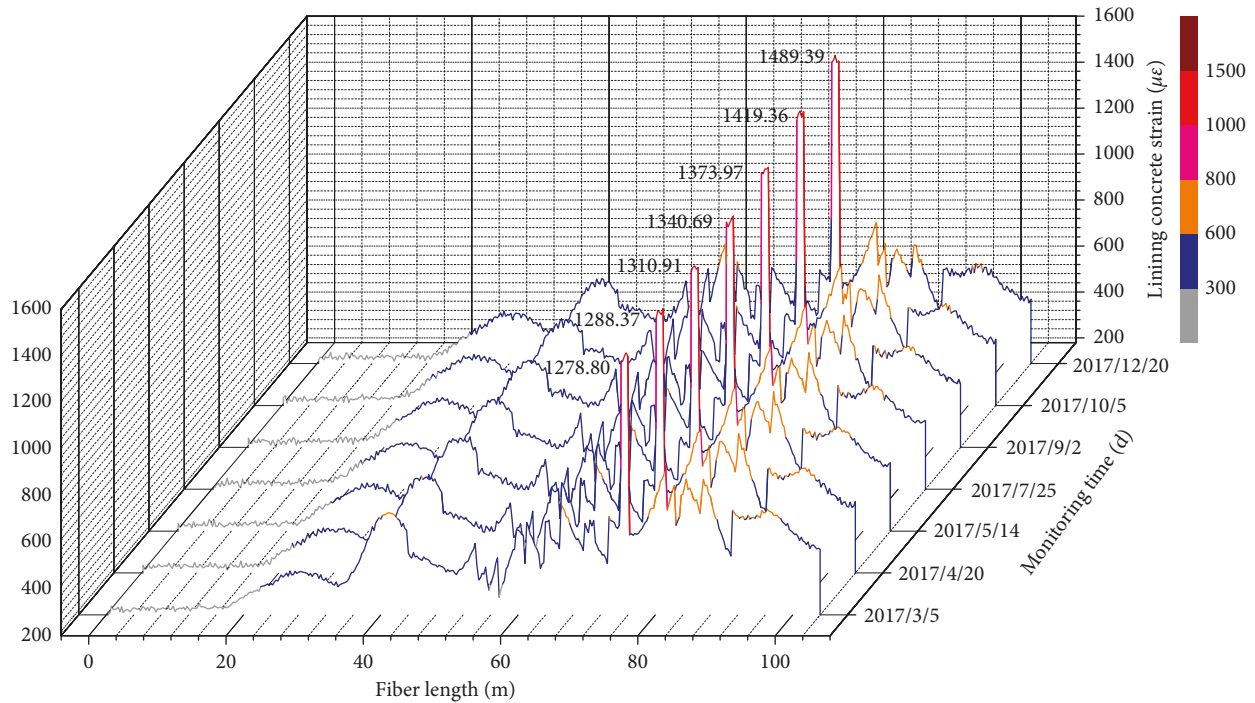
FIGURE 17: Tunnel lining concrete strain time space distribution (Color figure online).

As shown in Figure 17, in an almost section, the strains changed within 300 to 600  $\mu\epsilon$  and the corresponding crack width was 0.075 to 0.150 mm, which was smaller than the maximum allowable crack width of 0.20 mm. Hence, the structure of the tunnel liner was safe and stable in this section. Nevertheless, there were a series of convex points of the fiber length of 75 m (the red area of Figure 17), with the strain value of 1,278 to 1,498  $\mu\epsilon$ . The corresponding position

is located at the right sidewall on section YK9 + 685. After calculating, the corresponding crack widths were 0.35 to 0.37 mm, which exceeded the maximum allowable crack width and inflicted a negative effect on the health state of the tunnel supporting structure.

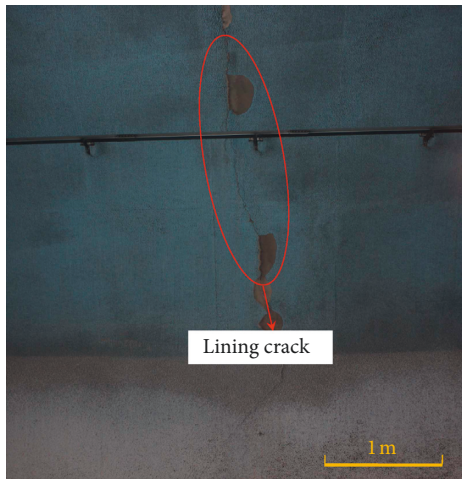
FIGURE 18: Photograph of the lining crack at site.

As shown in Figure 18, after a field investigation, it was revealed that there was a circumferential crack with a width of 0.30 to 0.85 mm identical with the results of the optical fiber monitoring. Furthermore, it can be seen that the strain had risen to  $1,489.39 \mu\epsilon$  of  $1,278.80 \mu\epsilon$  continuously as the days progressed in the red area of Figure 17. In this regard, it was concluded that the crack was still developing and threatened to the safety and stability of the tunnel liner structure. It shall take maintenance measures to prevent the further development of the crack. Furthermore, it will avoid the further decline of the health state of water-rich loess tunnel.
