Case Report

Cuff Failure of Spiral-Filled Polyvinyl Chloride Endotracheal Tube Immediately after Tracheal Intubation Using a Channeled Videolaryngoscope (Pentax Airway Scope)

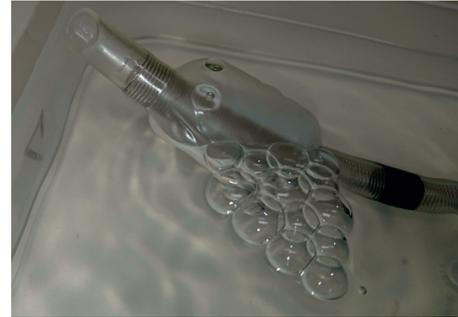
FIGURE 1: Ruptured cuff of the used ETT. When the air was inflated, air bubbles were leaking from the single, ruptured pinhole of the cuff.

Although the cause of the structural damage of the cuff is unknown, the following factors should be considered. First, the cuff may have broken while sliding the ETT within the introducer of the AWS. Moderate or severe friction may occur between the inner surface of the introducer and outer surface of the ETT, even when sufficient lubricant has been used, because of the 90-degree bend and small internal diameter of the introducer. Cuff failure was also noted in two female patients who were intubated with smaller ETTs (internal diameter 7.0 mm and external diameter 9.6 mm). As the friction between the ETT and the introducer is the most plausible reason for the damage, it would be appropriate to check the equipment by sliding an ETT through the introducer prior to inserting it into the patient. It is interesting that the damage occurred in a similar spot (near the proximal edge) of the cuff in all three cases. Frictional pressure may be applied to this part of the cuff during tracheal intubation using the AWS. The other possibility is that the cuff was not completely deflated after the initial inspection, which could have contributed to the damage by increasing the cuff pressure during insertion. We need to deflate the cuff completely after the inspection to avoid the possibility of rupture. Furthermore, there may be very small scratches or protrusions on the inner surface of the introducer that could damage the cuff. However, it is unlikely that these scratches or protrusions, which we did not find during the preoperative inspection, broke the cuff in all three cases. Still, the inner surface of the AWS should be checked during the initial inspection.

In conclusion, anesthesiologists should be aware that, in cases of tracheal intubation using the AWS, friction between the ETT and inner surface of the introducer of the AWS might result in sudden rupture of the cuff.
