## Case Report

# Challenges in Removing the Essure<sup>®</sup> Device

We present a case about Essure<sup>®</sup> removal surgery in which the third markers of the device have torn off. The woman needed a second surgery for complete removal of the devices. Fluoroscopy during surgery is a good method to visualize the lost fragments. With fluoroscopy, a hysterectomy is not needed for complete removal. It is important to understand the structure of the device and to be aware of the four radiopaque markers during surgery and their removal.

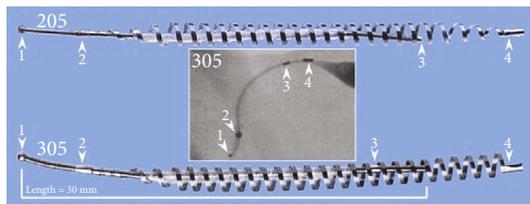
FIGURE 1: Essure<sup>®</sup> (Bayer AG, Leverkusen, Germany) with the four radiopaque markers (1). 1: distal end of the inner coil, 2: distal end of outer coil, 3: proximal end of the inner coil, and 4: proximal length of the outer coil [4].

Prior to removal surgery, it is important to understand the structure of the device. The inner coil consists of stainless steel and polyethylene terephthalate (PET) fibers running along the inner coil. The outer coil consists of nickel-titanium alloy (nitinol). [1, 10] The ESS205 and ESS305 are made from the same materials. Concerning the third marker, there is a difference between the two devices. The third marker of ESS205 is located at the proximal end of the inner coil. The third marker of ESS305 is situated a few millimeters more distal from the end. The third marker of ESS205 is prone to fragmentation after stretching the device during removal surgery, because of its position on the device, where this is less likely to happen with ESS305 because the marker is not terminal. The difference between the proximal part of the outer coil is that there is a little tube at the end of ESS205 that is placed over the nitinol coil. At ESS305 is a platinum plate attached at the end of the outer coil. In both models, the fourth marker is the biggest part of the device and prone to fragmentation. The PET fibers of the inner coil of Essure® react with the fallopian tube tissue which induces fibrosis. The outer coil becomes frail after some time, and traction may cause it to break. The most proximal part of the outer coil with the fourth marker is easily lost and can be hard to find. [6] In summary, not only the fourth marker but also the third marker of the ESS205 can tear off and can easily be lost during removal surgery.

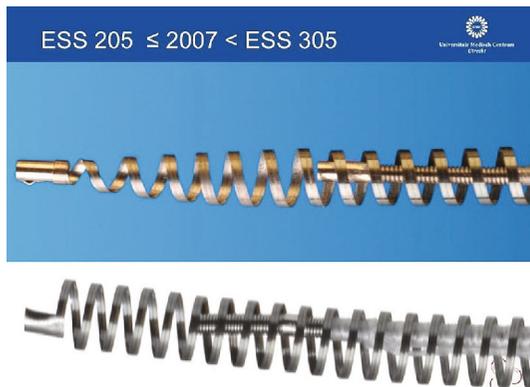
FIGURE 2: Difference of the third marker between ESS 205 and ESS 305.

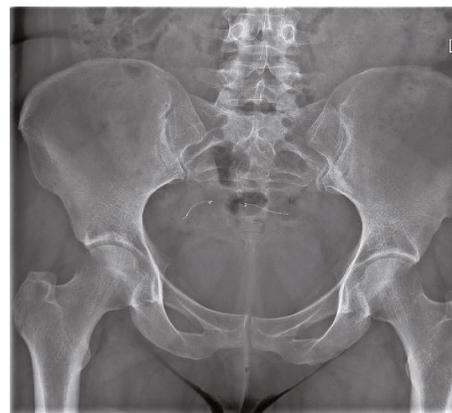
FIGURE 3: Flat panel abdominal X-ray (anterior posterior view) showing both implants (ESS 205) with symmetrical deployment in the pelvic area and the proximal markers are 25 mm apart.

During gynecologic examination in May 2016, no abnormalities were found. Both devices seemed to be in the right position, assessed by transvaginal ultrasound imaging. She obtained a flat panel abdominal X-ray showing both implants with symmetrical deployment in the pelvic area and the proximal markers 25 mm apart (Figure 3). The woman requested surgical removal of the devices. Because of her

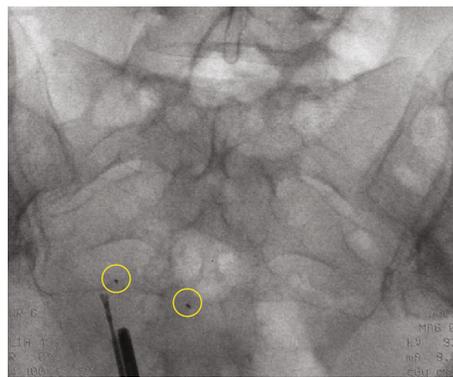
FIGURE 4: Fluoroscopy during surgery. Two markers are visible.

Intraoperative fluoroscopy is described in previous case reports to find lost fragments of the insert. [8, 11] It is a challenge to localize the exact localization of the fragment. Even with fluoroscopy, technical skills are needed for the removal. In view of the small size of the fragments and the limits of the human eye, this and other cases elaborate that there should be a low threshold for the use of intraoperative fluoroscopy. This technique can prevent the need for reoperation and eventually hysterectomy.

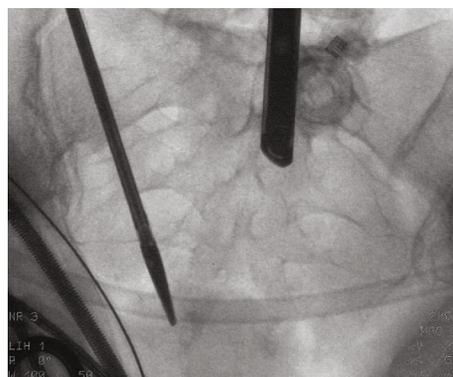
FIGURE 5: Fluoroscopy during surgery. The markers are removed.
