The Impact of Reservoir Fluctuations on Reactivated Large Landslides: A Case Study

Filling of Xiangjiaba Reservoir Lake in the Southwest China triggered and reactivated numerous landslides due to water fluctuation. In order to understand the relationship between reservoirs and slope instability, a typical reservoir landslide (Dasha landslide) at the right bank of Jinsha River was selected as a case study for in-depth investigations. The detailed field investigations were carried out to identify the landslide with respect to its surroundings and to find out the slip surface. Boreholes were drilled to find out the subsurface lithology and the depth of failure of Dasha landslide. The in situ geotechnical tests were performed, and the soil samples from exposed slip surface were retrieved for geotechnical laboratory analysis. Finally, stability analysis was done using the 3D strength reduction method under different conditions of reservoir water level fluctuations and rainfall conditions. The in-depth investigations show that the Dasha landslide is a bedding rockslide which was once activated in 1986. The topography of Dasha landslide is relatively flat, while the back scarp and local

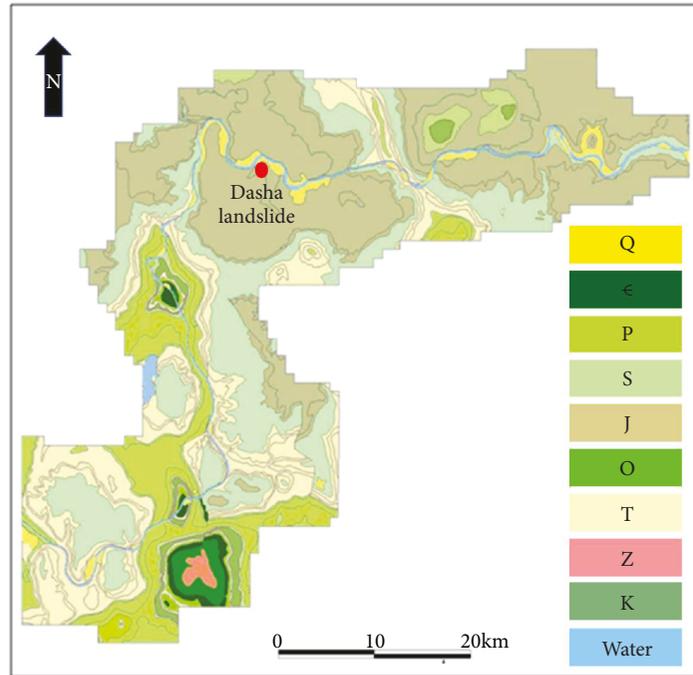
FIGURE 2: Generalized geological map of the Xiangjiaba reservoir area. Where Sinian system = Z; Cambrian system = Є; Ordovician system = O; Silurian system = S; Permian system = P; Triassic system = T; Jurassic system = J; Cretaceous system = K; Quaternary system = Q.

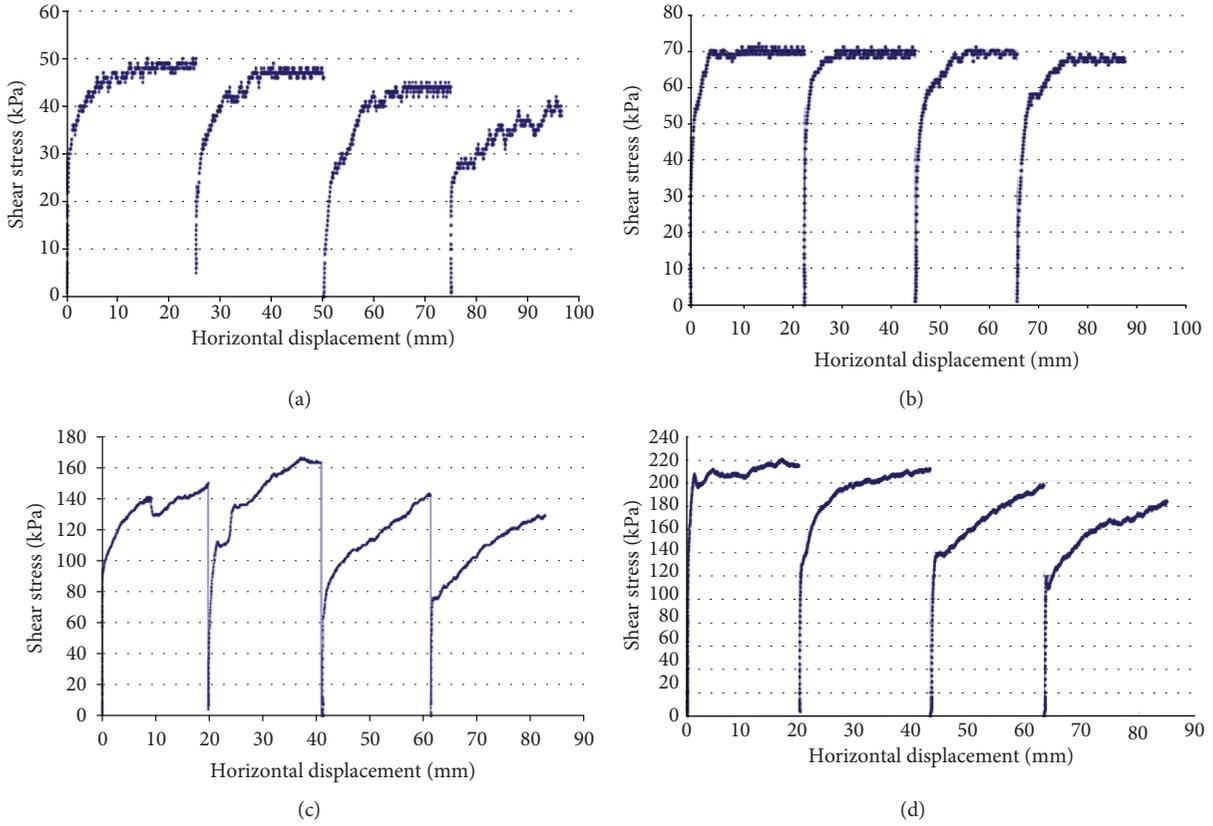
FIGURE 4: The shear stress-displacement curve of repeated direct shear at different normal stresses. (a) 60 kPa, (b) 110 kPa, (c) 260 kPa, and (d) 410 kPa.

The actual values of normal stress are 61, 110, 260, and 410 kPa, and the shear strength after the fourth cycles of shearing is considered the residual strength. The displacement of one-way shear is more than 20 mm, and the cumulative displacement would be more than 80 mm after four cycles of shearing. During the first shear, all of the four samples reached the peak quickly and kept the shear stress stable. However, it was different after the two or three times of shearing, and the shear stress tends to increase. The shear stress-displacement curves at different normal stresses are shown in Figure 4, and the first peak value of shear stress is peak strength. According to the first shear strength and the

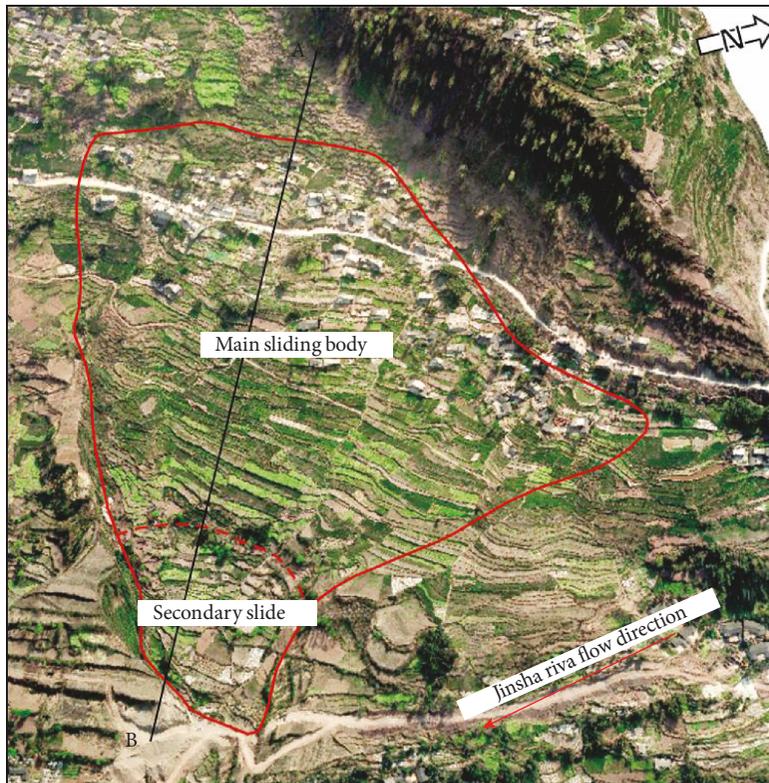
FIGURE 5: Remote-sensing image of Dasha landslide.

landslide with clear chair-shaped landform is about $2.7 \times 10^4 \text{ m}^2$ in area and about $16 \times 10^4 \text{ m}^3$ in volume with the average thickness of about 6 m (Figures 5 and 6).

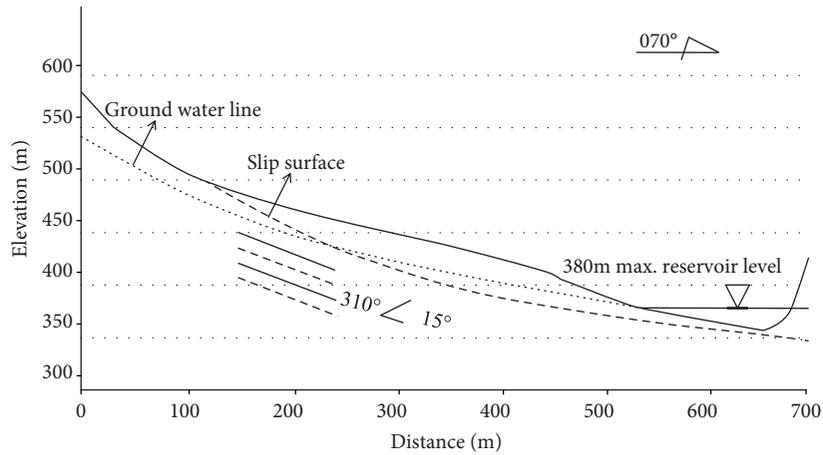
FIGURE 6: Cross-section of Dasha landslide (A-B).

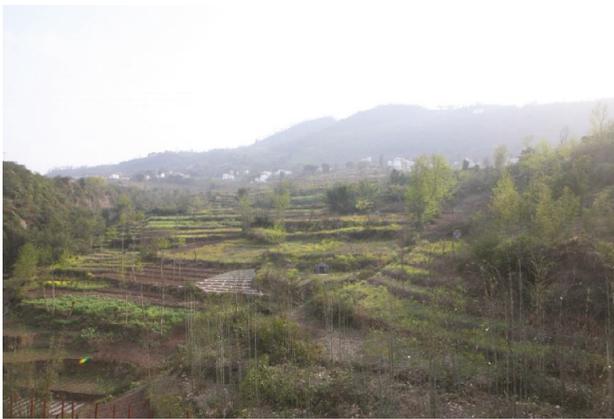
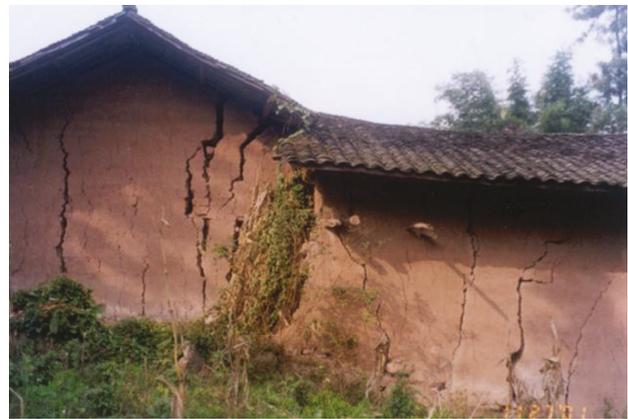
FIGURE 7: (a) A view of Dasha landslides; (b) tensional cracks in house wall.

but local visible cracks in the house wall can be found (Figure 7). This means that the landslide is still in the state of potential instability under the condition of the groundwater level rising or heavy rain. According to aerial photographs, houses are dense in the middle and back part of the landslide; hence, once the landslide moves perceptibly, it would create a huge loss in terms of human and property.

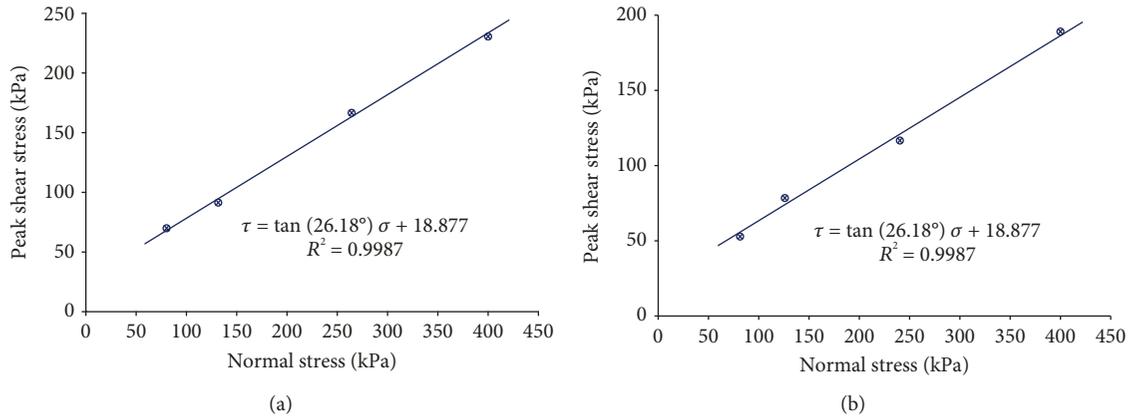
FIGURE 8: Graph showing the peak and residual strength parameters.

last stable strength, the relationship between shear strength and normal stress can be drawn. As shown in Figure 8, the peak shear strength and the residual shear strength in the form of frictional angle and cohesion are 26.18° , 18.88 kPa and 21.38° , 17.95 kPa, respectively. The average moisture content of the soil samples measured from shear surface after opening of the shear box is 17.0% .

the readers, however, as there were numerous tests and their subgroups, so we tried to summarize the tests and compared with the previous studies as concluding section of the shear strength tests. As shown in Figure 8, the drained undisturbed sample test results for the peak shear strength and the residual shear strength in the form of frictional angle and cohesion are 26.18°, 18.88 kPa and 21.38°, 17.95 kPa, respectively. The average moisture content of the soil samples measured from shear surface after opening of the shear box is 17.0%. In the remolded direct shear tests, it was noted that the cohesion as well as the angle of internal friction decreases in all cases with a decrease in water content which shows the reliability of the tests (Figures 9 and 10). Both groups of the triaxial consolidation undrained shear tests show similar results; however, they show slight variations in strength parameters from the direct shear tests which is acceptable due to difference in the rest of the methods. For the in situ tests, two shear rates of 1.3 mm/minute and 1.75 mm/minute were applied in this study and the results show that the cohesion increases with shear rate while the angle of internal friction decreases [39].

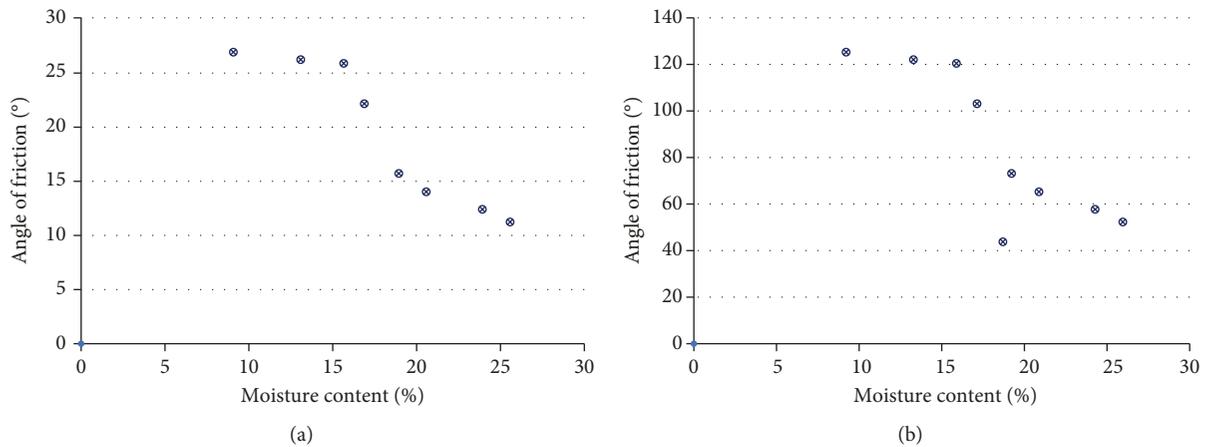
FIGURE 9: Effect of moisture on strength parameters.

3.2. Medium-Size Direct Shear Test on Remolded Samples. Dasha landslide is a typical bedding landslide of red beds, and the particle size decreases with increase in depth. The soil samples consisting of high proportion of gravel-sized particles were taken near the toe of landslide at a depth of 1.5 m. The soil samples were remolded and prepared with different moisture content in order to explore the relationship between soil strength of the slope and water content. The size of samples is $20 \times 20 \times 15$ cm, and the shear rate is 1.0 mm/min. Under the consolidated and drained conditions, seven groups (each group with three samples) were tested in this series, and the moisture content of each group was determined after each test (Figures 9 and 10). As shown in Table 1, the direct shear tests for the soil with less than 2 mm particle size, the strength parameters are greatly influenced by the moisture content, and with a decrease in moisture content, the angle of friction and cohesion increases.

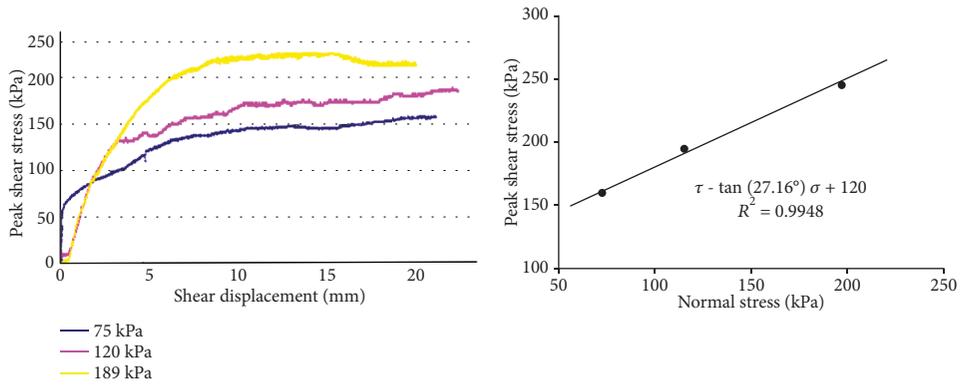
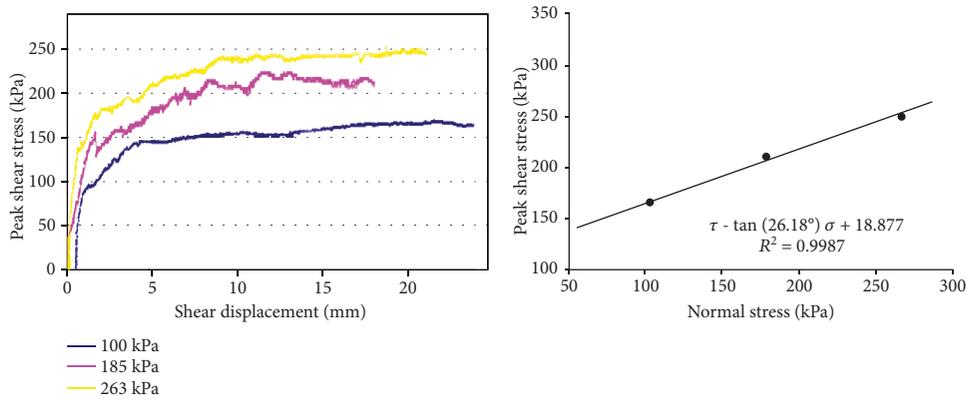
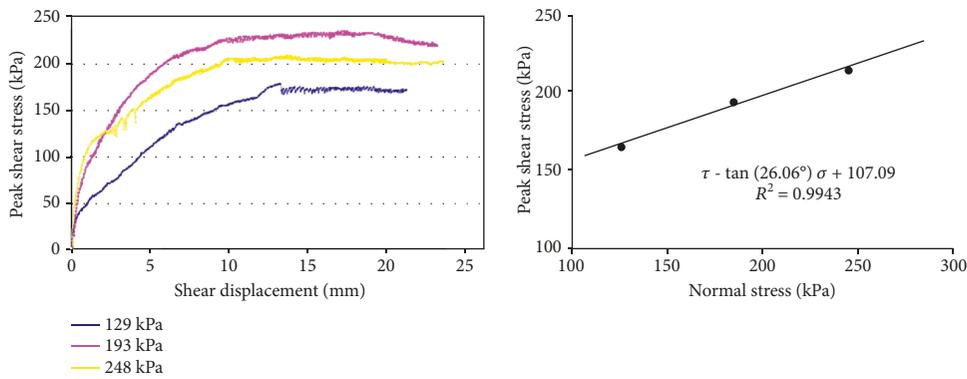
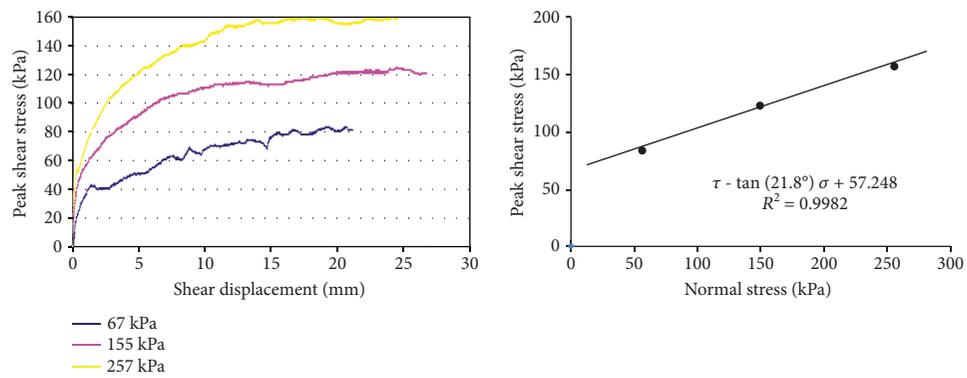
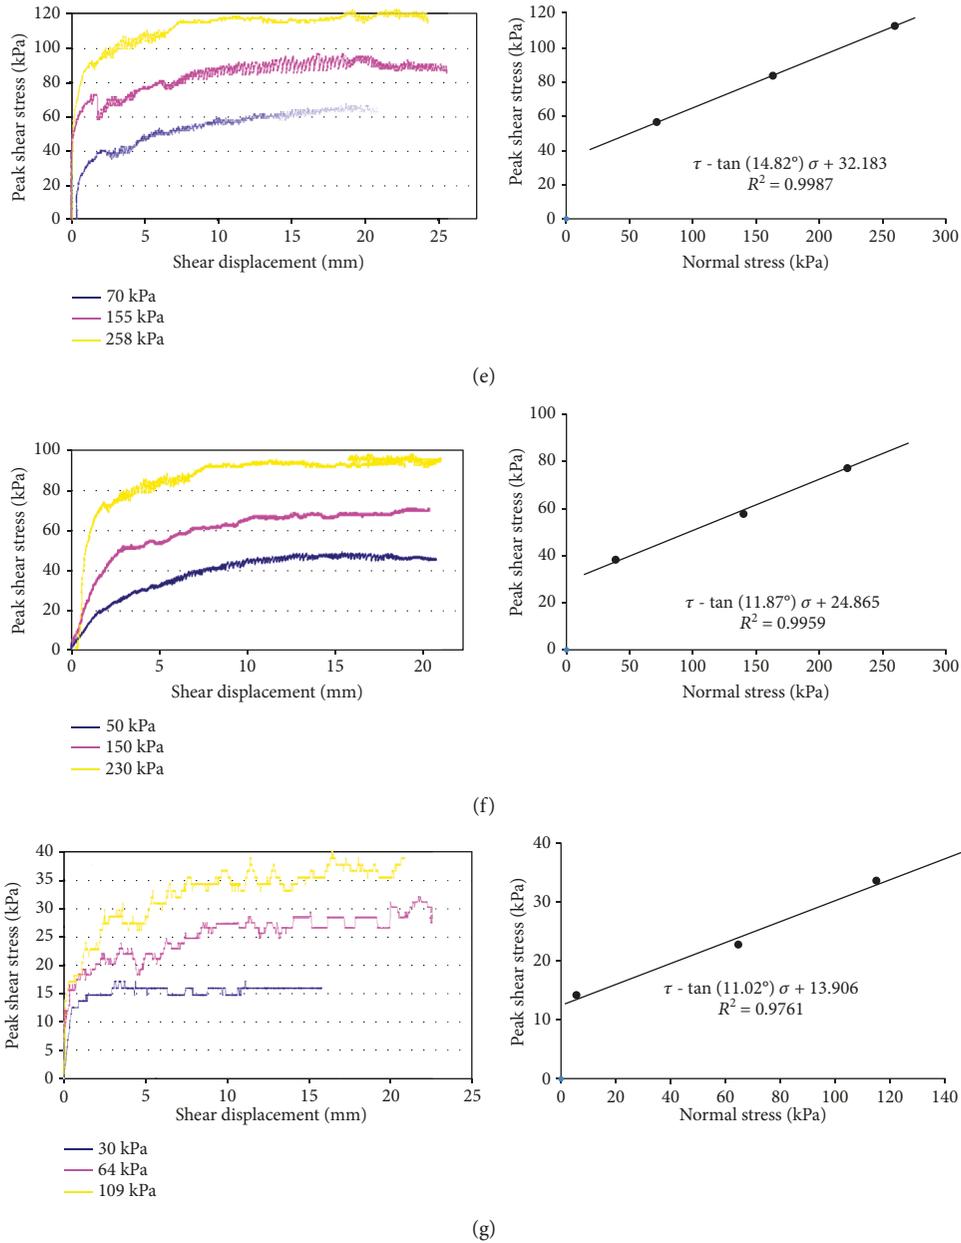
FIGURE 10: Medium-size direct shear test on remolded samples; shear stress-displacement curves and strength parameters of all seven groups.

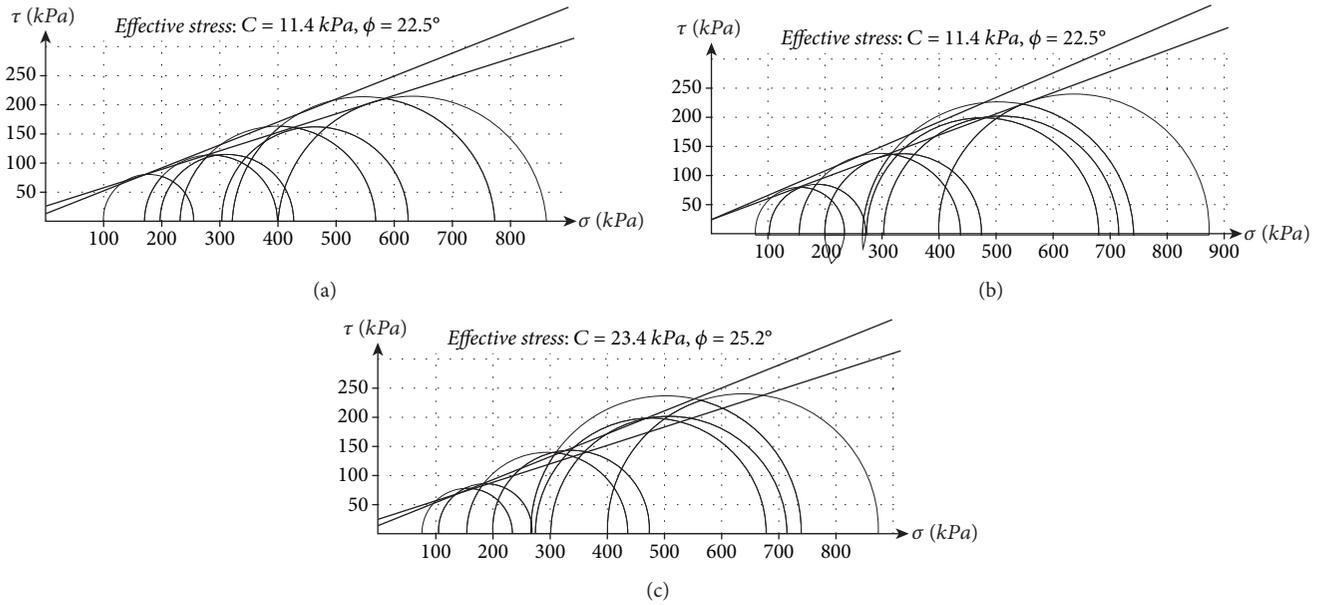
FIGURE 11: Tests fitting curve of soil samples for triaxial shear test (group a, b, and c).

3.3. The Triaxial Consolidation Undrained Shear Tests. Three triaxial shear tests for Dasha landslide were performed in consolidated-undrained condition. The results of shear tests are shown in Figure 11. The effective cohesion and angle of friction for groups A, B, and C are 11.4 kPa and 22.5° , 21.6 kPa and 24.1° , and 23.4 kPa and 25.2° , respectively (Figure 11 and Table 2). It is observed that the shear strength parameters including cohesion and angle of internal friction of all three groups (A, B, and C) are in very small range, showing the reliability of the results which were later used in the simulation process.

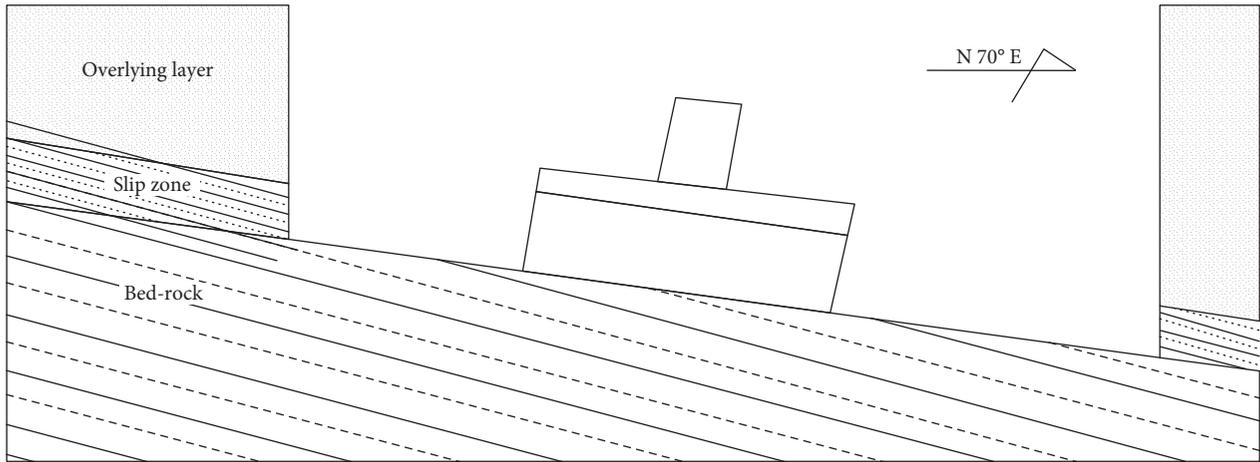
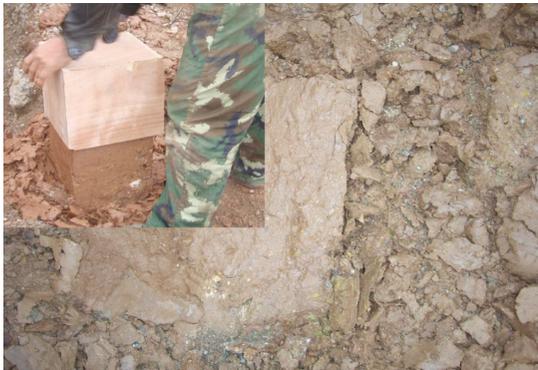
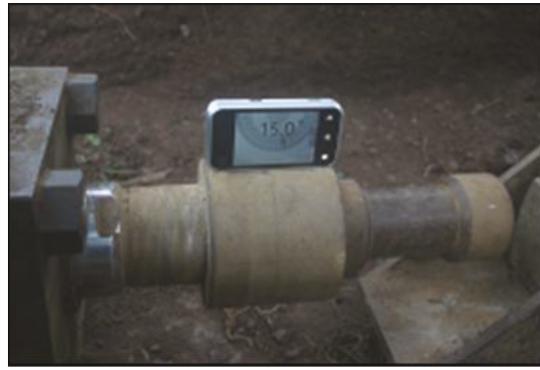
FIGURE 12: Sample preparation for test in field. (a) Schematic diagram of pruning samples, (b) inclined pruning samples, and (c) inclined push shear.

curves, the measured normal stress values were applied. There were six samples in the first group of tests; however, only four samples were remained effective. Four samples were used in the second group, and only three were proved to be effective. The normal stress of the tests was adjusted by manual pump control jack, and the horizontal shear force was applied through the electric pump drive jack with an average shear rate of 0.9 mm/min. The sample preparation process in the field is shown in Figure 12.

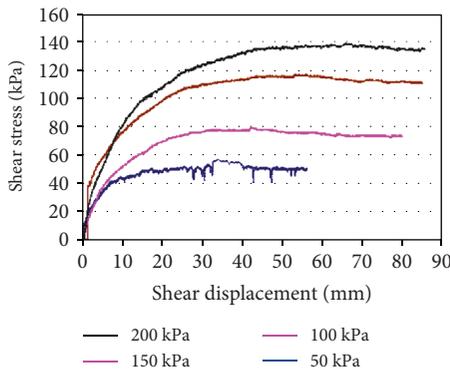
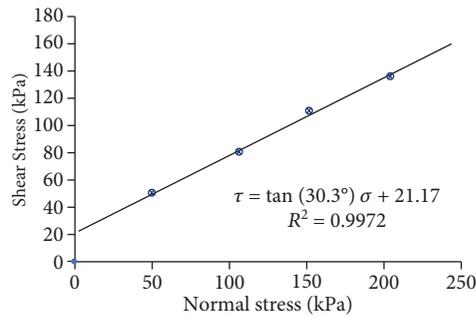
FIGURE 13: Shear stress-displacement curve and strength parameters of the first group.

174, and 200 kPa, the peak shear stress values are 50, 78, 110, and 137 kPa, respectively. The shear strength parameters in the form of cohesion and angle of friction are 21.17 kPa and 30.3°, respectively (Figure 13 and Table 3).

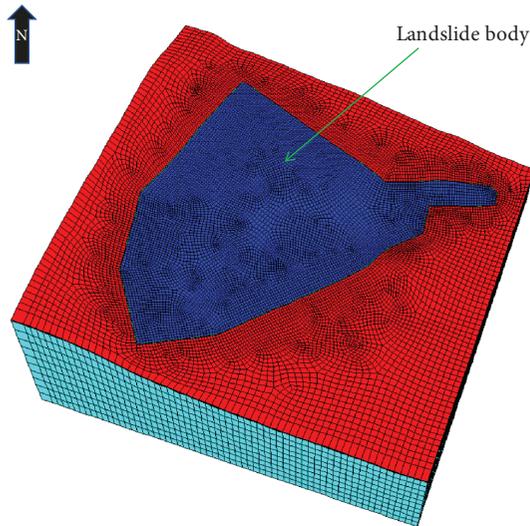
FIGURE 16: 3D numerical model of Dasha landslide.

5.1. *Three-Dimensional Stability Analysis Based on Strength Reduction Method.* FLAC 3D software is used for stability analysis. The model area is 880 m × 900 m. X-axis which is parallel with the cross-section 1-1' of the landslide with the

direction towards Jinsha River. Y-axis is vertical with respect to the cross-section 1-1' and the Z-axis with positive upward direction. The range of X-axis is 0~880 m, Y axis is 0~900 m, and Z-axis is from the elevation of 200 m up to the ground surface. Computational mesh is shown in Figures 16 and 17, and the model is divided into 182416 nodes and 166836 elements. In numerical analysis, the fixed constraints at the bottom of the model and normal constraints around the perimeter of the model were applied. X-axis is bounded by 0 m and 880 m, Y-axis is bounded by 0 m and 900 m, and Z-axis is bounded by 200 m. The slope materials were assumed to be perfectly elastoplastic and satisfy the Mohr-Coulomb failure criteria. Based on the actual geological and geomorphological conditions of the Dasha landslide, the numerical model was built which include the slip zone, the landslide, and the underlying bedrock. Three material layers were built including the slip zone, the landslide, and the bedrock. In order to obtain the geotechnical parameters of Dasha landslide, the in situ tests, as well as laboratory tests, were carried out. The parameters used in numerical modeling are shown in Table 4; bulk modulus (K) and shear modulus (E) were converted from Young's modulus (E) and Poisson' ratio (ν). The initial stress under the gravity and hydrostatic pressure were calculated under natural conditions.

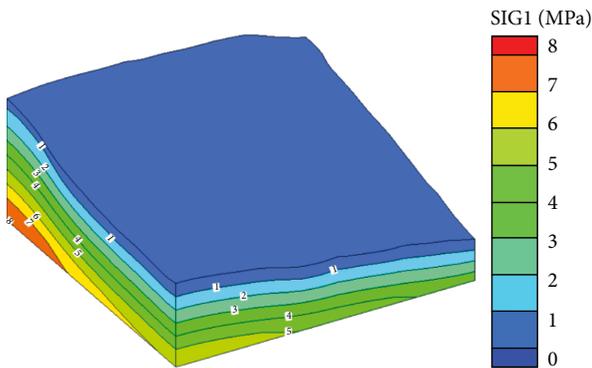
FIGURE 18: Maximum principal stress of Dasha landslide under the gravity.

5.2. Three-Dimensional Strength Reduction Analysis without Consideration of Groundwater. Every strength reduction calculation is carried out by using the test of transfixion of slip plastic zone. Under the natural conditions without considering groundwater, the maximum principal stress distribution is shown in Figure 18 and the development process of slip plastic zone is shown in Figure 19. When the strength reduction factor (RF) reaches 1.212, it indicates that the continuous yield area has basically formed in the slip zone, with only a small range of area not reaching the yield limit, i.e., the factor of safety of the landslide is 1.212. The distribution and development of the slip plastic zone at the left side and the middle upper side enter the plastic phase earlier than the right side. The maximum principal stress of Dasha landslide within the range of the numerical simulation is about 8.0 MPa; the maximum principal stress of the slope is about 0.1 MPa. The principal stress values of the landslide range approximately from 0.4 MPa to 0.8 MPa. The maximum principal stress whose direction is nearly vertical is almost equal to the vertical stress.

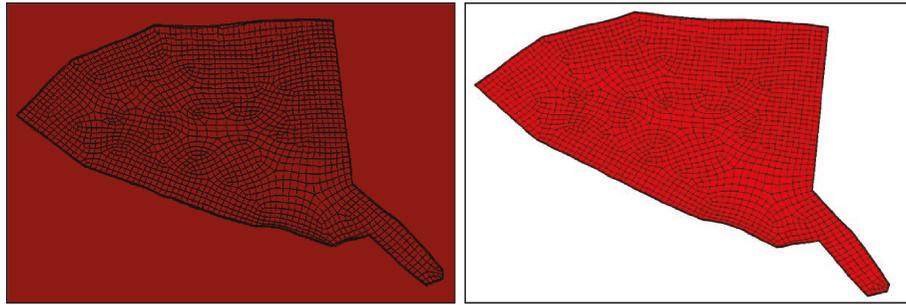
FIGURE 19: Plastic zone of Dasha landslide slip surface under the gravity.

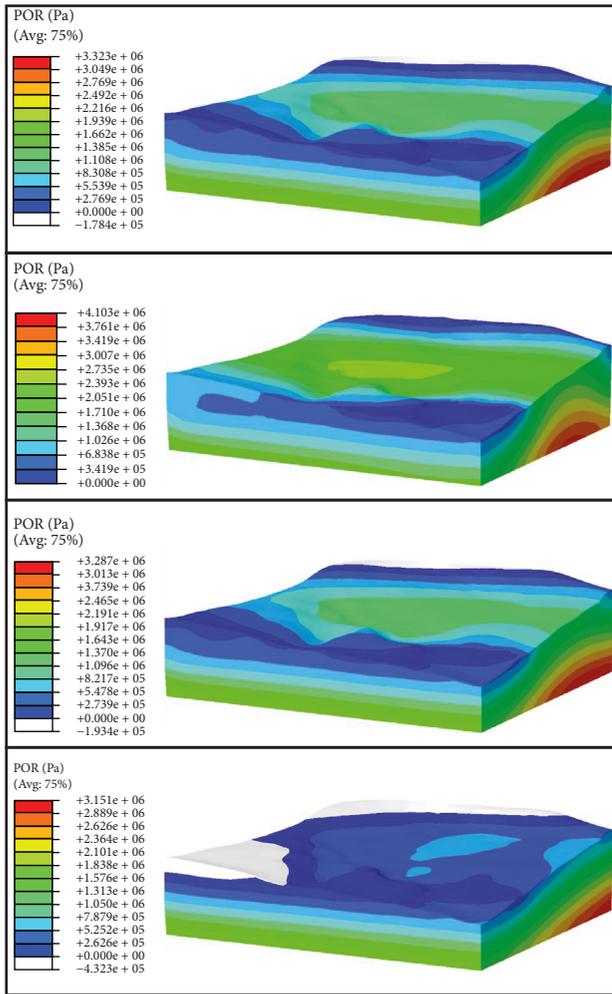
FIGURE 20: Distribution of water pressure of Dasha bank slope (rainfall in 2 hours is 94.7 mm).

5.3. Three-Dimensional Strength Reduction Analysis with Effect of Rainfall and Reservoir Filling. This condition is after the final phase of reservoir filling, which reflects the global stability of Dasha landslide with the consideration of the groundwater, reservoir level of 380 m, and rainfall conditions. For numerical simulation under the condition of heavy rainfall, the transient flow analysis is used. Under the condition of heavy rainfall, the changes of water pressures of Dasha landslide are shown in Figure 20. The figure shows that during heavy rainfall, the water pressures keep increasing gradually with the increase in rainfall, and the saturation line gradually increases as well. After the rain water pressure decreases, the saturation line gradually reduces to a particular reservoir level. The change of water pressures is not very significant after the rainfall. Under the condition of heavy rainfall of 94.7 mm in 2 hours, the factor of safety obtained by strength reduction method is 0.991, which does not meet the standards of safety requirements (Table 5).
