Research Article

Deformation and Failure Characteristics and Control Technology of Roadway Surrounding Rock in Deep Coal Mines

Key Laboratory of Safe and Effective Coal Mining of the Ministry of Education, Anhui University of Science and Technology, Huainan 232001, China

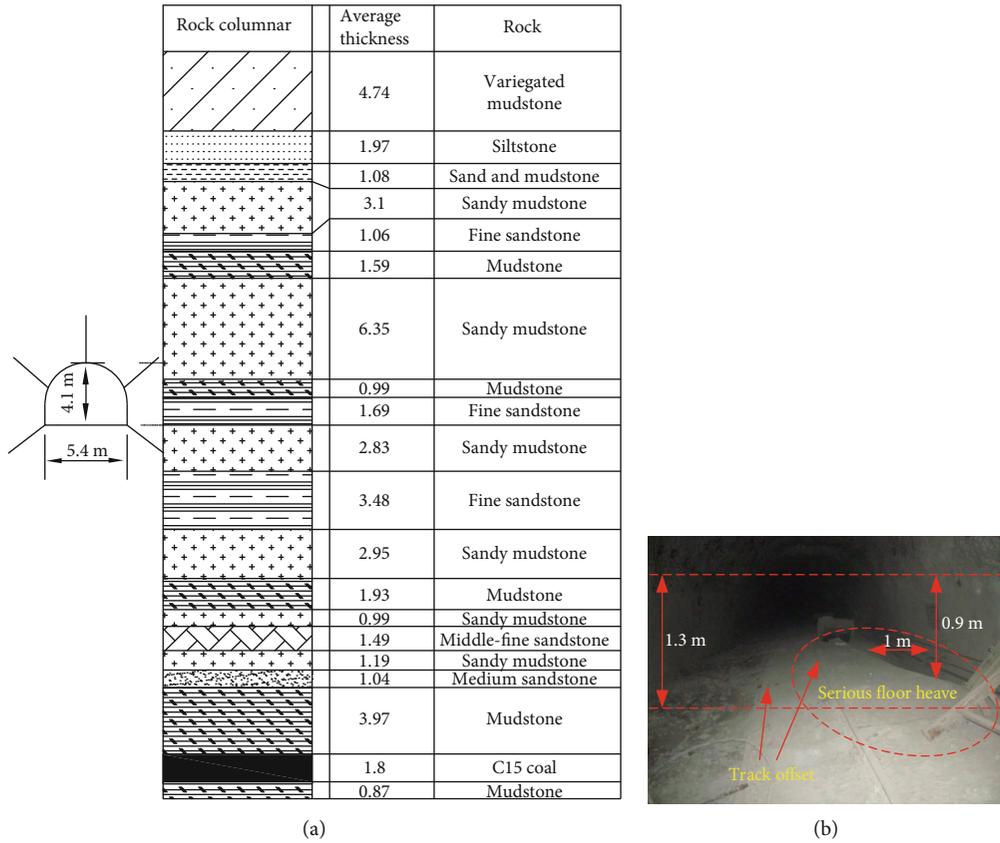
FIGURE 1: Roadway overview. (a) Borehole columnar section. (b) Floor heave figure.

The Xieyi Mine is located in Huainan City, China. Its primary horizontal transportation roadway is at a depth of -960 m, with a length of 2400 m. The roadway is approximately 20 m above the C15 coal seam. The coal seam is predominantly embedded in mudstone, sandy mudstone, and fine sandstone. The cross-sectional shape is a semicircular arch with a straight wall, a clear width of 5.4 m, and a clear height of 4.1 m. The maximum horizontal principal stress in the area is 20 MPa, and the lateral pressure coefficient is approximately 1.1. The location of the rock layer and the lithology of the roof and floor of the roadway are shown in Figure 1(a). As shown in the geological histogram, the immediate roof and floor of the roadway are sandy mudstone, and the two sides are mudstone. The lithology around the roadway is poor, and it is extremely prone to deformation and destruction from high stress and water.

The original support scheme of the roadway involved bolting, cables, and shotcreting with wire mesh on the roof and both sides; the floor was not supported. After 60 days of excavation, the maximum displacement at 1 m and 5 m of the inner side of the support were 20 mm and 2 mm, respectively. The maximum displacement 1 m above the roof of the roadway was approximately 24 mm, and the maximum displacement at 4–6 m was approximately 6–7 mm. After 100 days, the maximum displacement of the floor 1 m from the roadway was 55 mm. The surrounding rock was substantially deformed; both the bolts and the cable were broken, and the floor heave was severe. As shown in Figure 1(b), the floor of the tunnel was broken, and the track moves left. Even after repeated floor-cutting work on site, the conditions were not adequate. Therefore, it was necessary to study the deformation and failure characteristics of the roadway in the laboratory and summarize the mechanism of the tunnel's deformation and failure to establish targeted floor heave control measures.

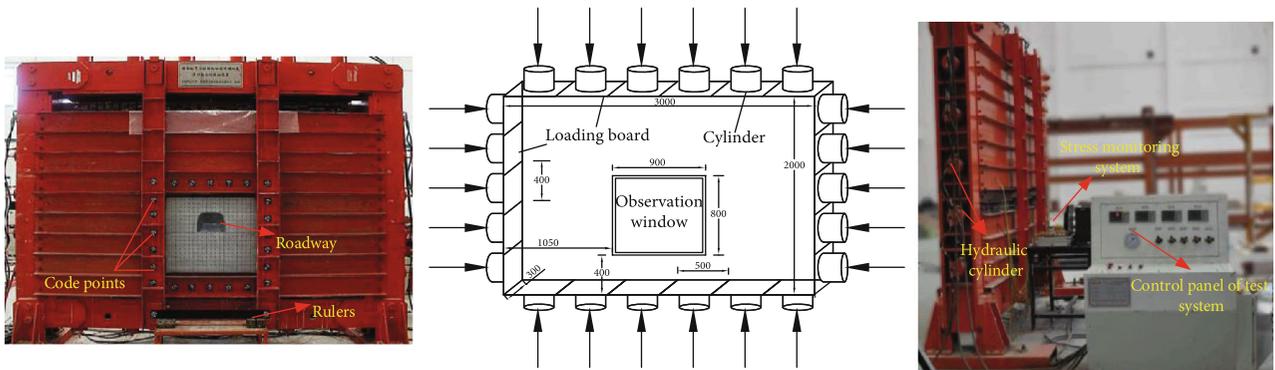
FIGURE 2: Model system. (a) The test model frame. (b) The model loading schematic. (c) The experiment control system and stress monitoring system.

A similar simulation experiment loading system primarily includes a model steel frame, restraint channel steel, observation window, hydraulic oil circuit, and load control system. The system applies a load to the model material through cylinders and loading plates in four directions of up, down,

left, and right. The dimensions of the test loading system are shown in Figure 2.

The console panel has 5 pressure control knobs and 4 display screens to display the cylinder pressure in the four directions in real time. There are 6 loading plates on the top and bottom, and 5 loading plates on the left and right, each of which corresponds to a hydraulic cylinder (Figure 2(b)). The pressure applied to the roof, sides, and floor in four directions can be controlled by a knob, and the loading board is linked in real time. The horizontal and vertical stresses in

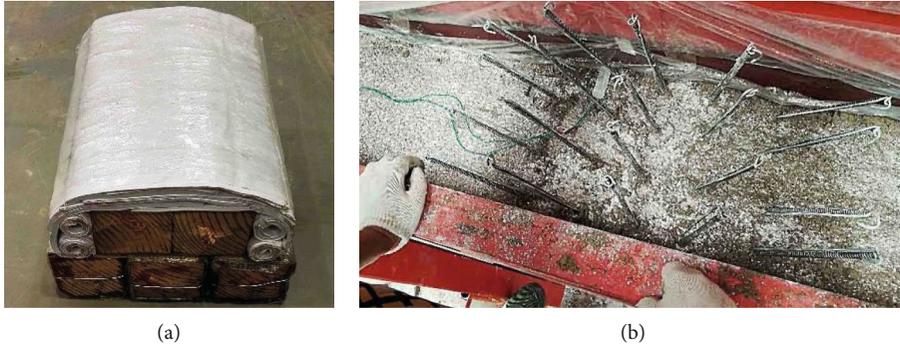
FIGURE 3: Roadway filling body and supporting structure. (a) Roadway model. (b) Roadway supporting.

3.2. Model and Monitoring. The roadway was prefabricated. Wood strips were used for filling before excavation and were extracted during excavation. The roadway was supported by a combination of steel wire mesh, bolts, and cables. The bolts and cables were made of type 15 and 16 wires, respectively. Considering the strong adhesion between the grouting bolt and surrounding rock, the cylindrical spiral spring was fixed outside the wire. The cable primarily served for suspension purpose; hence, the ends of the cables were shaped as hooks (Figure 3).

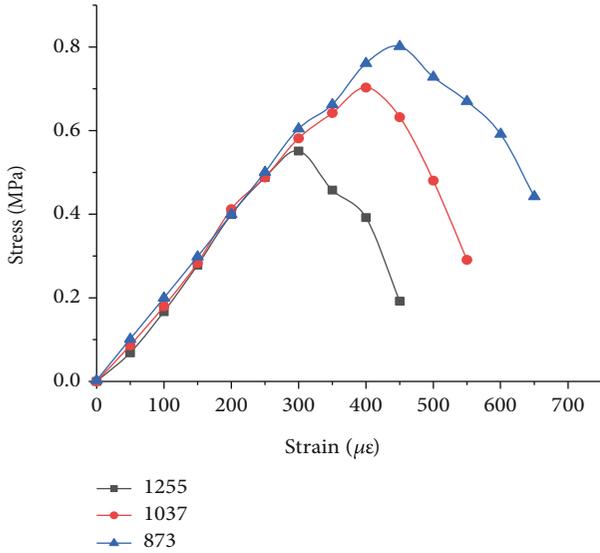
FIGURE 4: Strain gauge calibration curve.

In addition to the aforementioned calculation, sensors were fabricated for stress monitoring and were calibrated to analyze the stress state variation due to relative strain. The laboratory calibration curve of the strain gauge used in this test is shown in Figure 4.

The three elastic stages of the curves reflect the relationship between the relative strain measured by the strain gauge

in the model and the stress state. The equation $\sigma = 0.00195\epsilon$ was obtained by fitting the curves.

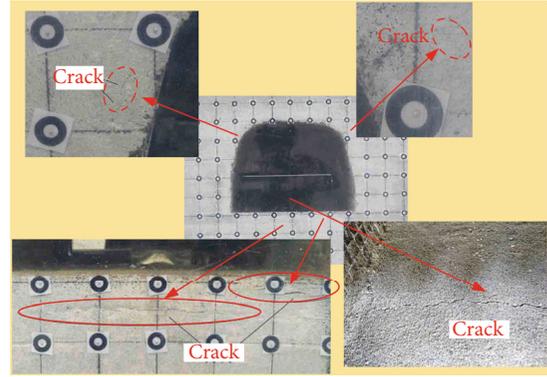
FIGURE 5: Cracks in the surrounding rock of the roadway.

(1) Initial Deformation Stage. The following experimental data were converted into corresponding prototype data. Cracks had developed when the surrounding rock and roadway support were combined and stabilized after the roadway excavation (see Figure 5). Cracks had formed within 0.4 m from the surfaces of the two sides of the roadway, with a length of approximately 0.2 m and at the lower right corner of the roadway, with a length of 1 m, which were caused by shear dislocation. Additionally, cracks with a length of up to 2 m also formed 0.4 m below the floor. The crack development trend was that the roadway formed a circle, conforming to the law of zonal fracture. Due to the compression and non-tension of the rock stratum, with horizontal stress, the tensile strain and cracks appeared in the floor. After loading for a few minutes, the floor began to warp upwards. The roadway contour and the circular fissure development before and after deformation are shown in Figure 6.

During the first stage (see Figures 5 and 10(a)), the roof was in the state of pressure relief, the floor was in the free surface, and a stress concentration was formed at the center and corner of the floor, which resulted in the floor deforming and generating cracks. Because of a stress concentration near the top corner, a small crack appeared in the side, and the floor suffered more damage than the side did. With time, the roof of the roadway was still under pressure relief, and the stress concentration factor of the floor reached 1.3. Additionally, the damage to the floor had increased. However, the stress at the midpoint and floor corner of the support was greater than that of the protolith, and the degree of damage to the support became larger. During the mild deformation stage, the roof and floor were in the pressure relief state, the top corner and the roof were in the stress concentration state. The top corner and the roof began to gradually fracture.

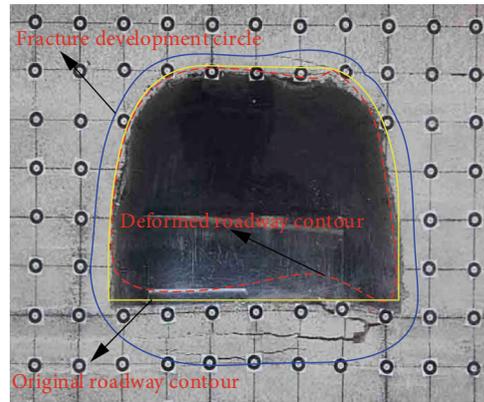
FIGURE 6: Roadway outline during slow deformation.

After the roadway excavation, under the transfer of self-weight stress and horizontal stress, the floor deformed at the free surface, and the floor heave increased gradually with time. The plastic zone gradually expanded to the depth of the floor. At this time, the maximum destroying depth was approximately 1 m. Due to self-weight stress, the surface of the roof at 2 m from the right side of roadway had begun to bulge.

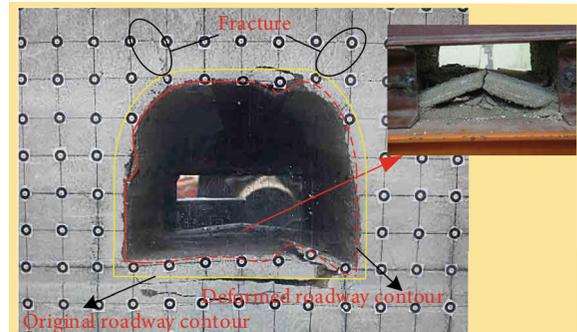
FIGURE 7: Deformation roadway profile during fissure development.

increased significantly after entering the second stage, resulting in severe floor heave. In the highly deformed area, the roadway floor bulged and broke (Figure 7), and the highest point of breakage was 0.5 m higher than the right-side corner of the roadway. The floor had broken along the axis direction of the roadway, with the most substantial floor heave in the middle of the floor. Furthermore, the deformation of the left side was significant, while that of the right side was small, and the entire roadway was noticeably compressed.

During this stage, the roof continued to sink, especially 2 m from the right side. The original bulging continued to develop. Approximate V-type fracture appeared at the top corner of the roadway roof, presenting obvious shear dislocation.

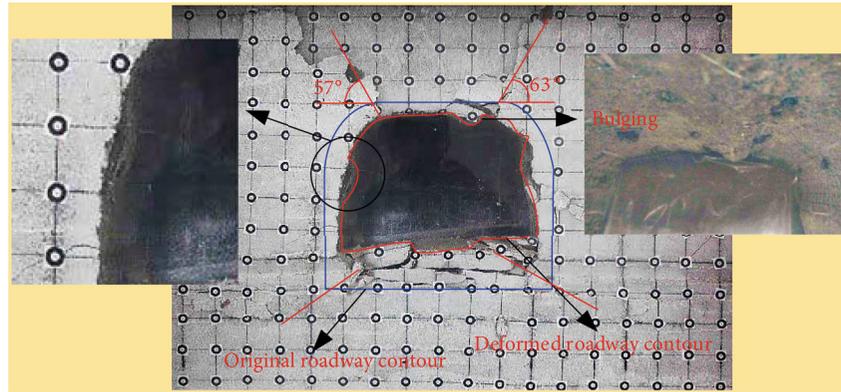
FIGURE 8: Deformation roadway profile during mitigating deformation period.

(3) Mild Deformation Stage. After the fissure development in the first two stages, the mild deformation stage was characterized by deformation and failure toward the end of the experiment. The rock pressure appeared as a 1.5 m-deep fractured zone beneath the floor, from which horizontal and gravity stresses were transferred to the floor, which had a lower support strength; in addition, massive folds and block dislocations had been formed in the aforementioned zone. When the two sides converged at the center of the roadway due to the deep high-ground stress, the sectional area of the roadway was reduced by approximately 1/3. Furthermore, an arc phenomenon had formed between the left side wire mesh and the spray layer and surrounding rock

Shear failure had formed at the two top corners and bottom corners of the roadway (see Figure 8). Due to the stress concentration, the entire structure appeared to have undergone X-shaped failure. According to the Mohr-Coulomb criterion, the angles of fracture were 61° for the top corner, 57° for the left side, and 63° for the right side.

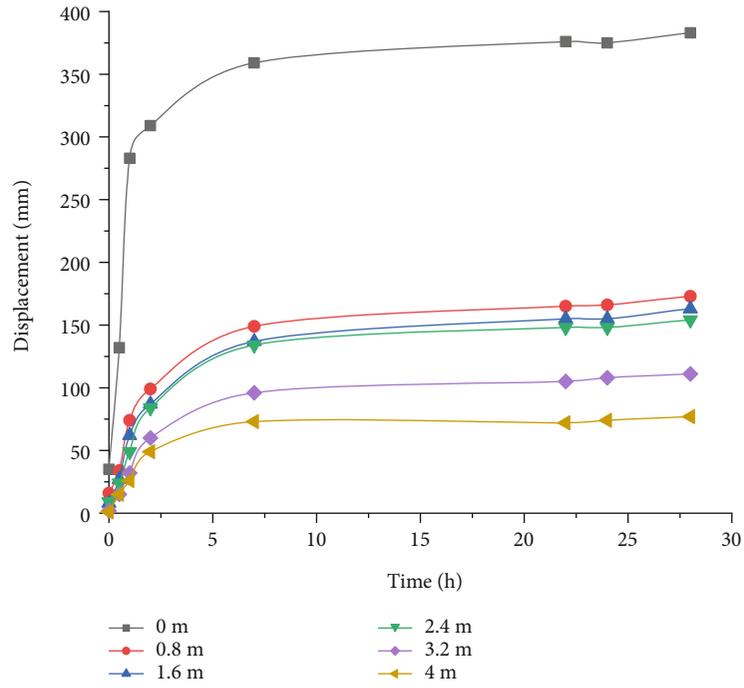
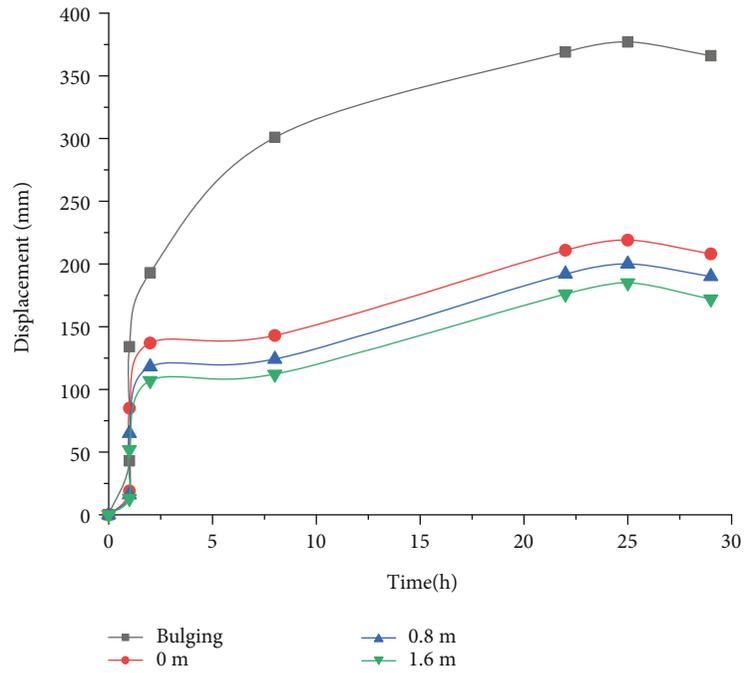
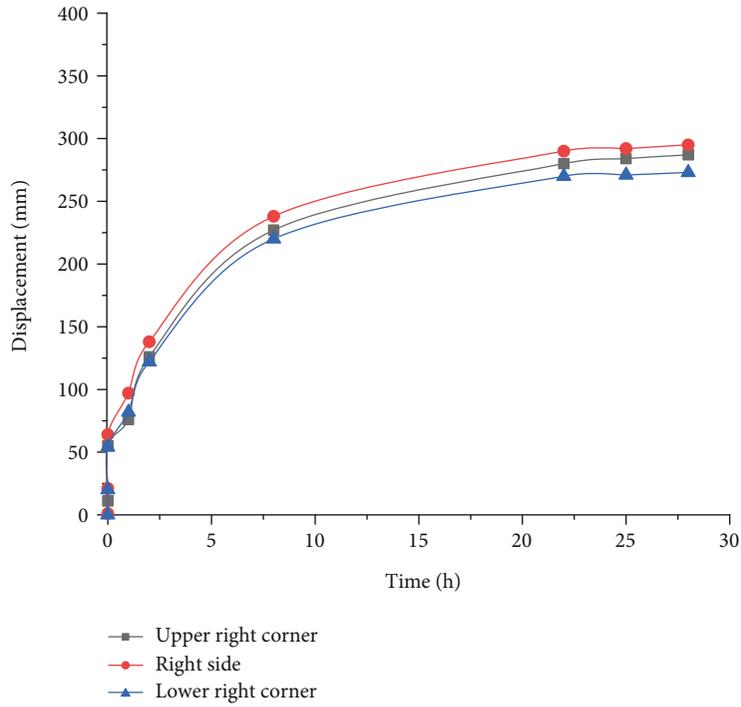
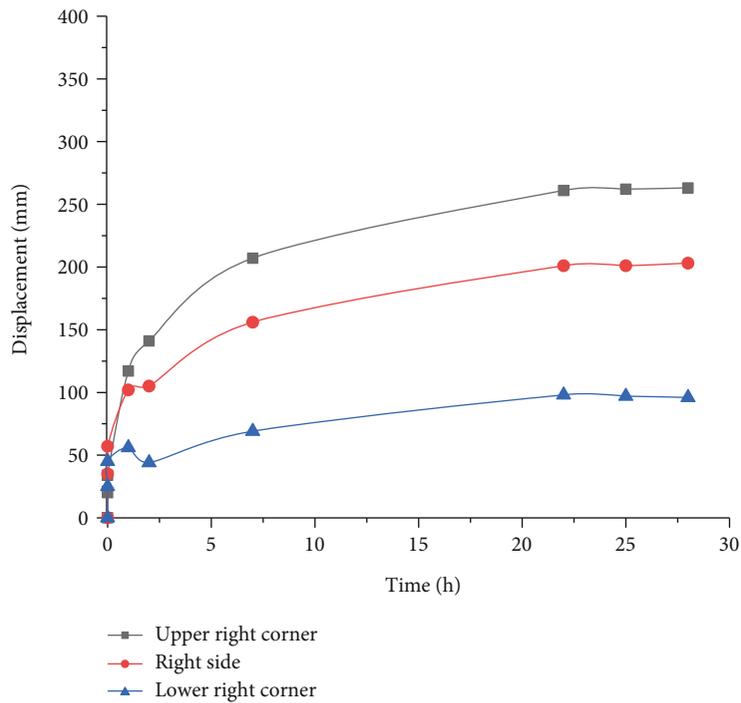
(a) Floor

(b) Roof

(c) Right side

(d) Left side

FIGURE 9: Displacement of surrounding rock in roadway.

3.3.2. Displacement Analysis of Surrounding Rock. The data measured using the three-dimensional optical photogrammetry system are shown in Figure 9. The surrounding rock of the experimental roadway underwent plastic deformation within 0.5 h after excavation, the displacement at different locations constantly increased, and the tunnel gradually

converged. Within 0.5–2 h, both the floor and the roof underwent severe deformation, which was characterized by an increase in the displacement rate, and deep fissures continued to develop, while the time for severe deformation of the floor was 0.5–6 h. After 6 h, the displacement rate gradually stabilized, but the surface displacement of the floor reached 380 mm, which could severely affect the usage of the trans-

Six measurement points, at depths of 0 m, 0.8 m, 1.6 m, 2.4 m, 3.2 m, and 4 m below the floor, were selected. The displacement change trend under the floor was the same as that on the floor surface, but the change rate was different. The farther away from the floor surface, the lower the change rate.

Additionally, four measurement points, the bulge of the roadway surface and 0 m, 0.8 m, and 1.6 m above the roof were selected. The displacement trend above the roof was also the same as that on the roof surface, but with a different change rate. The farther away from the surface, the lower the rate. It can be seen from the two sides that the inward convergence of the roadway was different and represented an asymmetric deformation. During self-stabilization after the roadway excavation, deformation and destruction had occurred. Due to the strength of the support, the displacements of the roof and two sides were controlled well, the floor became a weak surface, and the stress exceeded the long-term strength of the rock. Over time, the floor was gradually destroyed at a high deformation rate.

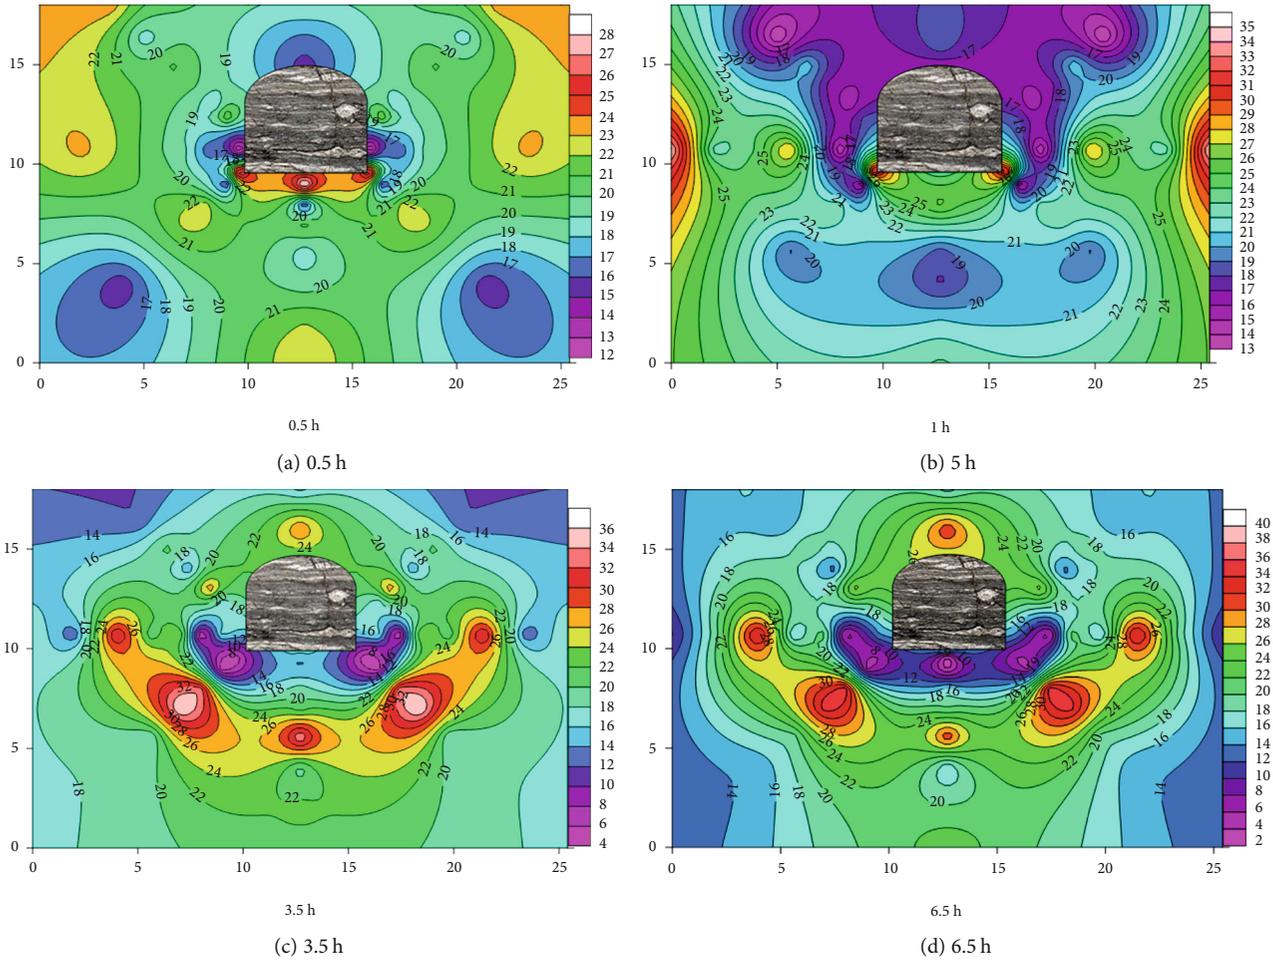
FIGURE 10: Stress cloud of surrounding rock in roadway.

3.3.3. Analysis on Stress Evolution of Surrounding Rocks. According to the vertical stress data measured using the strain gauge, the contour diagram was obtained using the SURFER software (Figure 10) (stress units of MPa).

After roadway excavation, in the initial deformation stage, the side wall was in the stress reduction area, and the stress increased until the cracks had become more serious during the fissure development stage. The side walls converged when squeezed under the vertical stress. However,

the stress concentration was maintained at the corner of the floor, and within 8 m, below the floor until the second stage. The stress release from the floor bulged upwards, causing damage, and the stress concentration occurred in the range of 1.5–3.0 m above the roof. In combination with the displacement changes and stress cloud, the roof stress shifted to the two sides and floor during the fissure development stage and released stress during the mild deformation stage.

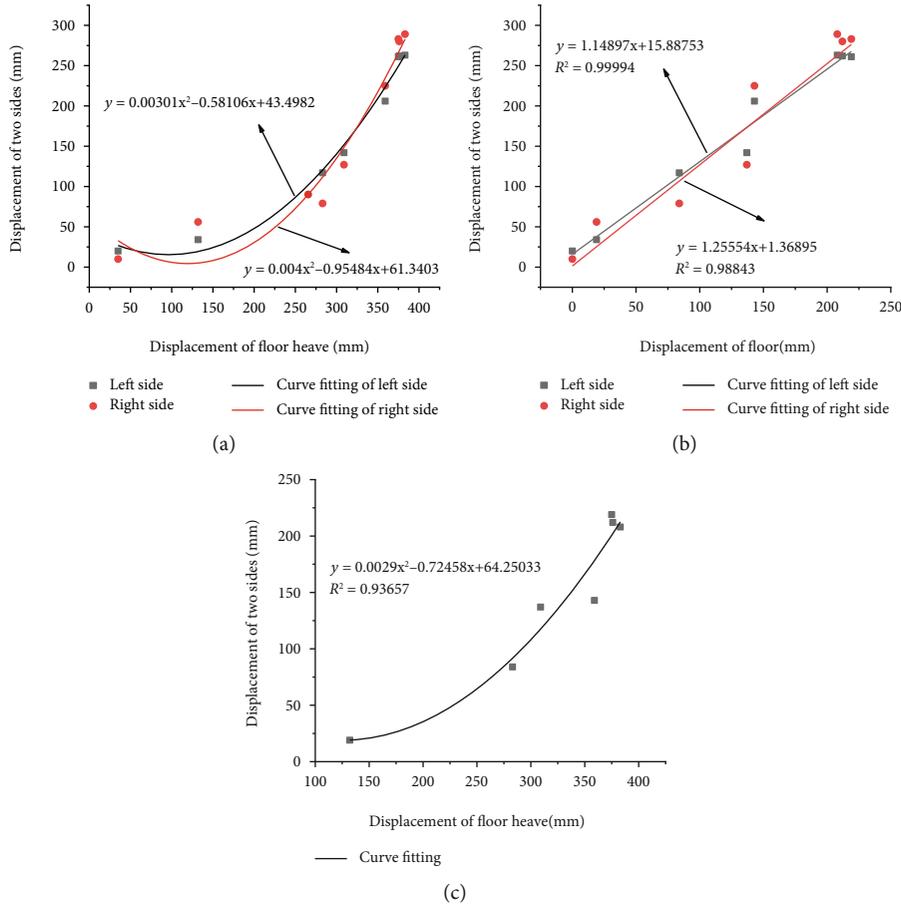
FIGURE 11: The displacement relationships between the floor heave, two sides, and roof. (a) The relationship between floor heave and the displacement of the two sides. (b) The relationship between roof subsidence and the deformation of the two sides. (c) The relationship between roof subsidence and floor heave.

The curves of the vertical displacement of the floor and roof and the horizontal displacement of the two sides were drawn and fitted (Figure 11). The floor heave is a quadratic function with the displacement of the two sides. With the increase in the floor heave, the deformation of the two sides intensified, especially after the floor heave reached 200 mm when the deformation rate was more apparent. There is a linear relationship between the roof subsidence and the displacement of the two sides. The deformation of the two sides was larger than that of the roof, and the two sides underwent asymmetric deformation. The deformation of the right side was larger than that of the left side after 140 mm. There is a quadratic relationship between the roof subsidence and the displacement of floor. After the floor heave reached 250 mm, the deformation speed of roof subsidence increased sharply, which indicates that support gradually began to lose stability.

According to the analysis presented above, the deformation of the floor heave affected the two sides and the two sides affected the roof. The roof subsidence caused further deformation of the floor. In order to control the floor heave, it is necessary to consider the two sides and the roof. To maintain the roof, we need to control the two sides, and to control the two sides, we need to protect the floor. The roof, sides, and

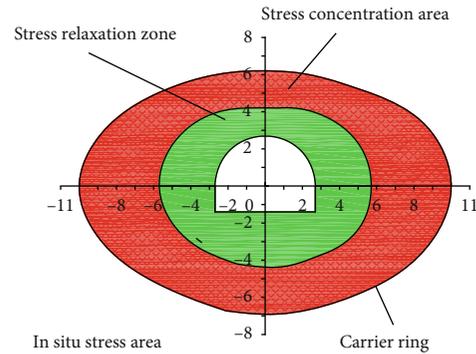
FIGURE 12: Schematic diagram of partition.

After the failure of the roadway, the surrounding rock is divided into a decreasing stress area, rising stress area, and primary rock stress area (see Figure 12). The load-bearing ring is 3.4 m above the roadway and 5.6 m below the roadway, and the decreasing stress zone is 1.5 m above the roadway and 3 m below the roadway. The range of the load-bearing ring and the decreasing stress zone for the floor is larger than that of roof.

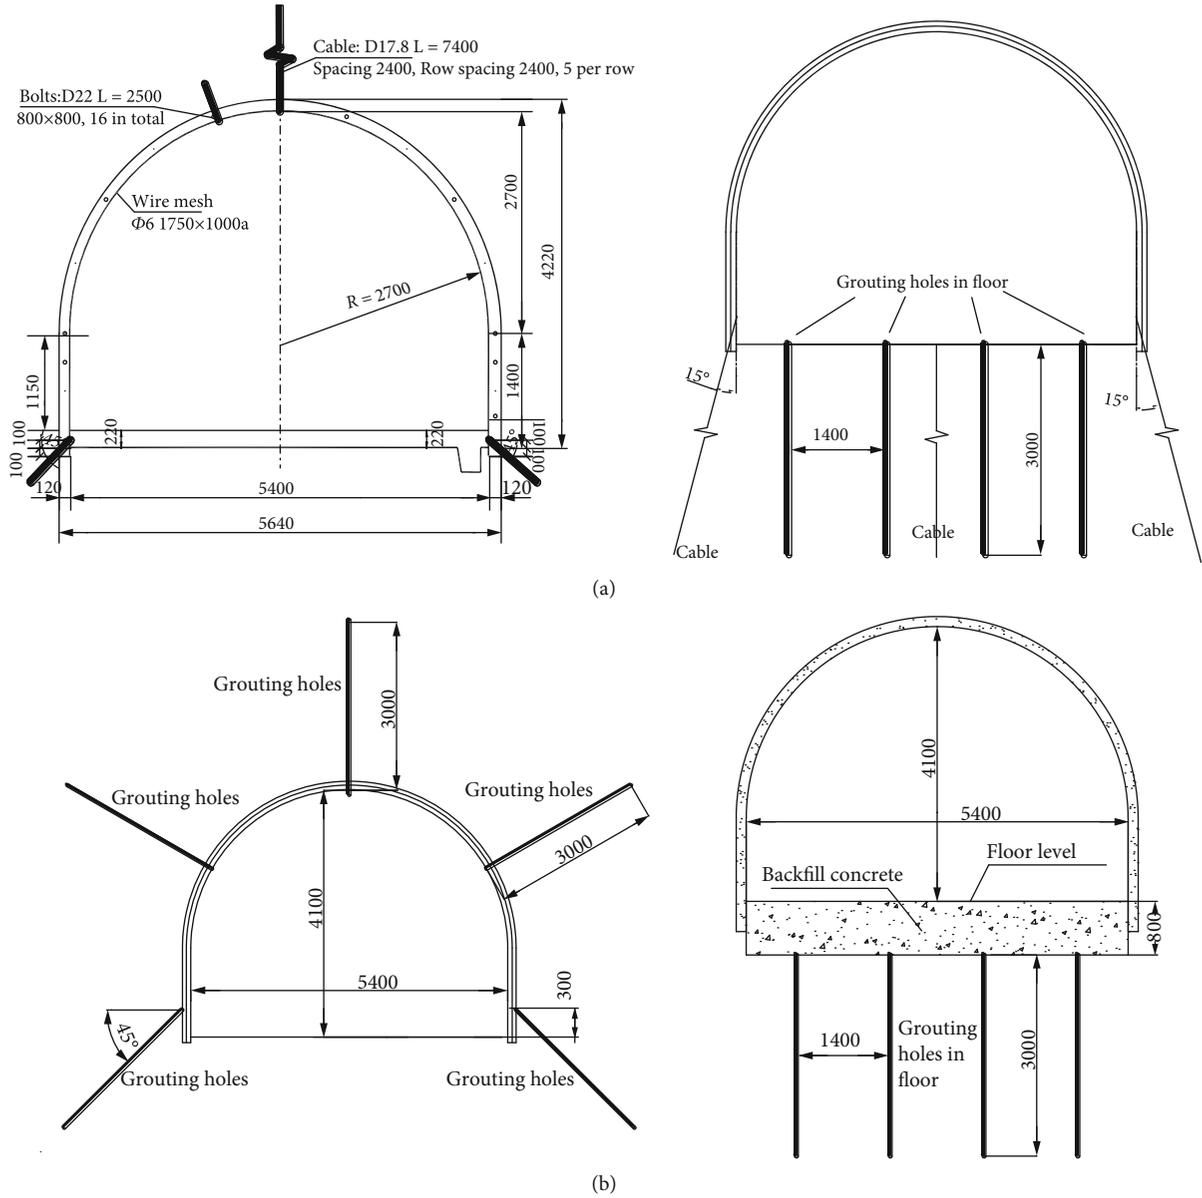
FIGURE 13: Cross-section of roadway.

The supports should consist of spatiotemporal coupling, so that the roof, floor, two sides, and the key parts can be effectively maintained within the service life of the roadway. Based on this requirement, overexcavation anchor injection backfilling technology can be used to comprehensively control the floor heave of the deep high-stress roadway [26, 27]. The specific measures are as follows: after the excavation of the tunnel, 50 mm of concrete is initially sprayed, and then the wire mesh is hung; then, the prestressed and high-strength anchor bolts are used for the shotcreting support of the anchor mesh, and the prestressed anchor cable support is placed in the key parts (top angle and bottom angle), and then a second 100 mm layer of shot concrete is sprayed. After the convergence of the tunnel in the initial deformation stage, the floor is grouted and reinforced. In areas with unfavorable engineering geological conditions, the roof and key parts are grouted, and the floor is backfilled with concrete via overexcavation. The specific support parameters and design drawings are shown in Figure 13.

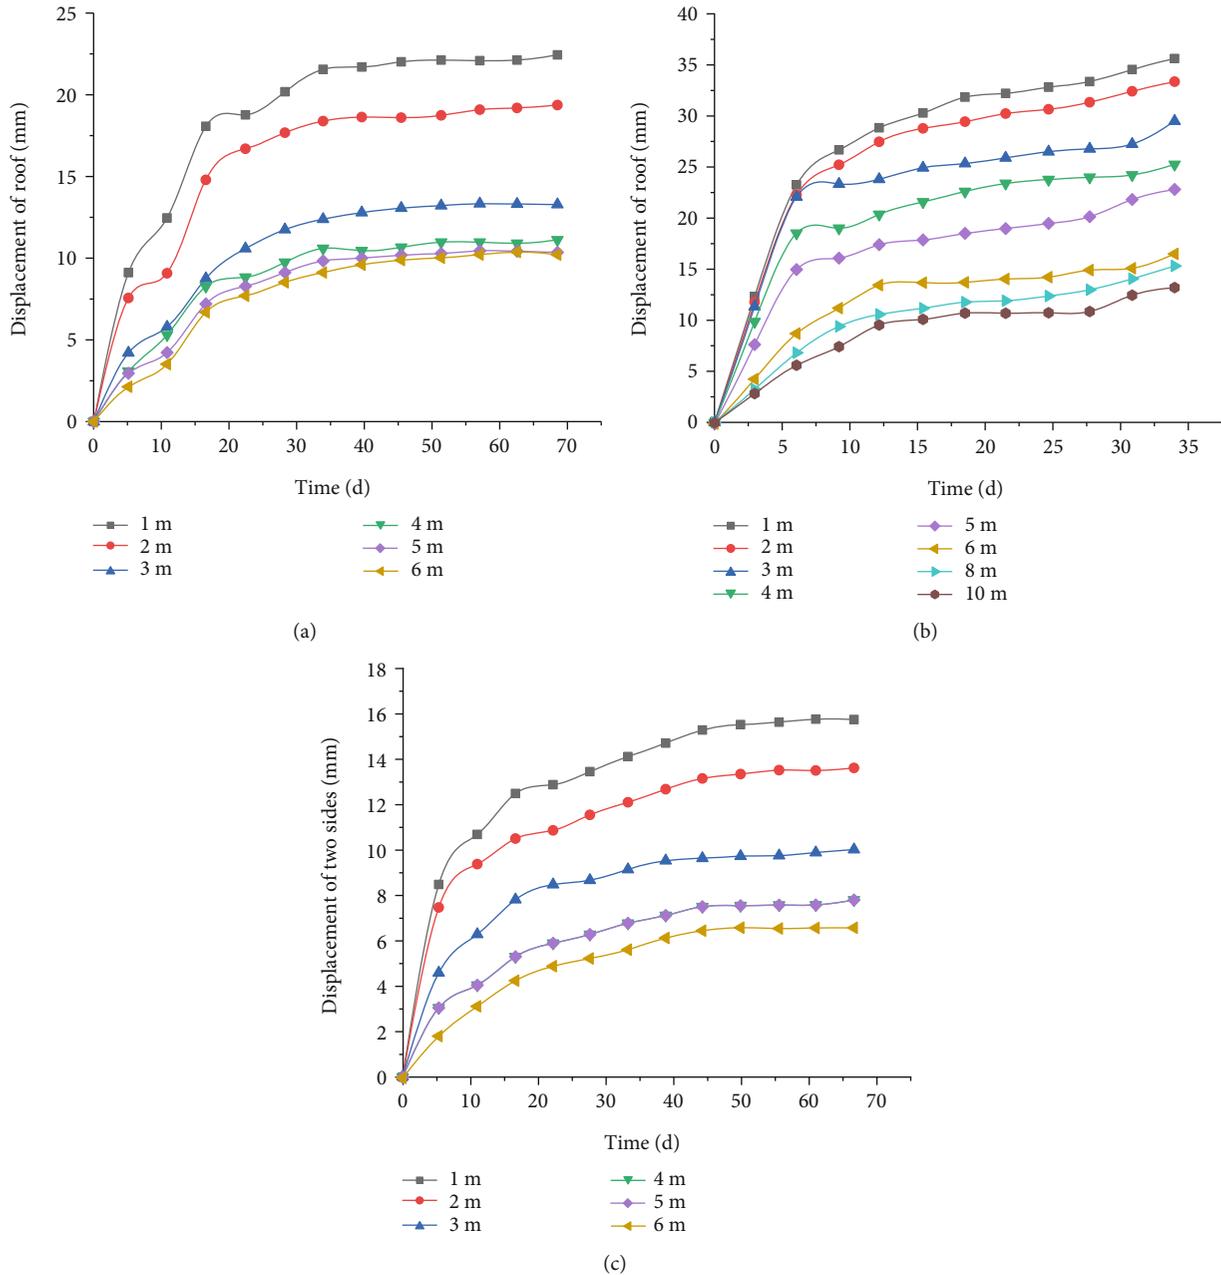
FIGURE 14: Displacement curve of surrounding rock of roadway in improved scheme.

5.2. On-Site Monitoring. After the completion of construction, a multipoint displacement meter should be installed in the surrounding rock, and 6 measuring points should be installed in the roof and sides at 1 m, 2 m, 3 m, 4 m, 5 m, and 6 m from the roadway surface; 8 measuring points should be installed in the floor at 1 m, 2 m, 3 m, 4 m, 5 m, 6 m, 8 m, and 10 m from the roadway surface. The field observation results of the measurement points in the surrounding rock of the tunnel are shown in Figure 14.

The displacement and velocity of the roof and the two sides decreased significantly. After 60 days, the displacement after the installation of the new support was approximately 50% less than that with the original scheme, while the displacements of the two sides were 25% less than that with the original scheme. Moreover, 35 days after the excavation of the roadway, there was no significant change in the roof and the two sides of the roadway. Although the initial deformation of the floor was slightly larger than that before the improvement, the deformation rate of the floor was significantly reduced, and the duration of the floor displacement

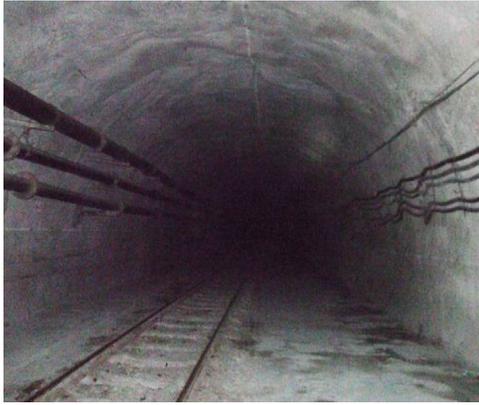
FIGURE 15: The supporting effect diagram.

in the fissure development stage was significantly shorter than before, which went from 15 days to within 6 days. Therefore, it was verified that the new support scheme could effectively control the surrounding rock (Figure 15).
