Research Article

Deformation Mechanism and Control Technology of Surrounding Rock in the Deep-Buried Large-Span Chamber

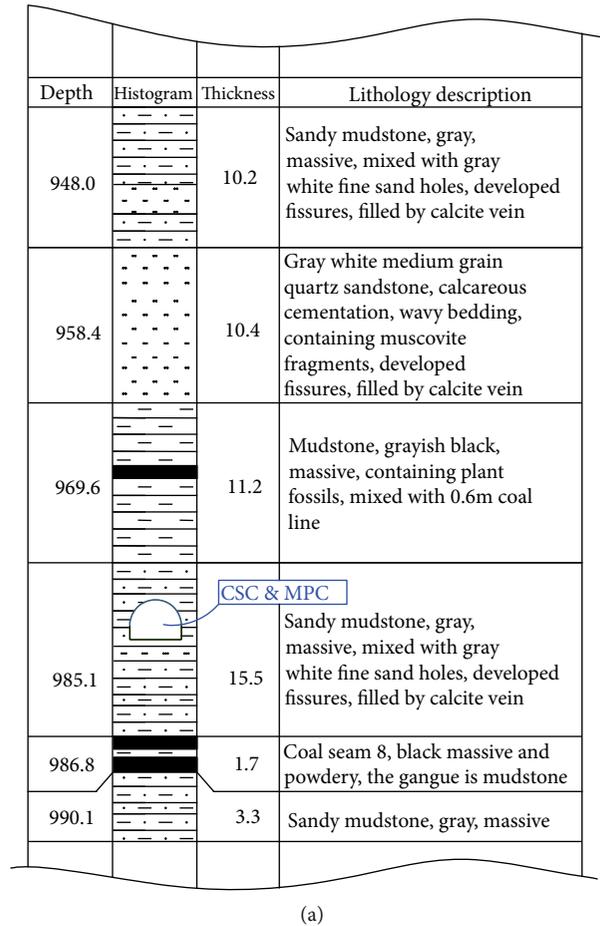
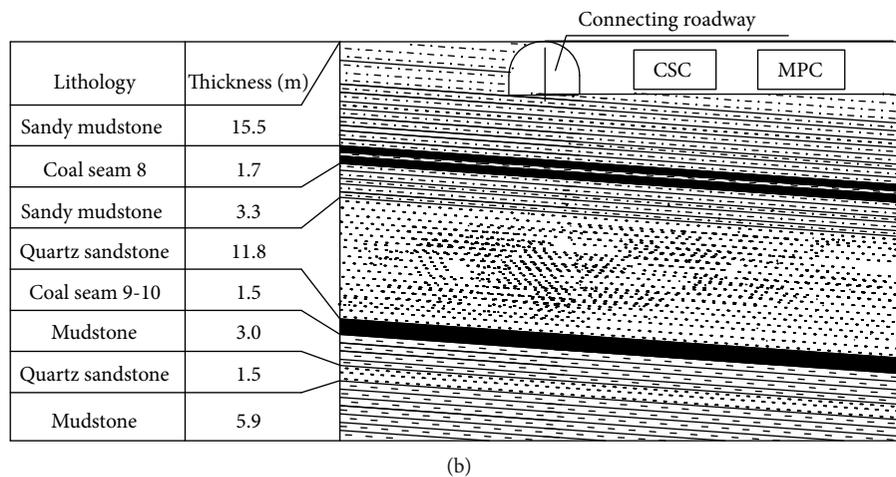
channel are located in the grey-black mudstone stratum, with general rock stability and no water inrush. MPC and its channel are located in grey sandstone and sandy mudstone stratum, with conventional rock stability, developed fracture, and no water inrush. The lithology of the two chambers is illustrated in Figure 1.

FIGURE 1: (a) Stratigraphic histogram of CSC and MPC. (b) Schematic diagram of floor strata of CSC and MPC.

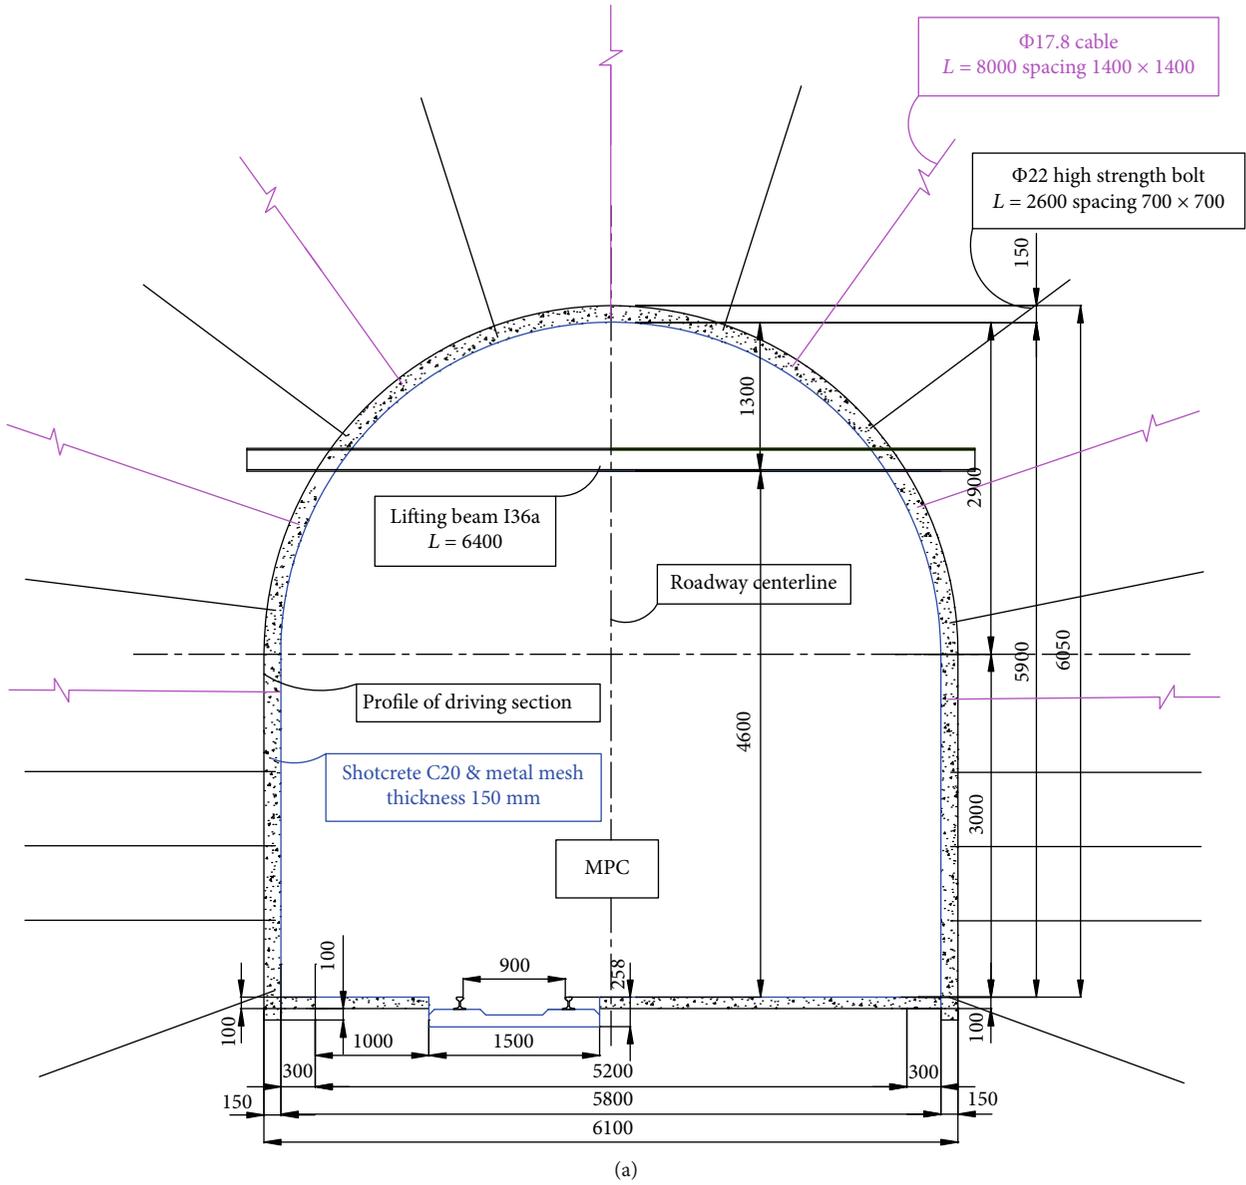
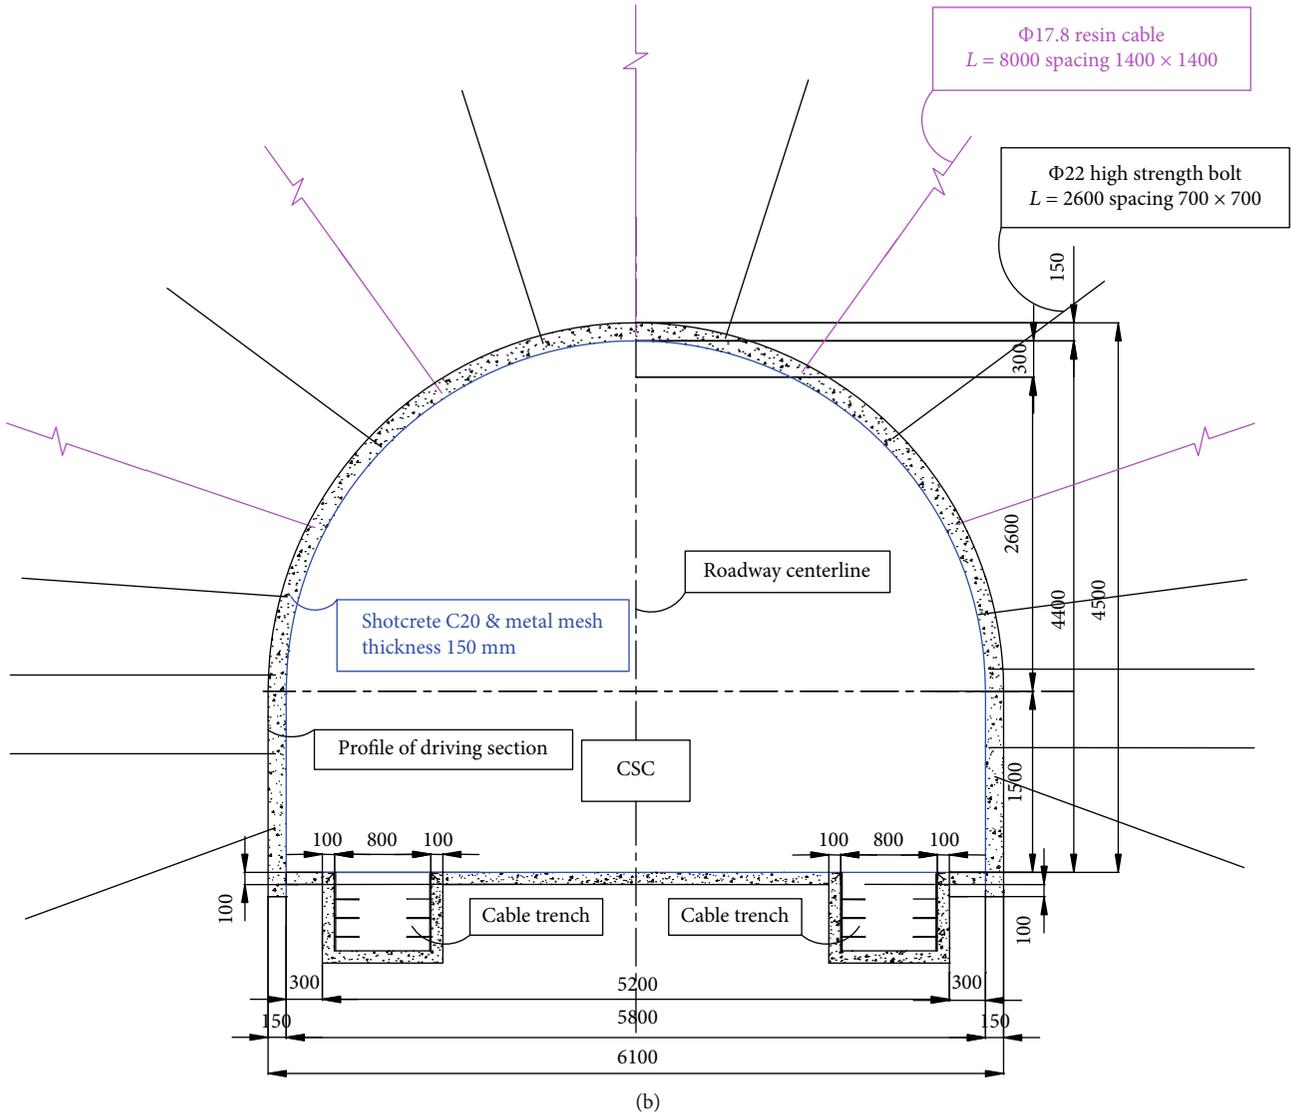
FIGURE 2: (a) Section and support parameters of MPC. (b) Section and support parameters of CSC.

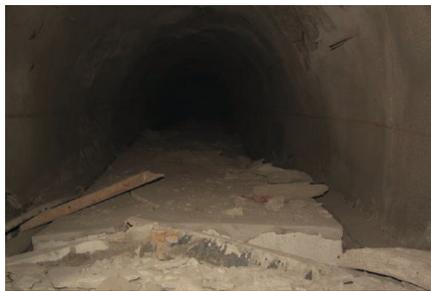
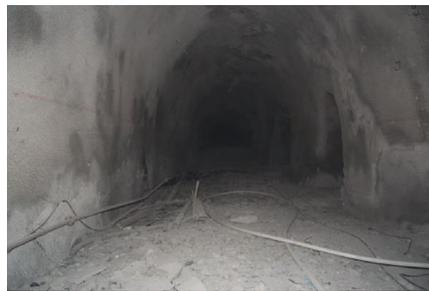
3.1. Investigation on the Damage of the Support Structure. The deformation speed of the surrounding rock of the two chambers was fast; the deformation amount was substantial (as shown in Figure 3). The deformation and failure were shown in three aspects: first, the floor structure of the chamber. Floor heave had taken place in both chambers, with the maximum value of floor heave up to 1.0 m, and even the pouring concrete block structure of the floor had been arched, cracked, and separated, resulting in the chamber being unable to be used; second, the concrete sprayed in the arch had cracked and fallen off, and the anchor bolt and anchor cable pad had been squeezed; third, the arch was extruded into a peach shape, the shotcrete of the arch crown cracks and falls off, and the metal mesh was extruded, twisted, or broken; fourth, the original design was a section width of 5.8 m (excluding the thickness of the poured concrete of 300 mm); after six months, the width of the two sidewalls of the chamber had been reduced to 4.2 m. Figure 4 shows the monitoring data. The absolute deformation of the sidewall of CSC was more than 800 mm, and the deformation was still continuous.

(a) CSC

(b) MPC

FIGURE 3: Deformation of the chambers.

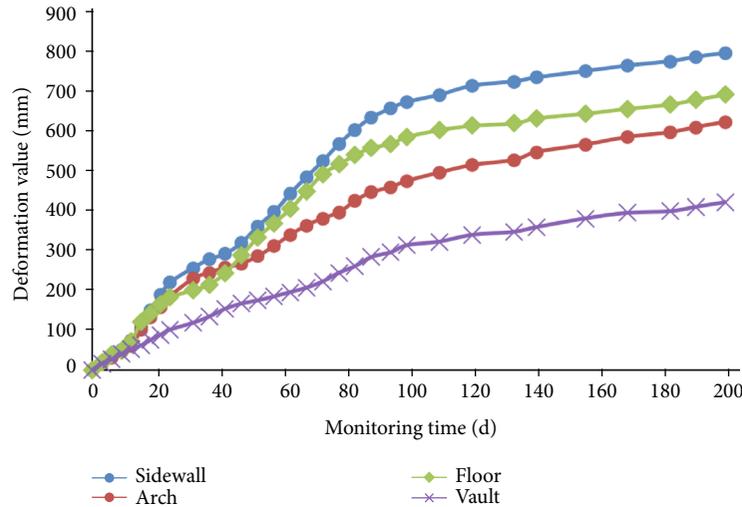
- (2) The internal displacement of the sidewalls was more noteworthy than that of other parts. Depending on the monitoring data and curve in Figure 4, the deformation of the straight wall of the chamber was relatively the largest, and the

absolute deformation value reached 802 mm. The deformation of extra parts was relatively small, the arch of the chamber was 627 mm, the value of the floor heave was 697 mm, and the value of vault subsidence was 425 mm, respectively. Although the deformation was all-round, due to the considerable horizontal stress, which first caused the sidewalls to bulge out seriously and then caused the deformation of other parts, especially the occurrence of the tip peach shape of the vault,

FIGURE 4: Deformation monitoring curve of the chambers.

- (4) Although the vault subsidence was small, the damage degree was significant. It can be seen from Figure 4 that the settlement of the vault was relatively the most minor. However, it can be seen from Figure 3 that the degree of damage is also high, which shows that the deformation of the vault was local, and local deformation is easy to cause stress concentration. Under both sides of the chamber's pressure, the vault produces a sharp peak shape, resulting in cracking and falling off of shotcrete, extrusion, distortion, or fracture of metal mesh and other damage phenomena. Therefore, it is necessary to strengthen the support of the vault.

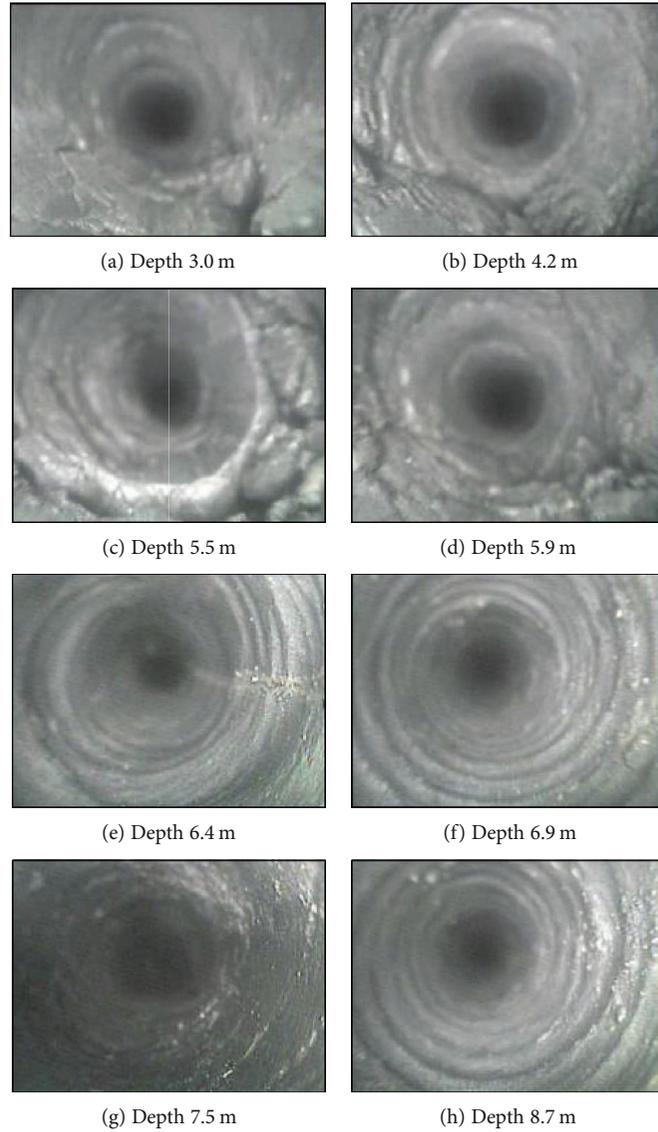
3.3. Fracture Structure Characteristics of the Surrounding Rock. Three boreholes ($l = 10$ m) were drilled in the sidewalls and the roof for peeping observation; Figure 5 shows the results. The longitudinal fracture development range of the surrounding rock mass at the borehole locations was uniform and consistent, indicating that the rock mass from the hole opening to the hole was relatively loose and the fracture

was developed. Still, the rock mass integrity was better after 6.0 m. Therefore, fracture expansion of the chamber surrounding rock was synchronous, showing the overall deformation law, and the loosening circle was about 5.5-6.0 m.

FIGURE 5: Borehole observation photos.

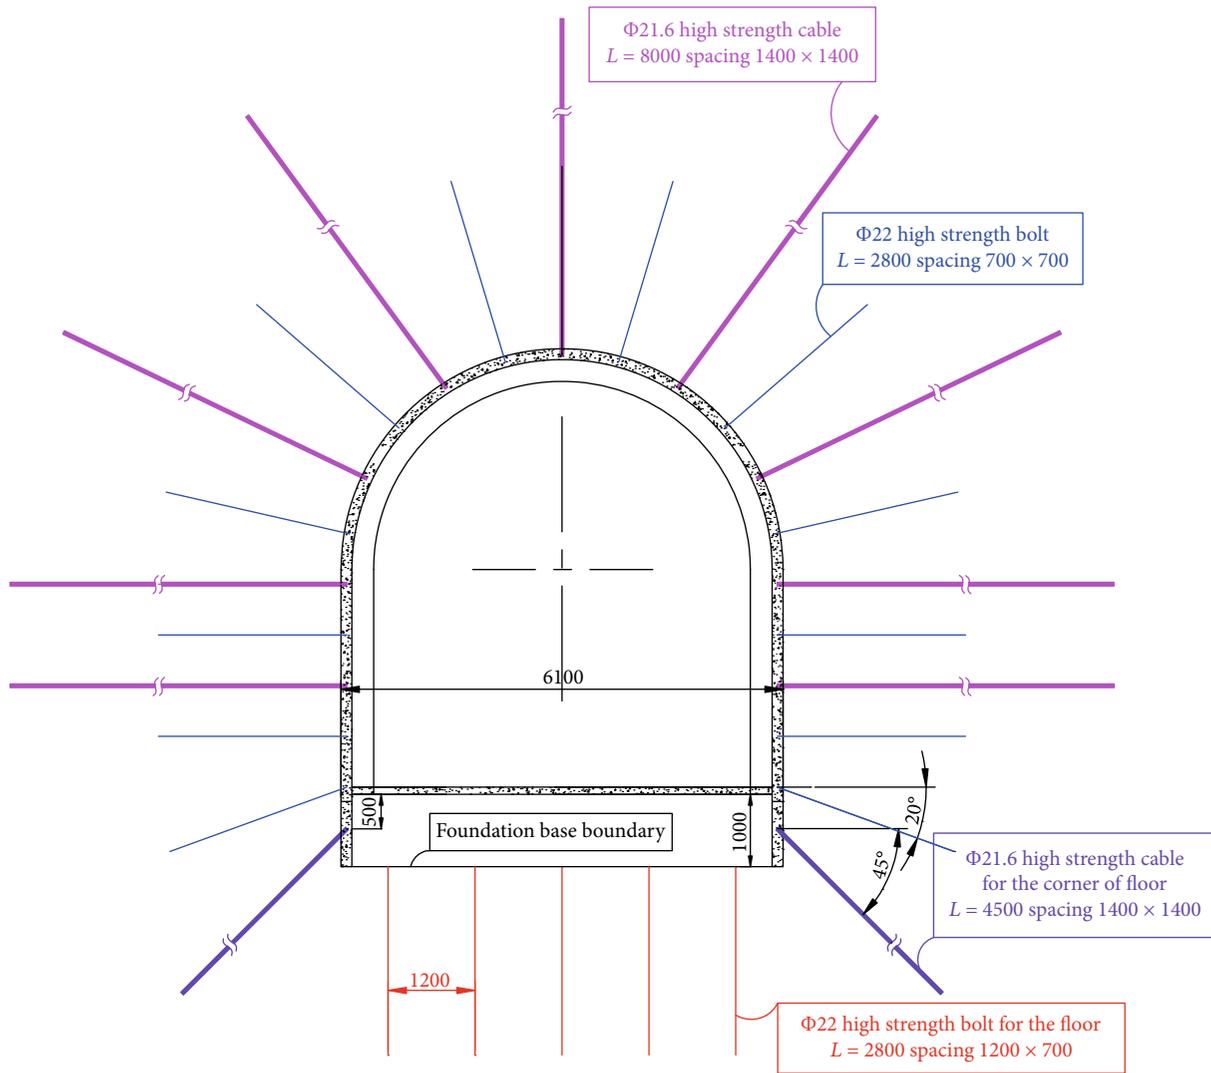
FIGURE 6: Deep hole (6 m) grouting scheme.

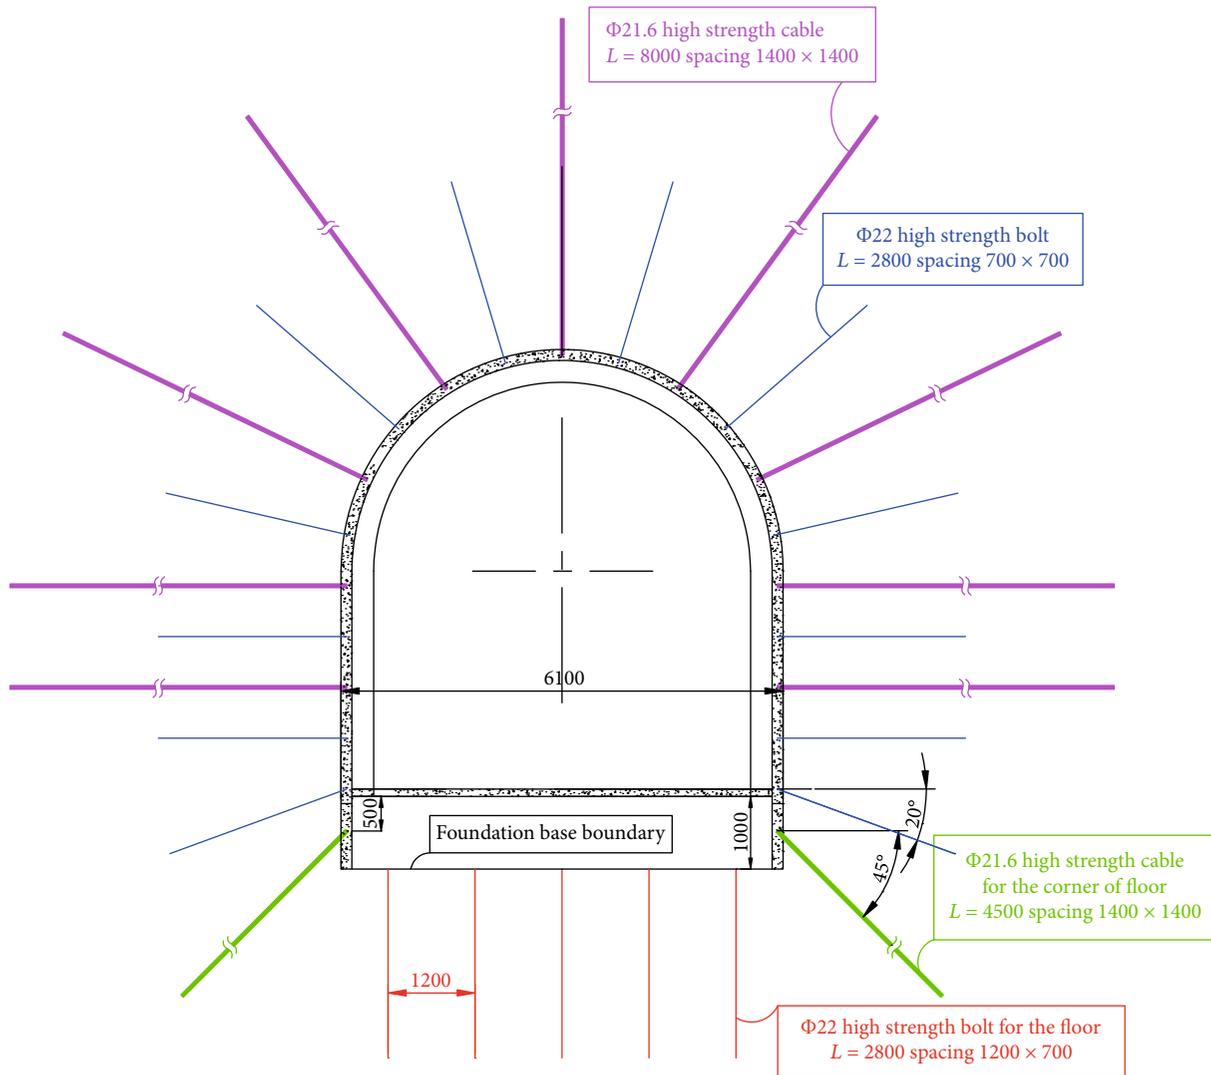
FIGURE 7: Full section support scheme after repair.

be used for each anchor bolt, with the pretightening force not less than 100 kN, and the row spacing between anchor bolts is 1200 mm × 700 mm, as shown in Figure 7. The anchor rod on the floor is attached by a reinforced ladder beam to form a whole.

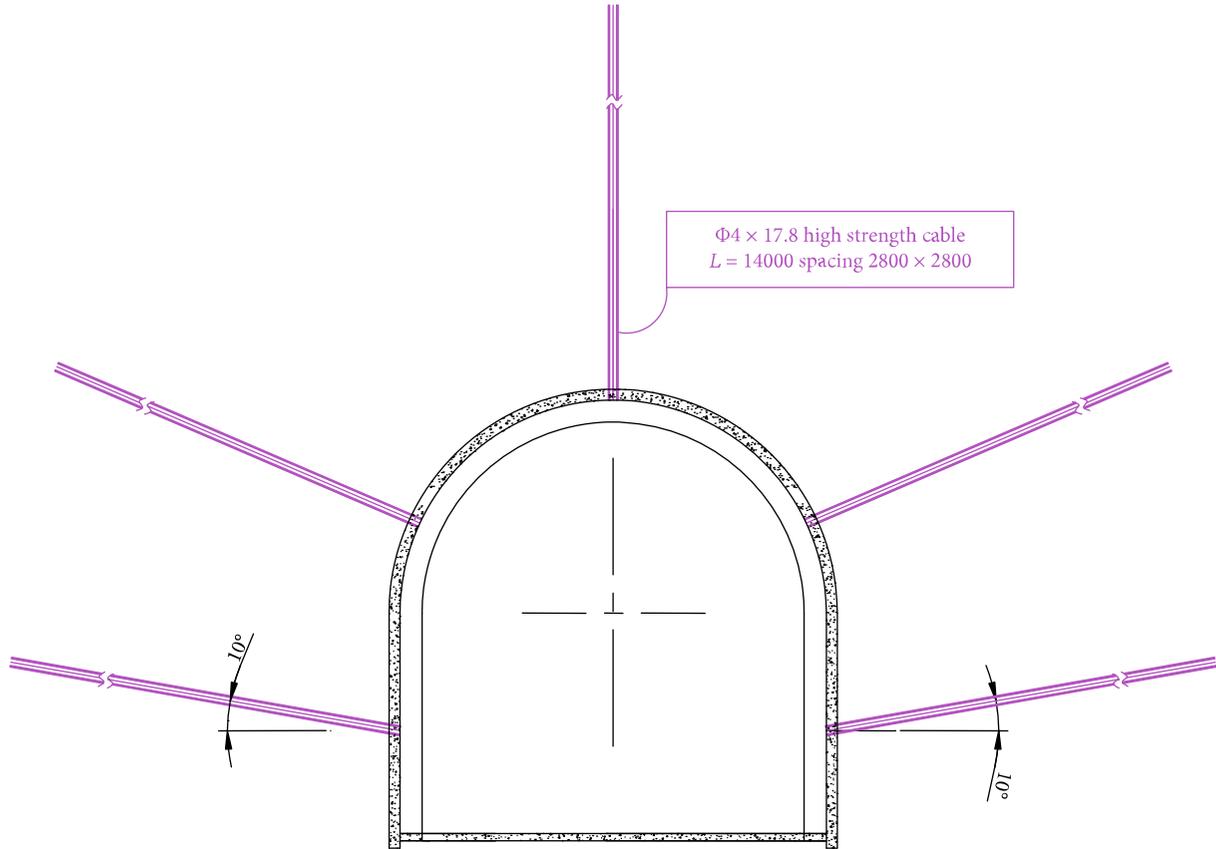
FIGURE 8: Combined grouting anchor cable support and parameters.

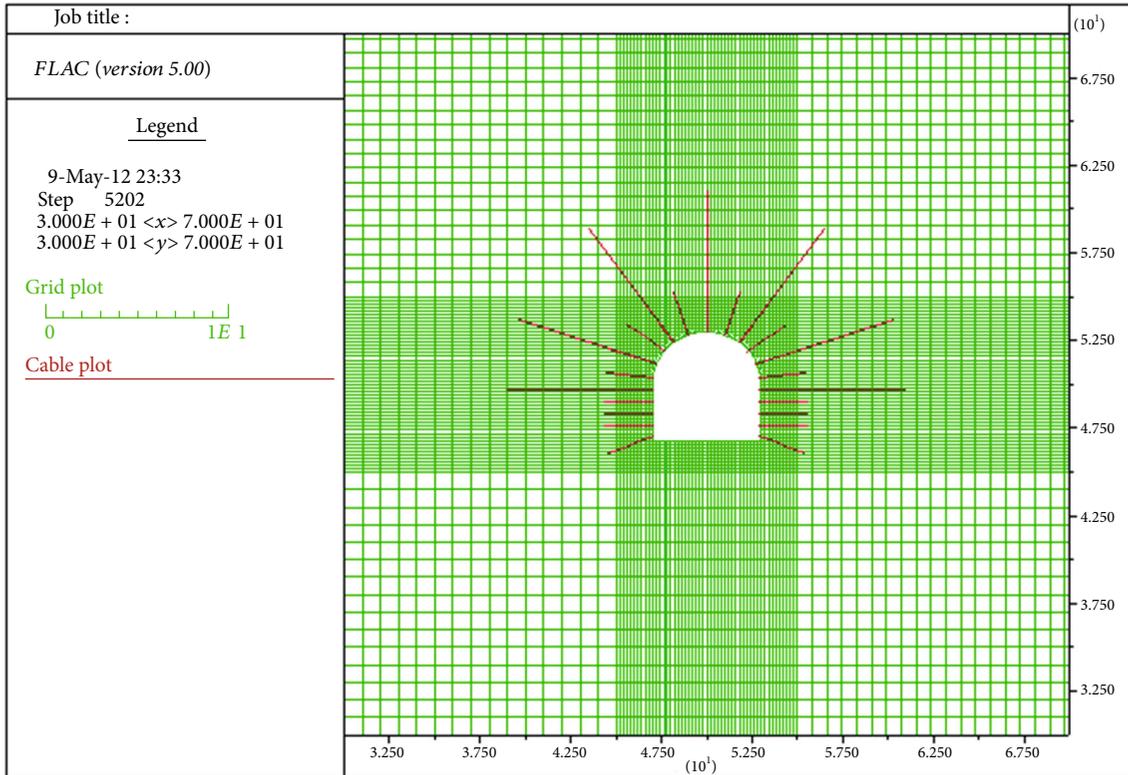
FIGURE 9: Numerical calculation model of the original support scheme of MPC.

- (1) The original support scheme: the chamber calculation model of the original support scheme is shown in Figure 9. After a certain number of steps in the iterative calculation, the distribution of deformation stress of MPC surrounding rock is shown in Figure 10 after the support of the original scheme. It can be seen that the deformation of each part of the chamber is larger than 2 m, which indicates that the chamber has been severely damaged and unstable, and within the calculation steps, it has not yet fully stabilized; from the distribution of stress and the plastic area around the chamber, the surrounding rock is in a large range of low-stress state, and the stress concentration around the chamber is apparent. Besides, the scope of the plastic zone is extensive, which is close to 3-4 times of roadway width. Therefore, the support scheme is not suitable for large chambers with the weak surrounding rock in high-stress areas, and the overall strength of the support structure and surrounding rock bearing body is low, which is unfavourable for the long-term stability of the roadway and prone to large deformation such as collapse.

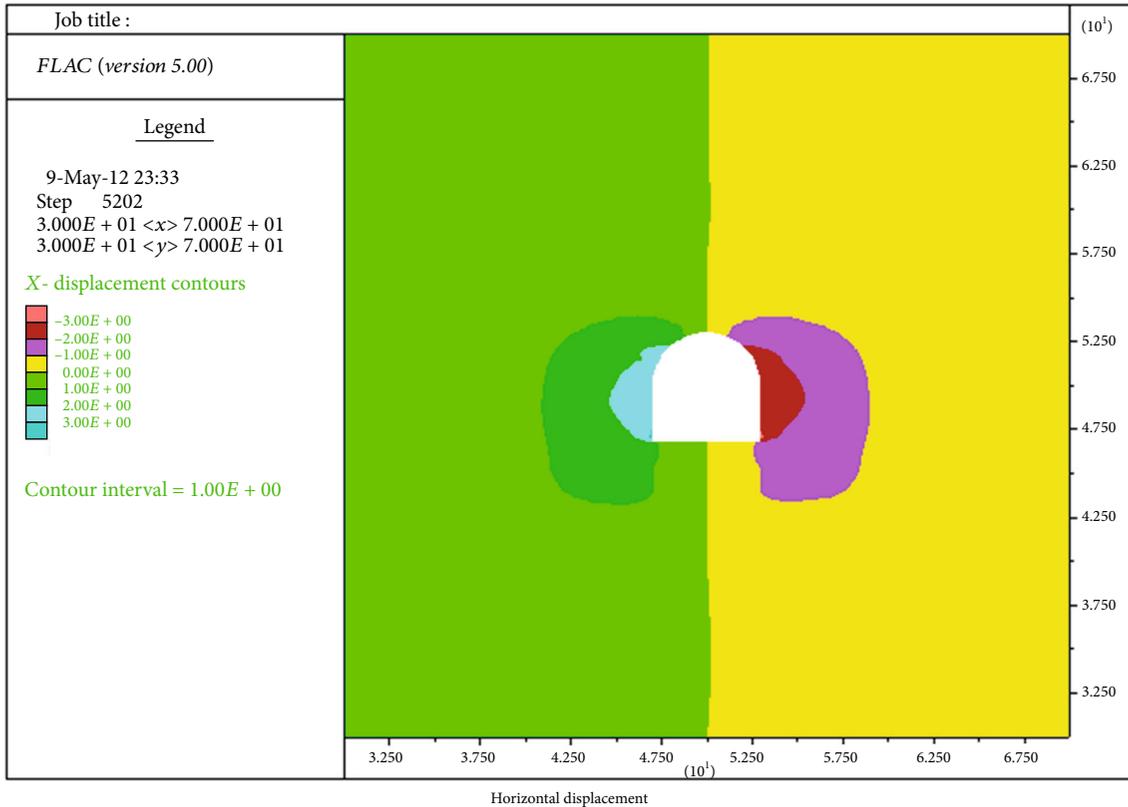
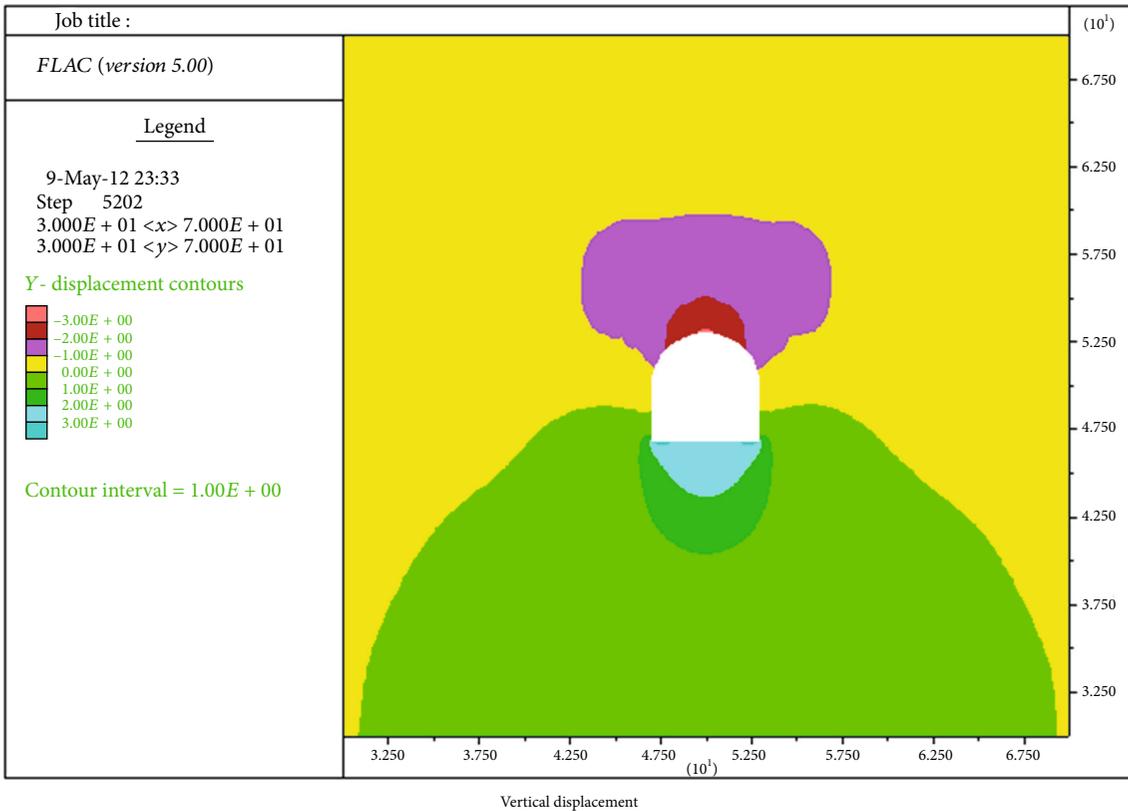
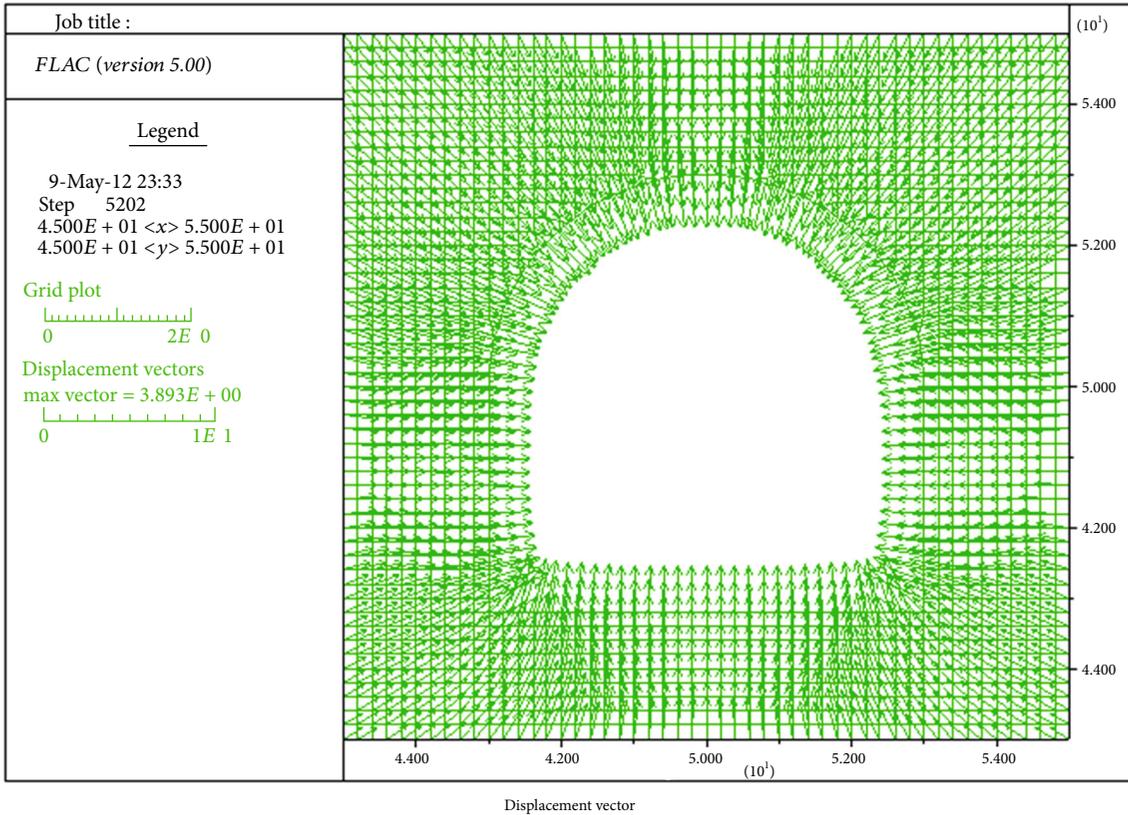
(a) Horizontal displacement

(b) Vertical displacement

FIGURE 10: Movement rule of surrounding rock in the original support scheme.

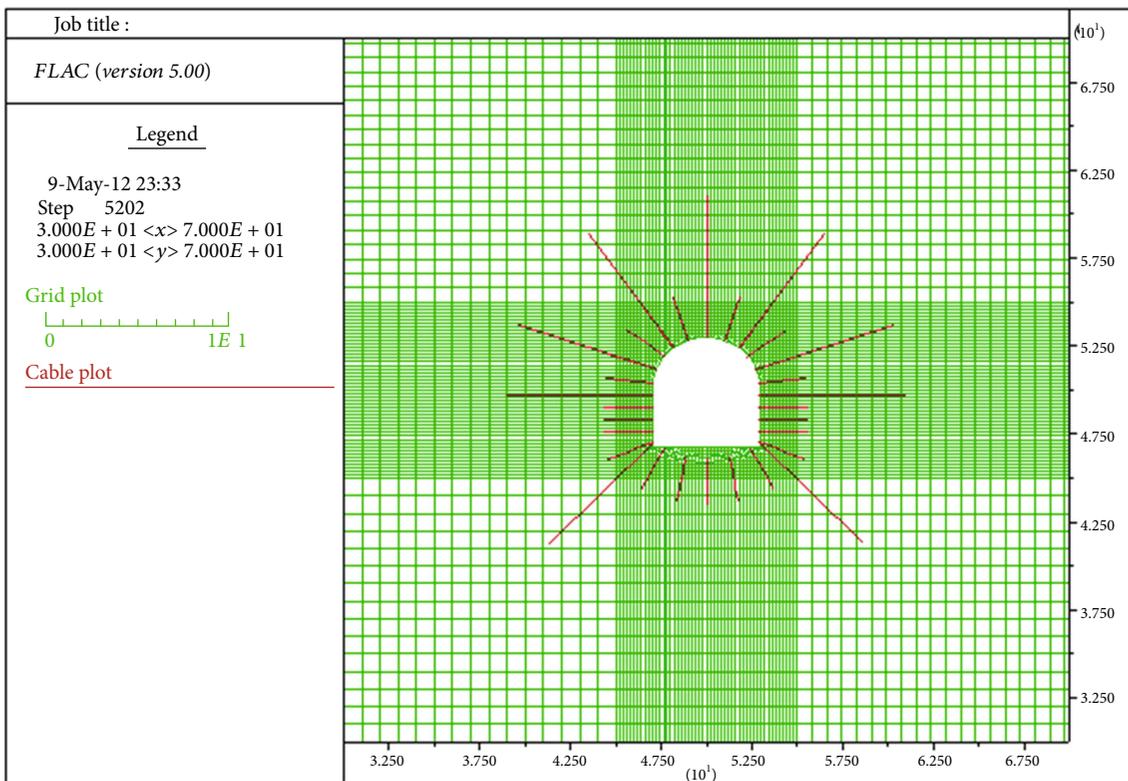
FIGURE 11: Calculation model of the MPC restoration support scheme.

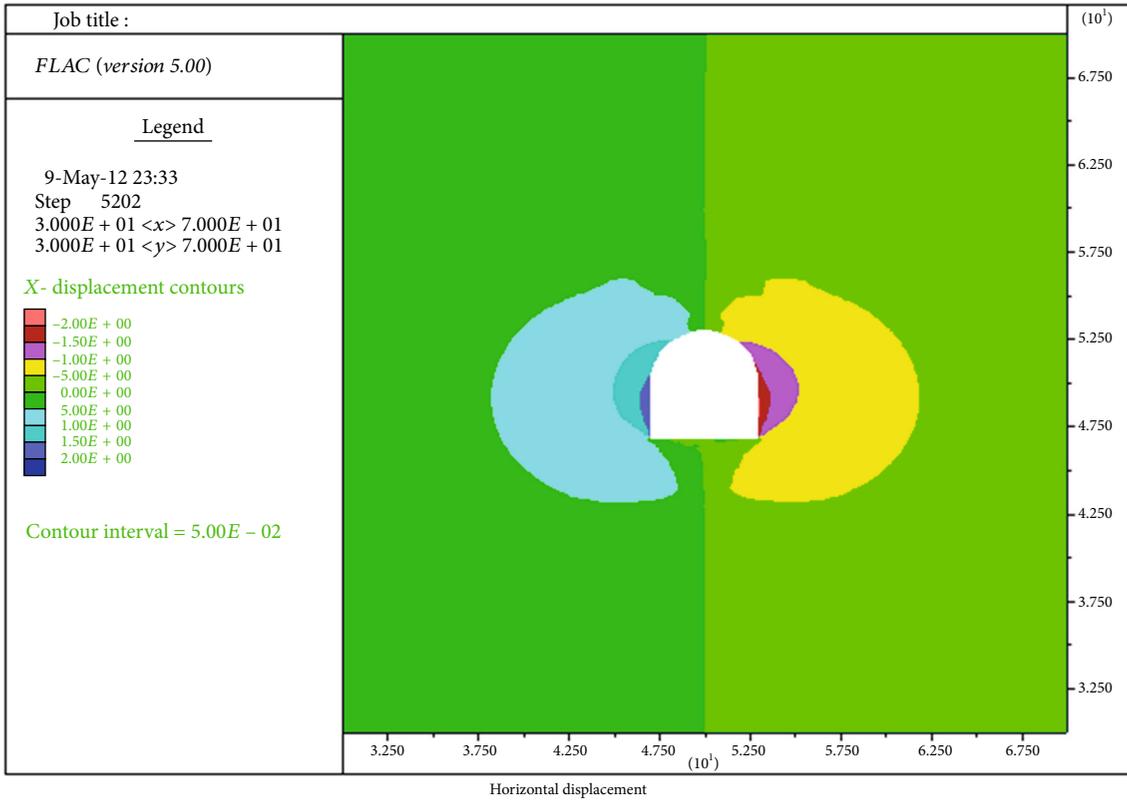
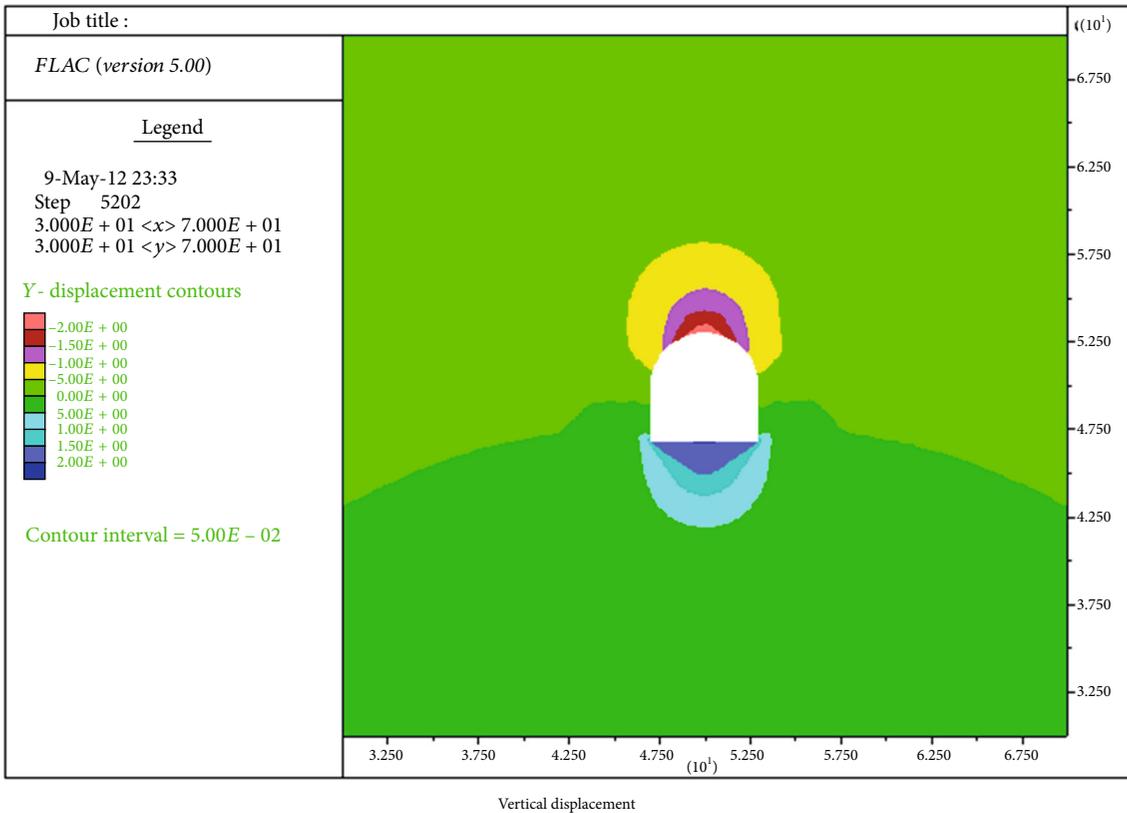
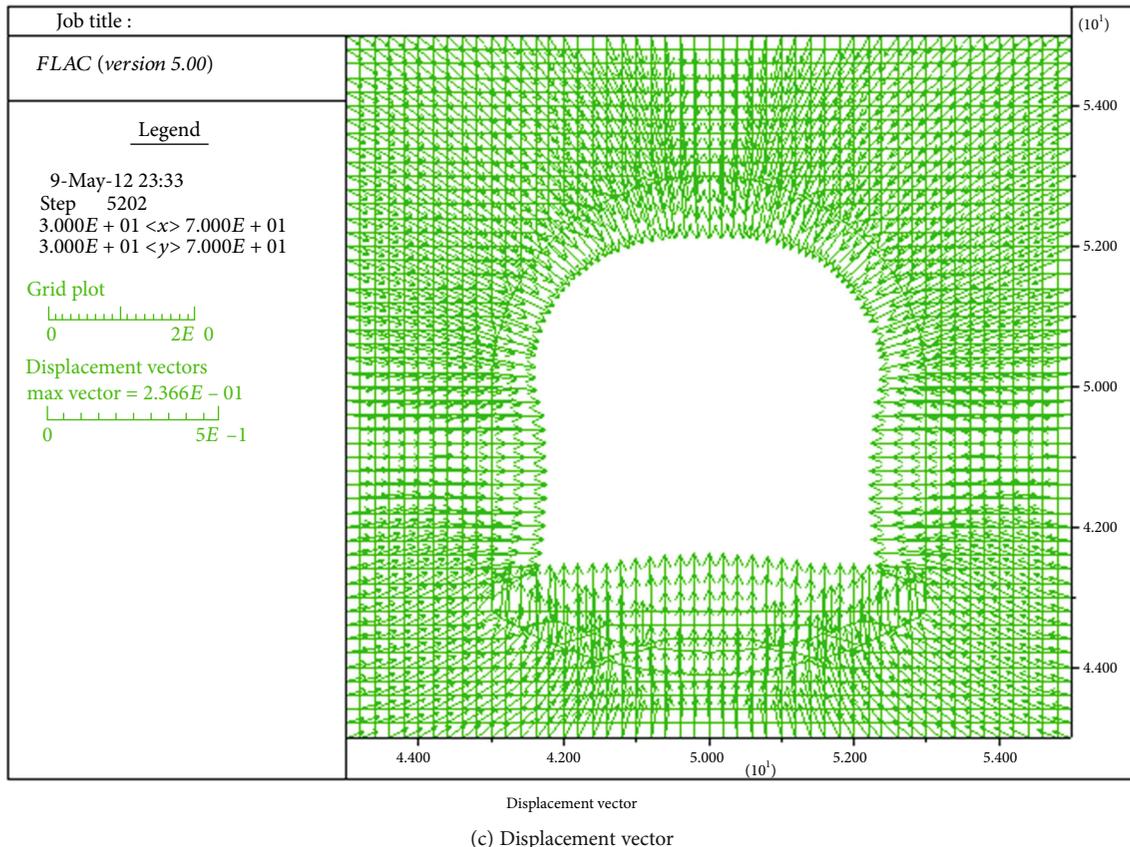
(a) Horizontal displacement

(b) Vertical displacement

FIGURE 12: Movement rule of surrounding rock in a restoration scheme.

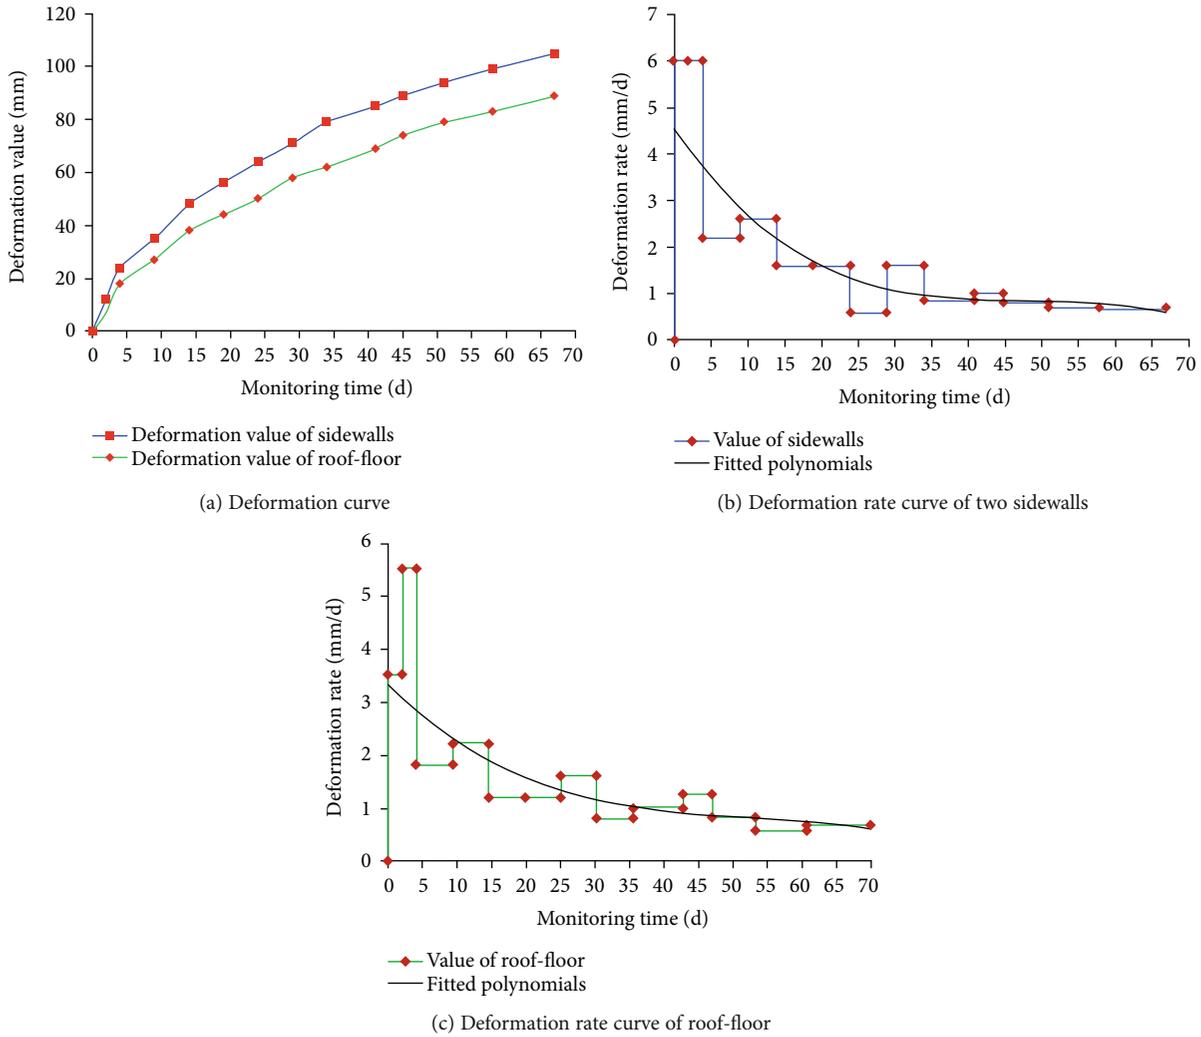
FIGURE 13: Deformation monitoring curve after repair of MPC.

6.2. Control Effects of Designing Support Scheme on Site. Deformation monitoring of surrounding rock is shown in Figure 13 after the chamber adopts the repair scheme to strengthen the overall support of the whole section. It can be observed that the deformation of the surrounding rock of the chamber has been stable at this time. After 67 days, the two sidewalls are moved by 105 mm and the top and bottom plates by 89 mm. From the deformation rate of the two sidewalls and the top and bottom plates, the deformation rate is less than 0.7 mm/d in the later monitoring period and finally tends to be stable. Therefore, the comprehensive control technology of “bolt, metal mesh, shotcrete, grouting, anchor cable, and combined anchor cable” is beneficial to the long-term stability of the surrounding rock of deep large-span chambers.
