Research Article

The Influence of Different Surface Cleansing Agents on Shear Bond Strength of Contaminated Lithium Disilicate Ceramic: An In Vitro Study

College of Dental Medicine, Rangsit University, Pathum Thani 12000, Thailand

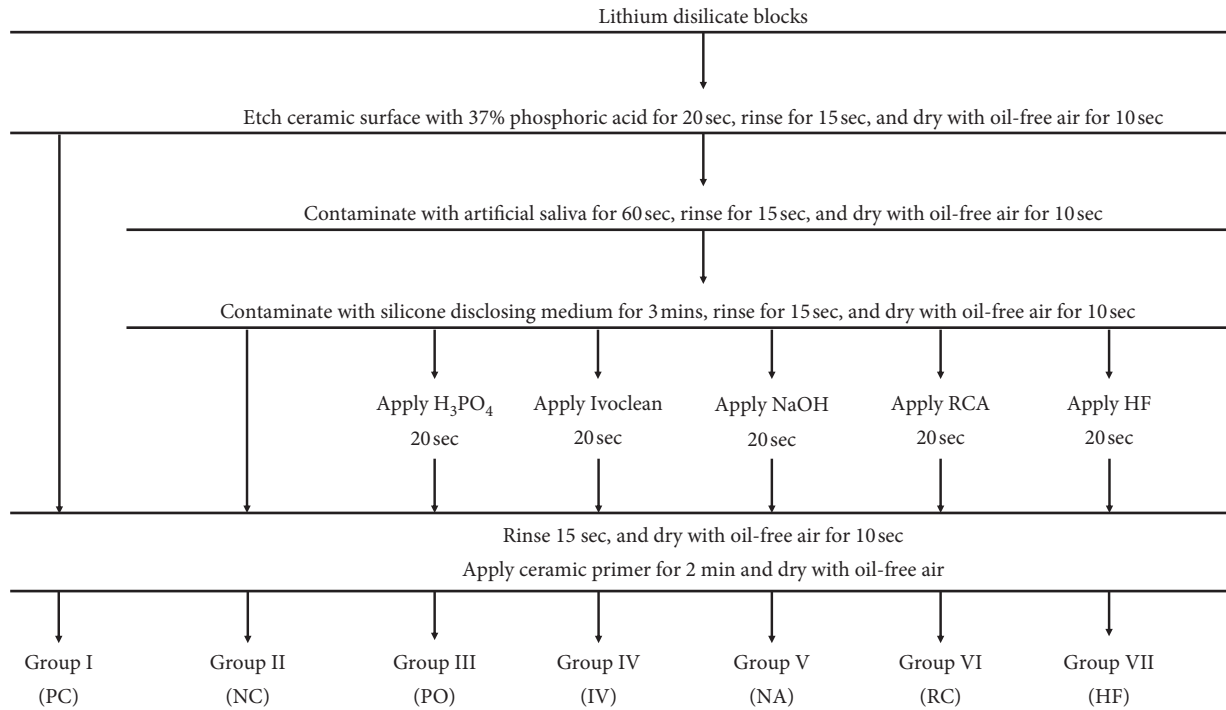
FIGURE 1: The protocols for surface treatment of each group.

In every group of the specimens, the ceramic surface was cleaned with 37% phosphoric acid (Scotchbond Etchant, 3M ESPE, Minnesota, USA) using a microbrush (Dentsply, New York, USA) for 20 seconds. Then, the ceramic was rinsed with water for 15 seconds and dried with oil-free air for 10 seconds. After that, the specimens were divided randomly into 7 groups, Figure 1.

2.2. Surface Contamination. In group 1, the specimens were left noncontaminated as the positive control group (PC). In group 2–7, the specimen surfaces were applied with artificial saliva (Faculty of Dentistry, Chulalongkorn University, Bangkok, Thailand) for 60 seconds, rinsed with water for 15 seconds, and dried with oil-free air for 10 seconds. The specimens were then contaminated with a Fit Checker (GC Corporation, Tokyo, Japan) for 3 minutes. After that, the silicone was removed and the specimen surfaces were rinsed with water for 15 seconds. Then, they were dried with an oil-free air for 10 seconds. In group 2, the specimens were not clean as the negative control group (NC). In group 3–7, the specimens were cleaned with different cleansing agents as follows (Figure 1):

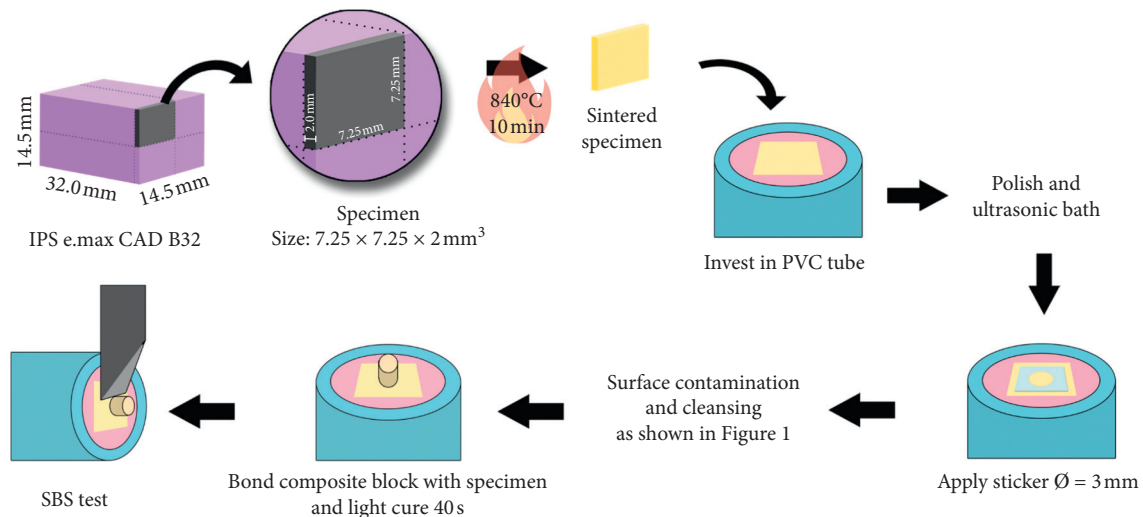
FIGURE 2: The illustration of the overall procedures.

2.4. Shear Bond Strength (SBS) Test. The specimens were immersed in 37°C water in an incubator for 24 ± 2 hours prior to the SBS test. The SBS test was performed with a universal testing machine (EZ-S, Shimadzu, Kyoto, Japan) with a crosshead speed of 0.5 mm/min. The shear force was applied to the ceramic-resin composite interface until fracture occurred, and the surfaces were examined. The data were analyzed by one-way ANOVA and Tamhane’s T2 using SPSS 16.0 for Mac OS (SPSS Inc., Illinois, USA). The overall procedures are illustrated in Figure 2.

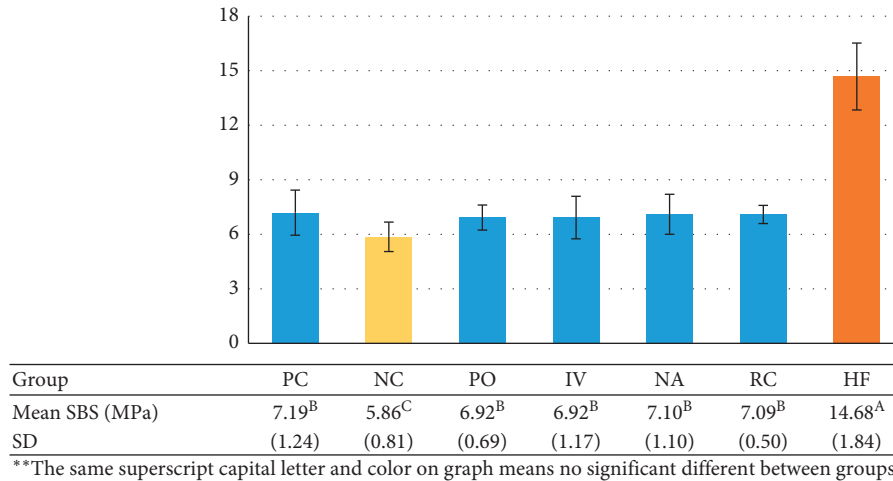
FIGURE 3: The mean SBS and SD of each group.

The data were analyzed using the Shapiro–Wilk test, and normal distribution was shown in all groups. Thus, one-way ANOVA and Tamhane’s T2 tests were used for the comparison test. The mean SBS values of all groups were summarized as shown in Figure 3. One-way ANOVA showed significant differences between groups. From Tamhane’s T2, the mean SBS values of every test group were shown to be significantly higher than NC ($p < 0.05$). Every group treated with surface cleaning agents showed slightly lower SBS values than PC with no significant difference ($p > 0.05$), exception of HF which showed the highest SBS values among all groups ($p < 0.05$).

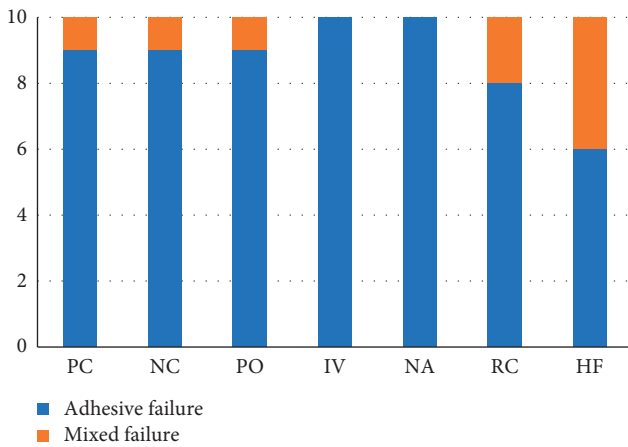
FIGURE 4: The number of specimens classified by the mode of failure in each group.

After evaluating the specimens under the stereomicroscope, the specimens in all groups were mostly found to undergo adhesive failure between the LDS specimen and resin cement, as shown in Figure 4. The number of adhesive failures was the least in HF with the highest mixed failure.

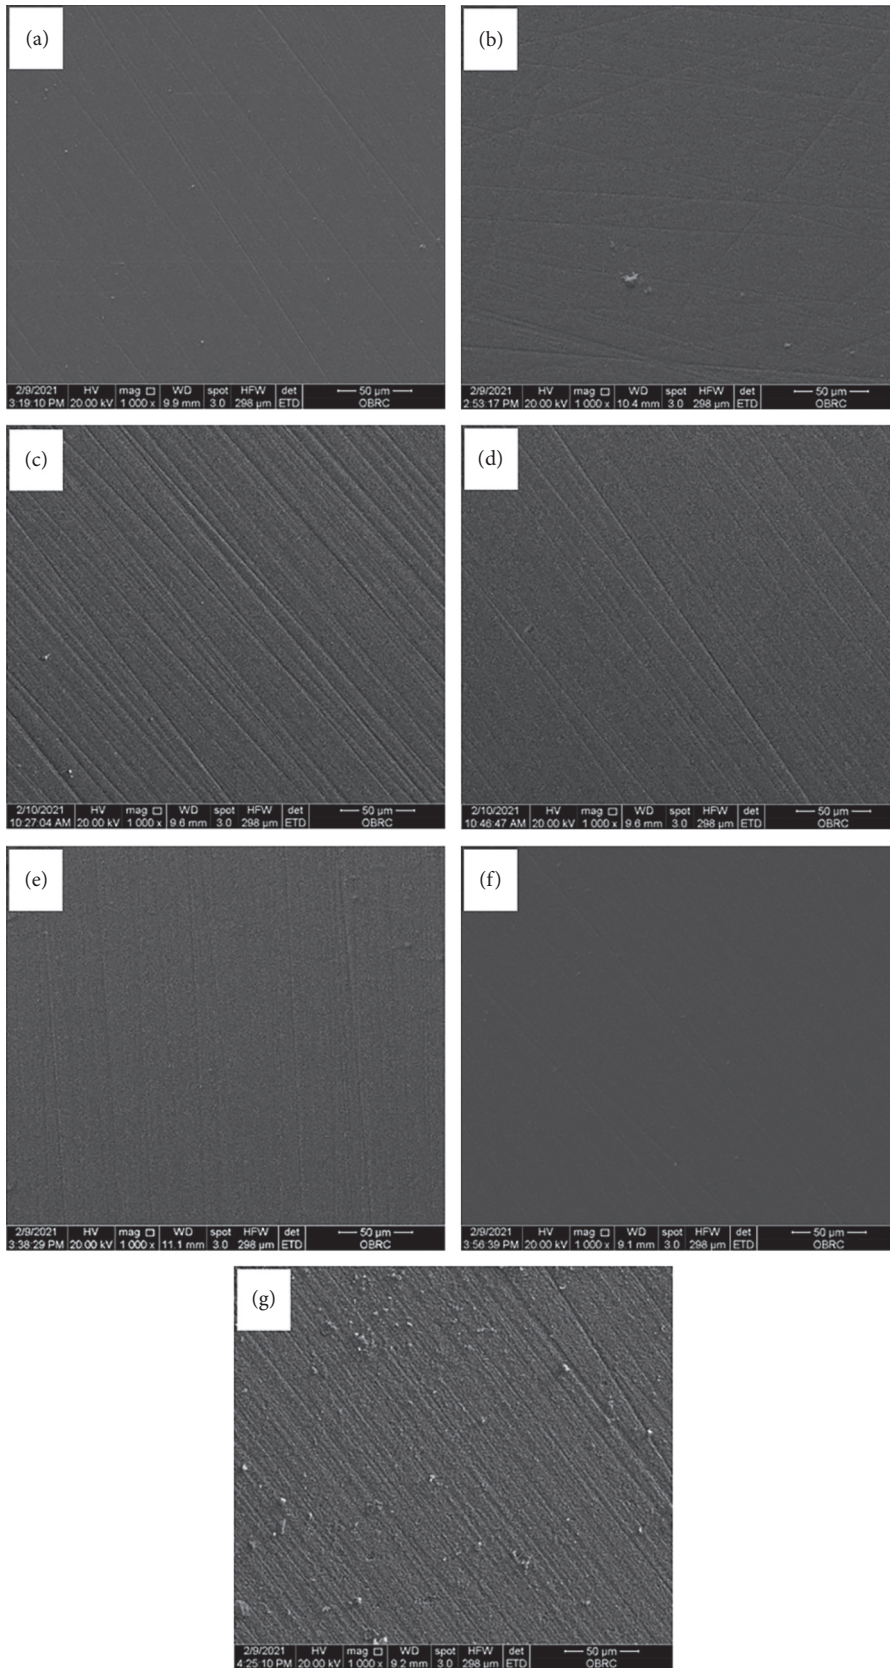
FIGURE 5: Surface characterization without cementation of PC (a); NC (b); PO (c); IV (d); NA (e); RC (f); and HF (g).

The surface characteristics of contaminated LDS after application of different surface cleansing agents investigated with SEM are shown in Figure 5.

The SEM of all groups was performed at 1000x magnification to compare the surface topography. Energy-Dispersive Spectroscopy (EDS) was also performed at 1000x magnification to determine the elements found on a particular area of the surfaces. From SEM, it was found that the surfaces of PC, NC, PO, IV, NA, and RC were similar in terms of surface character (Figure 5). However, the surface of HF showed higher roughness than the others (Figure 6). Moreover, it could be observed in HF that there were dust-like particles on the surface which was suspected to be fluorosilicate salt dissolved from the glassy phase of LDS [4].

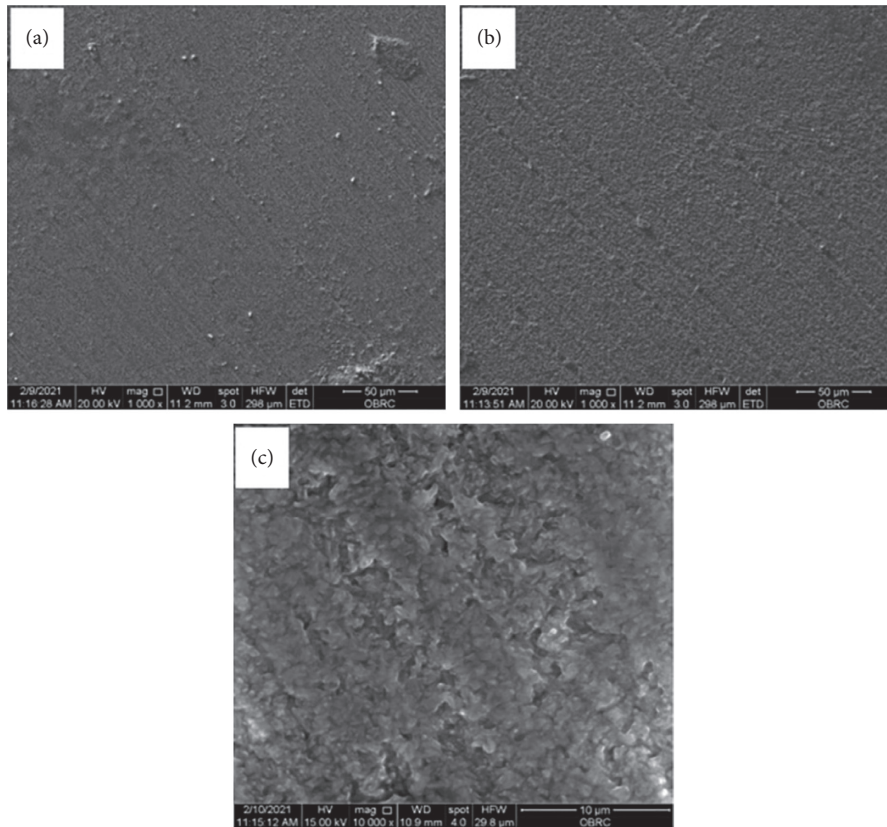
FIGURE 6: Surface characterization of specimens not etched with hydrofluoric acid 1,000x magnification (a); etched with hydrofluoric acid for 20 seconds at 1,000x magnification (b); and etched with hydrofluoric acid for 20 seconds at 10,000x magnification (c).

Acid-based groups such as phosphoric acid removed residual organic contaminants before the bonding procedure, providing a clean surface which resulted in a successful bonding between ceramics and adhesives [15]. The result is the same with that of alkaline-based cleansing agent. The HF group showed the highest mean SBS value which was statistically significant to every test group. The higher bond strength of the HF group was a result of micromechanical interlocking created by the surface roughness of the ceramic. HF is an acid that can dissolve the glassy matrix containing silica (SiO₂), silicates (SiO₄⁴⁻), and leucite crystals (K₂O•Al₂O₃•4SiO₂) in silica-based ceramic [16, 21]. HF did not only provide more surface area for resin bonding but also increased the wettability for bonding. Hence, the mean SBS value of the hydrofluoric acid group was higher than that of the other groups. The surface of LDS was observed under an SEM at 1000x magnification and 10000x magnification to identify the surface topographic change before and after etching with 5% HF for 20 seconds, as shown in Figure 6.

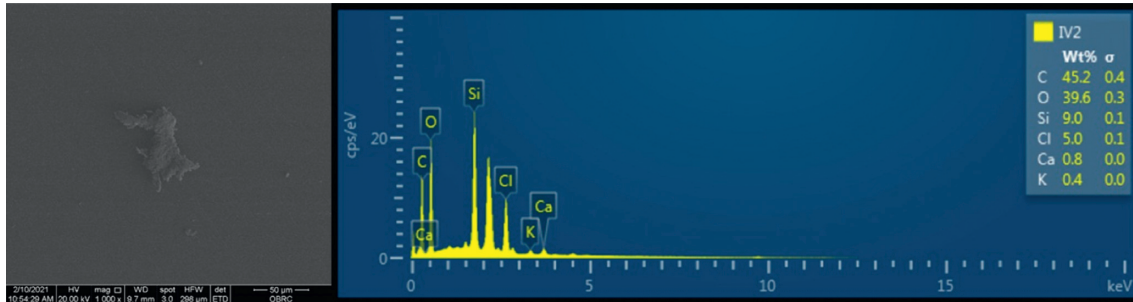
FIGURE 7: Fit checker residual observed under an SEM and elements detected at the area with a fit checker residual under an EDS.

In some areas of contamination, the silicone disclosing medium residual was also observed. The EDS was performed on the suspected area to identify the contamination. There were certain amounts of Si and C (Figure 7) which were the main compositions of the silicone disclosing medium. This was in agreement with previous studies in which the remnants of the silicone disclosing medium still remained after cleaning the contaminated surface with different cleansing agents. However, these residuals did not have a significant impact on the bond
