Research Article

Structural Health Monitoring of a Tall Building during Construction with Fiber Bragg Grating Sensors

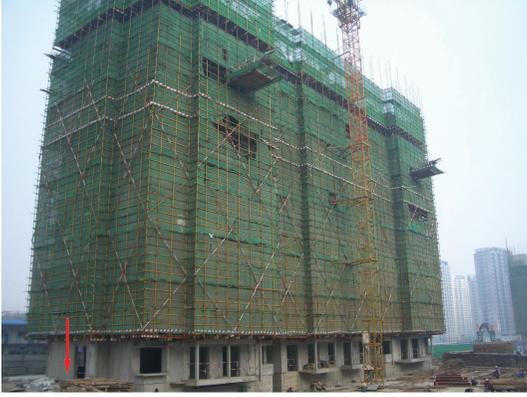
FIGURE 1: Dongsheng Garden A5 building in construction (on October 30, 2008).

2.1. Dongsheng Garden A5 Building: Description and Construction. The project under investigation is the Dongsheng Garden A5 building, located in Fushan Bay Area (Qingdao, China). The A5 building is an 18-story frame-shear wall residential building with 54.85 meters above ground. It includes one underground floor for parking, where FBG sensors were installed. The A5 building began to be constructed on April 25, 2008. Figure 1 shows that the 12th floor was being under construction on October 30, 2008 and the red downward solid arrow points FBG sensors' locations, that is, the underground floor wall and the first floor beam.

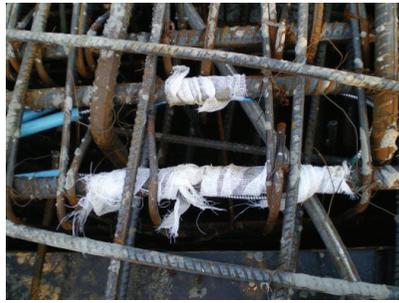
(a) Two rebars in the 1st floor horizontal beam bonded with FBG sensors; top: FBG 1#, 1529 nm; bottom: FBG 2#, 1564 nm

FIGURE 3: Installation of the FBG sensors, their position, and protection measures on site.

As pointed out in previous paragraphs, FBG sensors need to be protected from concrete aggregate during cement pouring. Details of FBG sensors' fixture to the rebars and their protection in the investigation are illustrated in Figures 3 and 4. Packaged FBG sensors were first bonded to the rebars with epoxy, and then wrapped with gauze patches to allow for solidification of the epoxy. In addition, steel hoses were presleeved to shield leadings of bonded FBG sensors (small silver steel hoses shown in Figure 3) and plastic pipes (large blue ones) were used to house optical fibers. Moreover, two junction boxes are placed in the wall to (1) protect optical connectors, (2) to check the integrity of each FBG sensor, and (3) to provide long-term monitoring once the building is completed. Furthermore, larger and harder pipes were used to protect communication fibers leading to the monitoring room as shown in Figure 4.

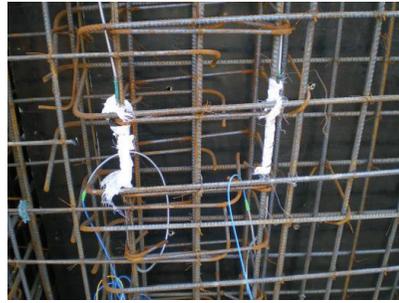
(b) Lower part of two rebars in the vertical underground column bonded with FBG sensors; left: FBG 5#, 1557 nm; right: FBG 6#, 1525 nm

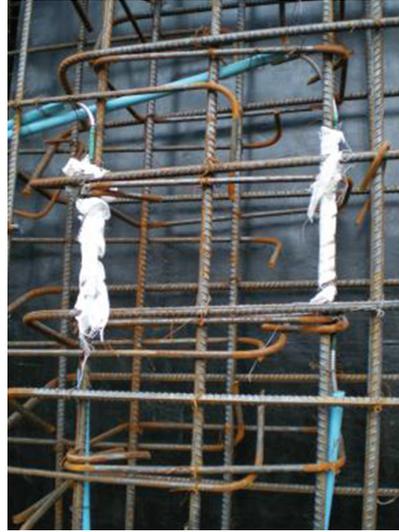
(d) Upper part of two rebars in the vertical underground column bonded with FBG sensors; left: FBG 3#, 1534 nm; right: FBG 4#, 1562 nm

The eight FBG sensors were multiplexed serially into two single-mode optical fibers (Figure 3(d)), which were protected in plastic pipes as shown in Figure 4(b) and routed to the monitoring room around 100 meters away. The acquisition system was composed of a demodulation unit FBG-SI425 (Micronoptics Incorporated), a personal computer, and a digital interface PCMCIA card. A customized program running under LABVIEW (National Instruments) on the PC was developed for acquiring data every minute from the FBG sensors through FBG-SI425 and the PCMCIA card. The acquired data are then saved in separate files automatically. The sampling interval can be adjusted for desired frequency

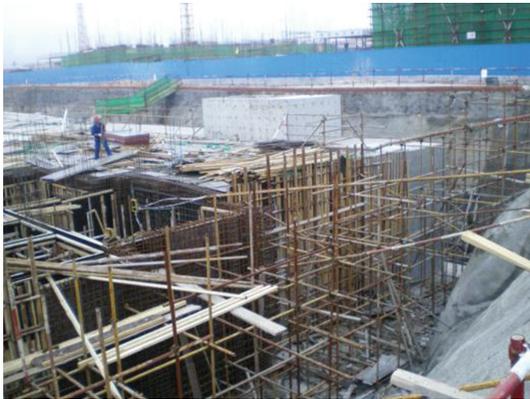
(a) Layout of the first floor and shear wall of the A5 building installed with FBG sensors (sensors bonded on the rebars underneath the standing worker)

FIGURE 4: Installation of the FBG sensors, their protection, and routing to the monitoring room.

In a later stage, another FBG temperature sensor was added. Among the eight FBG sensors, four FBG strain sensors are intended to measure column strain while the building was still in construction. Two of the four FBG strain sensors were bonded on the rebars of the upper part of the column, 40 cm below the beam as illustrated in Figure 3(a), and the other two on the lower part of the column, about 50 cm above the underground floor as shown in Figure 3(b). Another two FBG strain sensors were adhered to the horizontal beam as shown in Figure 3(c) to monitor relative displacements between two foundation blocks. As far as temperature is concerned, two FBG sensors were installed. One sensor (FBG 7#) was left freely in a plastic pipe between rebars to measure temperature variation inside concrete, whereas the other (FBG 8#) was laid in the junction box (not shown in the figure) to measure environment air temperature as shown in Figure 3(d). All the eight FBG sensors were located directly underneath the standing worker wearing a blue suit in Figure 4(a).

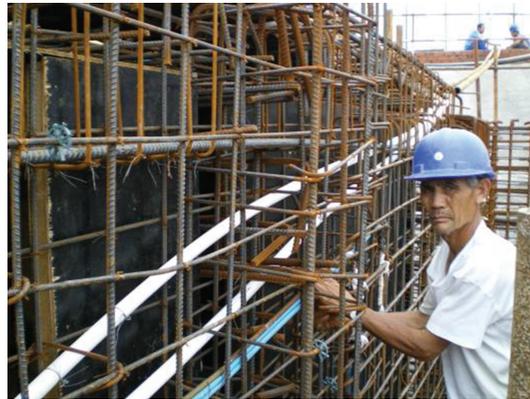
(b) Plastic pile protecting the connection fibers leading to the monitoring room
