Research Article

Detection of Leakage Areas in an Earth Embankment from GPR Measurements and Permeability Logging

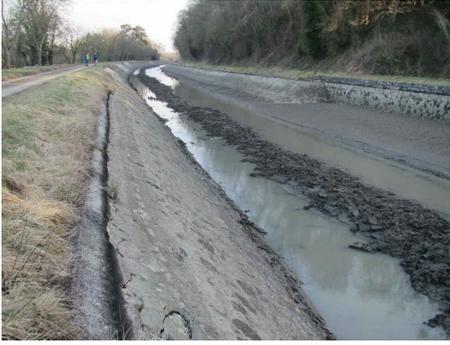
FIGURE 1: General view of the embankment.

In our case study (earth embankment running alongside the Loire river, Saint Firmin, France, Figure 1), the canal was emptied for the geophysical survey. This is the reason why other methods such as spontaneous potentials [12–14] were not used. Besides, GPR appears to be suitable for the characterization of potential defects underneath the paved revetment. Moreover, the dike is about 3 m in height. Thus, despite a limited depth of investigation, GPR remains a rapid and cost-effective method for the precise location of decompressed areas potentially associated with leakage pathways. Historical research [15] has shown that several resurgences have occurred for many years at the foot of the downstream slope. These leakages increased during 2011 and 2012, flooded the grasslands downstream, and induced drains of pluricentimetric diameter. The last resurgence was in February 2012.

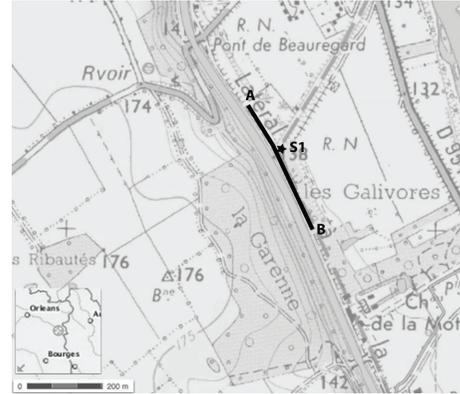
FIGURE 2: Location of the study zone and the S1 coring.

4.3.1. 200 MHz and 400 MHz GPR Survey. Figure 13(a) shows the data obtained with the 200 MHz antenna on the crest (profile P6) below the S1 coring at 167 m (Figure 2). As the waves' speed is fixed at $0.1 \text{ m}\cdot\text{ns}^{-1}$, a time delay of 40 ns corresponds to a depth of about 2 m. In fact, two layers are easily observed on this profile. The limit of the first layer is underlined by a major reflection at about 12 ns (50 cm). This layer may be associated with the silty-sand material present in some areas of the embankment. Underneath this layer, heterogeneous zones are observed, corresponding to the

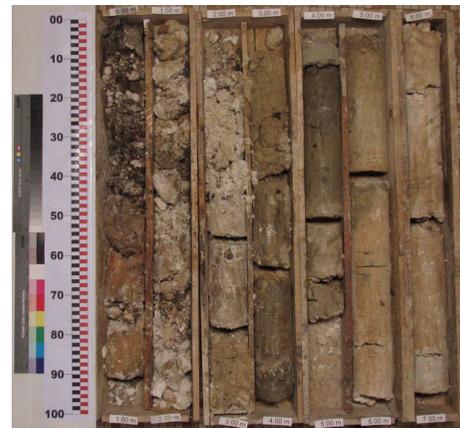
FIGURE 3: Soil samples obtained from the coring S1 on the crest of the embankment.

The embankment is built on Turonian limestone and chinks. It is made of modern and ancient alluvial soils from the Loire lying above the substratum. A coring S1 has been performed in 2012 on the crest of the embankment (Figure 3 [15]). S1 is located on the crest just above a leakage zone studied in Section 4.3. It is composed of the following materials.

- (i) The formation A (from 0 to 2-3 m in depth) is a filling material made of sand-gravel limestone with a clay matrix in variable proportions. Sand and silt materials, blocks of flint, and sandstone were observed in certain zones of the embankment, below the layer of vegetal soil, up to a depth of 50 cm to 70 cm.
- (ii) The formation B (from 4-5 to 6-7 m in depth) is a clayey filling material with limestone and chalk nodules. The clay-gravel filling material in S1 is liable to piping. In fact, granular materials were observed to be washed of their fine particles within the resurgence of February 2012. Furthermore, during the coring, the filling material was hardly compacted and very

limestone sand-gravel material with a clay matrix (formation A, see Section 2.1), as shown in Figure 3. Lateral variations of the reflected signals are visible along the profile: they reflect changes in the nature of the materials in the body of the embankment. An attenuated GPR signal area located between 175 m and 198 m at 70 cm depth (dotted line square in Figure 13(a)) is typical of a clayey content material.

In the same profile, a more heterogeneous zone is observed between 160 m and 175 m and at 60 cm depth. This zone is characterized by a much contrasted 200 MHz GPR signal, similar to the spillway response and to the heterogeneous area observed in Figure 12. It includes several diffraction hyperbolae, typical of a relatively resistive medium. This anomaly is very close to the second leakage area exactly located at the foot of the downstream slope (see *in situ* observation shown in Figure 6). The seepage was probably responsible for washing out the fine particles (clay and silt, i.e., conductive particles), keeping in place the limestone gravels (see Figure 3).

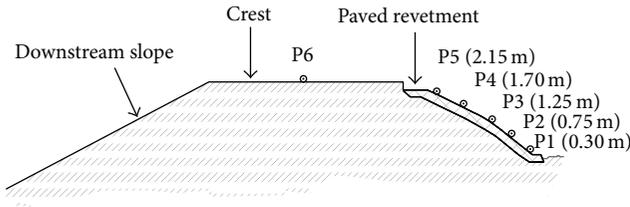
FIGURE 4: Transverse cross section of the embankment and location of the GPR profiles on the sloped paved revetment (P1 to P5) of the canal and on its crest (P6).

2.2. Morphological Characterization of the Embankment. Figure 4 represents a transverse cross section of the embankment. The slopes of the paved revetment and the downstream structure are steep, with angles lying between 20 and 35°. The structure can be as high as 7 m in certain zones, with a base extending up to 25 m in width. The downstream slope is covered in grass, whereas the canal side has a paved revetment made of carved limestones blocks (masonry). Some parts of the paved-revetment have been rebuilt with concrete slabs.

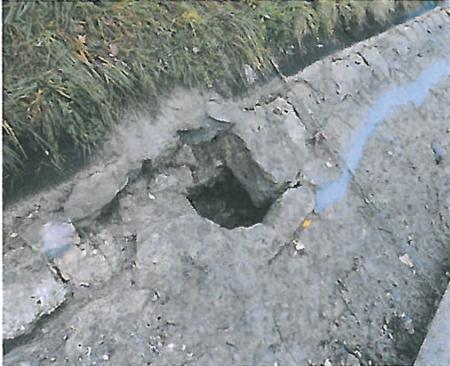
FIGURE 5: Example of serious undermining by internal erosion in the upper part of the paved revetment.

Several leakage areas appeared during the last 5 years. Degraded areas were then inspected and recorded (bulging, subsidence, cracking, and holes) and the width of cracks and the depth of holes were measured [15]. Huge bulgings (35 to 160 mm) and subsidence (50 to 95 mm) were also observed on the paved revetment. The last leakage area was observed in 2012, with new longitudinal and vertical cracks due to unsealed stones (1 to 8 mm in width), some of them joining up. Huge undermining was also observed in the revetment (Figure 5).

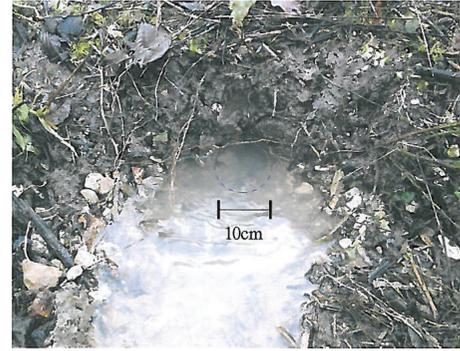
FIGURE 6: 10 cm diameter resurgence observed at the foot of the downstream slope.

Some of the resurgences of the observed leakages located at the foot of the embankment were around 10 cm in diameter (Figure 6). Given the nature of the paved revetment and the need to detect any structural voids, GPR is very suitable for an efficient use on the sloped paved revetment. Our objective, therefore, is to test this method on an embankment which is not in charge, to determine the presence of voids,

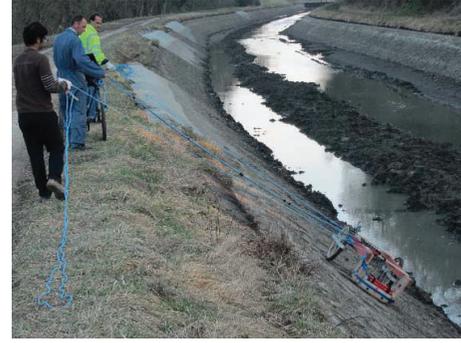
FIGURE 7: GPR acquisition on the paved revetment of the embankment.

3.2. GPR Acquisition Protocol and Processing. Shielded bowtie antennas of 200 MHz and 400 MHz and a SIR3000 GPR (Geophysical Survey Systems, Inc.) were used along the crest and on the paved revetment, respectively (Figures 1, 2, and 6). Five parallel longitudinal GPR profiles were made at various heights on the paved revetment: 0.30, 0.75, 1.25, 1.70, and 2.15 m, corresponding, respectively, to measurements P1, P2, P3, P4, and P5 (Figure 4). Profile P1 was very similar to P2 and is not presented. Profile P6 was made in the middle of the crest (Figure 4). As the profiles were needed to be measured on a steep slope (more than 30°), the antennas were mounted on a wheeled support and guided by ropes (Figure 7). As the speed of the GPR waves was unknown, an estimated speed of 0.1 m·ns⁻¹ was used in order to estimate the depth of any anomaly on the GPR results. The maximum depth of investigation is around 2 m for both types of antenna, that is, a similar value to our theoretical result. The raw data obtained is processed using the ReflexW software [18]. We performed a classic data processing: static correction was used in order to take into account the surface topography. A

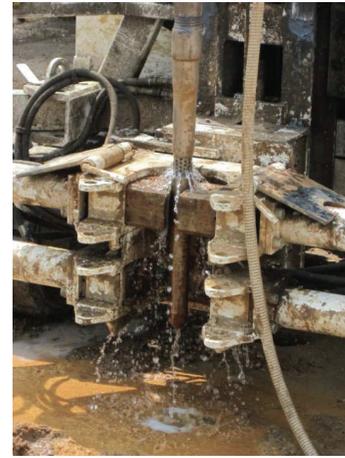
FIGURE 8: Photo of the Perm eafor on the field.

3.3. The Perm eafor System: Principle and Data Acquisition Protocol. The Perm eafor [19] was developed by Cerema in the early 80s and patented in 1986 (Figure 8). This hydraulic profiling tool (HPT) provides a quick estimate of the *in situ* soil permeability in an almost continuous way (approximately every 20 cm). The obtained permeability profile is supplemented by a penetration curve (for 20 cm) to qualitatively assess the resistance to soil penetration and identify heterogeneities in the ground mass. An updated version was recently developed and used for this study (Figure 9).

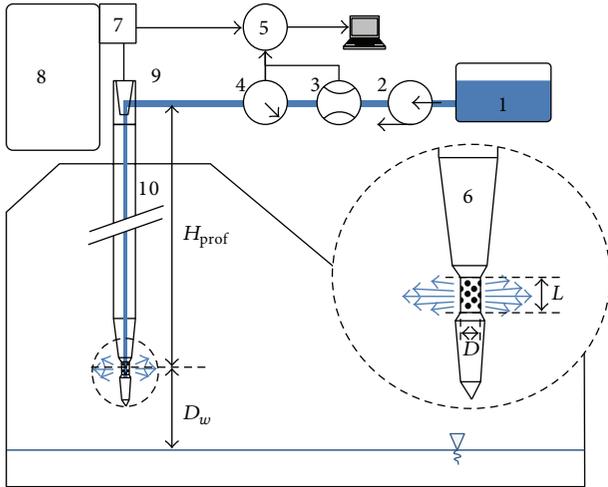
FIGURE 9: Scheme of the Perm  afor test procedure. 1: water tank, 2: pump, 3: flow meter, 4: pressure sensor, 5: data logger, 6: patented Perm  afor tip, 7: displacement transducer, 8: geotechnical drill device, 9: casing connector, and 10: conventional casing. D is the diameter of the screened tip (50 mm) and L is its length (50 mm).

The HPT tip is driven into the ground in 20 cm increments with the help of a drill rig using a conventional hydraulic hammer (Figure 9). When the screen is in the soil, the injection starts and is done continuously throughout the duration of the penetration. When penetration is stopped, the flow is recorded versus time for 10 s and then penetration is continued.

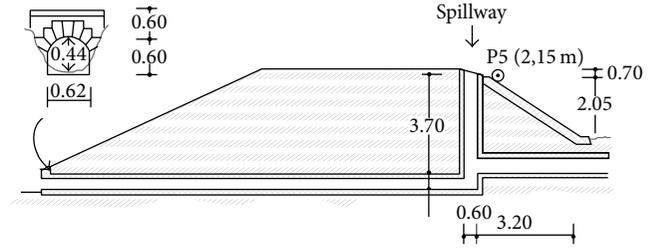
FIGURE 10: Transverse cross section of the embankment showing a spillway at 404 m and location of profile P5.

4.1. GPR Signal for a Typical Structural Void/Cavity (Embankment Spillway). Several spillways are present within the embankment (Figure 10). The 200 MHz GPR signal associated with one of these structures (a structural void/cavity zone) has been characterized. For that purpose, the nearest profile P5 was studied. Its dimensions (around 0.5 m wide) are in accordance with the maximum resolution obtained with the 400 MHz antenna, that is, 0.125 m.

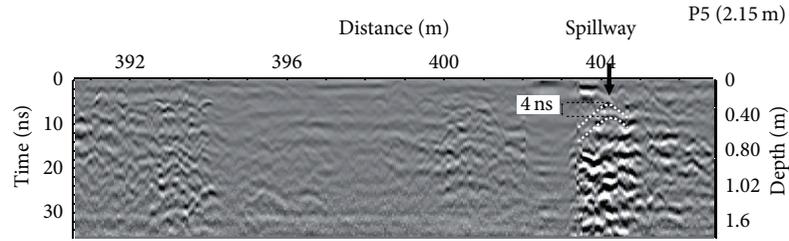
FIGURE 11: Profile P5 (200 MHz) on the paved revetment showing the hyperbolae directly above a spillway.

Figure 11 shows the GPR profile P5 (2.15 m high) carried out on the paved revetment, just below the spillway entry. This structure is located at the end of the profile P5 (404 m). With a wave speed at 0.1 m/ns, the 200 MHz antenna can reach a depth of investigation of about 1.70 m (reflection time 34 ns). Two distinct diffraction hyperbolae are visible (dotted lines) at 404 m from 7 ns (at a depth of about 35 cm), followed by large amplitude reflections. This observation reflects the presence of a pipe inside the embankment. The first and second hyperbolae are related to the top and the bottom of the spillway, respectively. The time delay between the two hyperbolae can be calculated using the formula $t = 2d\sqrt{\epsilon'}/c$. Considering a pipe with a diameter $d = 0.6$ m and a permittivity $\sqrt{\epsilon'} = 1$ for air, we obtain a time delay of about 4 ns, that is, the time observed between the two hyperbolae (Figure 11). Therefore, this observation can be used as a reference in order to make a qualitative characterization of the presence of structural voids underneath the paved revetment.

The first survey conducted with the 200 MHz antenna above a spillway (P5 profile) provides the typical signature of a void

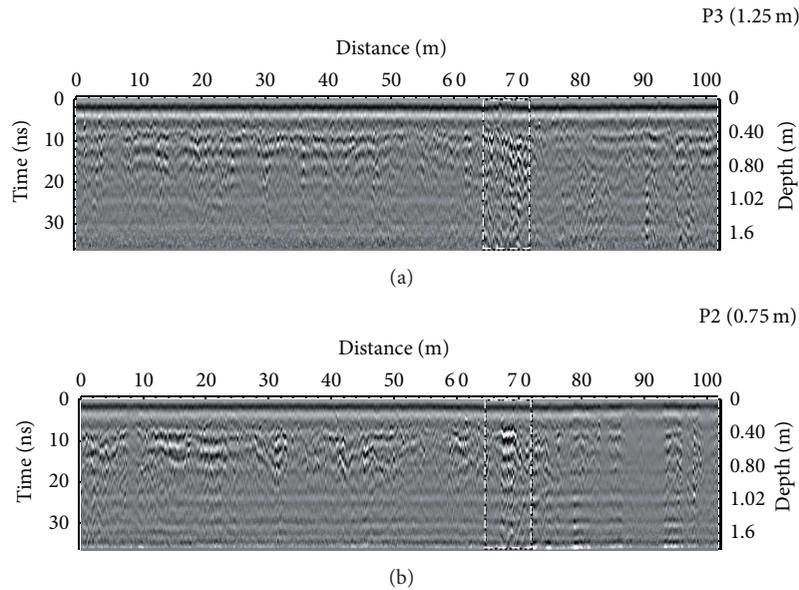
FIGURE 12: Possible seepage area detected with the 400 MHz GPR on the paved revetment, associated with the 20 m downstream leakage area: (a) profile P3 at 1.25 m high; (b) profile P2 at 0.75 m high.

4.2. Survey on a First Leakage Zone. Figure 12 shows the 400 MHz profiles P2 and P3 made under the paved revetment at 0.75 and 1.25 m in height, up to a distance of 100 m from point A (Figure 2). The two profiles show an anomaly characterized by strong reflections at 70 m, which also appears on three other profiles (P1, P4, and P5) not shown here. The 5 to 10 m wide anomaly starts near 6 ns (around 25 cm), that is, under the paved revetment, and finishes at about 30 ns (1.50 m). This anomaly is located at 20 m downstream from the leakage (not shown here). It may correspond to an area of

major water infiltration where the revetment is undermined as the fines have been washed out by the leaking water. These first 400 MHz GPR measurements performed on the paved revetment provide a signature that can be associated with leakage areas on this embankment.

The 400 MHz GPR survey on the first leakage area (P2 and P3 profiles) was performed on the paved revetment. The measurements show unconsolidated areas that may be linked to the observed leakage. 200 MHz GPR survey on the crest (not shown here) did not provide consistent results for this part of the embankment. First, the materials are probably too conductive and limit the GPR application. Second, the seepage area and pathways may be too deep to be detected. Third, the acquisition protocol (Figure 7) renders difficult the good maintenance of the antenna along its way.

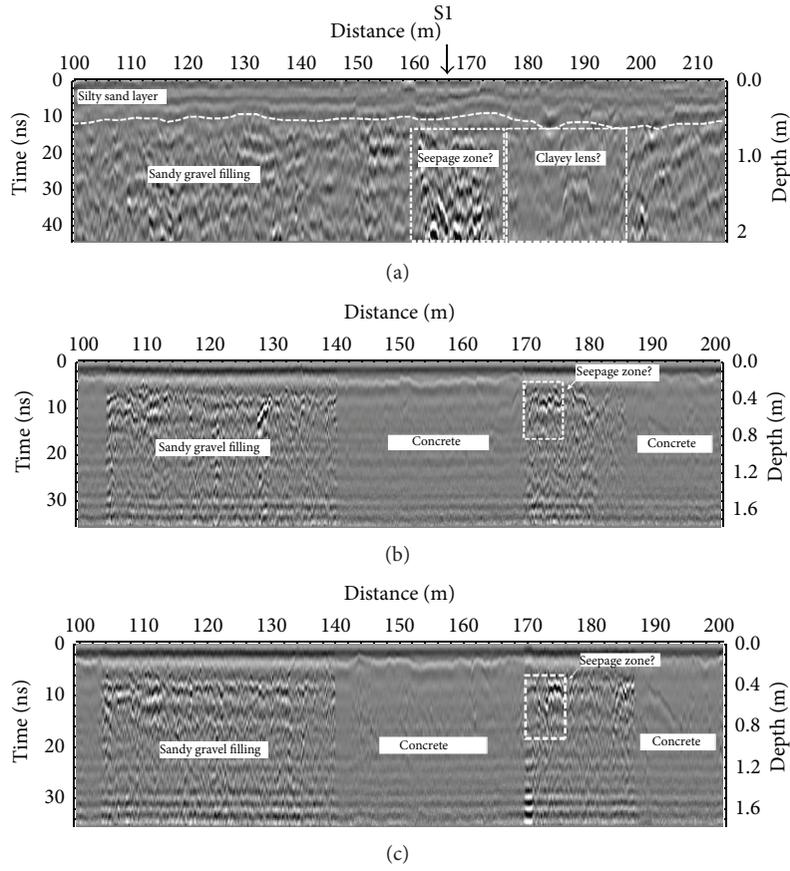
FIGURE 13: GPR signal associated with the second leakage zone. (a) GPR profile P6 on the crest (200 MHz); (b) GPR profile P5 on the paved revetment at 2.15 m high (400 MHz); (c) GPR profile P4 of the paved revetment at 1.7 m high (400 MHz).

Figures 13(b) and 13(c) present the 400 MHz GPR profiles P4 and P5 performed on the paved revetment at 1.70 m and 2.15 m high, respectively. The attenuated signal between 140 m and 170 m and between 190 m and 200 m corresponds to

previous repairs with concrete (i.e., an absorbing material). The heterogeneous zone observed on the 400 MHz profiles located between 170 m and 176 m (time delay and depth in the range [4–16] ns and [20–80] cm, resp., see Figures 13(b) and 13(c)) corresponds to the extremity of the seepage area on the 200 MHz crest profile.

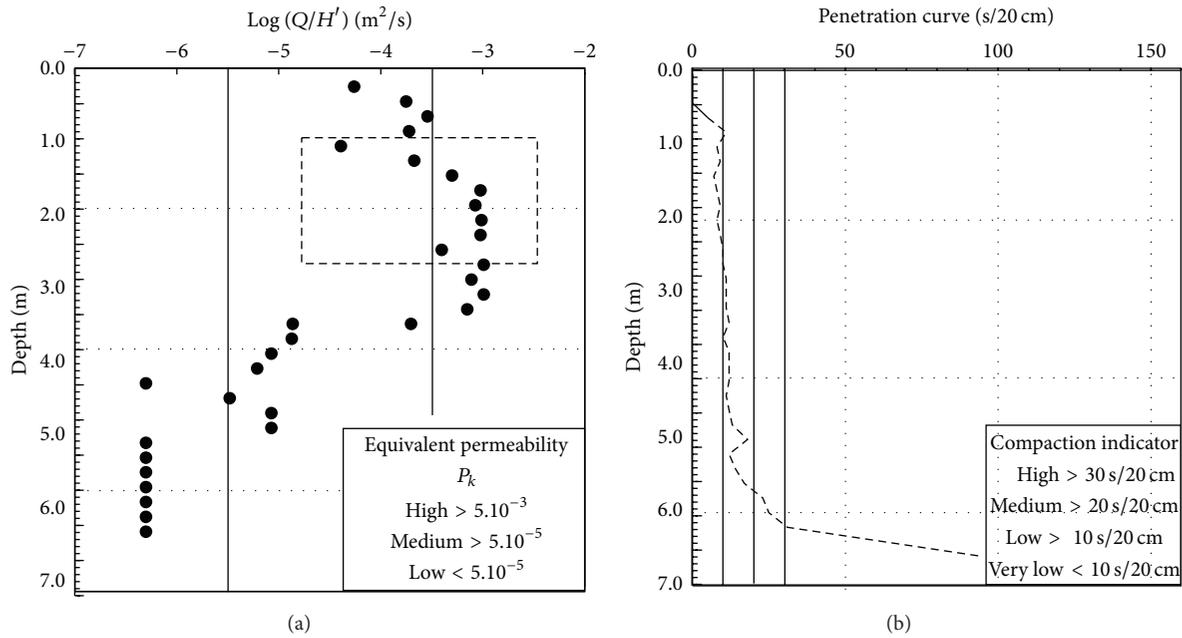
FIGURE 14: (a) Equivalent permeability P_k obtained with the Perm  afor located on S1 and (b) associated penetration curve.

4.3.2. *Perméafor Results.* The Perméafor measurement (Figure 14) was only carried out on the second leakage area. The equivalent permeability logging was exactly performed on the S1 location, that is, on the crest (see Figure 13(a)), and close to the leakage zone observed on the paved revetment. Such testing cannot be performed on the slopes. Between 1 and 2 m, the permeability drastically increases from 10^{-4} to $10^{-3} \text{ m}^2 \cdot \text{s}^{-1}$ and is typical of highly permeable soils. This result is perfectly correlated with the GPR section showing highly resistive materials and strong hyperbolae typical of gravels and sandy materials. Moreover, the S1 coring (Figure 3) performed one year before this study and exhibiting highly heterogeneous soils up to 3 m depth corroborates both the Perméafor and GPR results.

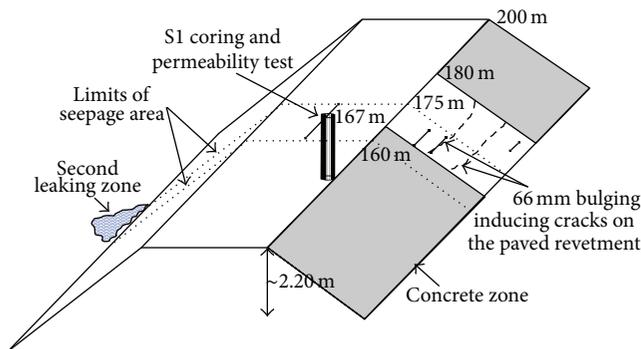
FIGURE 15: Sketch of the reported anomaly for the second leakage area (S1 coring and permeability testings at 167 m; see also Figure 13).

Figure 15 presents (i) all the GPR anomalies detected during the survey on the second leakage zone and (ii) areas of degradation recorded during visual inspections of the canal. A 66 mm bulging area in the centre of the paved revetment was observed. The presence of bulging in the lower or middle parts is associated with deformation and undermining below the revetment (see Figure 13). The medium has probably

been washed of its fines, inducing favourable conditions of seepage. Undermining induced an important compressive stress on the paved revetment, generating bulging as well as longitudinal cracking. Bulging is also observed in the concrete repairs and is not correlated with the nature of the surface revetment (limestones blocks or concrete repairs).
