Research Article

Technical Barriers and Development of Cu Wirebonding in Nanoelectronics Device Packaging

Bondpad cratering, Cu ball bond interface corrosion, IMD (intermetal dielectric) cracking, and uncontrolled post-wirebond staging are the key technical barriers in Cu wire development. This paper discusses the UHAST (unbiased HAST) reliability performance of Cu wire used in fine-pitch BGA package. In-depth failure analysis has been carried out to identify the failure mechanism under various assembly conditions. Obviously green mold compound, low-halogen substrate, optimized Cu bonding parameters, assembly staging time after wirebonding, and anneal baking after wirebonding are key success factors for Cu wire development in nanoelectronic packaging. Failure mechanisms of Cu ball bonds after UHAST test and CuAl IMC failure characteristics have been proposed and discussed in this paper.

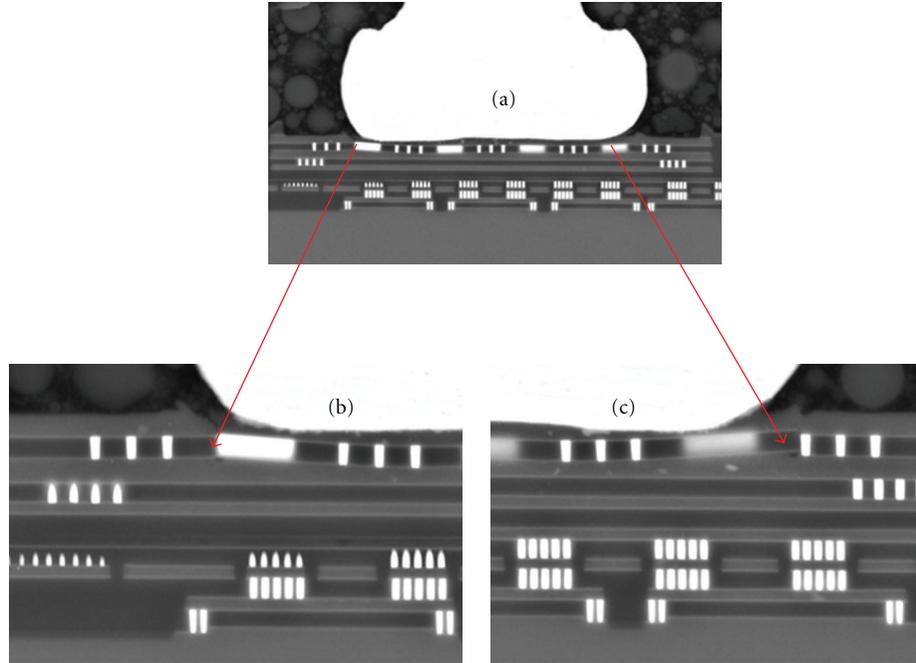
FIGURE 1: (a) Cratering at both Cu ball bond edges of leg no. 2 (b) and (c) IMD (Inter Metal Dielectric crater and crack) at silicon level.

3.1.1. Key Challenges and Development. Cu wire is well identified as a harder material compared to Au wire in nano-electronic packaging. Cratering (latent or otherwise) is one of the bonding failures attributed to over-bonding and appears as damage to the layers under bondpads [1, 2, 9]. Large stresses can be imparted on the layers under the bondpad as well as the silicon, leading to open failures. Sometimes, improper bonding over thin top Al metallization (<1.0 μm in thickness) will induce IMD (Inter-Metal Dielectric) cracking as depicted in Figure 1(a). It is crucial to implement optimized bonding parameters in devices with thin active circuits under bonding pads with Cu ball bonding [2, 3, 7, 8]. In our evaluation, overbonding parameter in Leg no. 2 is found with UHAST 96 hr opens which is attributed to IMD cracking as shown in Figures 1(a), 1(b), and 1(c).

According to the observation of Chen et al. after Cu wire-bonding, there is a residual stress remaining around the perimeter of the Cu ball bond, primarily due to the capillary bonding pressure. The maximum residual stress gradient under pad occurs at the bond periphery [6] and is the primary root cause of IMD collapse and cracking beneath Cu ball bond. Hence it is a crucial step in Cu wire-bonding development to identify and optimize the bonding parameter window in order to eliminate silicon cratering and IMD cracking. Severe IMD cracks may also cause cratering during wire pull test, and Tan and Yarmo [9] reported the silicon cratering during wire pull test after reliability tests.

- (1) Excessive ultrasonic bonding force will cause IMD cracks and in worse case silicon cratering will happen during wire pull [1, 2].
- (2) Green molding compound (with high-pH and low-Cl content) and low-halogen substrate material should be used in Cu wirebond package to ensure UHAST reliability [1, 10].

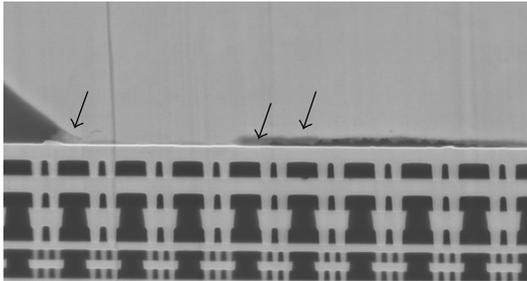
FIGURE 2: Initial CuAl IMC formation starts at both edges of Cu ball bond periphery.

Hang et al. posit that the deformation microstructures at Cu ball bond periphery also decrease the activation energy of metal atoms for interdiffusion and accelerate the initial CuAl IMC formation at the edge of Cu ball bond [14]. We also observed similar initial CuAl IMC formation at ball bond edges as shown in Figure 2.

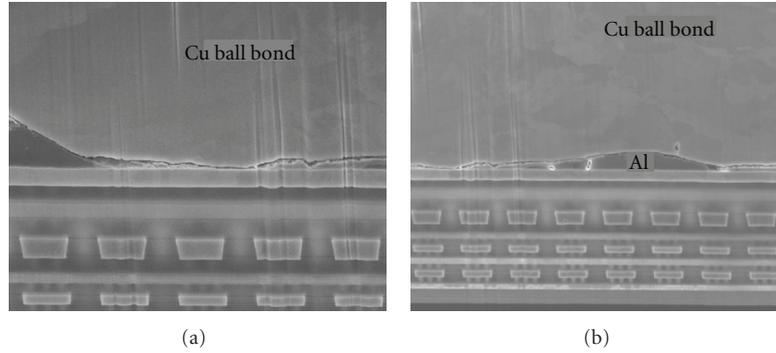
Representative Cu ball bond FIB cross-section SEM images confirm CuAl interface corrosion/cracking as shown in Figure 3(b) The detail of the mechanism of Cu ball bond interfacial corrosion and later cracking with non-green molding compound is addressed in a subsequent section. However, the data indicate the importance of implementation of Cu wirebonding in nanoelectronic packaging with

FIGURE 3: (a) CuAl IMC crack region post-UHAST 96 hr opens (b) Cu ball bond corrosion and interface cracking between CuAl IMC of Leg no. 4.

3.2.1. Green Molding Compound and Substrate. Leg no. 4 (Cu wirebond package which is assembled with non-green molding compound) observed severe post-UHAST 96 hr opens and Cu ball bond interfacial corrosion/cracking. Elemental analysis (EDX) was performed on failing Cu ball bonds and it revealed presence of 0.68 atomic % of Cl as indicated in Figure 3(a) and in Table 2. The presence of Cl in the EDX spectrum is believed to originate from the non green molding compound itself used in Leg 4.

Hydrolysis of IMC and AlCl_3 (intermediate product) under a moisture-rich environment forms aluminium (III) oxide which is a resistive layer and ionic Cl is usually found at the corroded ball bond. Cl also has been found in our EDX analysis as shown in Figure 3(a). Equation (3) indicates the hydrolysis of Cu_9Al_4 into Al_2O_3 and outgassing:

Cracking of the interface of Cu to the Cu IMC might be due to outgassing of H_2 during hydrolysis (as shown in (7) and (8)) in between Cu IMC to Cu ball bonds. Cracking usually starts at Cu ball bond periphery and will propagate towards center of Cu ball bond [1]. Hence, it is advisable to utilize greener mold compound and low-halogen substrate materials in the substrate (solder mask material specifically) to be used for Cu wirebond packages. Equation (9) explains that aluminium trichloride will undergo hydrolysis under high humidity of UHAST (85% RH) and produce acidic environment. This also explains the Cl present in EDX analysis of corroded Cu ball bond with non-green mold compound. Tan et al. [4] described the corrosion mainly found

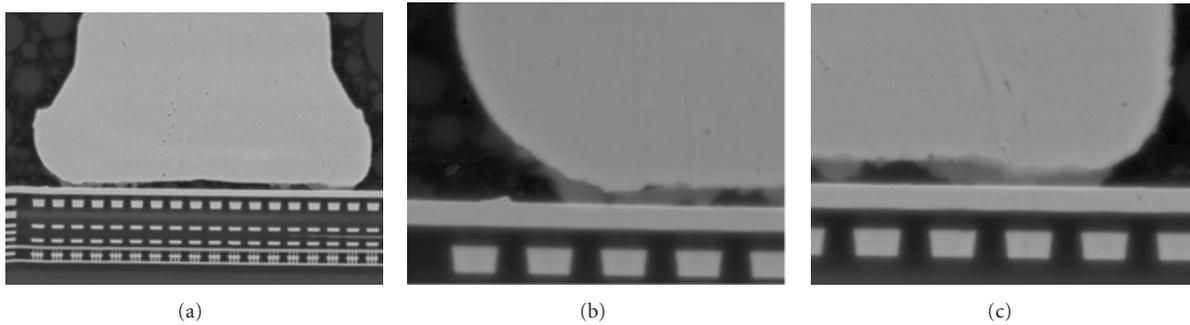
There is no presence of Cl⁻ in the Cu ball bond of UHAST 96 hr survivors (for Leg 3). SEM cross-section results as shown in Figures 4(a), 4(b), and 4(c) for green mold compound leg (Leg no. 3) show normal IMC growth and solid bonding.

FIGURE 4: (a) Cu ball bond, (b) and (c) edges of Cu ball bonds—no Cu ball bond corrosion or weaknesses with Green molding compound (Leg no. 3).

Confirmation on UHAST survivor from Leg 3 (Green mold compound) indicates no presence of Cl⁻ element at center of CuAl IMC region. Table 3 tabulates the detailed EDX analysis results.

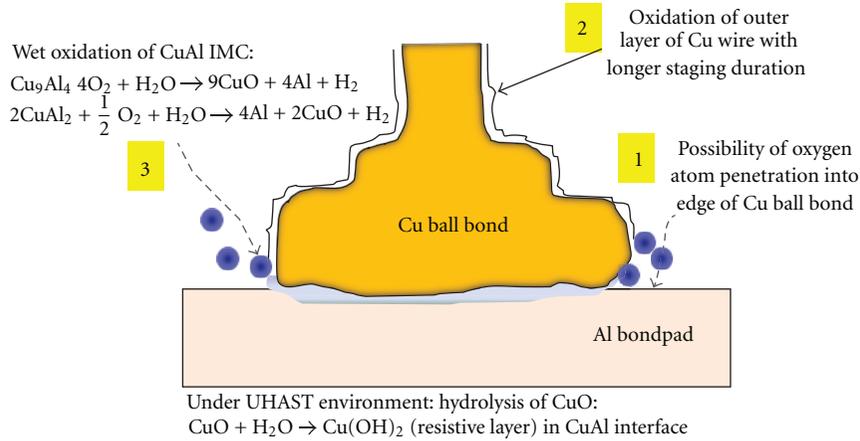
FIGURE 5: Proposed Cu ball bond oxidation mechanism due to long staging at production floor and induced resistive opens after UHAST reliability test.

Equation (2) reveals the wet oxidation of CuO to form Cu(OH)_2 which is an insulative layer which will induce opens after UHAST stress test (as in Figure 5) [1, 2]. Oxygen gas will penetrate into the edge of Cu ball bond and induce oxidation of CuAl IMC (in this case the majority of IMCs are Cu_9Al_4 and CuAl_2) as shown in (3) and (4) [10]. Oxidation in humid air environment during staging will produce CuO which is a resistive layer in CuAl interface. CuO will undergo wet oxidation in UHAST test environmental test and Cu(OH)_2 will be produced. This usually ended up with high peak of O in EDX analysis of an open failure after UHAST test. Our UHAST opens after UHAST 96 hr also indicated presence of O peak (8.64 atomic %) in Table 2.

step. Assembly staging time should normally be closely monitored and controlled to prevent Cu ball bond oxidation at production floor, and based on the results of our evaluation (Leg no. 5 to Leg no. 7), it appears to be that the appropriate staging time after Cu wirebond step to encapsulation step should be gated to less than 3 days, as UHAST 96 hr opens are observed with 7 days and 10 days of staging time. However, some industry data recommends bare Cu wire spool lifespan to be controlled less than 10 days on the factory floor [1]. The effect of assembly staging time on UHAST reliability of Cu ball bond is crucial to understand and could vary based on the assembly process and material set. The detailed failure mechanism is proposed as in (1) to (4) as follows:

- (4) Assembly staging time should be controlled to 3 days or less after Cu wirebond step prior to molding. It is recommended to store unmolded units in an N_2 cabinet [1].

- (5) Cu ball bond oxidation mechanism is a combination of a dry oxidation process occurring at the Cu ball bond wire, forming a CuO liner oxide layer. The CuAl IMC (Cu_9Al_4 and CuAl_2 primarily) will react with O_2 to form CuO. CuO will undergo wet oxidation in UHAST test environmental test and $\text{Cu}(\text{OH})_2$ will be produced.

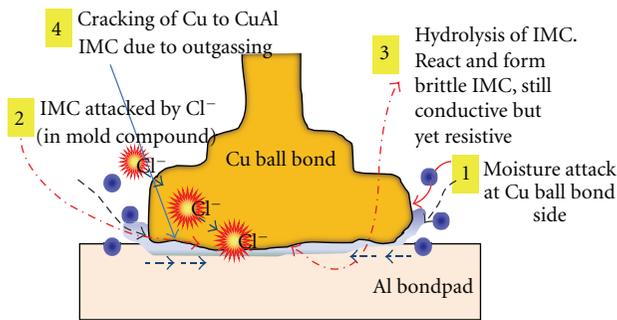
FIGURE 6: Proposed Cu ball bond corrosion failure mechanism in UHAST tests (Legs no. 4, 6, and 7).

3.4. Failure Mechanisms of Cu Ball Bond Wet Corrosion under UHAST. The Cu ball bond opens after unbiased HAST test mainly induced by Cl ionic content in mold compound. Figure 6 illustrates typical Cu ball bond failure mechanism. The initial formation of CuAl IMC beneath Cu ball bond is dominated by Cu_9Al_4 and CuAl_2 [10]. As mentioned before, pH and Cl ionic contents are critical parameters for mold compound.

- (3) Failure mechanism of post-UHAST 96 hr open failures for Cu ball bond belongs to CuAl IMC interfacial corrosion and cracking. Cu_9Al_4 and CuAl_2 react with ionic Cl to form AlCl_3 which is reactive and will further react with moisture (in UHAST) to form a weak Al_2O_3 insulative layer.

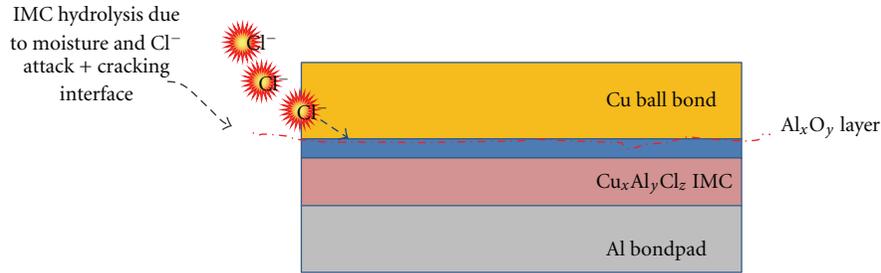
the mold compound and forms an intermediate product of AlCl_3 (reactive if under moisture environment such as unbiased HAST/PCT/biased HAST test) as shown in (5) and (6) below [21]. We propose the Cl^- attack from the edge of Cu ball bond as indicated in Figure 7:

FIGURE 7: Proposed Cu ball bond corrosion failure mechanism in UHAST tests (Leg no. 4, 6, and Leg no. 7) Cl^- attack from the edge of Cu ball bond.

at CuAl IMC interface. Hence, some researchers recommend Palladium-coated Cu wire to be deployed to minimize the Cu ball bond corrosion under moisture reliability condition [2, 11, 22, 24].
