## Research Article

# Magnetic Flux Leakage Sensing-Based Steel Cable NDE Technique

Nondestructive evaluation (NDE) of steel cables in long span bridges is necessary to prevent structural failure. Thus, an automated cable monitoring system is proposed that uses a suitable NDE technique and a cable-climbing robot. A magnetic flux leakage-(MFL-) based inspection system was applied to monitor the condition of cables. This inspection system measures magnetic flux to detect the local faults (LF) of steel cable. To verify the feasibility of the proposed damage detection technique, an 8-channel MFL sensor head prototype was designed and fabricated. A steel cable bunch specimen with several types of damage was fabricated and scanned by the MFL sensor head to measure the magnetic flux density of the specimen. To interpret the condition of the steel cable, magnetic flux signals were used to determine the locations of the flaws and the levels of damage. Measured signals from the damaged specimen were compared with thresholds that were set for objective decision-making. In addition, the measured magnetic flux signals were visualized as a 3D MFL map for intuitive cable monitoring. Finally, th

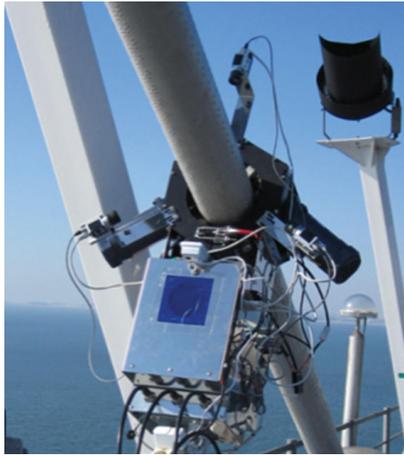
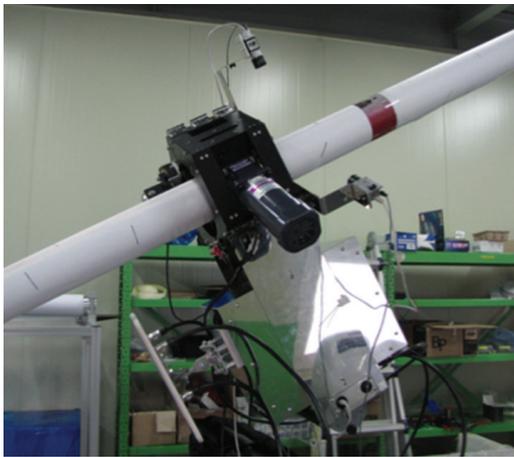
FIGURE 1: The cable-climbing robot with suitable NDE equipment.

suitable NDE technique and a cable-climbing robot that can approach the damaged point, which is shown in Figure 1.

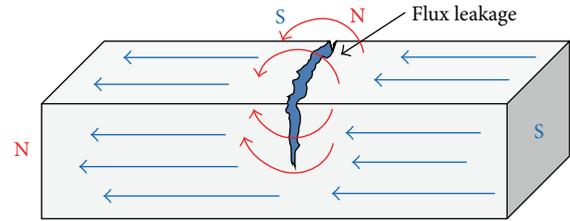
FIGURE 2: Principle of magnetic flux leakage.

specimen is called a pole. A magnet that is cracked, but not broken completely in two, forms a north and south pole at each edge of the crack, as shown in Figure 2. The magnetic field exits in the north pole and reenters the south pole. The magnetic field spreads out when it encounters the small air gap created by the crack, because the air cannot support as much magnetic field per unit volume as the magnet can. When the field spreads out, it appears to leak out of the material and is thus called a flux leakage field.

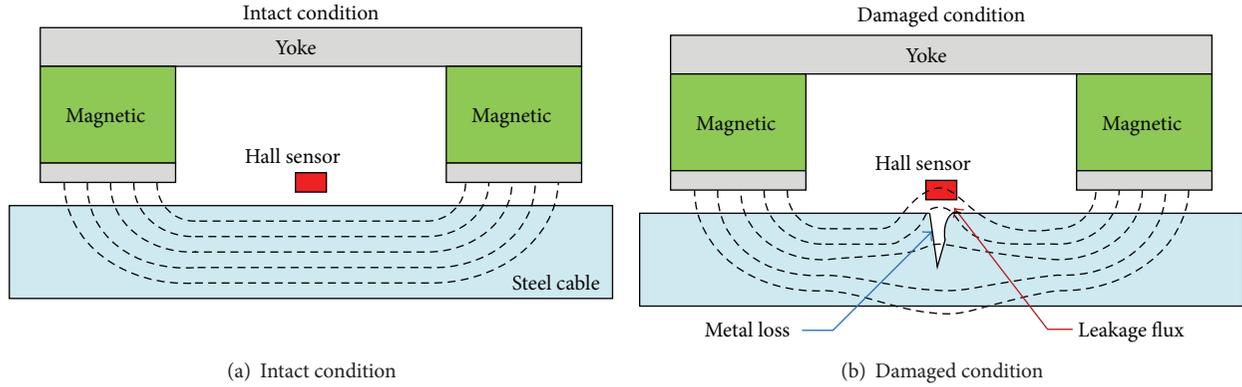
**2.2. Magnetic Flux Leakage-Based Local Fault Damage Detection Technique.** A strong permanent magnet or an electromagnet is used to establish a magnetic flux in the material to be inspected. When there is no defect, the flux in the metal remains uniform, as illustrated in Figure 3(a). In contrast, Figure 3(b) illustrates the flux leakage that occurs when there is LF damage, due to broken wire or wear. The flux leaks out of the metal near the defect. Sensors that can detect this flux leakage are placed between the poles of the magnet and they generate an electric signal that is proportional to the magnetic flux leakage [16].

FIGURE 3: The concept of MFL-based LF damage detection technique.

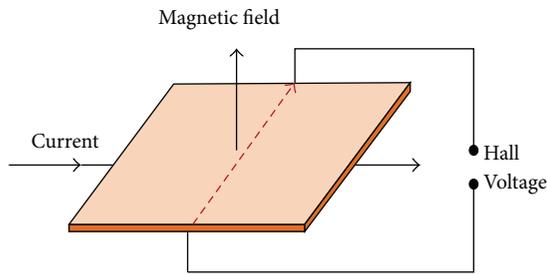
In this study, Hall sensors were used to capture the MFL. The Hall sensor operates based on the Hall effect and is illustrated in Figure 4. When a magnetic field is applied to a plate, an electron moving through a magnetic field experiences a force, known as the Lorentz force, that is perpendicular both to the direction of motion and to the direction of the field. It is the response to this force that creates the Hall voltage [17, 18]. This Hall voltage can be measured using a DAQ system and can be used to examine the condition of target structure.

FIGURE 4: Principle of the Hall effect.

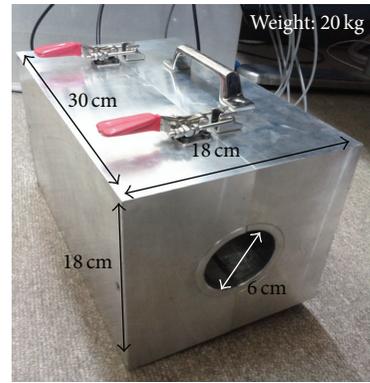
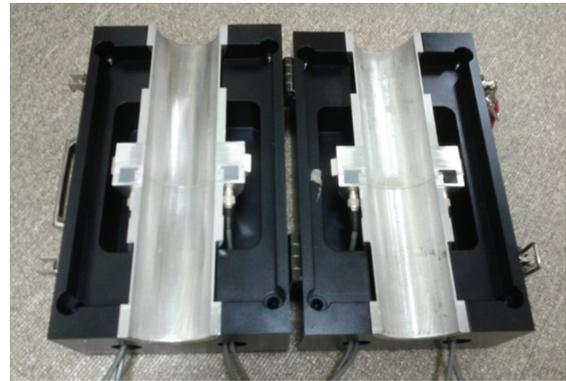
**3.1. Design and Fabrication of MFL Sensor Head Prototype.** An MFL sensor head prototype was fabricated, as shown in Figure 5, to perform the experimental study to verify the proposed cable NDE method. The sensor head was composed of a magnetization component and a signal measurement component, which were packed into an aluminum case of 18 cm width, 18 cm height, and 30 cm length. Additionally, the components could be detached conveniently, by making a system that could be readily opened.

FIGURE 5: The fabricated MFL sensor head prototype.

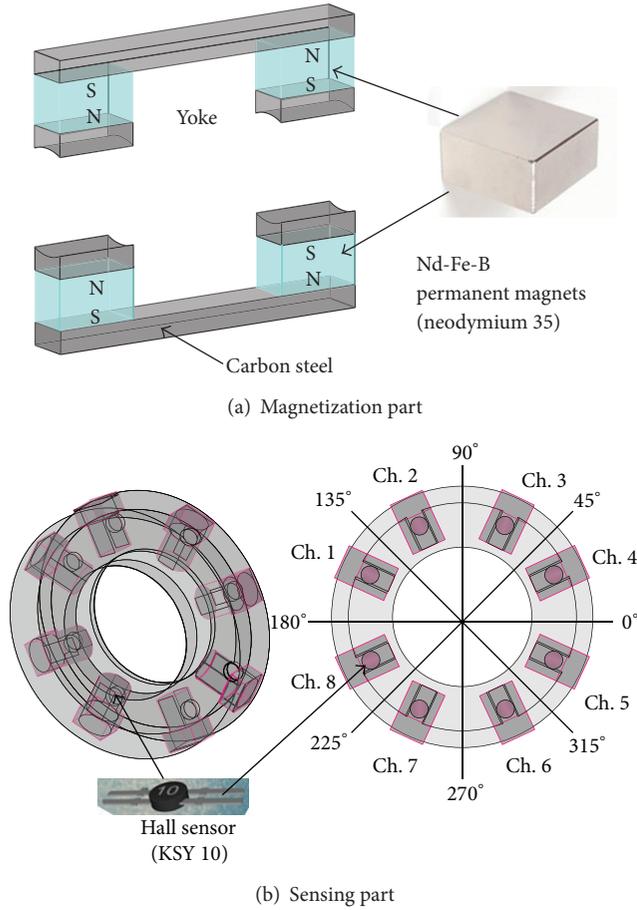
First, the magnetization component, which creates the magnetic field for magnetizing a portion of the steel cable specimen, is a pair of yokes, which consist of 2 high strength Nd-Fe-B permanent magnets (neodymium 35) and a plate of carbon steel, as in Figure 6(a). The permanent magnet has the advantage of not requiring any power for operation and allows for a lighter system than if an electromagnetic magnet was to be used.

The signal measurement component is composed of 8 channels of Hall sensors, which are circumferentially arranged at regular intervals around a circular configuration as shown in Figure 6(b). Each of the 8 arranged sensors converts the MFL signal to a voltage signal, which is transmitted to a DAQ system. The inner diameter of the sensor head is 60 mm, to accommodate steel cable of the same dimension.

FIGURE 6: Design of the MFL sensor head.

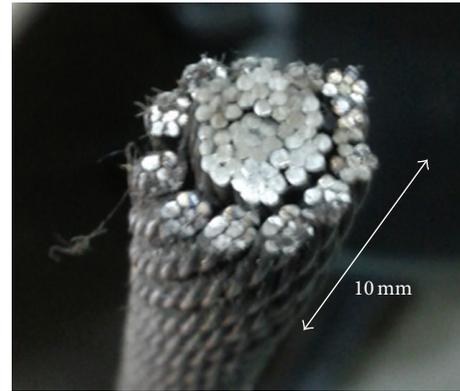
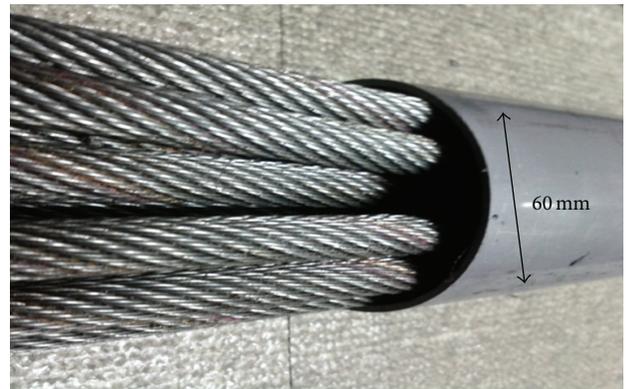
diameter and 1700 mm length was fabricated for the experiment, by filling 25 strands of steel cable in a pipe of 60 mm external diameter. Each strand of cable was stranded from 7 \* 19 element wires and was 10 mm in diameter, as shown in Figure 7.

FIGURE 7: Specifications of the steel cable specimen.

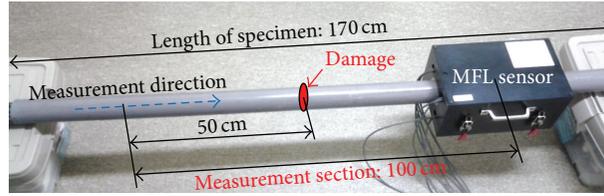
Using the sensor head, MFL signals were measured from only the center 1 m section of the damaged specimen for each damage level condition, as shown in Figure 8. The moving speed of the sensor head was 1 m/sec, and the sampling rate was 1 kHz. Therefore, the displacement resolution of this setup is 1 mm.

FIGURE 8: Test setup and measurement.

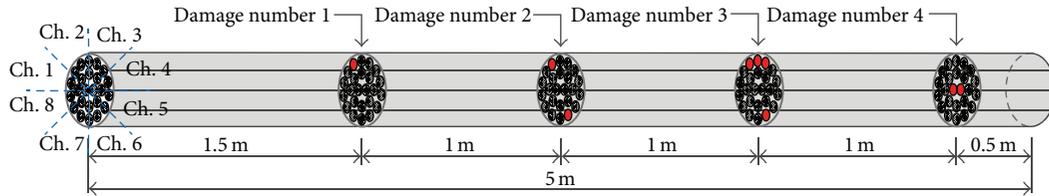
Next, a virtual 5 m length of steel cable was rendered, by combining the 5-measurement sections of each damage condition (from intact to damage level number 4), as shown in Figure 9.

FIGURE 9: Virtual combined steel cable specimen.

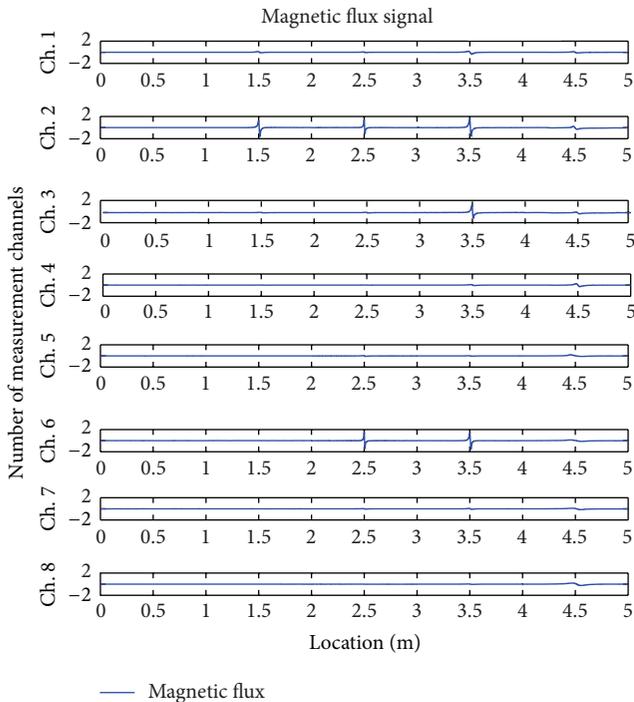
FIGURE 10: The raw magnetic flux signals from each channel.

**3.3.1. Results of LF Damage Detection Based on MFL Method.** The voltage signals that were measured from each channel of Hall sensors are displayed in Figure 10.

This figure shows symmetrical magnetic flux leakage signals measured at sensing channel 2 at the 1.5 m point along the length of the specimen and at channels 2 and 6 at the 2.5 m point. These MFL signals are consistent with the location of

the actual local fault damage formed in the specimen. The flux leakage was captured only at sensing channels adjacent to the damages. At the 3.5 m point, the flux leakage signals were measured at sensing channels 2, 3, and 6, and faint flux leakage signals were also measured at sensing channels 1 and 4. This shows that when the damage is greater, flux leakage can be measured in neighboring channels. In addition, small FL signals were captured from every channel at the 4.5 m point (where the cut damages are located at a similar distance from all sensing channels). These facts demonstrate that the MFL sensor method can detect LF damages, and sensing sensitivity is dependent on the distance between the damage and the Hall sensor. Additionally, the circumferential location of the damage can be judged, by arranging the sensors in an array.

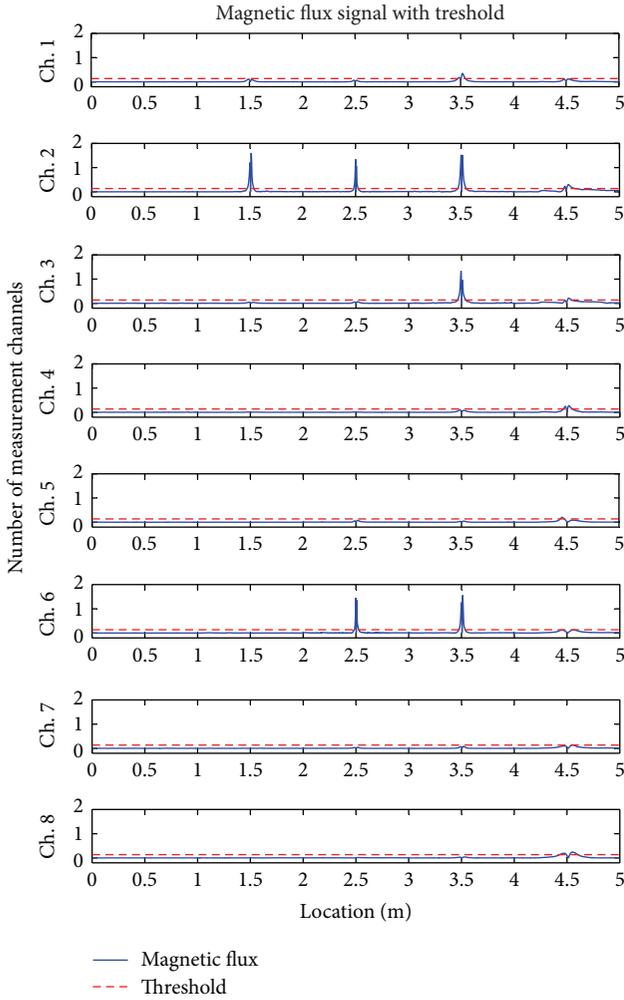
A threshold that distinguishes between intact and damaged conditions was set, to determine the damage objectively. Original MFL signals were converted to absolute values so that only magnitudes would be considered in the thresholds. In this study, a 99.99% confidence level threshold of the intact condition was set, using the generalized extreme value (GEV) distribution. The calculated threshold value is 0.1358 V, which is shown with the converted MFL signal in Figure 11.

The converted flux leakage signals exceeded the threshold at sensing channel 2 at the 1.5 m point, channels 2 and 6 at the 2.5 m point, and channels 1, 2, 3, and 6 at the 3.5 m point. At the 4.5 m point, the signals from almost all channels exceeded the threshold by a narrow margin. These measurements coincide with the actual damage locations and show that customized thresholds can be used as criteria to check whether or not damage has occurred.

FIGURE 11: The converted magnetic flux signals with threshold.

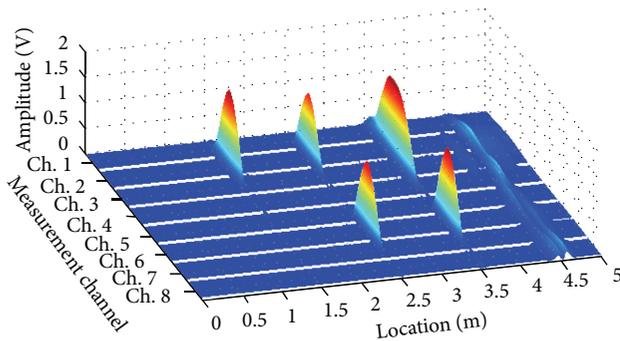
**3.3.2. Visualization of Magnetic Flux.** The MFL signal was expressed in a 3-dimensional graph, as shown in Figure 12.

The  $x$ -axis is the distance along the specimen, the  $y$ -axis is the measurement channel number that represents the position of the sensor in the circumferential direction, and the amplitude of the magnetic flux is displayed on the  $z$ -axis and is color coded. Interpolation was performed to overcome the limitations of the limited number of sensing channels

FIGURE 12: 3D magnetic flux graph.

for the smooth shape of the graph. In this figure, the large peaks that describe the flux leakage are clearly distinguishable from the intact signal, and they lay out the size and location of the LF damages efficiently. However, small leakage was not distinguishable, due to noise in the signal. Thus, a threshold surface (shown in black) was added on the MFL graph, as shown in Figure 13. This precisely distinguishes the LF damaged areas from noise signals and the intact condition.

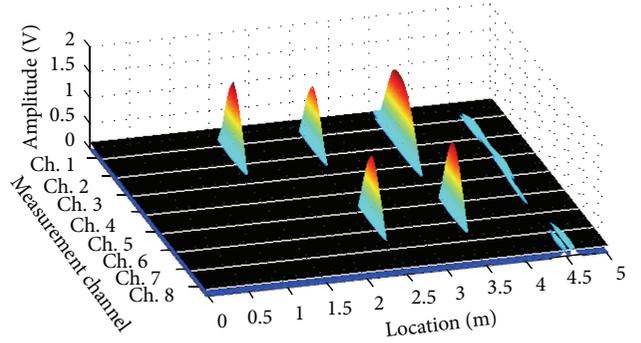
FIGURE 13: 3D magnetic flux graph with threshold surface.

In addition, the 3D magnetic flux map was wrapped with a cylindrical threshold, in a manner similar to Figure 13, as shown in Figure 15.

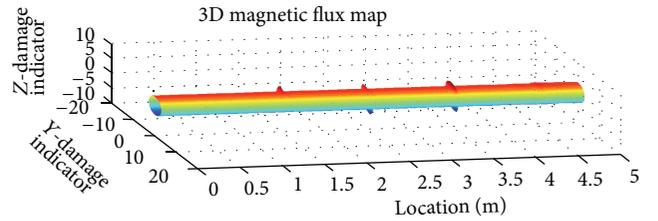
FIGURE 14: Visualized 3D magnetic flux map.

These calculated damage indicators were plotted on a 3D graph with a distance indicator, as shown in Figure 14.

This 3D magnetic flux map represents the damage location information in the longitudinal and circumferential directions and shows the level of damage at a glance, from any angle.

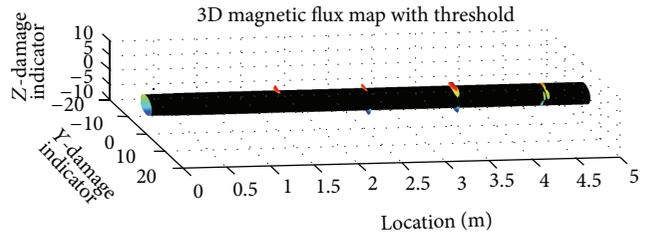
FIGURE 15: Visualized 3D magnetic flux map with threshold cover.

This figure shows the damage parts highlighted by the threshold covering process. In addition, the circumferential direction and size of damage can be detected more efficiently by using cross-sections of the 3D MFL map, as shown in Figure 16.

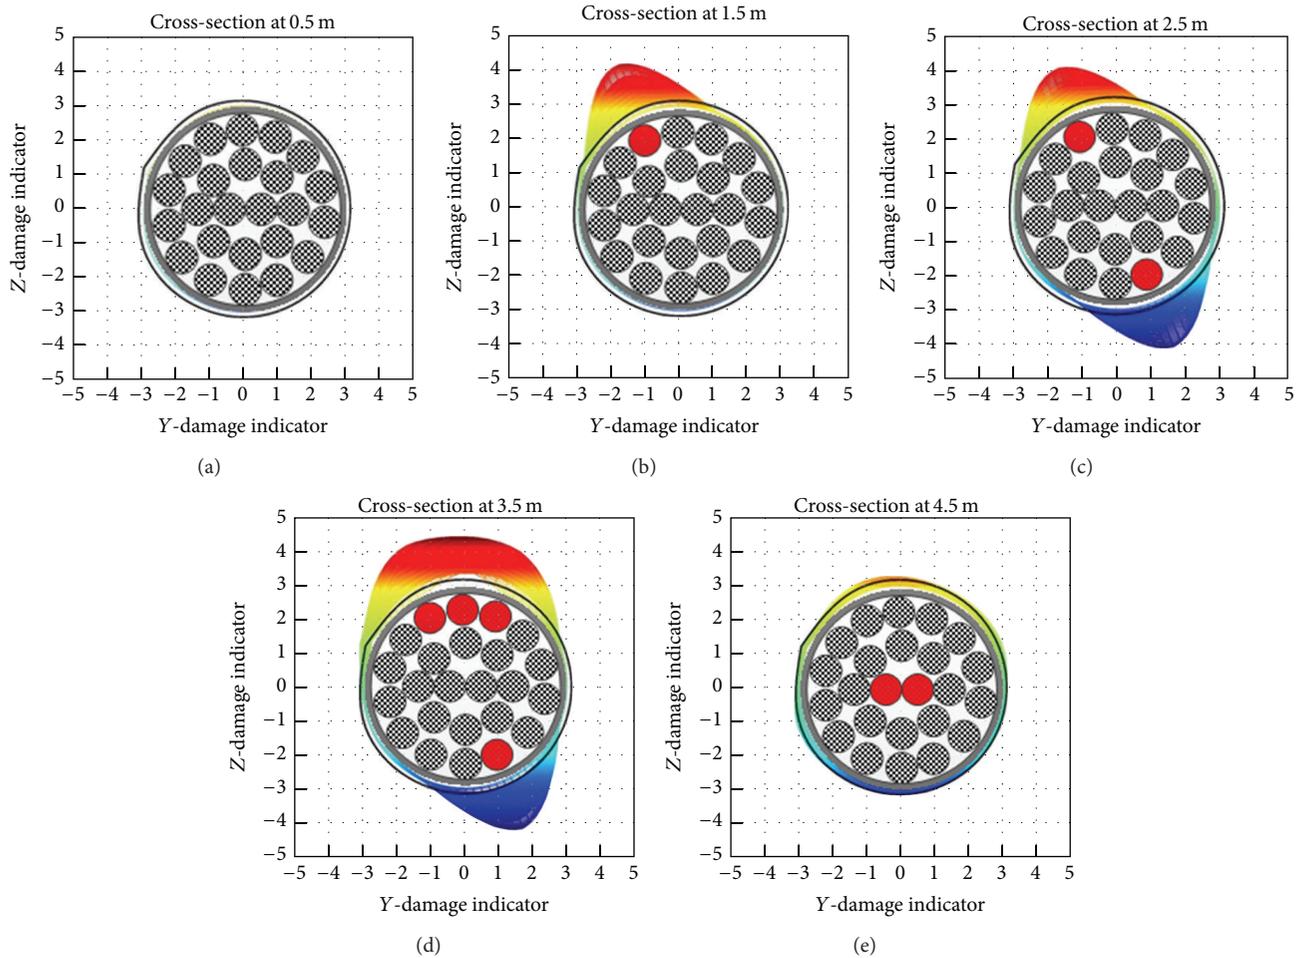
FIGURE 16: Visualized cross-sections with threshold cover.

Figure 16 shows visualized cross-sections with a threshold cover. Through this visualization work, it is expected that the damage in a cable can be detected by anyone, even by those with no professional experience with cable NDE.
