Research Article

Influence of Vibration Isolator Failure on Vehicle Operation Performance and Floating Slab Track Structure Vibration Reduction Effectiveness

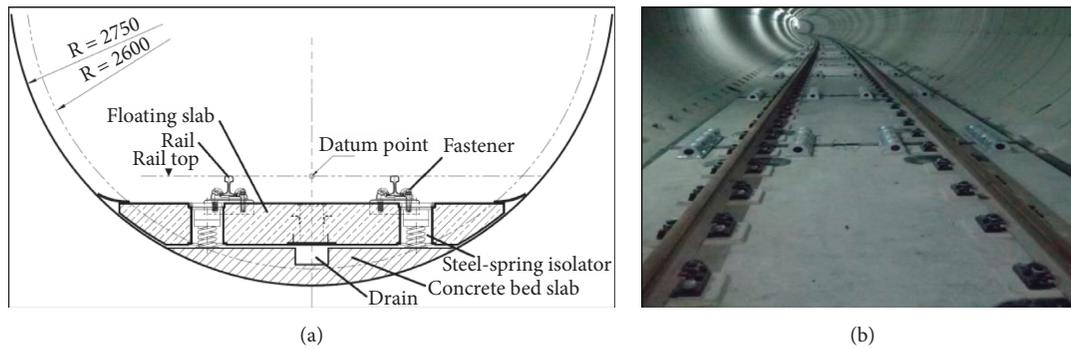
The steel-spring floating slab track vibration isolation system consists mainly of the concrete bed slab, steel-spring vibration isolator, concrete floating slab, track structure, and shear hinge [14] (see Figure 1). Its basic principle for

FIGURE 1: Structure of steel-spring floating slab track.

vibration reduction is to set a vibration isolator with a natural frequency far lower than the excitation frequency between the vibration source and foundation. The inertial force of the track slab mass offsets most of the dynamic load from the vehicle, and only the static load and a small amount of residual dynamic load are transferred to the vibration isolator and foundation after tuning, filtering, and energy absorption, thereby realizing vibration reduction [15]. It can be seen that the steel-spring vibration isolator is a discrete bearing structure for the floating slab track and a key part of vibration and noise reduction. It consists of inner and outer sleeves, a spiral steel spring, and viscous damping.

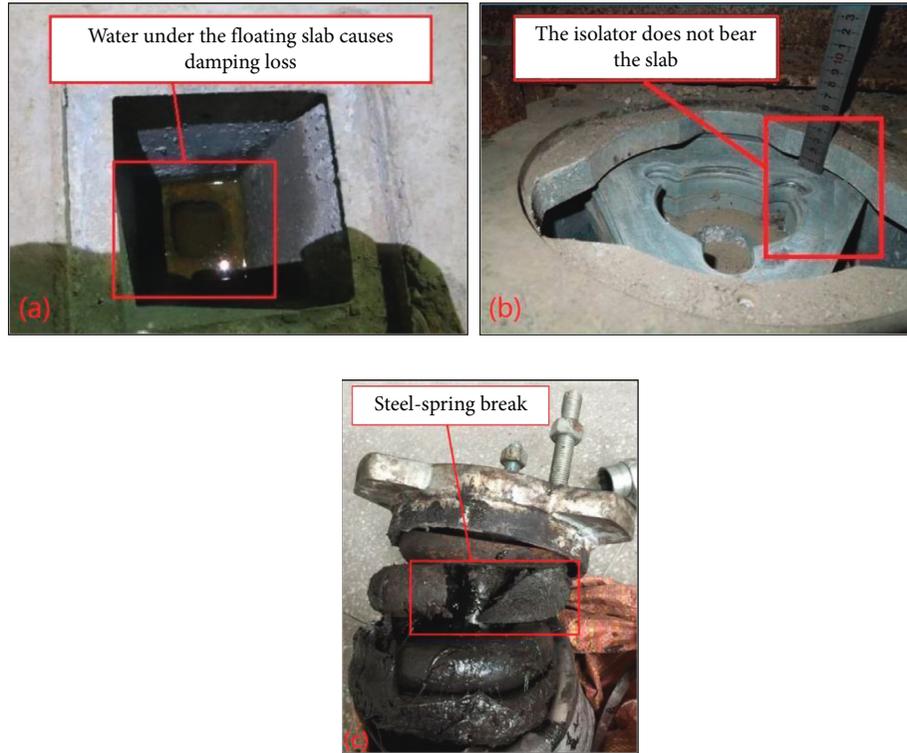
However, it has been found in the actual lines that steel-spring vibration isolator failures are subject to different conditions, as shown in Figure 2. Figure 2(a) shows some water seepage in the inspection tube, which is related to factors such as high rainfall or failure in the track drainage system. In this case, liquids can enter the inner sleeve and mix with the damping agent, causing loss of damping fluid in the sleeve, constant vibration isolator stiffness, and low damping. Figure 2(b) shows that suspended inner sleeve was caused by incorrect installation of the locking plate or by no or loosened locking bolt. Figure 2(c) shows that the steel-spring vibration isolator can break due to factors like fatigue or resonance, causing loss of damping fluid. The stiffness and damping of the steel-spring vibration isolator are both zero for the last two cases.

FIGURE 2: Vibration isolator failure. (a) Loss of damping fluid. (b) Inner sleeve suspension. (c) Broken steel spring.

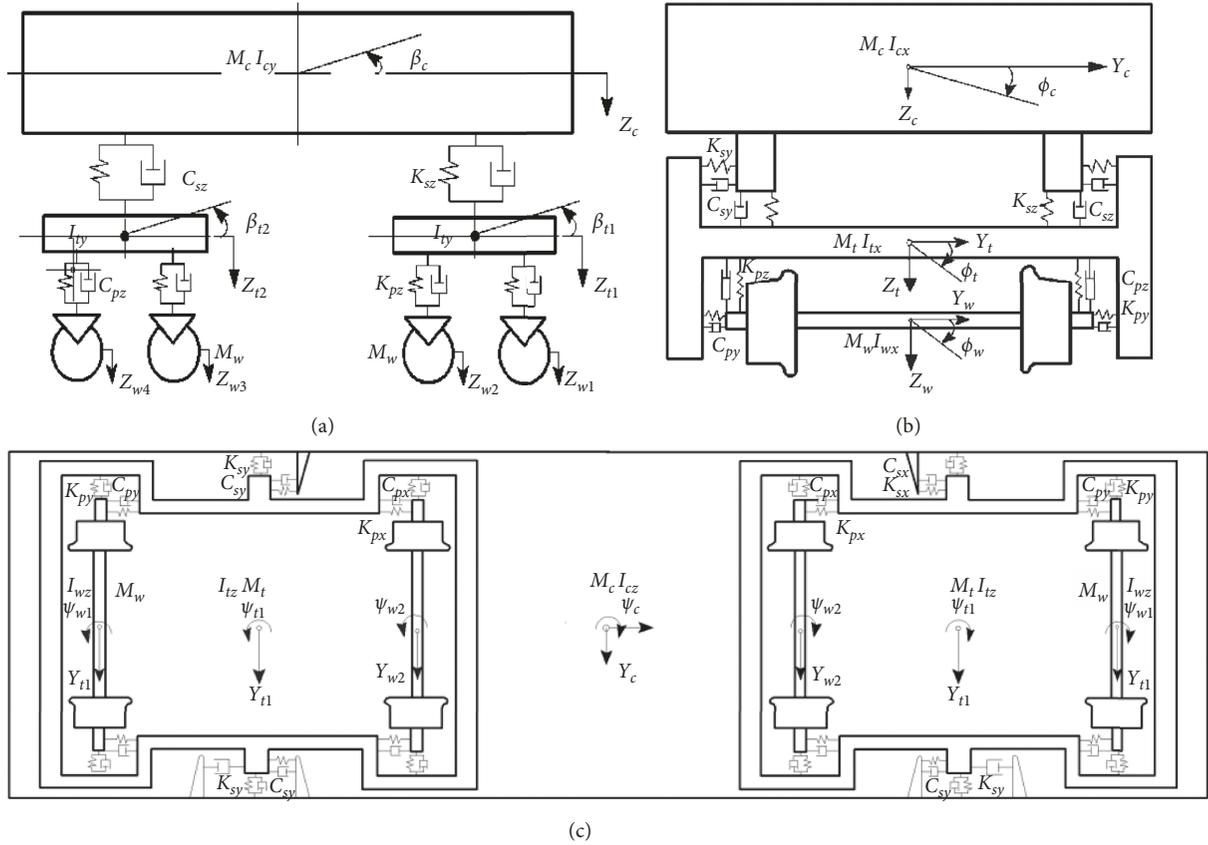
FIGURE 3: Dynamic vehicle model. (a) Side view. (b) Rear view. (c) Top view.

2.1. Vehicle Model. A vehicle model was established according to the basic parameters of Type A subway vehicles. The single-car train model formed vibrations via 1 vehicle body, 2 bogies, and 4 wheel sets. The bogies were connected with the primary damping springs via the wheel sets, and the vehicle body and bogies were connected with the secondary dampers (see Figure 3). The single-car vehicle body had 5 independent degrees of freedom (DFs) at the central point: vertical and lateral displacement, rolling, pitch, and yaw, denoted as $\{V_c\} = \{Y_c, Z_c, \Phi_c, \beta_c, \Psi_c\}$, respectively. Each bogie had 5 independent DFs corresponding to the center of gravity, defined as $\{V_b\} = \{Y_b, Z_b, \Phi_b, \beta_b, \Psi_b\}$, just as with the vehicle body. The wheel set had 4 independent DFs and 2 dependent DFs, the former of which were longitudinal

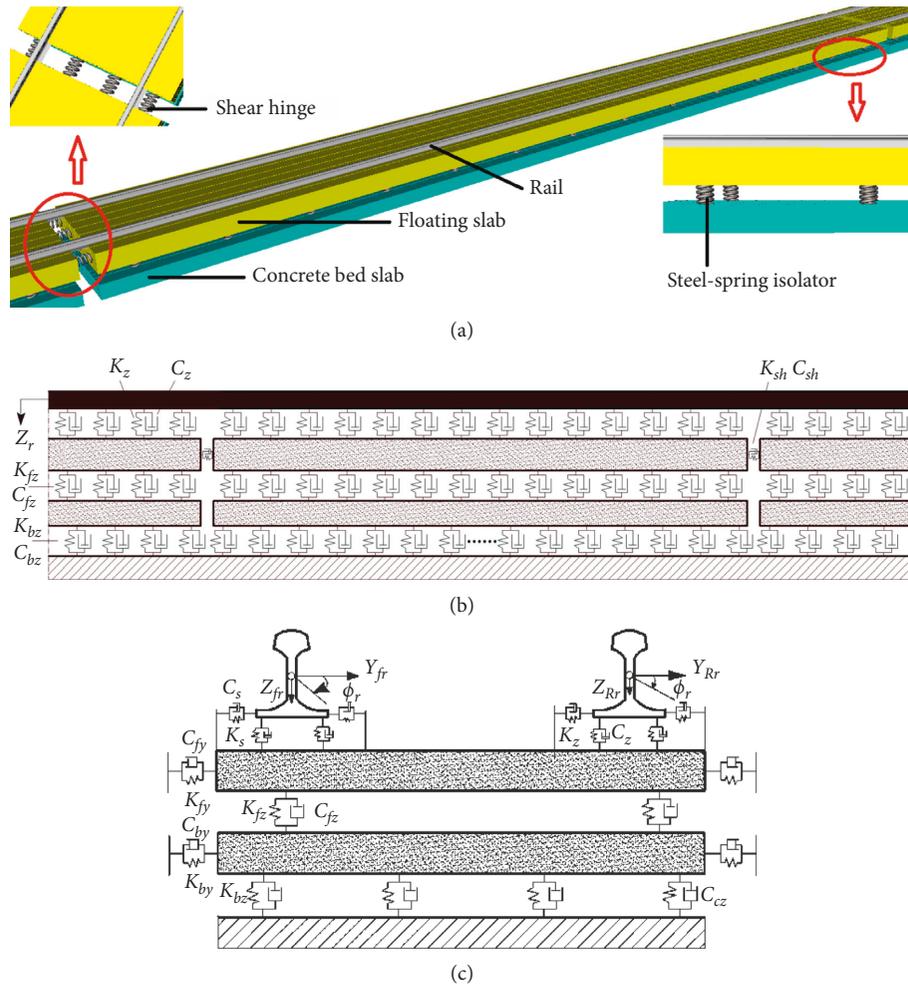
FIGURE 4: Simplified dynamic model of track structure. (a) Schematic diagram of track structure. (b) Side view. (c) Rear view.

2.2. Track Structure Model. The track system was simplified as a double-mass (floating slab and concrete bed slab) 3-layer (rail-floating slab-concrete bed slab-foundation) spring-damping vibrating structure, in which the rail, floating slab, and concrete bed slab were considered the flexible body. The rail was taken as Timoshenko beams on a discrete point-bearing foundation, involving vertical, lateral, and torsional vibration factors [20, 21]. The rail was connected to the floating slab via fasteners. Vertical equivalent stiffness and damping were denoted as K_z and C_z , respectively, and lateral equivalent stiffness and damping were denoted as K_s and C_s . The steel-spring vibration isolator was set between the floating slab and concrete basement, simulated as a linear spring. The vertical equivalent stiffness and damping were denoted as K_{fz} and C_{fz} and lateral equivalent stiffness and damping as K_{fy} and C_{fy} . The floating slabs were connected to each other via shear hinges. The concrete bed slab was connected to the foundation via bushing force elements. The vertical equivalent stiffness and damping were denoted as K_{bz} and C_{bz} , respectively, and lateral equivalent stiffness and damping as K_{by} and C_{by} (see Figure 4). The above structure's dynamic and geometric parameters are shown in Table 2. The grade six track irregularity PSD of the US Federal Railroad Administration (FRA) was adopted in this paper, considering track vertical irregularity and track lateral irregularity.

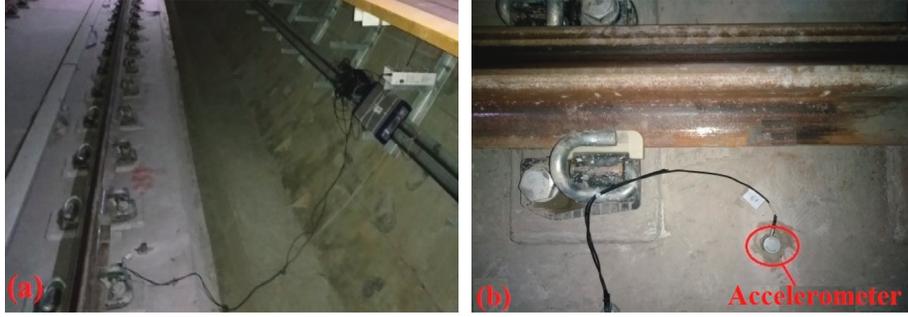
FIGURE 5: Position of measuring point at floating slab.

vertical acceleration at the same position in the model was extracted. Comparing and analyzing the measured and theoretical values in time domains to verify the rationality of the rigid-flexible coupling dynamic model and its parameters, which could provide the reliable support for studying the influence of vibration isolator failure on vehicle operation performance and floating slab track structure vibration reduction effectiveness. Measuring point is arranged as shown in Figure 5.

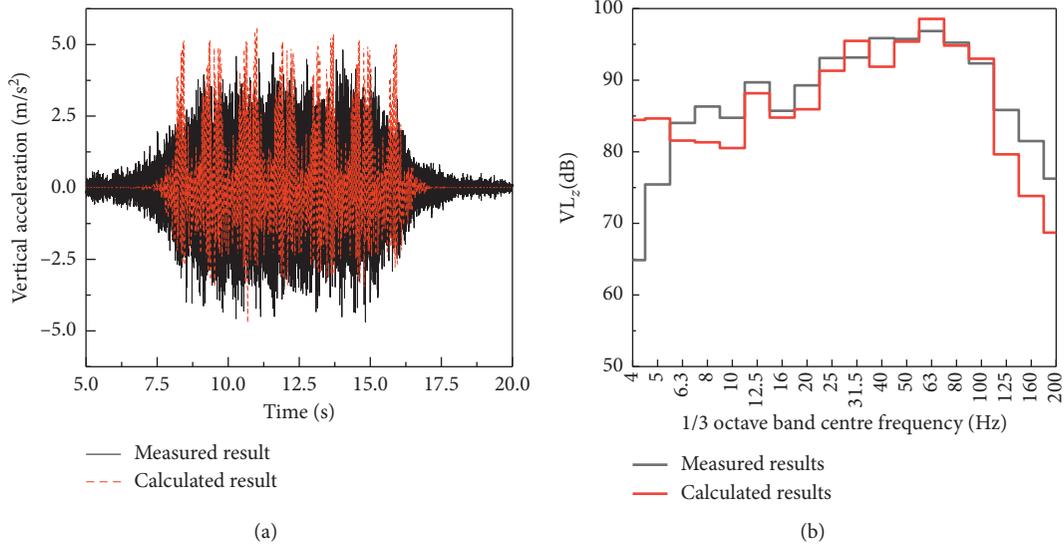
Table 3 and Figure 6(a) compared the calculated results and measured results of floating slab vibration response in time domain. It could be seen that the two had fairly consistent time interval amplitude extremum, but their forms were slightly different because the measured results were affected by background vibration. The 1/3 octave vertical frequency-weighted vibration acceleration Z vibration level (VL_z) obtained by processing the time-domain data in Figure 6(a) shall be analyzed comparatively, as shown in Figure 6(b). From the measured results, it could be seen that the main frequency of vertical vibration of steel-spring floating slab at the field measuring point was 6.3–100 Hz, and the advanced peaks are at the same central frequencies

FIGURE 6: Comparison of calculated and measured results of floating slab. (a) Time domain. (b) Frequency domain.

which are 12.5 Hz and 63 Hz, respectively. The larger one was located at 63 Hz of the central frequency, which was caused by inducing wheel-rail resonance. The calculated results are smaller above 125 Hz probably because the length of the minimum wavelength of track irregularity is not short enough. However, it does not affect the later analysis results. Similarly, the calculated results showed that the vertical vibration acceleration level of the steel-spring floating slab had a good coincidence, and the dynamic rigid-flexible coupling model had good calculation accuracy.

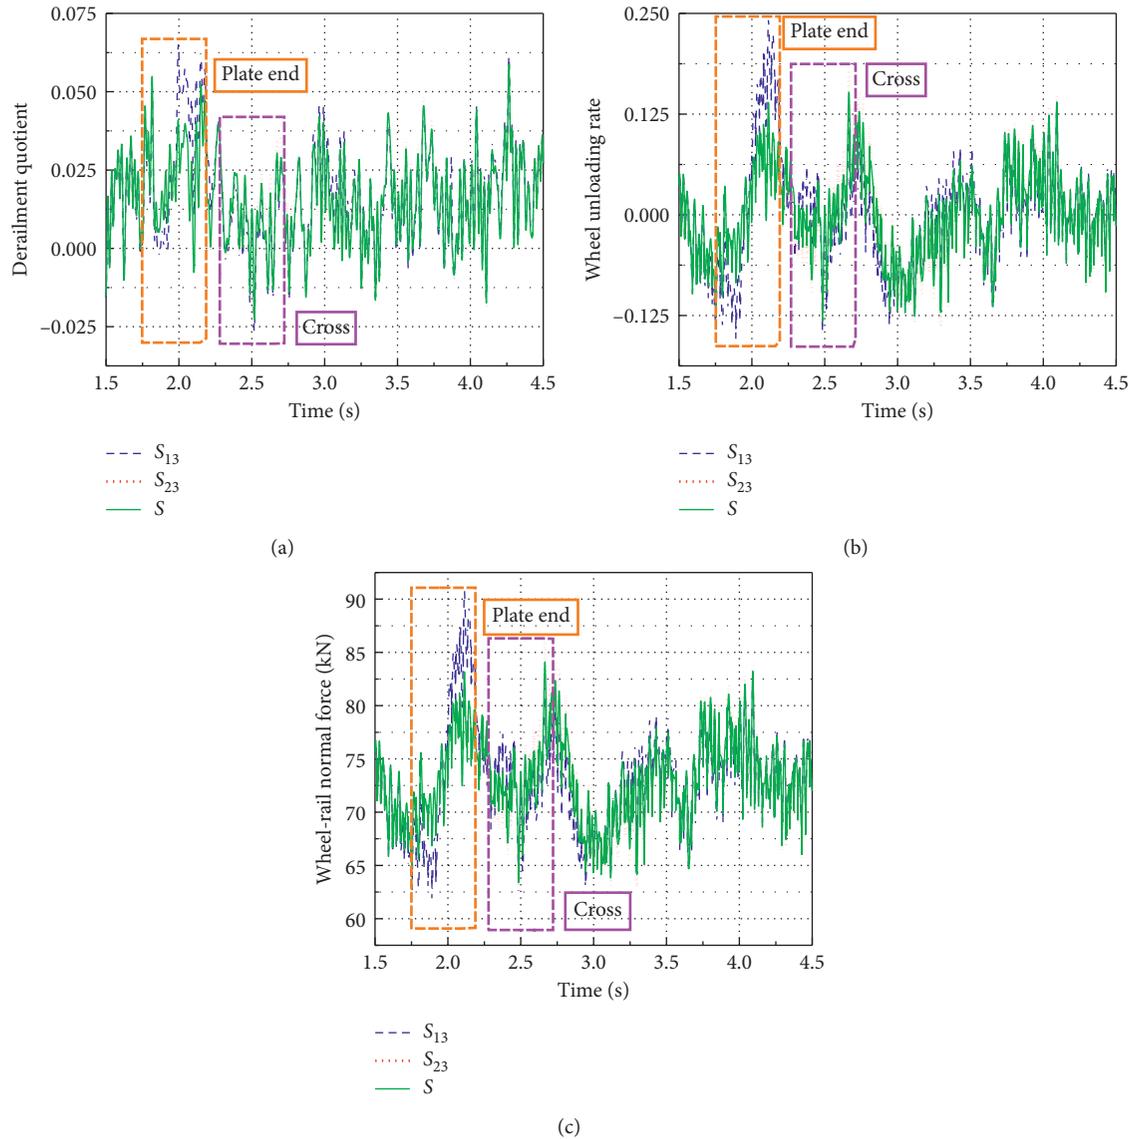
4.1.1. Steel-Spring Failure Position. Figure 8 shows the vehicle operation safety parameters of the 6 steel-spring pairs in the case of breakage at the slab end and midspan.

As shown in Figure 8, steel-spring failure increased the vehicle operation safety parameters in different degrees. When the steel spring failed at the slab end, the maximum derailment coefficient was slightly larger than that failed at the midspan, increased by 1.2 times, but both were within the safe range of it. Under normal conditions, the maximum wheel unloading rate was 0.152 and the maximum normal wheel-rail force was 84.11 kN. When the steel spring failed at the slab end, the maximum wheel unloading rate was 0.243 and the maximum normal wheel-rail force was 90.76 kN. When the steel spring failed at the midspan, the maximum wheel unloading rate was 0.180 and the maximum normal wheel-rail force was 86.15 kN. When the steel spring failed at the slab end and midspan, respectively, compared to normal conditions, the wheel unloading rate increased by 59.9% and 18.4%, respectively, and the normal wheel-rail force increased by 7.9% and 2.4%, respectively. Heavy positive wheel-rail pressure could cause damage such as flat spots, fractured rail head, bolt hole cracks, and broken fishplates, indirectly influencing operational safety [19].

FIGURE 8: Influence of steel-spring failure position on vehicle operation safety.

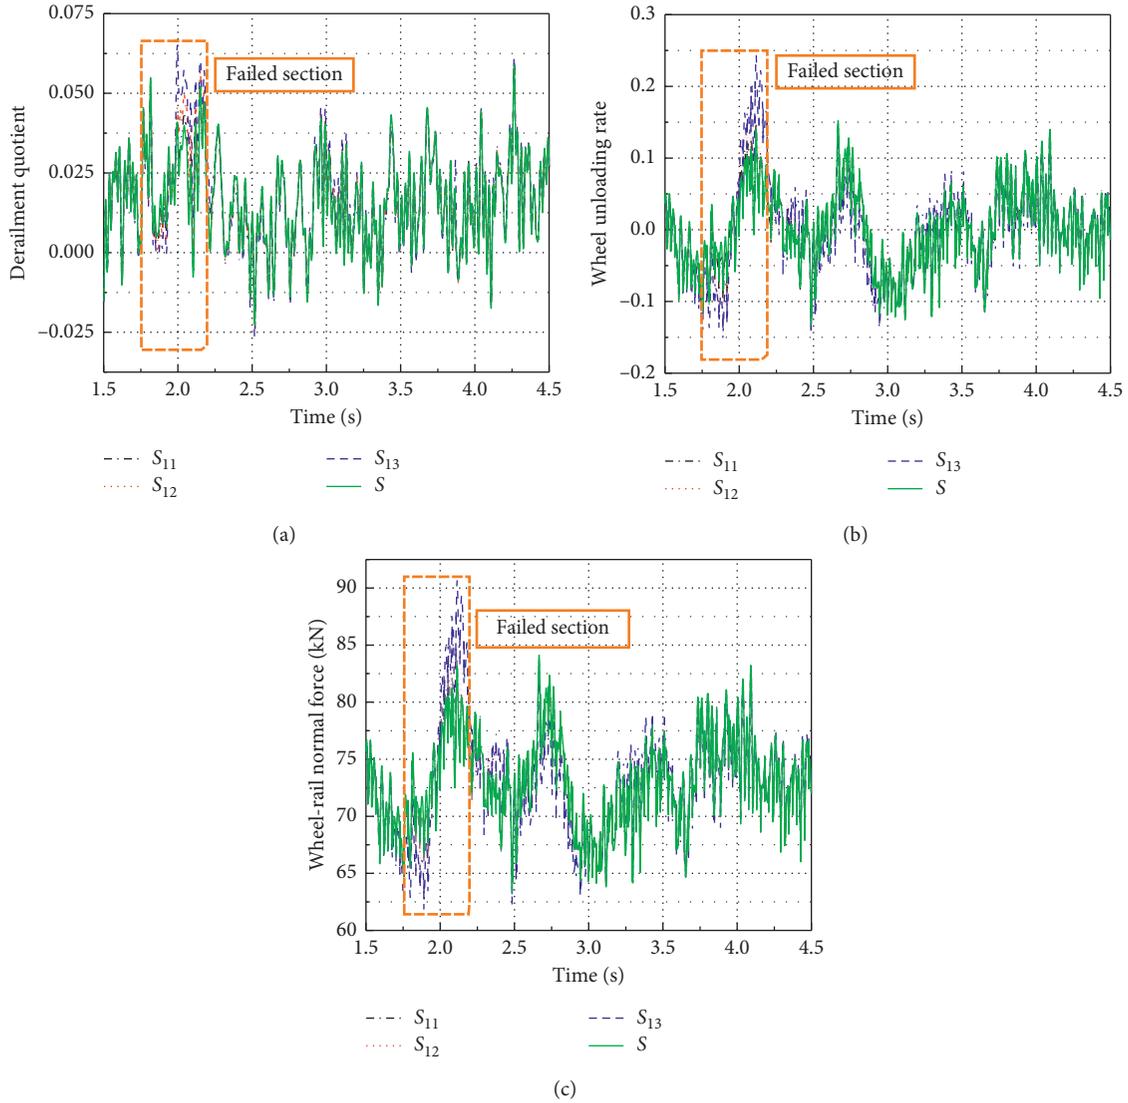
4.1.2. Number of Steel-Spring Failures. Figure 9 shows the vehicle operation safety parameters in the time domain when the slab end was subject to 2, 4, and 6 pairs of steel-spring break failures.

As shown in Figure 9, the derailment coefficient, wheel unloading rate, and normal wheel-rail force increased

continuously as the vehicle passed the failure positions with the increasing number of failures. Under normal conditions, the maximum values of derailment coefficient, wheel unloading rate, and normal wheel-rail force were 0.059, 0.152, and 84.11 kN, respectively. Going from 0 to 2, 4, and 6 pairs of failures, the maximum derailment coefficients were 0.060, 0.061, and 0.065, respectively, increased by 1.7%, 3.4%, and 10.2%. The maximum wheel unloading rates were 0.150, 0.185, and 0.243, respectively, decreased by 1.3% and then increased by 21.7% and 60.0%. The maximum normal wheel-rail forces were 83.92 kN, 86.51 kN, and 90.76 kN, respectively, decreased by 0.23% and then increased by 2.9% and 7.9%. It could be seen that there was a nonlinear relationship between the vehicle operation safety indices and the number of steel-spring failures. A few steel-spring failures had less impact, and with the increase of failure numbers, the operation safety indices could increase sharply, threatening the safety of the train.

FIGURE 9: Influence of number of steel-spring failures on vehicle operation safety.

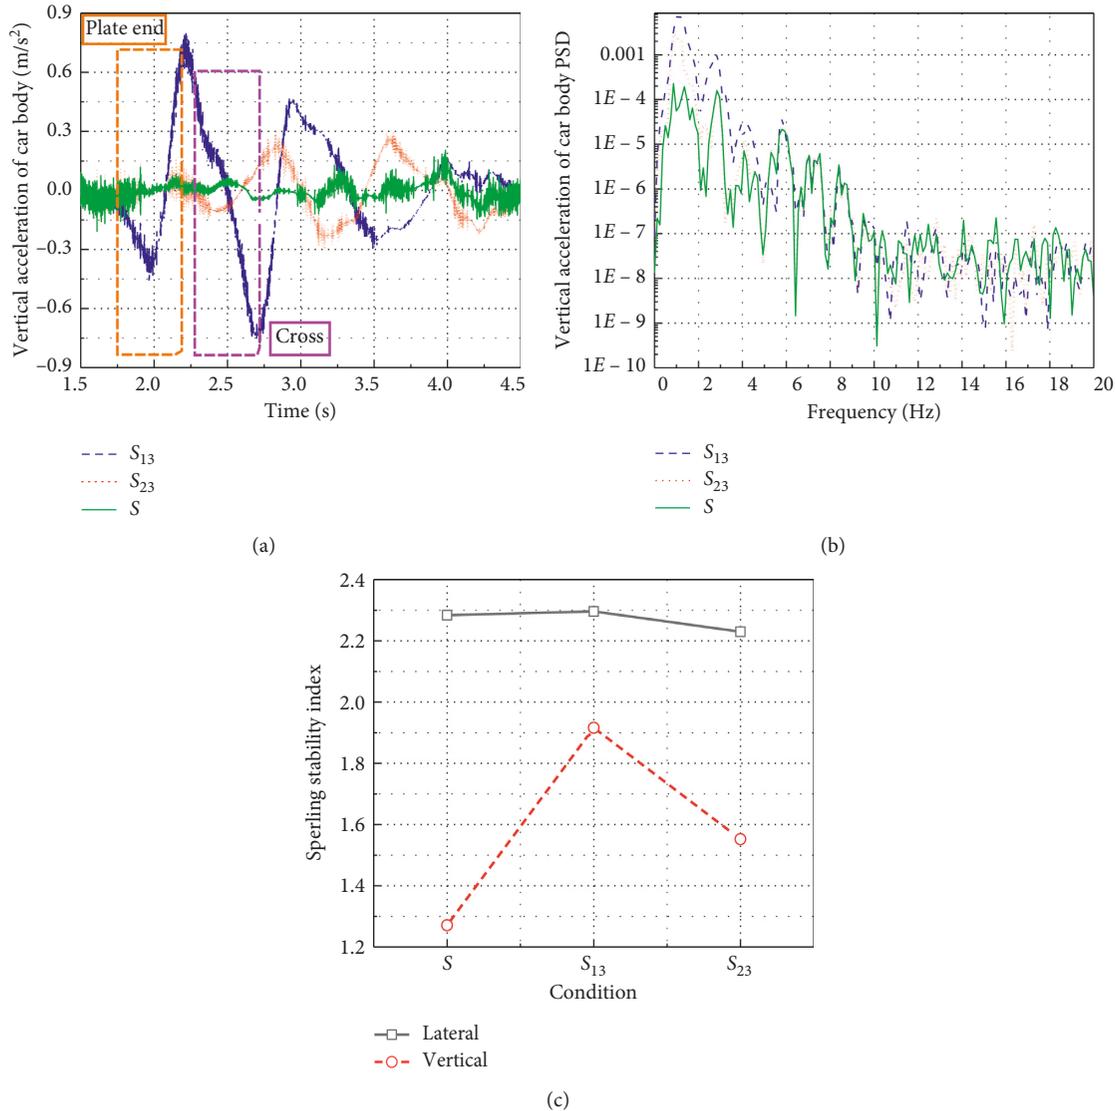
4.2.1. Steel-Spring Failure Position. Figure 10 shows vertical vehicle body acceleration in the time domain, the extracted vertical vehicle body acceleration in the frequency domain below 20 Hz, and the lateral and vertical Sperling stability indices, when 6 pairs of steel spring were subject to slab end and midspan breakage.

As shown in Figure 10, the point of steel-spring failure significantly influenced the vertical acceleration. The vertical acceleration sharply increased when vehicle passed through the failure section and changed more sharply when failure occurred at the slab end. Portions distant from the failure section were almost not affected. The PSD of the vertical vehicle body acceleration below 10 Hz was obviously larger than that beyond 10 Hz, significantly increased due to the steel-spring failure. It could be seen that the floating slab track had low vibration reduction effectiveness for the vibration below 10 Hz which was sensitive for precision instruments, buildings, and human bodies, and steel-spring failure would aggravate the vibration below 10 Hz, especially failed at the slab end.

FIGURE 10: Influence of steel-spring failure position on vehicle operation stability.

Under normal conditions, the maximum vertical vehicle body acceleration was 0.245 m/s^2 and the lateral and vertical Sperling stability indexes were 2.284 and 1.271, respectively. When the steel spring, respectively, failed at the slab end and midspan, the maximum vertical vehicle body accelerations were 0.808 m/s^2 and 0.310 m/s^2 , which were 3.30 and 1.27 times of normal conditions, respectively. The lateral Sperling stability indexes were 2.296 and 2.230, respectively, and compared to normal conditions, the former increased by 0.5% and the latter decreased by 2.4%. The vertical Sperling stability indexes were 1.916 and 1.552, which increased by 50.7% and 22.1% compared with normal conditions, respectively. It could be seen that when steel-spring failure occurred at the slab end, the vertical vehicle body acceleration, PSD of the vertical vehicle body acceleration, and vertical Sperling stability index were larger than that failed in the midspan. In addition, the lateral Sperling stability index was almost unaffected

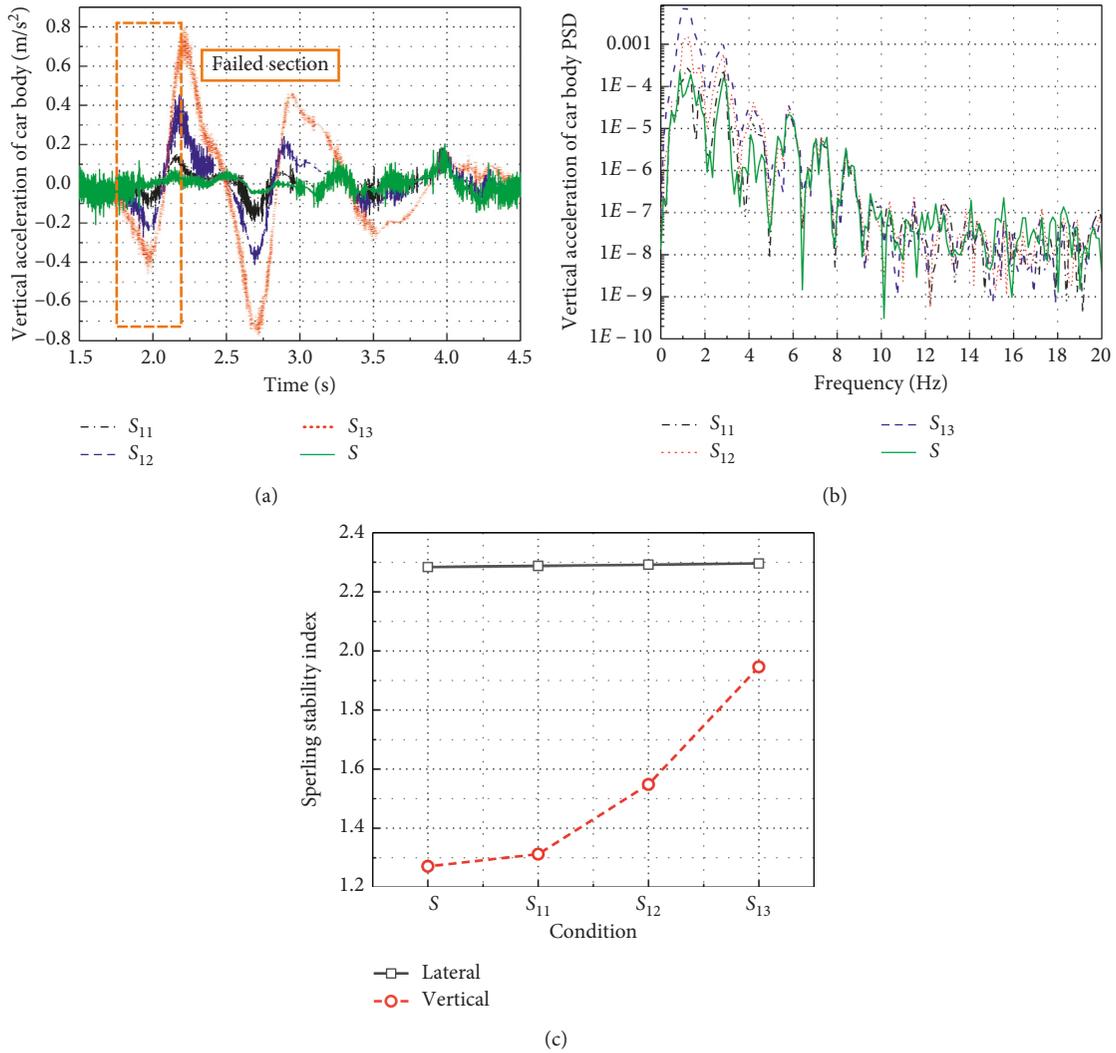
4.2.2. Number of Steel-Spring Failures. Figure 11 shows vertical vehicle body acceleration in the time domain, the extracted vertical vehicle body acceleration in the frequency domain below 20 Hz, and the lateral and vertical Sperling stability indices, when 2, 4, and 6 pairs of steel springs were subject to slab end failures.

As shown in Figure 11, the numbers of steel-spring failures had little influence on the shape of vertical acceleration but had a significant influence on the amplitude. Under normal condition, the maximum vertical vehicle body acceleration was 0.204 m/s^2 and the vertical Sperling stability index was 1.271. Going from 0 to 2, 4, and 6 pairs of failures, the maximum vertical vehicle body acceleration was 0.208 m/s^2 , 0.466 m/s^2 , and 0.808 m/s^2 , respectively, which increased by 1.02, 2.28, and 3.96 times, and the vertical Sperling stability index was 1.312, 1.548, and 1.916, which increased by 3.2%, 21.8%, and 50.7%, respectively. The maximum vertical vehicle body acceleration and vertical Sperling stability index increased nonlinearly with the increase of the numbers of steel-spring failures, while the lateral Sperling stability index did not change significantly.

FIGURE 11: Influence of number of steel-spring failures on vehicle operation stability.

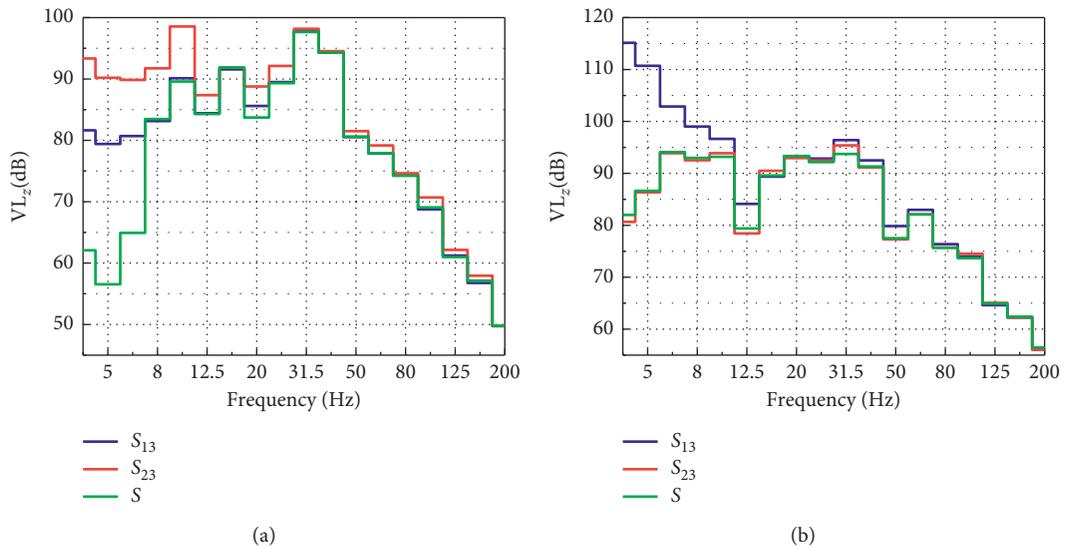
4.3.1. Steel-Spring Failure Position. The vertical acceleration Z vibration level at midspan and end of concrete bed slab under different steel-spring failure positions was calculated using the dynamic vehicle-rail-floating slab track model established above. The results are shown in Figure 12. Meanwhile, the vibration mode of single-span floating slab track structure was analyzed, considering the longitudinal

It was generally believed that steel-spring failure led to the decrease of overall stiffness so that the vibration reduction effectiveness of floating slab track should be enhanced. However, as shown in Figure 12, when failure occurred at the slab end, the vertical acceleration Z vibration level at midspan and end of concrete bed slab increased significantly in the range of 4–6.3 Hz and 4–12.5 Hz, respectively, and the maximum Z vibration level of 115.14 dB existed in the end of the concrete bed slab at 4 Hz. When failure occurred at the middle, the vertical acceleration Z vibration level at midspan generally increased, especially in the frequency range of 4–10 Hz, while the vertical acceleration Z vibration level at end did not change much. The maximum Z vibration level of 98.56 dB existed in the midspan of the concrete bed slab at 10 Hz. The maximum Z vibration level was related to the local vibration mode of floating slab track, caused by the decrease of local restraint ability of floating slab track, and decreased

FIGURE 12: Influence of steel-spring failure position on vibration reduction effectiveness. (a) VL_z at midspan. (b) VL_z at end of concrete bed slab.

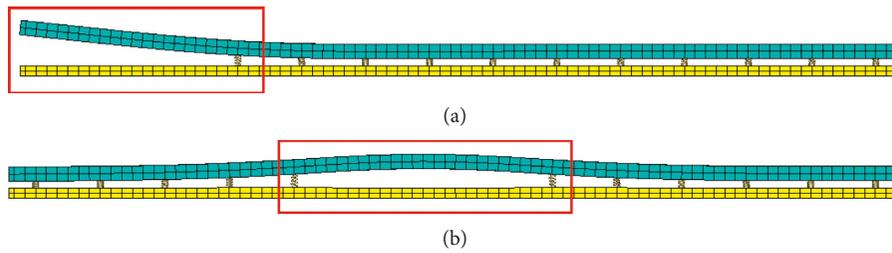
the vibration reduction effectiveness of floating slab track, as shown in Figure 13. It could be seen that the steel-spring failure mainly affected the vibration reduction effectiveness of low-frequency vibration of about 10 Hz, which was very sensitive to precision instruments, buildings, and human bodies. On the other hand, the steel-spring failure at end would reduce the vibration reduction effectiveness of the end and midspan of floating slab track, while the steel-spring failure at midspan would only have a negative impact on the vibration reduction effect of midspan.

FIGURE 13: Influence of steel-spring failure position on local vibration mode. (a) S_{13} , $f=3.4$ Hz. (b) S_{23} , $f=9.5$ Hz.

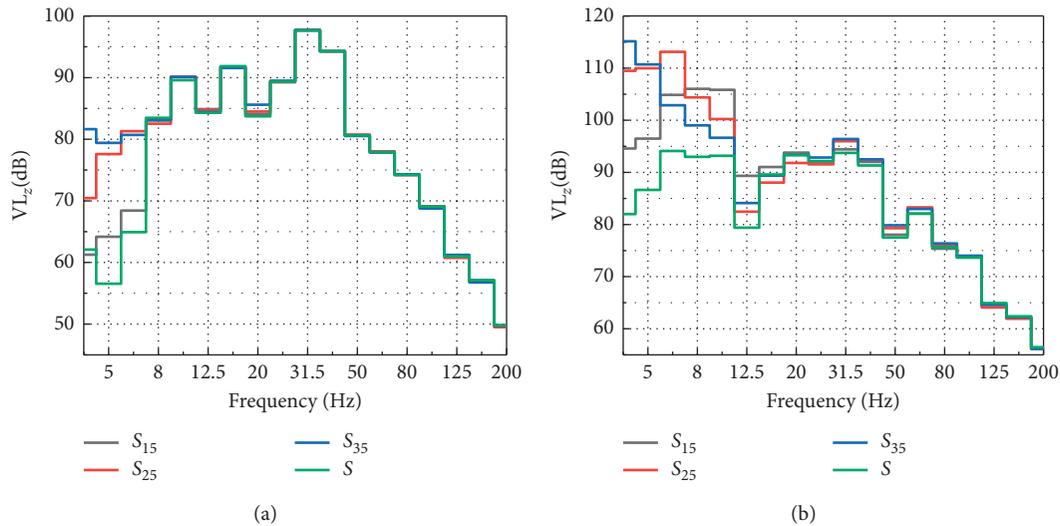
4.3.2. Number of Steel-Spring Failures. Figure 14 shows the vertical acceleration Z vibration level at midspan and end of concrete bed slab when 2, 4, and 6 pairs of steel-springs were subject to slab end failures. Figure 15 shows the local vibration mode under different failure conditions.

As shown in Figure 14, the 2 pairs of failures had little effect on vertical acceleration Z vibration level at midspan of

FIGURE 14: Influence of number of steel-spring failures on vibration reduction effectiveness. (a) VL_z at midspan. (b) VL_z at end of concrete bed slab.

concrete bed slab, but vertical acceleration Z vibration level at end was larger than other failure conditions in the frequency range of 8–12.5 Hz, which was due to the existence of local vibration mode in the end of the slab at 9.6 Hz (see Figure 15(a)). When the steel spring failed 4 pairs, the vertical acceleration Z vibration level at midspan of concrete bed slab was almost equal to that which failed 6 pairs. In addition, the vertical acceleration Z vibration level at end was larger than that under other working conditions because

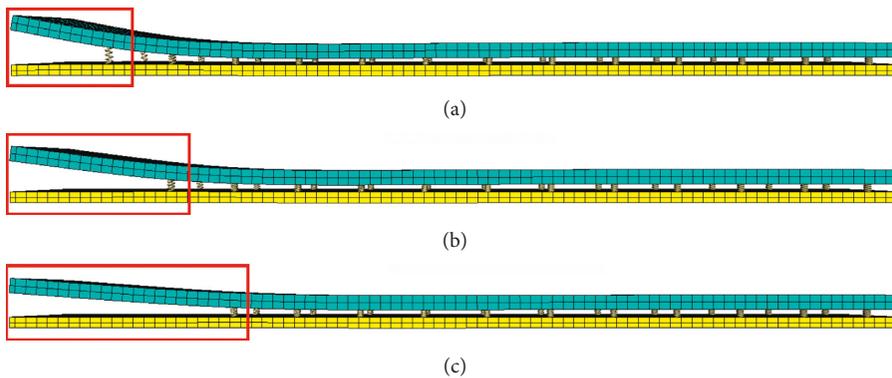
FIGURE 15: Influence of number of steel-spring failures on local vibration mode. (a) S_{15} , $f=9.6$ Hz. (b) S_{25} , $f=5.4$ Hz. (c) S_{35} , $f=3.4$ Hz.

of the local vibration mode of 5.4 Hz (see Figure 15(b)). When the steel-spring failed 6 pairs, the vertical acceleration Z vibration level at midspan and end of concrete bed slab was the largest in all working conditions at about 4 Hz and 5 Hz, respectively, caused by the local vibration mode at 3.4 Hz, as shown in Figure 15(c). It could be seen that there is no linear relationship between the vibration reduction effectiveness of floating slab track structure and the number of steel-spring failure. In a certain frequency range, a few

- (6) Going from 2 to 4 and 6 pairs of steel-spring failures at the slab end, the natural frequencies of local vibration modes were 9.6 Hz, 5.4 Hz, and 3.4 Hz, respectively, which would reduce the vibration reduction effectiveness of floating slab track around its natural frequency. Therefore, the adverse effects of steel-spring failures could not be evaluated simply by the number of steel-spring failures. In routine maintenance, no matter the number of steel-spring failures, the relevant departments should pay attention to it.
