Review Article

Utilization of Geotextile Tube for Sandy and Muddy Coastal Management: A Review

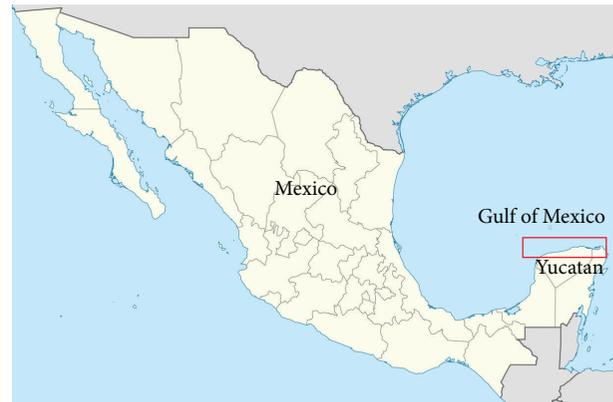
FIGURE 1: Eroded area at the northern coast of Yucatan, Mexico.

the last three decades. Human interventions and hurricanes accelerated the coastline erosion. In 2002, many areas along the coast had completely eroded. Therefore, coastline stabilization was urgently needed to prevent devastation on the shoreline and public properties. The red box in Figure 1 shows the eroded area at Yucatan, Mexico.

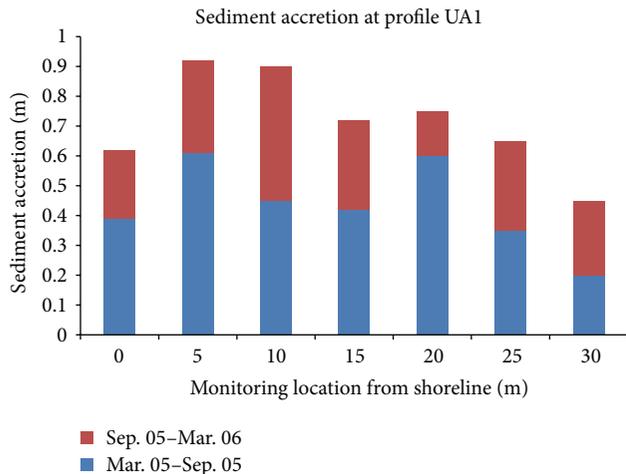
FIGURE 2: Sediment accretion at profile UA1, Project Yucatan, Mexico (adapted from Álvarez et al., 2006).

Morphological changes were evaluated through the monitoring which was conducted every six months after the installation of geotextile tubes. Álvarez et al. [14] reported sediment accretion ranging from 0.45 to 0.90 m at different monitoring locations. Figure 2 shows the sediment accretion at one of the monitored profiles in the project. Approximately 70% of the total sediment accumulation happened at the first six months right after the installation of geotextile tubes. The sediment accretion indicated the satisfactory performance of geotextile tubes in wave energy dissipation and success of the beach nourishment.

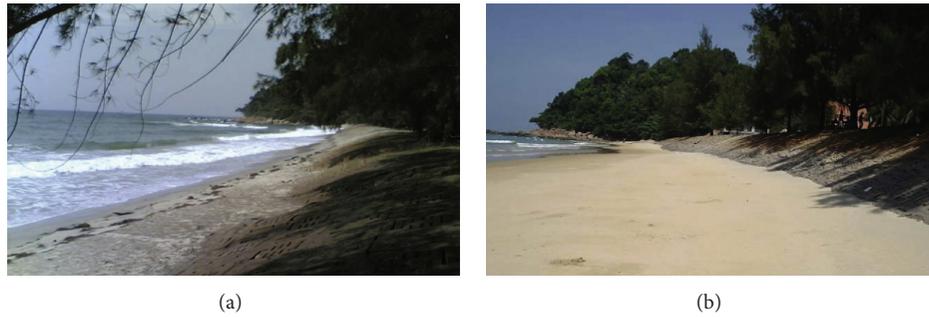
FIGURE 4: Condition of beach (a) before and (b) after the installation of geotextile tubes.

Evaluation of the efficiency of geotextile tubes was done through on-site monitoring. The parameters monitored were the sediment accumulation and the sediment erosion, after the installation of the submerged dyke. Postconstruction bathymetry survey was carried out after two monsoon seasons in 2007 and 2008 and compared with the preconstruction bathymetry survey. Lee and Douglas [24] reported the average increment of 1.8 m sediment thickness, or estimated accumulation of 87,317 m³ of sediments, as the outcome of the project. Figure 4 shows the conditions of the beach before and after the installation of geotextile tubes.

Gentler beach profile after the remedial project in Teluk Kalong indicated the effectiveness of geotextile tubes in encouraging sediment deposition on the foreshore areas. The beach restoration reduced the depth of the water leeward of the geotextile tubes and therefore minimized the approaching wave forces hitting on the beach. Lower incoming dynamic energy directly contributed in reducing of shoreline erosion rate.

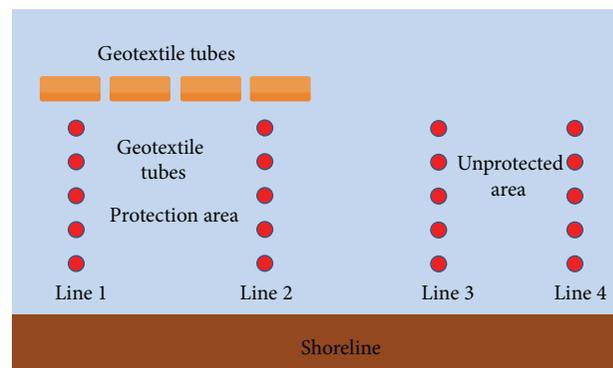
FIGURE 5: Location of measuring pins behind the geotextile tubes.

Monitoring works were done by observing the measuring pins installed. As shown in Figure 5, there were four monitoring lines. Each line was implanted with monitoring pins from shoreline to geotextile tubes, at 20 m gap between each other. These 0.3 m exposed monitoring pins were plastic pipes implanted along the baseline [26]. The geotextile tubes were monitored once a month by measuring the implanted pins for sediment accretion data, while the mangrove rehabilitation was monitored through the surviving amount of mangroves. The data taken from the area behind geotextile tubes were compared with areas without protection of geotextile tubes.

Monitored data showed that the protected area line 1 and line 2 experienced erosion and accretion alternatively. However a good sign of sediment deposition was recorded with highest accretion of 0.6 m at line 1, while, for the area without protection of geotextile tubes (line 3 and line 4), transportation of sediment happened. When line 3 experienced erosion of 0.4 m, line 4 had sediment accretion of 0.4 m. This indicated that the change in the wave pattern caused the transportation of sediment from line 3 to line

4 and vice versa. Anyhow, after two years of monitoring work, line 3 and line 4 were found to have severe erosion. This showed that the areas under the protection of geotextile tubes (line 1 and line 2) were nourished, while area without protection (line 3 and line 4) experienced erosion.
