Clinical Study

Late Removal of Titanium Hardware from the Elbow Is Problematic

Abdo Bachoura, Ruriko Yoshida, Christian Lattermann, and Srinath Kamineni

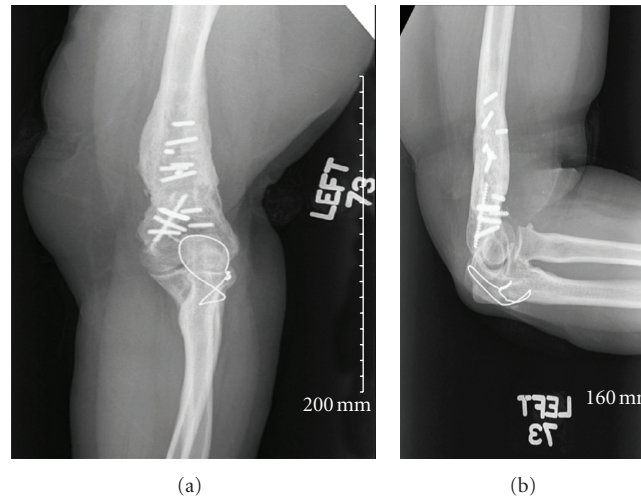
FIGURE 1: Broken hardware often poses a difficult problem and subsequent removal may increase surgical time and complexity of future surgeries. (a) shows an X-ray of an elbow (AP view) with broken and retained screws. (b) shows the same elbow in the lateral position.

Hardware removal is indicated for infection, nonunion, failure of fixation, pain, soft tissue irritation, and anticipated strenuous activity after fracture healing [1–4]. During removal cases however, hardware, especially screws, can break. Subsequent removal of broken hardware increases surgical time, and retained metalwork potentially complicates future surgeries (Figure 1) [5].

Hardware failure during removal cases is a commonly seen problem in orthopaedics [5] (Figure 1). Currently, there is

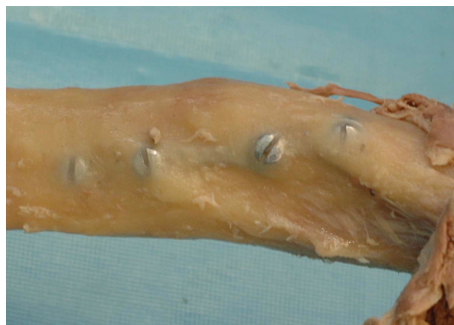
FIGURE 2: Bone ingrowth and on-growth onto metallic hardware in the humerus (cadaveric specimen). Due to a greater extent of osseointegration, greater removal torques will be necessary to extract the bone screws.

Osseointegration has been observed to occur within 3–10 months in titanium alloy [10, 11]. The degree of bone ingrowth and on-growth, however, continues to increase for years after initial implantation (Figure 2) [15]. Although there have been studies showing evidence of stainless steel osseointegration, it is generally accepted that commercially pure titanium and titanium alloy are more biocompatible and more likely to osseointegrate than stainless steel [16]. In our series, it is likely that as osseointegration became

more complete, greater removal torques contributed to the failure of titanium alloy screws in this series [17]. Given these properties, we postulate that over longer periods and increased loading cycles, the development of microfractures and osseointegration contributed to screw breakage during implant removal.
