## Research Article

# Heat Diffusion in Klinker Facade: The Study Case of a Gio Ponti Building

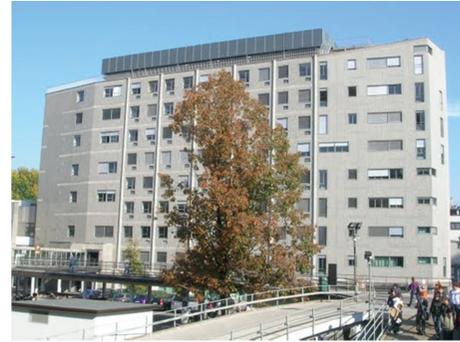
FIGURE 1: Gio' Ponti's building, *La Nave*, located in Milan, in Campus Leonardo, after restoration. Clinker finishing is better shown in Figure 3 that recaptures a small area of the Northern façade.

Leonardo Campus, Politecnico di Milano (Figure 1), served as a mock up (*La Nave* is a Gio Ponti's listed building; it recently underwent restoration of the facades due to the clinker tiles detachment). The wall has a solid concrete structure of 8 cm thick, an interior cavity of 23 cm, a finishing of mortar (2.5 cm thick), and grey clinker tiles (3 mm). The examined side of the wall is the Southern elevation, ground level. Southern orientation was chosen with the aim to exploit the solar irradiation and obtain a relevant thermal gradient for the following data processing and analysis. Measurements were performed in reflection mode, in two consecutive days, with clear sky and similar environment temperature (air temperature ranging between 15 and 24°C; RH 40–64%), in the same location. Three thermocameras (TVS Avio 700 LW, the same model used in the laboratory tests) recorded a sequence of 420 images each, at the rate of 1 frame per minute, during 5 hours of sun irradiation and 2 hours of cooling, for the purpose to investigate a wide surface at the same natural heating conditions. The recaptured images have a spatial resolution of few mm, which is necessary to detect the mortar joints between the tiles. Furthermore, the use of three thermocameras allowed the researchers to study the effects of different angles of view and solar irradiation on nonplanar surfaces. In particular, the test area on *La Nave* wall surface shows the presence of both Gio'

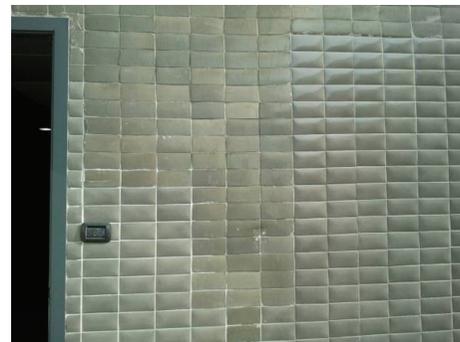
FIGURE 2: The two series of *La Nave* tiles after a first repair and substitution. Original tiles are on the right and the lower part of the left corner; the new tiles are on the upper/middle of left part of the wall.

Ponti tiles and new tiles, due to maintenance intervention. The new series of tiles have flat and smoother surface while the original ones have rounded polyhedral surface (Figure 2). All the tiles have similar grey colors therefore, it was possible to avoid the effects of the absorption of solar radiation due to the colors in the analysis of the heating curves.

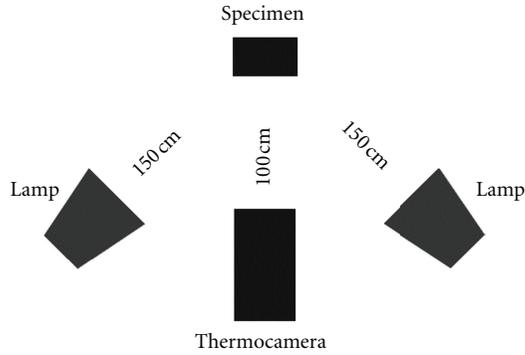
FIGURE 3: Plan of the experimental set-up in the laboratory.

Emissivity measurement was obtained by the comparison with a target of known emissivity (black carbon powder) by lighting of both the specimens and the target with two halogen lamps (650 W) symmetrically placed at 1.5 m from the objects. Measurements were obtained by a LW camera (microbolometric sensor, 0.08°C thermal resolution at 20°C). Results of laboratory tests (Table 1) were used for

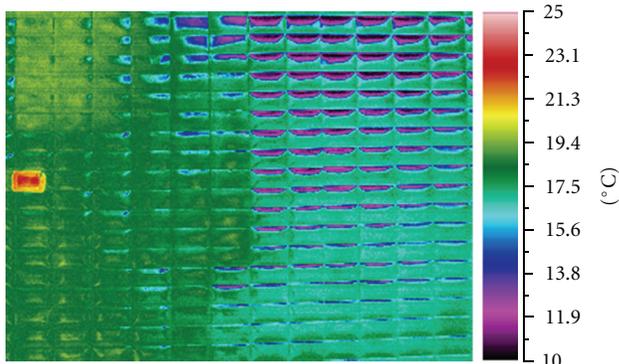
FIGURE 4: Infrared image of *La Nave* tiles. The recaptured area has a visualization in the visible range in Figure 2.

The thermocameras started the shooting 30 min before the direct solar irradiation and continued 1 hour after the shadowing, for a total time 7 hours, with a rate of 1 frame per minute. The first day, the lens axis of the three thermocameras was set perpendicularly to the surface (Figure 4).

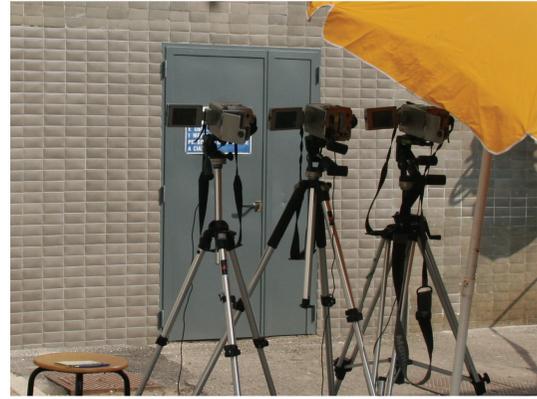
FIGURE 5: Experimental setup, three infrared camera, mod. TVS 700.

The selected area under investigation has been analyzed by means of three thermocameras, set at 4.5 m from the surface, recapturing different areas of 2 sq m at 1.5–3 m from the ground level (Figure 5).

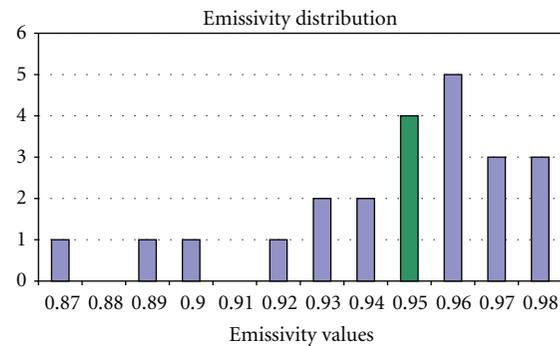
FIGURE 6: Emissivity distribution of samples based on the experimental recurrences.

The experimental results of the laboratory tests give a 0.95 average value of emissivity. Values of emissivity distribution are shown in Figure 6. In the cases under study, the temperature variations, due to the differences of the emissivity values and those linked to the surface irregularities and colors, resulted smaller than the instrumental and experimental error, in particular, when the thermal gradient is taken into account instead of the temperature's absolute values.

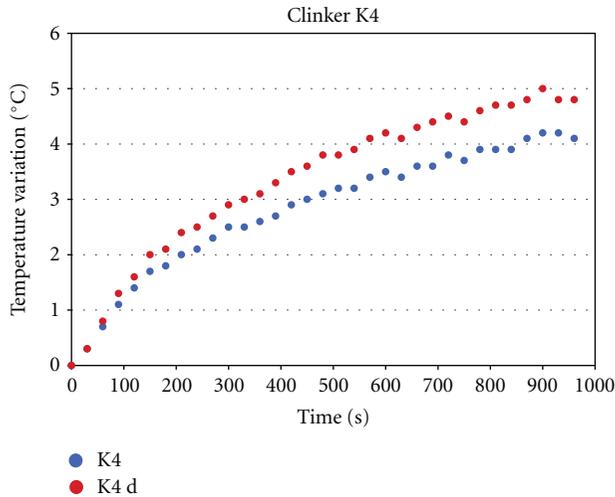
FIGURE 7: Heating of a sound area (K4) and delaminated one (K4 d) in clinker tile K4.

Temperature differences between sound and damaged areas resulted to be 1–1.5°C. As for the detection of detachments on plaster [14], the analysis of the thermal maps allows to find out the detachment of tiles. As an example of laboratory tests, Figure 7 shows the higher heating in the detached areas (the red dotted curve) due to the air gap underneath the tiles, as it happens for plaster and plaster detachments. The following tests were set on site with the aim to verify the real feasibility of the procedure on the real study cases.

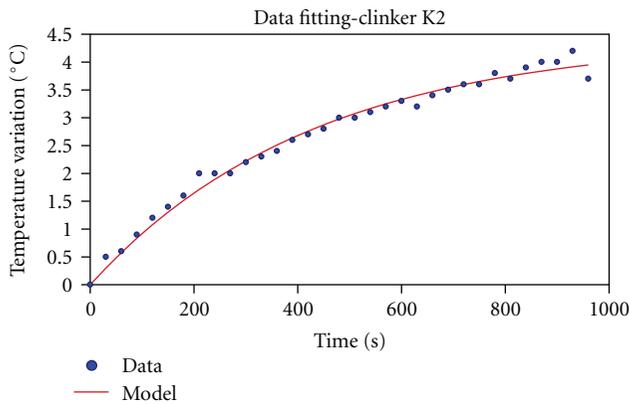
FIGURE 8: Fitting of the heating data obtained in the laboratory test with the mathematical model for K2 clinker.  $R^2 = 0.989$ .

As expected, the derived curves obtained by the laboratory tests (Figures 8, 9, and 10) fit better the mathematical model than the results of on-site tests. Errors of temperature evaluation have the same magnitude of incertitude of the thermocameras sensors ( $0.08^{\circ}\text{C}$ ). This is due to the higher irradiation necessary to heat the whole surface; in fact, the wall did not reach the equilibrium with the environment even after 5 hours of solar irradiation. On the contrary, during the laboratory tests, this steady condition was achieved after only 20 minutes of irradiation by halogen lamps.

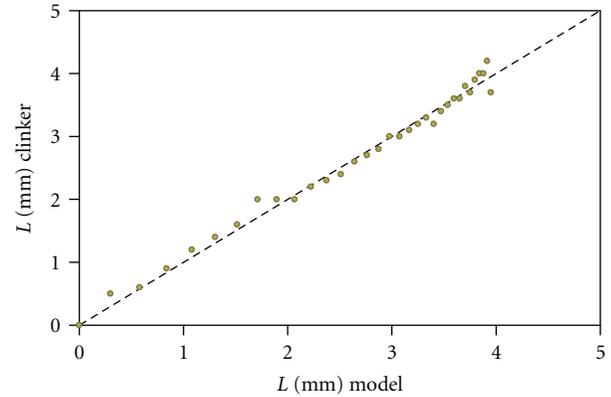
FIGURE 9: The relation between the calculated values and the experimental ones shows a close match in laboratory tests,  $R^2 = 0.989$ .

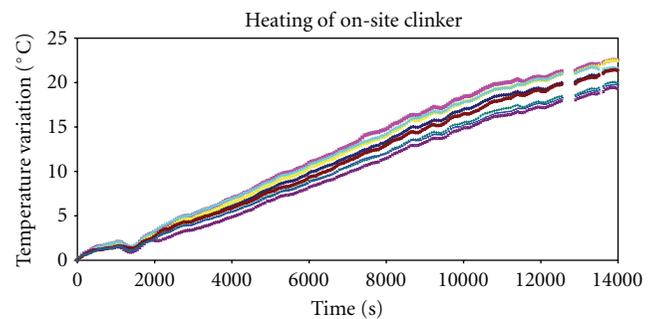
FIGURE 10: Experimental results of the on-site recaptures: the trend of the areas is similar and the differences of temperatures of the heating are very small at the end ( $<5^{\circ}\text{C}$ ).
