Research Article

Holistic Diagnosis of Rising Damp and Salt Attack in Two Residential Buildings in Kumasi, Ghana

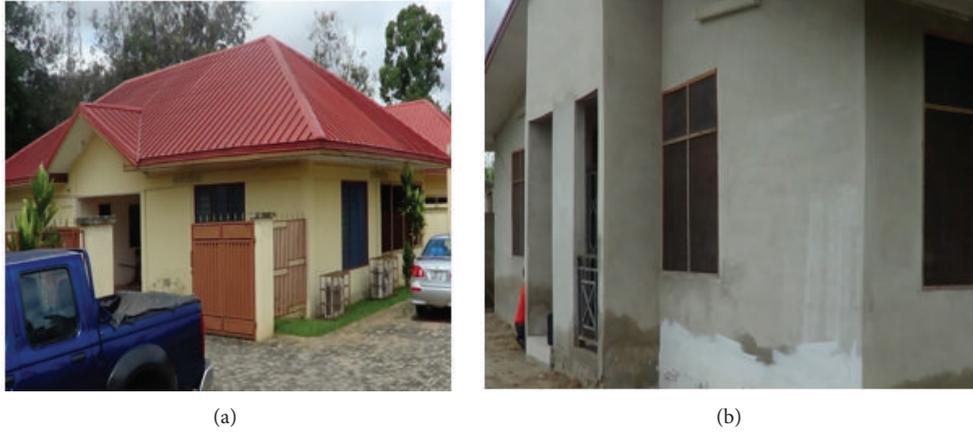
FIGURE 2: Three-bedroom apartments in Case 1 (a) and Case 2 (b), respectively.

This study sought to examine the problem of rising damp and salt attack in the walls of two residential buildings reported to be experiencing severe dampness problems using stages 3 and 4 dampness investigation approaches [2, 7, 11, 12]. The survey building in case study 1 is a semidetached building that belongs to the Department of Urban Roads in Kumasi, Ghana (Figure 2(a)). It was constructed between the years 2002 and 2006 and occupied in the year 2007 and has suffered from the problem of dampness for 6 years. Case 2 is a three-bedroom detached building that was sited near a water body and constructed between the years 2004 and 2010 and occupied in 2013 and has also suffered from dampness for 5 years (Figure 2(b)).

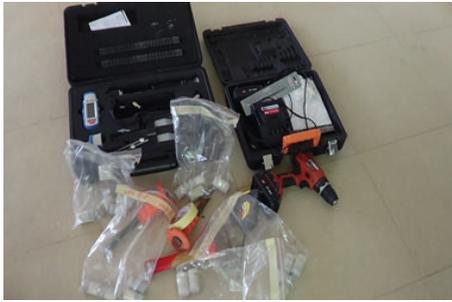
FIGURE 3: Equipment used in the sampling of mortar.

3.2. Sampling of Mortar. The walls of the buildings were constructed with sandcrete blocks, and the joints between the blocks were filled with 150 mm thick mortar. Mortar samples were selected because it is the dominant path through which damp rises in walls of buildings [6]. The equipment and materials used to obtain the mortar samples included cordless drills, sharp tungsten carbide drill bits, 35 mm camera film cases for holding samples, plastic resealable sample bags, sharp 65 mm bolster, small piece of card for collecting dust, PCE MMK1 universal moisture meter with deep probes, rule, note pad, and labels (Figure 3).

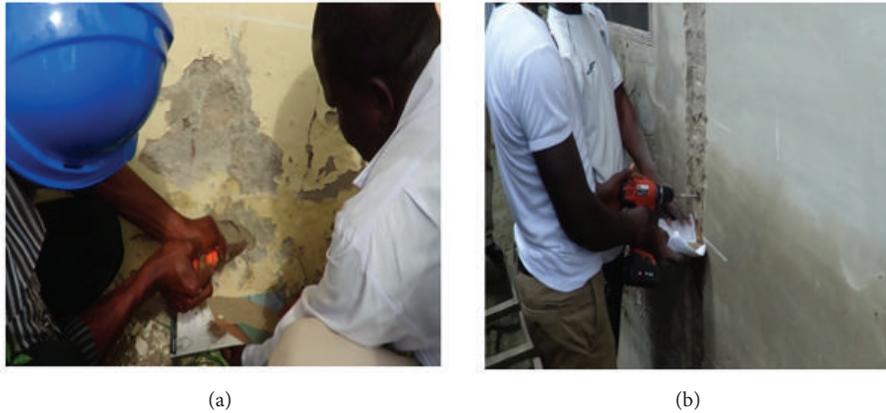
FIGURE 4: Mortar samples being drilled from buildings in Case 1 (a) and Case 2 (b).

Additional mortar samples for each case were collected about 1.5 m above the height of visible damp as controls. Mortar samples at depths of 0–25 mm, 25–50 mm and 50–75 mm were collected for each height (thus 300 mm, 600 mm, 900 mm, etc.) for each building, bringing the total number of mortar samples collected to 12 for each building. Mortar samples collected at depths of between 10 mm and 80 mm are recommended [38] (Figure 4).

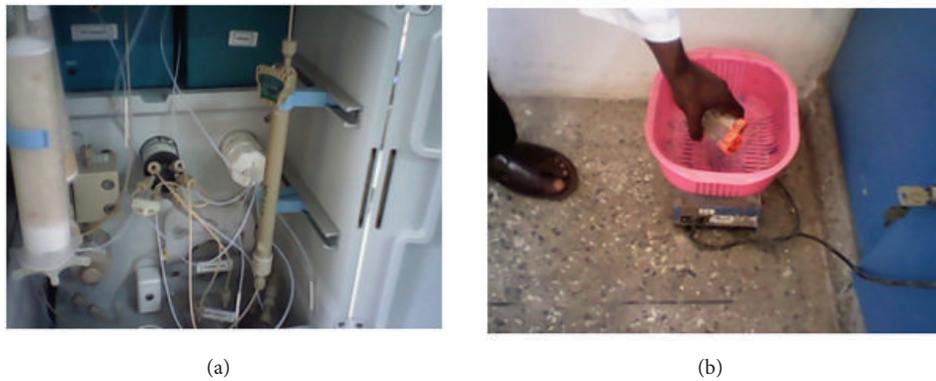
FIGURE 5: Mortar samples in Metrohm 861 Advanced Compact IC (a), mortar samples being placed in mechanical shaker (b).

and 50 mL), wash bottles, and volumetric flasks (2000 mL, 1000 mL, and 100 mL) (Figures 5 and 6).

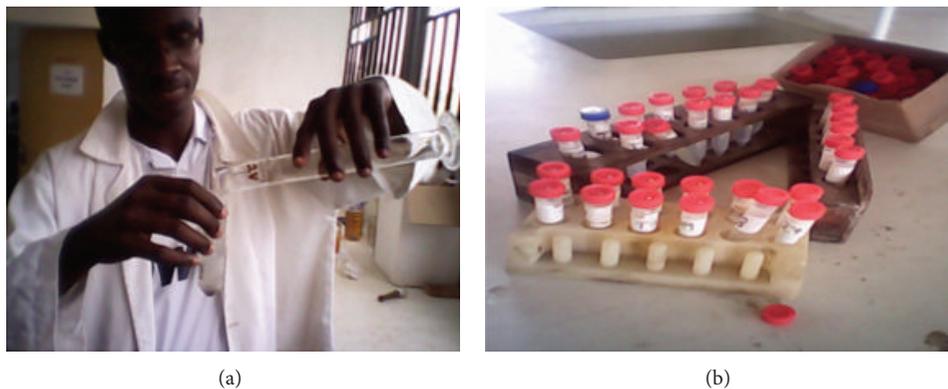
FIGURE 6: Distilled water being poured from 100 mL measuring cylinder (a) mortar samples in centrifuge tubes (b).

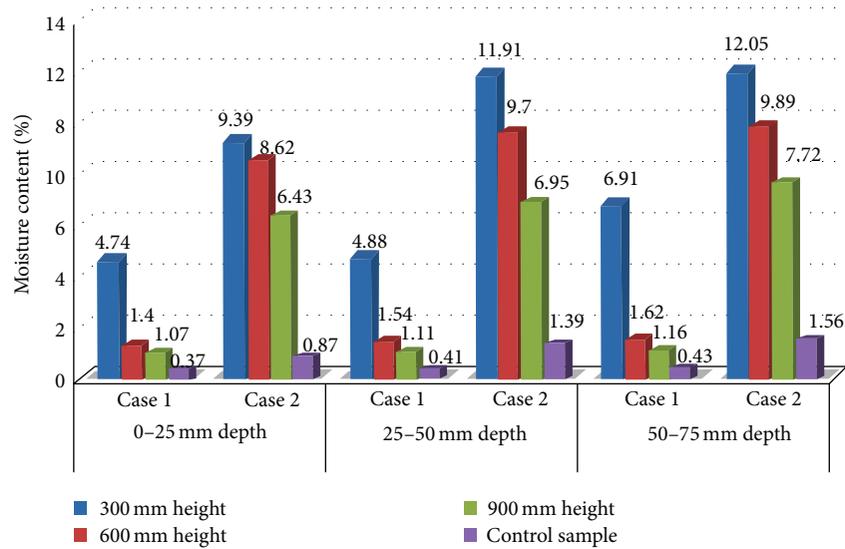
4.2. Moisture Contents of the Mortar Samples. Figure 7 shows a graphical comparison of moisture contents at different heights of mortar samples for different depths of walls.

The results show that, for the mortar samples collected from all the three depth ranges, moisture contents decreased with increasing heights. Mortar samples collected at heights of 300 mm in all the cases had the highest moisture content followed by the samples from heights of 600 mm in that

FIGURE 7: Comparisons of moisture content at different heights for differing depth of walls.

order (Figure 7). The results further show that the moisture contents varied with depths. Thus, the moisture contents increased from the depths of 0–25 mm up to 50–75 mm. Also, the results show that, throughout the various heights in the two cases, moisture contents recorded in Case 2 exceeded those in Case 1.

These higher values recorded for Case 2 indicate that the water body close to the site influenced water ingress into the building. The control samples collected above the height of visible dampness (i.e., 900 mm) at the various heights recorded the lowest moisture contents in all the cases. These samples were original and collected above the height of visible dampness. As a result, no significant dampness was found in those areas of the walls. The higher moisture contents recorded at the bases of the walls (300 mm) indicate a probable source of water ingress from the soil into the buildings. The above results imply that, at the maximum height of visible damp, most of the water in the walls had evaporated leaving behind efflorescent salts, a phenomenon typical of rising dampness [2]. A common source of water that contributes to rising dampness in masonry walls is groundwater [12] and this was responsible for the severity of the dampness in Case 2 compared to Case 1.

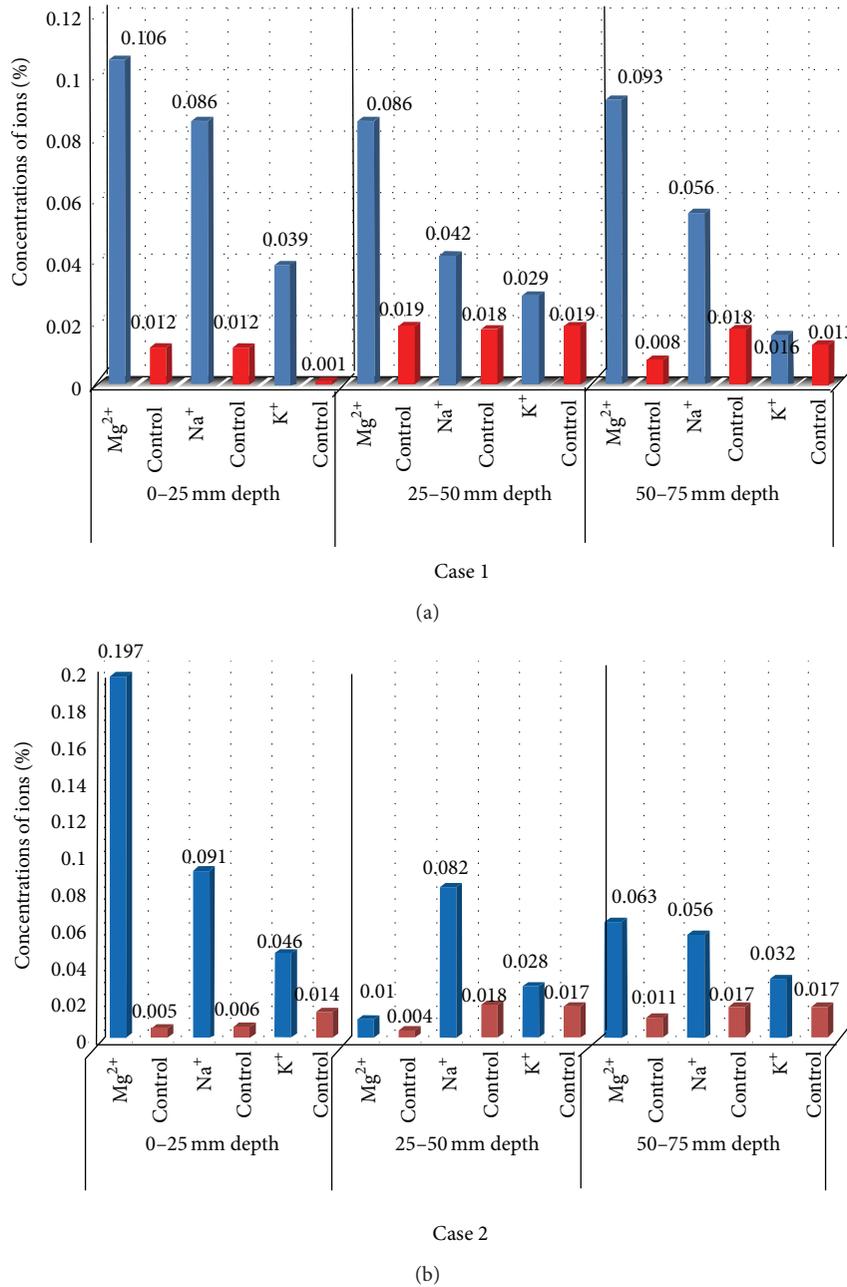
FIGURE 8: Comparison of ionic concentrations of the most predominant cations from Cases 1 and 2 at heights of 900 mm for different depths.

Figures 8 and 9 show that the salt contamination is low in the control samples (healthy mortar) collected from the two cases for all the cations and anions, with percentage ionic concentration less than 0.020%. These samples were original and were collected above the height of visible dampness. As a result, no significant dampness was found in those areas of the walls.

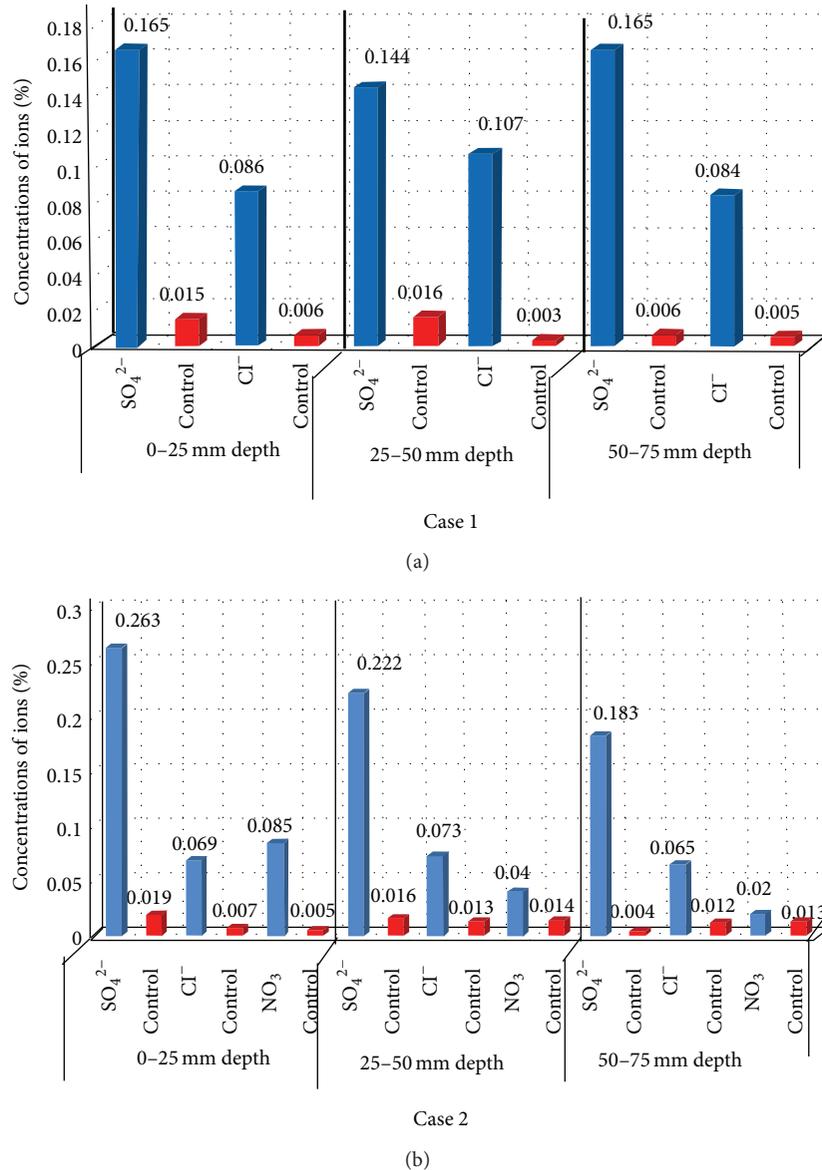
FIGURE 9: Comparison of ionic concentrations of the most predominant anions from Cases 1 and 2 at heights of 900 mm for different depths.
