Case Study of Remaining Service Life Assessment of a Cooling Water Intake Concrete Structure in Indonesia

This paper deals with the assessment of remaining service life of a cooling water intake concrete structure (CWICS) subjected to corrosion due to chloride attacks. Field and laboratory tests were performed to determine the current existing condition of the structure. Both destructive and nondestructive tests were employed to obtain the parameter needed for the assessment. Based on the current condition and test results, structural analysis was carried out and the remaining safety factor of CWICS was determined. From the analysis, it was found that most concrete elements of CWICS had safety factor greater than unity and might fulfil its intended service life up to the year 2033. However, fewer elements require immediate strengthening to extend their service life.

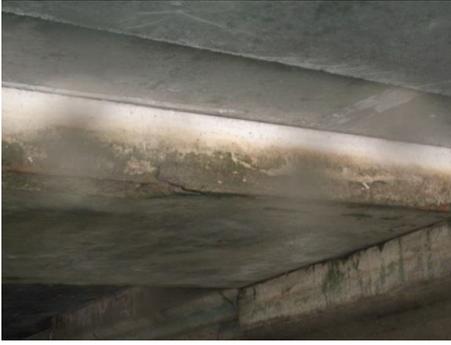
FIGURE 1: Cracking of concrete plate (slab) of CWICS.

and delamination of concrete, see Figure 1. These damages indicate that the chlorides may have already penetrated concrete cover, reached rebar level, and accumulated to threshold level chloride concentration to initiate corrosion. The corrosion may have reduced rebar cross-section and lead to a reduced strength capacity of some structural elements of CWICS. If this condition is not rectified soon, it may endanger the whole structure of CWICS and shut down the factory operation. The shutdown of the factory can lead to significant loss of revenue to factory owner.

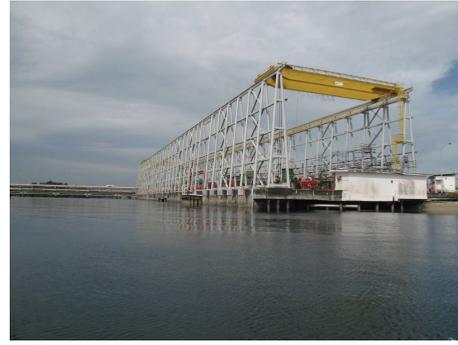
FIGURE 2: Front view of CWICS.

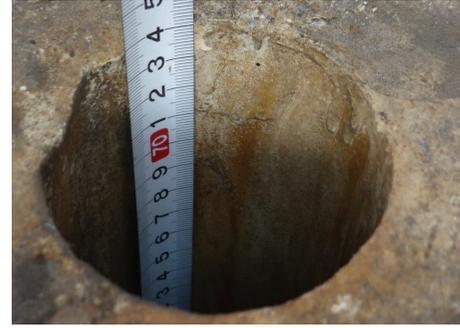
FIGURE 3: Core-drilled sample.

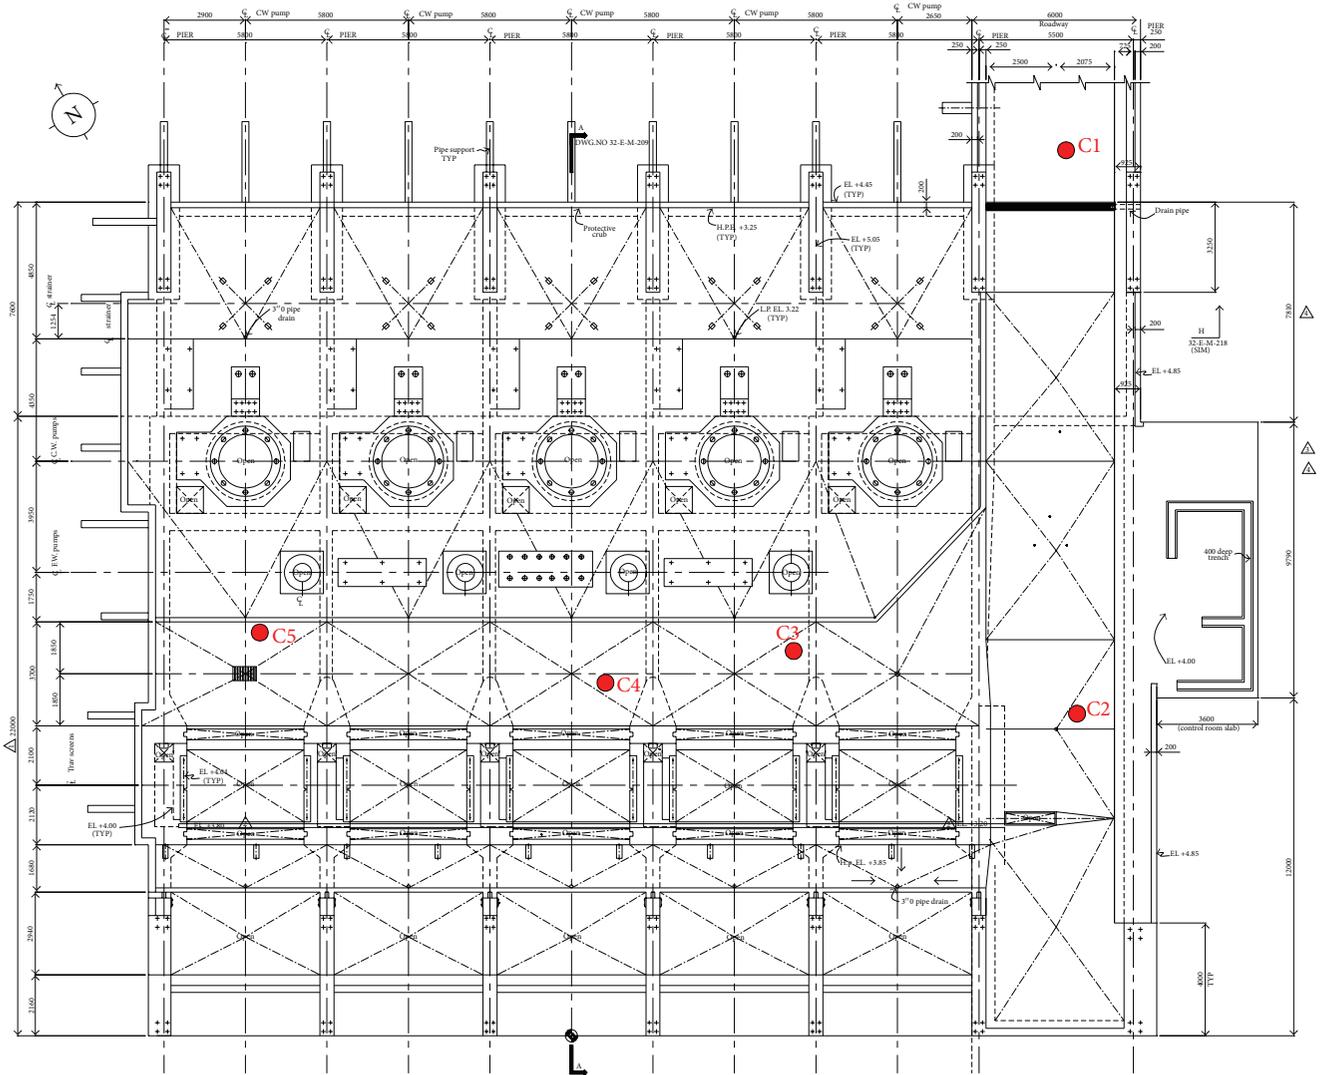
FIGURE 4: Core-drilled location at train A/B (Core 1/C1 up to Core 5/C5).

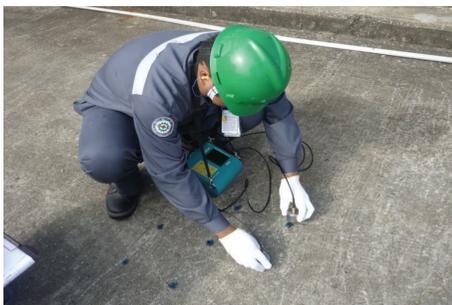
FIGURE 5: UPV test at train A/B.

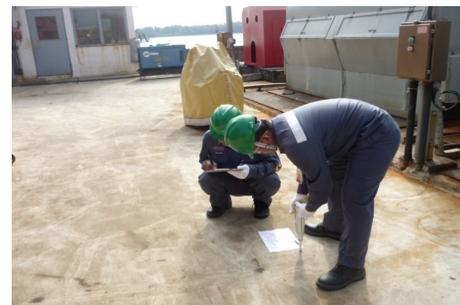
FIGURE 6: Hammer test at train A/B.

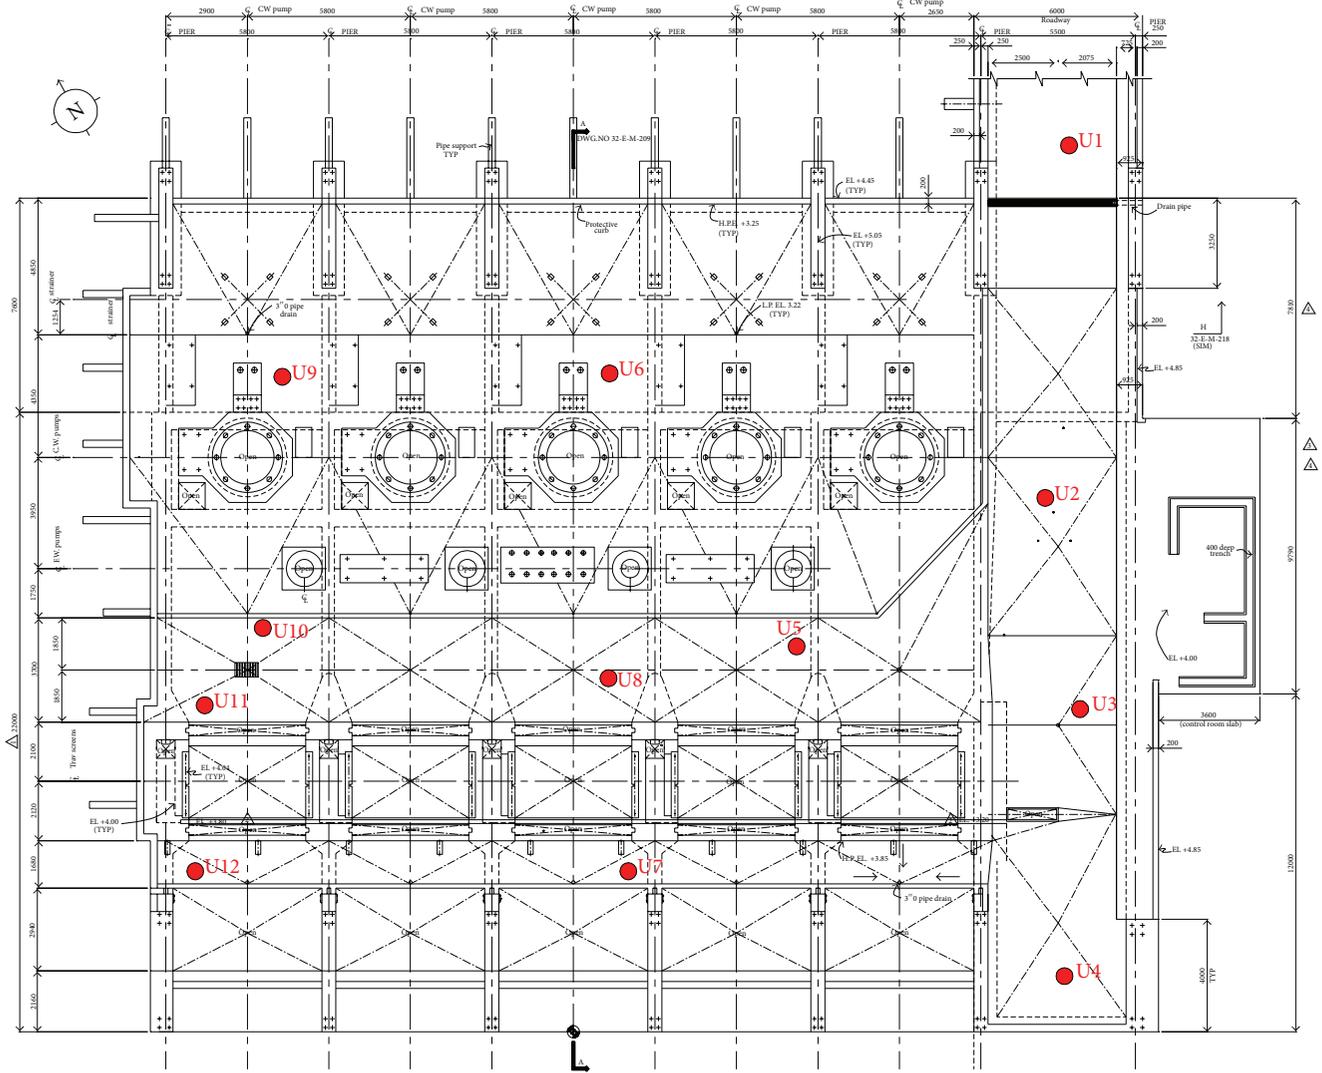
FIGURE 7: UPV test location at train A/B.

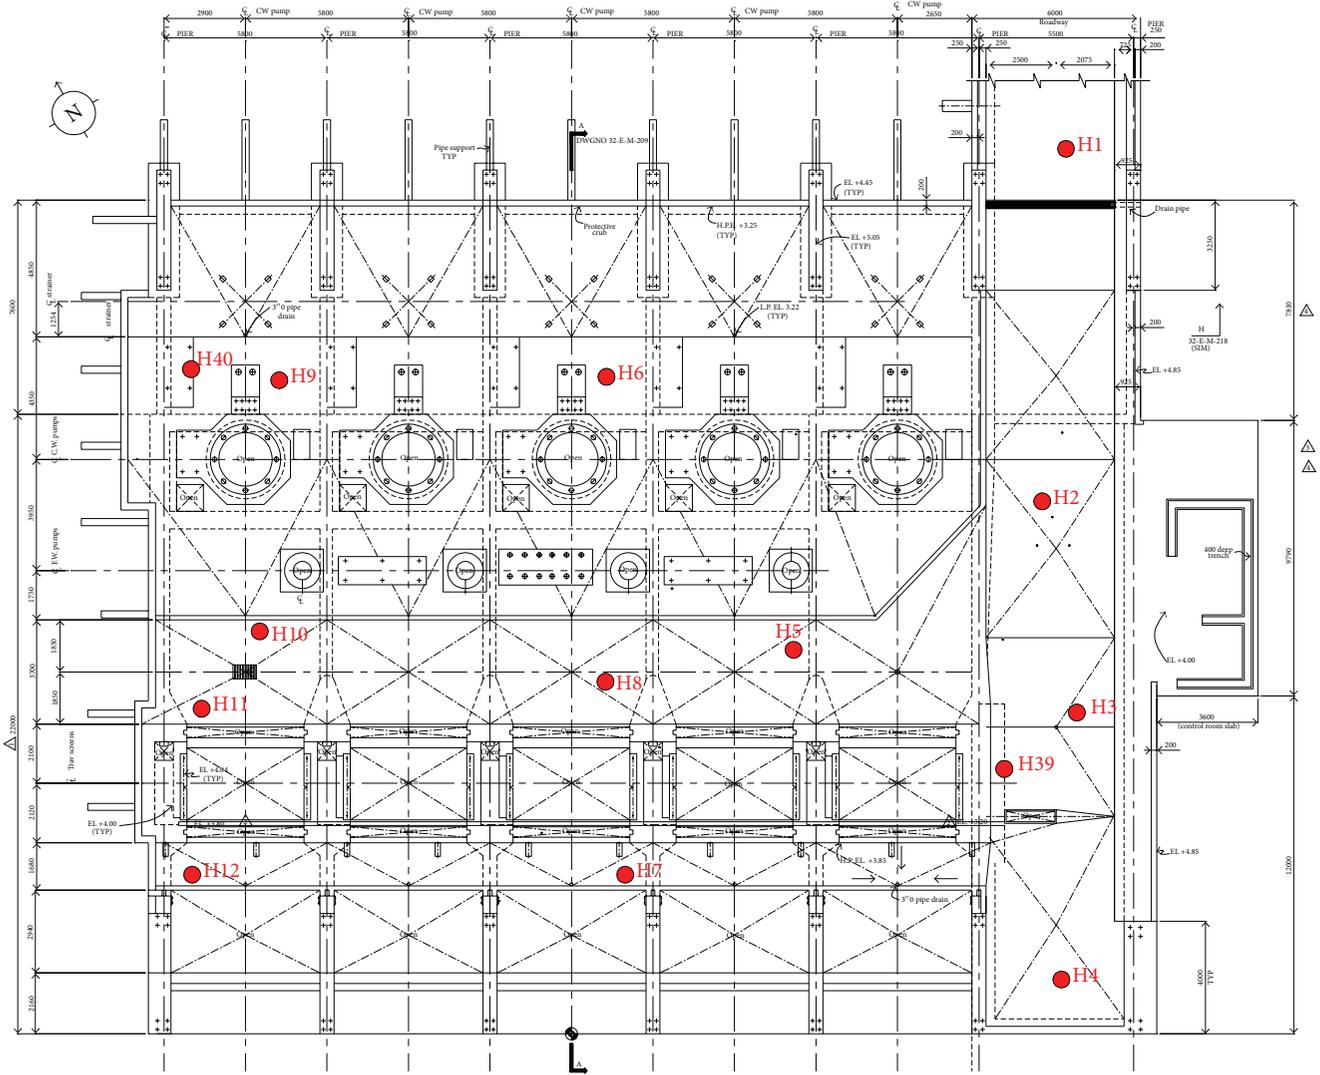
FIGURE 8: Hammer test location at train A/B.

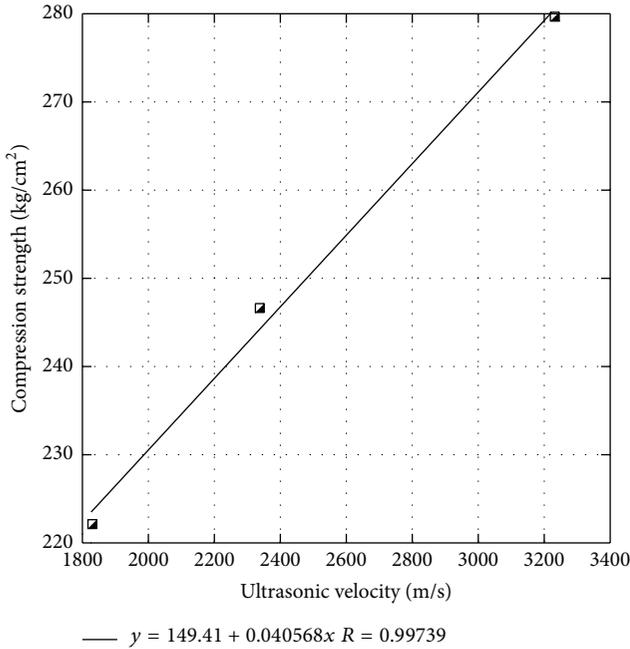
Figures 9 to 11 show that the best correlation between ultrasonic velocity and compressive strength is found for samples taken at train A/B, with a correlation factor (*R*) of 0.997. On the contrary, Figure 11 shows an opposite trend between these two tests at train E/F, where the highest ultrasonic velocity gives a lower strength. Again this result confirms that nondestructive test results should not be used solely without destructive test as it may lead to wrong interpretation.

FIGURE 9: Correlation between UPV and compression strength for train A/B.

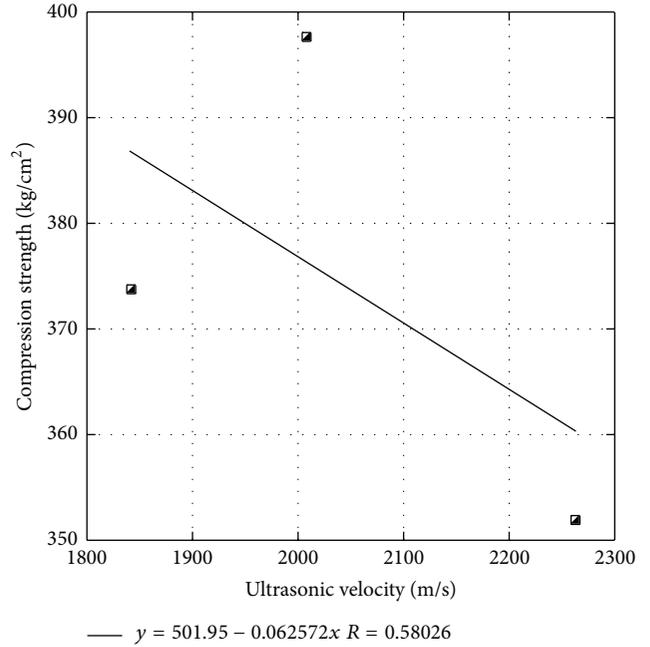
FIGURE 11: Correlation between UPV and compression strength for train E/F.

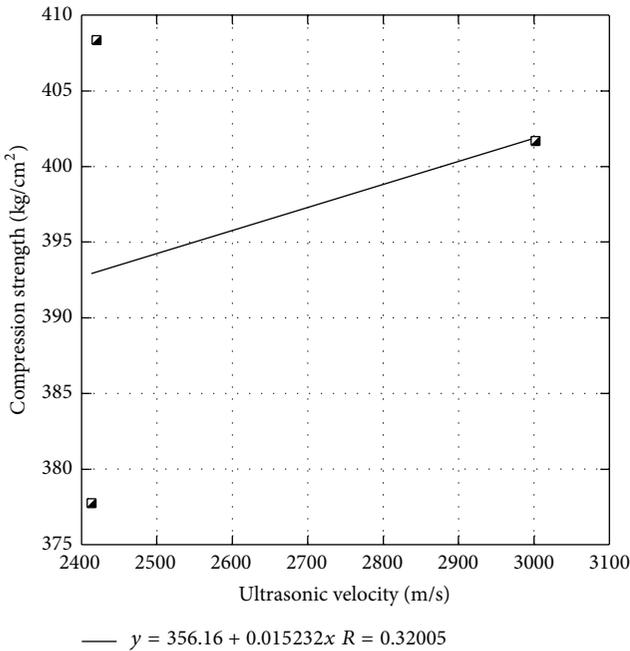
FIGURE 10: Correlation between UPV and compression strength for train C/D.

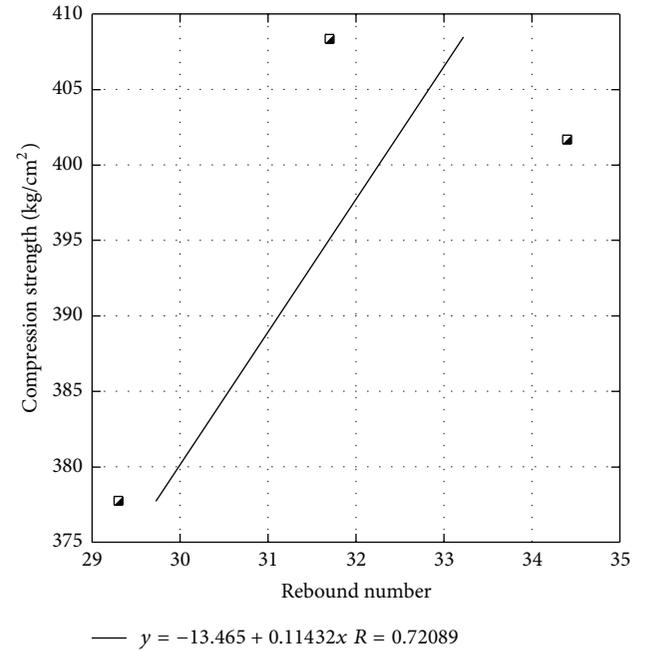
Figure 12 shows a correlation chart between hammer and compressive strength at train C/D. It gives a reasonable correlation factor (*R*) of 0.72089. However, if all hammer tests for all trains are combined in one chart, the correlation factor between hammer and compressive strength drops to 0.19884

FIGURE 12: Correlation between hammer and compression strength for train C/D.

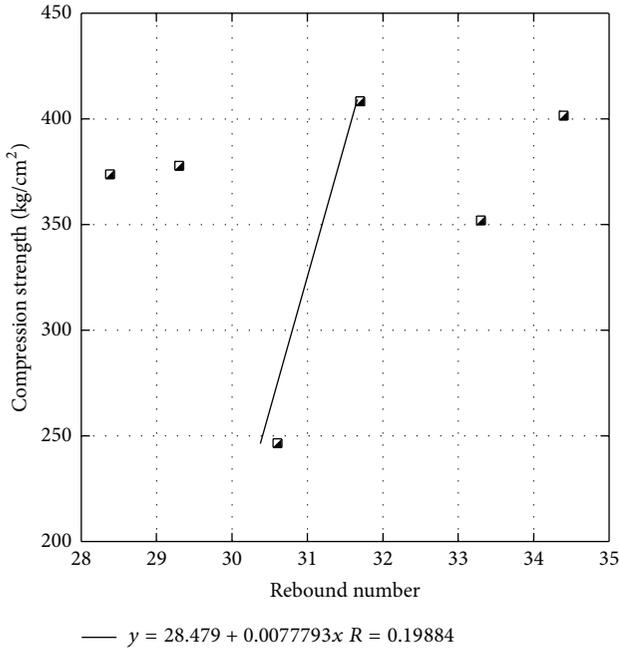
FIGURE 13: Correlation between hammer and compression strength for all trains.

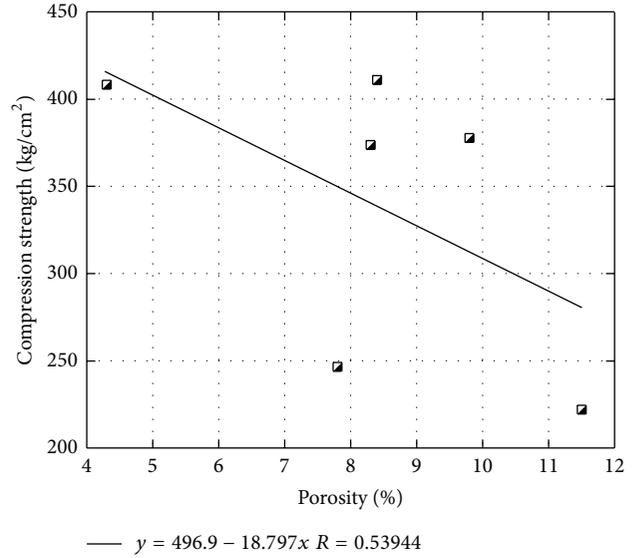
Figure 14 shows the correlation chart between porosity and compressive strength for all trains. Compared with Figure 13, porosity has a better correlation to compressive strength than hammer test, having a correlation factor of 0.54. This result again confirms that destructive test such as porosity test has a better accuracy than nondestructive test such as UPV test. However, porosity test requires the samples to be taken from an existing structure and therefore it is expensive to perform.

FIGURE 14: Correlation between porosity and compression strength for all trains.

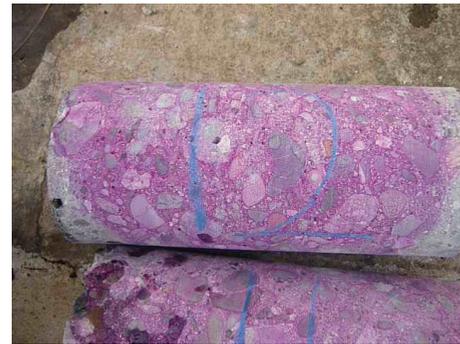
FIGURE 15: Carbonation test of core-drilled samples.

4.2. *Determine Carbonation Depth.* After concrete core-drilled sample was obtained, the cylinder specimen was then straight away tested for depth of carbonation. Depth of carbonation was checked using a solution of phenolphthalein indicator that appears pink in contact with alkaline concrete with pH values in excess of 9 and colourless at lower levels of pH [12]. This test is most commonly performed by spraying the indicator on freshly exposed surfaces of concrete broken from the structure or on split cores. All of the fourteen samples changed their color to pink as shown in Figure 15. This showed that no concrete carbonation was detected for CWICS up to the present, despite the fact that some of the trains have been in service for more than 30 years.

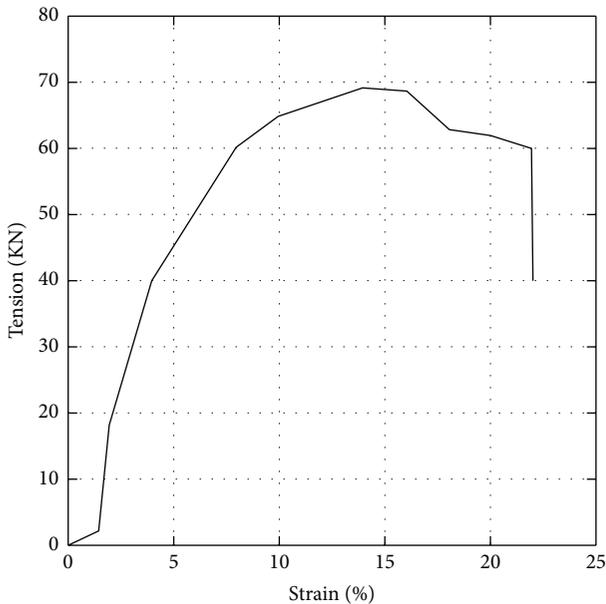
FIGURE 16: Force and displacement of rebar from tension test.

tensile tested. The result of one of tensile test is shown in Figure 16. The yield strength of rebar was found between 533 and 560 MPa, whereas their corresponding ultimate strengths were found between 759 and 878 MPa. This yield strength was higher than that of the specified yield strength of 400 MPa.

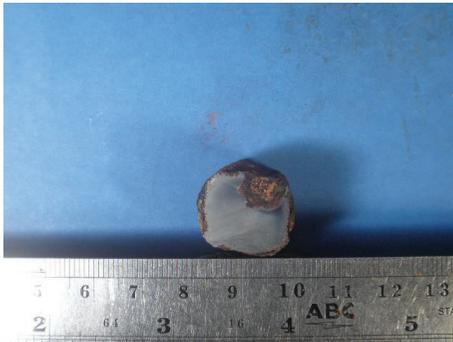
FIGURE 17: Corrosion thickness of 3 ~ 8 mm taken from core 15.

The loss of rebar thickness due to corrosion was measured using Olympus metallurgical camera and Union metallurgical microscope, as shown in Figures 17 and 18. The rebar samples for this test were obtained from concrete core-drilled. Table 5 shows the corrosion thickness of the rebar for each train. This table shows that train E/F has the highest

corrosion rates of 0.1875–0.5 mm/year. This corrosion rate is much higher than the corrosion rate of trains A/B and C/D at 0.0003–0.0006 and 0.0007–0.0017 mm/year, respectively. These two trains have almost negligible corrosion. The higher corrosion rate observed at train E/F is most likely due to local incidence such as local low concrete compaction. Therefore, this value should not be used as a representative value of the steel corrosion rate of train E/F. Furthermore, as only one sample was taken for this test for each train, this result should be used cautiously and should be compared with other forms of tests or formulae to determine the corrosion rate of CWICS. The representative value of corrosion rate of each train will be discussed and determined in Section 4.8.

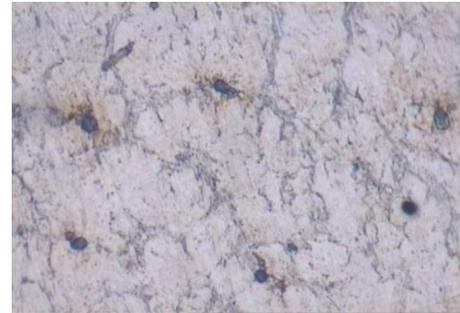
FIGURE 18: Microstructure with 500x magnification of rebar taken from core 15.

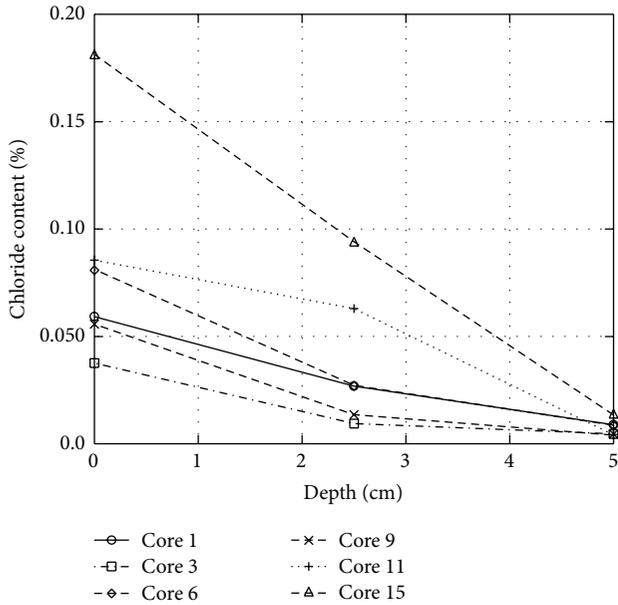
Figure 19 shows that the chloride content measured by weight of concrete (in %) at concrete surface for all samples is very close to one another, except sample taken from core 15. Core 15 drilled at train G/H shows the highest chloride content at all measured depths. This highest chloride content correlates with its highest thickness loss of rebar as presented in Table 5. Figure 19 also indicates that all of the samples have a very similar chloride content of 0.01% at concrete depth of 50 mm, where the rebar is located. This value can be compared with the chloride threshold level to initiate corrosion of 0.025% such as stipulates in Indonesia Concrete Building Code [2].

FIGURE 19: Chloride content at different depths.

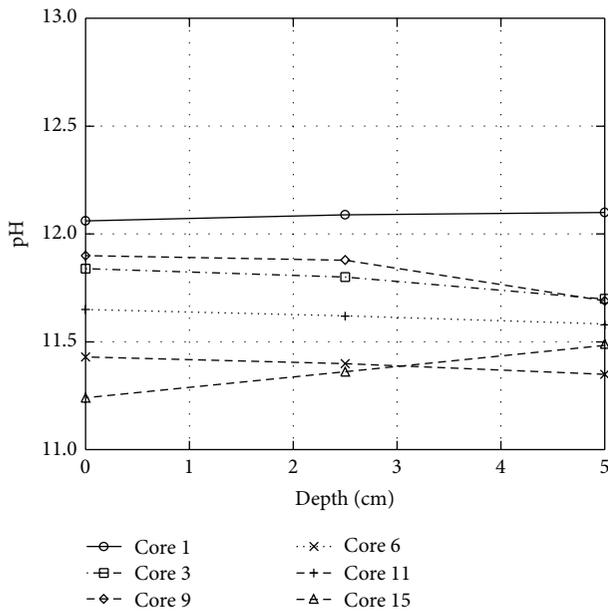
Figure 20 shows that the concrete pH is relatively constant as the depth from concrete surface increases. The lowest pH is

FIGURE 20: pH value at different concrete depth.

11.25 at concrete surface and 11.35 at 5 cm depth. This indicates that the concrete is still in a very high alkaline condition and has no experience pH reduction due to corrosion attack. This result corroborates with previous result (see Figure 19) which indicate that concrete corrosion has not yet initiated at CWICS. Note that core 15 which has the highest chloride content also has the lowest pH at concrete depth of 0.0 and 25 mm and the second lowest pH at concrete depth of 50 mm. Core 15 also has the highest thickness loss of rebar as shown in Table 5.

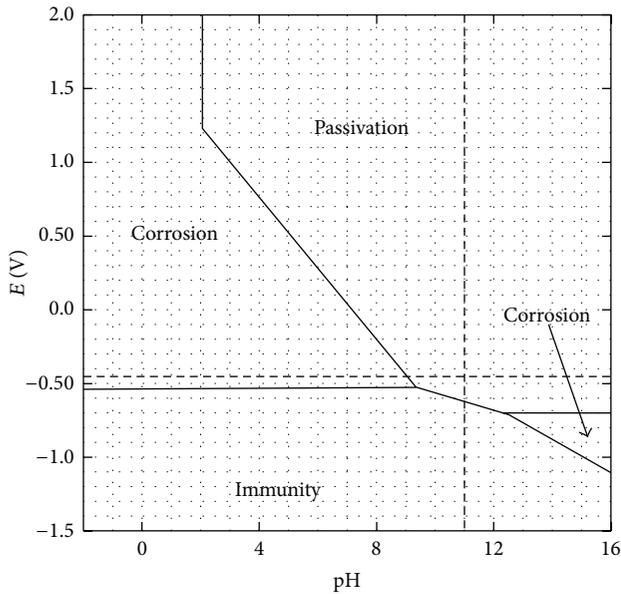
FIGURE 21: Pourbaix diagram of rebar.

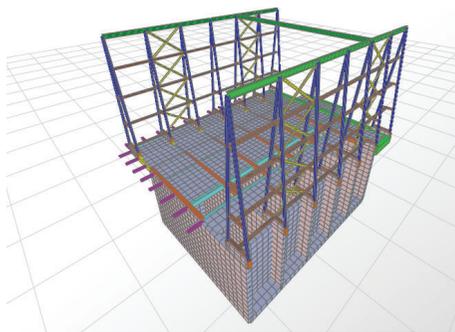
4.7. *Structural and Load Modelling of CWICS.* Structural and load modeling of CWICS was performed using SAP 2000 to determine the internal forces of CWICS. These internal forces were then compared with the remaining capacity of CWICS's structural elements. The remaining capacity of CWICS has decreased from its initial design capacity due to rebar corrosion. If ratio of the capacity of concrete element to the internal force of the element (defined herein as safety factor) is greater than unity, the element is considered in a safe condition. However, if this ratio reaches unity or less, the element theoretically has failed and has to be strengthened to achieve the minimum safety of 1.0. Note that the redundancy effect of this highly indeterminate structure

FIGURE 22: Structural model of train A/B.

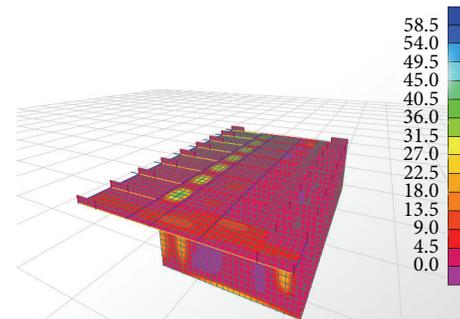
FIGURE 23: Bending moment distribution of train A/B.

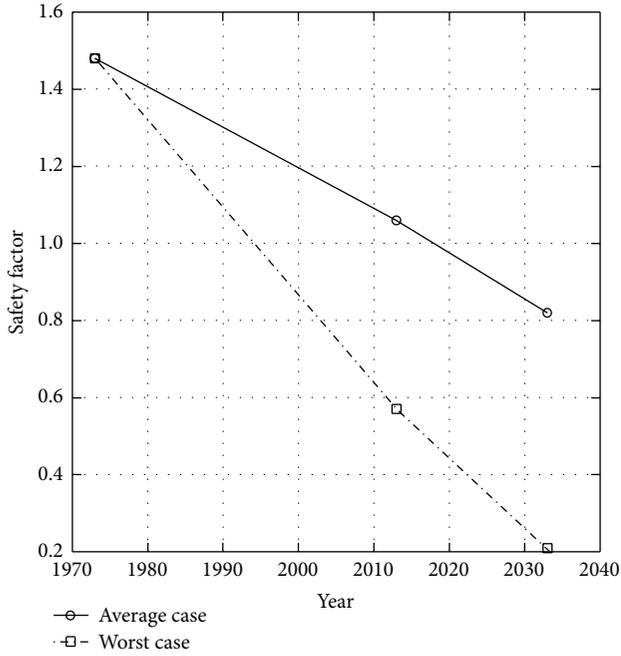
FIGURE 25: Safety factor for plate element with 600 mm depth and reinforced with 19 mm diameter rebar at 150 mm spacing.

- (v) Structural analysis shows that the safety factor of most concrete elements of CWICS was still higher than unity up to year 2033. However, fewer elements were also found to have safety factor approach to unity at year 2013. These elements with low safety factor require immediate strengthening to fulfill its intended service life up to 2033.

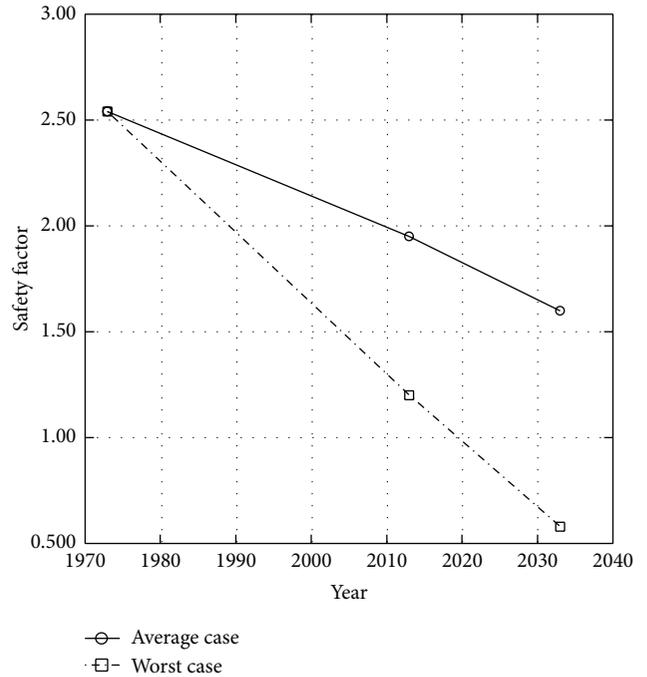
Figure 26 shows the reduction of safety factor for concrete wall element with 600 mm depth and reinforced with 22 mm diameter rebar at 150 mm spacing. This figure indicates that for average case scenarios, the safety factor of 600 mm wall element decreases from 2.54 to 1.95 at year 2013 and to 1.62 at year 2033, respectively. By comparison for worst case scenarios, the safety factor decreases from 2.54 to 1.20 at year 2013 and to 0.58 at year 2033, respectively. Thus, this element does not require immediate strengthening as the safety factor is still greater than 1.0 at year 2013 for both scenarios.

FIGURE 26: Safety factor for wall element with 600 mm depth and reinforced with 22 mm diameter rebar at 150 mm spacing.

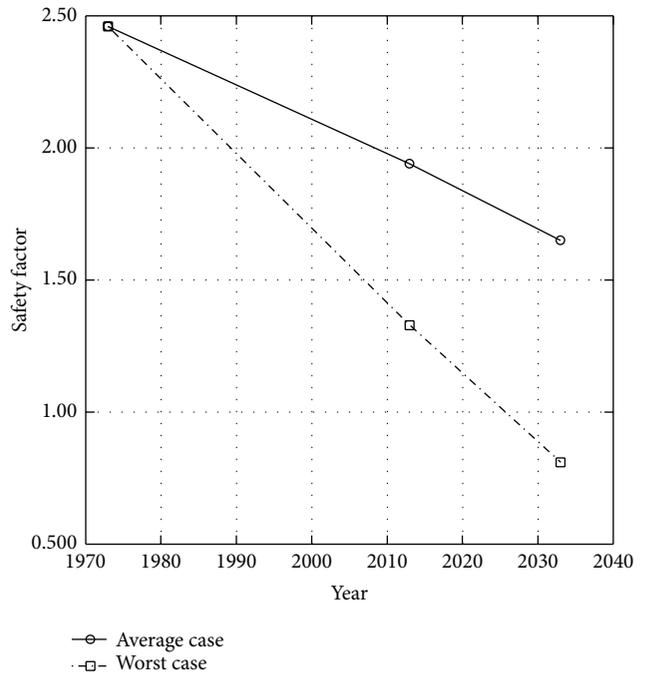
Figure 27 shows the reduction of safety factor for beam element with 500 mm × 800 mm cross-section and reinforced with 4D28 mm diameter rebar against flexure. This figure indicates that, for average case scenarios, the safety factor of the beam decreases from 2.46 to 1.94 at year 2013 and to 1.65 at year 2033, respectively. By comparison, for worst case scenarios, the safety factor decreases from 2.46 to 1.33 at year 2013 and to 0.81 at year 2033, respectively. Thus, this beam does not require immediate strengthening as the safety factor is still greater than 1.0 at year 2013.

FIGURE 27: Safety factor for beam element with 500 mm × 800 mm cross-section reinforced with 4D28 mm diameter rebar against flexure.

1.65 at year 2033, respectively. By comparison, for worst case scenarios, the safety factor decreases from 2.46 to 1.33 at year 2013 and to 0.81 at year 2033, respectively. Thus, this beam does not require immediate strengthening as the safety factor is still greater than 1.0 at year 2013.

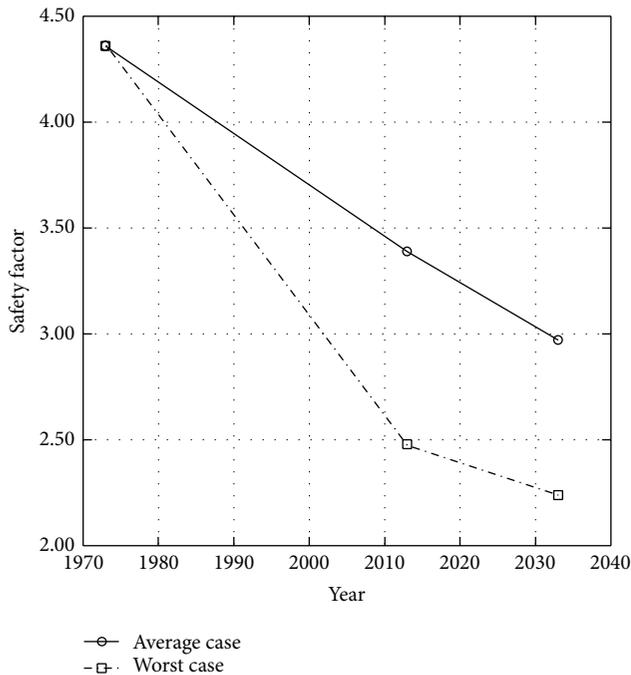
FIGURE 28: Safety factor for beam element with 500 mm × 800 mm cross-section and shear reinforced with 2D12 mm diameter rebar with 150 mm spacing against shear.

Figure 28 shows the reduction of safety factor for beam element with 500 mm × 800 mm cross-section and shear reinforced with 2D12 mm diameter rebar with 150 mm spacing against shear. This figure indicates that, for average case scenarios, the safety factor of the beam decreases from 4.36 to 3.39 at year 2013 and to 2.97 at year 2033, respectively. By comparison, for worst case scenarios, the safety factor decreases from 4.36 to 2.48 at year 2013 and to 2.24 at year 2033, respectively. Thus, this beam does not require immediate strengthening as the safety factor is still greater than 1.0 at year 2013.
