Research Article

Accident Analysis in Relation to Main Roof Structure When Longwall Face Advances toward a Roadway: A Case Study

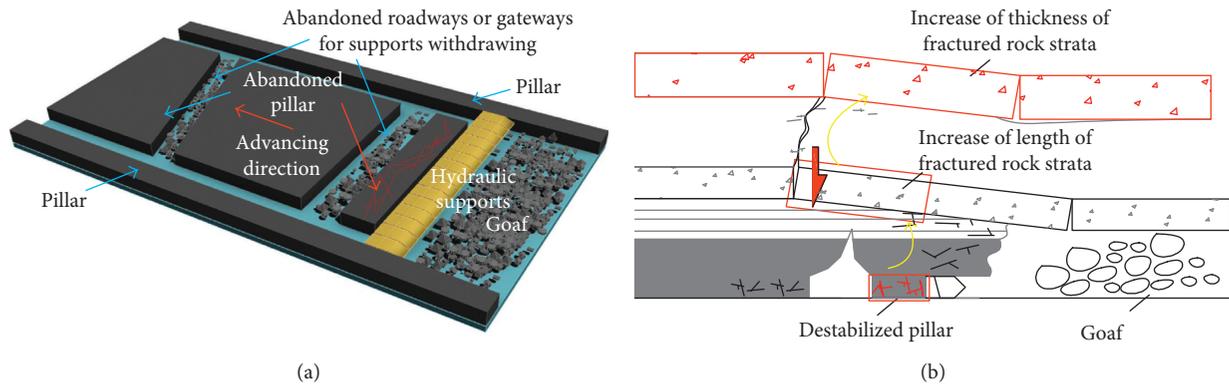
FIGURE 1: Diagram of abnormal fracture of overlying strata.

A lot of research has been done on situation I and II [2, 4, 6–8, 12, 15] (D Wichlacz et al., [17], Oyler D et al., [18]). As shown in these studies, though some technologies have been proposed to prevent a possible accident, much attention has been paid to roadway control technologies under large abutment loads. However, the weighting-induced failure has rarely been discussed. Therefore, Zhou [11], Wu et al. [10], Gu et al. [5], Wang et al. [17], and Lv [18] conduct a series of studies on the weighting-induced failure when the face advances toward the roadways. However, most of their studies are based on field practice which hardly detects the structural characteristics of the main roof and the corresponding strata behavior. In fact, taking gob-side entry as an example, structure and behavior of the main roof will largely affect its surrounding rock stability [19, 20]. Therefore, although the two types of potential failure have been realized, the structural characteristics of the main roof and the corresponding strata behavior have not been

clarified. This would lead to a misunderstanding of the loading on the roadway and then the targeted control technologies.

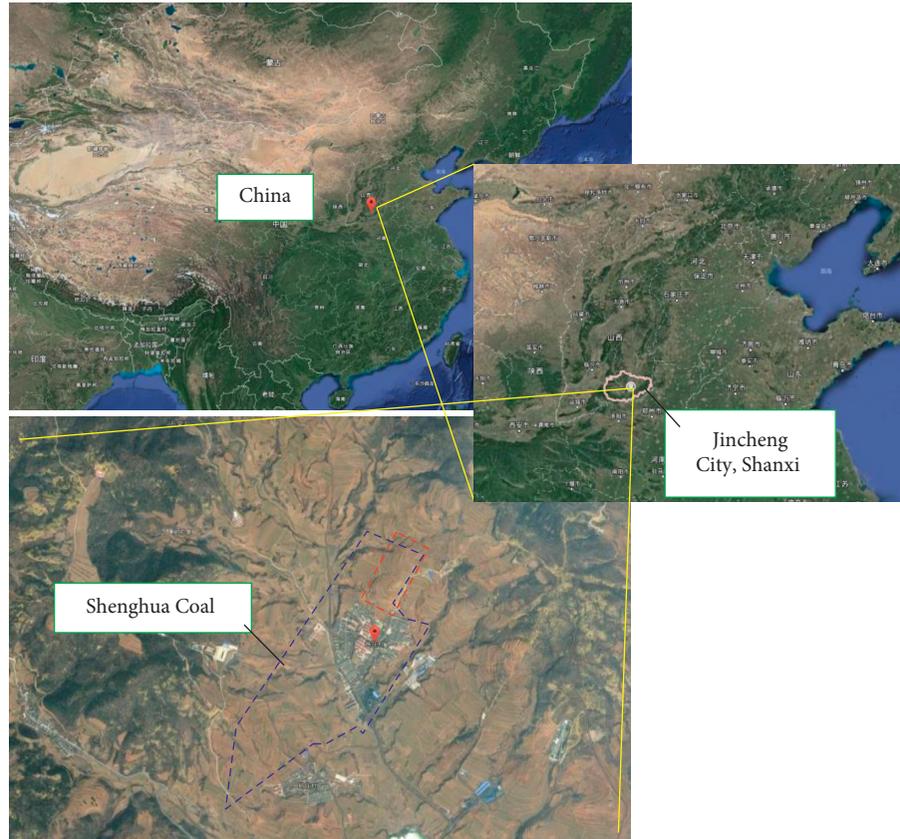
FIGURE 2: Location of the test site.

2.1. Mining and Geological Conditions. LW3101 of the Shenghua coal mine of the Jincheng Coal Group is a workface in coal pillar areas. The mine is located in the southeastern part of the Qinshui coalfield, as shown in Figure 2. A project was conducted to extract the massive valuable coal pillars. The average buried depth of the coal seam is 210 m. The average thickness of the coal seam is 6.5 m. A full-mechanized caving mining technology is adopted in the workface. The cutting height is 2.2 m, and the caving height is 4.3 m. The length of the workface is 84 m. The mining distance is 420 m. Geological conditions in the workface are not complicated except for the long-term abandoned roadways. The density of the coal sample is 1430 kg/m^3 . The compressive strength is 19 MPa. The immediate roof is made up of siltstone or mudstone, its thickness is 4.66 m, and its compressive strength is 32.2 MPa. The main roof is made up of siltstone or fine-grained sandstone, its thickness is 3.61 m, its compressive strength is 47.45 MPa, and tensile strength is 5.44 MPa.

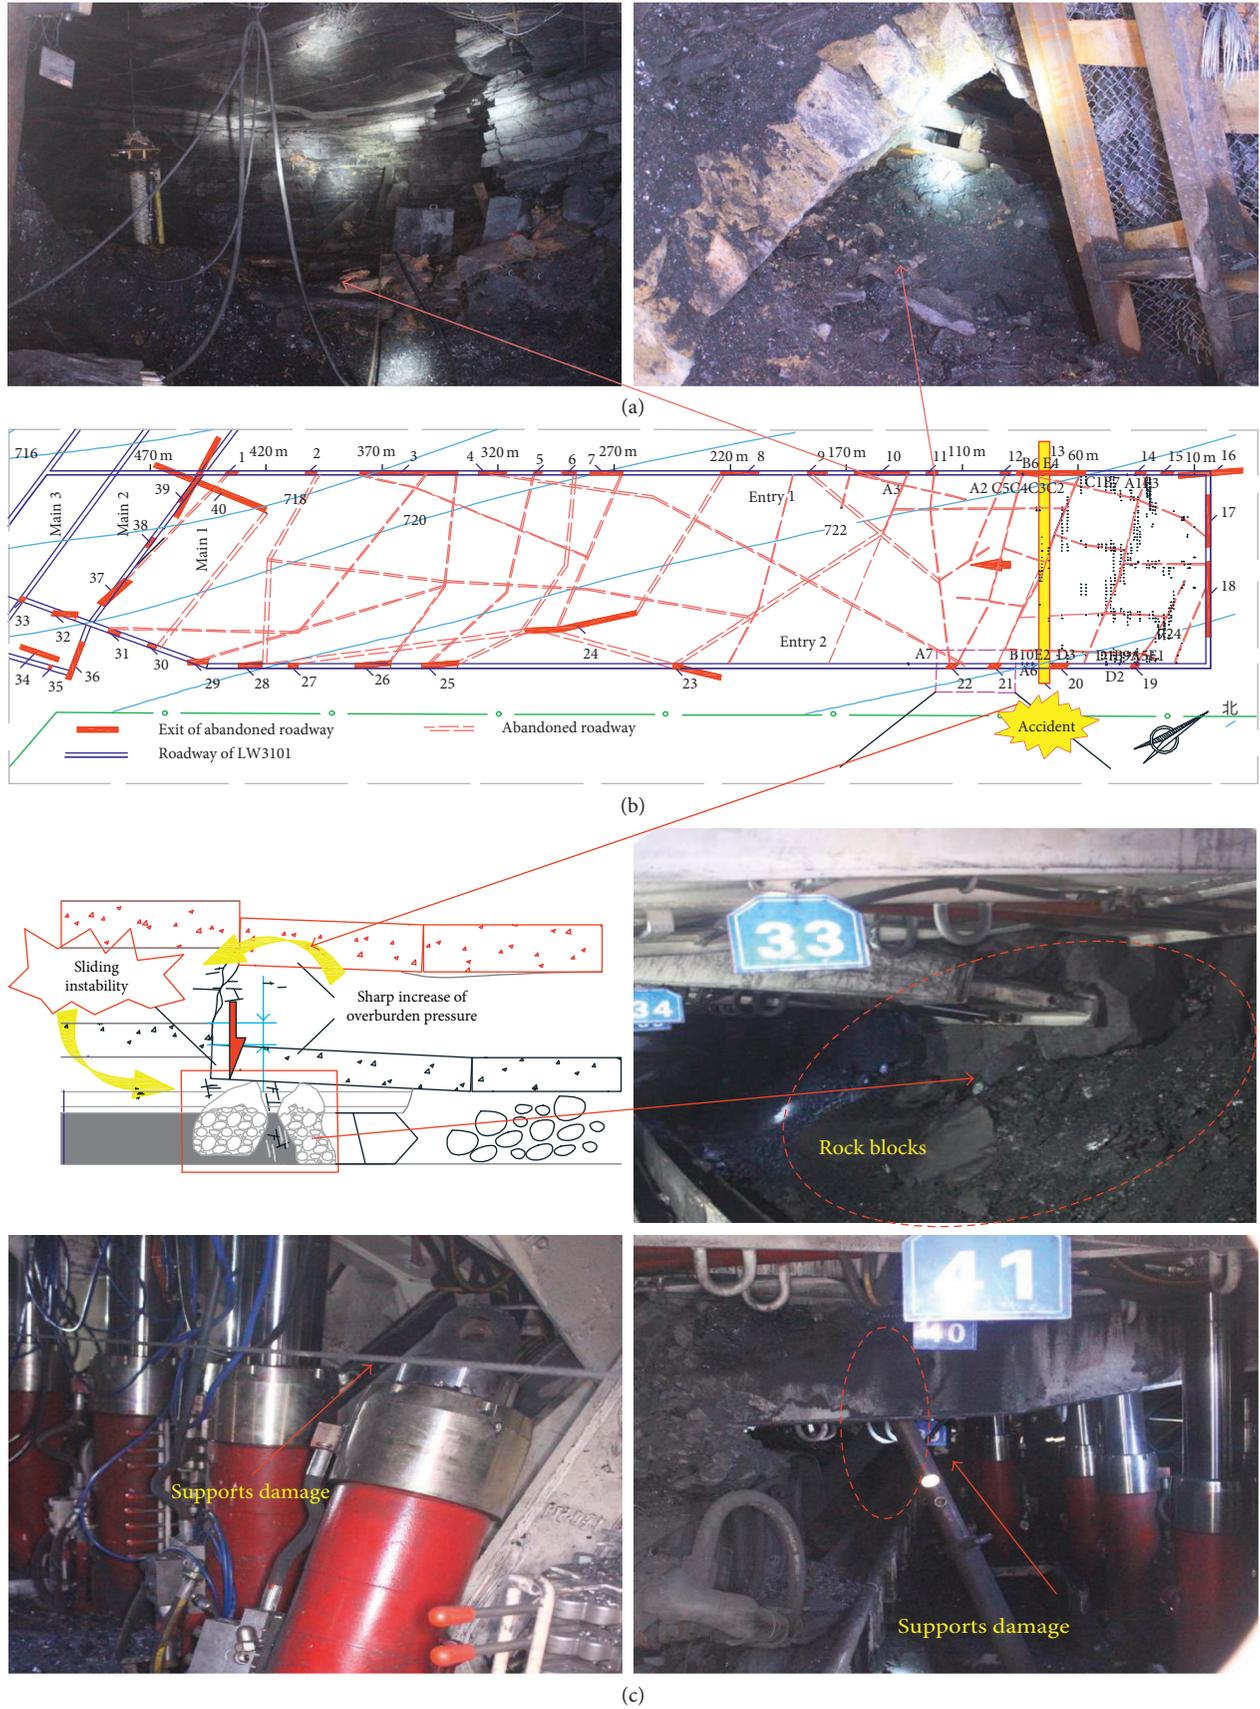
FIGURE 3: (a) Conditions of entry 1 during the drivage period. (b) Layout of LW3101 and abandoned roadways. (c) Sketch map of the strata behavior and photograph of the accident.

2.2. Accident Investigation. The abandoned roadways discovered during the roadways excavation period are shown in

Figure 3. As can be seen, the roadways are buried by the falling rock blocks, and its layout is hard to identify. Despite the complicated condition, simple measures were taken to crossing the roadway. Unfortunately, supports crushing accident took place when the workface crossed a 12 m width roadway. As can be seen in Figure 3, the coal pillar lost stability; the caving rocks buried the abandoned roadway and poured into the workface; the overlying strata slid rapidly and lost stability soon. The working resistance of supports increased sharply, and then the chocks had a sudden closure. Some supports were even damaged.

To avoid similar accidents and to put forward targeted measures, various methods were applied to make the abandoned roadways' layout clear. Finally, as can be seen in Figure 3, the result shows that there are about 15 roadways lying ahead of the workface. Based on this, the experiment can be conducted and the mechanical model can be established.

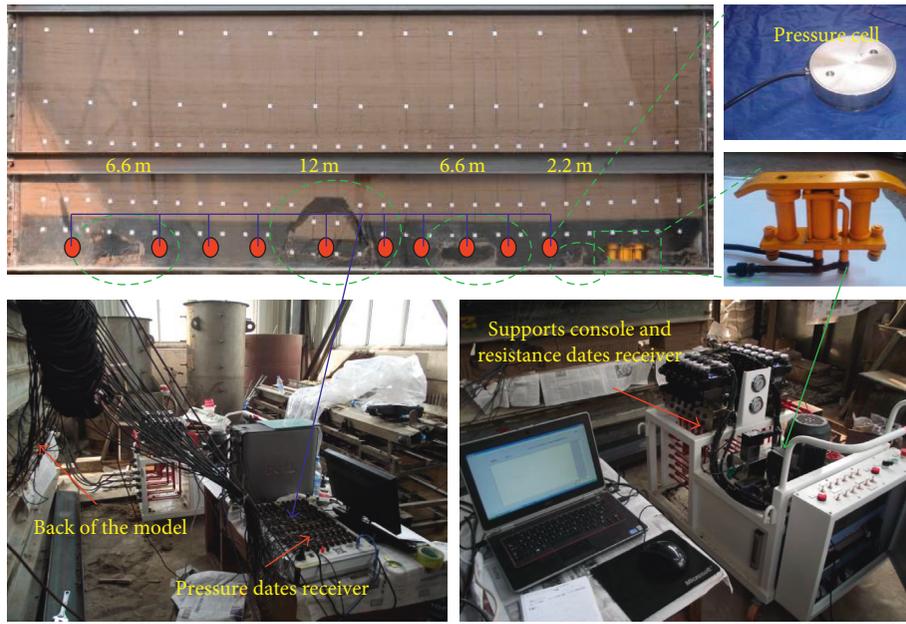
FIGURE 4: Experiment model and microsupport and real-time monitoring devices.

3.1. Equipments and Experimental Design. Physical models on a 1:30 scale of an overburden system were constructed which is a mixture of sand, plaster, calcium carbonate, mica, and water. As shown in Figure 4, four abandoned roadways were set ahead of the workface. The internal dimensions of the test rig were $3 \times 2 \times 0.2 \text{ m}$ (length \times height \times width). Monitoring devices to measure the abutment pressure in the "coal" layer and loading exerted on supports were used. The results are shown in Figure 5(e) and have been converted to field's scale dates. The structural characteristic of the main roof and strata behavior is shown in Figures 5(a)–5(d).

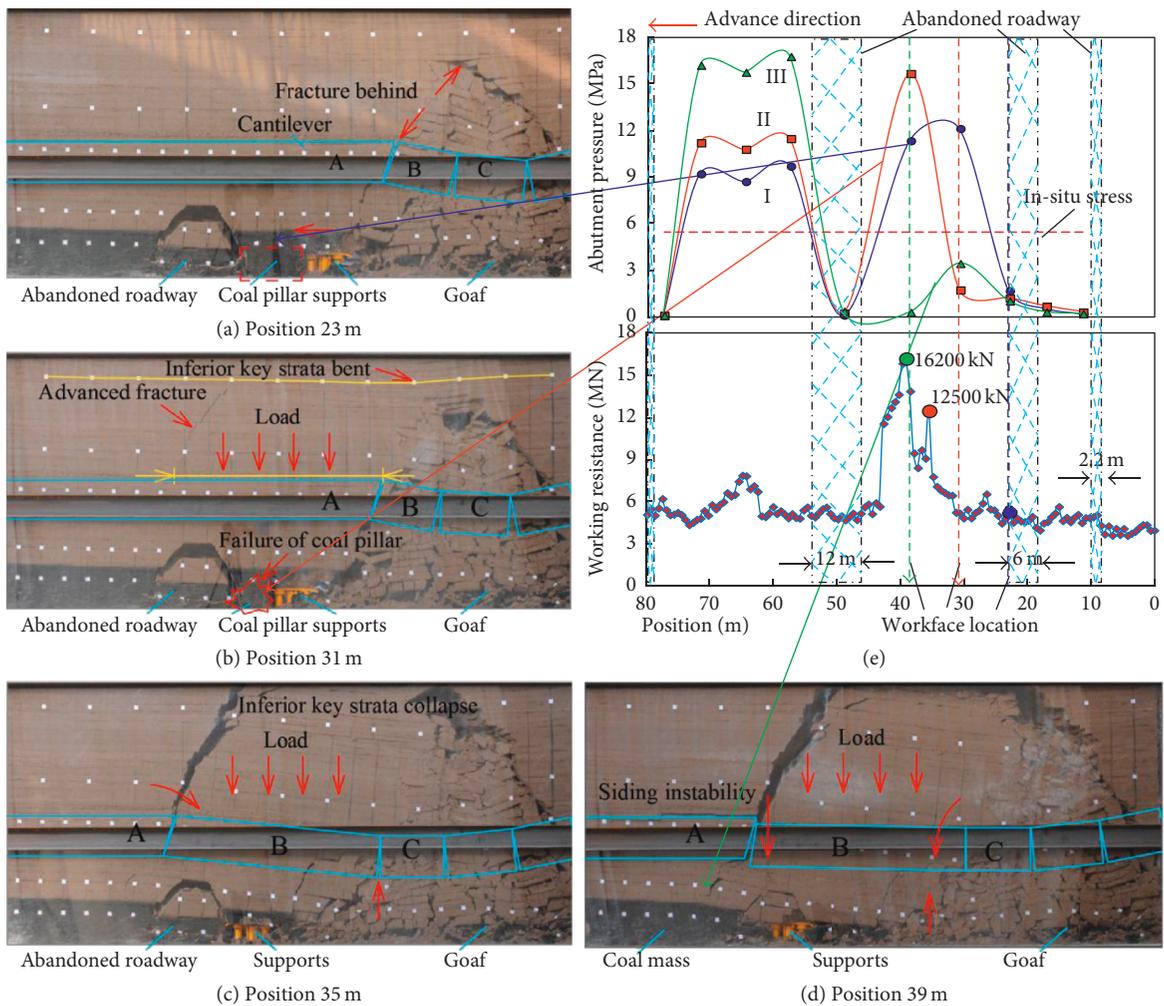
FIGURE 5: Result of the 2D similar simulation. (a) Position 23 m, (b) position 31 m, (c) position 35 m, and (d) position 39 m.

3.2. Results of the Experiment. As can be seen in Figure 5, accident shows up when the workface moves close to the 12-meter-wide roadway.

In Figure 5(a), when the workface crosses the narrow roadways (6 m or 2.5 m wide), the roof strata fractures behind the workface, and the workface is under the protection of the cantilever made up of the roof strata. In this situation, the abutment pressure is the blue line, and the load on support is the blue point in Figure 5(e). The loading on the support changes little with the workface moving forward.

In Figures 5(b) and 5(c), when the workface crosses the 12 m-wide roadway, the coal pillar breaks down, and the roof strata fractures ahead of the workface, and the length and the thickness of the fractured roof strata increase sharply. The supports are no longer under protection of the cantilever, the loading on support soars to 12500 kN as shown in Figure 5(e).

In Figure 5(d), the main roof slides down to the supports. As a result, in Figure 5(e), the load soars to 16200 kN (the green point), and the abutment pressure in the coal pillar increases (the III curve).

It can be concluded from the evolution of the three curves (I, II, and III in Figure 5(e)) that the abutment pressure transfers forward with the face advancing and increases sharply when there is an abandoned roadway. This evolution will largely impact the stability of the rib and the roadway and then induces a support failure of the roadway.

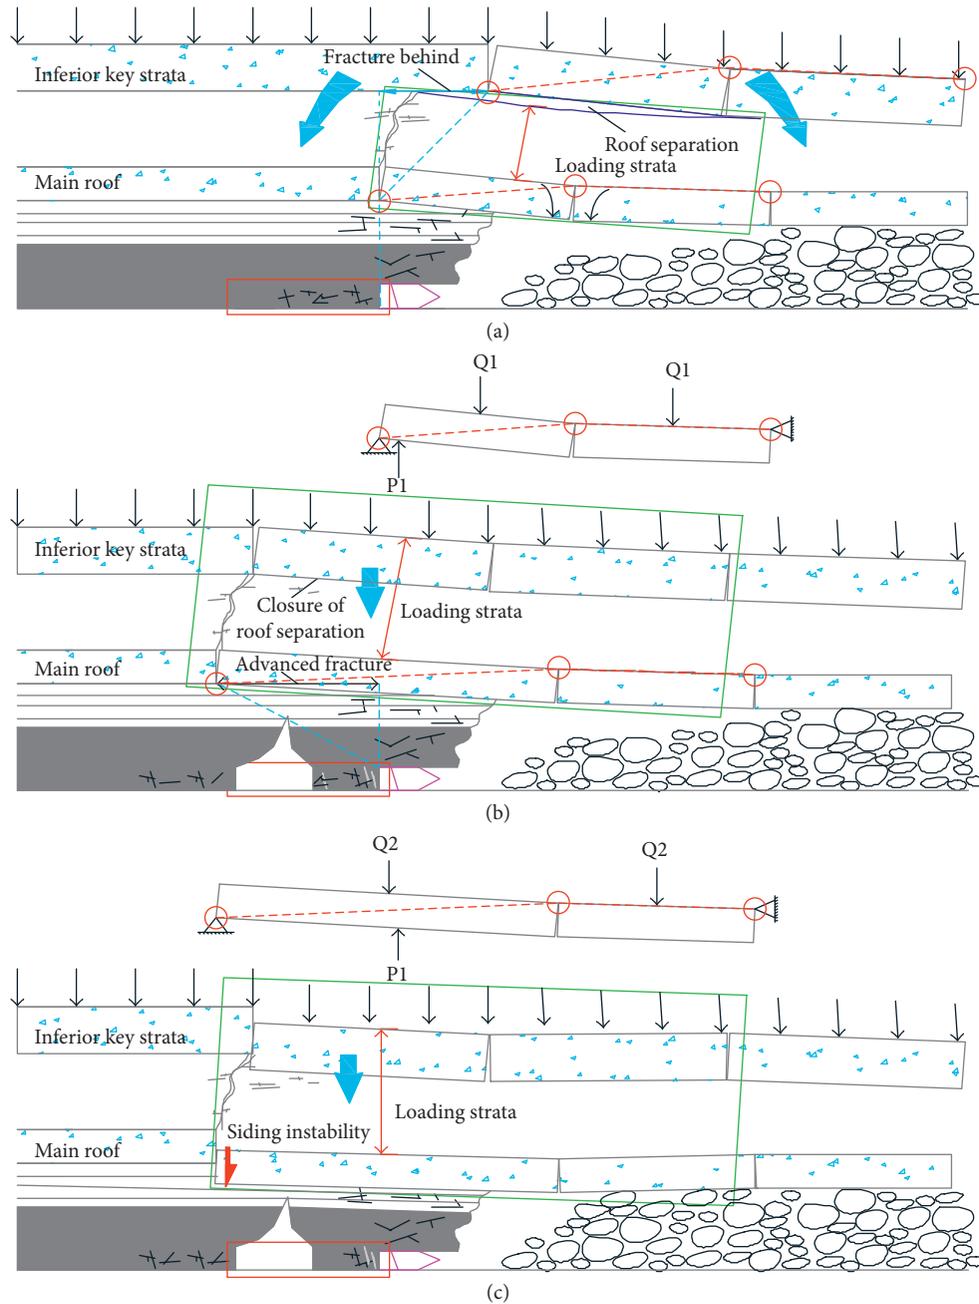
FIGURE 6: Evolution of the supports crushing accident.

3.3. Evolution of Support Crushing Accident. Figure 6 is the simplified model of the evolution. As can be seen in Figure 6(a), in most situations, the supports are under the protection of a cantilever or an arch structure made up of

main roof. The inferior key strata over the main roof always fracture far behind the workface and therefore have little effects on the workface. The main roof only needs to bear the loading strata.

However, the aforementioned case shows a different structural characteristic. As shown in Figure 6(b), the main roof breaks ahead of the workface and then induces the inferior key strata's fracture. As a result, the inferior key strata act as a loading being exerted on the arch structure which can easily destroy the stability of the main roof and slides on the supports as shown in Figure 6(c). Once the sliding instability takes place, the loading on the supports increases sharply, and the supports crushing accident takes place.

In contrast to Figures 6(a) and 6(b), the different structural characteristics between a normal workface and an abnormal workface can be concluded. Firstly, the length of the fracture interval increases, and the fracture position moves forward. Secondly, the thickness of the fractured roof strata increase and then lead to a sharp increase of the loading on the support.

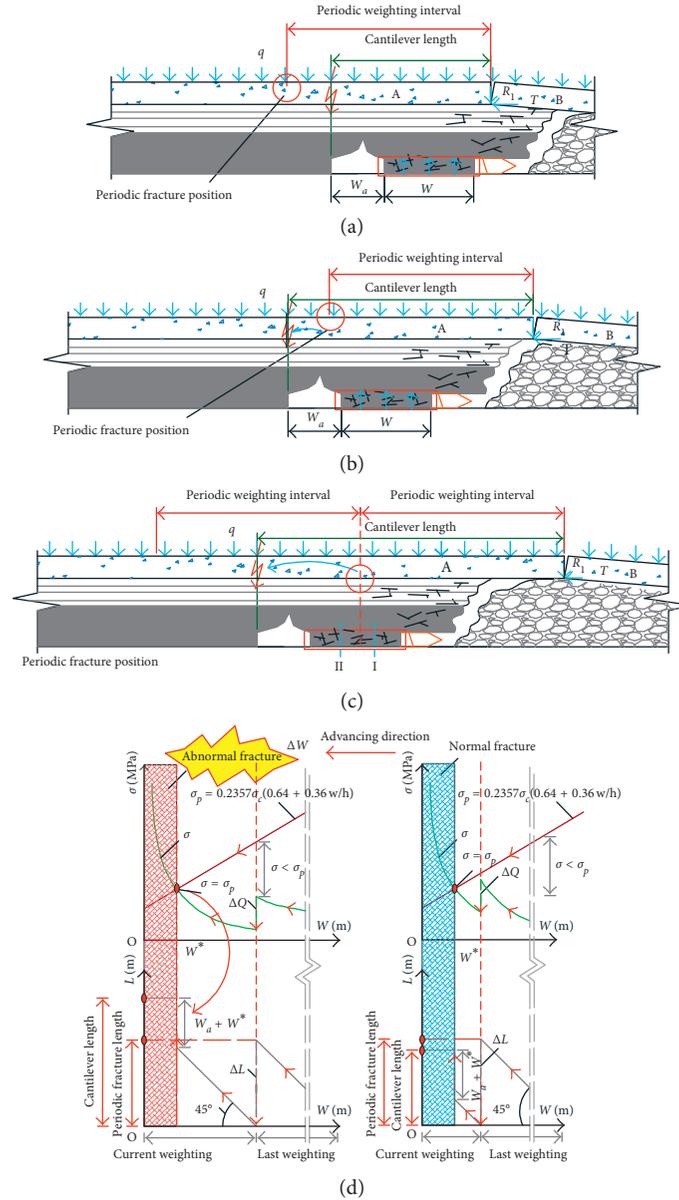
FIGURE 7: Relative positions of the abandoned roadway and fracture position.

Figure 7 shows three relative positions between the abandoned roadway and periodic fracture position. Based on this, the abnormal fracture can be predicted.

In Figure 7(a), both the abandoned roadway and the coal pillar are within the scope of the next periodic weighting interval. As can be seen, the cantilever is shorter than the

interval. As a result, even the coal pillar breaks down and the roof strata would not suffer the abnormal fracture.

In Figure 7(b), the abandoned roadway is partly within the scope of the interval and the coal pillar is also within the scope of the interval. As a result, the cantilever is longer than the interval. Once the coal pillar breaks down, the roof would suffer an abnormal fracture.

In Figure 7(c), the abandoned roadway is beyond the scope and the pillar is partly within the scope. As a result, the cantilever is far longer than the interval. In this case, the critical width of the coal pillar is important. If the coal pillar breaks down in position I, the roof would suffer an abnormal fracture. If the coal pillar breaks down in position II, the roof would not suffer abnormal fracture.

Figure 7(d) shows the relationship between stress on the coal pillar, strength of coal pillar, and cantilever length. As can

be seen, the stress increases as the width of the coal pillar decreases, and its variation agrees with a hyperbolic law. The strength decreases with the decrease in the width of the coal pillar and conforms to the linear law. Once the stress increases to the strength, the coal pillar collapses and the cantilever length increases by $W^* + W_a$. A comparison of the periodic weighting interval and cantilever length can conclude whether an abnormal fracture would take place (Figure 7(d)).

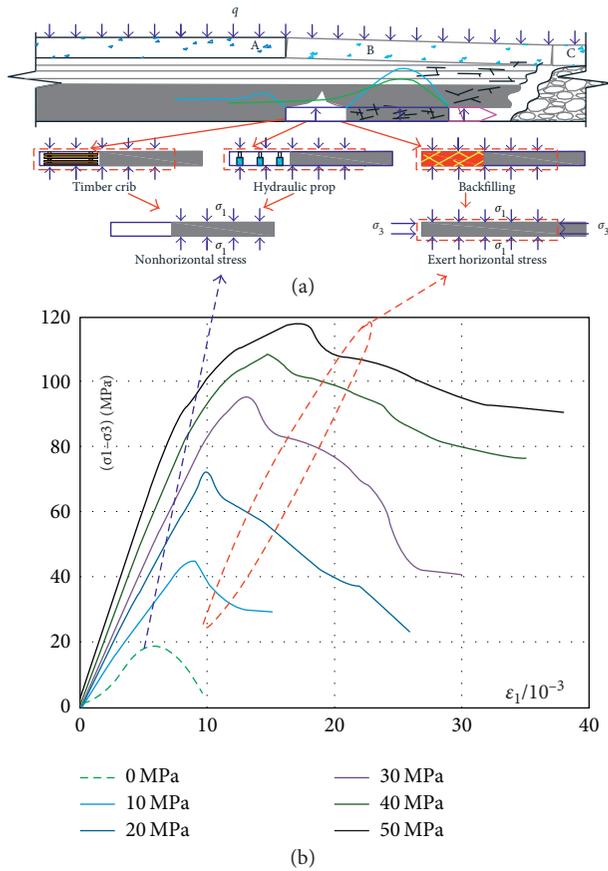
FIGURE 8: Schematic diagram for preventive measures.

As can be seen in Figure 8, the abandoned roadway backfilling technology can exert horizontal stress on the coal pillar and transforms its uniaxial compression state to triaxial compression state. This improvement transform coal pillar to integrated coal from a view point of mechanics. Then, the coal pillar will hardly lose its stability.

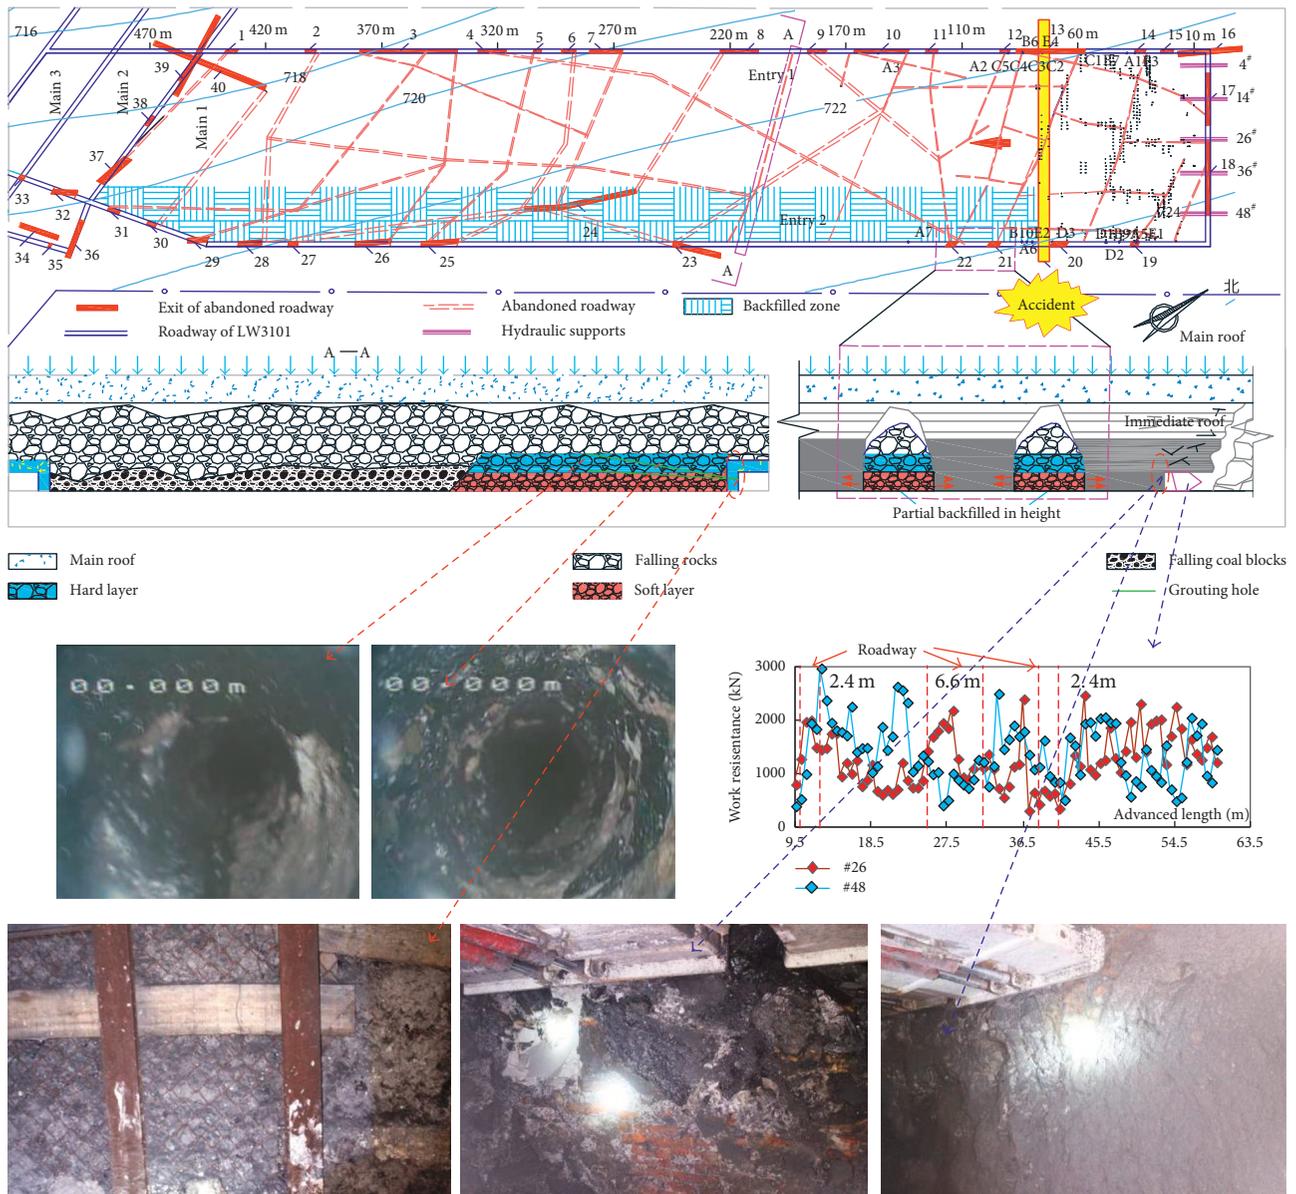
FIGURE 9: Field backfilled plan and the effects.

It should be noted that the backfilled body does not necessarily contact the roof. The main purpose of the technology is to maintain the stability of the coal pillar and prevent falling rock blocks. Thus, the backfilled body is made up of two layers. The soft layer which changes the uniaxial compression of the coal pillar to the triaxial compression is a mixture of woods, gangues, coal blocks, and low-strength cementing body. The hard layer which ensures the supports to contact roof and prevents gangues pouring into the workface is made up with high-strength cementing body. Figure 9(a) shows the backfill plan in the field.

Figure 9(c) records the work resistance during the mining period. The result shows that the maximum work resistance in both areas is less than 3000 kN, and the periodic weighting interval is 10.2 m~11.6 m. An abnormal weighing accident never appears again.
