Research Article

Experimental Study on the Shear Performance of Shallow Hinge Joints for Prefabricated Hollow Slab Bridges

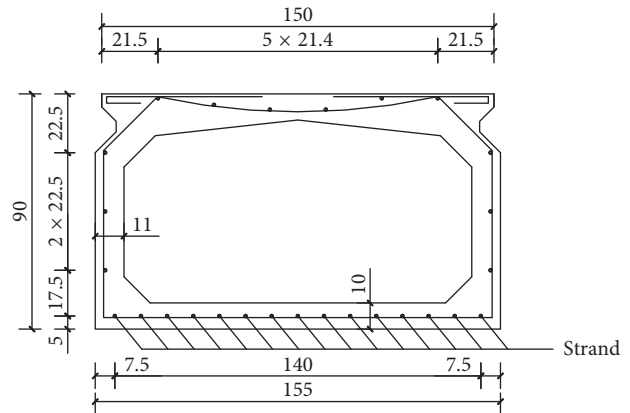
FIGURE 1: Wide prefabricated concrete hollow slab midspan section (cm).

The parameters of each hollow slab are as follows: precast width, 155 cm; height, 90 cm; top/bottom slab thickness, 10 cm; and web thickness, 11 cm. Each slab had 15 ASTM A416-90a 270 grade (diameter of 0.6 inch) steel strands (Figure 1), and the hollow slab was based on no. 40 gravel concrete.

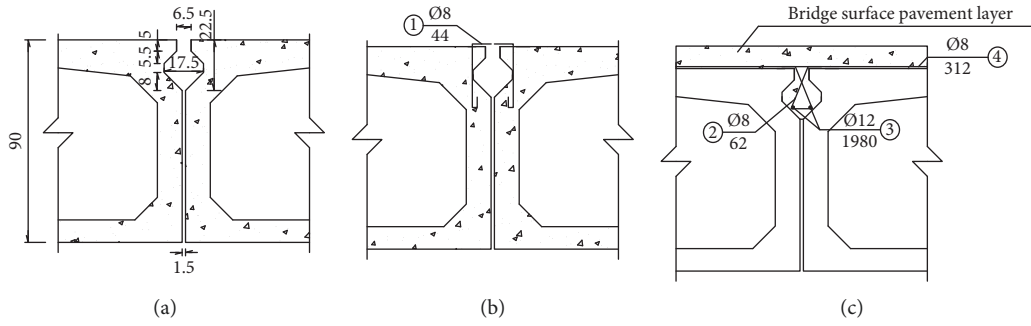
FIGURE 2: Hinge joint structure and reinforcement (cm): (a) hinge joint detailed drawing, (b) hinge joint connection rebar, and (c) hinge joint rebar.

The dimensions of the shallow hinge joint are shown in Figure 2(a). Connection rebar N1 is buried in the hollow slab with 10 cm spacing along the direction vertical to the bridge. The detailed structure is shown in Figure 2(b). There are two types of hinge joint rebar structures, scissor rebar N2 and longitudinal rebar N3 with 10 cm spacing along the direction vertical to the bridge. Details are shown in Figure 2(c).

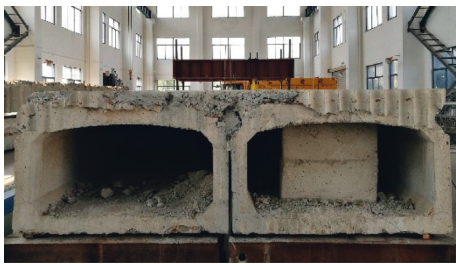
FIGURE 4: Hollow slab prototype test.

then, the blocks were hoisted to the support (one end of the test girder support was slab rubber support, and the other end was Teflon slide plate rubber support), as shown in Figure 3. After the rebar was added to the hinge joint, C40 grade concrete was poured onto the hinge joint and the bridge surface pavement layer. The concrete bridge surface pavement layer was 10 cm thick. A layer of $\phi 8$ plain round rebars was deployed along the girder longitudinal direction with 10 cm spacing. After curing for 28 days, the hinge joint test was performed. The final test girder is shown in Figure 4. The IDs for the hollow slab and hinge joint are shown in Figure 5.

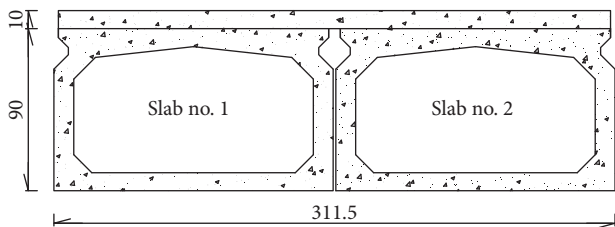
FIGURE 5: Cross section of a hollow slab (cm).

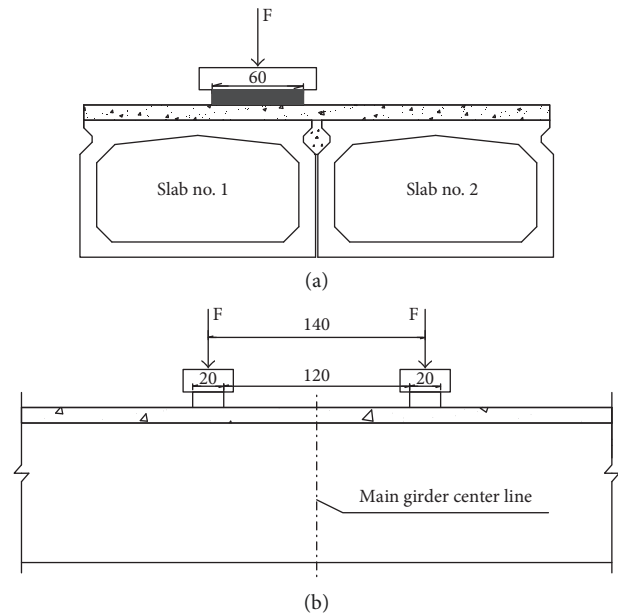
FIGURE 6: Vehicle loading position: (a) direction horizontal to the bridge and (b) direction vertical to the bridge.

3.1. Test Loading. The main subject of this experimental study was the hollow slab hinge joint structure. Based on Section 4.3.1(2) in the General Code for Design of Highway Bridges and Culverts (JTG D60-2004), the local load calculation of the bridge structure was based on vehicle load [14]. Based on the principle of the most unfavorable deployment, standard vehicle rear axial load was converted to uniformly distributed stress on the test girder. Additionally, the load of two wheels was applied to the same horizontal position. The ground contact area of standard vehicle rear axle tire was $0.6 \text{ m} \times 0.2 \text{ m}$ [14]. The detailed loading position is shown in Figure 6.

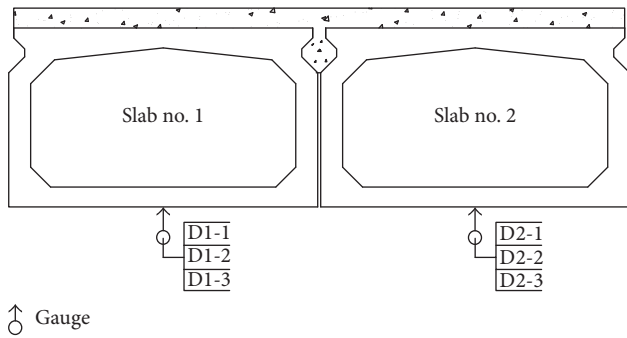
FIGURE 7: Deflection measurement points for the hollow slab.

3.2. Placement of the Measurement Point for the Hollow Slab Girder. To understand the hinge joint load transmission effect, the hollow slab deflection measurement point placement is shown in Figure 7. In the direction vertical to the bridge, they are placed at 3 sections, i.e., the $L/4$ section,

the L/2 section, and the 3L/4 section. The IDs of the deflection measurement points at slab no. 1 are D1-1, D1-2, and D1-3. The IDs of the deflection measurement points at slab no. 2 are D2-1, D2-2, and D2-3.

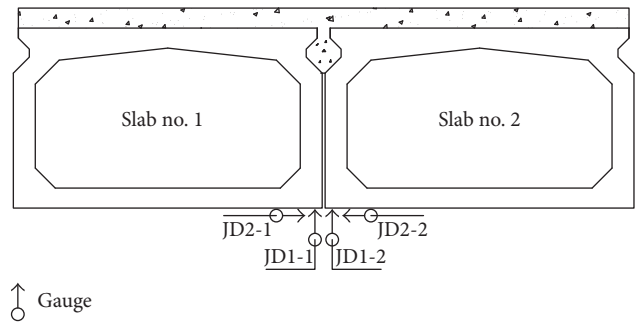
FIGURE 9: Displacement measurement points at the hinge joint.

3.3. Deployment of Measurement Points at the Hinge Joint. The relative displacement difference is an important index to evaluate the hinge joint damage level and load-transfer performance. In this test, 4 measurement points were used to measure the change of the hinge joint relative position. Among them, JD1-1 and JD1-2 measured the vertical displacement of the hinge joint; JD2-1 and JD2-2 measured the horizontal displacement of the hinge joint. They

are placed at the midspan section along the direction vertical to the bridge, as shown in Figure 9.

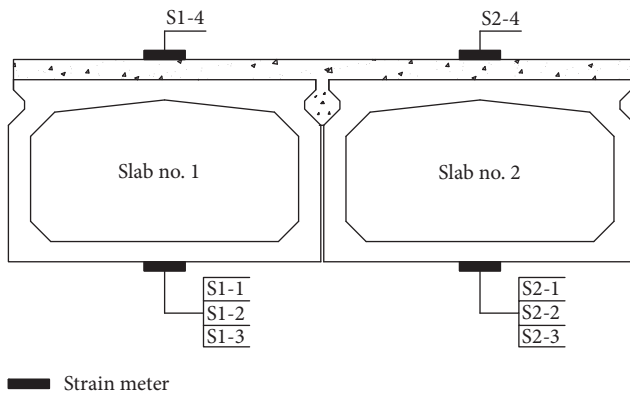
FIGURE 8: Strain measurement points for the hollow slab.

The hollow slab strain gauge measurement points are placed at the L/4 section, the L/2 section, and the 3L/4 section along the direction vertical to the bridge, as shown in Figure 8. The IDs of the strain measurement points for hollow slab no. 1 are S1-1, S1-2, S1-3, and S1-4 (midspan roof). The IDs of the strain measurement points for hollow slab no. 2 are S2-1, S2-2, S2-3, and S2-4 (midspan roof).

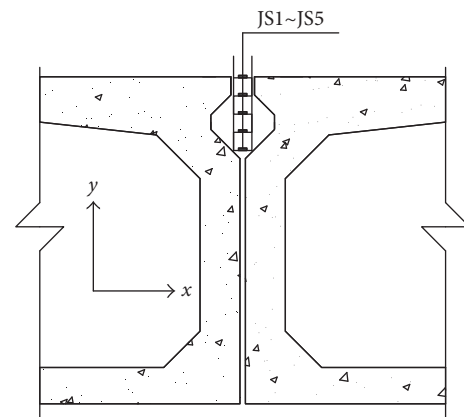
FIGURE 10: Strain measurement points at the hinge joint.

Before pouring concrete at the hinge joint, measurement points for the hinge joint x direction strain are buried at the midspan in advance along the direction vertical to the bridge. The IDs of the strain measurement points along the hinge joint height direction are JS1, JS2, JS3, JS4, and JS5. Detailed placement is shown in Figure 10.

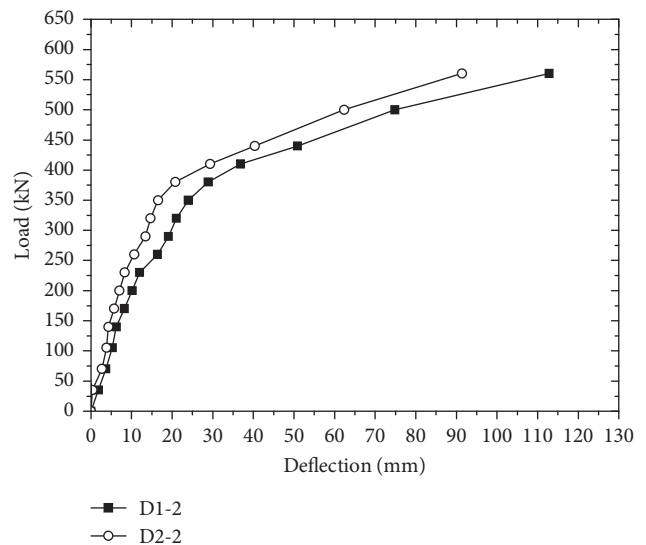
FIGURE 11: Load-deflection curve at the midspan section of the hollow slab.

4.1. Test Procedure. For each loading stage in the test, the load-deflection curve and load-strain curve of the hollow slab are shown in Figures 11 and 12.

At the initial stage of loading, the structure stress was in the elastic stage. The load-deflection curves of two slabs demonstrated a linear variation. Additionally, the variation rates were consistent. The bonding surface between the hinge joint and girder had no fracture.

When the load increases to approximately 365 kN, i.e., 1.3 times the designed vehicle load (highway-grade I), the midspan pure bending sections of hollow slabs no. 1 and no. 2 developed bending fractures. The structures entered the elastoplastic state. The stiffness reduced gradually. When the load increased further, the slab load-deflection curves demonstrated a nonlinear variation. This stage continued until the load reached 560 kN, i.e., 2.0 times the designed vehicle load (highway-grade I). At this moment, the roof concrete of hollow slabs no. 1 and no. 2 approached collapse.

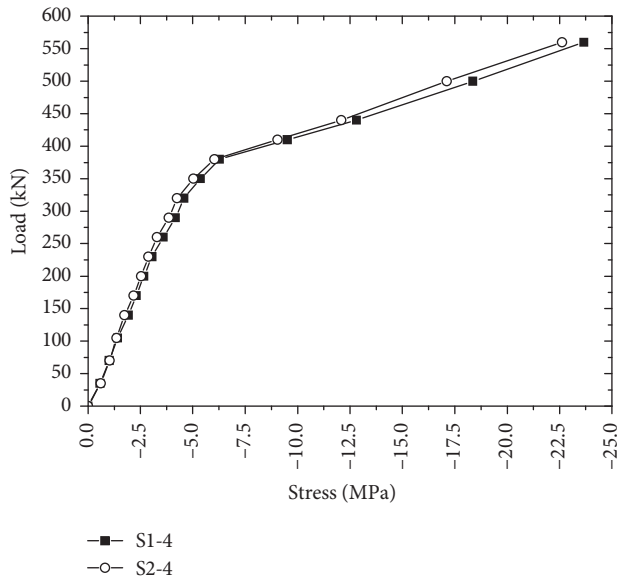
FIGURE 12: Load-stress curve at the midspan roof of the hollow slab.

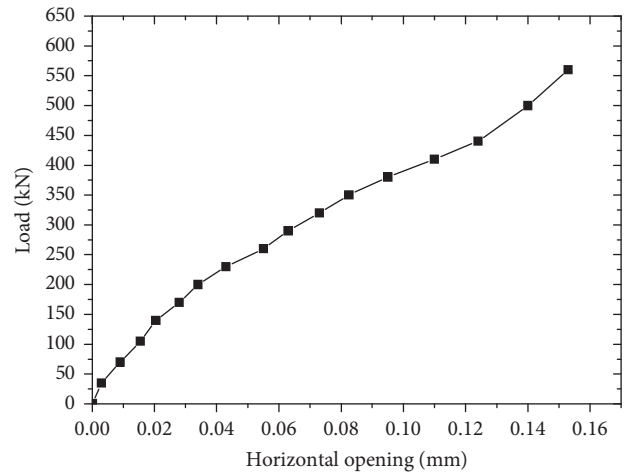
FIGURE 13: Load-horizontal opening curve at the hinge joint.

4.2. *Relative Hinge Joint Displacement.* Variations of hinge joint horizontal opening and vertical relative displacement at the L/2 section compared to load are shown in Figures 13 and 14. The diagrams show that during the entire loading process, hinge joint horizontal opening and vertical relative displacement essentially increased linearly with load. When the load reached 560 kN, the horizontal opening was 0.153 mm and the vertical relative displacement was 0.201 mm. When the test loading was completed, hinge joint fracture was not observed.

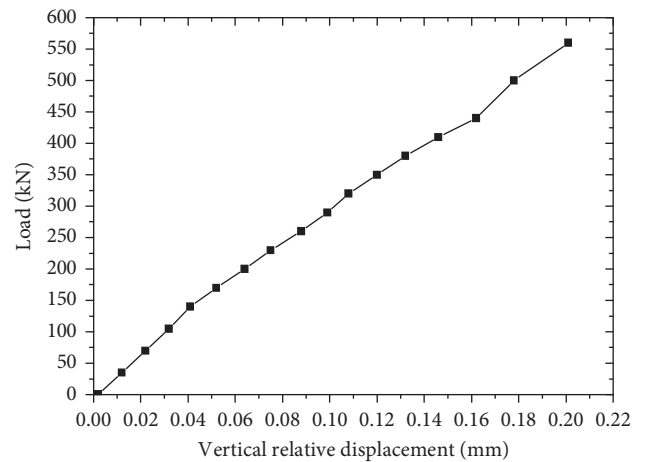
FIGURE 14: Load-vertical relative displacement curve at the hinge joint.

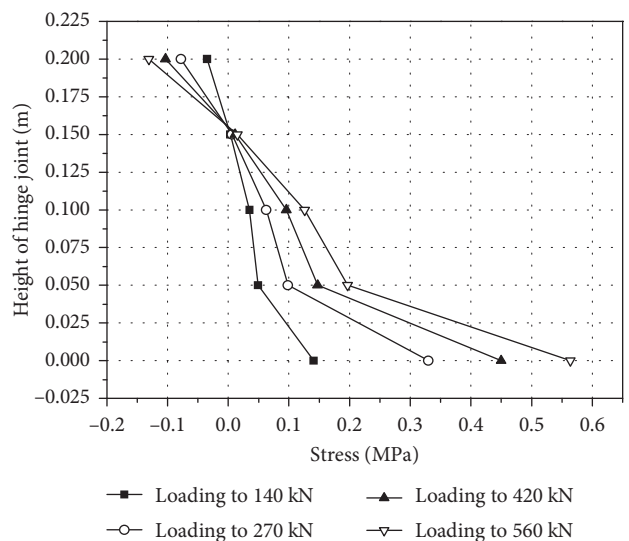
FIGURE 15: Transverse strain curves along the section height of the hinge joint.

4.3. *Stress on Hinge Joint.* Traverse stresses at strain measurement points JS1~JS5 at the midspan along the height direction of the hinge joint section are shown in Figure 15. During the entire loading process, the bottom of the hinge joint was under tension (JS1~JS4 measurement points), and the top was under compression (JS5 measurement point). As the load increased, stress at the measurement point basically changed linearly. When the load reached 560 kN, tensile stress at measurement point JS1 at the bottom of the hinge joint was 0.56 MPa.

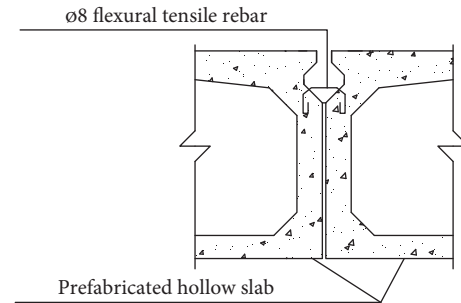
FIGURE 16: Tensile rebar of the hinge joint.

controlled by flexural tensile stress on the bonding surface. It is suggested that the tensile bearing capability of the bonding surface between the hinge joint and the hollow slab should be enhanced by some structures and reinforcement measures, as shown in Figure 16.

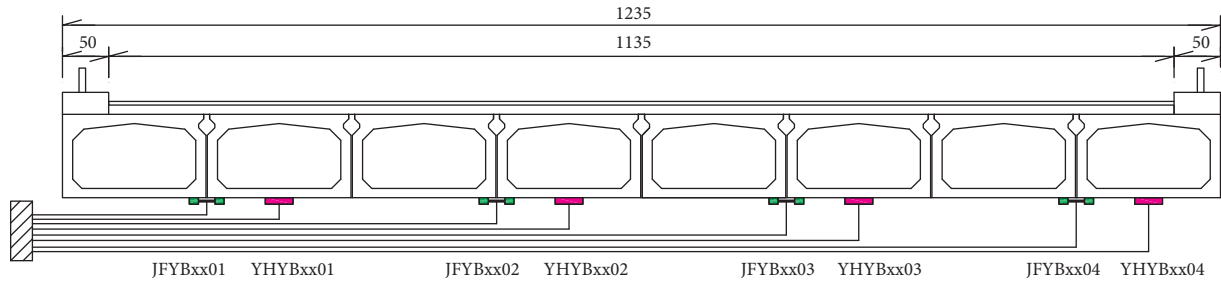
FIGURE 17: Layout of strain measurement points.

In order to verify the conclusion of test and monitor the health of hollow slab in the long term, a number of test points for the lateral strain of the hinge joint and the longitudinal strain across the middle of the hollow slab have been arranged on the real bridge recently, as shown in Figures 17 and 18. It was found that there was no disease phenomenon in the hinge joint based on the most recent monitoring data.

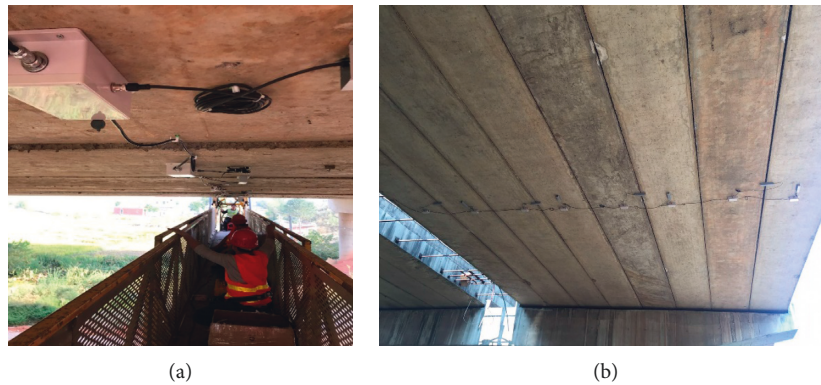
FIGURE 18: Site installation of strain measurement points.
