## Research Article

# Discrete Element Simulation of Roadway Stability in an Efflorescent Oxidation Zone

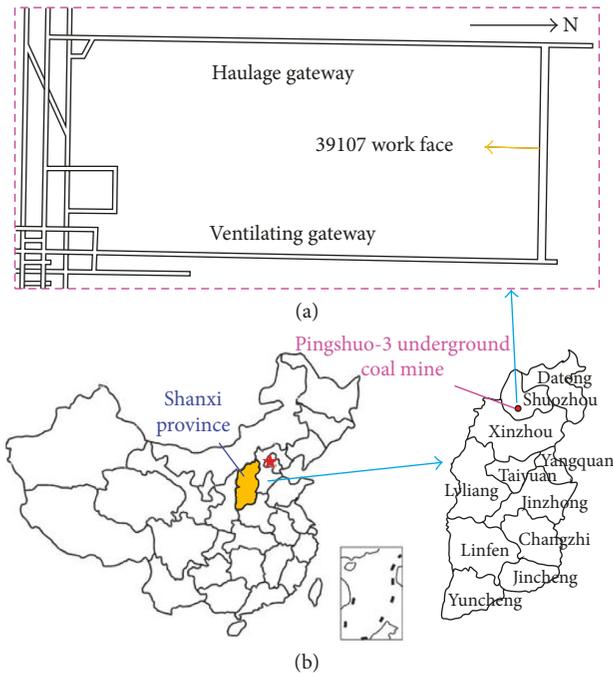
FIGURE 1: (a) Plan view of the roadway and panel of the study site and (b) location of Pingshuo-3 underground coal mine.

The number 39107 working face is located in the northern part of the east mining area, as shown in Figure 1. The thickness of the number 9 coal deposit ranges from 7 to 11 m, and the coal seam sits at an angle of 2°. This dip angle anomaly in the coal seam is the result of efflorescent oxidation and nearby faults. Hydraulic fracturing was used to test the in situ stress of the large efflorescent roadway near the number 39107 working face. Measured values of  $\sigma_{h-max}$ ,  $\sigma_{h-min}$ , and  $\sigma_v$  were 7.2 MPa, 4.3 MPa, and 5.6 MPa, respectively.

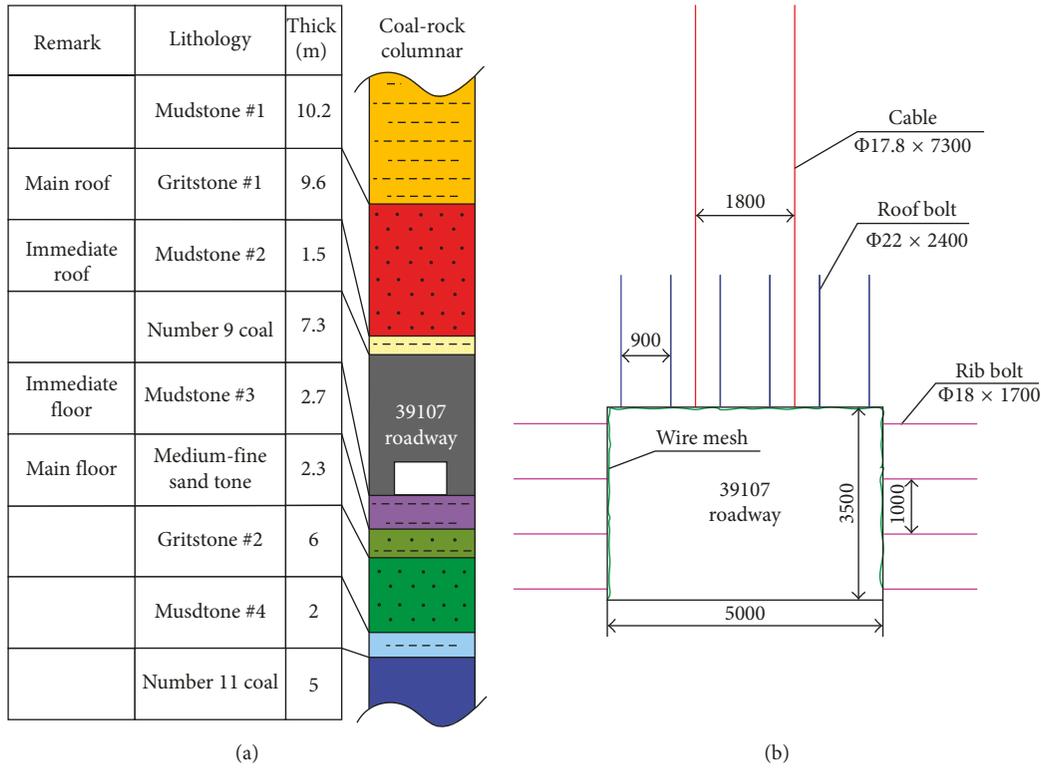
FIGURE 3: (a) Synthesis column map of the number 39107 auxiliary roadway strata and (b) corresponding support scheme.

the roadway, is still challenging to control. Material in the roadway such as these significantly affects the safety and efficiency of excavation and construction. A synthesis column map of the number 39107 roadway strata is shown in Figure 3. The lithologic characteristics of the efflorescent-oxidised rock mass are shown in Table 1.

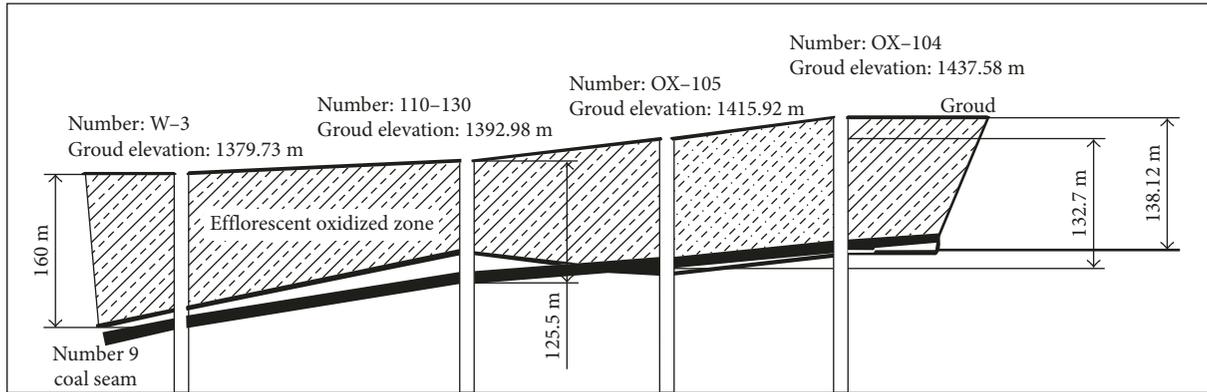
FIGURE 4: Borehole profiles.

- (1) The strata exposed by the existing boreholes in the three mine wells are shown in Table 2 and Figure 4. At depth, efflorescent oxidation of the #9 coal seam is significant, and the degree of oxidation diminishes toward the surface. The number 39107 fully mechanised coal caving face outside the mining area shows significant efflorescent oxidation, while the working face shows only local invasions of oxidation. The number 39107 auxiliary roadway is only partially in the oxidation zone and shows efflorescent oxidation from the QF9 control point to the open cut at 525 m. This area is the focus of this study.

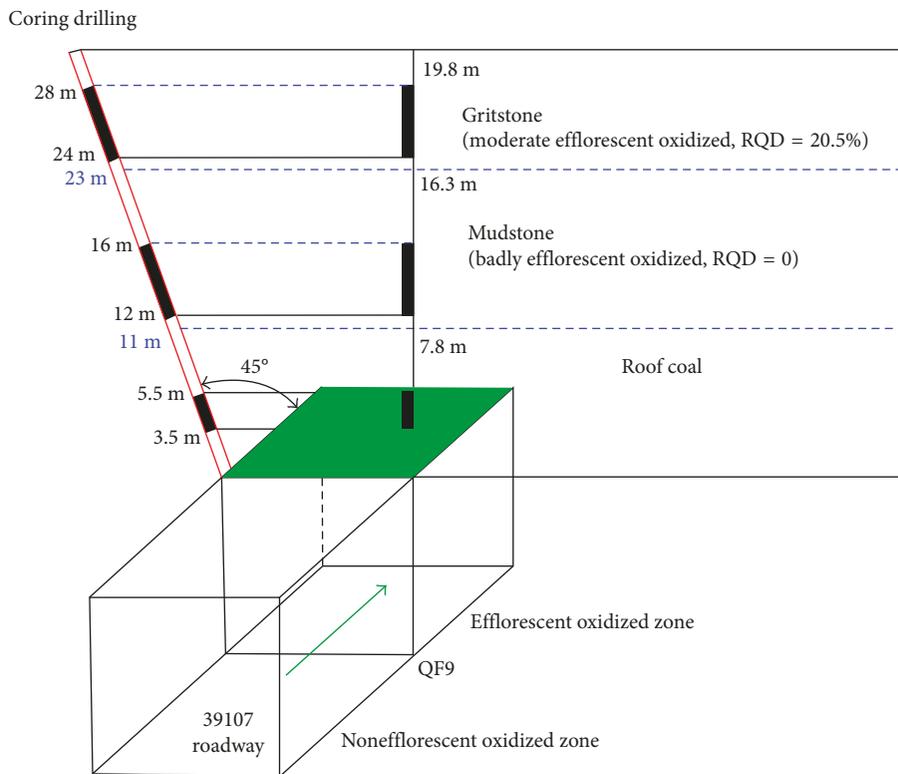
FIGURE 5: Core drilling in the number 39107 roadway roof.

- (2) The roof of the roadway in the efflorescent oxidation zone is shown in Figure 5. Weathering has removed the coal layer overlying the roadway, and the mudstone unit on the surface of the roadway has weathered to silt and clay. Drilling is challenging as the coal and mudstone units overlying the roadway are significantly oxidised, and only a few small pieces of the broken rock blocks from the column are removable. The RQD value is zero. It was originally the basic roof of medium sandstone, moderate efflorescent-oxidised weak weathering of yellow sandstone, and yellow mudstone result in an RQD value of 20.5%, but still has a certain thickness as the roof is not completely weathered away. Thus, it is very important to stabilise the rock surrounding the number 39107 roadway.

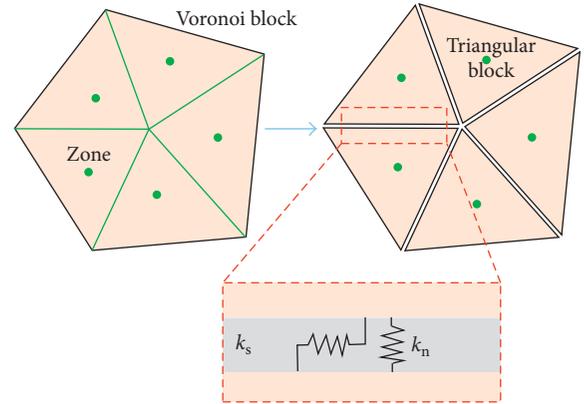
FIGURE 6: Voronoi steps of dividing blocks into triangular blocks and defining the shear and normal stiffness values between blocks.

In UDEC simulation, rock material is regarded as a large number of deformable microblocks, bound together by contacts. The average block size is selected to provide the numerical model with a sufficient number of blocks to obtain stable and repeatable results. The mechanical properties of different rocks are defined by indicating the contact parameters of single blocks and the contact parameters between blocks. The deformation characteristics of each block are represented by the bulk modulus,  $K$ , and the shear modulus,  $G$ . The deformation at block-block contacts are characterised by the contact normal stiffness,  $K_n$ , and the tangential stiffness,  $K_s$ . The contact strength is defined by the contact friction angle,  $j_k$ , the cohesion,  $C_j$ , and the tensile strength,  $j_t$ . The Voronoi block is shown in Figure 6, and the constitutive contact model is shown in Figure 7.

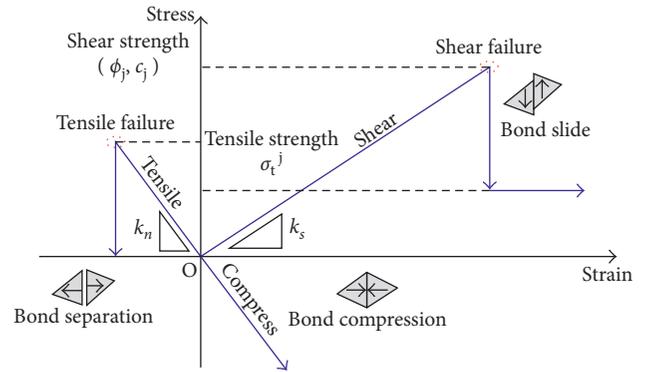
FIGURE 7: The constitutive contact model.

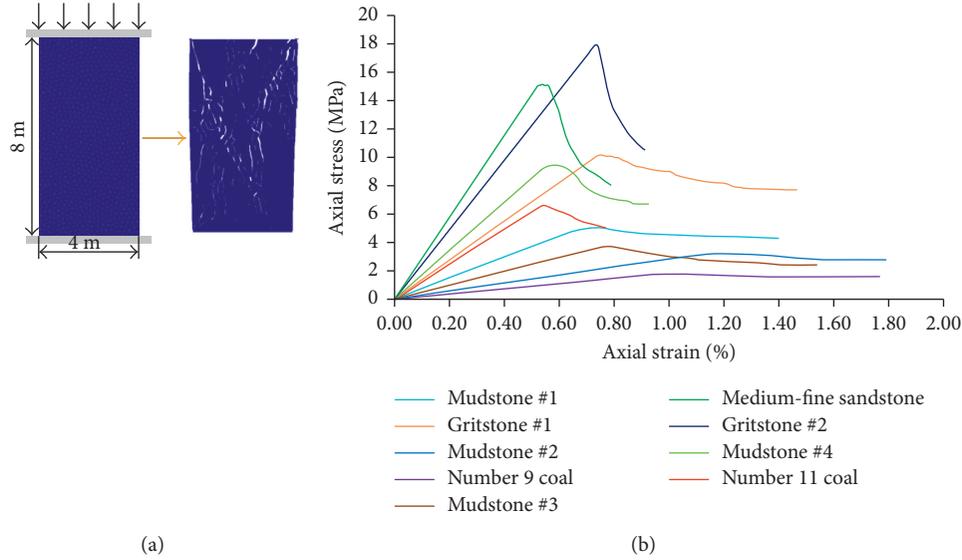
FIGURE 8: Uniaxial compression simulation tests: (a) schematic diagram and failure mode and (b) simulated stress and strain curves.

Required inputs include the microparameters of the block and the contact, which do not directly depend on the physical and mechanical characteristics of rock mass. Therefore, this study uses a uniaxial compression simulation to calibrate the microparameters through UDEC triangle blocks. The simulation and the specimen failure mode are shown in Figure 8.

We continue to simulate the microparameters (required in the final UDEC simulation) until the results agree with the rock mechanic parameters. The simulations of the stress-strain curves in the rock strata are shown in Figure 8. The calibrated parameters are shown in Table 5.

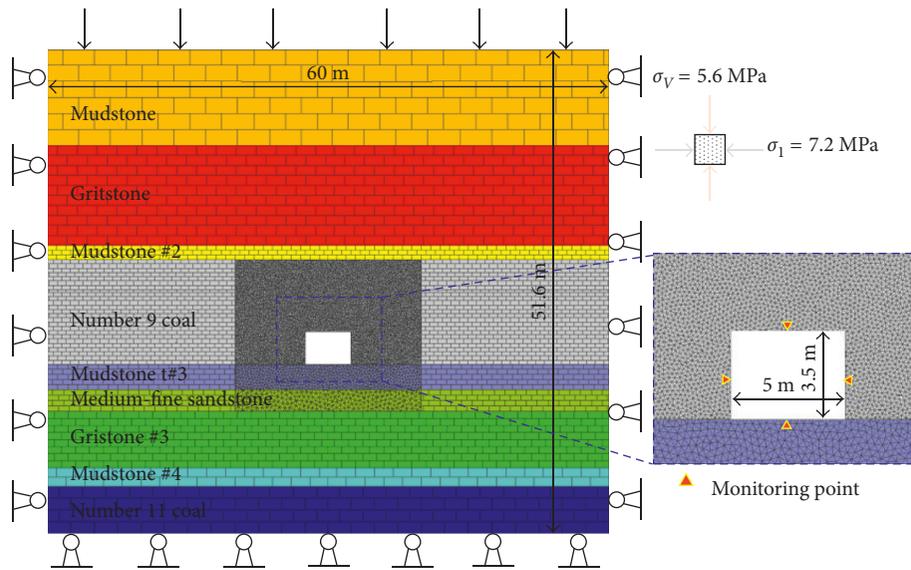
FIGURE 9: Numerical model of the number 39107 roadway.

In order to improve calculation efficiency, this paper uses the triangular block model for the roadway to simulate rock strata in other areas. In some locations, the rectangular block model is used to simulate the rock strata. In the area surrounding the coal seam, each random triangular block has a length of 0.2 m and an area of 0.017 m<sup>2</sup>. The sizes of the triangular blocks in the mudstone and medium sandstone units are 0.3 m and 0.45 m, respectively. Thus, as this model incorporates realistic field conditions, it effectively simulates the failure processes in the soft, weak, efflorescent-oxidised rocks surrounding the roadway. In order to avoid a sudden size increase of a model block, the dimensions of the rectangular block outside of the triangular block gradually increase. The modelled area is 60 m  $\times$  51.6 m and includes a total of 9014 blocks. The lateral boundary of the model is fixed in the horizontal and vertical directions. In accordance with the ground stress test results, the vertical stress is 5.6 MPa to simulate the

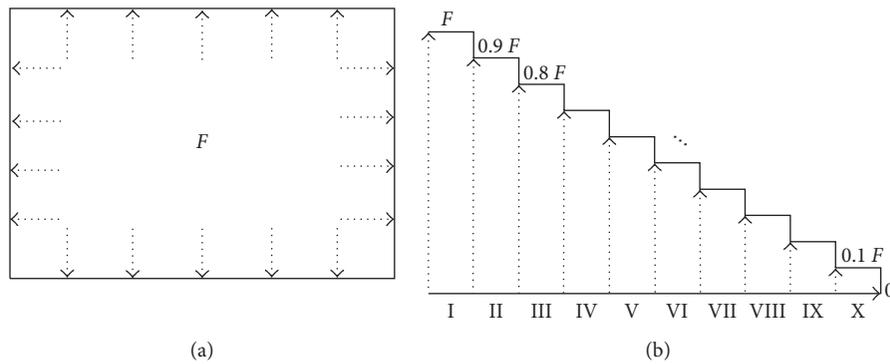
FIGURE 10: The model diagram: (a) virtual supporting force and (b) step of unloading path.

First, the model is run to equilibrium under the boundary stress conditions. Then the model eliminates a block to simulate the excavation of the roadway. As the roadway is progressively excavated by a roadway machine, there are complex temporal and spatial effects. UDEC is a 2D numerical simulation and to achieve 3D conditions, we apply a virtual force,  $F$ , on the tunnel walls. By gradually releasing the support reaction force, we can control the final convergence of tunnel wall displacement (Figure 10) [21].

Therefore, in order to realistically simulate the decreasing stress on the surrounding rock during the roadway excavation, we use UDEC embedded with a FISH function to divide the rock stress into 10 grades of attenuation, each showing a 10% decrease from the previous grade. The model runs to the programmed balancing force and then progresses to the next stress attenuation level.

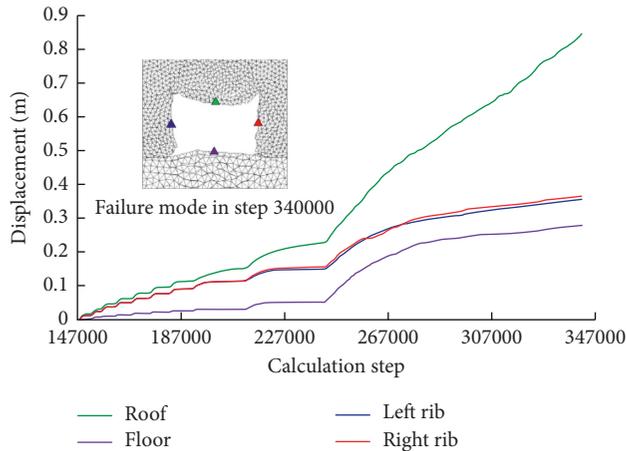
FIGURE 11: Calculated displacement at various time steps.

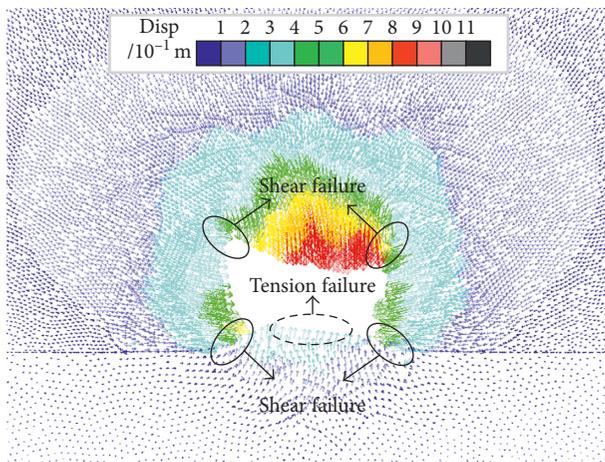
FIGURE 12: Displacement vector graph in the absence of support.

surrounding rock in Figure 12, shear failure occurs on the roadway roof, while tensile failure occurs in the floor.

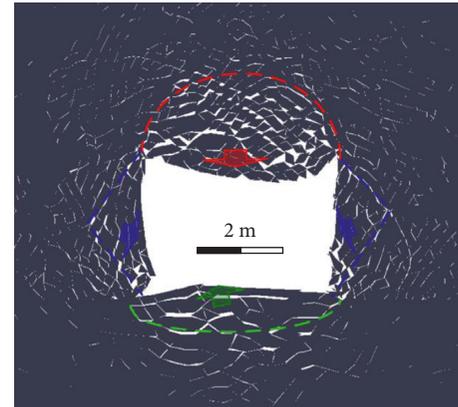
FIGURE 13: Surrounding rock damage.

The failure mode in Figure 13 shows that there is a large amount of broken rock mass observed in the roof rock and gravity will cause additional rock to fall. The two groups are the triangle and the sliding failure areas. The bottom of the surrounding rock is crowded in the wrong movement, resulting in the floor heave.

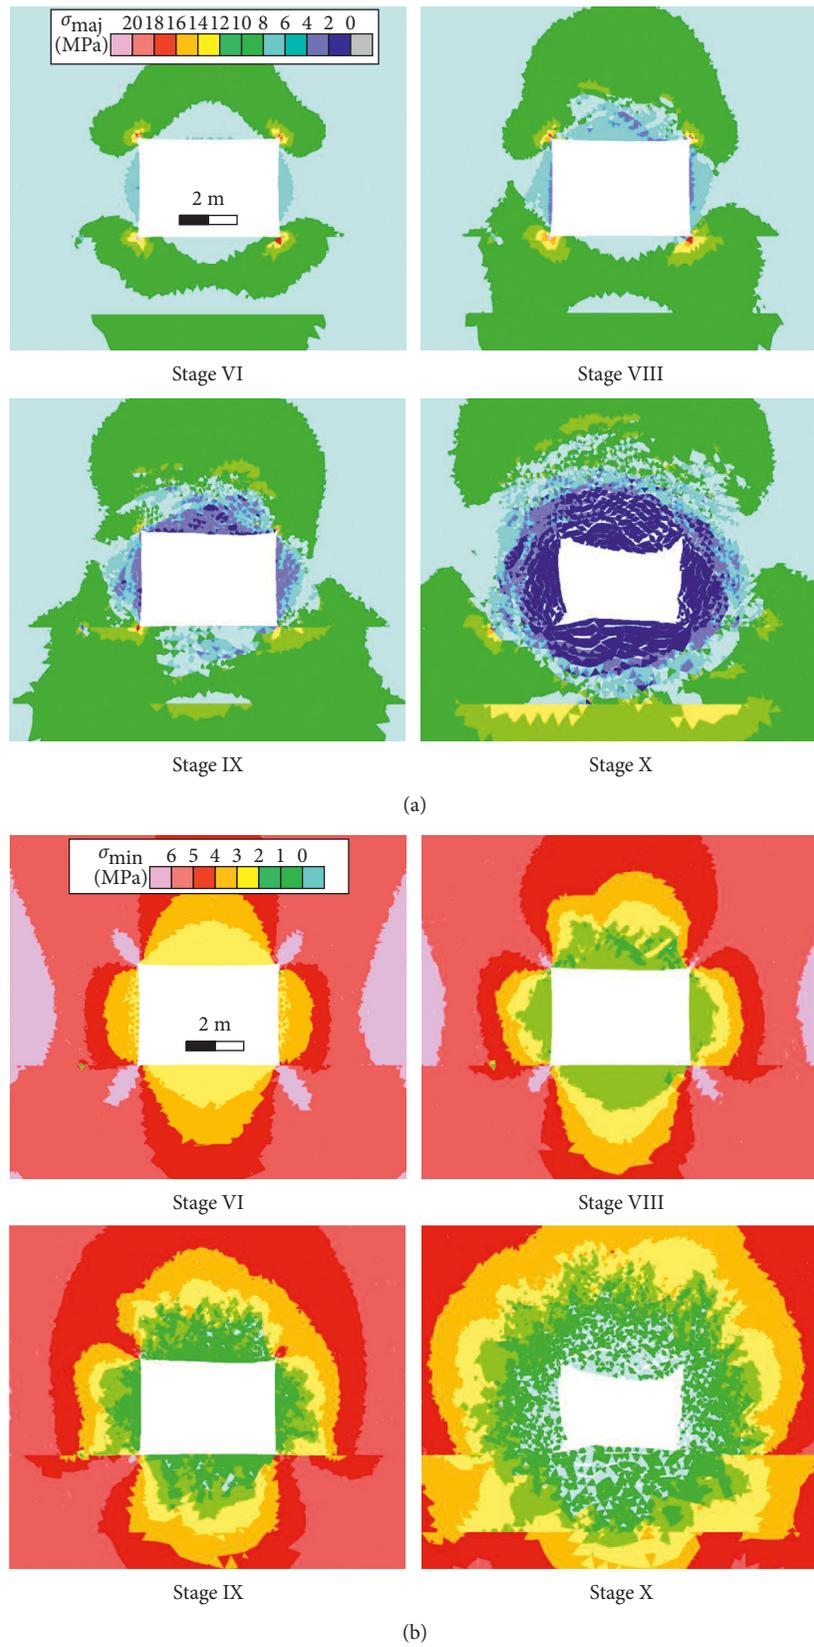
FIGURE 14: Stress evolution diagram: (a) the maximum principal stress distribution and (b) the minor principal stress distribution.

Furthermore, the maximum and minor stresses on the surface of the surrounding rock increase causing the surrounding rock stress state to rapidly deteriorate and deform (Figure 14).

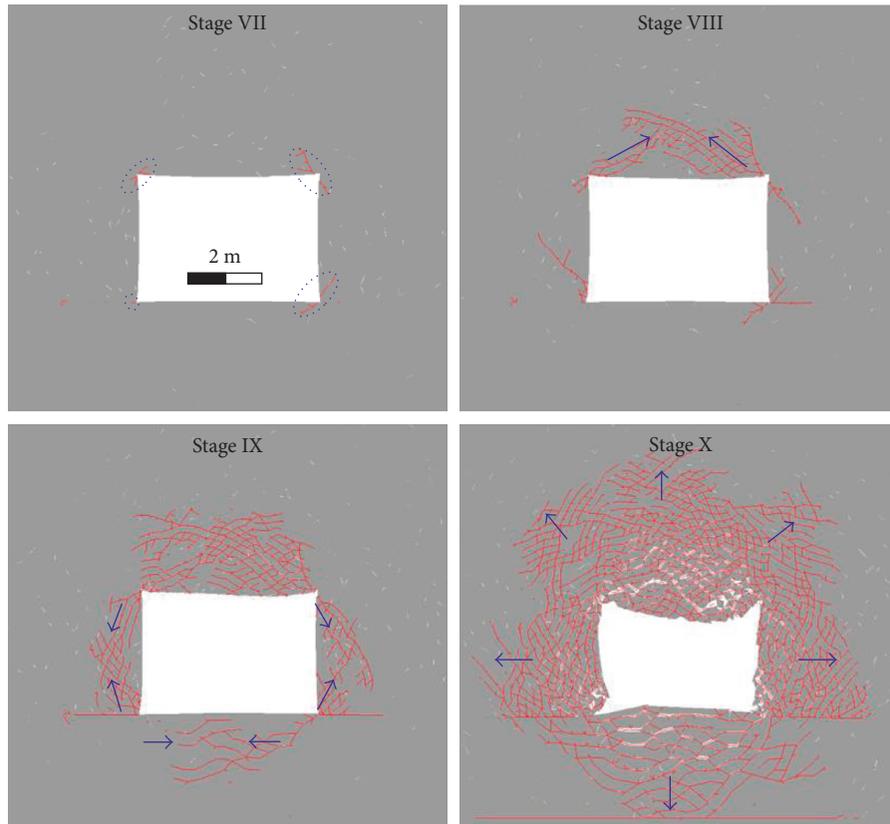
FIGURE 15: Process of crack evolution.

**4.4.3. Crack Propagation in the Surrounding Rock.** After roadway excavation, the stress in the surrounding rock gradually decreases and concentrates in the roadway corners. Thus, the four corners of the roadway achieve the first fracture failures due to high compressive stresses.

As stress continues to release into the VIII stage, shear failure occurs due to gravitational and horizontal stresses on the middle roof section of the tunnel. A large number of roof cracks appear and extend from the two corners of the roadway to form an arch-like fracture surface. When the stress is released in the IX stage, there is a considerable overburden gravity transfer from the roof to these two crack zones due to roof damage. Under the vertical and horizontal

stresses, these two crack zones extend along the roadway and eventually intersect. While the roof cracks develop, stress cracks expand and penetrate to the middle section of the floor. When the stress is released, roadway width increases due to the propagation of the two crack zones and a negative feedback loop [22] that leads to cracks penetrating deeper into the surrounding rock (Figure 15).

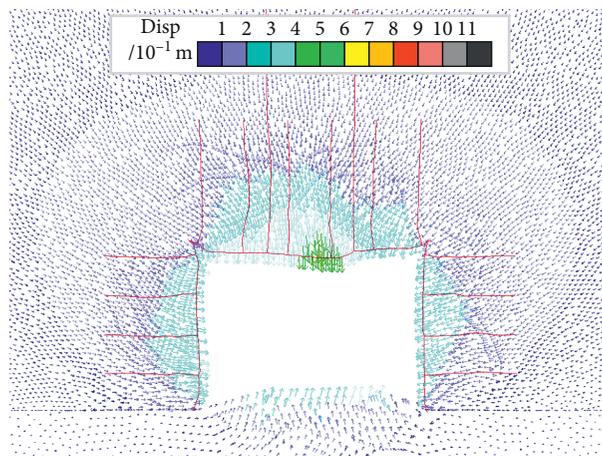
FIGURE 16: Displacement vector of the surrounding rock after added support.

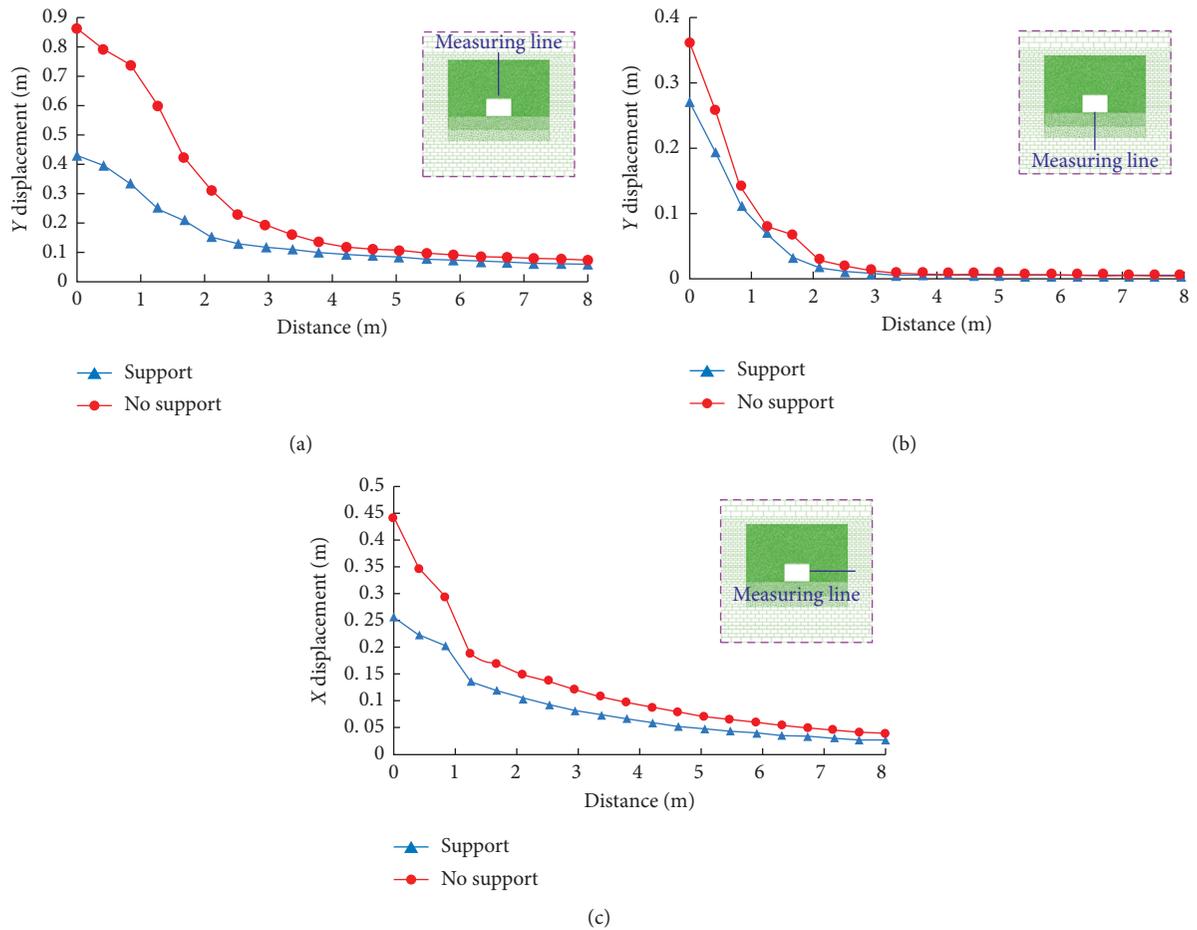
FIGURE 17: Displacement control of the surrounding rock: (a) vertical roof displacement, (b) vertical floor displacement, and (c) horizontal displacement of the right rib.

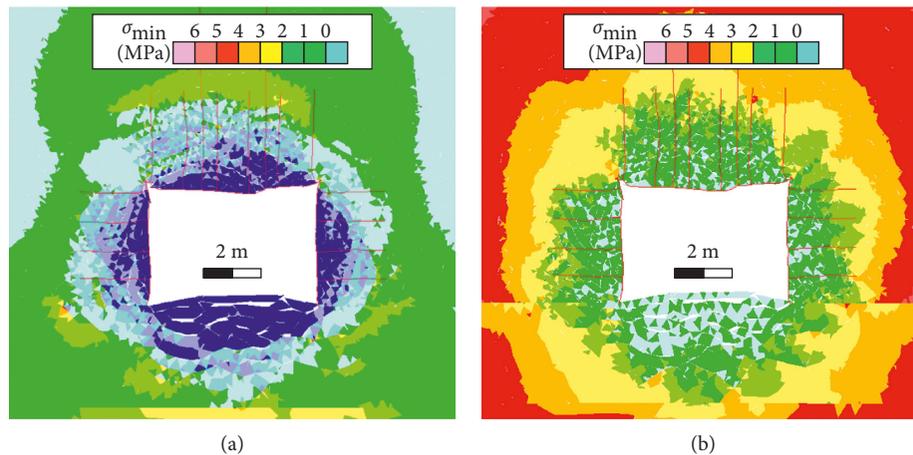
FIGURE 18: Stress distribution after added support: (a) the maximum principal stress distribution and (b) the minor principal stress distribution.

The added support results in no change in the distribution of the main stresses. According to the principal stress analysis, the added support reduces the stress relaxation zone on the roof and two side ribs and improves the stress state of the surrounding rock. However, without added support, horizontal pressure on the roadway floor results in a high tensile stress and the occurrence of a heave phenomenon (Figure 18).

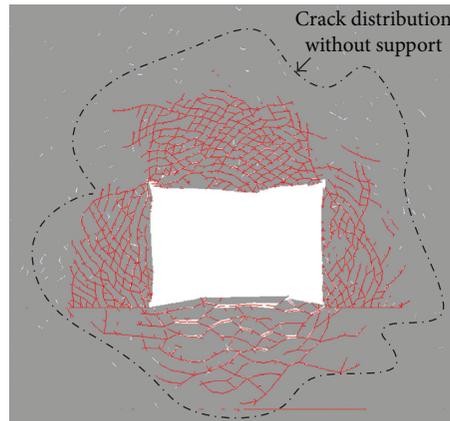
FIGURE 19: Comparison of crack distribution characteristics.

Figure 19 shows the comparison of crack distribution characteristics, with the blue line indicating the dimensions

of the crack in the absence of support. This comparison shows that roof crack propagation depth is greatly reduced by the added support. This is particularly true in the upper corner cracks, indicating that the roof and the two side ribs maintain their stability. However, the degree of fracturing in

the floor does not show significant improvement with added support.

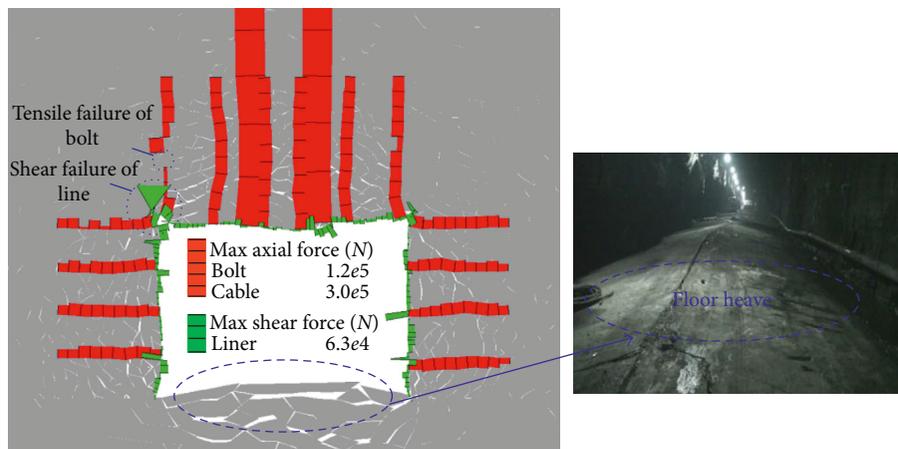
FIGURE 20: Supporting body stress state and floor heave simulation results compared to field tests.

In Figure 20, the red represents the axial force of the anchor and anchor cable, and the green represents the shear stress of the steel strip. The surrounding rock is affected by

roof subsidence and the influence of the two groups. There is a large extrusion deformation failure, resulting in the left corner of the steel strip shear failure that occurs near the corner of the top bolt pull failure. Thus, the stress state of the surrounding rock is not conducive to stability, and measures should be taken to improve the support scheme. In the simulation, floor heave also occurs and is consistent with field observations (Figure 20).
