Stability of Close Chambers Surrounding Rock in Deep and Comprehensive Control Technology

2. Project Overview and the Original Design Support Program

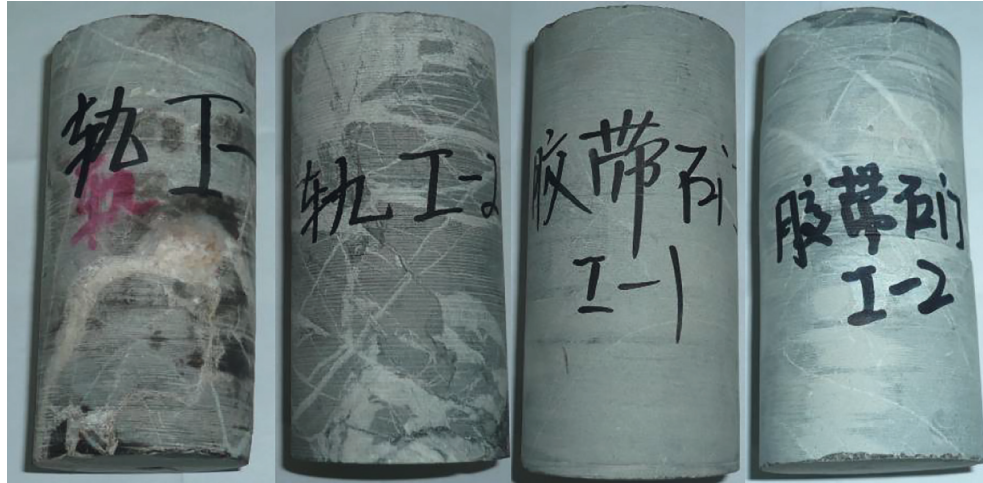
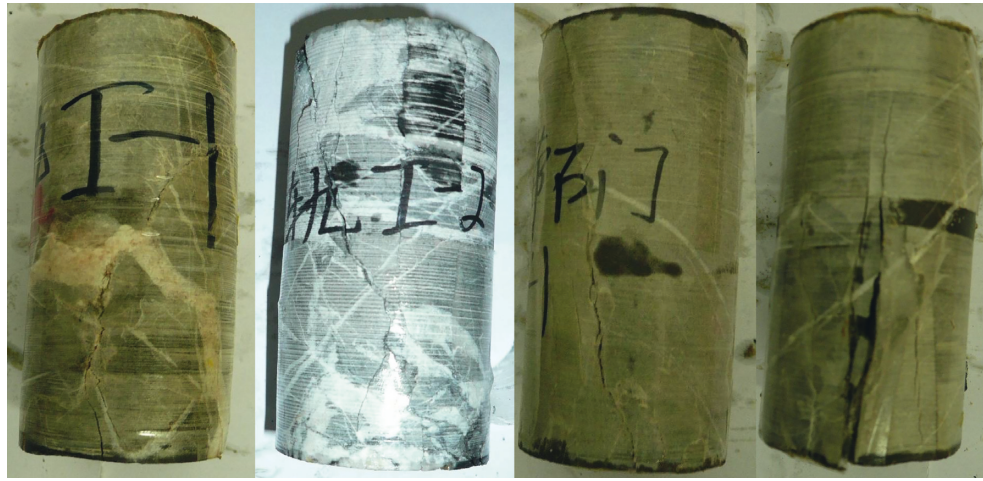
FIGURE 2: Uniaxial test failure results of some rock specimens: (a) rock samples before destruction; (b) damaged rock sample.

difference between the failure law of the secondary fracture and primary fissure because of the similar degree of rock failure (as shown in Figure 2(b)). The test results showed that the mechanical properties of the rock were significantly different. It indicates that the rock mass was greatly affected by the structural plane. That is, the different degrees of crack development result in inconsistent mechanical strength of the rock mass in the same roadway.

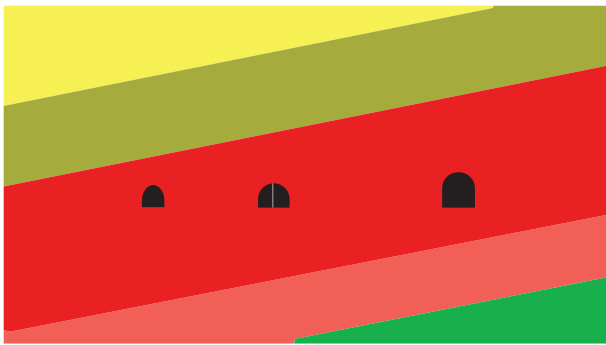
FIGURE 3: Numerical calculation model of the chamber surrounding rock.

load was applied by the overlying strata thickness. The lower boundary was 920 m above the surface, and the vertical stress of 21.75 MPa was applied on the upper boundary. The Mohr–Coulomb criterion was used in the failure process. The rock formations and the mechanical parameters of the rock strata are shown in Figure 3 and Table 2, respectively.

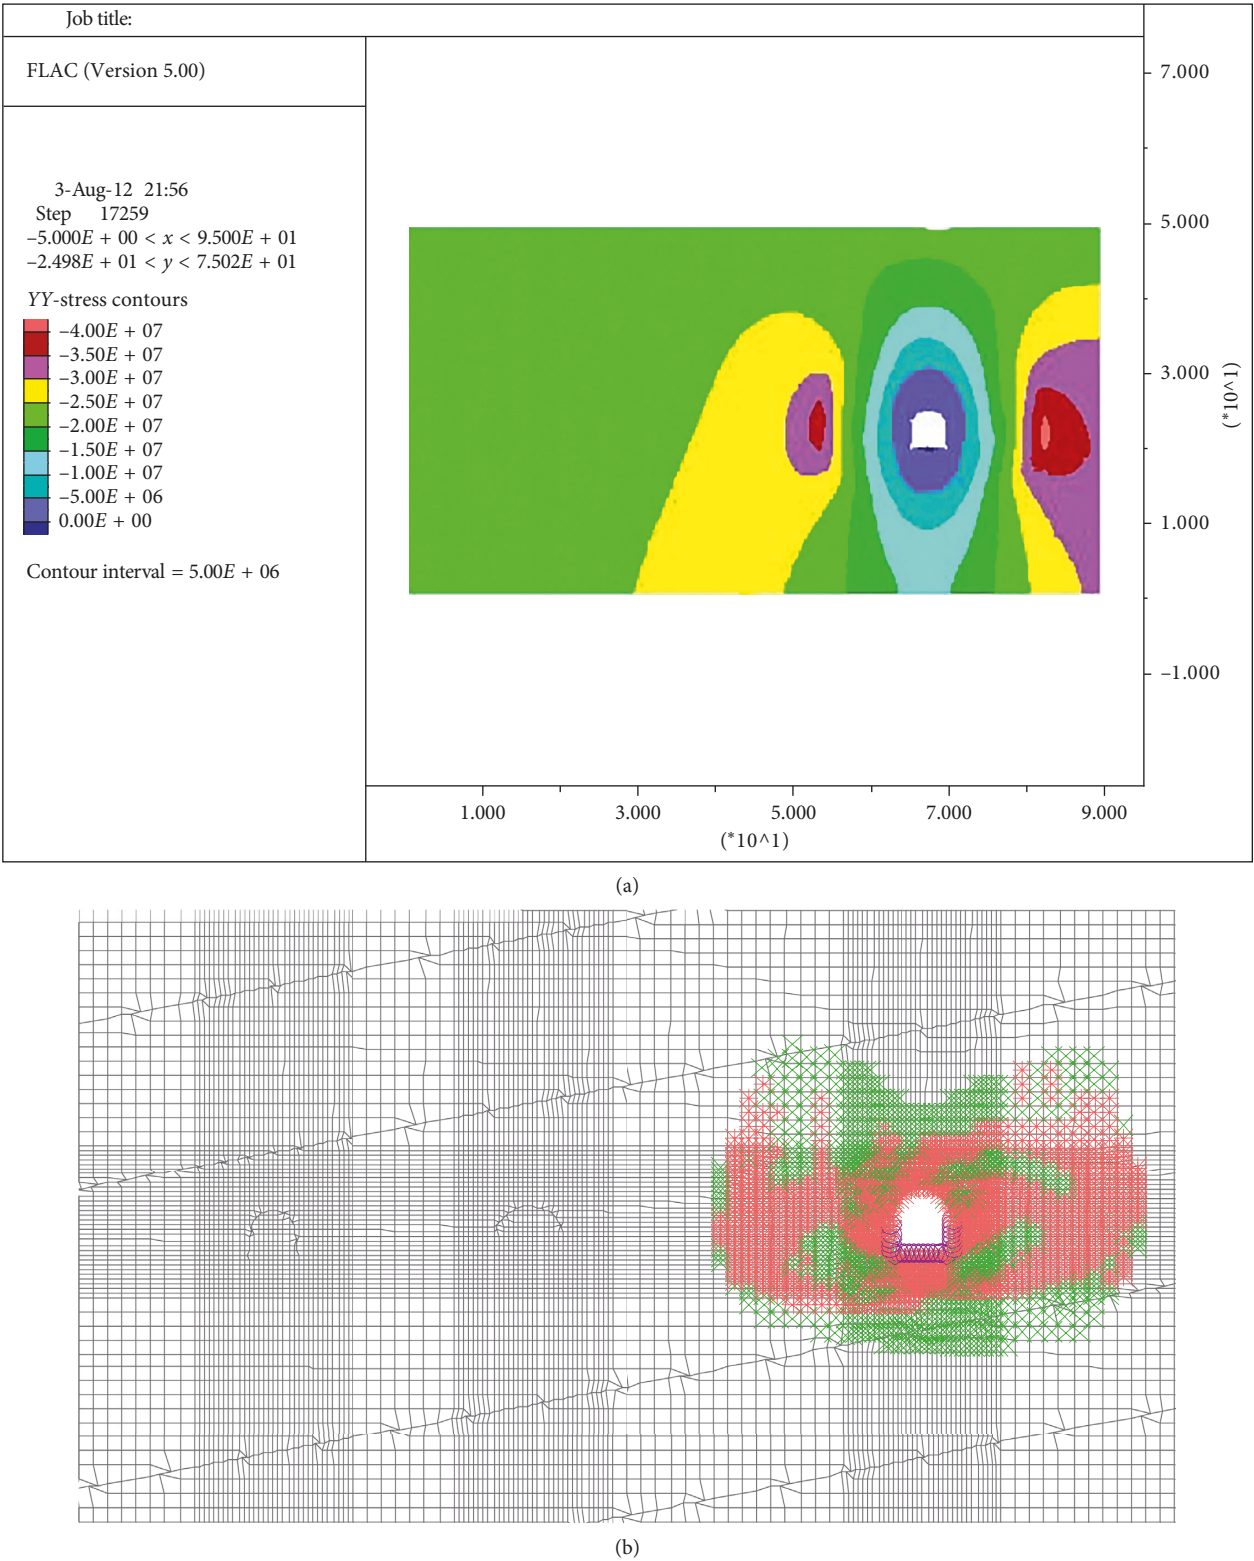
FIGURE 5: Calculation results when the excavation of the water pump house alone is done: (a) vertical stress of surrounding rock; (b) plastic zone of surrounding rock.

excavating waiting room, main haulageway, and water pump house at the same time was carried out, respectively, and the results are shown in Table 3. The vertical stress and the plastic zone of surrounding rock during the excavation of the water pump chamber are shown in Figures 5(a) and 5(b), and the vertical stress and the plastic zone of surrounding rock during the excavation of the water pump house and main haulageway are shown in Figures 6(a) and 6(b), respectively.

In contrast, the deformation of the sides and roof-floor was relatively small when the excavation of the water pump house alone is considered. The stress distribution changed while the water pump house and main haulageway are excavated at the same time. Especially, the stress redistribution of surrounding rock was caused by the excavation of the main haulageway, and a higher degree of the stress concentration was reached, by which the convergence of the sides and roof-floor significantly increased and the interaction between excavations of adjacent chambers was relatively intense.

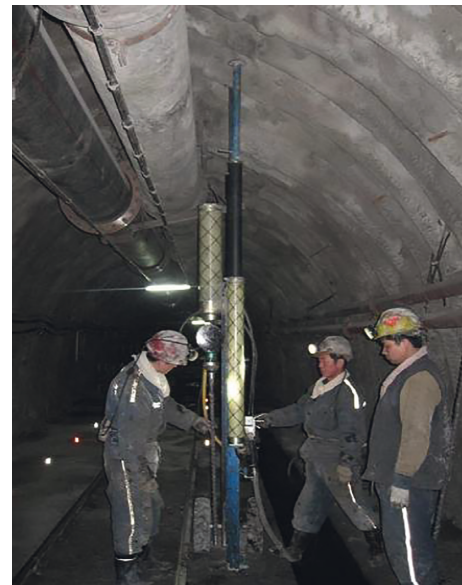
FIGURE 9: Anchor cable rig dedicated by the floor.

The construction technology of combined grouting anchor mainly composed of assembling, drilling, grouting, and prestressing processes. The equipment of special floor anchor cable drill was applied into the combined anchor of the floor. There are several examples of successful applications in China at present; for example, the pneumatic frame column Type Anchor Cable drill for ZQJ-300 was constructed into holes effectively (Figure 9). This equipment can drill and construct the floor anchor and anchor hole in the soft rock roadway, avoiding the phenomenon that collapse, stuck, break the bar, and so on because the deep gravel cannot be eliminated. For the floor drilling, the construction quality was improved, the hole formation rate was increased, the drilling depth was extended, and construction time was shortened, and thus a lot of costs for mine roadway construction were saved.

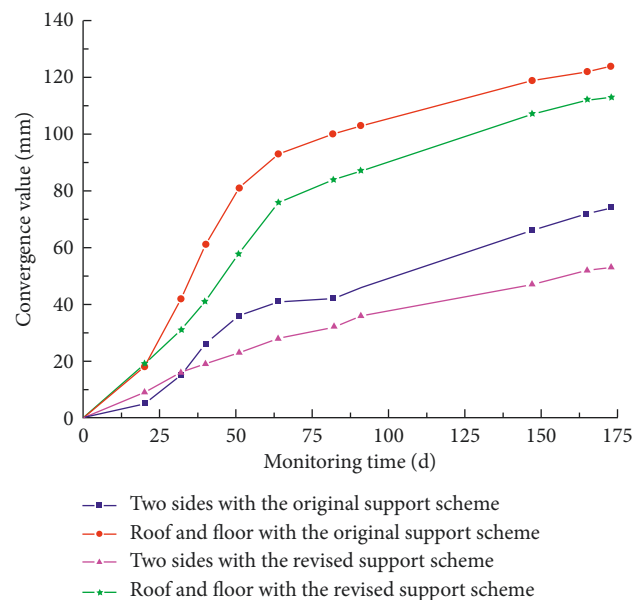
FIGURE 15: Comparison curve of deformation monitoring.

Whether it was the roof-floor or sides, the loosening range was smaller significantly (Figure 15). Also, the support of bolt, anchor cable, and grouting were strengthened, and the anchor cable was anchored in a stable fine sand stratum with the deformation of surrounding rock. The large deformation and the extending range of loose rock were resisted effectively, so that the stress release of rock mass was significantly reduced. Therefore, it can be seen from the stress distribution situation (as shown in Figure 16) that the horizontal stress and vertical stress were less than 7.5 MPa and 15 MPa, respectively. That is, the surrounding rock area at the lower stress level was less than 0.5 times roadway size range, especially the vertical stress at a low level of surrounding rock. However, the deformation of the roadway has been restrained, and the stress around the roadway has concentrated due to the full exertion of the tensile and reinforcement effects of the anchorage cable. The plastic area under strengthening support is shown in Figure 17, and the yield area and destruction range of surrounding rock was reduced, within the control range.

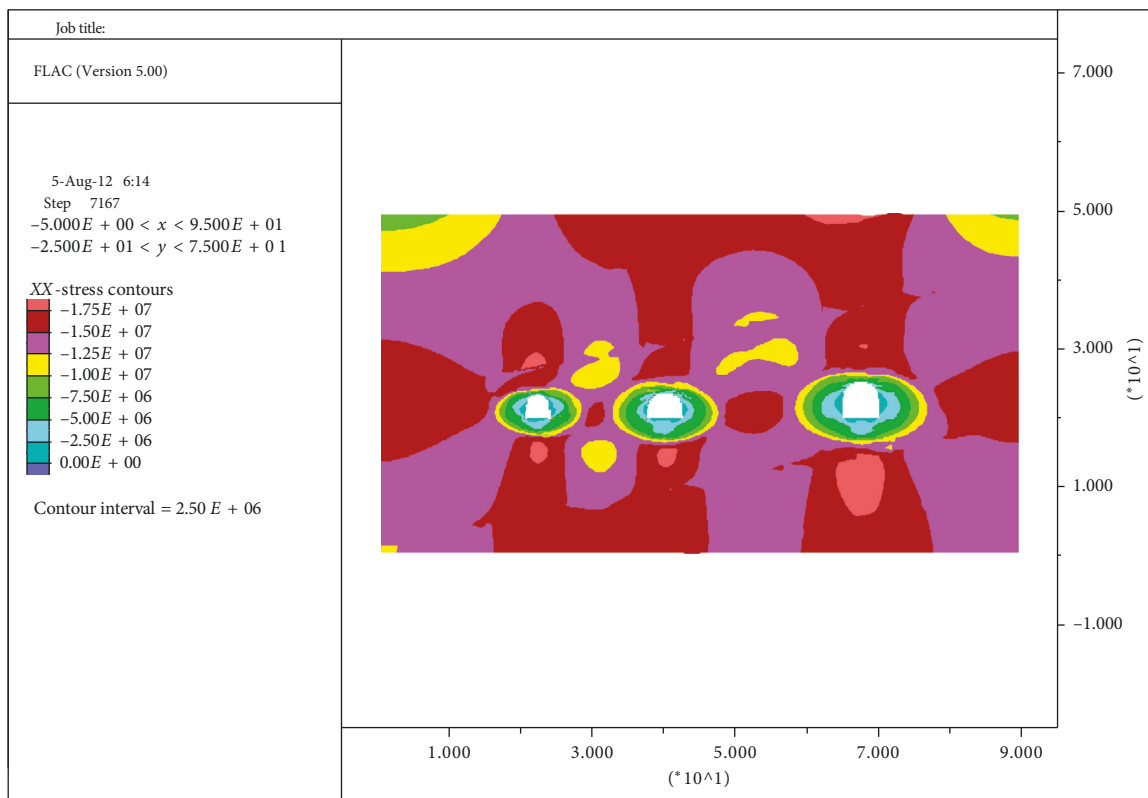
FIGURE 16: Surrounding rock stress distribution of each repaired chamber. (a) Vertical stress field. (b) Horizontal stress field.

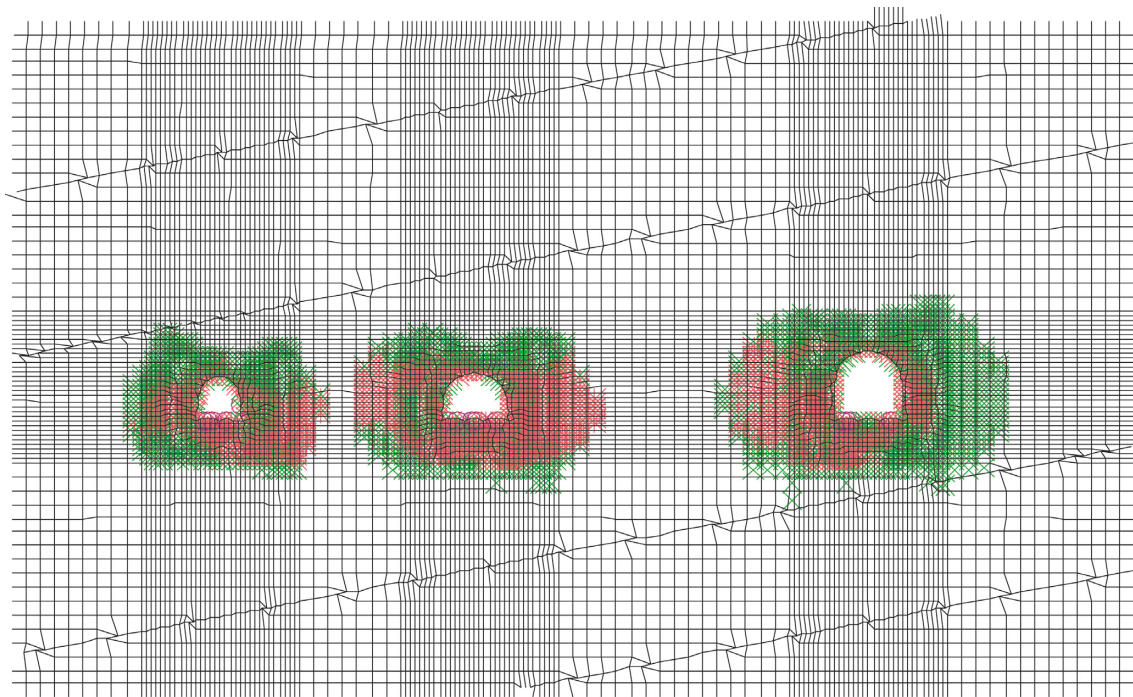
FIGURE 17: Plastic regions of each repaired chamber.

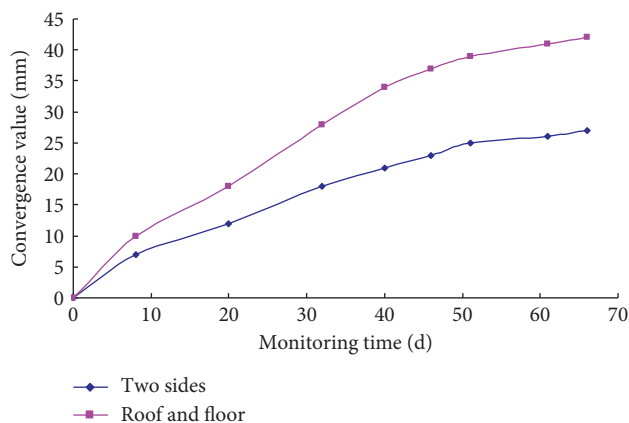
FIGURE 18: Monitoring curve of the surrounding rock in the chamber of the water pump house.

6.2. Field Monitoring. The deformation of roadway was observed by the interior extrapolation method, and the monitoring curve is shown in Figure 18. After 66 days of monitoring, the average convergence of surrounding rock in sides of the chamber and the average movement of the roof-floor were 27 mm and 42 mm, respectively. The results showed that the modified deformation value of supporting surrounding rock was within the controllable range, all deformations were tended to stabilize at the later stage of monitoring, and the convergence rate was less than 0.2 mm/d. Therefore, the comprehensive control method of the anchor, metal mesh, grouting, combined anchor, and large diameter anchor has dramatically suppressed the rock deformation of the chamber and roadway, and the deformation of the floor heaving was well controlled by the technology of the floor anchor combined with cable support and grouting.
