Research Article

Analyses of Archival Cartographic Materials for Geomorphological Changes of River Channel

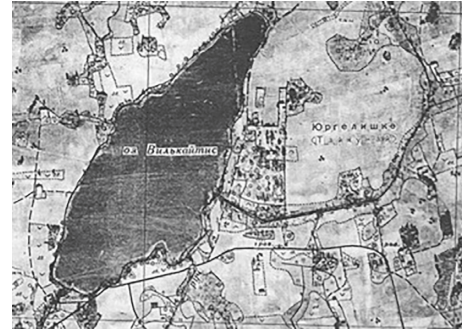
FIGURE 1: Fragment of the contour photo plan N-34-72-G-b-1 of 1953 made on the basis of the flight of 1946 (source: the Lithuanian State Land Fund archive).

2.1. The Archival Cartographic Materials in Lithuania. In order to record the condition of objects and to monitor the geometric changes, it is proposed to use the following archival cartographic material data sources: contour photo plan or geographic location of different period, scale 1:10,000 (archive of the Lithuanian state company Land Fund); topographic maps of different periods of the geographic location of the scale 1:25,000 or 1:50,000 (Land Information System (LIS)) data from on-line (<http://www.geoportal.lt>) [22]; and land management projects of location of different periods (LIS data). The Lithuanian State Land Fund archive keeps aerial photographs compiled for the country's mapping, based on the flight details of Soviet military aviators in 1945–1948 and in 1951–1952, and contour photo plans on a scale of 1:10,000 drafted from them. During the period 1945–1948, photographs of locations were made using a camera with a lens of focal length of 154 mm. Format of aerial reverse photographs is 23 × 23 cm. The scale of aerial photographs depended on the flight altitude of the aircraft and ranged from 1:18,500 to 1:22,000 (Figure 1) [23].

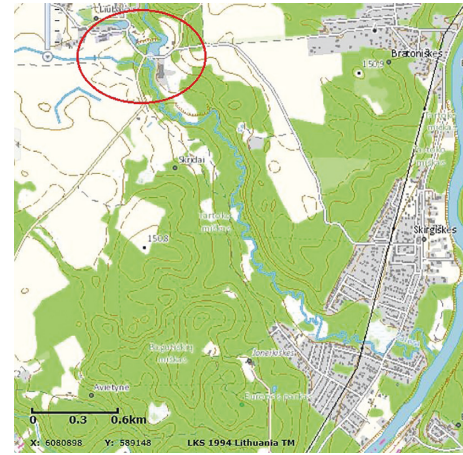
FIGURE 2: River Žalesa (the mill-museum in the red circle) (source: <http://www.geoportal.lt>).

2.2. Experimental Object. The water source of state significance—River Žalesa in Vilnius (capital of Lithuania) district—is analysed. The river belongs to the basin of small tributaries of the river Neris (the Neris). This river has historical significance. In old Baltic and Slavic word outlook, river took a really important place, along the shores; until now, there are left a lot of burial places, barrows, sacred oak woods, and mythological stones. In the Neris river landscape developed the state of Lithuania. It is known that in the Middle ages existed the land of Neris. Next to Neris, there is the mountain of Gediminas and the Vilnius castle location. The river Žalesa is the right inflow of the river Neris. The length of the river Žalesa is 18.8 km, and the catchment area is 9.2 hectares. Also, the river flows from the northern Gulf of Lake Žalesas (Pikeliškiai) (Figure 2).

The separable river channel leads to Liubavas Manor mill, which was first mentioned in 1727, rebuilt in 1902, and refurbished by establishing the museum in 2011 (Figures 2 and 3).

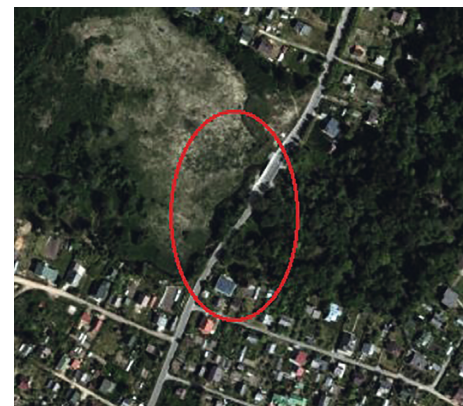
FIGURE 4: Analysed river section in the digital raster orthophotographic map (source: <http://www.geoportal.lt>).

Because the length of the river is 18.8 kilometres and watershed area is 97.1 square kilometres, only part of the river in the village of Skirgiškiai will be studied. The length of the analysed river section is about 250 metres. The analysed part of the river is parallel to the asphalt road (Bagutiškių street) (Figure 4).

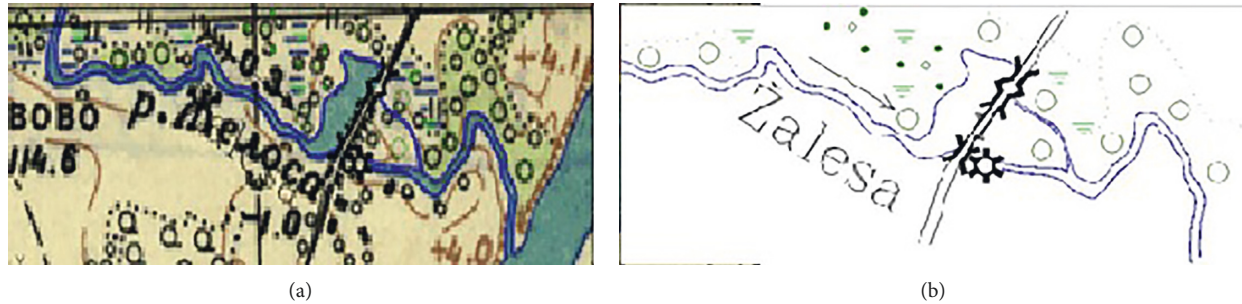
FIGURE 5: Digitized section of River Žalesa is represented in the topographic map of 1950 (source: <http://www.geoportal.lt> and authors' digitalization).

To monitor the geomorphological changes of the water shore, digitization of the part of the river channel in the topographic maps was performed using the GeoMap software. Digitization results are presented in Figures 5–8. In Figures 5–7, we have seen that the river configuration remained almost unchanged from 1950 to 1972. Larger changes were observed in the mapping data of 1986 (Figure 8).

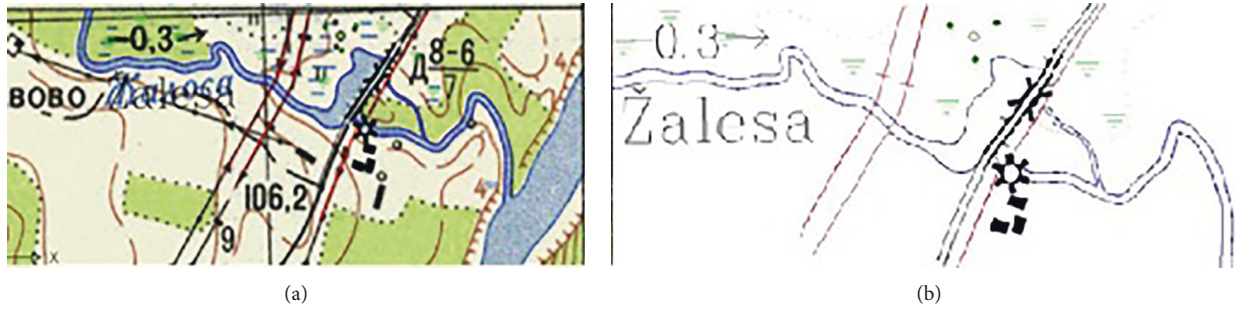
FIGURE 6: Digitized section of River Žalesa is represented in the topographic map of 1966 (source: <http://www.geoportal.lt> and authors' digitalization).

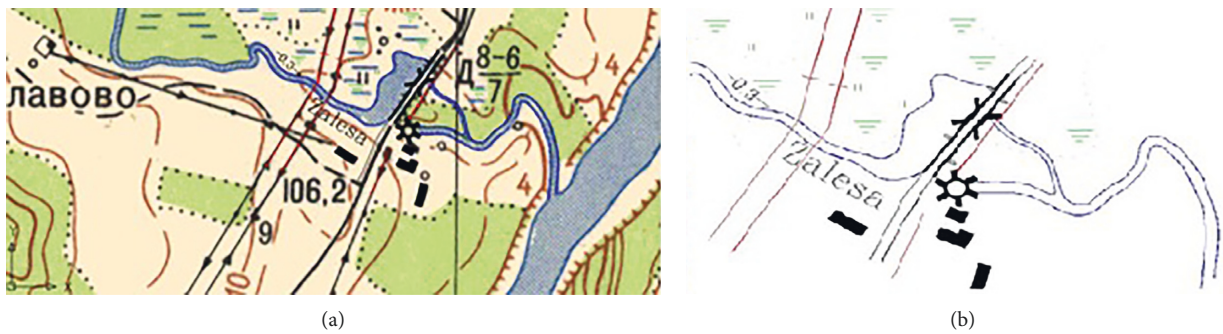
FIGURE 7: Digitized section of River Žalesa is represented in the topographic map of 1972 (source: <http://www.geoportal.lt> and authors' digitalization).

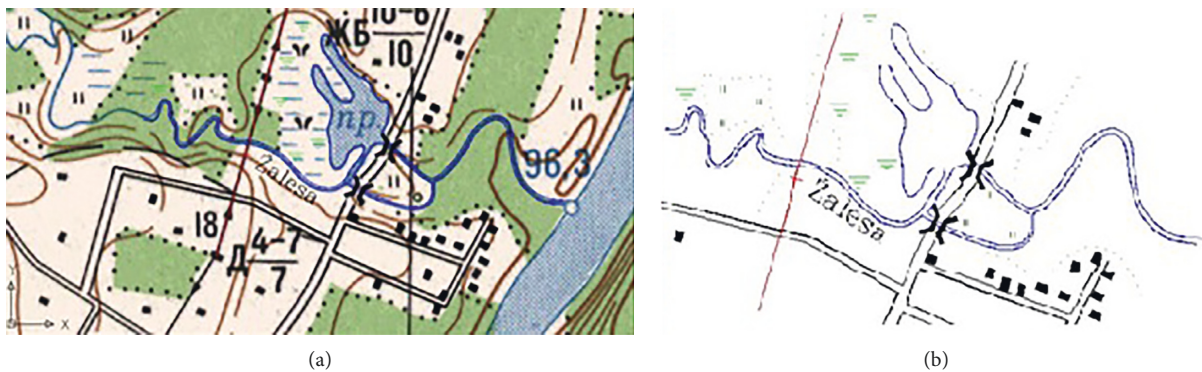
FIGURE 8: Digitized section of River Žalesa is represented in the topographic map of 1986 (source: <http://www.geoportal.lt>).

The river sections presented in the map of 1986 have completely changed (100%) by both the river channel curves and the width (Figure 8). The river channel is narrowing and is marked with a single line, while according to the requirements of topographical maps, one line indicates a river no wider than five metres. Also, throughout the period in question the dimensions, shape, and area of the river pond are changed (section 3 of the river channel (Figure 9; Table 1)). Points of 1 and 4–6 sections of the river channel are shown (Figure 9; Table 1). In the topographic maps of 1950 and 1986 years, there was established x, y coordinates (in the coordinate system LKS-94). The calculated coordinate changes are in Table 2. The section points of coordinate changes in x -axis range from -19 to -105 metres and in y -axis from -9 to -73 metres. It can be stated that such a geometric change in the river channel was due to extensive human activity, for large areas of ameliorated land, construction of residential buildings, new roads, farming, and forests not felled at the river (Figure 10) [27]. Archival cartographic material shows that within thirty-six years, the number of residential houses around the river grew, forest areas expanded, and new roads were built (1986). The topographic plan of 2011 shows a newly built culvert under the road and the bridge over the wider river channel. The landscape has undergone major changes that, over time, may become irreversible [5]. The high urbanization rate stimulates renaturalization acting, in the opposite direction. A comparison of the details of digital raster orthophoto maps of 1995–2013 shows no big changes in the river channel, but the drying swamp is perfectly visible (Figure 11). The orthophoto maps of 2005 does not show the pond presented on the topographic map of 1986. The orthophoto maps of

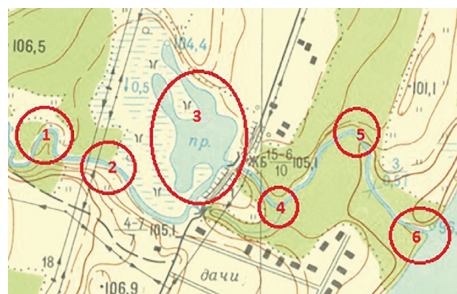
FIGURE 9: Section of River Žalesa is measured in the topographic maps (source: 1984 year topographic map. <https://www.geoportal.lt/geoportal>).

To accurately assess the geomorphologic changes of the river banks, six sections of the river channel of the basin were chosen, marked in the topographic map, and analysed (Figure 9):

- (i) River bend (set bend point coordinate) (sections 1 and 5 in the river channel)

- (ii) The river channel towards the resulting water body (set width of the river channel) (section 2 in the river channel)
- (iii) Border that deformed from the river (set body area) (section 3 in the river channel)
- (iv) Merger of the river branches (set point coordinate) (section 4 in the river channel)
- (v) Estuary (set point coordinate) (section 6 in the river channel).

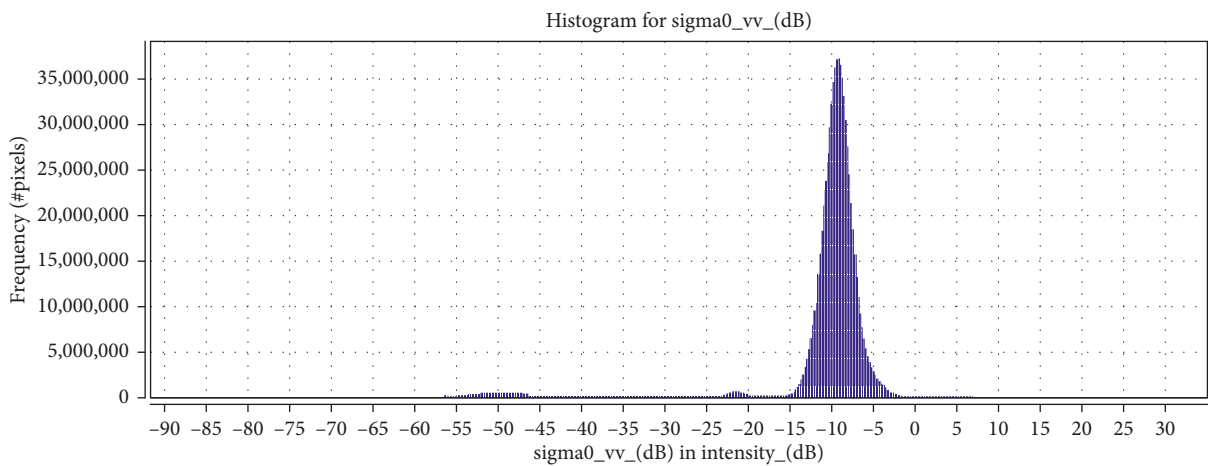
FIGURE 12: Computing histogram (source: authors).

The polarization histogram band-VV is computed into the decibel units. The results are presented in Figure 12.

Low pixels number shows that the surface is of low reflectivity (-15 db). We created water body information placing it into the new math band <-15 db. The information about the river channel with width more than 20 m is shown in the Figure 13. Because of low resolution of satellite data, the water source of River Žalesa is not visible in Figure 13(b).

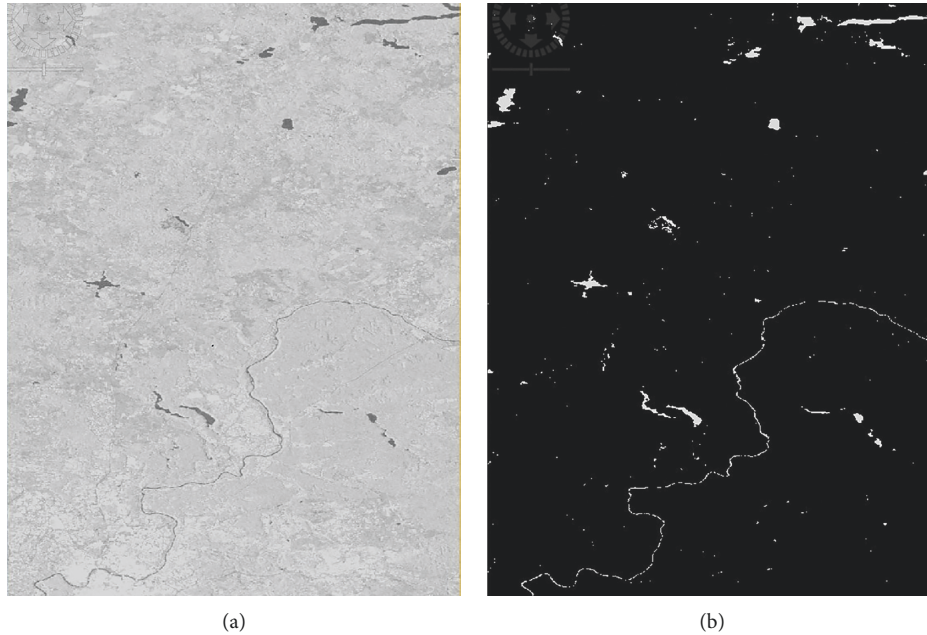
FIGURE 13: The river channel in the satellite data: (a) band-VV polarization data and (b) new river channel math band (source: authors).
