## Research Article

# Experimental Study on Flexural Behavior of Prestressed Concrete Beams Reinforced by CFRP under Chloride Environment

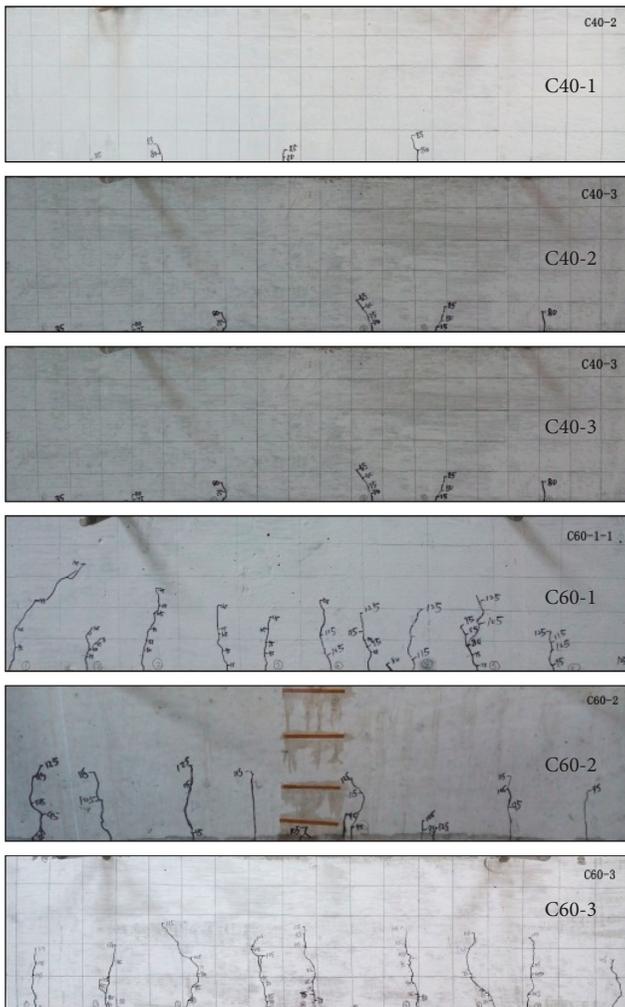
FIGURE 2: Initial cracks on the PC beams after preloading.

In order to simulate the influence of initial damage on the durability of PC beams, six beams were preloaded to crack with 40% and 60% of the ultimate load. The distributions and parameters of initial cracks are shown in Figure 2 and Table 2.

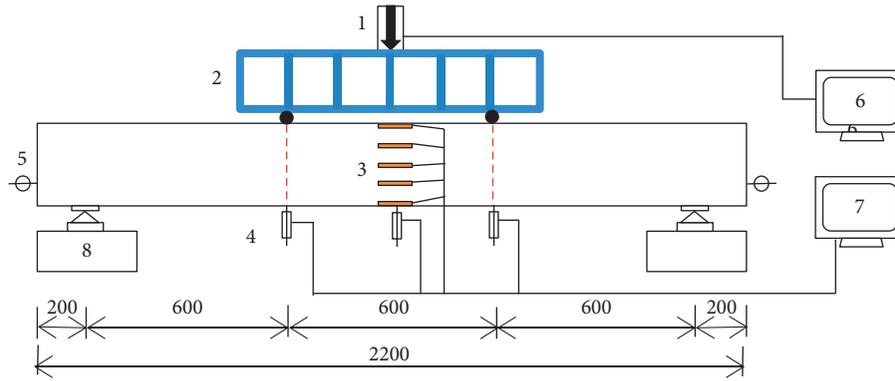
*2.3. Loading Process.* The actions of multifactor, such as initial damage, CFRP reinforcement, and chloride corrosion, change the bond performance between steel bars and concrete and affect the propagation of bending cracks. The design codes are very difficult to predict the flexural behavior and crack widths of these PC beams. The four-point bending tests were employed to study the effects of multifactor on the flexural behavior in the current study. Each beam was simply supported and had a pure bending span of 600 mm and two shear spans of 600 mm. Figure 5 shows the details of loading setup.

FIGURE 5: Loading test setup (unit: mm). Note: 1, load cell; 2, steel spreader beam; 3, strain gauge; 4, displacement sensor; 5, dial indicator; 6, computer; 7, data acquisition system.

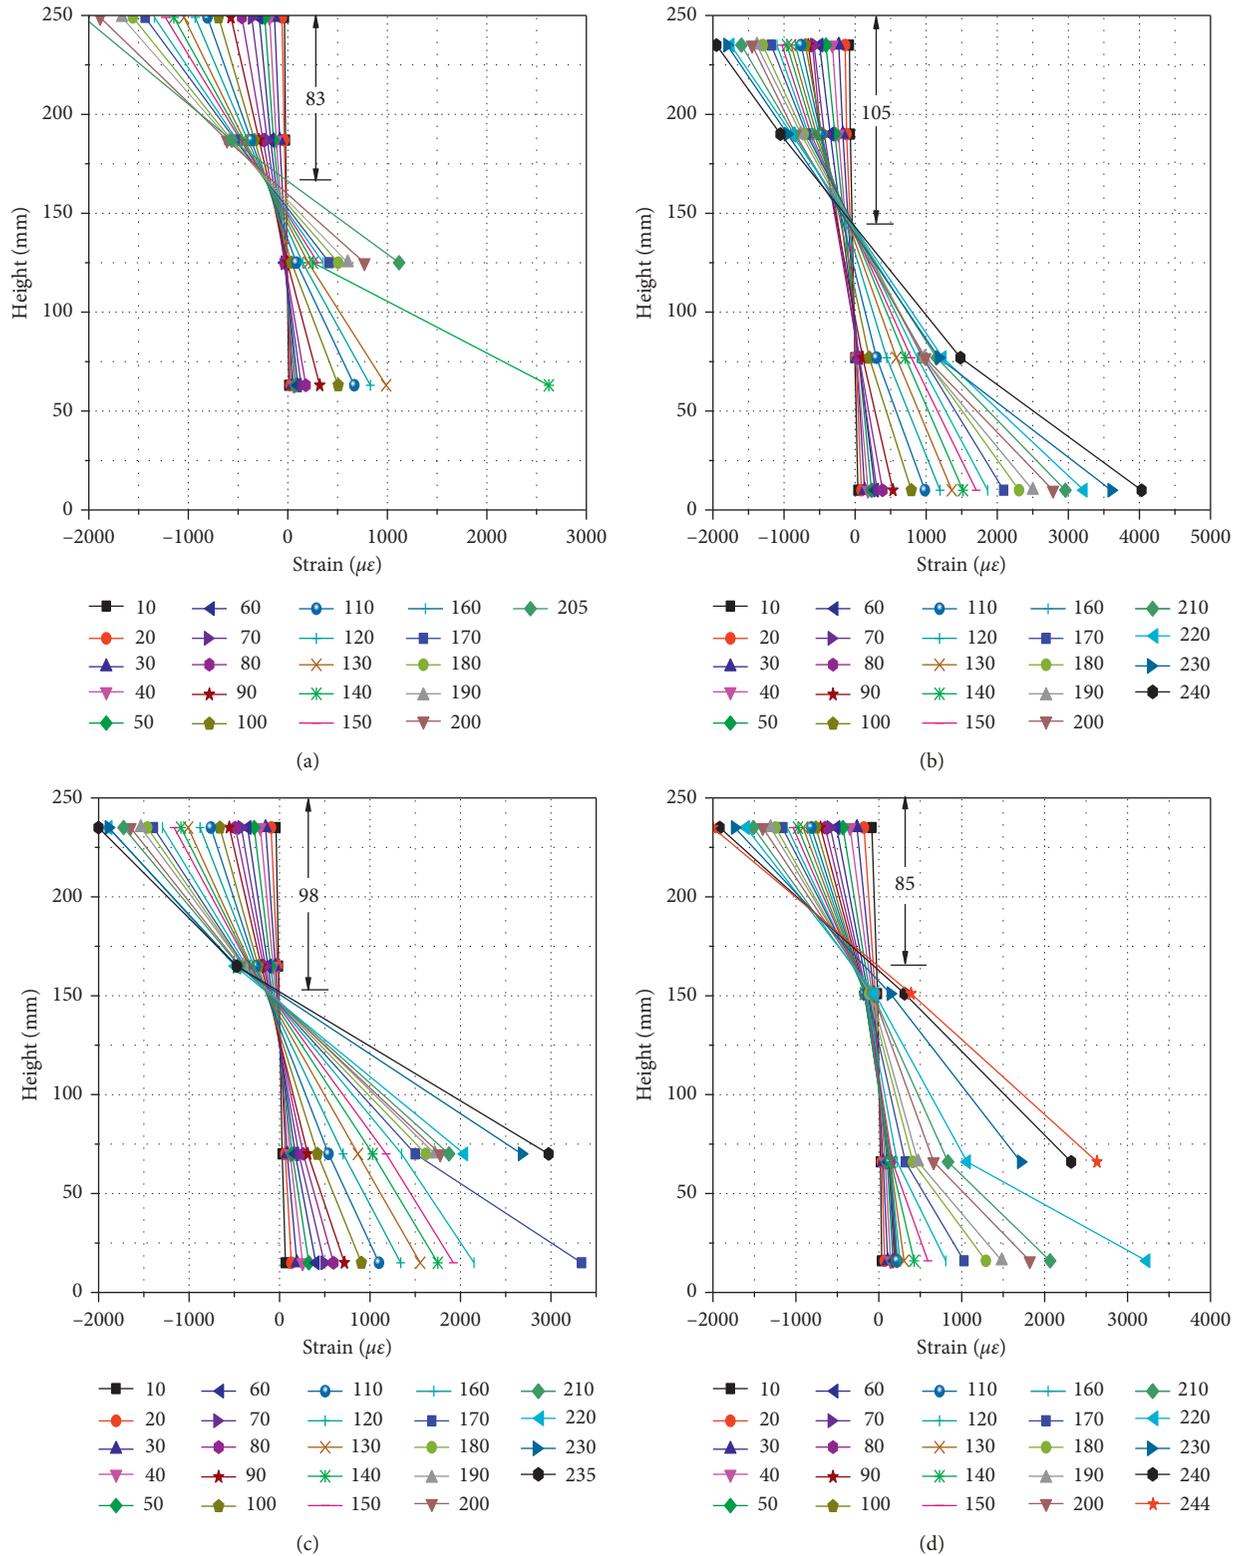
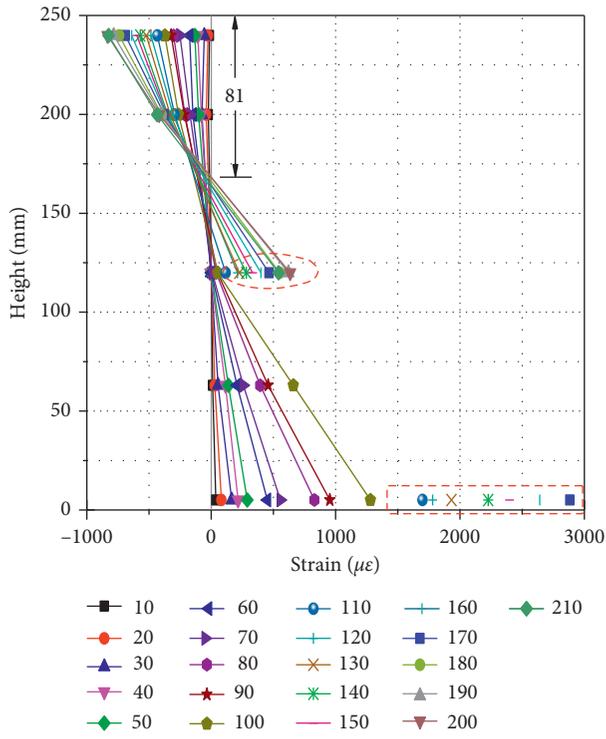
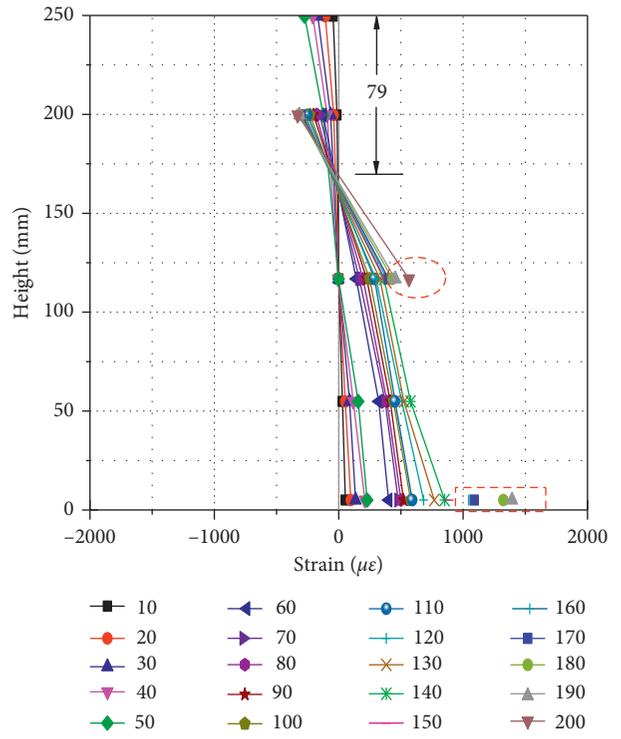
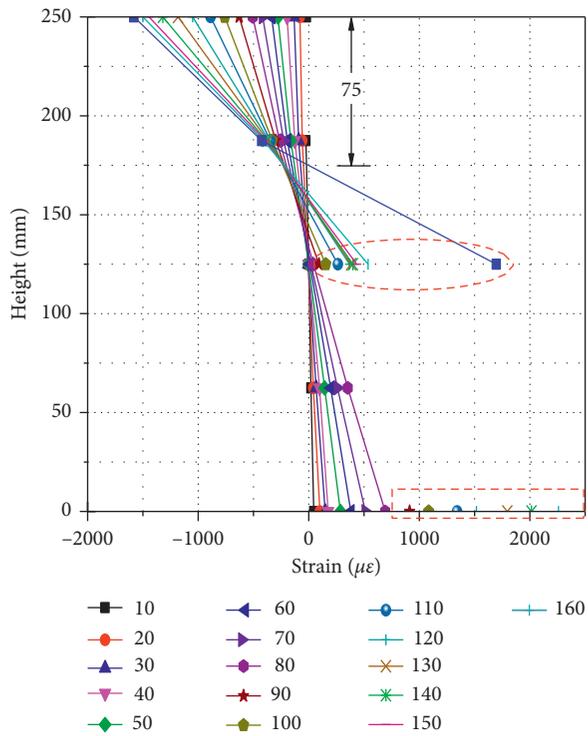
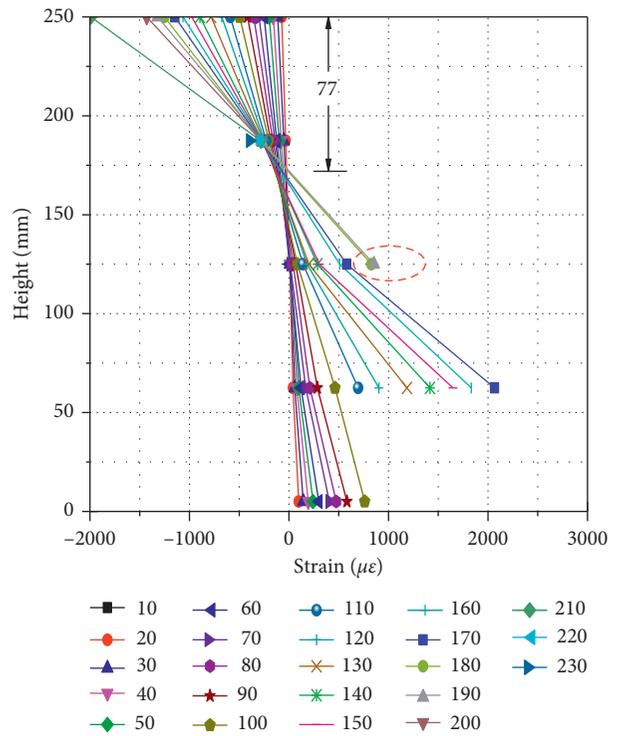
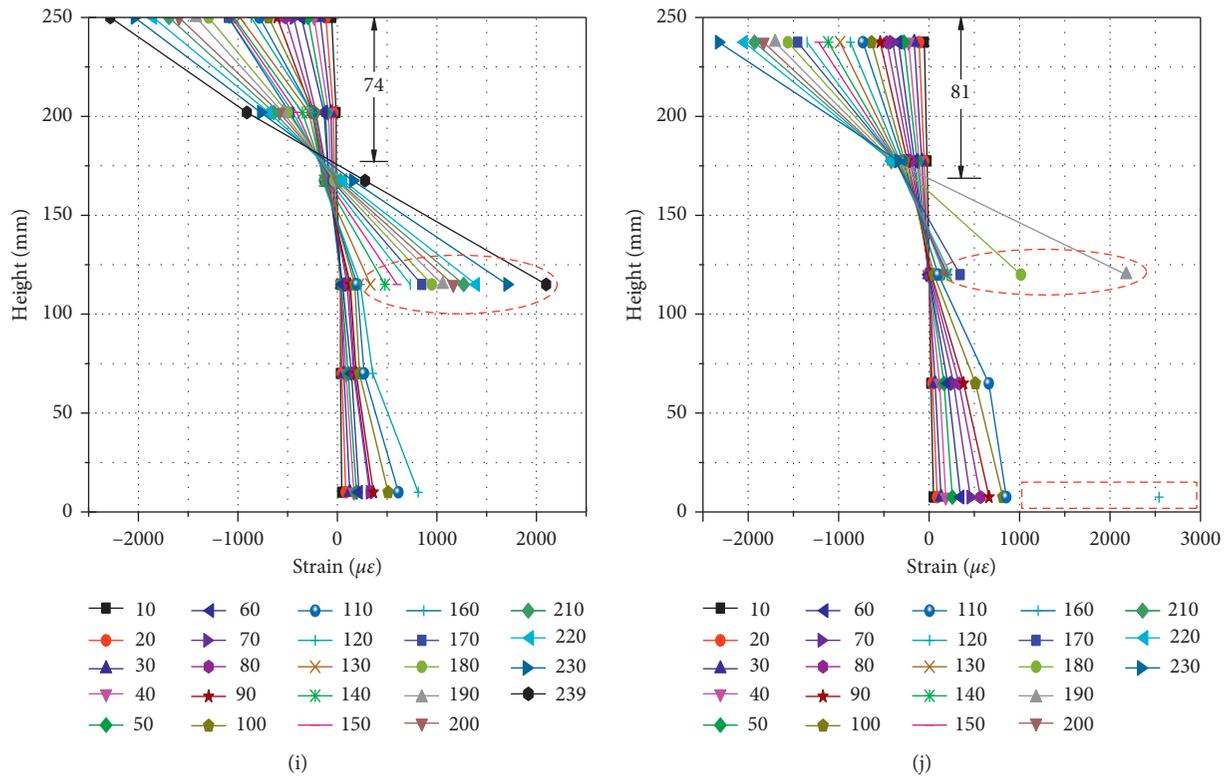
**3.1. Distribution of Cross-Sectional Strain.** The strain distribution curves of PC beams are shown in Figure 6. In the approximately elastic stage, the strains of concrete at different heights are small and vary linearly. After cracking, the strains increase rapidly. And the section in the midspan, perpendicular to the beam longitudinal axis, is still plane after a pure bending deformation. It is found that the sectional strain at the midspan of the test beams still follows the plane section assumption after preloading, chloride corrosion, and CFRP reinforcement.

According to the strain distributions of beams C0-3, C40-3, C60-3, C0-2, C40-2, and C60-2, it can be seen that, after the immersion in chlorine salt for 120 d, the steel bars were corroded and expanded, resulting in microcracks in the surrounding concrete. During the loading process, the corrosion microcracks developed rapidly until the strain gauge failed. And the corrosion microcracks in the beam with the initial damage cracked earlier under the loading process. At the same time, CFRP pasted on the bottom has little effect on chloride corrosion.

It can be seen from Figure 6 that the ultimate compressive strain of control beam A1 and CFRP reinforced beams C0-1, C40-1, and C60-1, which are under natural conditions, is about 0.002. The ultimate compressive strain of CFRP reinforced beams C0-2, C40-2, and C60-2 in chloride condition is about 0.002. And the ultimate compressive strain of beams C0-3, C40-3, and C60-3 is about 0.001. It follows that the ultimate strain of concrete decreases with the corrosion of steel in the beam, and the

FIGURE 6: Distribution of strain at the midspan. (a) Beam A1, (b) beam C0-1, (c) beam C40-1, (d) beam C60-1, (e) beam C0-3, (f) beam C40-3, (g) beam C60-3, (h) beam B2, (i) beam C40-2, and (j) beam C60-2.

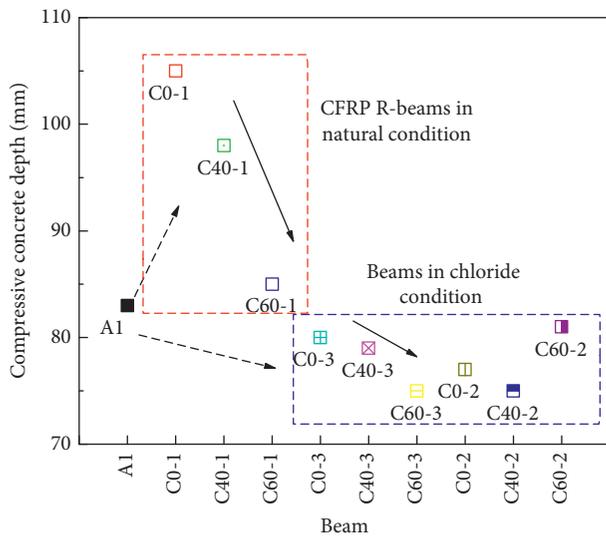
FIGURE 7: Compressive concrete depths at midspan.

With the increase of load grades, the neutral axis moved up from the middle of the beam. After cracking, the movement increases and the height of the compression zone decreases gradually. The compressive concrete depths of each PC beam under the ultimate load are shown in Figure 7. Under natural condition, the compressive concrete depth of the CFRP reinforced beam is higher than that of the control beam, and that of each beam decreased compared with that of the control beam under chloride corrosion for 120 d. Also, the compressive concrete depths of beams C0-1, C40-1, C60-1, C0-3, C40-3, and C60-3 decrease with the increase of the initial damage degree, while the law of C0-2, C40-2, and C60-2 is not obvious.

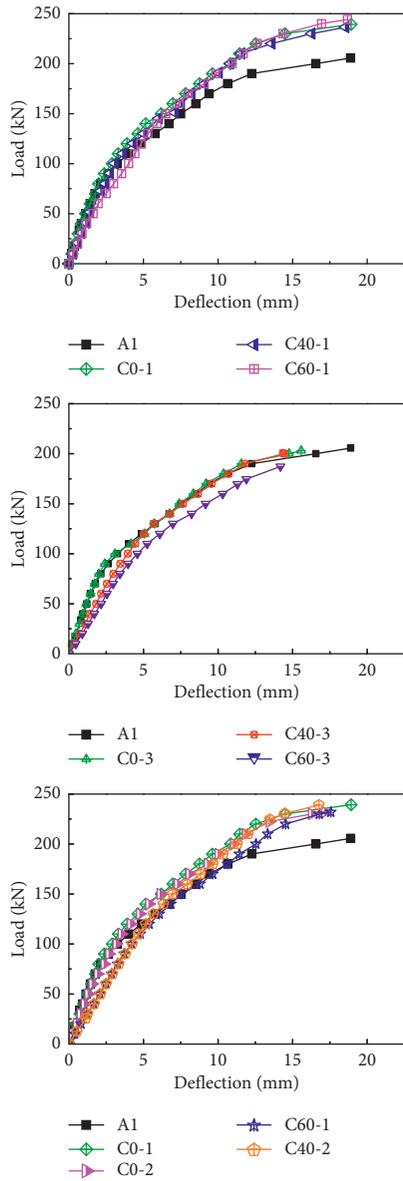
FIGURE 8: Load-deflection curves.

**3.2.1. Load-Deflection Curves.** According to the test results, the load-deflection curve of PC beams in the midspan is drawn, as shown in Figure 8. With the increase of load grade, the deflection in the midspan goes through three stages:

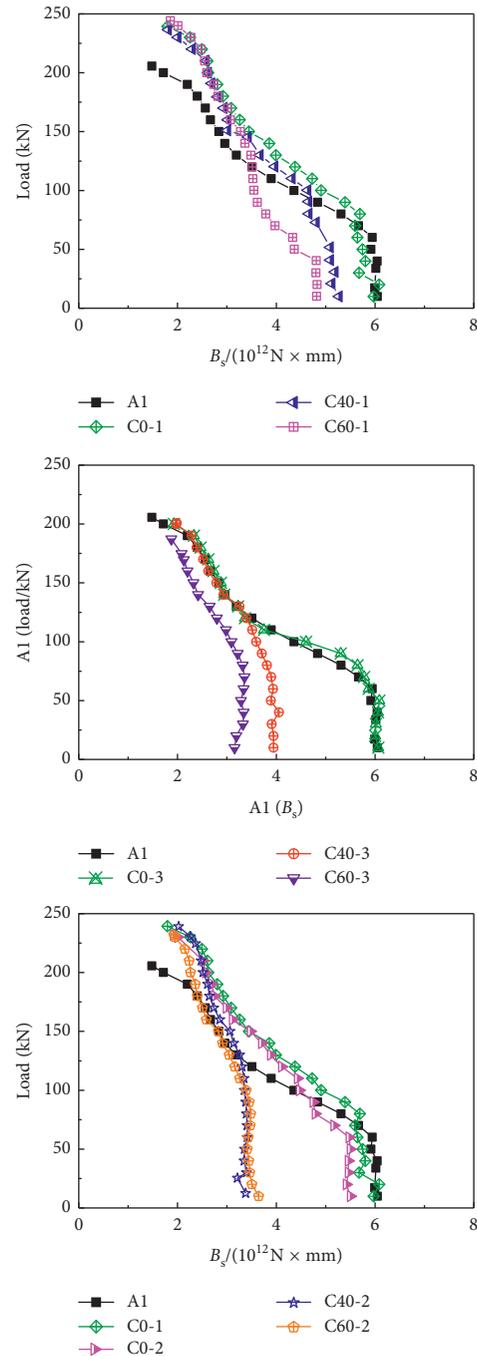
FIGURE 9: Flexural stiffness.

cracking, the flexural stiffness of the test beams is basically unchanged, and the initial stiffness of the nondestructive beams C0-1, C0-2, and C0-3 is close to that of the control beam. Under the chloride condition, the initial flexural stiffness of beams C40-3 and C60-3 with initial cracks decreases by about 32.5% and 47.8% compared with the control beam and that of the CFRP reinforced beams C40-2 and C60-2 decreases by about 44.1% and 39.7%, respectively. Under the natural conditions, the initial stiffness of the CFRP reinforced beams C40-1 and C60-1 decreases by about 12.8% and 20.4%, respectively, compared with the control beam. After cracking, the stiffness of the test beams decreases with the increase of load grade. Moreover, the degradation rates of the stiffness of CFRP reinforced beam are lower than that of the control beam.

It can be seen that the change rule of the stiffness of the test beams is consistent with that of the deflection in the midspan. The initial flexural stiffness of the test beams is decreased due to the initial cracks. After the chloride corrosion, the cross-sectional areas of the internal steel bars and strands are decreased, the bond behaviors between the steel strand and concrete are weakened, and the effective prestress is decreased accordingly. Therefore, the flexural stiffness of the test beams decreases with the increase of damage degree under the same load grade. After strengthened by CFRP, CFRP exerts its high tensile performance in the cracking stage and inhibits the structural deformation, and the degradation rates of the flexural stiffness of the CFRP reinforced beams are reduced compared with the control beam. However, CFRP reinforcement has little effect on the initial flexural stiffness.

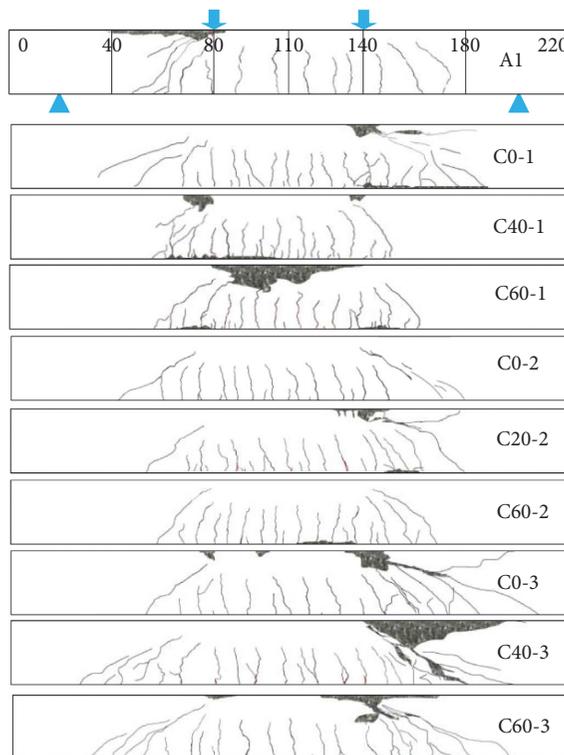
FIGURE 10: Distribution maps of cracks.

distribution maps of cracks are shown in Figure 10. The parameters of cracks in the pure bending span are shown in Table 6.

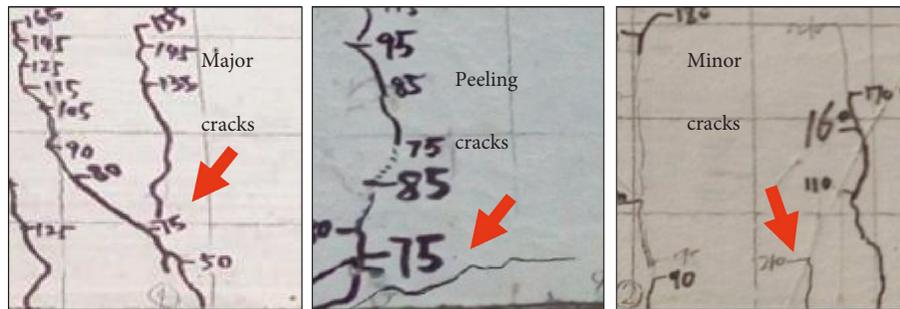
FIGURE 11: Classification of cracks.

During the cracking stage, initial cracks, CFRP reinforcement, and chloride corrosion all have impacts on the cracks of PC beams. According to their locations and causes, the cracks in Figure 10 can be divided into three categories, as is shown in Figure 11:

- (1) Major cracks caused by bending stress appear in the midspan and below the loading points of the test beams. And the distribution of major cracks depends

- (2) Minor cracks occur near the major cracks. The local bond stress between concrete and CFRP increases

with the increases of load. When the local tensile stress of concrete between major cracks reaches the ultimate tensile strength, the minor cracks appear between major cracks. Due to the low influence height of bond stress, such cracks are relatively short.

- (3) CFRP peeling cracks are the third kind of cracks. Arriving at the ultimate load, there has a tendency of local peeling between the CFRP and concrete at the beam bottoms, and the peeling cracks are short and inclined or even parallel to the bottom surface and intersect with the major cracks and then cause the peeling off of the CFRP and concrete.

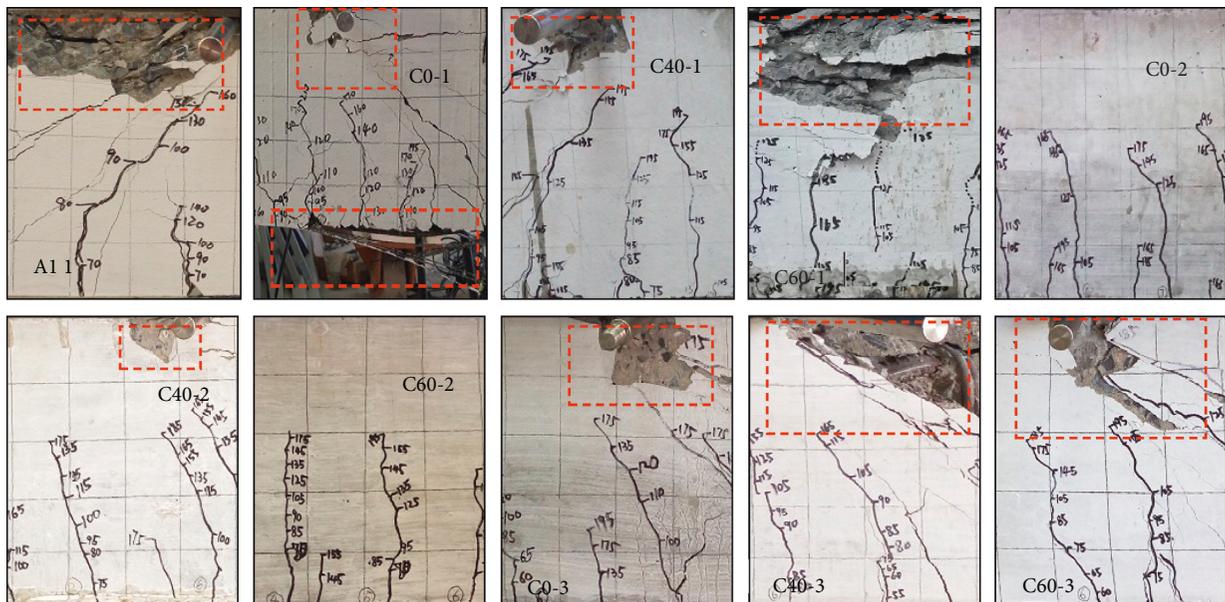
FIGURE 12: Failure modes of the test beams.

**3.3.2. Failure Modes.** The failure modes of the test beams are shown in Figure 12. In the bending test, the major cracks in the pure bending span of the control beam are vertically upward and evenly distributed with the increase of load grade. When the ultimate load is reached, the concrete beams A1, C0-1, C40-1, C60-1, and C40-2 are crushed.

Under the chloride condition, the crack patterns and the numbers of unreinforced beams C0-3, C40-3, and C60-3 are similar to that of the control beam, and part of the major cracks are developed from the position where the steel bars or strand was corroded. In addition, the reduction in the cross-sectional area of the steel bars and stirrups leads to the weakening of shear capacity. Arriving at the ultimate load, the oblique cracks are penetrated from the support to the loading point, leading to the concrete crushing at the loading point, and the compressive strength of the concrete on the midspan was not fully utilized. And the structure is subjected to shear failure.

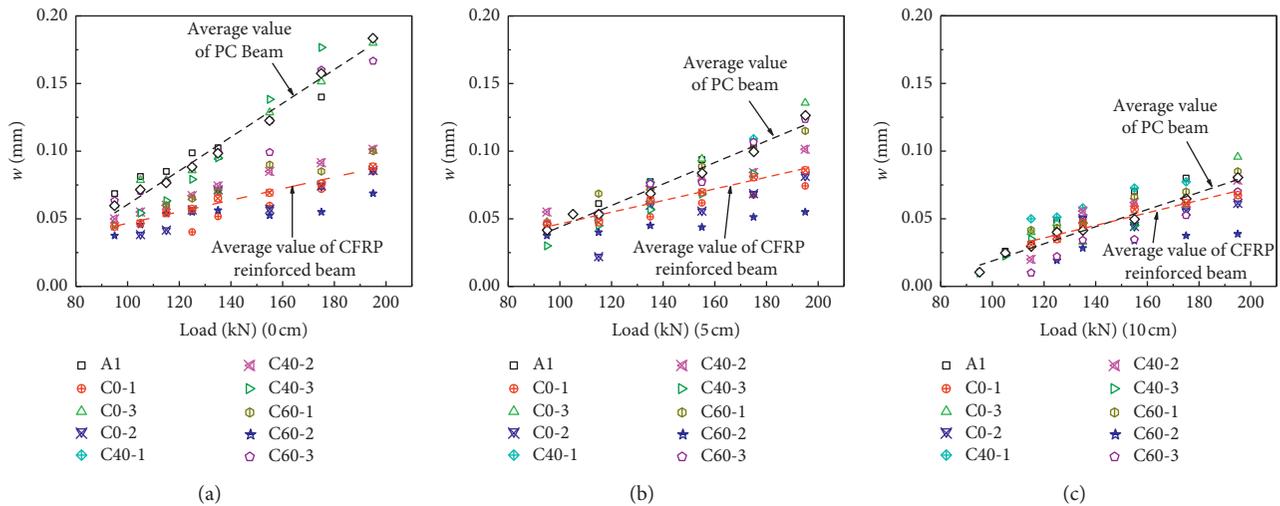
FIGURE 13: Crack widths and loads curves. (a) Average widths of cracks on the bottom, (b) at 5 cm, and (c) at 10 cm.

As can be seen from Figure 13, the reinforcement of CFRP has a greater impact on the development of cracks compared with initial damage and short-term chloride corrosion. Therefore, the average crack widths of CFRP reinforced and unreinforced beams were fitted with the linear method. When the load is 115 kN, the average crack widths of the CFRP reinforced beams at 0 cm, 5 cm, and 10 cm from the beam bottom decrease by 29%, 11%, and 5%, respectively, compared with that of the unreinforced beams. When the load is 195 kN, they decrease by 52.5%, 32.5%, and 17.5%, respectively. At the same time, the average crack widths of the unreinforced beams at 5 cm and 10 cm are 31.1% and 56.3% smaller than those at the bottom, while the average crack widths of the CFRP reinforced beams at 5 cm and 10 cm are only 3.1% and 24% smaller than those at the bottom.

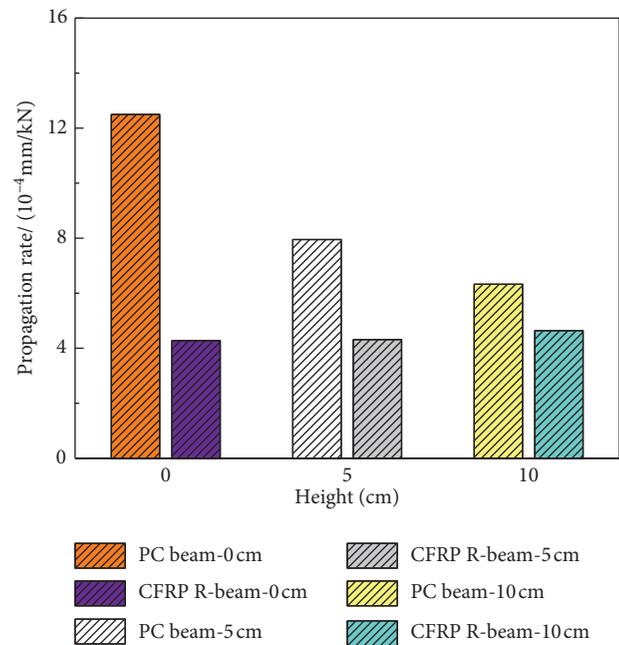
FIGURE 14: Cracking rates.

The cracking rates of the test beams are shown in Figure 14. The cracking rates of unreinforced beam gradually decrease with the increase of cracking heights. For example, the cracking rate at the beam bottom is  $1.25 \mu\text{m}/\text{km}$ , and the cracking rate at 5 cm and 10 cm decreased by 36.4% and 71.0%, respectively. The cracking rates of the CFRP reinforced beams at 0 cm, 5 cm, and 10 cm are almost same, and the cracking rates are 65.8%, 45.7%, and 26.7% lower than that of the unreinforced beams, respectively.
