## Research Article

# Fire Resistance Investigation of Simple Supported RC Beams with Varying Reinforcement Configurations

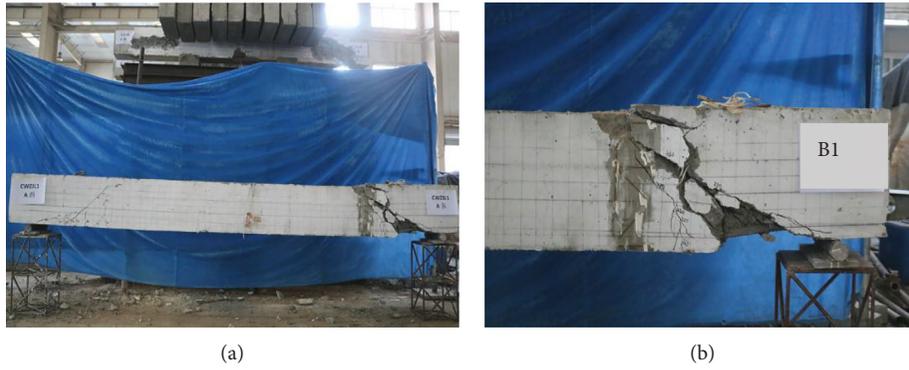
FIGURE 4: The failure modes of B1. (a) Overall failure mode; (b) partial failure mode.

To determine their ultimate load bearing capacity, the experimental program comprised firstly four-point-bending tests on reference beams at ambient temperature. These tests were carried out for having reference values to compare with the ones calculated according to Chinese Standard [24] requirement and define the loads to be applied in the tests at high temperature. Considering all the specimens experienced a similar damage process, the test phenomenon will not be described in detail one by one. Only the failure mode of specimen B1 is illustrated in Figure 4.

As can be seen in Table 4 and Figures 4 and 8, it is important to note that almost all beams, with the exception of B4, achieved 180 + minutes of failure time. This is pretty much comparable to an RC beam loaded primarily in flexure. The failure modes of beams at high temperature show very different shapes, comparing with the reference beams under room temperature. The change of failure mode shifting from shear failure at ambient temperature to shear-bend failure at high temperature may be caused by a combination effect of compression and shear, the concrete in shear-compression crushed accompanied with spalling of concrete cover, the strength degradation of concrete exposed
