Seismic Failure Pattern Prediction in a Historical Masonry Minaret under Different Earthquakes

Halil Nohutcu

Manisa Celal Bayar University, Engineering Faculty, Civil Engineering Department, 45140 Manisa, Turkey

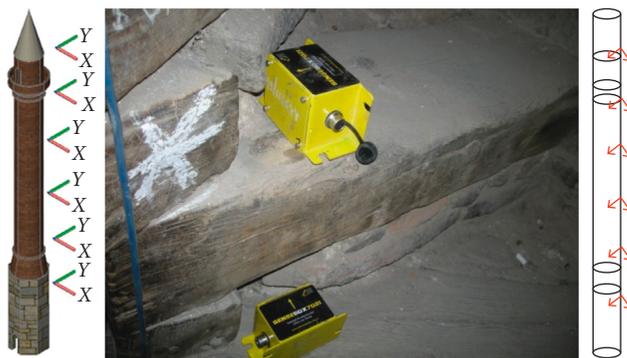
FIGURE 5: Locations and directions of the accelerometers on the minaret.

OMA is an output-only method based on ambient vibration data. In the experimental study, the connection points of the accelerometers were identified using the initial finite element (FE) mode shapes of the minaret. A total of 12 uniaxial accelerometers were placed at these points as shown in Figure 5. Vibrations generated by the environmental effects on the minaret were collected by 12 uniaxial accelerometers and data acquisition units.
