Research Article

Experimental Study on the Structural Performance Degradation of Corrosion-Damaged Reinforced Concrete Beams

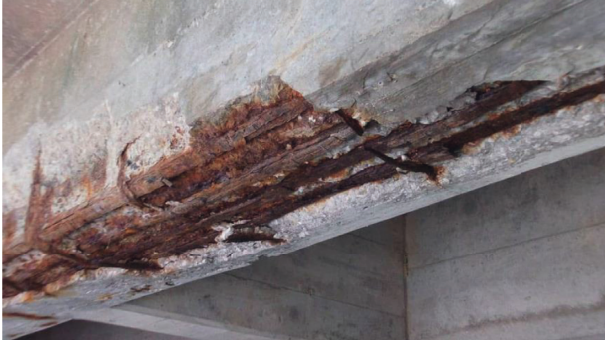
FIGURE 1: Structural performance deterioration of a reinforced concrete (RC) structure caused by reinforcement corrosion [10].

Reinforced concrete (RC) structures are the most common structural systems in modern society, due to their low construction and maintenance costs and high durability compared to other types of structures. The structural performance of RC structures, however, deteriorates over time for various reasons, such as changes in the environmental conditions, design load, and material properties, as well as structural design errors and defective construction. Among these factors, reinforcement corrosion is one of the primary causes of deterioration, affecting a large number of RC structures [1–10]. This results in a shortened service life and reduced structural performance (Figure 1).

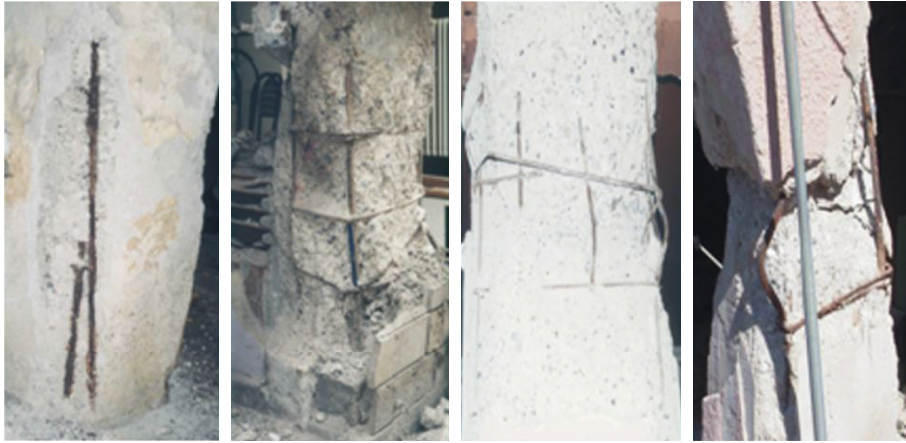
FIGURE 2: Corrosion of RC members damaged during the 1999 Izmit Earthquake in Turkey [7].

There have also been frequent earthquakes all over the world in recent years. If RC structures in earthquake-prone areas are seriously corroded, this will inevitably affect their seismic performance and safety. As shown in Figure 2, reinforcement corrosion of RC members has a significant impact on the structural performance deterioration (i.e., seismic performance degradation) caused by earthquakes [7], as seen following recent strong earthquakes including the 1995 Kobe Earthquake in Japan ($M=7.3$), the 1999 Jiji Earthquake in Taiwan ($M=7.3$), the 1999 Izmit Earthquake in Turkey ($M=7.4$), the 2008 Sichuan Earthquake in China ($M=8.0$), the 2010 Chile Earthquake ($M=8.8$), the 2012 Great East Japan Earthquake ($M=9.0$), the 2013 Lushan Earthquake in China ($M=7.0$), and the 2016 Kumamoto Earthquake in Japan ($M=7.0$).

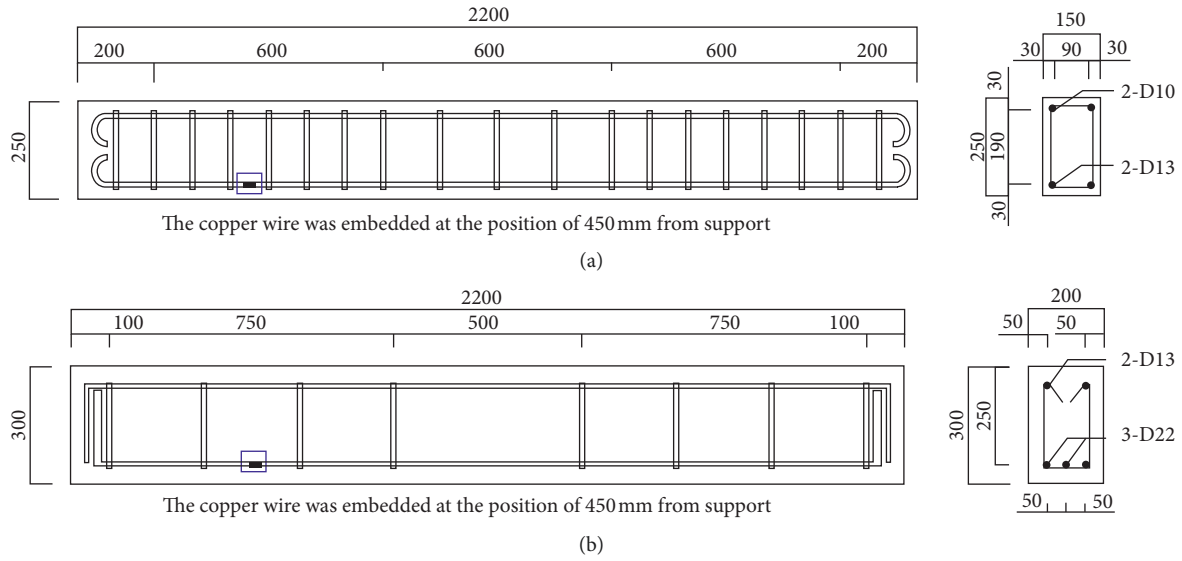
FIGURE 4: Reinforcement details of beams: (a) flexural failure type beam and (b) shear failure type beam.

The flexural failure type beam was designed to have longitudinal reinforcements in the form of two D13 bars (tension) and two D10 bars (compression), as well as shear reinforcements in the form of D10 bars at 150 and 100 mm, with a closed-loop stirrup used in the pure bending region and the region between the support and load points. The

shear failure type beam was designed to have longitudinal reinforcements of three D13 bars in tension and two D10 bars in compression and shear reinforcements in the form of D10 bars at 150 and 100 mm, with an open-loop stirrup used in the pure bending region and the region between the support and load points. Specimens F-B0 and S-B0 were used as control flexural and shear failure type beam specimens, respectively, without corroded reinforcing bars. Specimens FB-C0 to FB-C7 and SB-C0 to SB-C7 were sequentially degraded by reinforcing bar corrosion. To accelerate the corrosion of the reinforcing bar, a copper wire was embedded at a position 450 mm from the support, as shown in Figure 4.

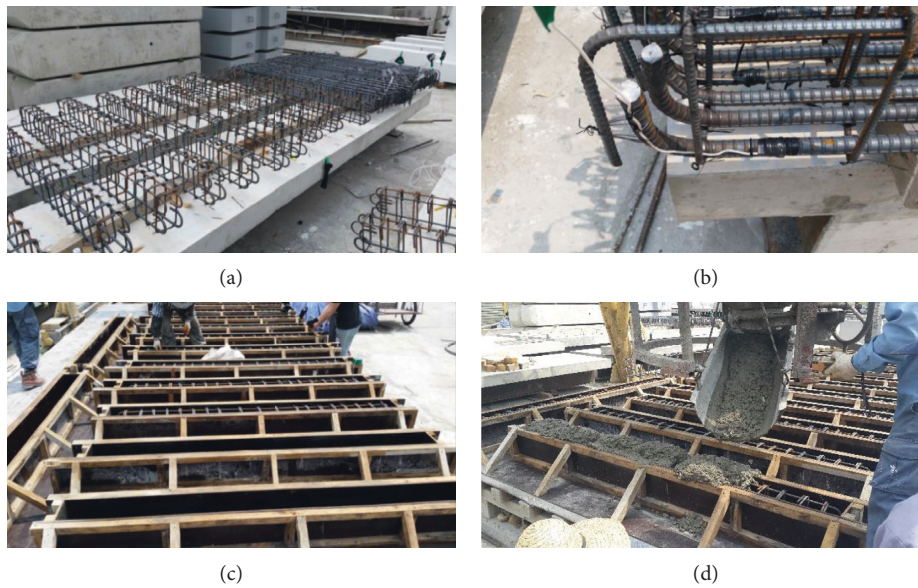
FIGURE 5: Beam manufacturing process: (a) assembly of reinforcing bar cage, (b) wire for corrosion of reinforcing bar, (c) installation of reinforcing bar cage, and (d) placement of concrete.

We manufactured the beam specimens by assembling a reinforcing bar cage, as shown in Figure 5. Next, the wire for accelerating the corrosion of the reinforcing bar was installed and the reinforcing bar cage was placed within the formwork. Finally, the concrete was placed in the specimen.

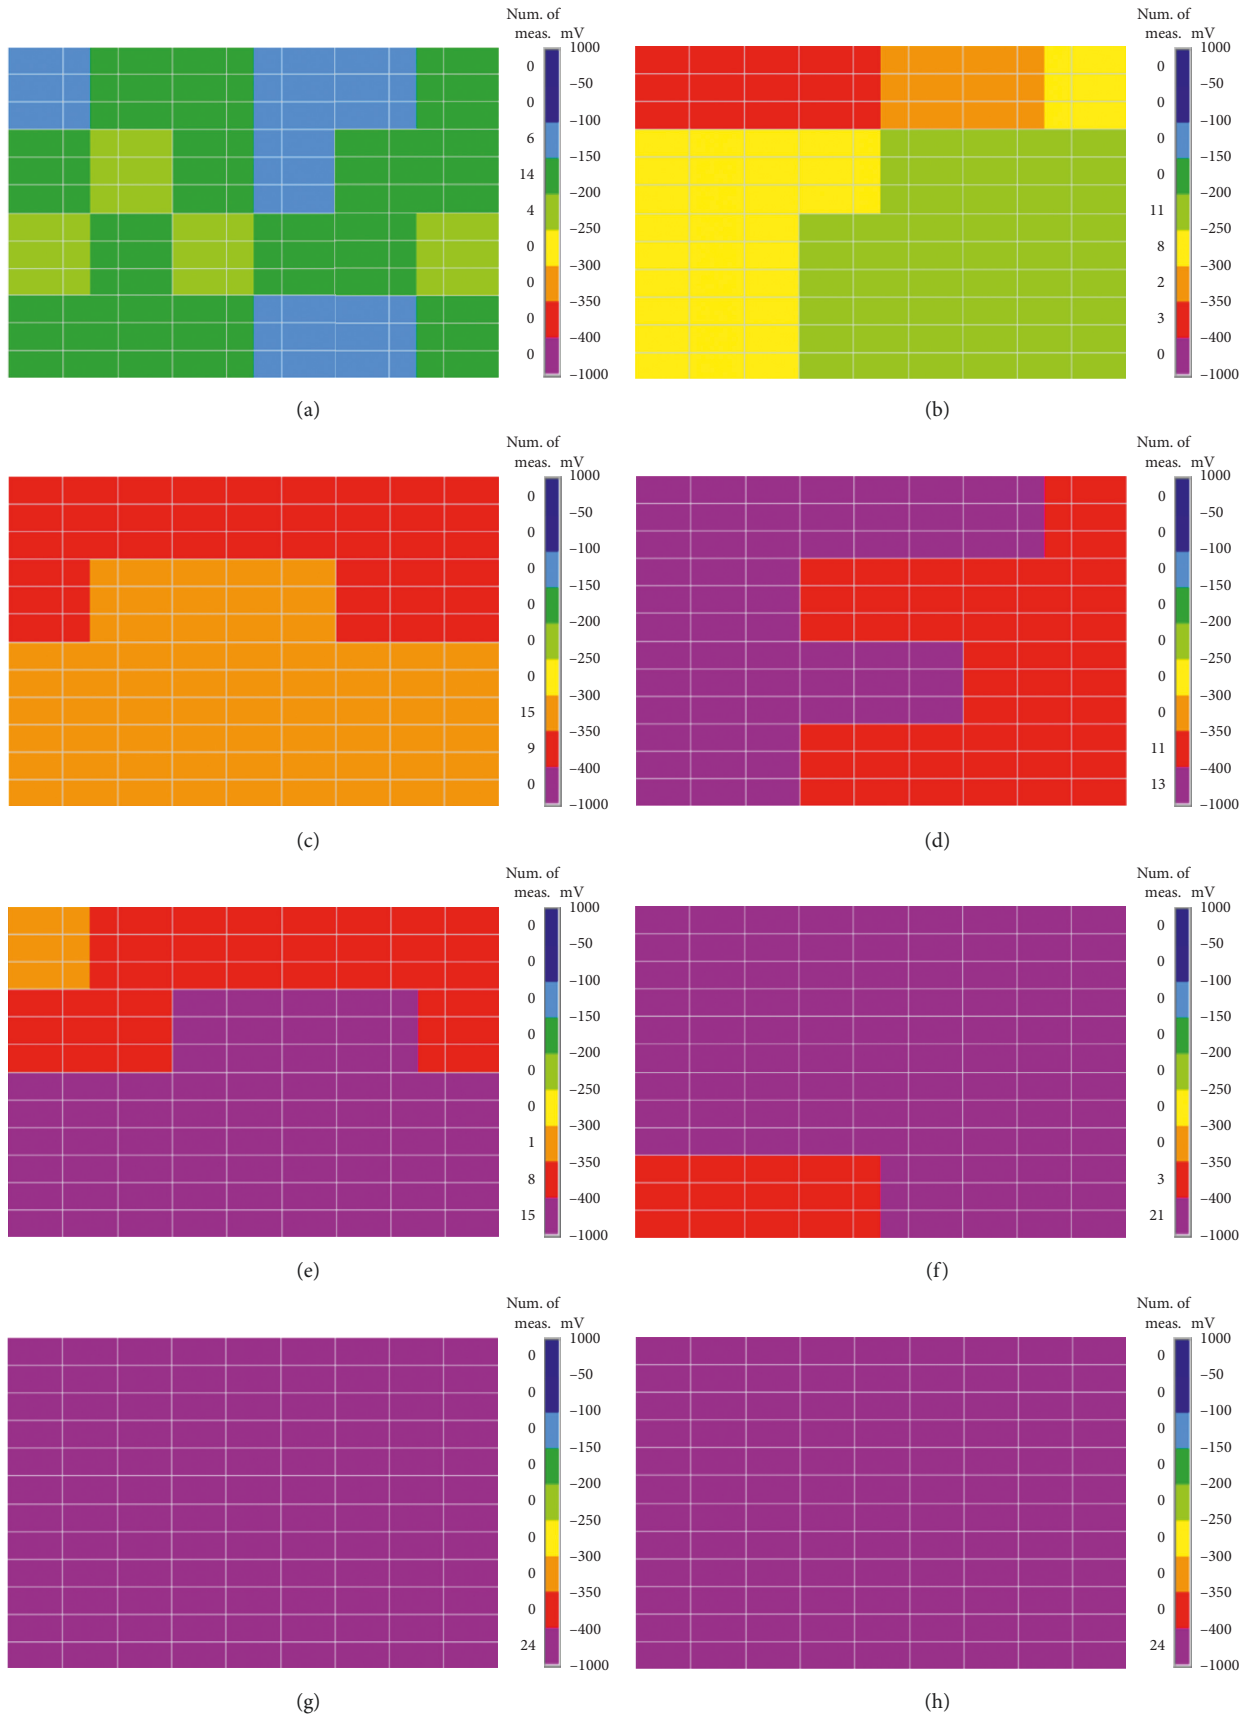
FIGURE 9: Potential map of beams controlled by shear: (a) SB-C0, (b) SB-C1, (c) SB-C2, (d) SB-C3, (e) SB-C4, (f) SB-C5, (g) SB-C6, and (h) SB-C7.

The half-cell potential of the reinforcing bars of the FB-C1 to FB-C7 and SB-C1 to SB-C7 specimens increased sequentially, i.e., increased with increased duration of the accelerated corrosion process. Figures 8 and 9 show the half-cell potential map of each measurement point.

observed that two beams (FB-C6 and FB-C7) in the FB-C series beams had half-cell potentials less than -350 mV CSE and five beams (SB-C3 to SB-C7) in the SB-C series beams had half-cell potentials less than -350 mV CSE.

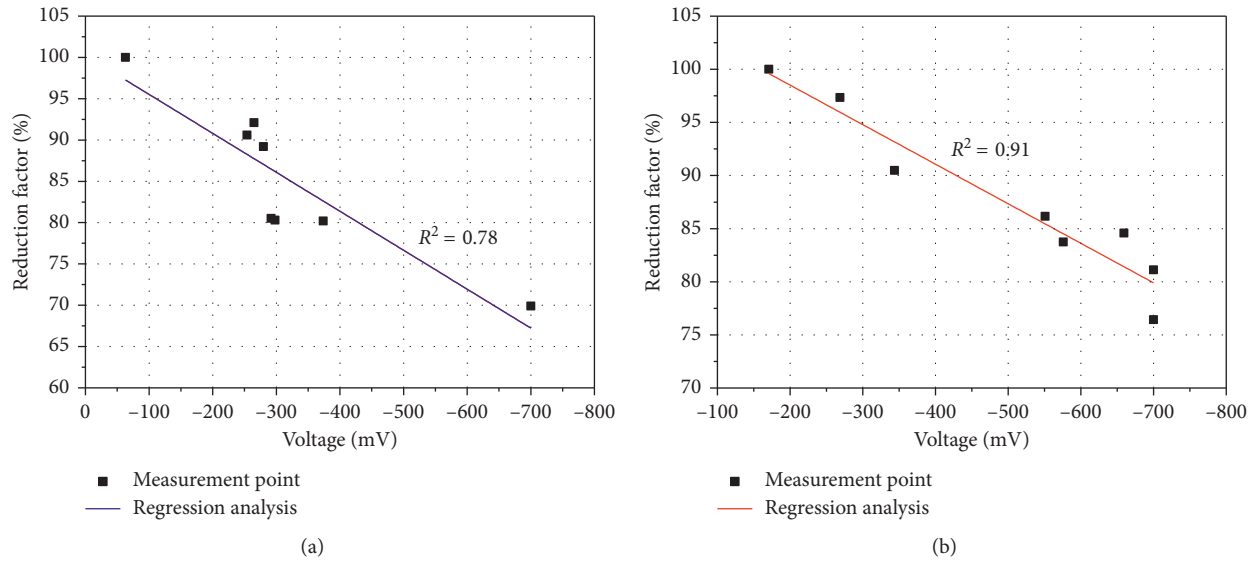
FIGURE 13: Relationship between the performance degradation factor and average potential difference in terms of voltage: (a) flexural failure type beams and (b) shear failure type beam.

Figure 13 shows the relationship between the performance degradation factor and average potential difference. We applied empirical regression models to derive the

quantitative relationship between the performance degradation factor and the average potential difference. As shown in Figure 13, we detected a relatively strong correlation between the performance degradation factor and average potential difference. The coefficients of determination (R^2) of the FB-C series beams and SB-C series beams were 0.78 and 0.91, respectively.

By using relationship between the performance degradation factor and average potential difference in terms of voltage, the energy absorption capacity (the reduction factor in Figure 13), calculated based on strength-deformation capability of corrosion-damaged RC members, can be evaluated. The result of each energy absorption capacity of corrosion-damaged members can be utilized for predicting the seismic capacity of entire RC buildings. For instance, for the corrosion-damaged members, the basic structural performance index (E_O) calculated with respect to the ultimate horizontal strength and ductility for each member can be quantitatively and directly calculated when applying the Japanese standard for seismic evaluation of entire RC buildings.
