## Research Article

# Fire Behavior of Continuous Assembled Monolithic Hollow-Ribbed Slabs

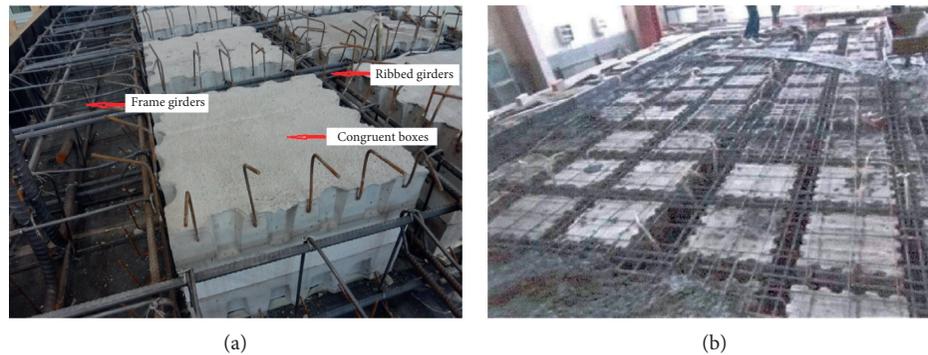
FIGURE 1: View of the continuous AMH slabs. (a) Structural skeleton; (b) concrete construction.

The AMH slab floor develops from the traditional ribbed floor and the cast-in-situ concrete hollow floor [1]. As a new type of floor slab, the characteristics of the AMH slab are not only light in weight and flexible structurally but also able to reduce floor height, save energy, and insulate sound. Therefore, the AMH slab is suitable for large-span buildings with relatively large loads. Figure 1 presents one type of the AMH slabs, and it consists of prefabricated congruent boxes and cast-in-place concrete ribbed girders and frame girders [2]. The prefabricated congruent boxes participate carrying the load with the ribbed girders and frame girders, as well as can be used as their side templates when casting concrete. The frame girders can be divided into frame hidden girders and edge girders as shown in Figure 2.

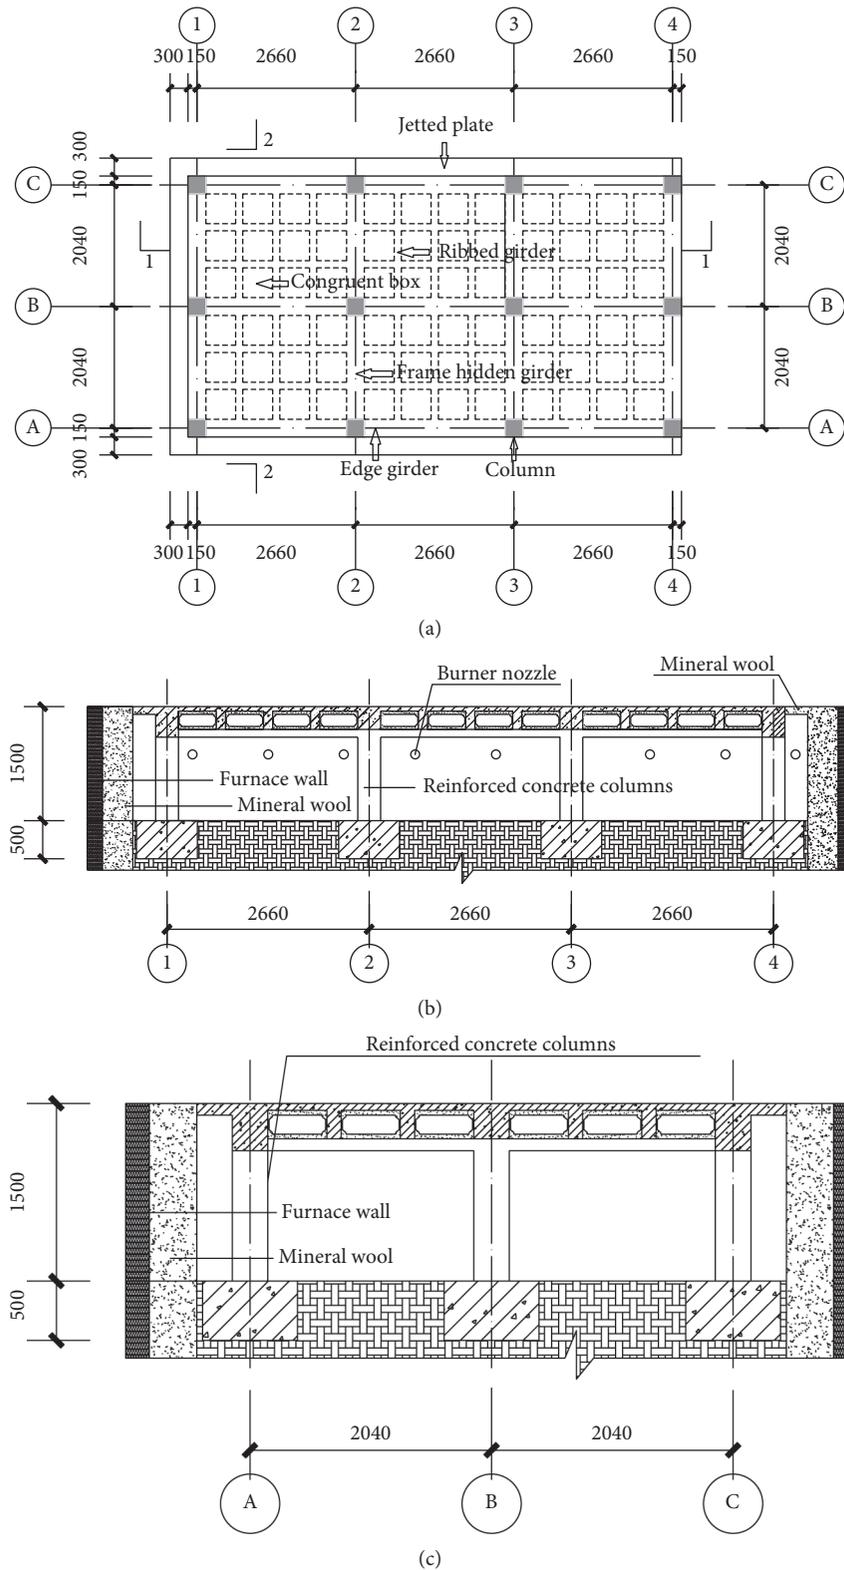
FIGURE 2: Plan view and front elevation view of the furnace. (a) Plan view of the continuous AMH slabs; (b) section 1-1; (c) section 2-2.

As shown in Figure 2, the test slabs located between the grid line A to C and 1 to 4 with an area of  $3 \times 2660$  mm long and  $2 \times 2040$  wide. Only three sides of the test slab installed jetted plates (150 mm deep), which were designed to seal the furnace without load imposed, and the last side only installed edge girders. Obviously, the test slab itself is a part of the closed furnace.

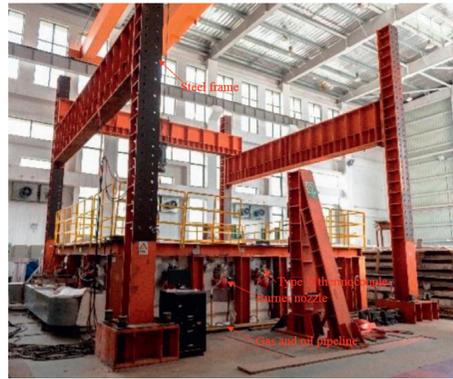
FIGURE 3: View of the furnace.

The fire test was conducted on a specially designed fire test furnace at Shandong Jianzhu University, China, as shown in Figure 3. The test furnace has been designed in compliance with the requirements of industrial furnace and consists of a gas evacuation system, a smoke flue, a real time data acquisition system, and an observation system and restraint or support steel frames. It is designed to follow either a custom designed fire development profile or a time-temperature curve specified in fire resistance standards such as ISO-834 and ASTM-E119. The furnace can test vertical and horizontal elements such as floor, beam, wall, and slab elements and subject them to specific heating and load conditions. A plan view of the furnace, along with two sectional views (sections 1-1 and 2-2), has been shown in Figure 2. The underside of the test slab was heated by 14 oil-fired burner nozzles which was located in the furnace walls symmetrically, and each nozzle was controlled independently from each other. The furnace walls at the perimeter of the furnace were constructed from firebricks and the mineral wool layer with a low thermal conductivity of  $0.035 \text{ W}/(\text{m} \cdot \text{k})$  at ambient temperature. The stainless steel plates were also installed at the four external sides to ensure the overall stability and fire insulation of the furnace. The gap between the top of the furnace walls and the test slab was filled with mineral wool to keep the test components deforming freely and to reduce heat loss. Four types N thermocouples N1–N4 were installed (two in each side as shown in Figure 3) to measure the temperatures of the gas inside the furnace. The construction of the furnace is similar to that in [12].

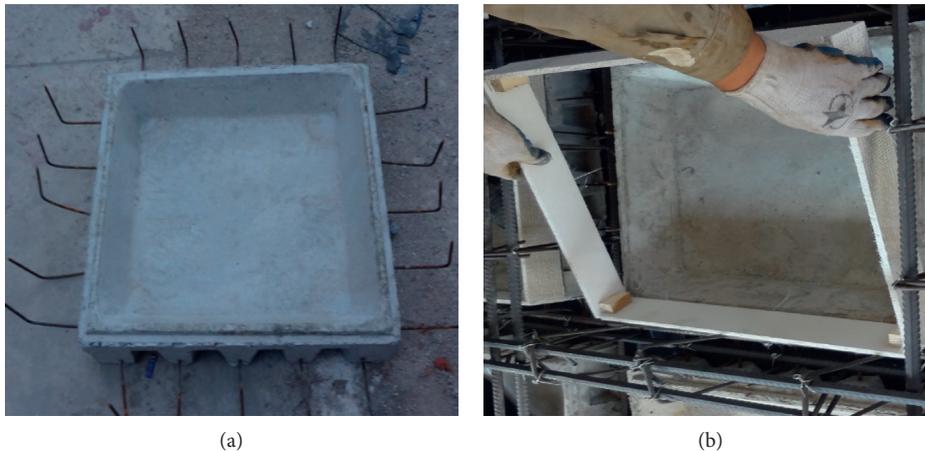
FIGURE 4: Congruent box. (a) Soleplate or top plate; (b) rectangular frame plate.

As shown in Figure 4, each congruent box has a plane size of  $500 \text{ mm} \times 500 \text{ mm}$  and consists of a soleplate, a top

plate, and a rectangular frame plate. The soleplate and top plates are both 40 mm thick and reinforced by low carbon steel wires (4 mm in diameter) which are arranged at a spacing of 150 mm along both directions. The rectangular

frame plate is 40 mm thick without reinforcement and can be used as side templates when casting concrete. Furthermore, each congruent box has a section height of 240 mm, while the section height of the test slab is 300 mm because

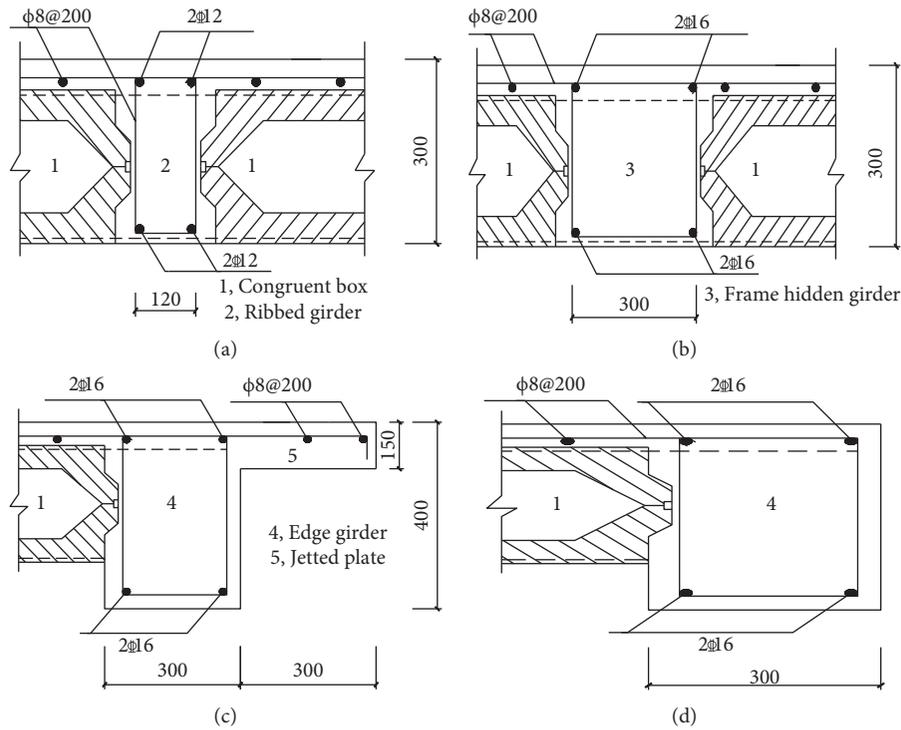
FIGURE 5: Sketch map of the AMH slabs. (a) Ribbed girder; (b) frame hidden girder; (c) edge girder with jetted plate; (d) edge girder without jetted plate.

Figure 5 illustrates the detail constructions of ribbed girders, frame hidden girders, and edge girders within the AMH slabs. Their rectangular sections are 120 mm  $\times$  300 mm, 300 mm  $\times$  300 mm, and 300 mm  $\times$  400 mm, respectively. They are all reinforced with grade three hot-rolled reinforcing bars with a characteristic yield strength of 400 MPa. The actual yield and ultimate tensile strength are 426 and 573 MPa, respectively. The details of reinforcement arrangements are also annotated in Figure 5. In addition, the cast-in-situ layer at the top surface of the AMH slabs is reinforced with grade one hot-rolled reinforcing bars (8 mm in diameter) at a spacing of 200 mm along both directions. All congruent boxes are prefabricated by normal weight C40 concrete in factory, while the other cast-in-situ structural components are composed of normal weight C30 concrete. The average moisture content of the AMH slabs is 2.3% by weight measured ten days before the fire test.

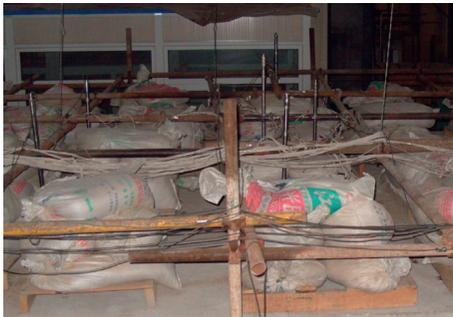
FIGURE 6: View of the loading.

**3.1. Loading Equipment.** As shown in Figure 6, sand bags were placed on the upper surface of the AMH slabs to

simulate the uniformly distributed load of 3.0 kN/m<sup>2</sup> in addition to self-weight during the fire test [18]. The test slab was loaded at least two hours before the fire test. These sandbags were insulated from the test slab with wooden supports to avoid being damaged by high temperatures.

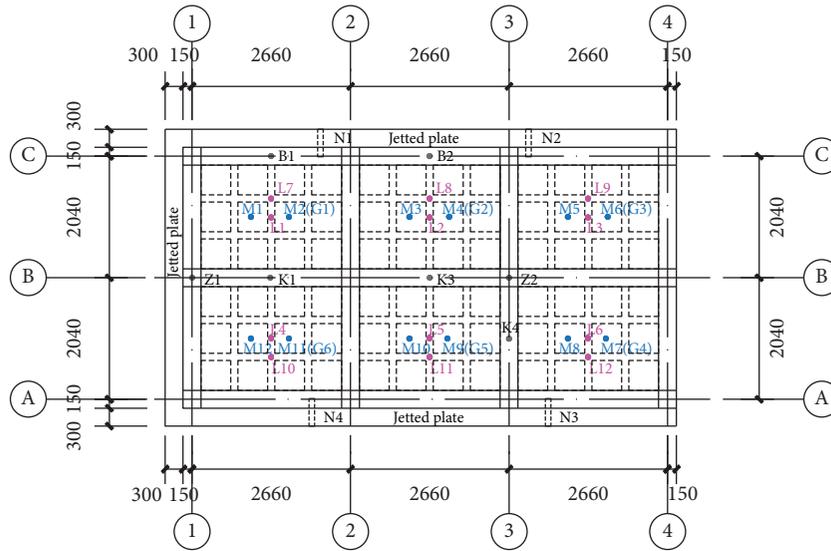
FIGURE 7: Furnace thermocouples and thermocouple trees in the AMH slabs.

**3.2. Temperature and Displacement Measurement.** As shown in Figure 7, four N-type thermocouples N1–N4 were installed around the furnace walls to measure the gas temperatures; twelve thermocouple trees L1–L12 were used to record the temperature gradients along the cross-sections of the ribbed girders. In each thermocouple tree, thermocouples 1–5 were arranged to measure concrete temperatures of ribbed girders and the distance between them was approximately 65 mm; likewise, thermocouples 6–7 were used to record the reinforcing steel temperatures, as shown in Figure 8. Four thermocouple trees named K1–K4 were arranged evenly to measure the temperatures of frame hidden girders, while thermocouple trees B1 and B2 were used to record the temperatures of edge girders. They received similar layouts of thermocouples as thermocouple trees L1–L12. Twelve types of K thermocouple trees M1–M10 were used to measure the temperatures of congruent boxes. And, in each thermocouple tree, two

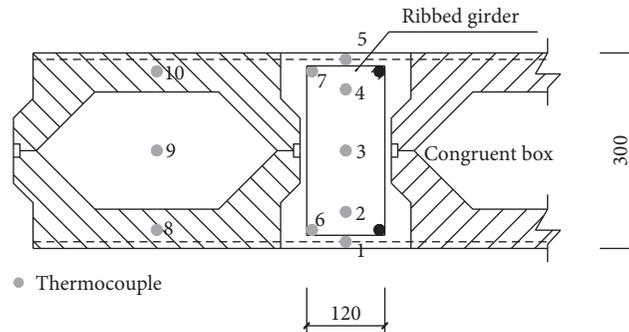
FIGURE 8: Arrangement of thermocouples.

thermocouples 8 and 10 were settled to record the temperatures of the soleplates and the top plates, respectively. At the same time, six type K thermocouples named G1–G6, corresponding to the thermocouple 9 as shown in Figure 8, were embedded to measure the air temperatures within congruent boxes. Thermocouple trees Z1 and Z2 were used to record the temperatures of beam-columns connections, and in each thermocouple tree, four thermocouples were arranged to measure concrete temperatures and the distance between them was approximately 130 mm.

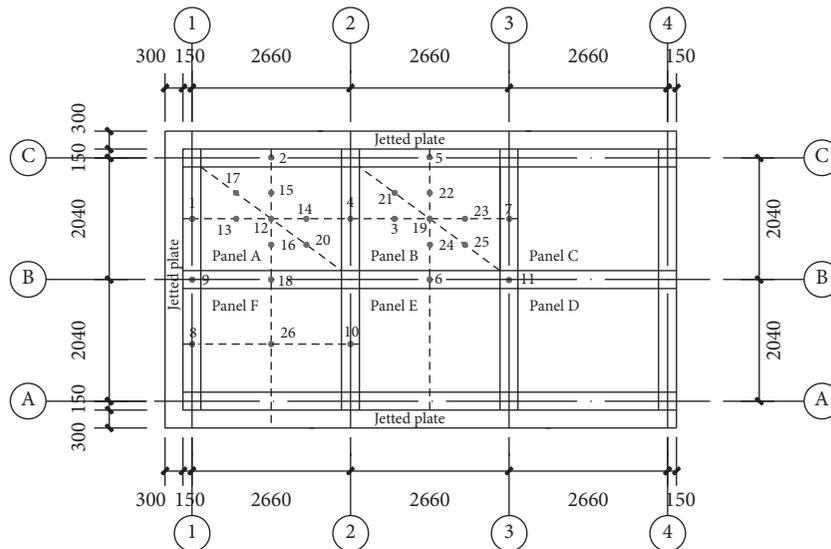
FIGURE 9: Displacement measure points at the top surface of the AMH slabs.

As shown in Figure 9, 26 linear voltage displacement transducers (LVDTs) were installed on the top surface of the test slab to measure its vertical displacements. The vertical displacements were measured across the center of the slab in the long and short directions. In this paper, the vertical upward displacements are positive and downward displacements are negative. Regretfully, its horizontal

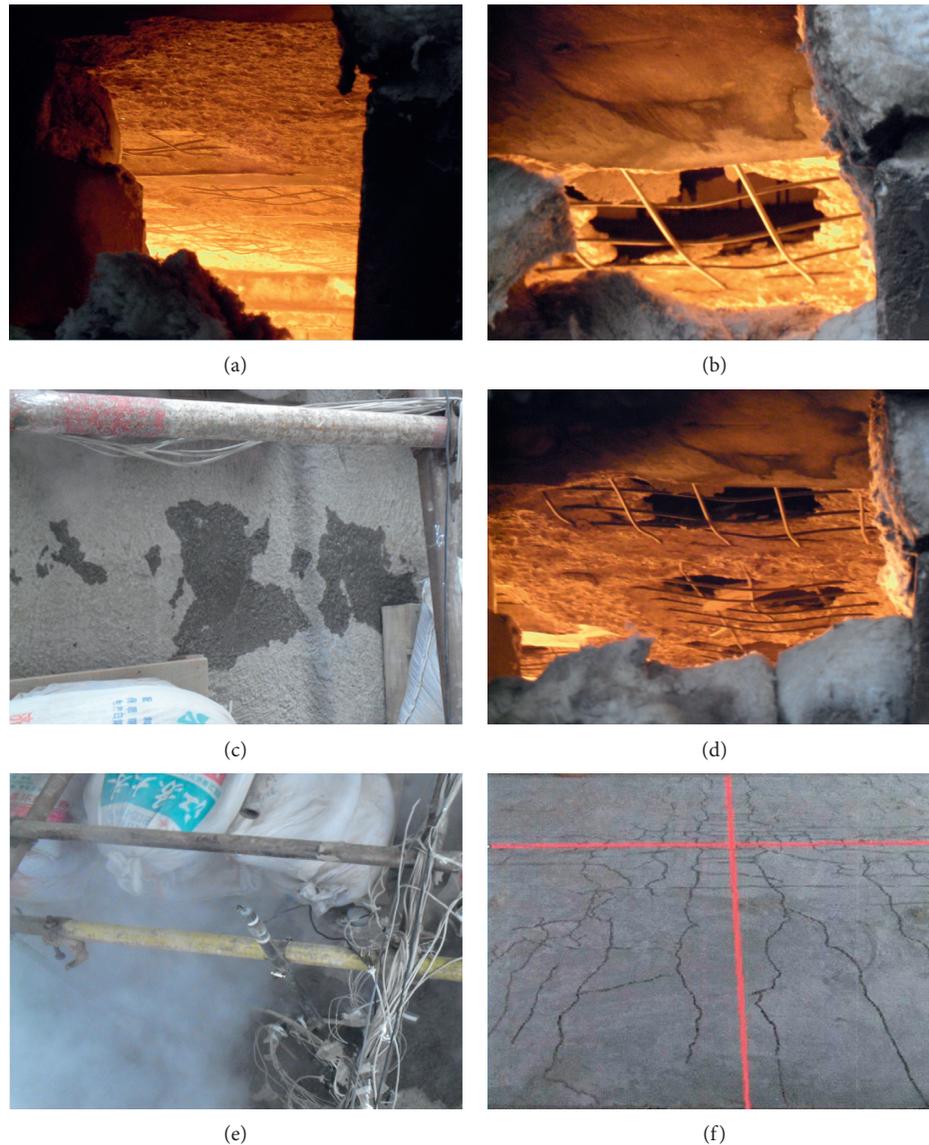
FIGURE 10: Photograph of the test slabs during the fire test at (a) 13 minutes, (b) 24 minutes, (c) 36 minutes, (d) 44 minutes, (e) 69 minutes, and (f) 119 minutes.

4.1. *Testing Phenomenon.* Some testing phenomenon observed during the fire test was recorded as shown in Figure 10. At 13 min after ignition, the test slab began popping noise due to crack propagation of the soleplates. At 24 min, the fire has burned through some soleplates and entered the interior of the congruent boxes; meanwhile, the test slab fluctuated obviously. At 36 min, some water marks occurred at the upper surface of the test slab due to evaporation of moisture and water migration. At 44 min, most soleplates had been burned through and fell off seriously. At 69 min, various hairline cracks began to appear at the top surface of the test slab; accordingly, lots of water vapor escaped from the cracks. At 119 min, an increasing number of longitudinal cracks parallel to the frame hidden girders appeared. At 268 min, the furnace was switched off in account of testing safety, although the test slab was not burned through significantly. Unfortunately, the crack spread during the cooling phase was not supervised. Therefore, some information of cracks was missing.

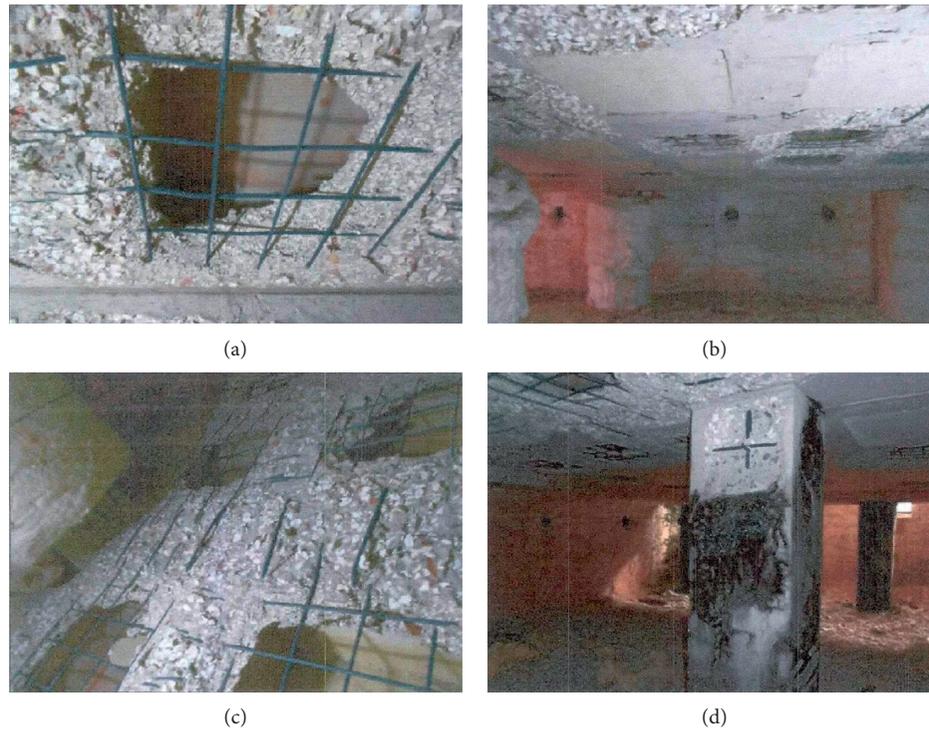
FIGURE 11: Concrete spalling at the bottom surface of the AMH slabs. (a) Burn through of soleplates, (b) without burn through of soleplates, (c) ribbed or frame hidden girders, and (d) column ends.

After the fire test, partial tiny cracks inevitably closed, but the main concrete spalling at the bottom surface of the test slabs were retained as shown in Figure 11.

Obviously, most of soleplates of congruent boxes turned white and fell off seriously, and only a few of soleplates were not burned through, but the frame plates showed almost no

damage, which protected two sides of the ribbed girders and frame hidden girders against fire effectively. Thus, it seemed that they only subjected to fire directly at the bottom

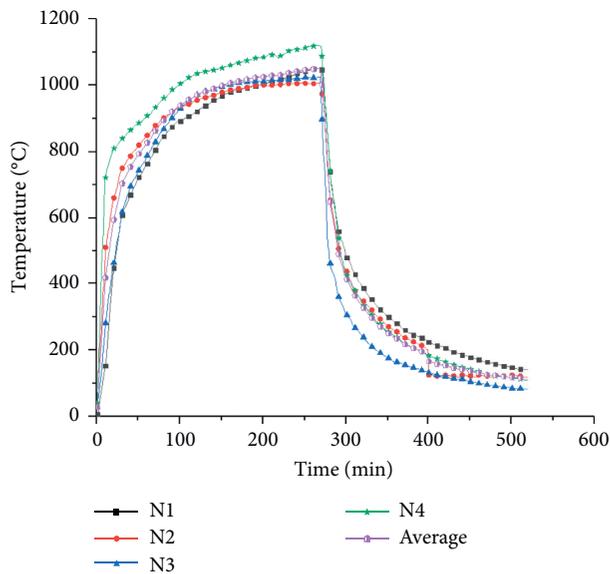
FIGURE 12: Recorded temperature-time relationships.

**4.2. Gas Temperatures.** Four types of K thermocouples N1–N4 were used to monitor the furnace temperatures. As shown in Figure 12, the furnace temperature curves were similar to the standard ISO834 curve. During the fire test, the curves initiated a sharp rise and then continued to increase slowly until the furnace was shut off. The peak temperatures at 268 min after ignition were 1122, 1007, 1029, and 1050°C, with an average value of 1052°C. After the furnace was shut off, the gas temperature dropped quickly until termination

of the test at 520 min after ignition. Apparently, the furnace temperature distributed evenly within the furnace during the fire test.

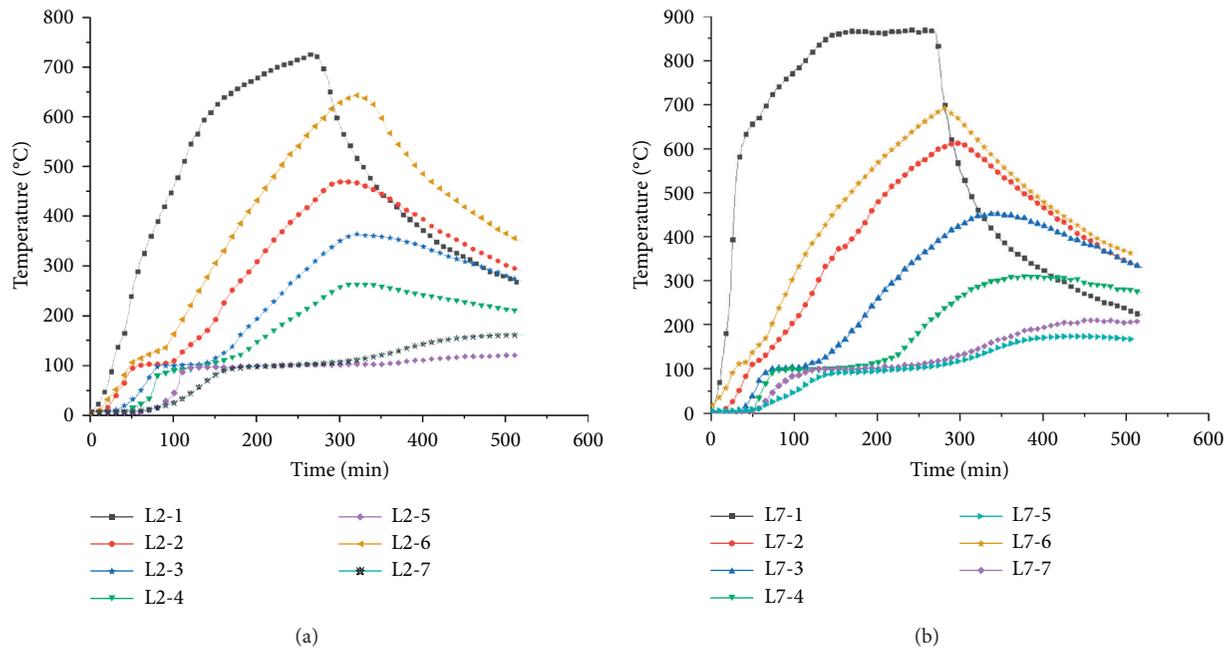
FIGURE 13: Temperature-time relationships of ribbed girders. (a) L2 measure point; (b) L7 measure point.

**4.3. Temperatures of Ribbed Girders.** During the fire test, Type K thermocouples were used to measure the concrete and reinforcing steel temperatures. Two thermocouple trees L2 and L7, as shown in Figure 7, were chosen to analysis the temperature distributions of ribbed girders because all measure points received similar temperature curves during the fire test. Figure 8 shows the details of the layout of the thermocouple trees L2 and L7. Figure 13 shows the temperatures of thermocouple trees L2 and L7 in the ribbed girders. The peak temperatures at bottom of ribbed girders were 730°C and 874°C, respectively, due to different levels of concrete spalling. The temperatures at the upper parts were

much lower than those at bottom surfaces compared with the conventional reinforced concrete beams subjected to fire, because the frame plates of the congruent boxes can protect the ribbed girders effectively; in other words, it seemed that only the bottom surfaces were exposed to fire. Thus, the ribbed girders in the test slab could form a reliable framework, which maintained the load bearing function during the fire test. The temperature curves of thermocouples 2–4 at the

central part of the ribbed girders initiated a slow rise and then continued to increase sharply as the fire developed until the furnace was shut off. This was due to that the ribbed girders were changed gradually from single surface subjected to fire to three surfaces subjected to fire [2]. Figure 13 also shows the temperatures of the top and bottom reinforcing bars during the fire test. The maximum temperatures of top reinforcing bars at L2 and L7 measure points were 175°C and 161°C, respectively. Thus, the top reinforcing bars remained low temperatures without significant strength loss. However, the maximum temperatures of bottom reinforcing bars reached 643°C and 693°C, respectively. Thus, their yield strength dropped markedly due to their elevated temperature [20]. Figure 13(a) also shows that the temperatures of bottom reinforcing bars continued to increase dramatically after the shut off time, because heat conduction from the heated air within the congruent box to the ribbed girders held on, while Figure 13(b) never occurred above the phenomenon because the soleplates around the test ribbed girder were burned through and fell off; correspondingly, the temperatures recorded by L7 were relatively higher.

The temperatures at upper parts of the ribbed girders showed a clear plateau during the temperature rise phase at about 100°C level due to water evaporation. Additionally, after the furnace was shut off, the temperatures at upper parts continued to increase because heat conduction from the heated side to the unheated side held on as a result of temperature differentials. The above phenomenon also occurred during the heating of conventional reinforced concrete beams [21].

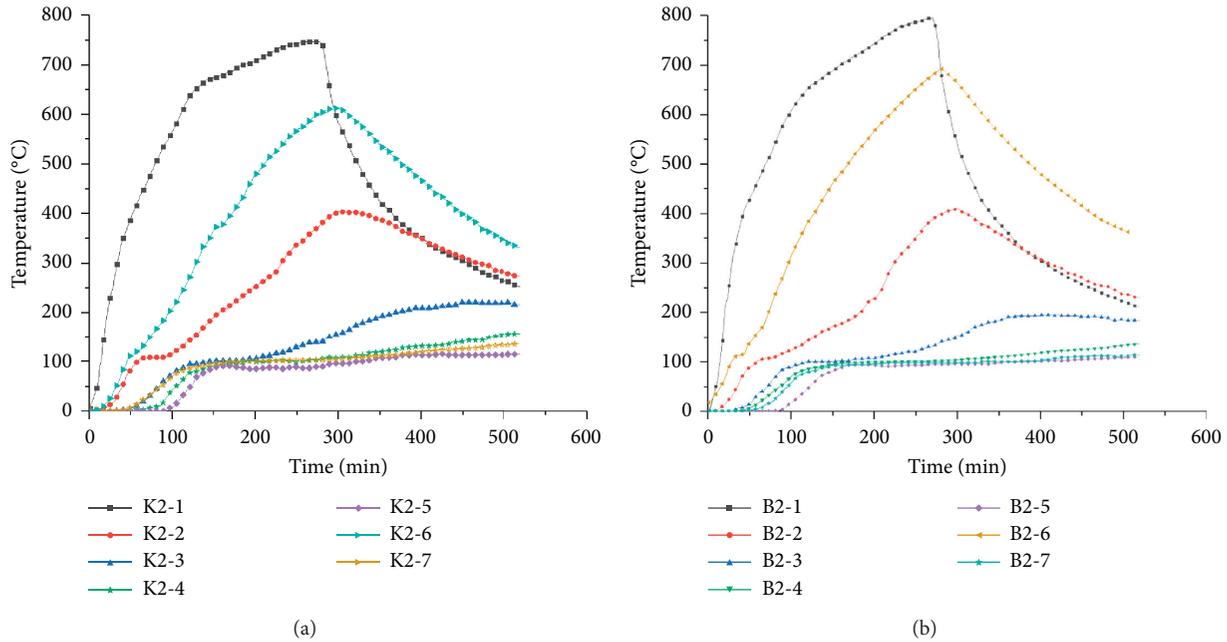
FIGURE 14: Temperature-time relationship of frame hidden girders and edge girders. (a) K2 measure point; (b) B2 measure point.

As shown in Figure 14, thermocouple trees K2 and B2 were chosen to discuss the temperature distributions of frame hidden girders and edge girders, respectively, because relevant temperature measure points recorded similar temperatures. Five thermocouples were embedded every 75 mm along the depth of frame hidden girders to only record the temperatures of concrete measure points; the maximum temperature at the bottom surface was 743°C at the shut off time. Obviously, the frame hidden girders received similar temperature distributions compared with the ribbed girders around which the soleplates were not burned through. While in edge girders, five thermocouples were attached every 100 mm distance along the section height to record the temperatures of concrete measure points and the maximum temperature at the bottom surface was 797°C, which was relatively high compared with that in frame hidden girders, because both the bottom surface and partial side surface were subjected to fire directly. Due to concrete spalling at the bottoms of frame hidden girders and edge girders, the maximum temperatures of bottom reinforcing bars reached 613°C and 692°C, respectively. But, the top bars remained low without significant strength loss.

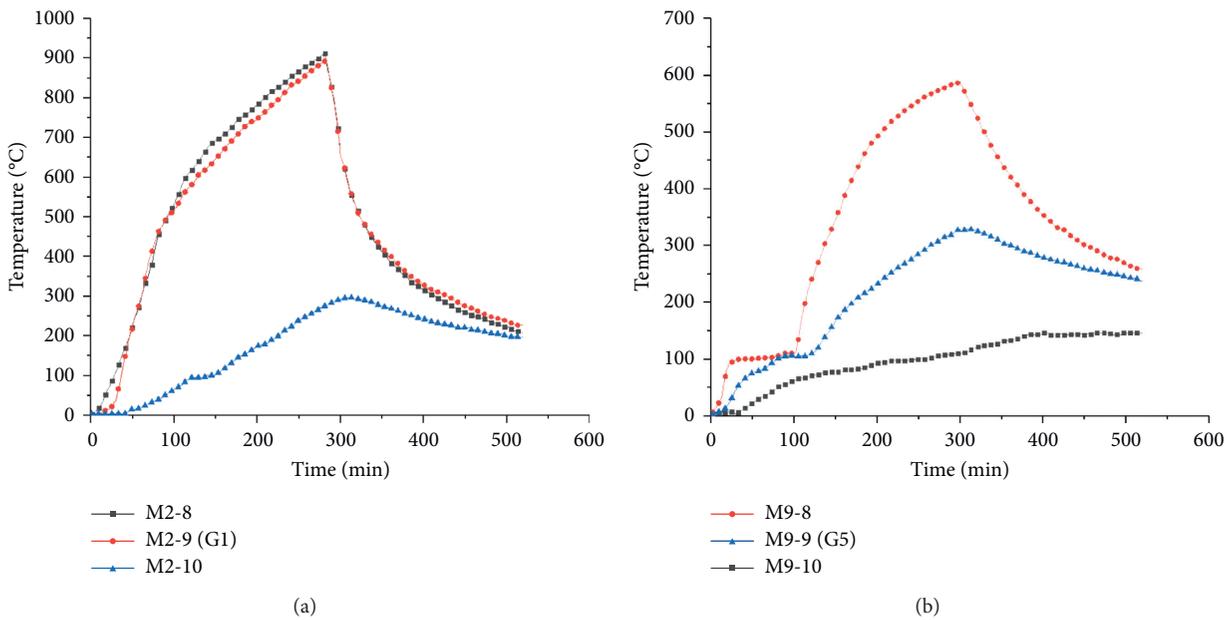
FIGURE 15: Temperature-time relationships of the congruent boxes. (a) M2 (G1); (b) M9 (G5).

**4.5. Temperatures of Congruent Boxes.** As mentioned above, most soleplates of congruent boxes began to generate concrete spalling and were burned through quickly at the early stage of the fire test. During the fire test, most soleplates were burned through and fell off seriously. Figure 15(a) shows the temperatures recorded by thermocouples M2 and G1 within congruent boxes, and their soleplate were burned through during the fire test. Apparently, temperatures of air within the congruent boxes and the soleplates were basically

the same and obviously much higher than that of the top plates. The maximum temperature of air reached 888°C, which led to serious concrete spalling of the top plates. Figure 15(b) shows the temperatures of the thermocouples M9 and G5 plotted as a function of time under the condition that the soleplates were not burned through. It could be found that the temperature gradients increased slowly at the initial stage and then quickly after 100 min of the fire test. The temperatures of the soleplates showed a clear plateau during the temperature rise phase at about 100°C level due to evaporation of water. After the furnace was shut off, the temperatures of the top plates of the congruent boxes continued to increase because heat conduction from the heated air within the congruent boxes to the top plates held on. Therefore, avoiding premature explosion of the soleplates of congruent boxes was crucial to improve the fire resistance of the AMH slab.

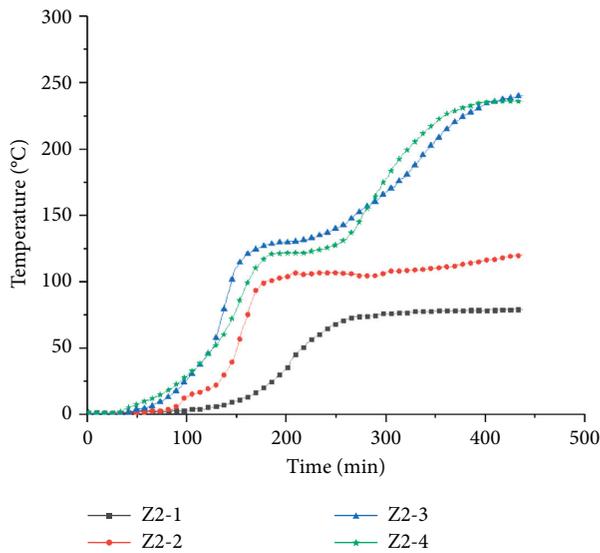
FIGURE 16: Temperature-time relationships of slab-column connections.

**4.6. Temperatures of Slab-Column Connections.** To maintain the stability of the test building, the slab-column connections were all protected from furnace heating by the aluminium-silicate refractory fiber blankets. Figure 16 shows the temperatures of the thermocouple tree (Z2). Within Z2, four thermocouples numbered Z2-1 to Z2-4 were placed at 20, 150, 280, and 430 mm intervals from the up surface of the test slabs to measure temperatures of the slab-column connection. The temperatures recorded continued to rise until 438 min after ignition due to heat conduction from the heated areas to the connections. Regrettably, the temperatures between 438 min and 520 min (shut off time) were not recorded because of equipment failure. The final temperatures recorded did not exceed 240°C, thus the effect of temperatures on the reinforced concrete columns was not noticeable.

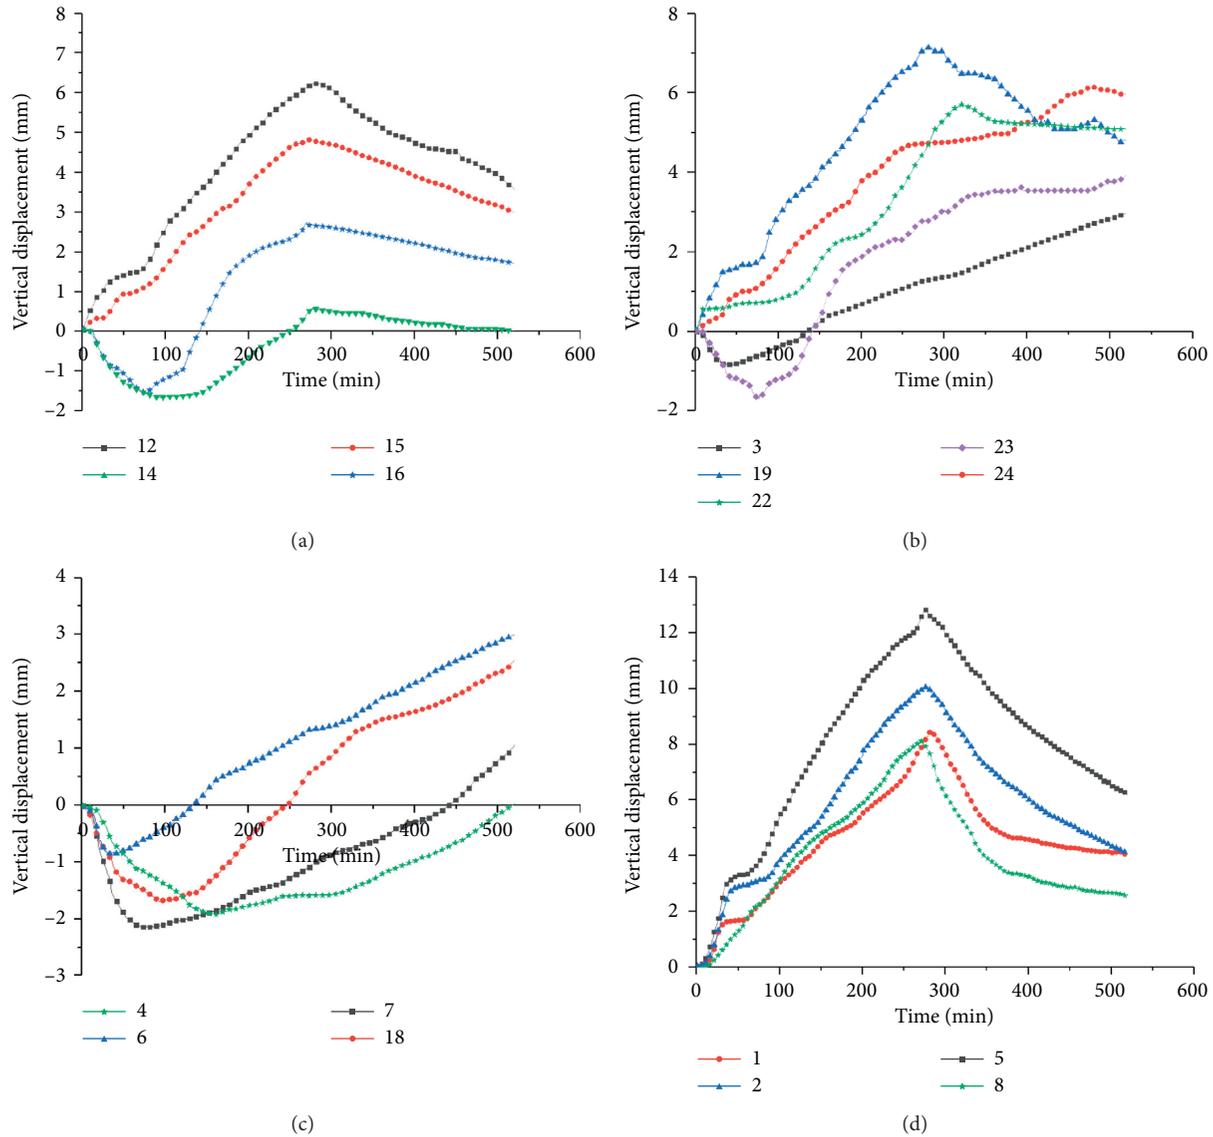
FIGURE 17: Vertical deflections-time relationship of the AMH slabs. (a) Panel A; (b) panel B; (c) frame hidden girders; (d) edge girders.

4.7. Deflection Analysis. As discussed earlier, the displacements were measured by a set of LVDTs as shown in Figure 9. Figure 17(a) shows the variation of the vertical displacements of panel A plotted against time during the heat-up and cool-down phases. Obviously, the deflections at the central point of panel A were upward because the thermally induced deformation (directed backwards the fire) is larger than the deflection due to load [22]. The maximum displacement recorded at the central point was 6.2 mm, which corresponded to the maximum furnace temperature

of 1050°C at the shut off time. It also indicated that the deflections of measurement points 15 and 16 at the upper surface of panel A were not symmetric due to the asymmetric boundary conditions. This phenomenon occurred due to the upward curvature and torsion of the heated edge girders, which provided additional displacements to point 15. Furthermore, the vertical displacements at points 14 and 16 were negative at the initial heating stage and changed gradually into positive displacements as the fire continued; the main reasons were as follows: firstly, 13 min after

ignition, the soleplates began to show surface spalling and fell off quickly, which led to stiffness degradation of the panel A; thus, the downward deformation increased gradually; secondly, as the soleplates were burned through and exited the work, the structural system transformed into the ribbed floor system, which postponed the high temperature deformation. Meanwhile, the column strips turned gradually into frame hidden girders, which led to abrupt stiffness degradation. In fact, the above phenomenon is a complex interaction of the panel A and adjacent frame hidden girders. After the furnace was shut off, the displacements gradually recovered. Obviously, the panel A showed strong displacement restoring capacity after cooling.

Figure 17(b) shows vertical displacements of panel B plotted as a function of time. The maximum upward displacement of panel B recorded by measure point 19 at its central point was 7.2 mm, and it was larger than the maximum displacement of panel A due to stronger constraints around the panel B. After the furnace was shut off, the displacements began to recover slowly and fluctuation remained and the final residual deflection was 4.8 mm. The displacements at measure points 3 and 23 were approximately equal due to similar boundary conditions. The displacements were all negative during the first 140 min of fire due to serious concrete spalling at the soleplates of congruent boxes and growing longitudinal cracks parallel to frame hidden girders, after which the displacements reversed and continued to increase until the test was terminated due to the remaining big flexural stiffness and constrained thermally induced deformation (upward). The displacements at points 22 and 24 always showed positive displacements; this was due to the upward displacements of the adjacent heated edge girders and frame hidden girders.

Figure 17(c) shows the midspan displacement changes of frame hidden girders. Obviously, they had similar deflection stages during the fire test. The maximum positive

displacements at measure points 6 and 18 exceeded that at the measure points 4 and 7 because of greater boundary restraints. At neighboring measure points 4 and 7, premature concrete spalling at the soleplates of congruent boxes occurred, which alleviated the constrained thermal expansion effectively, thus almost all negative displacements were observed at measure points 4 and 7. During the fire test, an increasing number of longitudinal cracks parallel to the frame hidden girders appeared and developed quickly; accordingly, frame hidden girders (columns strips) have become the frame beams; thus, the upward displacements at all measure points of the frame hidden girders increased slowly due to reduction of overall stiffness. After the shut off time, the displacements at measure points 6 and 18 maintained fluctuation due to complex stress redistributions within the AMH slabs.

Figure 17(d) shows the midspan displacements plotted as a function of time of edge girders. Obviously, the edge girders had similar deflection stages during the fire test. In the initial heating stage, a clear plateau occurred in the displacements at the measurement points 1, 2, and 5; the main reasons were as follows: firstly, as the fire continued, the mechanical properties of the edge girders deteriorated gradually; additionally, the soleplates of the congruent boxes showed surface spalling and fell off quickly, which further led to stiffness degradation, and thus the vertical deformation increased gradually; secondly, as the soleplates of the congruent boxes were burned through and exited the work, the edge girders transformed into the frame girders, which postponed the high-temperature deformation. While the displacements at the measurement point 8 never exhibited plateau phenomenon, because some soleplates of the congruent boxes around the edge girder were not burned through and kept working. Thus, the integrity of the edge girder was kept, and the stiffness degradation was relatively low.
