# Experimental Analysis of Seismic Performance of Masonry Shear Wall Reinforced with PP-Band Mesh and Plastering Mortar under In-Plane Cyclic Loading

*School of Civil Engineering and Architecture, Nanchang University, Nanchang 330031, China*

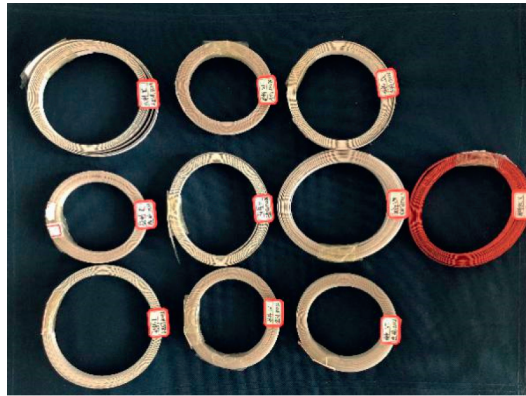
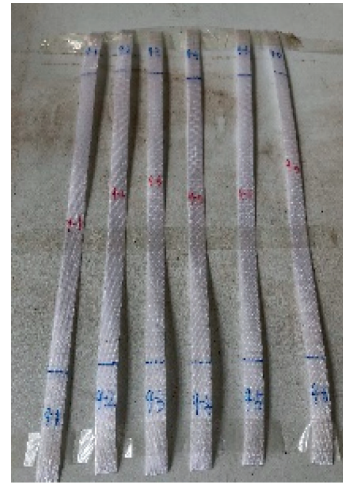
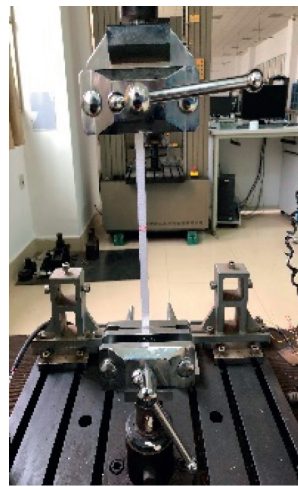
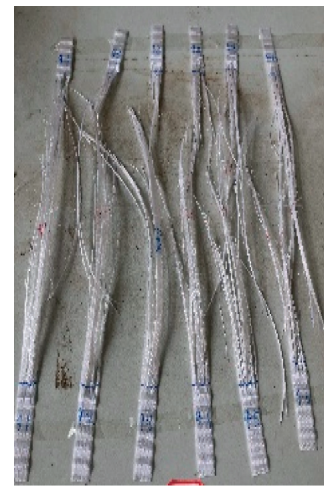
FIGURE 1: PP-bands tensile test. (a) 10 kinds of PP-band samples, (b) PP-band before test, (c) tensile mechanical properties test of packing strap, and (d) PP-band after test.

**2.1.2. Mechanical Property Test of Different PP-Band.** According to the relevant statements in [25], we have selected 10 kinds of PP-band with the different size, color, and transparency for tensile test (Figure 1).

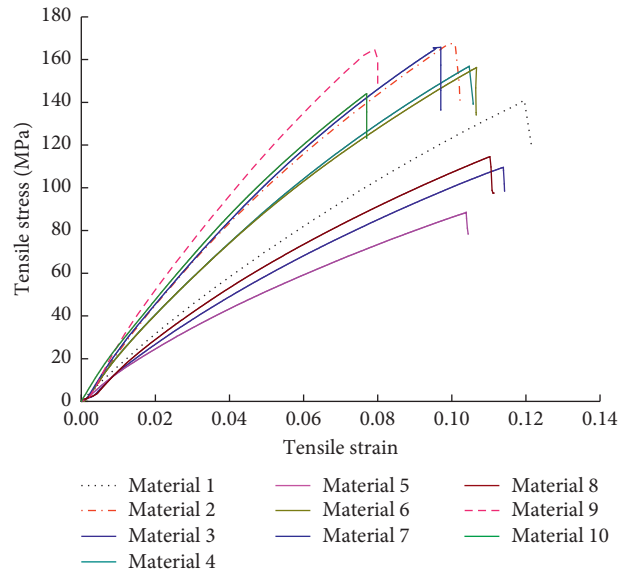
FIGURE 2: Stress-strain curve.

The stress-strain curve of each kind of PP-band samples is shown in Figure 2. It can be seen from the figure that the material 9 and material 2 have stronger ultimate tensile strength. But the ultimate tensile strain of material 2 is better, while the elastic modulus of material 9 is larger. Although material 1 has the strongest ultimate tensile strain, its ultimate tensile strength is weak. The ultimate tensile strength of 10 materials is compared and we chose material 1, material 2, and material 9 as the research object. The basic mechanical properties of material 1, material 2, and material 9 are shown in Table 2.

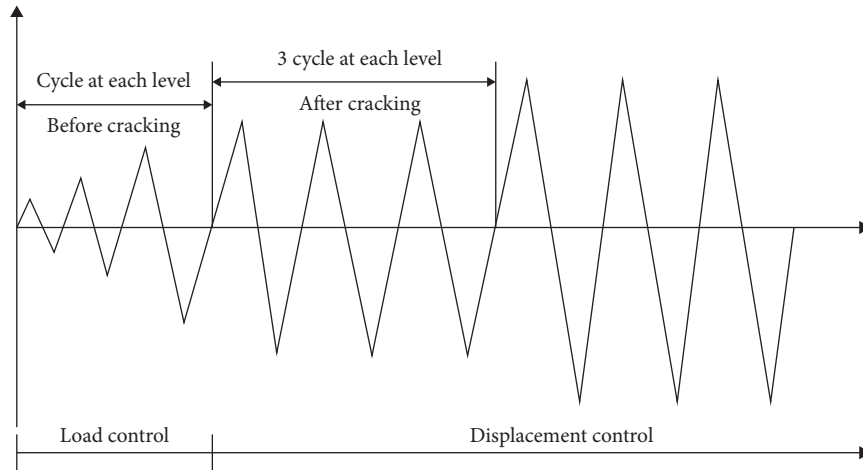
FIGURE 5: Loading system.

The test adopts the load-displacement mixed loading mode. The loading system diagram is shown in Figure 5. Before the wall is cracked, load control is adopted. The horizontal cyclic force is loaded stage by stage; the increment of each stage is 20 kN. Each stage cycle is run for 1 time. After wall cracking, displacement control is adopted. Taking the cracking displacement  $\Delta_c$  as an increment to load stage by stage, each stage cycle is run for 2 times. Stop loading until the load-bearing capacity of the wall drops to 85% of the ultimate load.

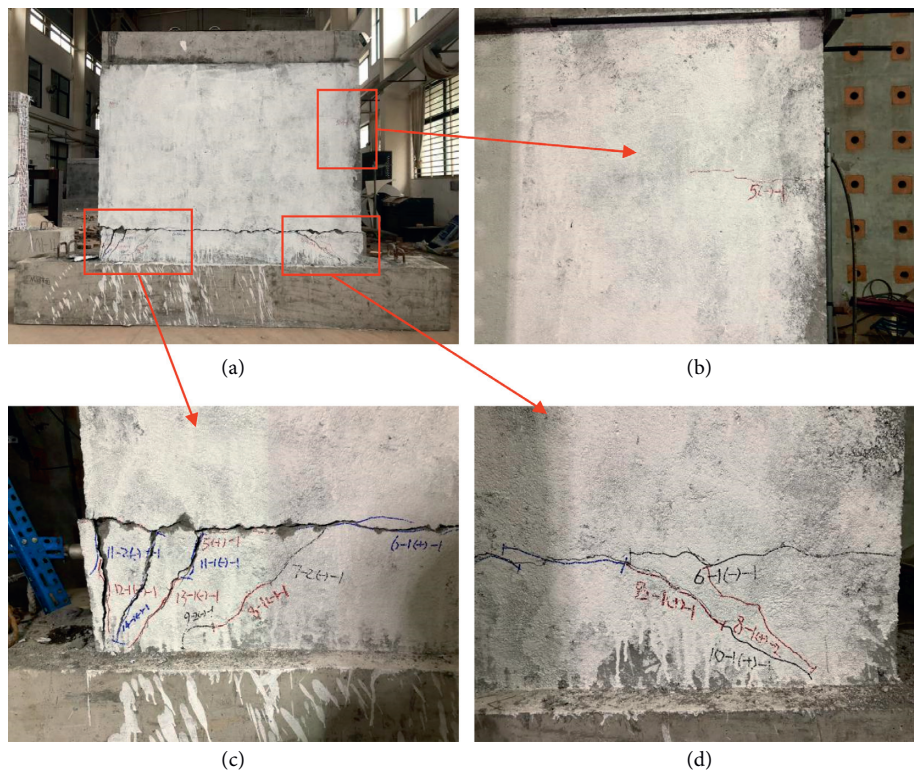
FIGURE 6: Damage mode of unstrengthened specimen W-1. (a) Overall damage, (b) local cracks, (c) damage in the bottom left corner, and (d) damage in the bottom right corner.

**3.1.1. General Observation for Specimen W-1.** Before loading to 110 kN, the wall had no visible cracks, and the specimen was basically in the elastic state. When the forward force (from left to right, the same below) loaded to 115 kN, the first horizontal crack appeared at the 3rd and 4th bricks layers on the lower left side. The length of this crack was about 65 cm and the width was about 0.5 mm. When the forward displacement loaded to 1.8 mm, the crack between the 3rd and 4th brick layers on the left side of the wall developed in the horizontal direction. When the backward displacement (from right to left, the same below) loaded to 1.8 mm, the cracks in the bottom right side of the wall also extended horizontally and formed a through-slit. Due to the formation of horizontal through-slit, no new cracks appeared in the upper part of the wall. As the displacement increased, the

wall below the through-slit was squeezed. Finally, a lot of oblique cracks were formed at the lower left and right sides of the horizontal crack. The bricks on both sides of the bottom were crushed and the plastering mortar had a slight shedding. The damage is shown in Figure 6.

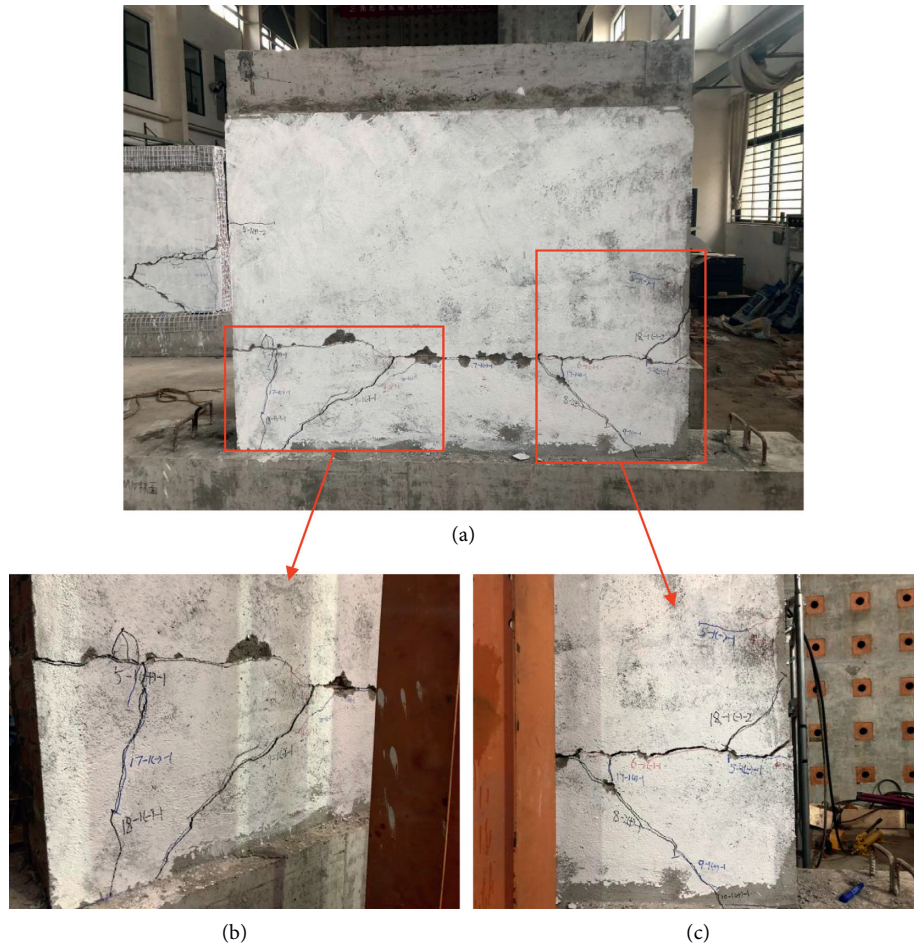
FIGURE 7: Damage mode of unstrengthened specimen W-2. (a) Overall damage, (b) damage in the bottom left corner, and (c) damage in the bottom right corner.

**3.1.2. General Observation for Specimen W-2.** When the reverse force loaded to 120 kN, a thin crack with a length of about 20 cm and a width of about 0.2 mm appeared at the lower right side of the wall. When the forward displacement loaded to 1 mm, a horizontal crack with a length of about 80 cm and a crack width of about 1 mm appeared at the lower left side of the wall. When the displacement loaded to 1.5 mm, the cracks on both sides continued to develop in the middle horizontal direction. When the displacement loaded to 2 mm, the horizontal cracks between the 7th and 8th brick layers on the left and right sides were connected. When loaded to 3 mm, the horizontal cracks on both sides of the wall penetrated down to the bottom of the wall along the diagonal of about 45°. After that, as the displacement increased, the crack width gradually increased, part of the plastering mortar fell off, and a vertical crack was formed at the bottom left side of the wall. The damage is shown in Figure 7.

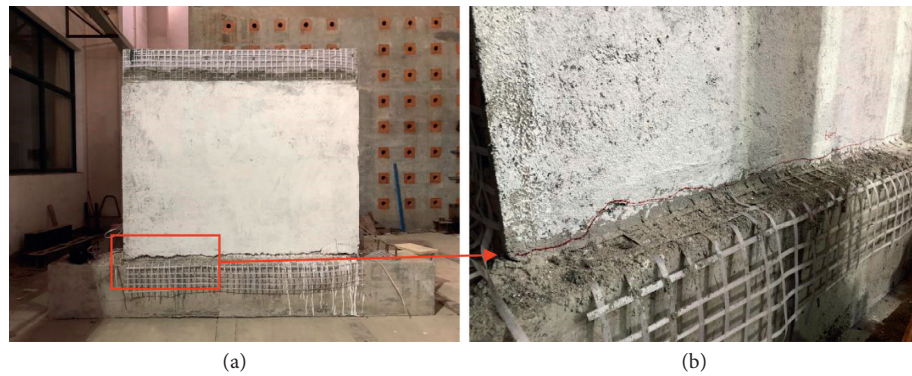
FIGURE 9: Damage mode of unstrengthened specimen JW-2. (a) Overall damage and (b) local cracks.

**3.2.2. General Observation for Specimen JW-2.** No cracks appeared in the wall before loading to 130 kN. When the forward force loaded to 130 kN, a crack with a width of about 2 mm was formed at the bottom left side of the wall. When loaded to 130 kN, the bottom of the right side of the wall was cracked, and a through-slit formed at the bottom of the wall. Then the displacement control was adopted. With the increase of the displacement, there was no new crack on the surface of the wall, the horizontal crack at the bottom was widened, and the corner was partially crushed. The horizontal load continued to rise at this moment. At the later stage of loading, the wall was sliding on the bottom beam. The load-carrying capacity gradually decreased; finally, the shear-slip damage occurred. The damage is shown in Figure 9.

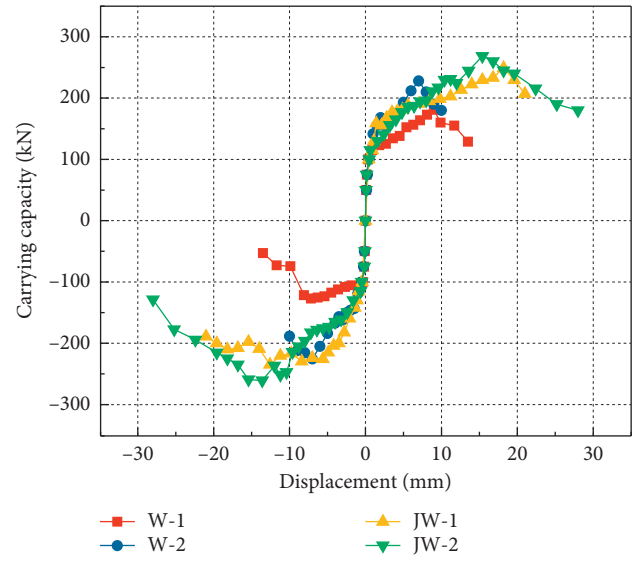
FIGURE 11: Skeleton curves of specimens.

**3.5. Skeleton Curve.** Figure 11 shows the skeleton curve of the four walls in this experiment. The skeleton curve refers to the envelope curve of the hysteretic curve. It can be seen from the figure that the mechanical properties of the four specimens are in different loading status. The skeleton curve is almost straight before cracking, and the wall is in the elastic stage. After the wall cracks, the skeleton curve begins to bend, showing that the loading state of the wall is in a nonlinear state. When the wall reaches the ultimate load, the bearing capacity decreases and the wall is in the state of failure.

- (1) After reaching the ultimate load, the skeleton curve of specimens W-1 and W-2 drops faster. Due to the higher strength of the plastering mortar of the specimen W-2, its ultimate load is greater than W-1. Although the plastering mortar reinforcement can increase the ultimate load of the wall, it does not constrain the cracking process of the wall.

- (2) After reaching the ultimate load, the skeleton curve of specimens JW-1 and JW-2 declines slowly. It shows that the reinforcement of PP-Band can restrain the extension of crack and damage to the wall. The strength of the plastering mortar has a certain influence on the reinforcement effect of the PP-Band. Specimen JW-2 with high strength plastering mortar, ultimate load, and ultimate displacement are greater than the specimen JW-1. It indicates that PP-band reinforcement with higher strength plastering mortar can better improve the integrity between the wall and PP-band.

- (3) The ultimate load of the PP-band reinforced specimens JW-1 and JW-2 is larger than the unreinforced specimens W-1 and W-2. In the forward loading, when the PP-band reinforced specimen reaches the peak load, the corresponding displacement is larger than of that unreinforced specimen. It shows that the specimens reinforced by PP-band have the better bearing capacity and deformability.

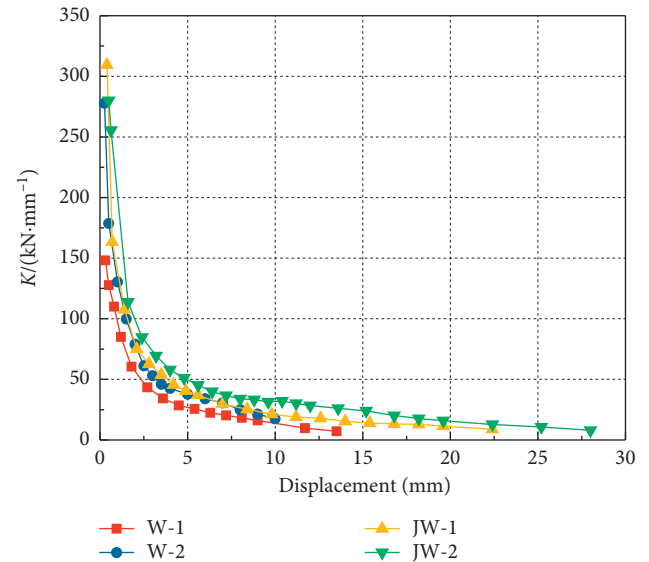
FIGURE 12: Stiffness degradation curve.

In Figure 12, the secant stiffness is used to express the degradation of the specimens' stiffness. The abscissa represents the horizontal displacement, and the ordinate represents the ratio of the secant stiffness of each stage [26]:

Figure 12 is the stiffness degradation curve obtained by the above formula.

- (1) In the elastic stage, the longer the curve the greater the stiffness. It can be known by comparison that, in the elastic stage, the curve length of specimens JW-1 and JW-2 is longer than that of specimens W-1 and W-2. This shows that PP-band can improve the stiffness of the wall.
- (2) The higher the stiffness degradation curve the slower the stiffness degradation. By comparison, it can be seen that the stiffness degradation curve of specimen W-1 is lower than that of JW-2. The stiffness degradation of JW-1 lags behind the W-2. This shows that the strength of plastering mortar and PP-band has a certain influence on the stiffness degradation. The higher the strength of plastering mortar, the

slower the stiffness degradation. The reinforcement of the PP-band has a greater impact on stiffness degradation. The joint reinforcement of the PP-band and plastering mortar has a better restraint effect on the masonry wall, which enhances the integrity of the wall.

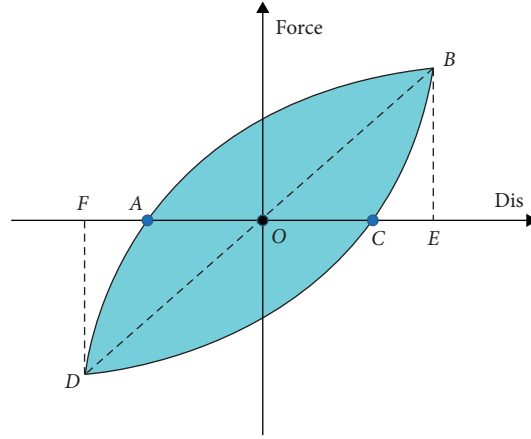
FIGURE 13: Calculation of energy dissipation coefficient.

Energy dissipation capacity is an important indicator to measure the seismic performance of a structure. The energy dissipation capacity of the structure is usually determined by the energy dissipation coefficient  $E$  or the equivalent viscous damping coefficient  $\zeta_{ep}$ , which is calculated by the area enclosed by the displacements load curve (Figure 13). The energy dissipation coefficient  $E$  and the equivalent viscous damping coefficient  $\zeta_{ep}$  are calculated as follows [26]:

$$E = \frac{S(ABC + CDA)}{S(OBE + ODF)}, \quad (3)$$

$$\zeta_{ep} = \frac{1}{2\pi} \cdot \frac{S(ABC + CDA)}{S(OBE + ODF)}, \quad (4)$$

where  $S(ABC + CDA)$  is area enclosed by a hysteresis curve;  $S(OBE + ODF)$  is sum of area of triangle OBE and ODF.
