Research Article

Deformation Characterisation and Distress Diagnosis of a Metro Shield Tunnel by Adjacent Constructions

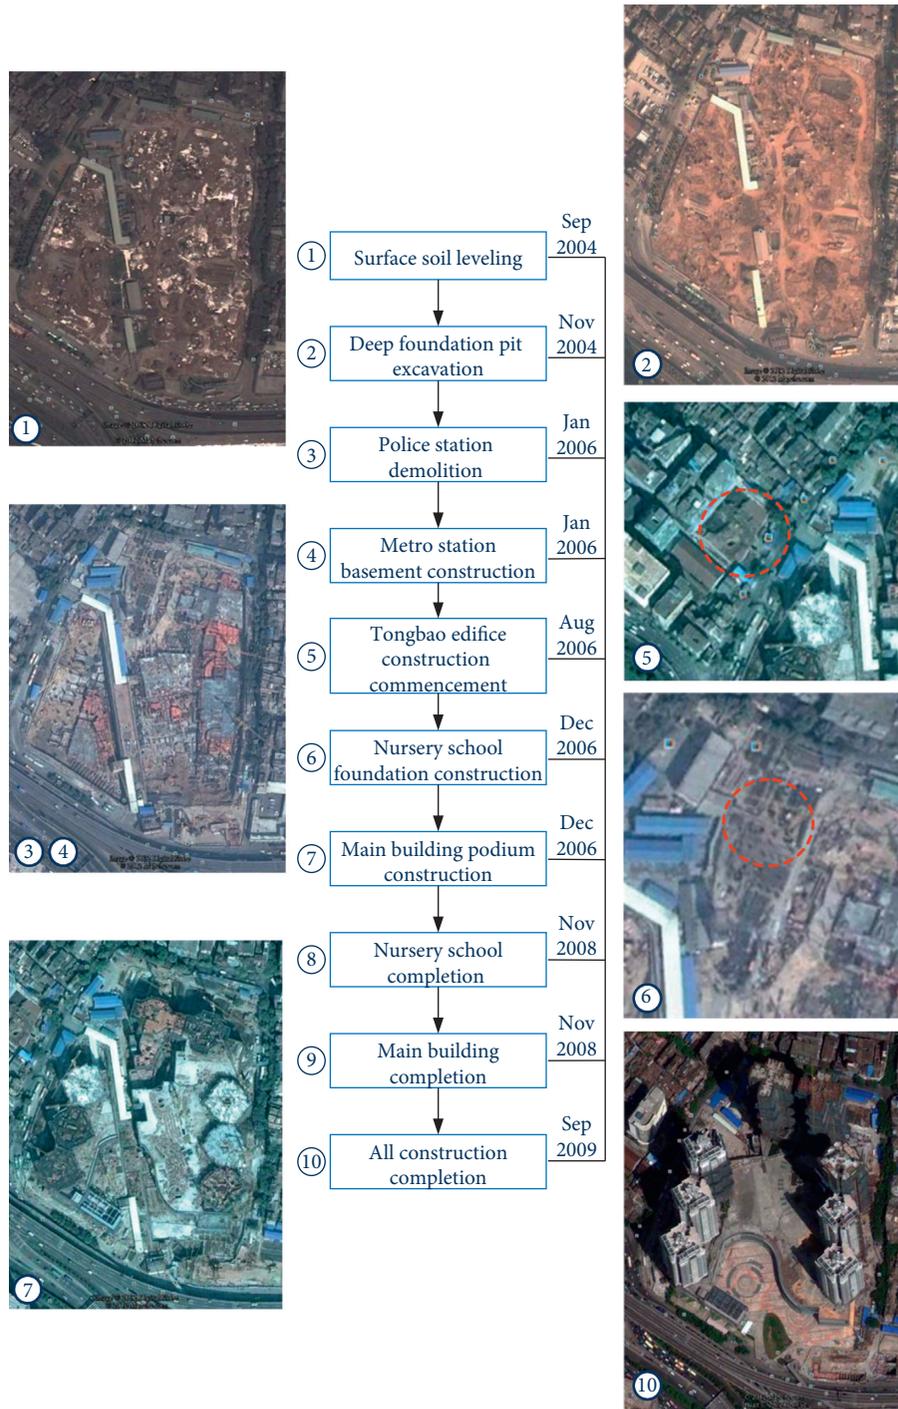
FIGURE 5: Flowchart showing the major stages of construction.

As shown in Figure 5, surface soil levelling commenced in September 2004, followed by a series of different construction stages until the main building completion in November 2008 and the completion of all construction in September 2009. For safety considerations, in tunnel monitoring (every 24 h) of the tunnel deformation was conducted from January 2004 to August 2008 when most constructions were completed. The monitoring results indicated that, since the start of construction, considerable settlements and horizontal displacements were observed, and the tunnel had a significant translation towards the foundation pit excavation.

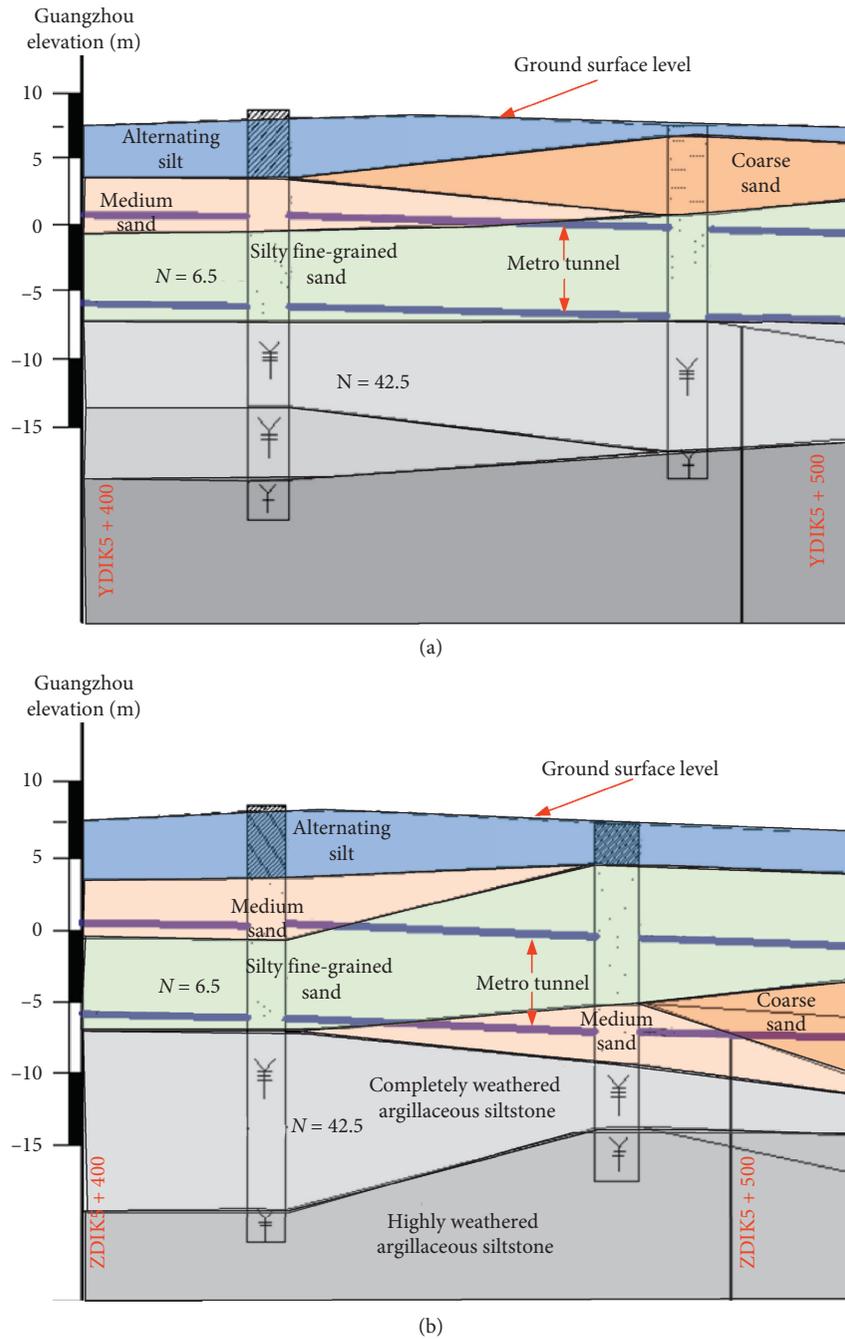
FIGURE 6: Geological profiles of the tunnels. (a) Geological profile of the eastbound tunnel. (b) Geological profile of the westbound tunnel.

2.2. Engineering Geology. Figure 6 shows the geological profiles along the paths of the tunnels. The geology at the worksite generally contains a 5 m thick alluvial formation of alternating silt, a 10 m thick sand formation, and a rock formation below, which represent the typical upper-soft and lower-hard composite strata in the Guangzhou region. The engineering geology shows that the strata surrounding the shield tunnel structure beyond the northern end of the Huangsha station contain mainly fine sand and medium coarse sand. The standard penetration testing (SPT) values of these strata are only 5.0~6.5 hits. However, there is a strong weathered argillaceous siltstone stratum of approximately 1~2 m beneath the tunnel, the SPT values of which are 36~42.5 hits, much larger than those of the upper strata.

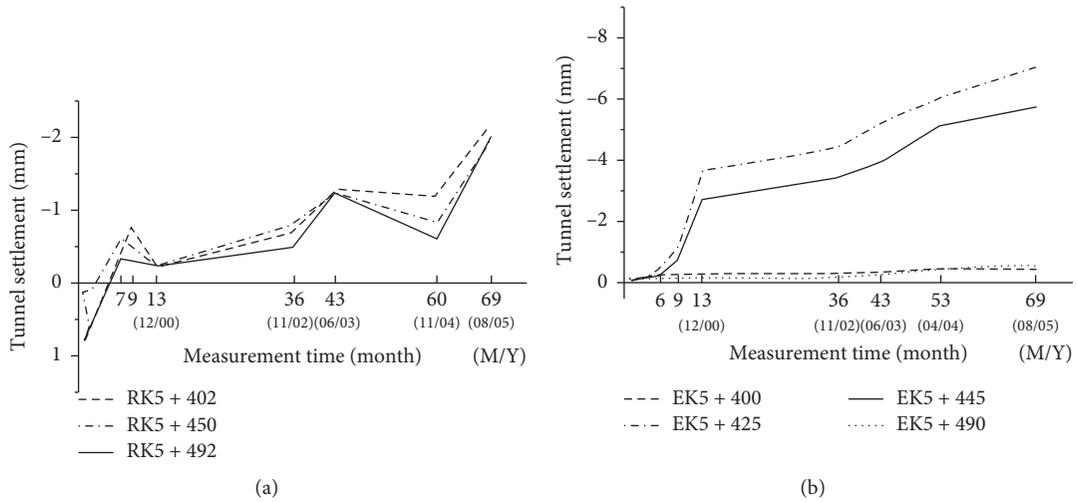
FIGURE 7: Variations in tunnel settlement before construction: (a) westbound tunnel and (b) eastbound tunnel.

3.1. Tunnel Response before Construction. Figure 7 shows the variation in the tunnel settlement following each measurement. Since November 1999, when the monitoring

commenced, until August 2005, that is, before the pit excavation started, the maximum cumulative settlement of the westbound tunnel was measured as 2.25 mm (at survey station WK5+402 with a changing rate of -0.002 mm/d). The maximum cumulative settlement of the eastbound tunnel was -7.15 mm (at station EK5+425.0 with a changing rate of -0.006 mm/d). The comparison between the variation curves of both tunnels indicated that the settlement of the westbound tunnel fluctuated, while that of the eastbound tunnel showed a mild sinking trend. The absolute settlement magnitude of the eastbound tunnel turned out to be larger, but the settlement tended to be stable. The measured maximum horizontal displacement along the two tunnels was less than 2 mm. Therefore, since completion of the tunnels, only natural small-amount settlements were detected in both tunnels.

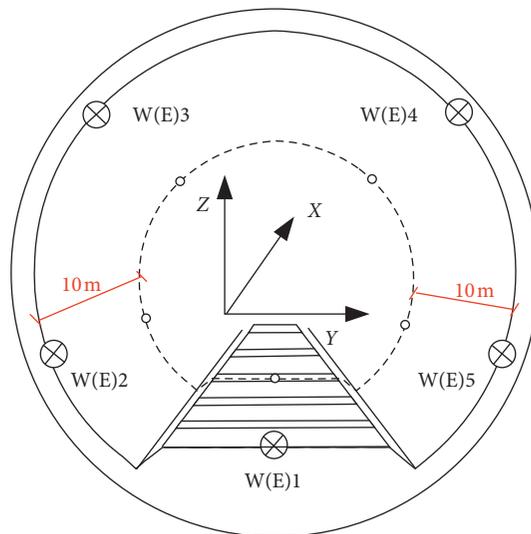
FIGURE 8: Schematic for measuring arrangements.

Figure 8 shows a schematic sketch of the deformation measuring points installed inside the metro tunnel. The measuring rings are 10 m apart. Figure 9 shows photographs of both the measuring instruments and the prisms. As shown in Figure 8, the positive direction of the X -axis of the monitoring coordinate system points along the tunnel path starting from the station, the positive direction of the Y -axis

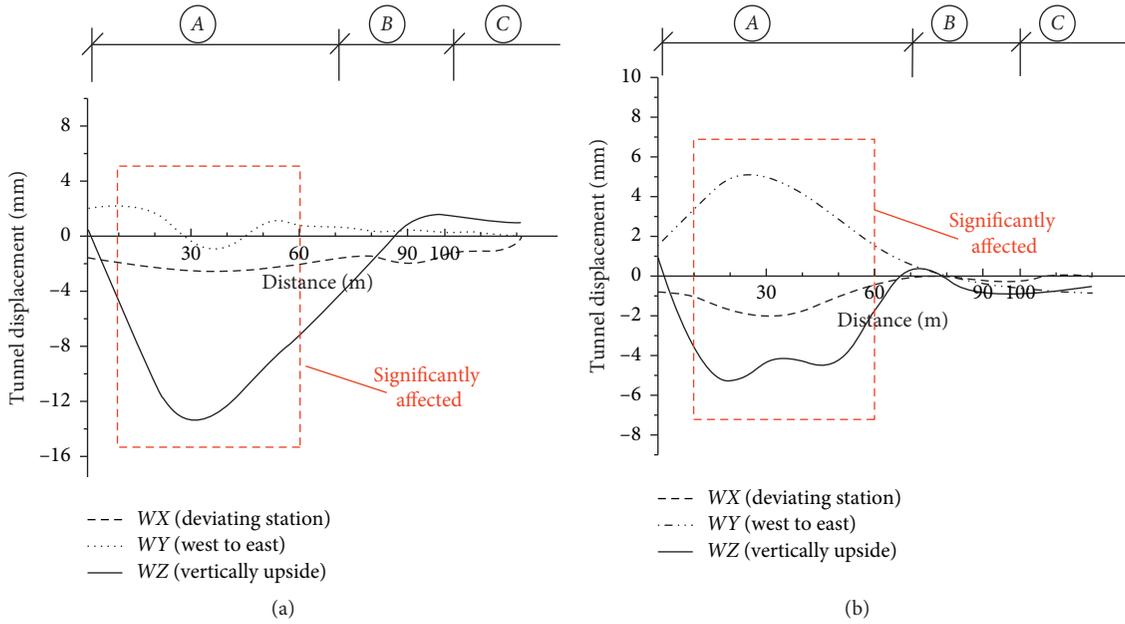
FIGURE 10: Variations in tunnel displacement: (a) westbound tunnel and (b) eastbound tunnel.

Figure 10 shows the integral displacements monitored at each measuring circle of the westbound and eastbound tunnels along the tunnel path starting from Huangsha station. It can be summarized from the variation curves that the deformation of both tunnels occurred mainly in the interval of 0 to 70 m from the north end of the station, especially in the Y - Z planes (Figure 8). The integral translation of the tunnel in this range generally faced the inside of the excavation pit in the northwest corner (Y -positive in Figure 8). Vertical settlements were also observed in both tunnels, while the monitored displacements along the tunnel path were much smaller than those in the Y - Z planes. For the westbound tunnel, the maximum horizontal displacement was measured as 2.6 mm, while the settlement was -14.4 mm, which was detected 30 m from the north end of the station. For the eastbound tunnel, the maximum horizontal displacement was measured as 5.2 mm, while the settlement was -5.1 mm. According to different levels of deformation, the whole tunnel can be divided into three ranges: (a) heavy disturbance (0 to 70 m), (b) moderate disturbance (70 to 100 m), and (c) mild disturbance (more than 100 m). In addition, the section from 10 m to 60 m was defined as the alert range.

An interesting fact is noticed from the variations in the monitored tunnel displacements. Although the average horizontal displacement of the eastbound tunnel was apparently larger than that of the westbound tunnel, the average vertical settlements of the westbound tunnel turned out to be even larger than those of the eastbound tunnel within the alert range defined above, despite the eastbound tunnel being closer to the excavation foundation pit. The authors attributed this difference to the mitigation effect of the demolition of the police station, which was just above the

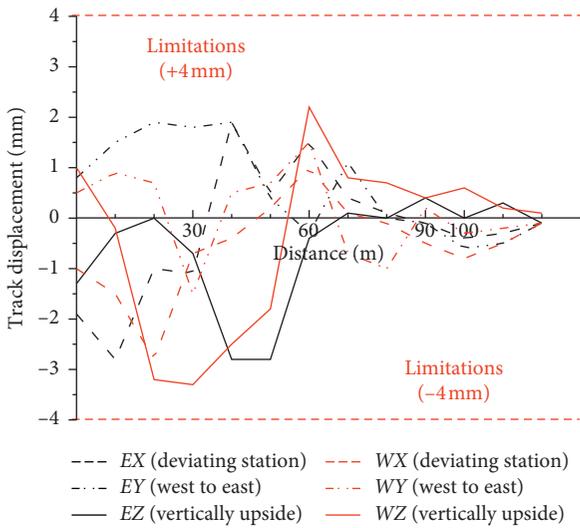
FIGURE 11: Variations in track bed displacement.

Figure 11 plots the variation in the absolute displacements monitored on the track beds, which are often adopted as a tunnel distress stage assessment criterion in practical engineering. The limitation of the absolute displacement of 4 mm on the track bed was recommended to ensure tunnel safety. It can be concluded from Figure 11 that the largest displacements were detected within the range from 0 to

60 m, which is consistent with the tendency observed above. Moreover, the settlements governed the fluctuating amplitude for all three directions, and the maximum settlement was 3.2 mm monitored on the track bed at 30 m from the north end of the station in the westbound tunnel.

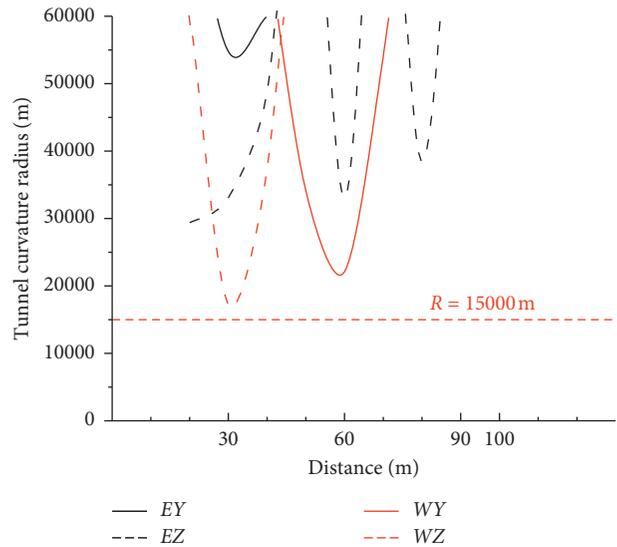
FIGURE 12: Variations in tunnel curvature radius.

Figure 12 shows the curvature radius, equal to the radius of the circular arc, which best approximates the curve at that point of the vertical and horizontal directions of the westbound and eastbound tunnels caused by the pit excavation.

The smaller curvature radius of both tunnels was mainly concentrated in the 0–80 m section of the tunnels. The minimum radius of curvature in the horizontal plane was 19,500 m, occurring 60 m from the north end of the station, while that in the vertical plane was 17,167 m, occurring 30 m away from the north end of the station. This outcome is also consistent with what was observed in Figure 10.

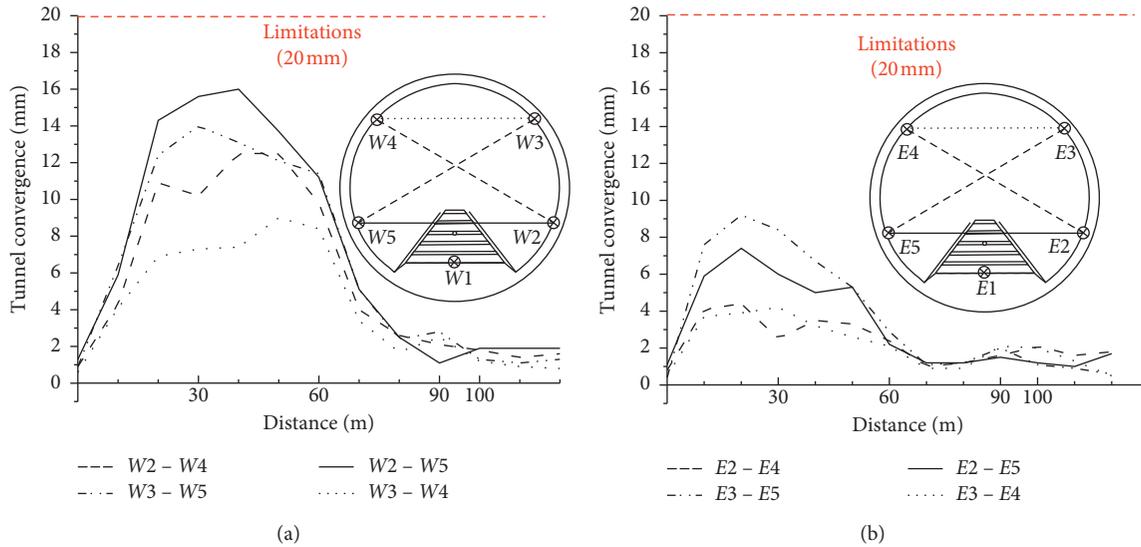
FIGURE 13: Variations in tunnel convergence: (a) westbound tunnel and (b) eastbound tunnel.

Figure 13 shows the variation in the tunnel convergence due to pit excavation. The convergence of the eastbound tunnel between measuring points No. 3 and No. 5 reached a

peak with a maximum of 9.1 mm, which occurred 20 m from the station north end, while the maximum convergence of the westbound tunnel between measuring points No. 2 and No. 5 was 16.0 mm, which occurred 40 m away from the north end of the station. Again, the main convergence occurred mainly in the heavy disturbance range as described above. Moreover, a larger amount of tunnel convergence was observed in the westbound tunnel than in the eastbound tunnel, while the eastbound tunnel was closer to the pit excavation. It is believed that the horizontal translation of the eastbound tunnel drove

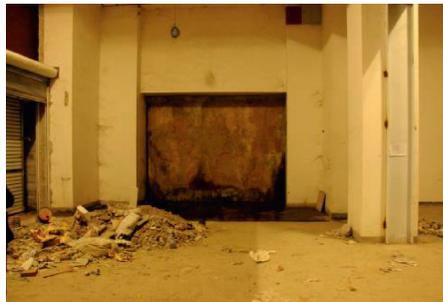
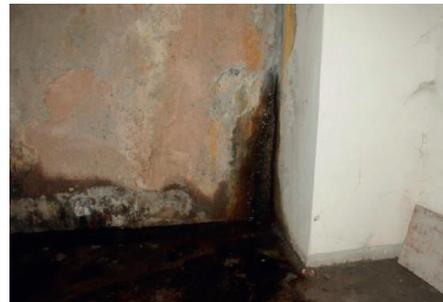
FIGURE 14: Water seeping inside the station.

Those blocks were confirmed to be from a top cracked longitudinal segmental joint (K5 + 404.8). For safe metro operation, professional investigations were conducted to determine the current safety status of the tunnel and how to prevent further tunnel deterioration, which are presented in the following sections.

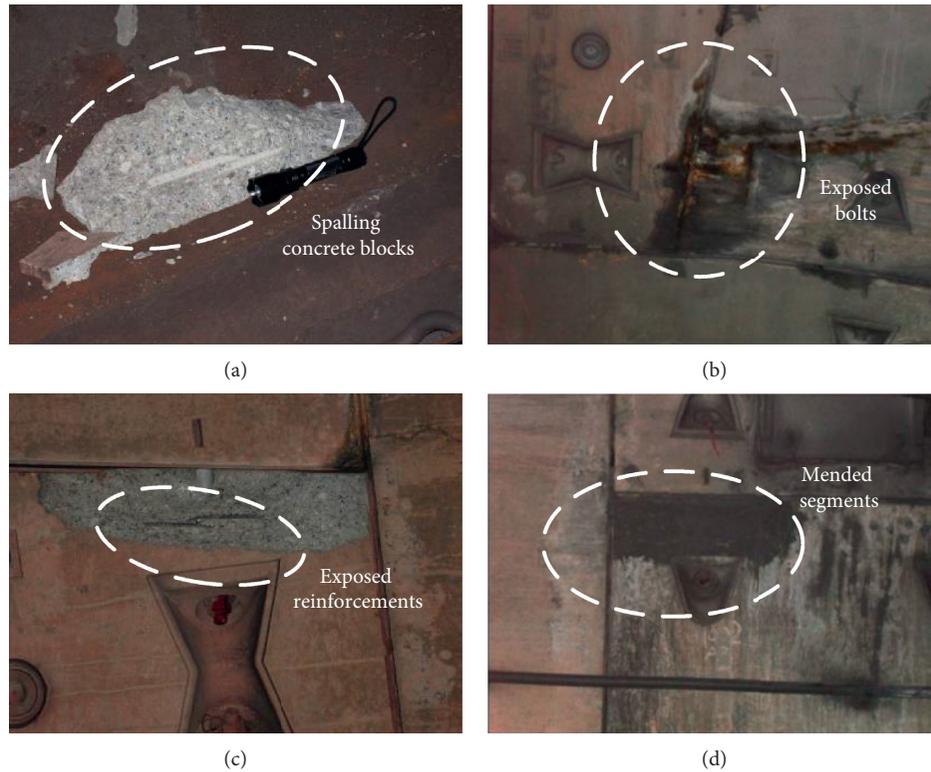
FIGURE 15: (a) Spalling blocks, (b) exposed bolts, (c) exposed reinforcements, and (d) mended segments.

4.1. Spalling Concrete Blocks. In the westbound tunnel, 19 spalling concrete blocks were detected, where segmental reinforcements as well as nine segmental bolts were directly exposed to air. The maximum size of the dropped block was

57 × 13 × 10 cm, located on the 38th ring (45.6 m away from the north end of the station). Within the alert range, the broken segments comprised 14.2% of the total 84 segmental rings. Spalling concrete blocks were mostly found around the circumferential segmental joints in the tunnel vault (known as the key segment). The measured exposure rate of the reinforcements was 14.4% and that of the bolts was 10.7% along the complete alert range of the westbound tunnel. In the eastbound tunnel, 11 spalling concrete blocks were found with segmental reinforcements and bolts directly exposed to the air. The largest size of detached concrete was 56 × 10 × 10 cm, which was located at the fifth ring (6 m away

from the station). After the investigation, the spalling concrete blocks were removed, and the broken segments were then amended with grouting mortar, which is shown in the photographs taken in situ in Figure 15.

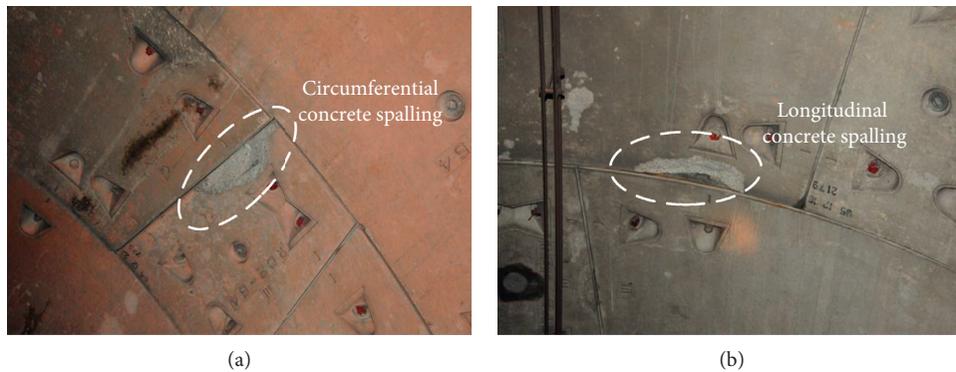
FIGURE 16: Two types of concrete spalling.

Among the spalling blocks found in both tunnels, 76.7% were found along circumferential joints (between the segments of the same ring), and 23.3% were found along longitudinal joints (between the segmental rings). Examples of the spalling blocks around the circumferential and longitudinal joints are shown in the photos in Figure 16, while the amount and location of the falling blocks found in both tunnels are presented in Figure 17. A smaller stiffness between the longitudinal segmental rings was believed to contribute to less stress on the concrete along corresponding hand holes, which is why fewer longitudinal spalling blocks were found.

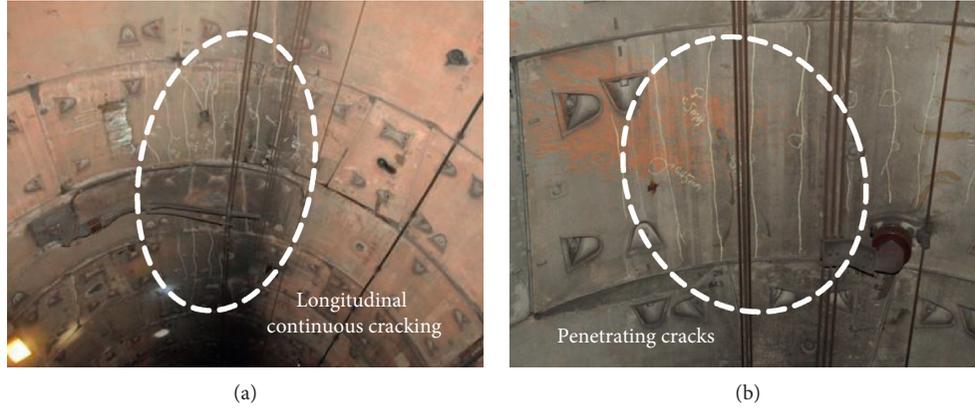
FIGURE 18: Cracking tunnel.

4.2. Segmental Cracks. 143 cracks were detected in the westbound tunnel, and 119 cracks were identified in the eastbound tunnel. Most of the cracks propagated throughout the segments along their width (i.e., the length exceeded 1.20 m). The maximum widths of the cracks were measured to be 0.53 mm and 0.51 mm, appearing on the 22nd segment (26.4 m away from the station) and 47th segment (56.4 m away from the station) in the westbound and eastbound tunnels, respectively, which are shown in the photographs taken in situ in Figure 18.

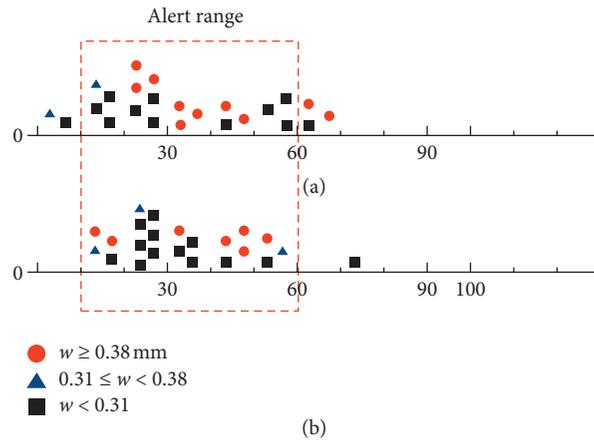
FIGURE 19: Distribution of cracking segments: (a) westbound tunnel and (b) eastbound tunnel.

According to the analysis presented later in Section 5, the segments with different crack widths were then classified into three groups according to their maximum crack widths, as shown in Table 2. Figure 19 shows the distribution of the cracking segments with various crack widths, where a red circle indicates a cracking segment with a maximum crack width $w \geq 0.38$ mm, a blue triangle indicates a maximum crack width $0.31 \text{ mm} \leq w < 0.38$ mm, and a black rectangle indicates a maximum crack width $w < 0.31$ mm. The classifications are discussed later in Section 5. The cracking segments with large crack widths were mostly found within the alert range of the tunnels, which was consistent with the tunnel deformation responses described in Section 3. Apparently, the cracking was more severe in the segments of the westbound tunnel than that in the eastbound tunnel. To determine how the tunnel deformed, postdistress monitoring was then conducted, and the results are shown in Section 4.4.

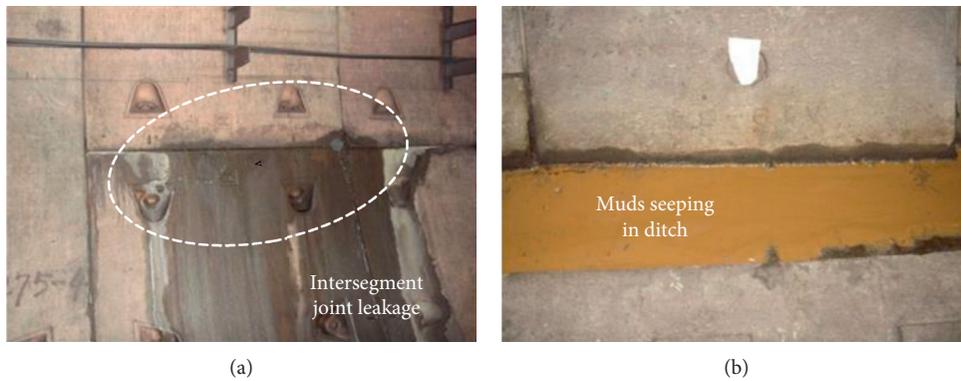
FIGURE 20: Joint leakage.

4.3. Leakage through Joints. Due to the increase in Earth pressure on the tunnel, the segmental joints were found to be opening to a larger amount. Soil, water, sand, and mud gushed through the openings. A total of 13 intersegment

water leaks were identified in the westbound tunnel, which mostly accompanied the large cracks on the segments. In the eastbound tunnel, six intersegment water leaks were also identified. Approximately 25 m away from the north end of the station, the track bed concrete ditch on the side near the foundation pit of the Hehuang project had cracked with a small area of mud seeping out, which is shown by the photo in Figure 20 taken in the field.

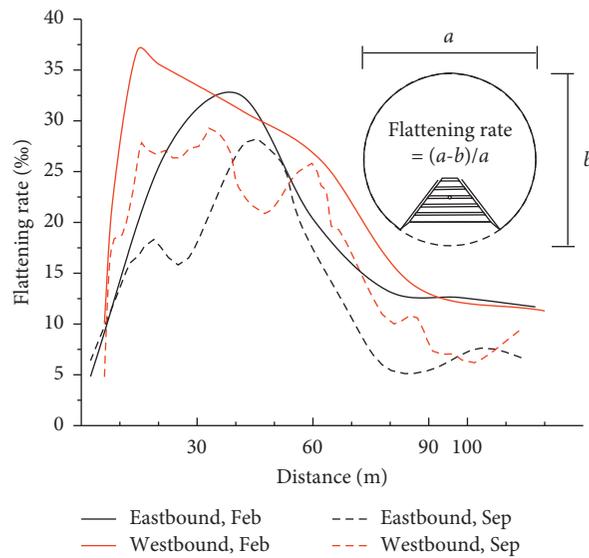
FIGURE 21: Tunnel flattening rate.

The positive value of the flattening rate indicates that both tunnels sustained horizontal expansion and vertical convergence along the tunnel path, which validates the previous results reported in Section 3. Considering the distributions of both spalling blocks and segmental cracks (see Figures 17 and 19, respectively), the high values of the curvature radius and flattening rate (see Figures 12 and 21) always corresponded to concentrations of concrete spalling blocks and larger segmental cracks. Moreover, their excessive values represented larger Earth pressure concentrations sustained by the segmental rings. After the area where the segmental rings were affected the most was identified, steel plates were adhered to the inner surface of the segmental rings to strengthen the tunnel inside, and adjacent backfilling soils were grouted to strengthen the outside of the tunnel. As a result, the flattening rate for both tunnels decreased integrally from Feb. 2011 to Sep. 2011, which could be primarily attributed to the counteractive emergency measures taken.

Computational results clearly show that, under normal working conditions, the deformation of the shield tunnels turns out to be very small. Regardless of the variation in the lateral soil pressure (even inactivity), the yielding of the connecting bolts (10% reduction in the stiffness of the bolts), or the cracking of the segments, the tunnel structure would deform slightly with a small equivalent-severe flattening rate. The equivalent-severe flattening rate would be larger than the actual rate with the same maximum deformation. However, the maximum measured flattening rate (see Figure 21) turned out to be even larger, which indicated that the soil surrounding the tunnel should be loosened. The computational results supported the distress incentives concluded later in Section 5.3. With a reduction in the Earth pressure, the equivalent-severe flattening rate was even smaller than the largest one measured. Therefore, in the alert ranges of both tunnels, a portion of the connecting bolts yielded. The results also showed that the segments would crack if a larger flattening rate was measured, which is also consistent with the results from in situ observations, as shown in Figure 21.

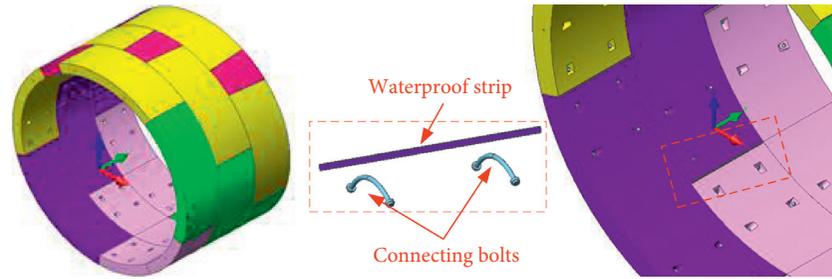
FIGURE 22: Staggered assembly of segments.

5.1. Numerical Simulation. The reinforced lining structure consists of segments, steel rebars, connecting bolts, and waterproof strips. Thus, three kinds of materials, including concrete, steel, and rubber, should be introduced. In the finite-element analysis presented herein, the total strain crack model is adopted to describe the nonlinear response of concrete under excessive loads. For the steel material, the von Mises model is implemented. The uniaxial tensile/compressive stress-strain relations of C40 concrete and the yield hardening behaviour of steel are introduced according to the parameters provided by the standards in China [19]. The waterproof strip made from ethylene-propylene-diene monomer (EPDM) rubber is simplified as a linear elastic material because the rubber strip is designed to remain in an elastic state to meet waterproofing requirements. Figure 22

shows the 3D detailed FE model. Typical working conditions were simulated to discuss possible incentives for an excessive tunnel flattening rate. Table 3 summarizes the induced deformation under each working condition.
