Research Article

Research on the Reinforcement Mechanism and Safety Monitoring of Heavy-Duty Concrete-Encased CFST Columns

2. Engineering Situations

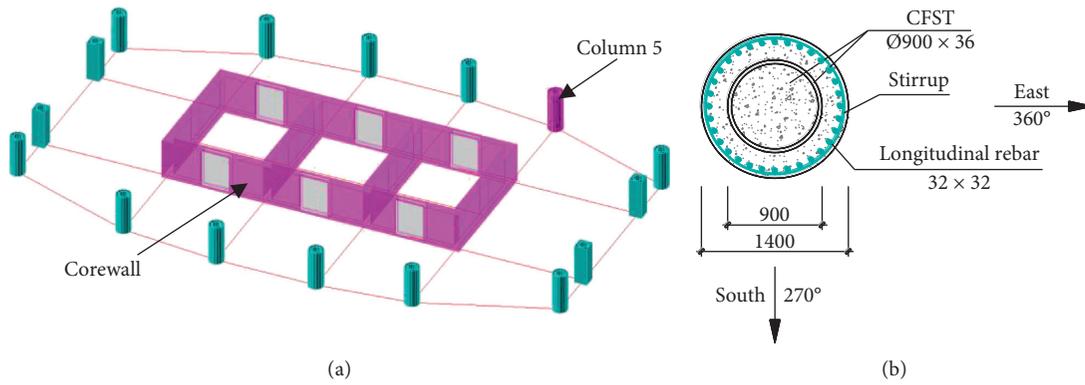
Column 5 of the 15th to 18th floor is a concrete-encased CFST column with a cross section depicted in Figure 1(b). The inner steel pipe is a $\text{Ø}900 \times 36$ Q345 steel pipe; the outer part is reinforced concrete, with an outer diameter

of 1,400 mm, in which 32×32 longitudinal rebars made of HRB400 material are arranged. A ring beam with a radial thickness of 500 mm and a height of 900 mm is set up at the intersection of the CFST composite column and the frame beam; the section of the frame beam is $500 \text{ mm} \times 800 \text{ mm}$, and the thickness of the floor plate is 120 mm. The concrete strength grade of all the components is C40.

FIGURE 1: (a) Standard floor plan and (b) column 5 section on the 15th floor (unit: mm).

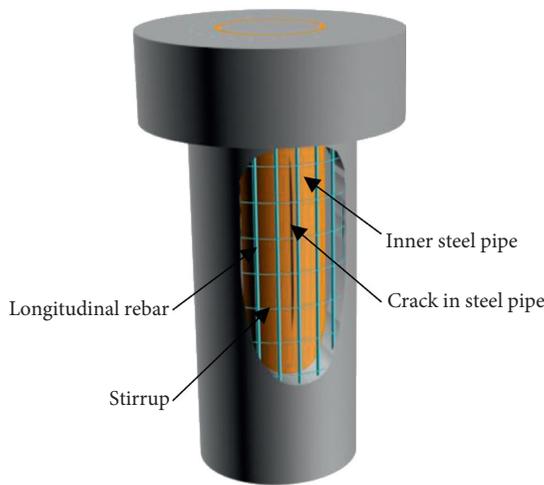
2.1. Accident Cause Analysis. Column 5 of the 15th floor was seriously damaged; in fact, five vertical cracks were created on the surface of the outer reinforced concrete from the elevation of 0.85 m to 2.40 m in a horizontal angle range of 270° – 360° ; the angle is defined as shown in Figure 1(b), with the south direction being 270° and the east direction being 360° . The five vertical cracks were of a penetrating type, reaching a length of about 1.0 m and a maximum width of about 4.5 mm; the longitudinal rebars were also bent at the corresponding positions. After chiseling the column, it was found out that the inner steel pipe was also cracked in the vertical direction at the corresponding positions. The length and the maximum width of the crack were, respectively, about 1.50 m and 10.0 mm, and the surface of the steel pipe laterally bulged out convexly. The concrete inside the steel pipe was relatively humid, and substances such as segregated water, mud, and discrete aggregates were seen at the locations. The damage to the inner steel tube is schematically illustrated in Figure 2.

The accident was caused by the frost heaving of the internal concrete. After the internal concrete is condensed, the excess free water will accumulate within a certain range. When the accumulated water reaches a certain level, it freezes at low temperatures in winter, which causes the concrete inside the steel pipe to swell. Consequently, the circumferential tensile stress on the steel pipe increases and reaches the yield stress of the steel pipe in winter. Then, the steel pipe begins to plastically deform and bulges out at the stress location. On the contrary, steel becomes brittle as temperature decreases, which means that its plastic deformation ability is greatly reduced. Therefore, the deformation of the steel owing to lower ductility at low temperatures is limited, and a brittle fracture failure occurs when the steel pipe is unable to withstand the circumferential tensile stress generated by the significant expansion of the internal concrete.

FIGURE 2: Crack in the inner steel pipe of column 5 on the 15th floor.

(1) *Repairing Steel Plates and the Crack in the Steel Pipe.* The internal steel pipe was severely damaged due to a vertical crack with a length of about 1.50 m and a maximum width of about 10.0 mm. The outer surface of the steel pipe on both sides of the crack bulged out convexly; the curved surface was also irregular, and the curvature was inconsistent. Therefore, instead of one large steel plate, eight patch-shaped small steel plates, with a length, width, and thickness of about 400 mm, 200 mm, and 20 mm, respectively, were used to repair the crack (Figure 4). The outer curvature of the small steel plate was the same as that of the original steel pipe. The inner concave surface of the patch was in contact with the local convex surface of the original steel pipe, and the patch was fitted to the steel pipe surface as good as possible. Therefore, the inner concave shape of each patch was designed using more details and data control. A four-sided welded joint was used between the small steel patches and the original steel pipe.

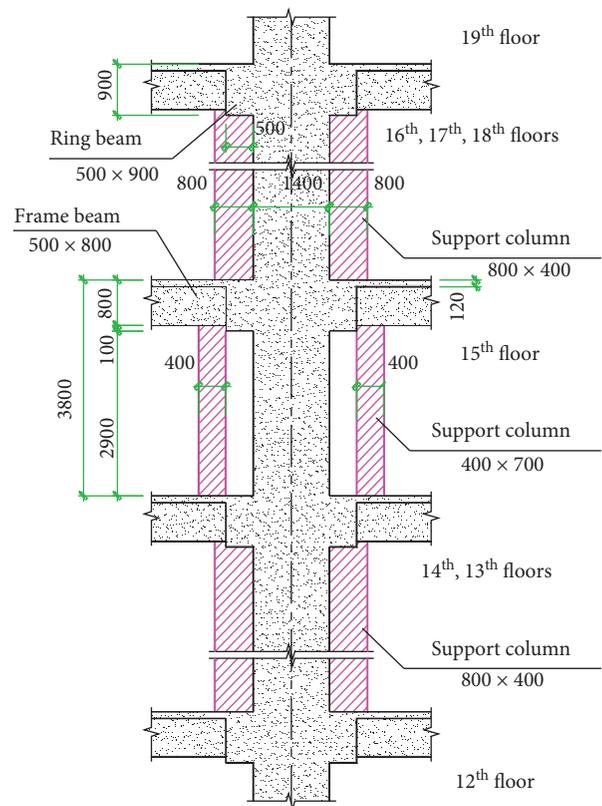
2.2.1. Design of Temporary Support Columns. The tall building has a total of 34 floors, and the destroyed columns are column 5 on the 15th to 18th floor. During the reinforcement construction, load of the original composite column 5 should be transferred to some temporary support columns. The standard load on column 5 on the 15th floor is 12,230.0 kN, which is calculated according to the existing dead load (including the concrete filled in the steel pipe) and the live load of 0.5 kN/m² per floor. The column is subjected to a large load, and it is difficult to unload it; thus, the design of the temporary support columns is proposed as shown in Figure 3.

FIGURE 3: Design of temporary support columns.

For column 5 on the 13th–18th floor, the temporary support columns made of reinforced concrete were set up, as presented in Figure 3. Relative to column 5, the temporary reinforced concrete support column was more lateral than the temporary steel column. Four temporary support columns were set up around column 5 on the 15th floor. The support columns and the original column were designed to be independent of each other. The center-to-center distance between the support column and the original column was 1,400 mm, and the clearance between them was 500 mm. The

cross section of the east, south, and west support columns was 400 mm × 700 mm, and that of the north one was 500 mm × 600 mm; the frame beam was also 500 mm wide. The support columns were equipped with 10 × 18 longitudinal rebars embedded in microexpansion injected concrete with a strength grade of C60. The bearing capacity of the support columns and the partial pressure bearing capacity of the column top section met the calculated load requirements. Moreover, the longitudinal rebars were anchored in two ways in the support columns: (1) the longitudinal rebars in the beam range were anchored by implanting the beam to a depth of 300 mm; (2) the longitudinal rebars in the floor range were anchored by the anchor bolts penetrated into the floor. Four support columns with a section size of 800 mm × 400 mm were also designed and placed identically on the 13th, 14th, and 16th to 18th floor. The support columns were connected to the original column using alloy steel grade M20 8.8 anchor bolts. There are three anchor bolts in a row in each column, and the vertical spacing between the rows is 200 mm.

The temporary support column was rooted on the ring beams and the frame beam, which was equivalent to attaching a corbel with a height of 8.5 m to the original column 5 below the 15th floor and a corbel with a height of 12.3 m to the original column 5 above the 15th floor. Four support columns and four corbels surrounded column 5, and the temporary support columns on the 15th floor were placed between the upper and lower corbels. This arrangement was called the upper and lower corbel-shaped temporary support column design.

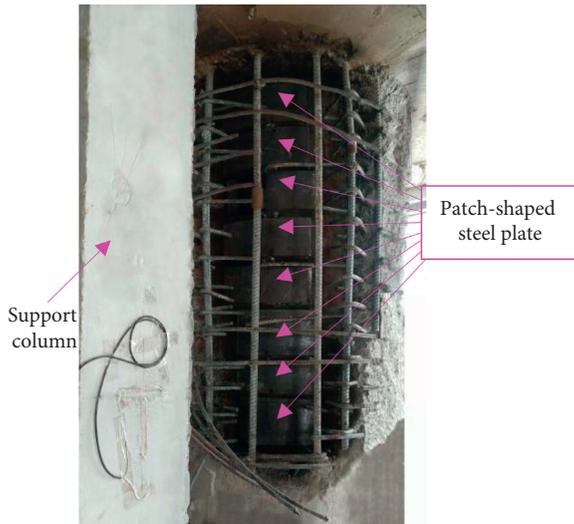
FIGURE 4: Crack repairing of the inner steel pipe.

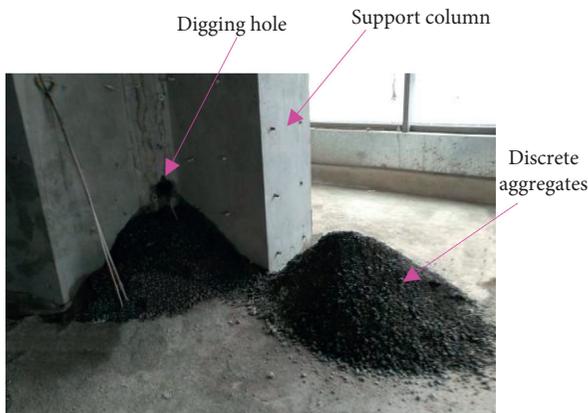
FIGURE 5: Flushing and digging out the concrete inside the damaged steel pipe.

- (a) Concrete flushing and digging: some holes with a diameter of 50 mm were drilled horizontally at the top and the bottom of the original column. Through the top hole, the damaged concrete inside the steel pipe was flushed by pressurized water injection. Through the bottom hole, the mud, discrete aggregates, slag, etc., generated by the damaged concrete inside the steel pipe were manually dug out. Figure 5 illustrates flushing and digging out the concrete inside the damaged steel pipe of column 5 on the 16th floor.

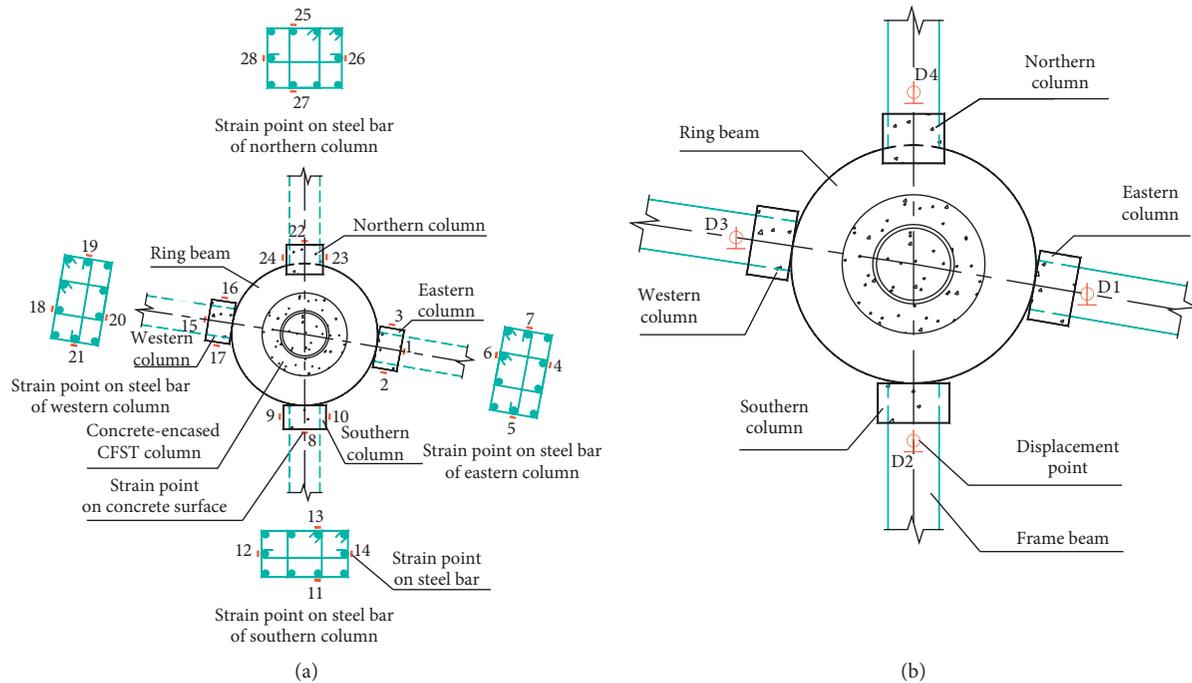
The arrangement of the strain measuring points at the temporary support columns of column 5 on the 15th floor is presented in Figure 6(a). Seven strain measuring points were arranged on each support column on the far-side facade and on both left- and right-side facades of the support columns; three measuring points were set up on their concrete surface, i.e., measuring points 1–3 of the eastern column in Figure 6(a); four measuring points were also considered on the four sides of the reinforcing rebars inside the concrete, i.e., measuring points 4–7 of the eastern column. No measuring point was set up on the near-side facade of the support columns due to construction reasons. The far- and near-side facades of the support columns were defined by the distance from the

FIGURE 6: Strain points of the support columns and the displacement points of beam ends. (a) Arrangement of strain measuring points; (b) arrangement of displacement measuring points.

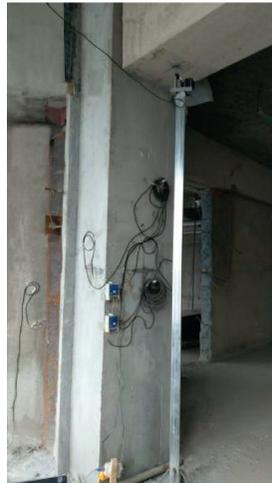
FIGURE 7: Actual arrangement of strain and displacement measuring points.

original composite column. The steel strain gauge was attached to the partially ground surface of the steel rebar and was protected before pouring concrete. The strain gauge wire was pulled out of the template through a protective sleeve. The strain gauges were all located at the mid-height of the columns. A displacement measuring point was also set up at the ends of four frame beams connected to column 5 on the 15th floor and at the bottom of the frame beams. The specific positions of the displacement measuring points, i.e., D1–D4, are illustrated in Figure 6(b). On the construction site, data acquisition was performed by using a resistance strain displacement meter. The layout of strain and displacement measuring points is depicted in Figure 7.

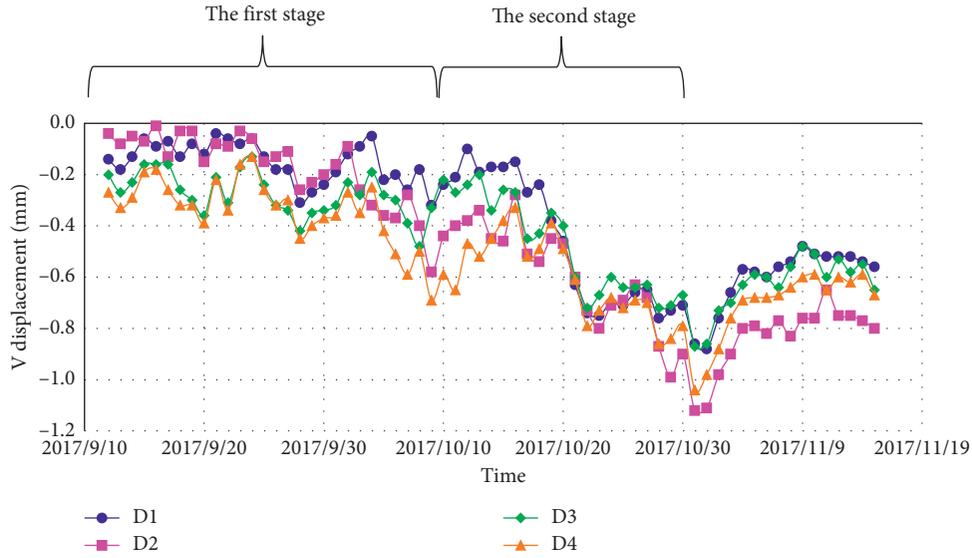
FIGURE 8: Plot of beam end displacement versus time during construction process.

- (1) The trend of the stress variation of the corresponding measuring points of the four supporting columns

was the same (Figure 8). At the end of the reinforcement construction stage, the stress values of the reinforcing rebars are tabulated in Table 1 for the eastern, southern, western, and northern support columns.

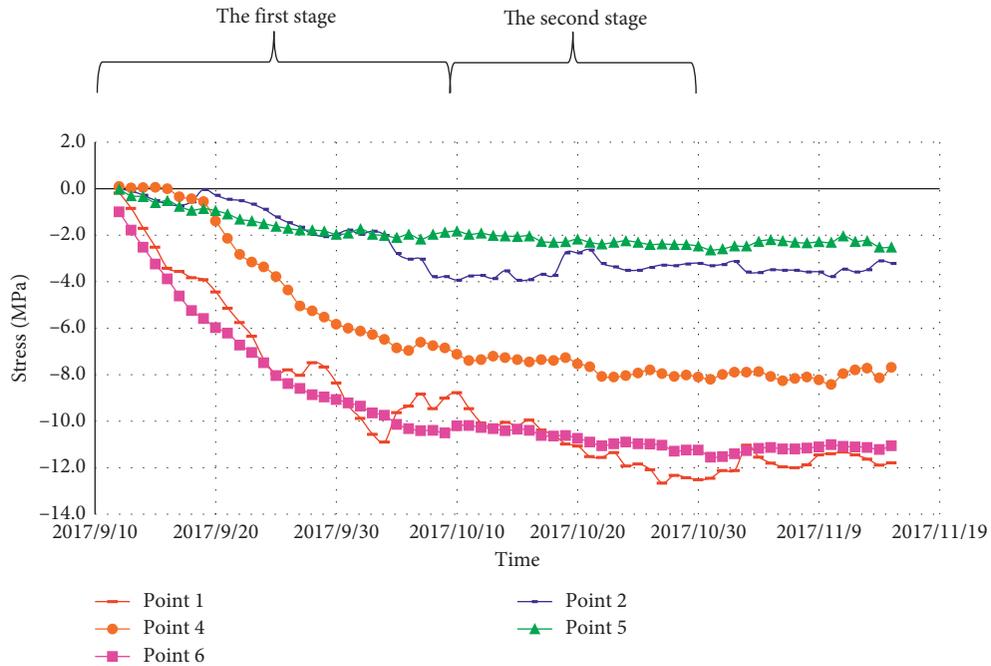
FIGURE 9: Plot of stress versus time of the eastern column during construction process.

- (2) The stress values of the measuring points of the five steel rebars in the eastern support column were also compared (Figure 9). The stress value of the proximal steel rebar measuring point 6 was the largest, and those of steel rebar measuring points 2 and 5 on both sides were the smallest. These two maximum and minimum values differed greatly, which can be attributed to the fact that the longitudinal rebars in the beam range were anchored by implanting the beam to a depth of 300 mm, while those in the floor range were anchored by the anchor bolt penetrated into the

floor. The steel rebars at measuring point 5 were anchored by being penetrated into the floor, whereas the steel rebars at measuring point 6 were anchored to the implanted beam. Therefore, the steel rebars at measuring point 5 were weakly anchored compared to those at measuring point 6, thereby showing a smaller stress value.

- (3) Figure 9 compares measuring point 1 on the concrete surface with steel rebar measuring point 4 in the adjacent concrete cover and contrasts measuring point 2 with measuring point 5; it can be seen that the stress values of the measuring points on the concrete surface are larger than those of steel rebar measuring points. The stress values of the concrete surface were also uneven over time, and the curves were not smooth and showed slight variations (Figure 10),

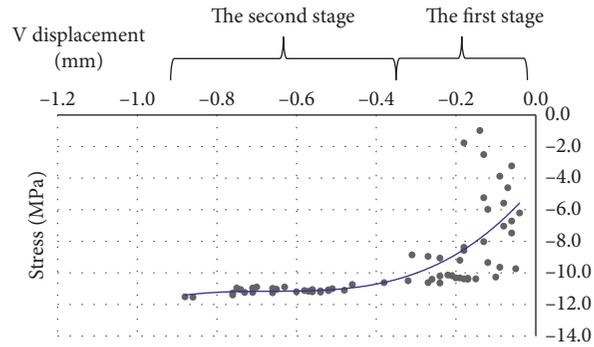
FIGURE 10: Plot of stress versus beam end displacement of the point 6 on the eastern column.

- (4) According to Figure 10, the relationship between the stress (σ) of steel rebar measuring point 6 on the eastern column and the vertical displacement (Δ_z) of the beam end can be expressed by

$$\sigma = 22.553\Delta_z^3 + 45.074\Delta_z^2 + 30.135\Delta_z - 4.424. \quad (2)$$

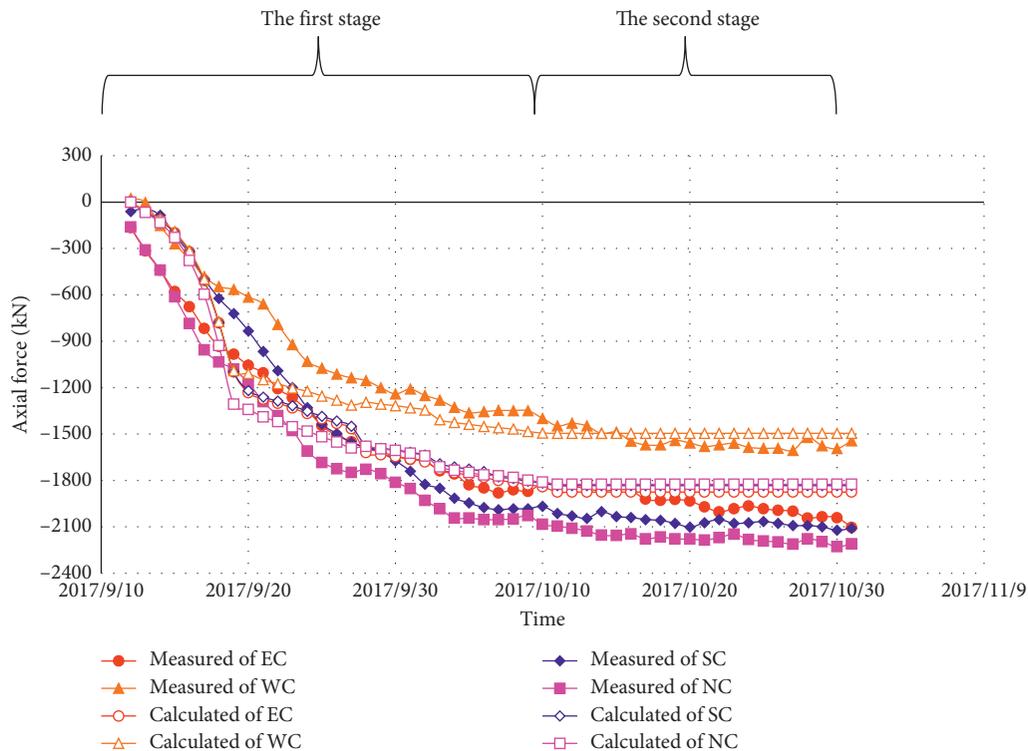
FIGURE 11: Plot of axial force versus time of each support column during construction process.

The construction steps completed in the first stage (September 11, 2017, to October 9, 2017) were crack repairing steel pipe in column 5; flushing and digging out concrete damaged inside the steel pipe of column 5 on the 16th to 18th floor; and repairing steel rebars and recasting outer concrete. The displacement curves of the beam ends decreased slowly and uniformly at the first stage, and the four displacement values were similar (Figure 8). The stress of measuring points 4 and 6 increased sharply at the first stage, and the slope of the stress-time curve was large; the stress value changed evenly (Figure 9). The axial forces of the four support columns varied uniformly, and the axial force of each column continued to increase daily; the slope of axial force versus time curve was large for each column (Figure 11).

The construction steps completed in the second stage (October 9, 2017, to October 31, 2017) were flushing and digging out concrete damaged inside the steel pipe of column 5 on the 15th floor; pressure grouting of the steel pipe of column 5; outsourcing the steel pipe of column 5 on the 15th floor; and removing the temporary support columns of column 5 on the 18th floor. In this stage, the displacement of the beam ends dropped rapidly, and the slope of the curves was larger than that of the curves at the first stage; the displacement value changed steadily, and the four displacement values were similar (Figure 8). The stress growth of measuring points 4 and 6 were slow at the second stage, the stress-time curve tended to be horizontal, and the stress value changed regularly (Figure 9). The axial force of the four support columns rose slowly, the axial force versus time curve gradually tended to be horizontal, and the axial force value was stable (Figure 11).

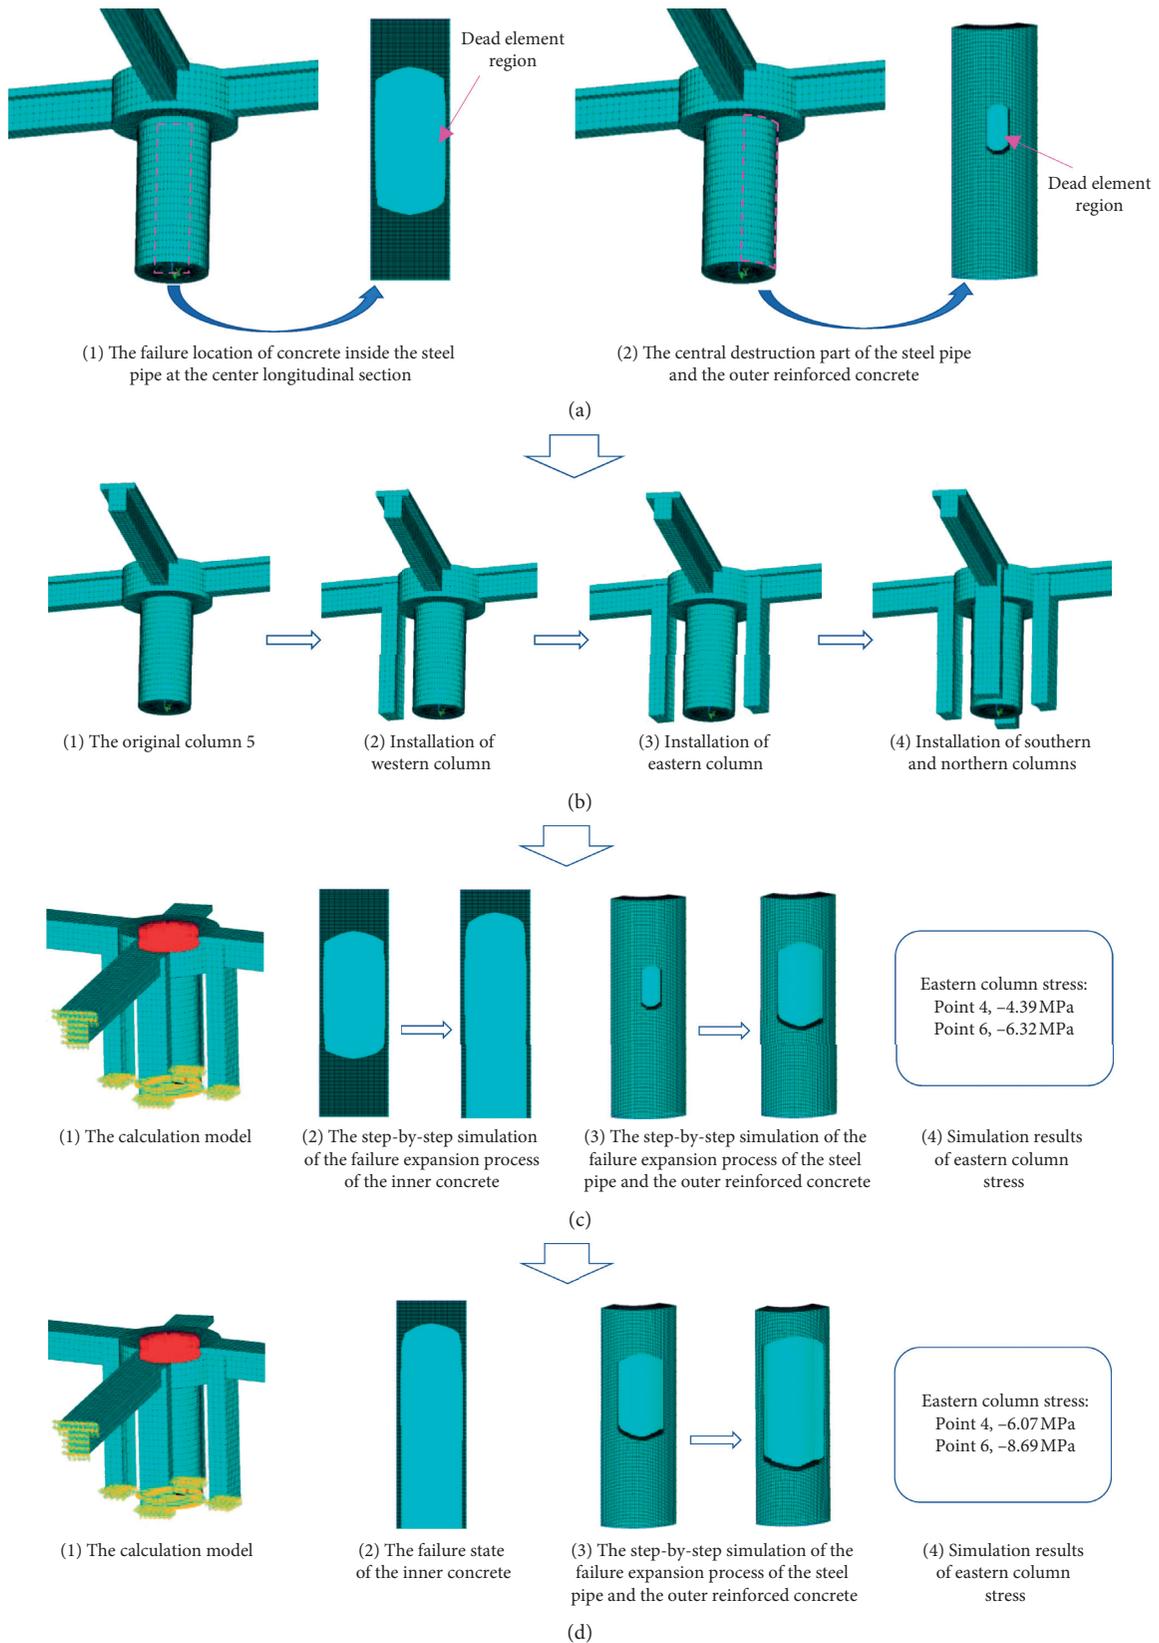
- (1) Temporary jacking steel columns that were removed before the temporary reinforced concrete support columns began to work are not considered in the simulation. Under the action of 20% of the vertical standard load of the original composite column, i.e., $20\% \times 12,230 = 2,446$ kN, the element life and death technology were used to give death to 50% of the concrete elements inside the steel pipe and those of the four supporting columns. And the elements of the central destruction part of the original column were given death, as shown in Figure 13(a). The central destruction part refers to the part of the inner steel pipe and the outer reinforced concrete in the elevation range of 1.45 m–2.03 m and in a horizontal angle range of 302° – 328° . The angle is defined as described above: the south direction is 270° , and the east direction is 360° . The load was only shared by the steel pipe and the outer reinforced concrete, and the calculation results were considered as the initial stress state of the following step.

FIGURE 13: The numerical simulation process of the reinforcement construction for column 5.

- (2) Under the effect of all the standard vertical loads, i.e., 12,230 kN, the elements of the four supporting columns were given birth, and the elements of the central destruction part of the original column were kept to be death, as shown in Figures 13(a) and 13(b). The load was shared by the remaining intact part of the inner steel pipe, the outer concrete, and the four supporting columns. The continuous calculation was then performed.

- (3) Based on the second step, the failure elements of the concrete inside the steel pipe gradually developed from 50% to 85%; the destruction range of the central destruction part was gradually expanded along the upper and lower sides as well as the horizontal sides. In other words, the range of the failure elements, which are given death, was gradually extended, as shown in Figures 13(c) and 13(d). Each step on the upper and lower sides was expanded by 0.145 m, and each step on the horizontal side was extended by 8°. Step-by-step calculation and continuous solution were performed in the simulation. Finally, the destruction of the inner steel pipe and the outer reinforced concrete in the original column ranges from the elevation of 0.73 m to 2.61 m and the horizontal angle of 270° to 360°.

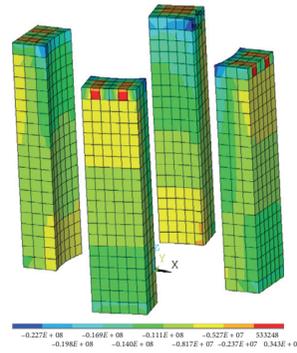
FIGURE 14: Stress analysis of support columns at the end of the construction process.

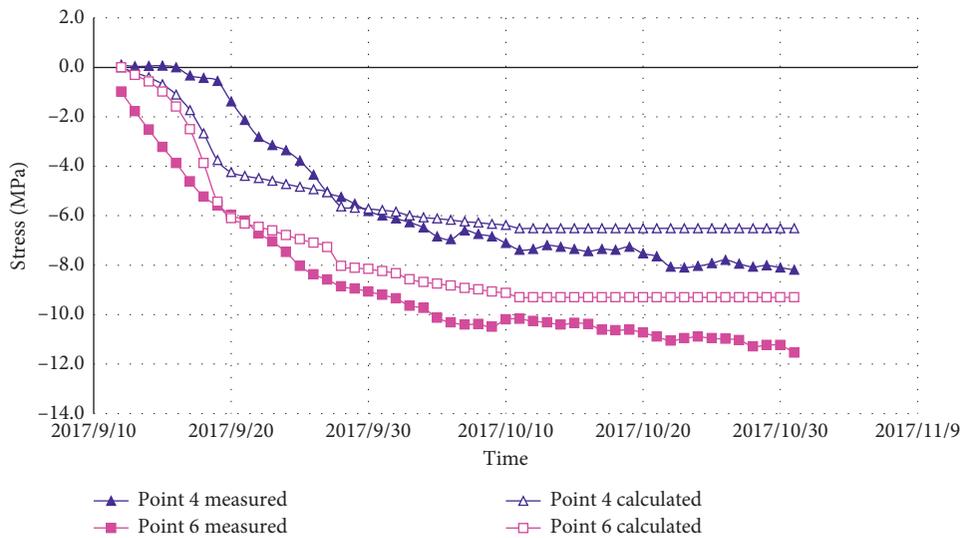
FIGURE 15: Stress simulation and measurement of measuring points 4 and 6 on the eastern column.

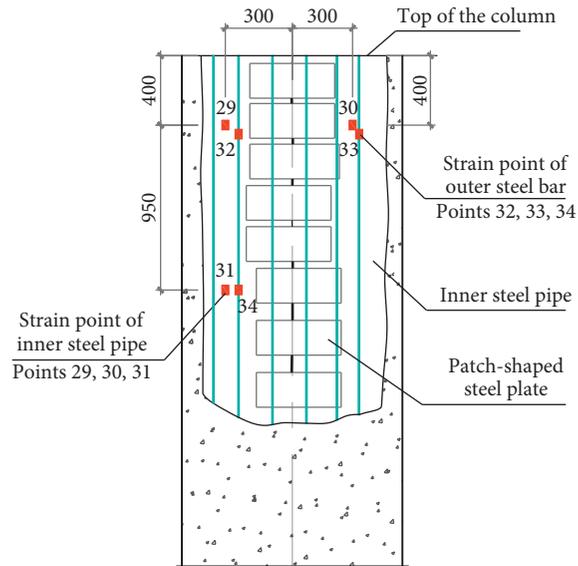
4.1. Arranging Measuring Points. In order to monitor the bearing capacity recovery of column 5 on the 15th floor, prior to repairing concrete and encasing the steel pipe in reinforced concrete, on October 12, 2017, three strain measuring points (29–31) were set up on the inner steel pipe, and three strain measuring points (32–34) were arranged on the longitudinal rebars of the outer reinforced concrete. This specific arrangement is illustrated in Figures 16 and 17. The four displacement measuring points D1–D4 continued monitoring work, and their data were continuous with that of the above reinforcement construction stage.

FIGURE 16: Strain point of the inner steel pipe and the outer steel rebars during the process of bearing capacity recovery.

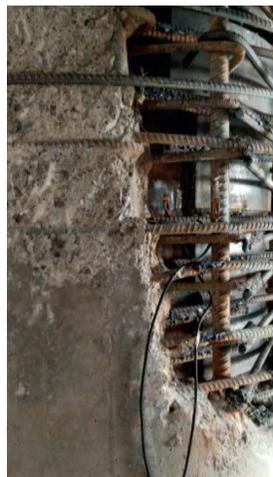
FIGURE 17: Actual arrangements of strain measuring points 31 and 34.

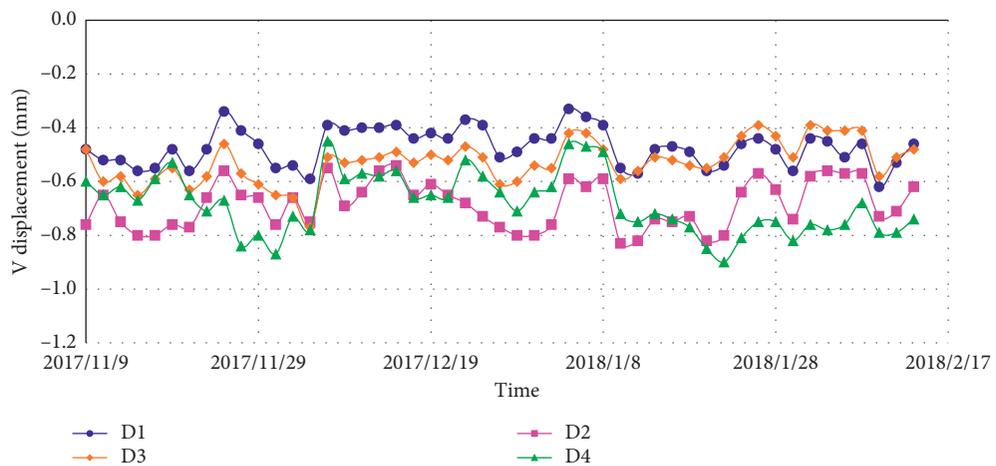
- (1) During the stage of bearing capacity recovery of column 5, the displacement value of each beam end was basically stable, and the values of the eastern displacement, southern displacement, western

FIGURE 18: Plot of beam end displacement versus time during the process of bearing capacity recovery.

displacement, and northern displacement ranged from -0.62 mm to -0.33 mm, from -0.83 mm to -0.54 mm, from -0.77 mm to -0.39 mm, and from -0.90 mm to -0.45 mm, respectively; the displacement variation trend of the beam end was relatively uniform (Figure 18). The displacement value was also reduced compared to the value obtained before the support columns were removed.

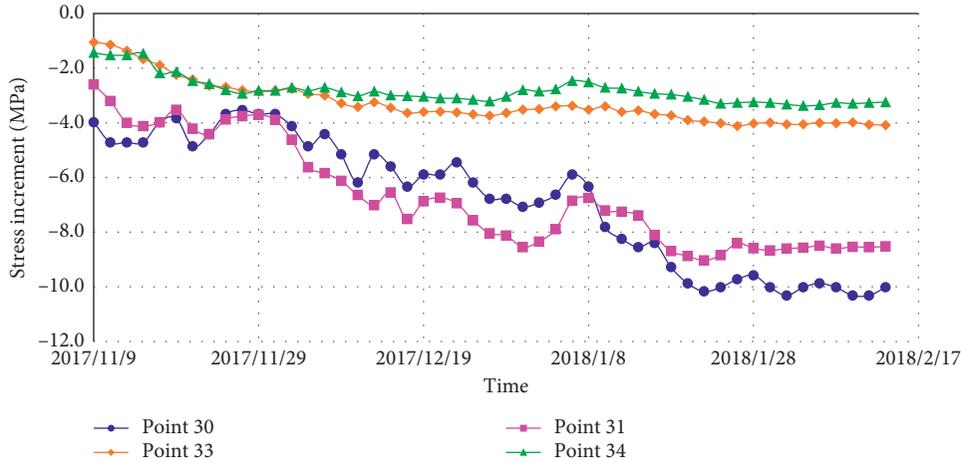
FIGURE 19: Stress increment in the z direction of each measuring point during the process of bearing capacity recovery.

- (2) Since the temporary support columns were demolished on November 15, 2017, the increment in the stress of each measuring point on the inner steel pipe and on the steel rebars of the outer reinforced concrete gradually increased, and the trend gradually stabilized after January 18, 2018. After about one month of stabilization, the monitoring work was stopped on February 12, 2018. The measured values and the simulated values of the increment in stress increments were within the reasonable range of the design.
- (3) The duration of the process of bearing capacity recovery of column 5 was about 60 days and can be categorized as a process of slow time-dependent structural mechanics. Moreover, the bearing capacity recovery of column 5 satisfied the design requirements. Finally, during this process, the structural components were safe and reliable.
