Research Article

Study on Fatigue Characteristics of Carbonation Erosion Prestressed Hollow Slabs in Whole Life Cycle

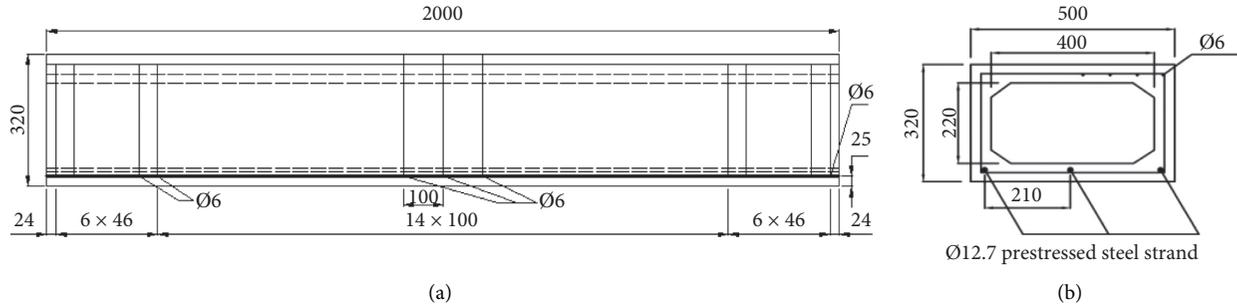
FIGURE 1: Cross section, longitudinal section, and bar arrangement drawing of test plate: (a) longitudinal section and (b) cross section.

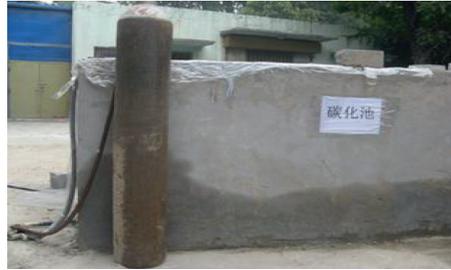
FIGURE 2: Modified carbonized corrosion device.

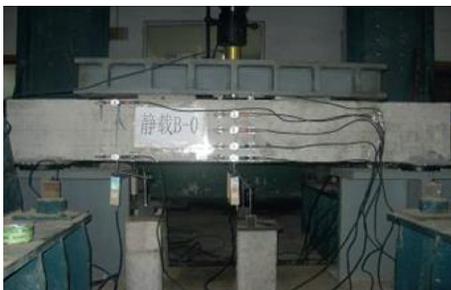
FIGURE 3: Static load test of the prestressed hollow beam.

3.2.1. Static Load Test of Prestressed Hollow Slab. The static load test was mainly used to determine the ultimate bearing capacity, failure mode, and deformation characteristics of the slab beam. The determination of fatigue test loading stress amplitude and load value is also based on the static load failure test results. The static load test was performed using a microcomputer-controlled electrohydraulic servo bending tester. The loading device is shown in Figure 3.

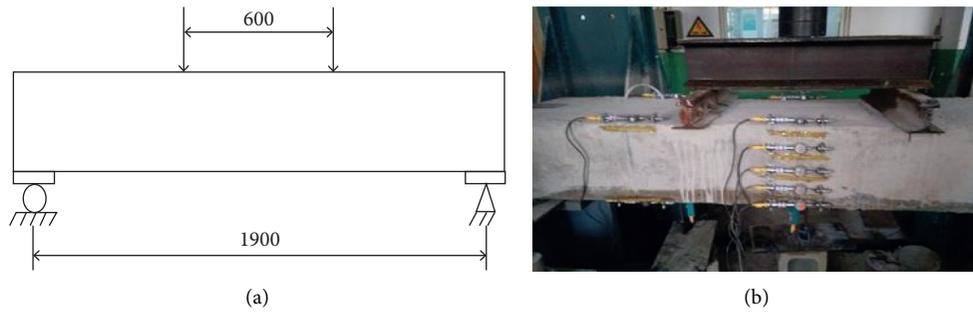
FIGURE 4: Fatigue loading diagram (units: mm): (a) loading diagram (units: mm) and (b) fatigue loading (units: mm).

3.2.2. Fatigue Failure Test of Prestressed Hollow Slab Beam under Carbonization Erosion. The fatigue test was performed of different carbonization erosion degree hollow slab beams by the method of three-point loading. The loading mode is shown in Figure 4. Based on the static load test results, the fatigue loading stress amplitude was determined as 0.8, and the fatigue test loading scheme is shown in Table 3.

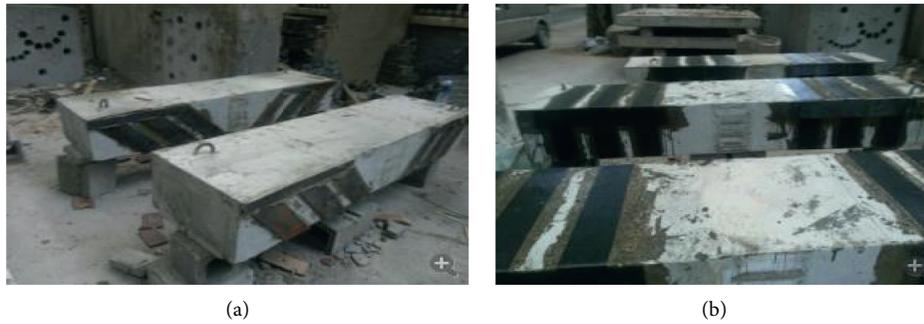
FIGURE 5: Reinforcement model: (a) steel plate reinforcement and (b) carbon fiber cloth reinforcement.

3.3.2. Reinforcement Scheme for Prestressed Hollow Slab. The carbon fiber cloth reinforcement and bonding steel plate reinforcement technology do not change the stress system and structural form of the original component and can effectively improve the structural bearing capacity and rigid fracture performance, and are widely used in reinforced engineering. In this experiment, two types of reinforcement methods were applied to reinforce the damage components. The strengthened components are shown in Figure 5.

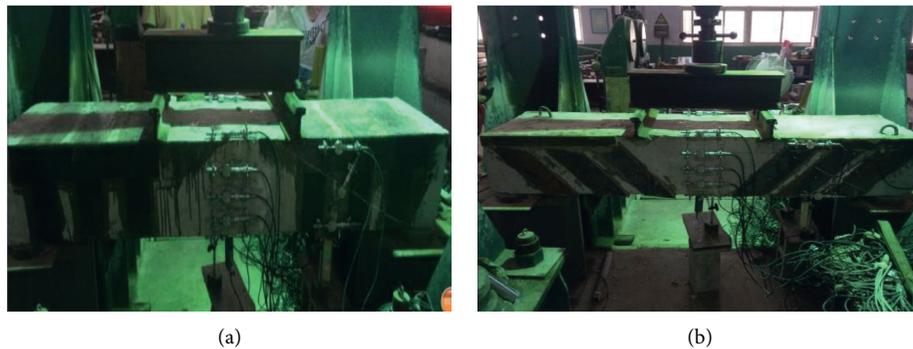
FIGURE 6: Static load test of prestressed hollow beam: (a) static load test of carbon cloth reinforcement and (b) steel plate reinforcement static load test.

method. The length of the test plate was 2000 mm, its net span was 1900 mm, and rubber bearings were used at both ends. Considering the difference in the bearing capacity before and after the reinforcement, the maximum load of the test plate was determined to be 150 kN, the loading device was a kind of 25-ton multifunctional hydraulic testing machine, and an I-beam was used as the guide beam to transmit the load. The static load test process measurements mainly include the load, deflection, and strain measurements. The loading equipment is shown in Figure 6.

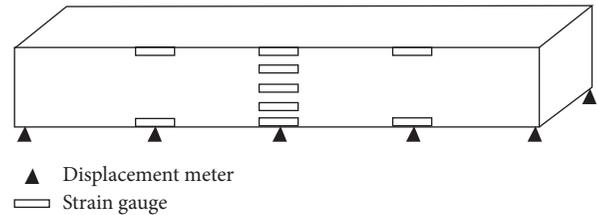
FIGURE 7: Layout of strain gauges and displacement meters.

(1) *Strain and Displacement Measurement.* Before the start of the fatigue test and after each 500,000 cycles of the fatigue loading, the static load test was performed to record the strain and deflection under each load, and the attenuation law of the static parameters of the test beam with the increase in the fatigue loading was studied. The strain and displacement at the $1/2L$ section was clearly observed and recorded, where L was the length. The strain gauges were evenly arranged along the beam height in the $1/2L$ section. The displacement gauges were arranged at $1/2L$, $1/4L$, and beam-ends. The specific arrangement is shown in Figure 7.

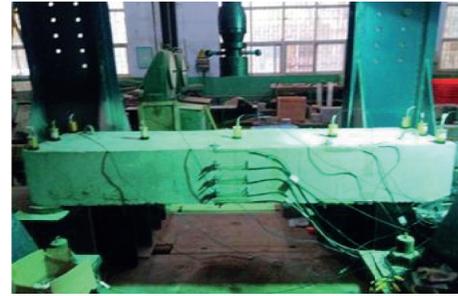
FIGURE 8: Measurement of fundamental frequency and damping.

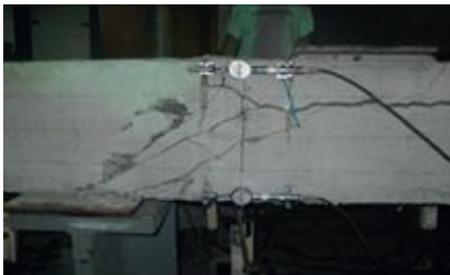
FIGURE 9: Final failure mode of the test plate by static load.

(1) *Failure Analysis of Static Load Test.* The first crack occurred in prestressed concrete hollow slab beam when it was loaded to 165 kN. The main failure location was the prestressed concrete test hollow slab support. The crack mainly appeared at the bearing in the oblique upward 45° direction. With the gradual increase in the load, the prestressed test plate gradually displayed transverse through cracks, vertical through cracks, oblique end cracks in the beam end, and even cracking of the roof. When loaded to 245 kN, the prestressed test hollow slab reached the ultimate bearing capacity failure state, and the maximum crack width was 1.675 mm. The maximum crack width value during loading is shown in Table 7, and the final failure mode of the test plate is shown in Figure 9.

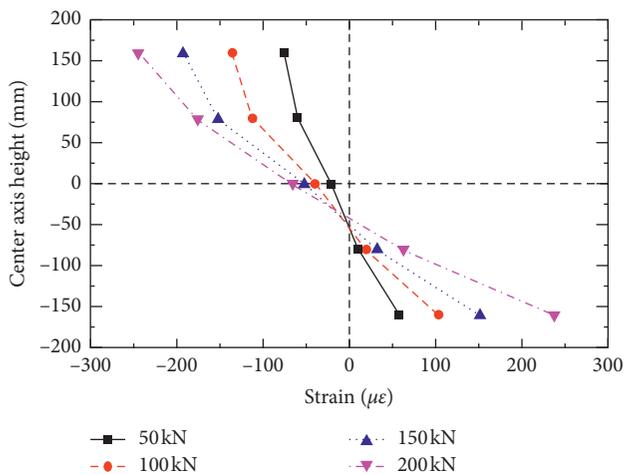
FIGURE 10: Concrete strain along the cross section.

① *Strain analysis:* in the static load failure test, the concrete strain along the beam height changes is shown in Figure 10. During the test, with the neutral axis as the boundary line, the tensile strain and compressive strain increased with the increase in the loading level. At the end of the test, the strain increase rate of the concrete increases with the increase in the load. When the load exceeded

beam section height was almost linear. As the load increased, the height of the compression zone decreased, the neutralization axis continued to rise, and the stress of the prestressed concrete hollow slab conformed substantially to the flat section assumption.

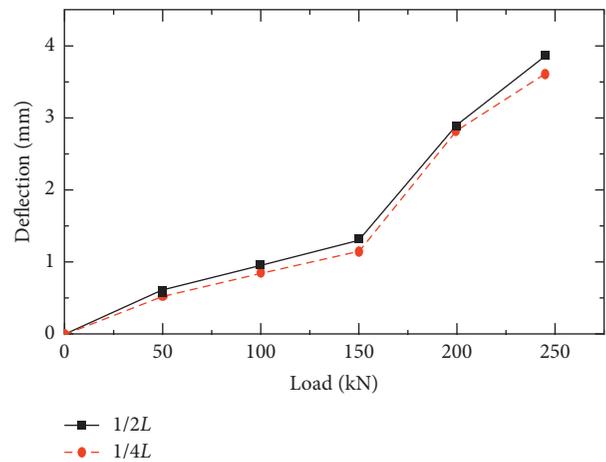
FIGURE 11: Load-deformation curves of static load test.

② Deflection analysis: the relationship between the deflection and load at 1/4L and 1/2L of the test plate during the static loading was shown in Figure 11. Before the crack appeared in the test plate, the deflection at 1/4L and 1/2L exhibited a steady increase with the increase in the load. However, the difference in deflection at 1/4L and 1/2L gradually increased, which was consistent with the deflection trend of the prestressed test plate by the method of three-point loading. With the gradual increase in the loading level, cracks gradually appeared in the test plate, and the downward deflection speed increased. When the cracks occur on a large scale, the deflection of the test plate began to gradually slow down owing to the effect of the prestressed steel bar. This trend could be clearly observed in the load-deflection curve of the test plate.

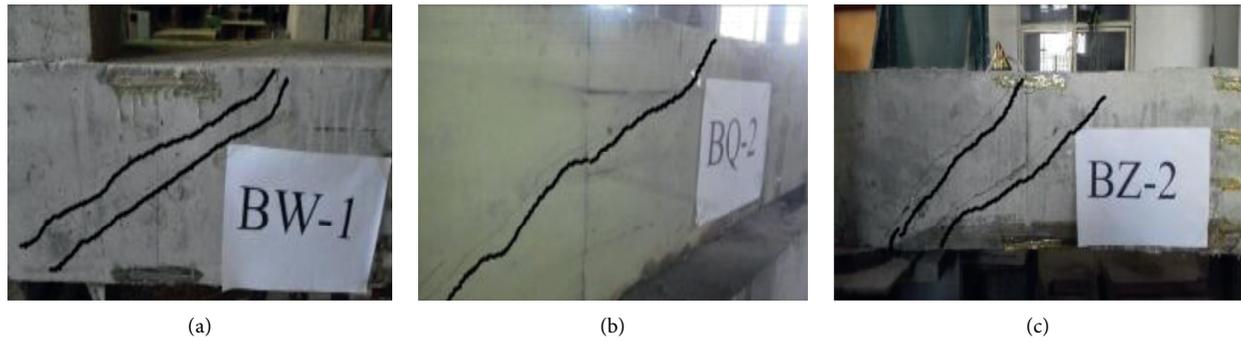
FIGURE 12: Development of cracks under the fatigue test: (a) BW crack map, (b) BQ crack map, and (c) BZ crack map.

(1) *Fatigue Failure Analysis of Prestressed Hollow Slabs with Carbonization Erosion.* The first crack appeared at the same position of the different carbonization corrosion test slab beams subjected to the fatigue load, and the crack development trend was similar. Table 8 shows the relationship between the maximum crack width and the number of fatigue cycles for the different carbonized corrosion test panels. It can be observed from Table 8 that after the carbonization corrosion, cracks appear earlier with the number of fatigue loading cycles increases, and the crack development speed is significantly greater than that of the healthy components. The fatigue life of the erosion test board decreases significantly, especially for the test plate subjects to severe carbonization corrosion, and the fatigue life was only 50,000 cycles. The more serious the degree of carbonization corrosion, the lower the number of fatigue cycles required for cracks to appear. For example, cracks begin to appear while subjected to 20,000 fatigue cycles for the severe carbonization corrosion test board. After the cracks appear, the crack width increases along with the degree of carbonization corrosion under the same number of fatigue cycles. As the degree of carbonization increases, the number of fatigue cycles required from the occurrence of cracks to the failure of the test plate gradually decreases. The healthy test plates require nearly 1.4 million fatigue cycles to progress from the first appearance of cracks to failure, and the test plates subjected to mild corrosion required less than 1.3 million fatigue cycles, while the test plate subjected to severe carbonization corrosion required only 30,000 fatigue cycles to progress from the first appearance of cracks to fatigue damage.

In summary, as the depth of carbonization increases, the prestressed test panels become larger than the healthy test panels and both in terms of the crack occurrence time and the crack development speed. The cracked model of test plate is shown in Figure 12.

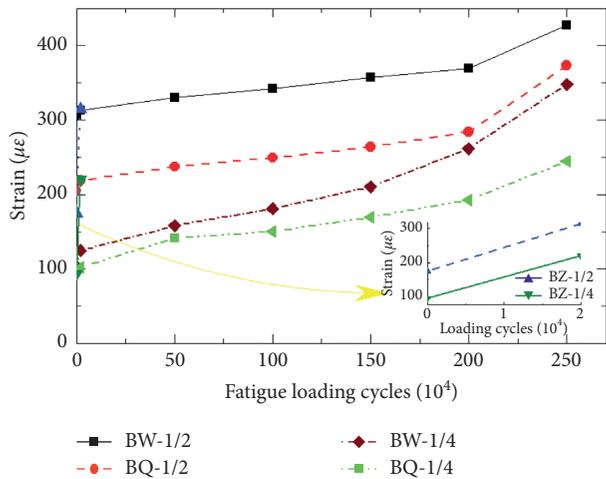
FIGURE 13: Development of static strain under fatigue testing.

① *Strain analysis:* Figure 13 shows the relation of the tensile strain at the $1/2L$ and $1/4L$ sections of the test plate as a function of the number of fatigue cycles. As shown in the figure, the tensile strain at $1/2L$ and $1/4L$ of the prestressed test plate gradually increases with the increase of fatigue loadings times. For the same fatigue cycle times, the strain of the carbonization corrosion

test plate was less than that of healthy test plate. Before 2 million fatigue cycles, the tensile strain at $1/2L$ of the healthy test plate and the mild carbonization corrosion test plate increased with the increase of fatigue loading times and showed a linearly increasing trend. After fatigue cycle times of the test plate reached 2 million, the strain difference between the two test plates gradually decreased. The original $100\mu\epsilon$ gradually reduced to approximately $50\mu\epsilon$ when the test plate beam fatigue cycles reached 2.5 million cycles, and the strain difference between the two sets of test plates reached a minimum value. The strain of the severe carbonization test plate increased with the increase in the fatigue frequency, and the strain increases rapidly. From the beginning of the test till the occurrence of damage at nearly 50,000 cycles, the strain increased by $100\mu\epsilon$.

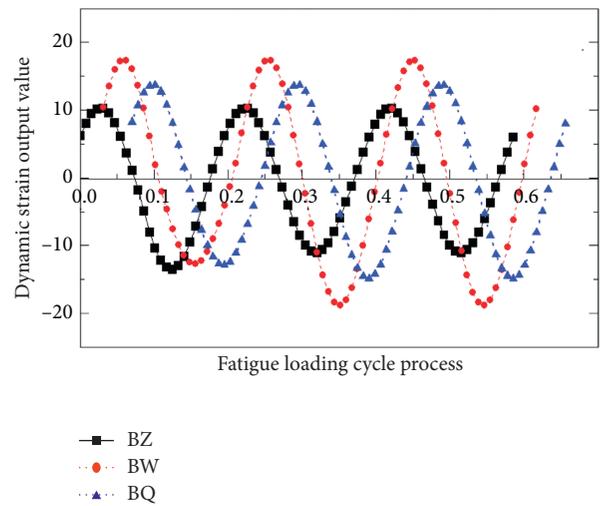
FIGURE 15: Dynamic strain of test plate under fatigue testing.

① *Dynamic strain of test plate under fatigue loading:* Figure 15 shows the dynamic strain of the test plate as a function of the carbonization corrosion under the same fatigue cycle times. The dynamic strain of the test plate changes sinusoidally with the fatigue loading process, which is consistent with the actual loading mode. On analyzing the data and integrating the stress data of the different test panels, it can be found that with the carbonization depth increases, the dynamic strain under the same fatigue time gradually decreases.

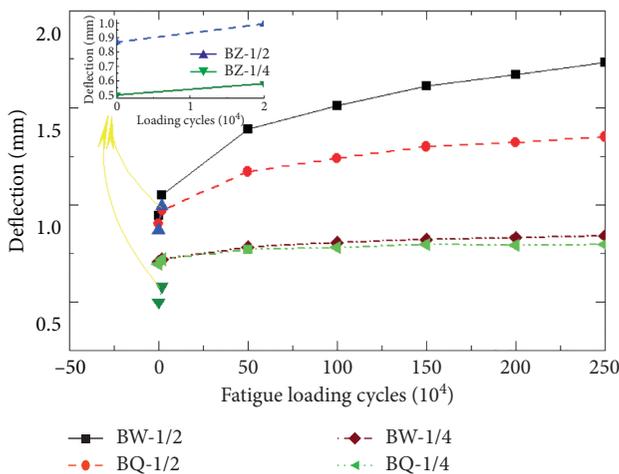
FIGURE 14: Development of static deflection under fatigue testing.

② *Deflection analysis:* Figure 14 shows the relationship between the deflection at the $1/2L$ and $1/4L$ sections of the test plate and the fatigue cycle times. It can be observed from Figure 14 that as the fatigue cycle times increase, the deflection of the test plates at the $1/2L$ and $1/4L$ sections tends to increase slowly, and under the same fatigue cycles times, the deflection of the test plate gradually decreases with the increase in the degree of carbonization corrosion. The deflection difference between the mild carbonization corrosion test plate and healthy test plate gradually increases with the increase in the fatigue frequency, and the deflection of the slightly carbonized test plate under the same fatigue cycles times is smaller than that of the healthy test plate. From the appearance of cracks till fatigue failure, the crack size of the severely carbonized test panels only increased by 0.126 mm during the 50,000-fatigue-cycle process. The test plate with severe carbonization corrosion is prone to brittle failure and poor fatigue resistance.

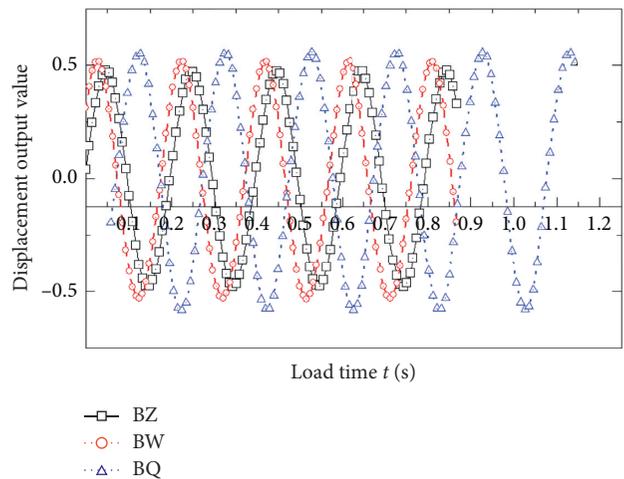
FIGURE 16: Dynamic displacement of test plate under fatigue loading.

② *Transverse displacement of test plate under fatigue loading:* the midspan dynamic displacement of the test plate during the fatigue testing is shown in Figures 16 and 17. Under the sinusoidal load, the midspan dynamic displacement of the test plate shows a sinusoidal change. As fatigue cycle times increase, the midspan dynamic displacement of the test plate increases with

the same loading. However, as the depth of the carbonization increases, the dynamic displacement of the test plate under the same number of fatigue cycles gradually decreases. The dynamic displacement of the test plate subjected to carbonization is significantly smaller than that of the test plate that is not subjected to carbonization.

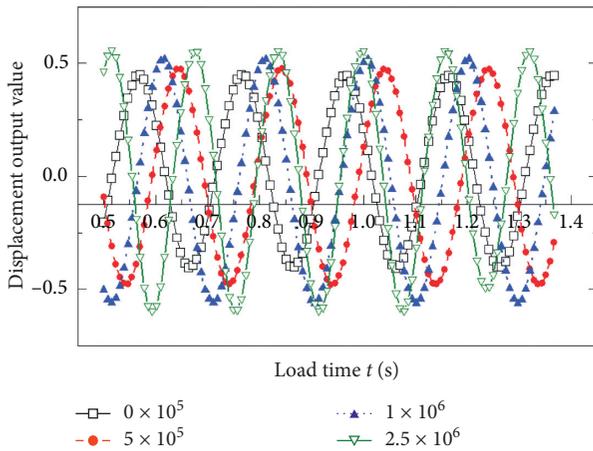
FIGURE 17: Dynamic strain of test plate under fatigue loading.

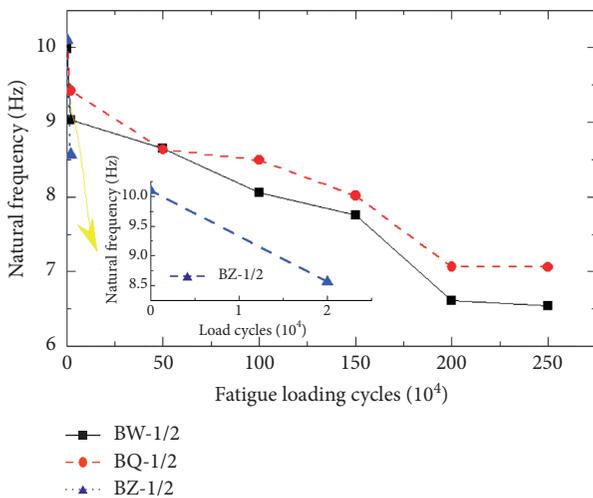
FIGURE 18: Natural frequency of test plate under fatigue loading.

(4) *Modal Analysis of Prestressed Hollow Slabs under Carbonization Erosion.* The modal data of the test plate under fatigue loading are shown in Figures 18 and 19. The degree of carbonization corrosion influences the natural frequency and damping of the test plate. Before the start of the fatigue

test, the corrosion test plate caused a slight increase in the self-vibration frequency of the healthy test plate. This may be because, after the test plate was carbonized, the

capillary channel in the concrete was filled with the reactants of the carbonization reaction, and the concrete integrity was improved. As a result, the stiffness of the plate was increased, and as the fatigue test progresses, the test plate showed tiny cracks, and the stiffness of the test plate decreased. The natural vibration frequency of the mild corrosion test plate was greater than that of the healthy test plate in the fatigue process, and although the self-vibration frequency was slightly increased in the severe corrosion test plate, the stiffness decreased rapidly owing to the earlier crack occurrence during the fatigue process. During the fatigue test, as the tiny cracks appeared in the concrete and developed, the crack interfaced rubbed against each other, caused the damping to increase. Therefore, as compared with the other test components, the heavy carbonization test plate had the fastest rate of increase in damping, which indicated that the fatigue resistance was relatively poor.

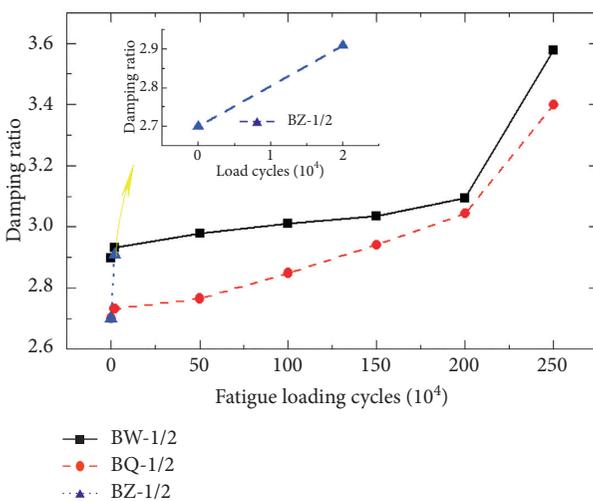
FIGURE 19: Damping ratio of test plate under fatigue loading.

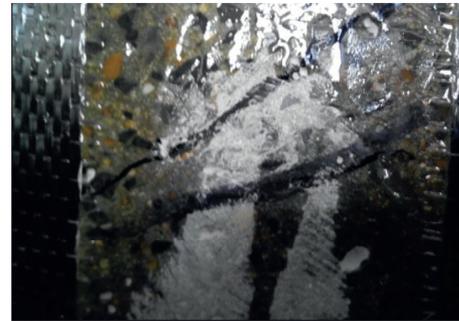
FIGURE 20: The cracks under the 1.2 million fatigue load test.

(1) *Fatigue Experiment Process of Carbon-Fiber-Cloth-Reinforced Test Plate.* The prestressed hollow slabs strengthened by the method of the carbon fiber cloth effectively inhibited the development of the original cracks, and the crack development in the fatigue process was slow. Before the start of fatigue cycles, the original crack reached 0.22 mm, and after 500,000 cycles, the crack width reached 0.28 mm. And after 1 million fatigue cycles, the maximum crack width increased to 0.3 mm and a new tiny crack appeared in oblique section shears. When the fatigue cycle times reached 2 million cycles, the maximum width of the crack at the fulcrum of the original support reached 0.35 mm. The fatigue test crack is shown in Figure 20, and the fatigue test data are shown in Table 11.

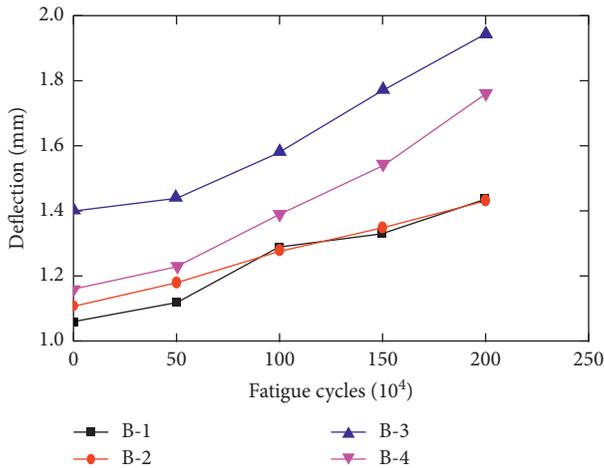
FIGURE 21: The relation between deflection and fatigue cycle times for different test beams.

The two reinforcement methods are compared below. Figures 21–23 show that the deflection of the bonded carbon-fiber-reinforced plate is less than the deflection of the bonded steel reinforced members during 0 to 1 million fatigue cycles. During the 1 to 2 million fatigue cycles, the deflection of the bonded carbon-fiber-reinforced member is close to that of the bonded steel reinforced member. The compressive strain of the bonded carbon-fiber-reinforced member is higher than that of the bonded steel reinforced member during the fatigue process. The tensile strain of the bonded steel reinforced member is higher than that of the carbon-fiber-reinforced member before 1.5 million fatigue cycles and is close to that of the carbon-fiber-reinforced member after 1.5 to 2 million fatigue cycles. Excluding

Figures 21–23 show that the deflection of the reinforcement members increases gradually during the fatigue process, and the increase rate is faster during the 50–200 million cycles of fatigue loading. It is found that the deflection of the carbon-fiber-reinforced member is greater than that of the bonded steel reinforced member during the fatigue loading process. The strain of the bonded carbon fiber and the bonded steel reinforcement member increases

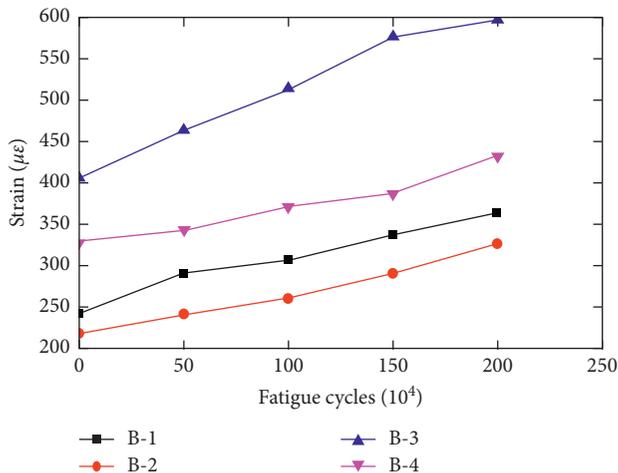
FIGURE 22: The relation between midspan compressive strain and fatigue cycle times for different test beams.

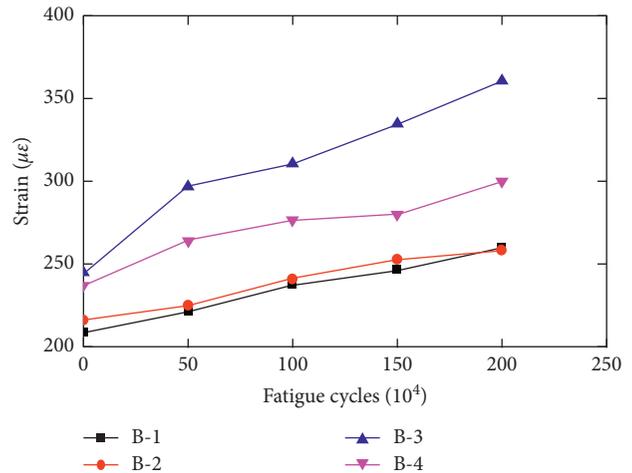
FIGURE 23: The relation between midspan tensile strain and fatigue cycle times for different test beams. B-1: uneroded carbon-fiber-reinforced test plate, B-2: uneroded bonded steel-plate-reinforced test plate, B-3: carbonized eroded carbon-fiber-reinforced test plate, and B-4: carbonized eroded bonded steel-plate-reinforced test plate.
