Research Article

Prototype Experimental Investigation of the Failure Mechanism and Crack Propagation of Segment Lining for Staggered Jointed Assembly

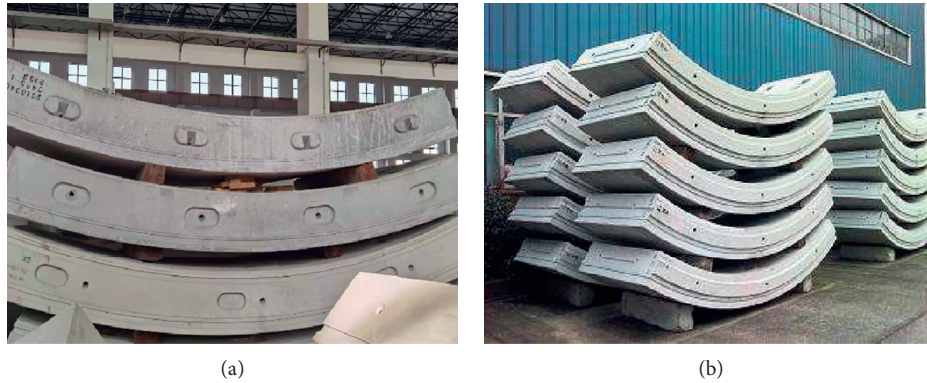
FIGURE 1: Circumferential joint. (a) Distributed mortises and tenons. (b) Full-ring mortises and tenons.

2 m, and the thickness is 0.55 m. There are a total of 24 circumferential bolts in the structure of the segment, and there are 34 longitudinal bolts between the rings, as shown in Figure 3. Four pairs of distributed mortises and tenons are used for the circumferential joint.

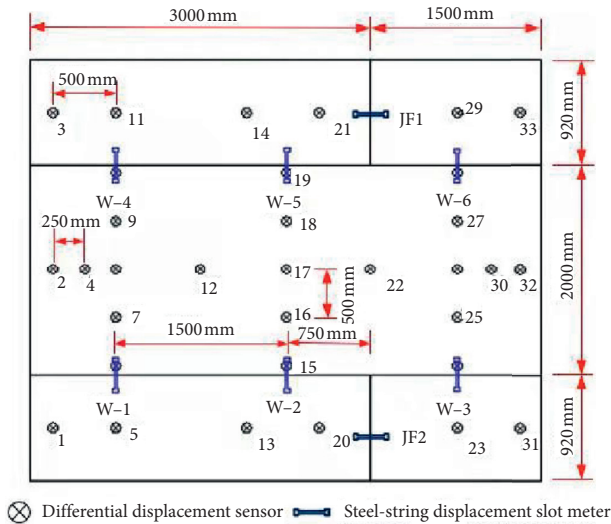
FIGURE 5: Layout of the measured points.

The parameters measured in the experiment were internal force, vertical displacement, concrete strain of the segment structure, and the joint opening. These measurements were performed by a differential displacement sensor with an accuracy of 0.01 mm. The layout of the measuring points is shown in Figure 5. Due to the elasticity of concrete, uneven displacement occurs in horizontal and longitudinal direction frequently; to more accurately analyze the segment deformation, a series of displacement gauges were arranged equidistantly on the arc surface of the vault for the middle segment and each adjacent segment ring; the chord length is shown in Figure 3. Three sets of displacement slot meters are placed equidistantly for the observation of circumferential joint openings, while two more slot meters are used for longitudinal joint openings.

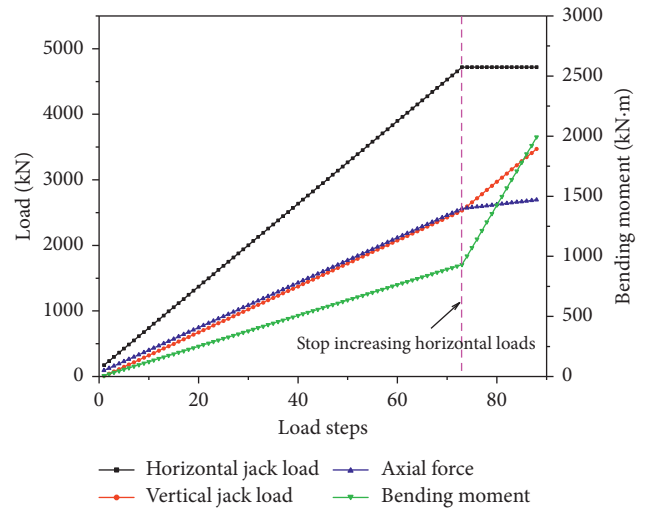
FIGURE 6: Test loading process.

- (1) Eccentricity is maintained constant in the normal loading stage, and the horizontal and vertical loads are applied gradually. The horizontal jack was loaded to 0.4 MPa per level, and the corresponding horizontal force was 50 kN per level. The load was increased gradually until the load on the horizontal jack reached 4725 kN and $\lambda = 0.1$.
- (2) The axial force was kept constant in the failure stage. Only the force of the vertical jack was increased, that is, to 0.4 MPa per level, and the corresponding vertical force was increased by 50 kN. The load was increased gradually until the vertical displacement of the structure entered the platform stage, and, finally, the structure was damaged and failed.

Figure 6 shows the change law of the thrusts of the horizontal and vertical jack loads and the internal force as the load increases. In the normal load stage, as the load of the vertical jack increases, the axial force and bending moment of the segment control section also increase gradually. During the second stage of loading, as the vertical load increases continuously, the eccentricity of the section increases rapidly, which leads to a significant increase in the bending moment of the control section. Thus, the structural deformation increases, and, as a consequence, the structure of the segment finally reaches its bearing limit.

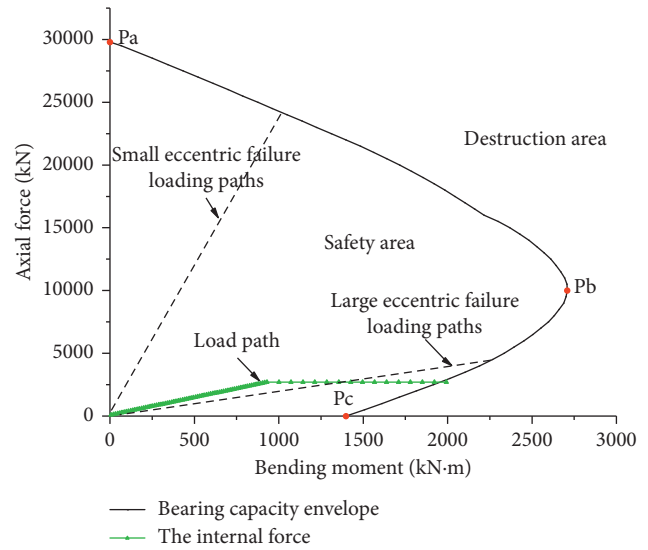
FIGURE 7: N-M curve for control section.

design value of tensile strength was $f_t = 1.89$ MPa, and the design value of the compressive strength was $f_c = 23.1$ MPa; the internal steel bar was HRB400. The thickness of the protective layer was 55 mm, the width of the segment was 2 m, and the thickness of the segment was 0.55 m. According to the design parameters above, the bearing capacity curve of the main section of the segment was calculated according to the eccentric compression of the reinforced concrete structure, as shown in Figure 7.

The N-M curve of the main structure for the segment shows that as the axial force increased, the bending moment increased first and then decreased. The inside of the curve is defined as the safe area, while the outside of the curve is the failure area. As presented in Figure 6, the Pa point is presented as the axial compression failure; the bending moment at this position is equal to 0, the axial force reaches its maximum value, and the ultimate axial force is 29,800 kN; the Pc point is pure bending failure, and the Pb point is the maximum bending moment, and the ultimate bending moment is 2,708 kN m, which is the boundary failure. The other locations are compression-bending failures. The PaPb section is damaged by the small, eccentric compression. As the axial force increases, the bearing capacity of the bending moment of the section becomes smaller, and the PbPc section is damaged under large eccentric compression. As the axial force increases, the bending moment bearing capacity of the section becomes larger [23].

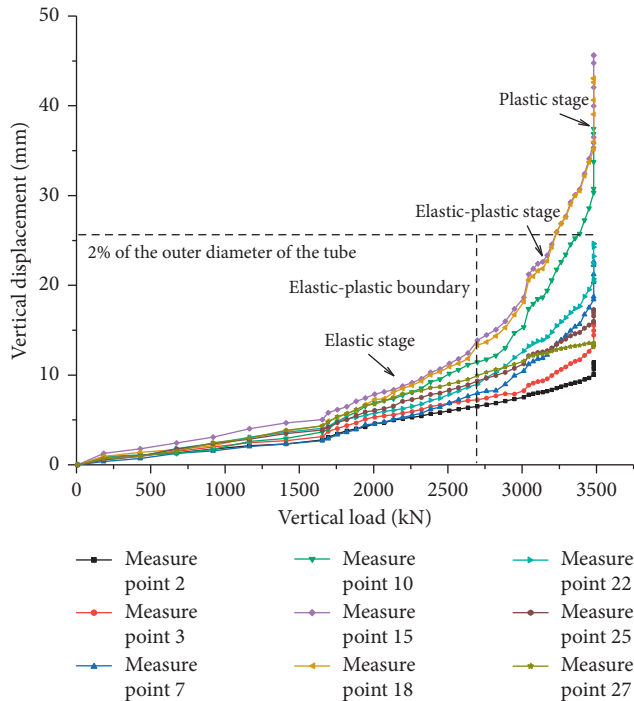
FIGURE 9: Change in the single-point displacement of each measuring point for different vertical loads.

As presented in Figure 9, the maximum displacement of a single point at the position of each measuring point increases as the vertical load increases. Basically, the growth law can be divided into three stages. In the first stage, from a vertical load of 0 kN to a vertical load of 2721 kN, the single-

point displacement of each measuring point increases linearly, and this stage is defined as the elastic stage. After the vertical load reaches 2721 kN, the increase in the vertical displacement of each measuring point accelerates, and the inflection point appears. This stage is defined as the elastic-plastic stage. When the failure load is reached, the vertical displacement of each measuring point continues to increase even though loading has been stopped, and the segment

becomes unstable. This stage is defined as the plastic stage. According to the limit index of the single-point maximum displacement of 2% in the failure state, the maximum vertical displacement of the vault reaches 45.1 mm, which is 3.5% of the outer diameter of the segment. In the elasto-plastic stage, only three vertical displacements reach the limit index, that is, measuring point 15 (the vault position), measuring point 10 (close to the left side of the vault), and measuring point 18 (close to the right side of the vault), and the proportion of the corresponding load (2% of the diameter) to the failure load is about 90%. In other words, when the displacement reaches the limit index, the segment is about to approach the limit of its bearing capacity. Thus, it is apparent that, for the segments with distributed mortises and tenons, it would be dangerous to use a single-point displacement of 2% as the deformation limit index to guarantee the displacement inside the elastic-plastic stage, and the increase in the slope of the displacement is relatively small, and it can be reduced appropriately to the range of 1.5% to 1.8%.

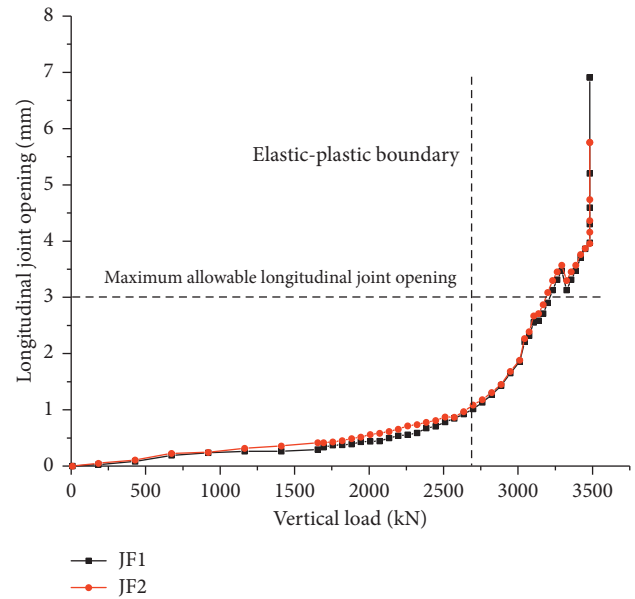
FIGURE 10: Variation law of longitudinal joint opening for different vertical loads.

the corresponding development law. Figure 10 shows the change law of the amount of opening for the two longitudinal joints for different vertical loads.

The longitudinal joint opening increases as the load ratio increases. It also can be divided into three stages, i.e., slow increase, accelerated increase, and sharp increase. The first stage is the slow increase stage (in which the vertical load is in the range of 0–2,721 kN). When a small load is applied, the longitudinal joint opening of the segment develops slowly, showing a linear growth trend. At the end of this stage, the longitudinal joint openings of JF1 and JF2 on both sides of the combined segment are 1.1 mm. Generally speaking, the development of longitudinal joint openings at this stage is relatively stable, and the value is also small.

The second stage is the accelerated increase stage, in which the vertical load is in the range of 2721 to 3482 kN. When the applied load increases gradually, the openings of the longitudinal joints of JF1 and JF2 accelerate, and the growth rates of the longitudinal joint openings continue to increase. When the vertical load was at 3,294 kN, the longitudinal joint opening suddenly decreased and then immediately resumed its linear growth. This may have been related to the severe dislocation between the segments when the damage was developing and the mortises and tenons in circumferential joint also were damaged. When the failure load was reached, the openings of the longitudinal joints of JF1 and JF2 were 3.971 mm and 3.955 mm, respectively.

The third stage is a sharp increase stage, and the failure load is unchanged. After the load is stopped, the longitudinal joint openings of JF1 and JF2 increase sharply, and the segment is in the unstable stage. The final openings of the two longitudinal openings were 6.9 mm and 5.7 mm, respectively. Compared with the maximum opening amount of 3.9 mm in the second stage, the amounts of the openings of the longitudinal joints in this stage increased by 2.9 mm

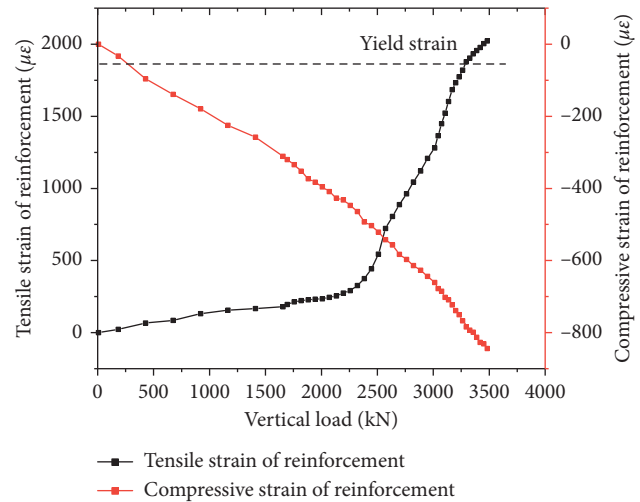
FIGURE 11: Strain of the main reinforcement at the vault position of the target segment of the middle ring.

3.4. Rebar Strain Characteristics. The inner steel bar of the segment is under tension, the steel bar of the outer side is compressed, and the maximum tensile strain of the steel bar occurs at the position of the middle ring vault. The maximum tensile strain of the inner main reinforcement was $2023 \mu\epsilon$. The type of steel used in this test was HRB400, and the corresponding yield strain was $1904 \mu\epsilon$. Therefore, the inner main reinforcement of the middle target segment in this failure test yielded, and the other positions had small strains but had not reached yield status. The maximum compressive strain of the outer main reinforcement was $-844 \mu\epsilon$, which was less than the yield state. Therefore, the tensile strain and compressive strain of the steel bar at the position of the vault were selected to analyze the change law of the vertical load, as shown in Figure 11. The process for the variation of the stress of the inner main reinforcement of the middle target segment basically can be divided into two stages, that is, a linear change and a nonlinear change. When the vertical load is small, the strain of the steel bar basically changes linearly as the vertical load increases. As the vertical load continues to increase and reaches about 2500 kN, the strain of the steel bar begins to show the characteristics of nonlinear growth, and the growth rate increased significantly compared with the first stage. When the vertical load was 3325 kN, the main reinforcement reached the yield strain. When the outer main reinforcement for the segment of the middle ring was compressed, the change law of compressive strain was different from the law of tensile strain. With the increase of the vertical load, the strain of the steel bar basically followed the linear growth law. The maximum compressive strain of $-844 \mu\epsilon$ occurred at the failure load, but the value of the compressive strain was small and had not yet reached the yield strain.

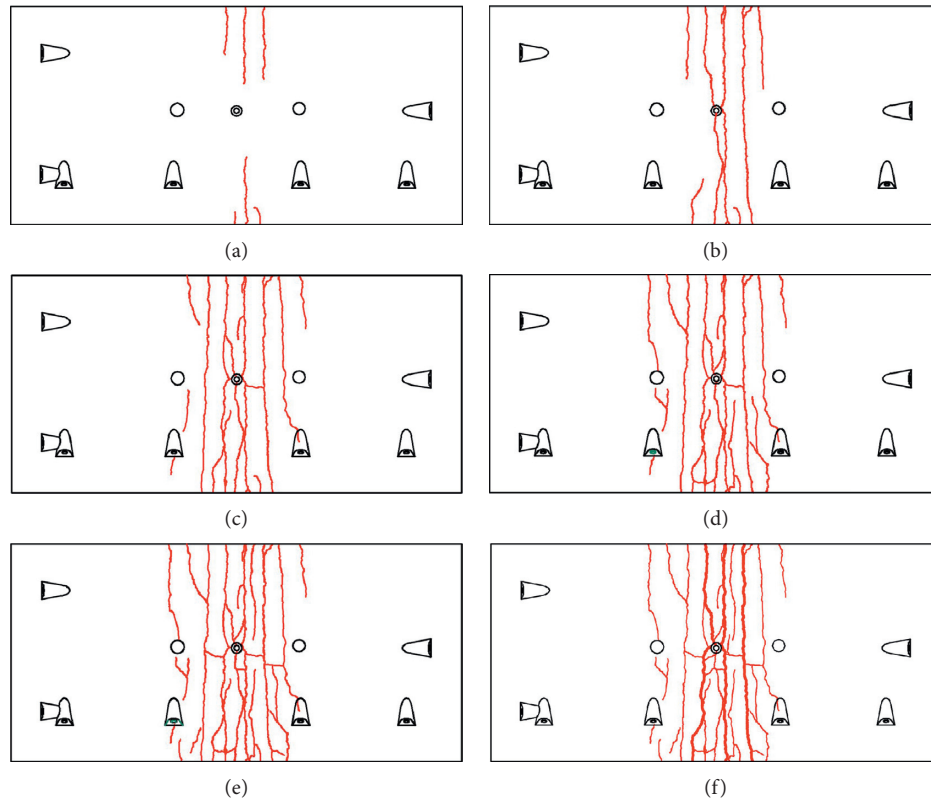
FIGURE 12: Development of cracks in the surface of the arc in the intermediate ring. (a) Vertical load = 1901 kN, (b) vertical load = 2182 kN, (c) vertical load = 2533 kN, (d) vertical load = 2784 kN, (e) vertical load = 3035 kN, and (f) failure load = 3482 kN.

4.1. Development of Cracks. During the test, the inner and outer surfaces of the arc of the middle ring of the assembled segments had different degrees of damage, but there was no damage to the adjacent rings. This was mainly due to the fact that the middle target segment was very rigid. The deformation of the segments was small, and the structure bore a large positive bending moment, which, in turn, caused the inner concrete to be under tension, and it finally reached the ultimate tensile strain and resulted in damage. However, due to the lessening of the stiffness of the longitudinal joints, the stiffnesses of the rings on both sides were small, and the ring bolts were oblique. The openings of the longitudinal joints were not constrained sufficiently. Under the combined influence of the factors, the segment rings on both sides can produce greater deformation without cracks. The failure process and the law of the development of cracks in the intermediate ring segment are illustrated in detail below. Figure 12 shows the process of the development of cracks in the arc for the segment.

When the vertical load reached 2182 kN, a second batch of cracks appeared in the middle of the structure of the segment, and cracks were generated at 7 new places. The maximum length of the cracks was 2,000 mm, and their maximum width was 0.21 mm. The first batch of 6 cracks gradually spread to the middle along the width direction, forming 3 parallel, penetrating cracks. The width of the main crack increased, and small, minor cracks were generated around it. All of the cracks were in the longitudinal direction; that is, no transverse cracks were found.

When the vertical load reached 2533 kN, the third batch of cracks appeared in the middle of the structure of the segment. Thirteen new cracks were generated, and the maximum length and width of the cracks were 2000 mm and

When the vertical load reached 2784 kN, the fourth batch of cracks appeared in the middle of the segment, and 9 new cracks occurred. The maximum length of the cracks was 2000 mm and their maximum width was 0.5 mm. The numbers of the secondary cracks and transverse cracks increased gradually. A new connecting crack was formed between the positioning hole and the edge of the segment. The rate of growth in the number of cracks was decreased.

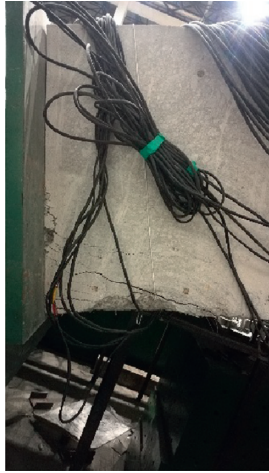
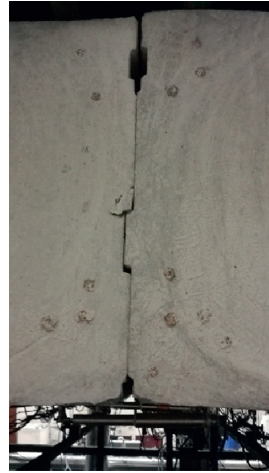
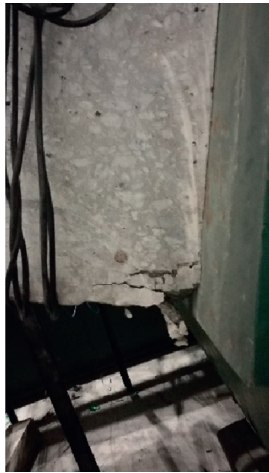
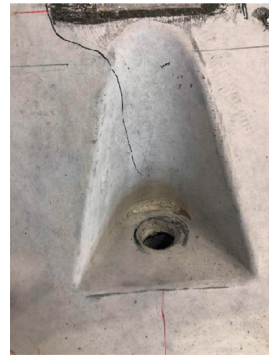
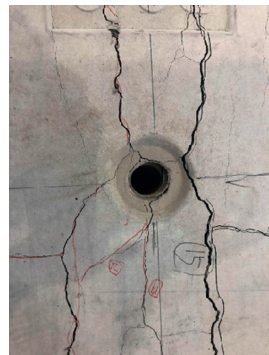
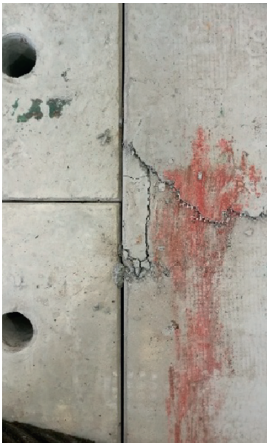
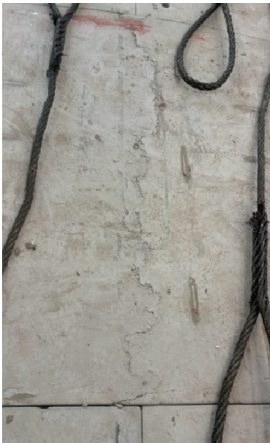
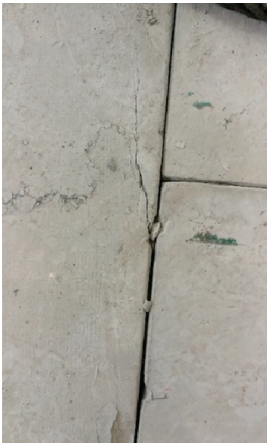
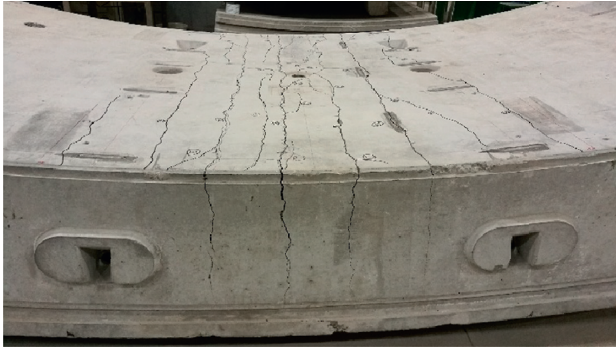
FIGURE 14: Final broken shape of the intermediate ring segment: (a) damaged in left inner corner, (b) local failure of longitudinal joints, (c) failure of the right inner corner, (d) bolt hole crack, (e) longitudinal crack, (f) cracks around the grouting hole, (g) partial failure of the left lateral longitudinal joint, (h) outside the vault collapsed, (i) local failure of the outer longitudinal joint on the right, (j) schematic diagram of the internal crack, (k) schematic diagram of cracks in thickness direction, and (l) the damage of mortises and tenons.

4.2. Final Failure State. When the segment finally failed, there were many cracks along the width direction on the surface of the arc of the middle ring segment structure vault. Among them, there were 5 parallel penetrating cracks, 3 cracks with widths of more than 5 mm, and 5.4 mm was the maximum width of a crack. In addition, there were a few diagonal and lateral cracks. Local compression and shear failure occurred at the left and right ends of the inner arc. The concrete at the top of the outer arc of the middle ring was crushed, and local compression-shear failure and cracks appeared near the longitudinal joints. Four longitudinal penetrating cracks with larger widths along the thickness of the segment gradually had extended from the inner arc to the outer arc in the thickness direction of the segment. The shallowest depth of the cracks was 323 mm, which was 58.7% of the thickness of the segment; the deepest crack exceeded the depth of 430 mm, reaching 78.2% of the thickness of the segment. The maximum opening of the longitudinal joint was 6.914 mm, the vertical displacement continued to increase to 45.65 mm, and the final failure form was compression-bending failure. Figure 14 shows the final broken shape of the segment. The mortises and tenons are damaged

but not failed, the damage degrees of the mortises and tenons are different, and the middle tenons are damaged the most.

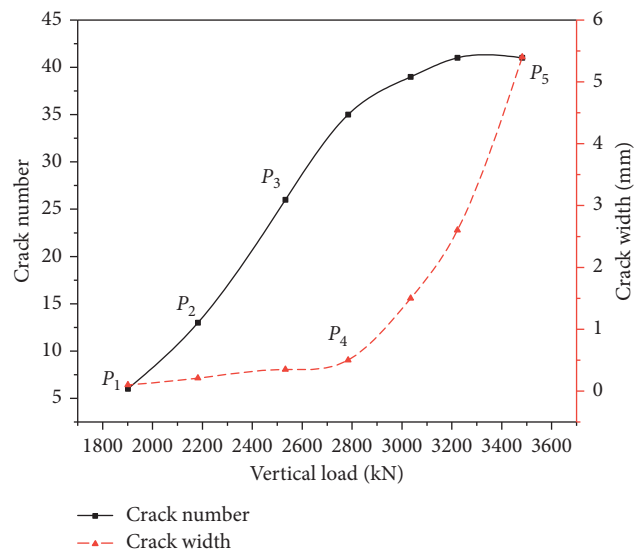
FIGURE 15: Variation of the number and width of cracks.

4.3. Analysis of the Mechanism of the Damage. The development of cracks on the inner arc had a greater impact on the load-bearing capacity of the structure of the segment. Thus, attention should be directed to the development of cracks on the inner arc during the construction and operation periods. Therefore, the characteristics of the development of cracks on the surface of the internal arc were analyzed in order to determine the failure mechanism. Figure 15 shows the rule concerning the development of cracks, including their numbers and widths. The law associated with the development of cracks in the surface of a segment of the arc and their widths is the opposite of the development law concerning the number of cracks. Thus, the change in the process of the development of cracks can be divided into two stages, that is, (1) the stage in which there is rapid growth in the number of cracks and (2) the stage in which the widths of the cracks increase rapidly. In the initial stage of loading, both the horizontal load and the vertical load are small, and the segment is not damaged. As the vertical load increases gradually, the bending moment of the segment also increases gradually. At this time, the structure of the segment is stretched on the surface of the inner arc. Small cracks began to appear where the stress was greater, and then the first batch of cracks quickly penetrated, forming several parallel cracks. Immediately afterwards, more cracks occurred around the main crack, and longitudinal cracks gradually appeared in other positions. At this stage, there were more cracks in the segment, and the growth rate was large, but the widths of the cracks developed slowly. After the continuous development of each secondary crack, there were connected transverse cracks between the longitudinal cracks, but there was a small number of them, and the width of the cracks increased rapidly at this stage.

In order to facilitate the analysis, five characteristic nodes were selected when the cracks were developing; that is, (1) the first visible cracks appeared on the arc surface of the segment, corresponding to node P1; (2) the first visible cracks penetrated, forming parallel and longitudinal cracks, and the maximum width reached the limit value of 0.2 mm in the use stage, corresponding to node P2; (3) the number of cracks increased the fastest, corresponding to node P3; (4) the widths of the cracks began to increase rapidly, corresponding to node P4; and, (5) finally, the segment failed, corresponding to node P5. The corresponding vertical loads for each node were 1901, 2182, 2533, 2784, and 3482 kN.
