Research Article

Bearing Repair and Monitoring for Poyanghu Cable-Stayed Bridge

Currently, the bearings of Poyanghu Bridge, a 636-meter long cable-stayed bridge, have been damaged. According to numerical analyses, the mechanical state of the damaged bridge unfavorably deviates from the ideal design state, and the bridge should be repaired in time to restore its safety and serviceability. However, compared with the bearing repair of beam bridges, much less scientific and engineering endeavors have been made in the history to direct the bearing repair of cable-stayed bridges. This article proposes two innovative bearing repair schemes for cable-stayed bridges and reports the numerical validations, the on-location applications, and the monitoring of the proposed repair schemes under the engineering background of Poyanghu Bridge. Through these works, it is found that the proposed repair schemes are effective in practical use.

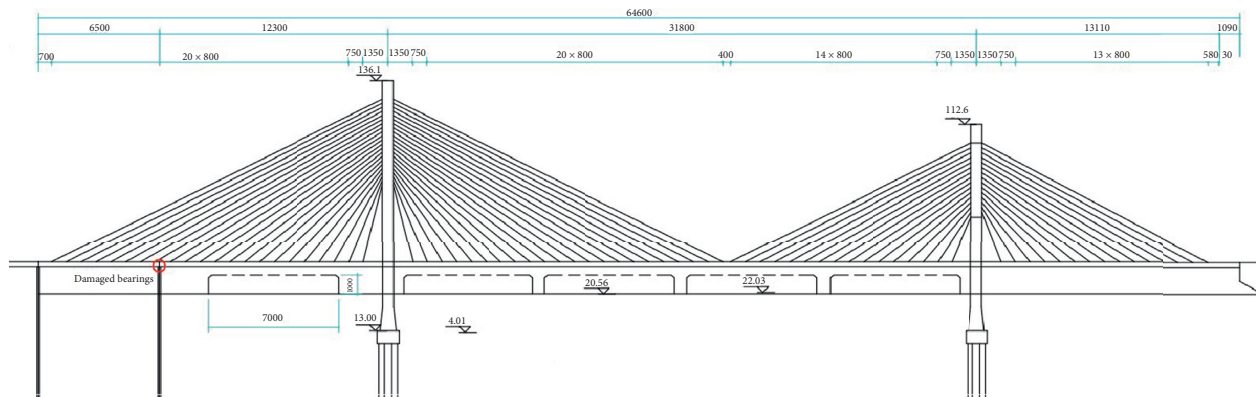
FIGURE 2: Elevation sketch of Poyanghu Bridge (unit: cm).

cable-stayed bridge with high and low pylons (Figure 2). The structure is a fundamental semifloating system with the main girder and the pylons separated. Bearings are arranged on the lower cross-beams of the pylons to support the main girder. In the side span of the high pylon, auxiliary piers are constructed with bearings arranged on top to support the main girder. The main girder cast in C55 concrete is *n*-shaped in cross section. The width of the main girder is 27.5 m.

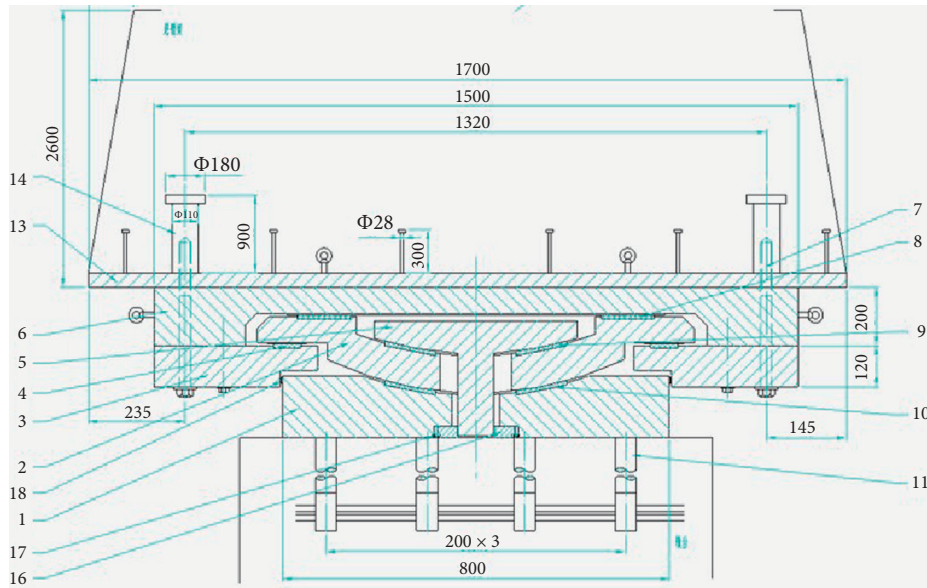
FIGURE 3: Details of the bearing (unit: mm).

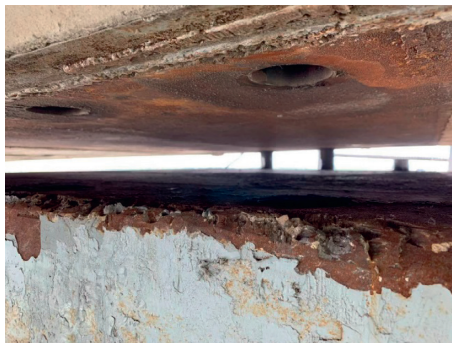
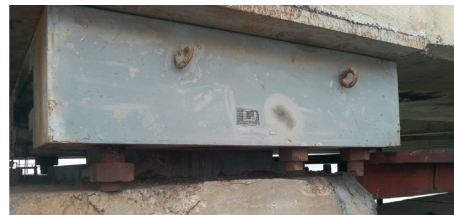
Poyanghu Bridge was constructed and opened to traffic in 2000. However, in July, 2019, its administrative staff detected damages in both the downstream side and the upstream side bearings arranged on top of the auxiliary piers. The damaged bearings of type QZL-3300-4200ZXS are spherical tension-compression type. Their tensile capacity is 3300 kN, and compressive capacity is 4200 kN. The size of the damaged bearings is 150 cm × 112 cm. The rotation angle limit is 0.02 rad, and the longitudinal and the transverse displacement limits are ±15 cm and ±2 cm, respectively, for the bearings. The cross-section view of a bearing is shown in Figure 3. For the downstream side bearing, all anchoring bolts connecting the upper steel plate to the main girder fell off, and the main girder and the bearing were separated (Figure 4(a)). Besides, transverse displacement was observed for the main girder near the downstream side bearing. For the upstream side bearing, two anchoring bolts broke (Figure 4(b)). Based on engineering experiences, the administrative staff thought that the mechanical state of

FIGURE 4: Damaged bearings: (a) downstream side bearing and (b) upstream side bearing.

1.4. Bearing Repair Undertaken on the Location. Based on the numerical investigations of the repair processes, both of the two repair schemes are proved to be effective in solving the strength and the stiffness problems with the damaged Poyanghu Bridge. However, in view of the feasibility, the repair cost, and the local behaviors of the piers in the emergency rescue cases, the repair personnel finally chose to repair the bearings according to repair scheme 2.

During September to October in 2019, repair scheme 2 was successfully implemented on the location by practicing engineers. Four steps were actually undertaken during the repair process with details shown in Table 1. According to Table 1, the displacements of the main girder and the forces of the stayed cables near the auxiliary piers were monitored during the whole repair process, which guaranteed the safety of the structure during the repair process and the quality of repair.

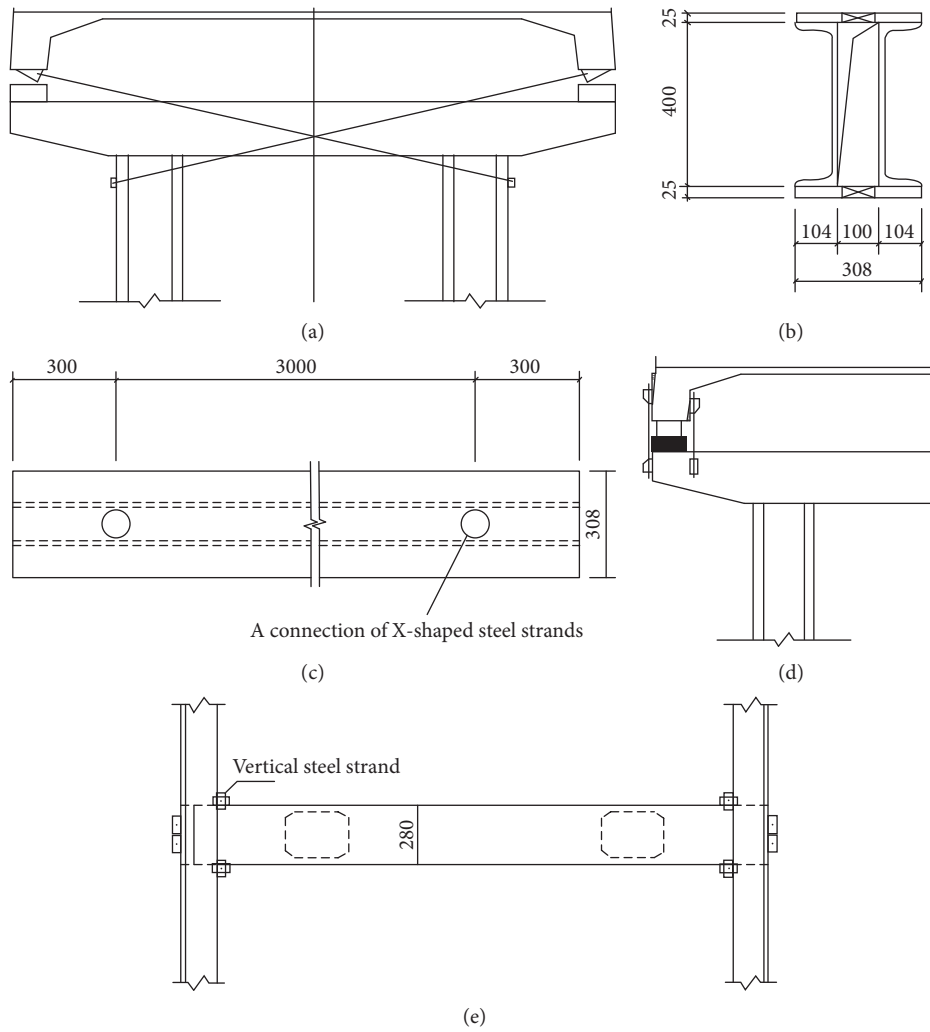
1.2.1. Repair Scheme 1. Repair scheme 1 is a two-level repair plan, which relies on the tensioning of the steel strands. The 1st level of repair is an emergency rescue practice, which utilizes the four X-shaped steel strands arranged near the bearings tensioned with 1000 kN force each to rapidly strengthen the stability of the structure (Figure 5(a)). The X-shaped steel strands are attached to two 3.6 meter long steel channel members with the dimension shown in Figures 5(b) and 5(c) arranged on two sides of the bridge piers by planting reinforcing bars at the height of 1 meter below the capping beam. Therefore, the repair practice might cause the damage of the piers at the connections of X-shaped steels. X-shaped steel strands employed are PES5-85 type hot extrusion polyethylene sheath cables made of 85 5 mm-in-diameter steel wires. Their cross section area is 16.69 cm²; their weight per unit length is 13.1 kg/m; their external diameter is 6.1 cm; their

breaking force is 2620 kN; and their strength is 1570 Mpa. The 2nd level of repair is a repair practice in its true sense, which utilizes eight vertical steel strands tensioned with 2000 kN force each to position correctly the main girder in relation to the bearings to facilitate the repair of the bearings (Figures 5(d) and 5(e)). The vertical steel strands employed are PES7-85 type hot extrusion polyethylene sheath cables made of 85 7 mm-in-diameter steel wires. Their cross section area is 32.71 cm²; their weight per unit length is 25.7 kg/m; their external diameter is 8.3 cm; their breaking force is 5136 kN; and their strength is 1570 Mpa.

FIGURE 5: Sketches for repair scheme 1. (a) 1st level repair (emergency rescue). (b) Cross section of steel channel members arranged on two sides of the bridge piers for fixing the X-shaped steel strands (unit: mm). (c) Top view of steel channel members arranged on two sides of the bridge piers for fixing the X-shaped steel strands (unit: mm). (d) 2nd level repair (bearings repair). (e) Plan view of 2nd level repair.

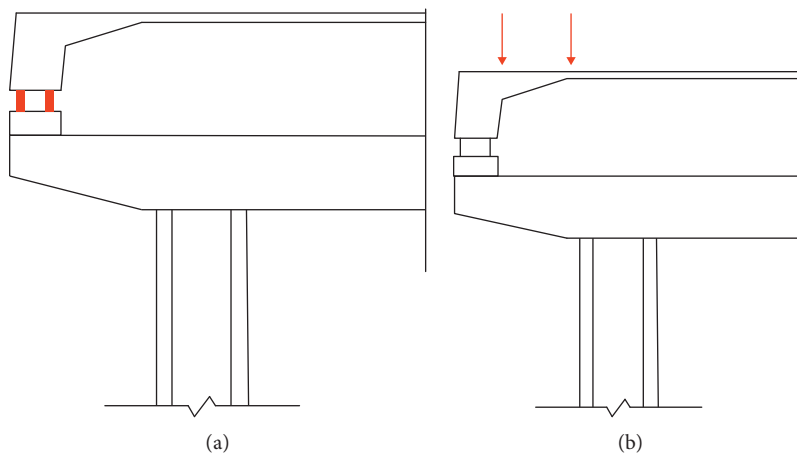
1.2.2. Repair Scheme 2. Due to the feasibility and other considerations, another two-level repair plan (repair scheme 2) is also proposed by the practicing engineers. During the 1st level of repair, two steel cylinders of 25 cm in diameter are arranged near each of the two damaged bearings as temporary supports so that emergency rescue can be realized (Figure 6(a)). During the 2nd level of

repair, after the bearings are repaired, a vehicle of around 25 kN is utilized as ballast to adjust the position of the main girder to facilitate the tensioning of the anchoring bolts arranged between the main girder and the bearings (Figure 6(b)).

FIGURE 6: Sketches for repair scheme 2: (a) 1st level repair (emergency rescue); (b) 2nd level repair (bearings repair).

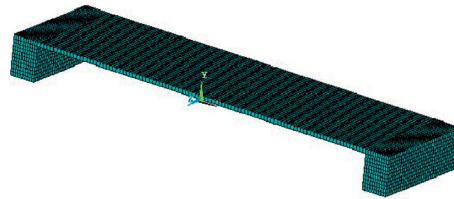
The solid element model is established for the main girder section above the auxiliary piers on ANSYS FE platform using 12803 hexahedron elements (Figure 8). The numerical simulation process for the solid element model is of three steps: (1) extracting the displacements of related nodes from the computational results of the beam element model in different scenarios; (2) calculating the displacement distributions on the whole cross-sections of the solid element model using linear interpolations based on the plane-section assumption; and (3) calculating the whole-field stress responses of the solid element model in different scenarios by applying the displacement boundary conditions calculated in the previous step.

FIGURE 8: Detailed solid element model.

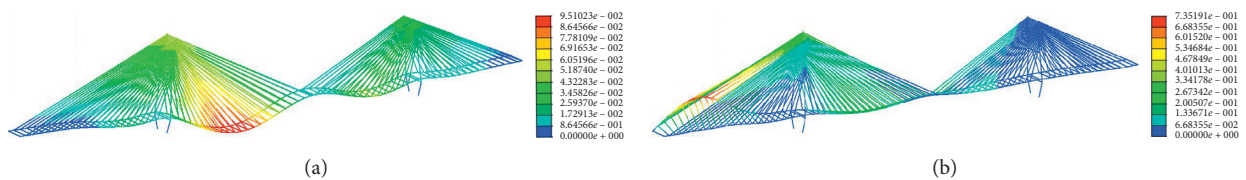
1.3.2. Mechanical States of Poyanghu Bridge for Intact and Damaged Cases. The beam element model is utilized to calculate the static mechanical states of Poyanghu Bridge under the dead load for the intact and the damaged cases. The displacement responses, the stress distributions, and the cable force distributions calculated are shown in Figures 9–11, respectively. As shown in Figure 9, the surface of the main girder is smooth along the bridge for the intact case; for the damaged case, the main girder section above the auxiliary piers noticeably deflects upward on the downstream side, which adversely affects the driving safety for vehicles running along the bridge. In Figure 9(b), the displacements calculated at the damaged support from the numerical model are $5.31113E-003$ m, $2.50000E-002$ m, and $7.33101E-001$ m for longitudinal, transverse, and vertical directions, respectively. They are with 15.96%, 19.09%, and 1.26% relative errors compared with the values measured in the real site ($6.32E-03$ m, $3.09E-02$ m, and $7.24E-01$ m). According to Figure 10, after the bridge is damaged, the stress distribution on pylons and the main girder changes

FIGURE 9: Displacement responses for (a) intact case and (b) damaged case (unit: m).

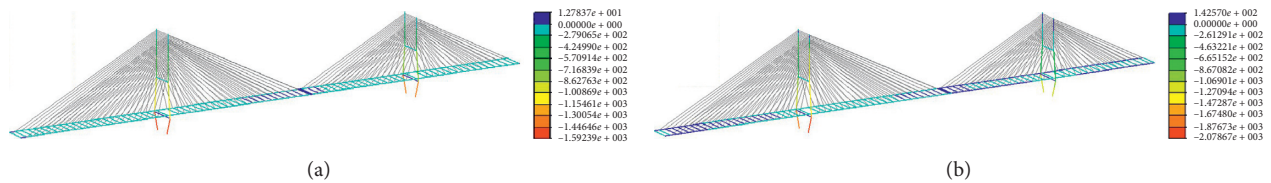
noticeably; the maximum compression stress increases, and the maximum tensile stress is amplified by an order of magnitude. According to Figure 11, after the bridge is damaged, the cable force distribution deviates from the ideal design state; the cable forces distributed nonuniformly at the side span of the high pylon, and the cable force changes significantly between neighbouring cables there. According to Figures 10 and 11, the calculated stresses for the pylons, the main girder, and the cables of the damaged bridge are fortunately within the strengths of these components. Although there is no serious safety issue for the time being, the stability of the entire bridge might still be endangered if the bearings were not repaired in time.

FIGURE 10: Stress distributions on pylons and the main girder for (a) intact case and (b) damaged case (unit: tonf/m²).

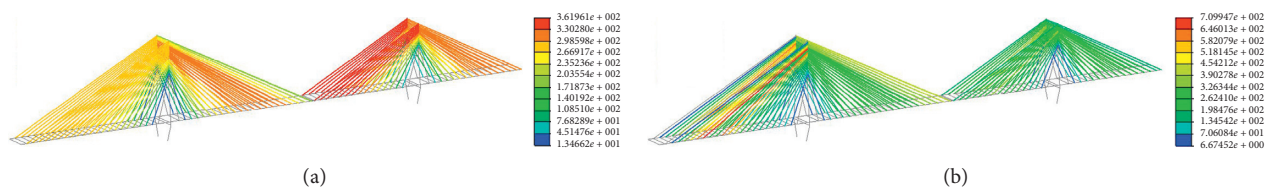
FIGURE 11: Cable force distributions for (a) intact case and (b) damaged case (unit: tonf).

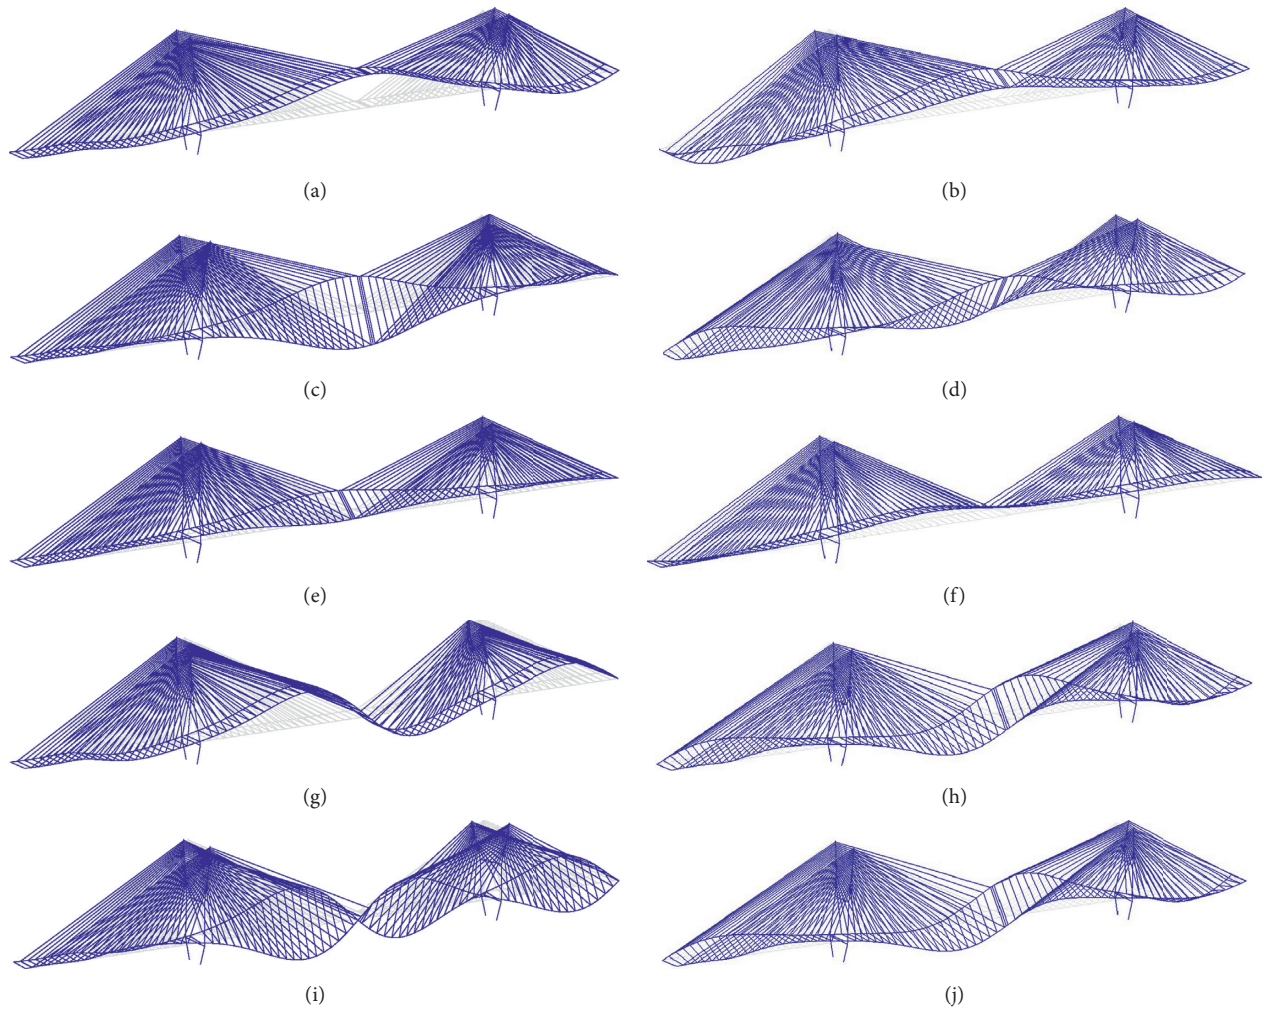
Besides, the dynamic characteristics of Poyanghu Bridge are also calculated using the beam element model for the intact and the damaged cases and shown in Figure 12. As can be seen, after the bridge is damaged, the low-order natural frequencies of the bridge decrease, possibly leading to stronger resonances of the bridge under strong winds. Besides, the mode shapes of Poyanghu Bridge in intact case can be clearly classified as vertical bend type (Figures 12(a) and 12(g)) or torsion type (Figures 12(c), 12(e), and 12(i)); however, the mode shapes of the bridge in damaged case usually feature complicated coupling between vertical bend and torsion (Figures 12(b), 12(d), 12(h), and 12(j)).

FIGURE 12: Mode shapes for intact and damaged cases. (a) 1st mode for intact case (1.13 Hz). (b) 1st mode for damaged case (0.98 Hz). (c) 2nd mode for intact case (1.44 Hz). (d) 2nd mode for damaged case (1.33 Hz). (e) 3rd mode for intact case (1.51 Hz). (f) 3rd mode for damaged case (1.5 Hz). (g) 4th mode for intact case (1.67 Hz). (h) 4th mode for damaged case (1.57 Hz). (i) 5th mode for intact case (2.13 Hz). (j) 5th mode for damaged case (1.94 Hz).

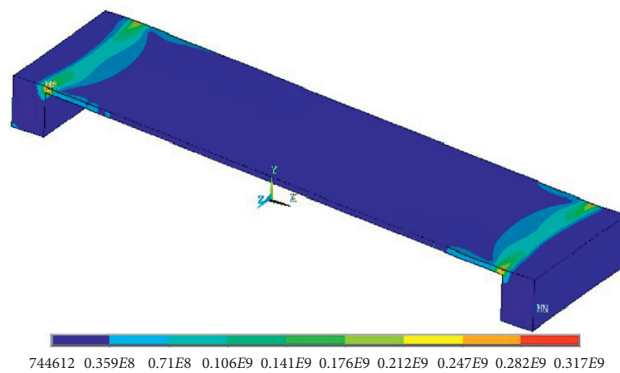
Both the static responses and the dynamic characteristics calculated using the simplified beam model suggest that the Poyanghu Bridge becomes unfavorable in safety and serviceability after the damage, and it must be repaired in time to avoid the structural failure and restore its serviceability. Similar results are obtained by using the solid element model to calculate the local stress field of the main girder section above the auxiliary piers in the damaged case. As shown in Figure 13, for the damaged case, stress concentrations can be observed on the corners of the main girder section. Besides, the maximum von Mises equivalent stress exceeds the material strength of C55 concrete, suggesting that local strength failures might be induced on the bridge in the damaged case.

FIGURE 13: Von Mises equivalent stress distribution on the main girder section for the damaged case (unit: Pa).

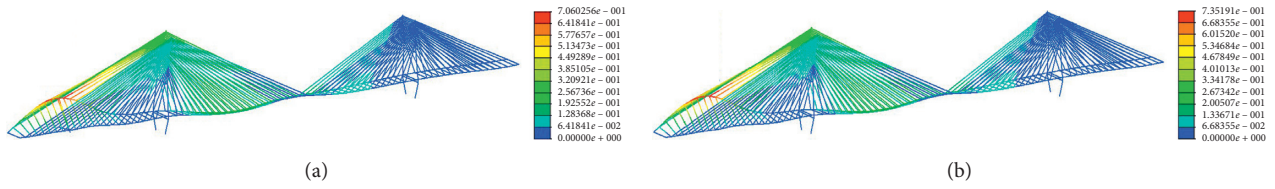
1.3.3. Mechanical States of Poyanghu Bridge for the Emergency Rescue Cases. For both the repair scheme 1 and the repair scheme 2, the mechanical states of Poyanghu Bridge in emergency rescue cases under the dead loads are calculated. As shown in Figure 14, the displacement responses calculated for the two emergency rescue cases are close, and they are also close to the displacement response calculated for the damaged case (Figure 9(b)). Similar situations hold true for the stress distributions on pylons and the main girder (see Figures 15 and 10(b)) and the cable force distributions (see Figures 16 and 11(b)). Besides, the von Mises equivalent stress distributions on the main girder section calculated for the two emergency rescue cases (Figure 17) are both close to stress distribution calculated for the damaged case (Figure 13). These analyses suggest that the static mechanical state of the damaged Poyanghu Bridge is not improved by the emergency rescue for both the repair scheme 1 and the repair scheme 2. In addition, for the

FIGURE 14: Displacement responses for the emergency rescue cases (unit: m): (a) repair scheme 1 and (b) repair scheme 2.

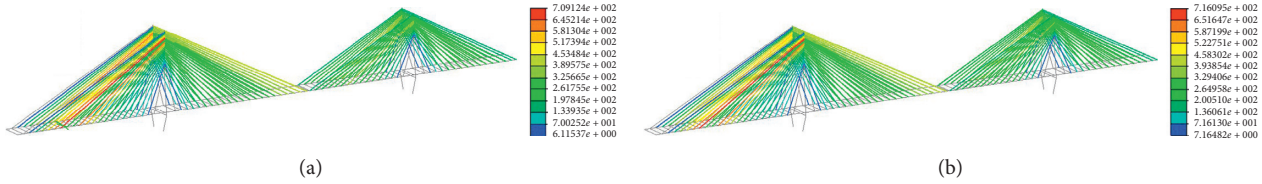
FIGURE 16: Cable force distributions for the emergency rescue cases (unit: tonf): (a) repair scheme 1 and (b) repair scheme 2.

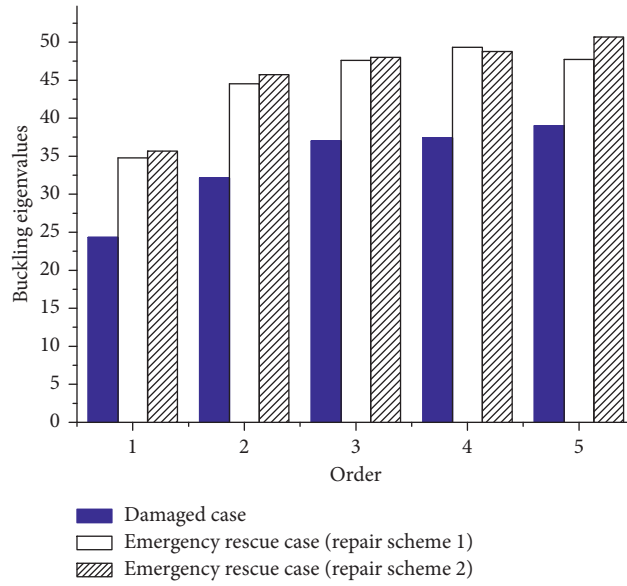
the bridge. As shown in Figure 18, for both the repair scheme 1 and the repair scheme 2, the buckling eigenvalues of the entire bridge calculated for the emergency rescue cases increase to 1.25~1.5 times the original values calculated for the damaged case. Besides, according to Figure 19, when the emergency rescue is undertaken on the damaged bridge, most low-order instability shapes change from unfavorable out-plane patterns to favorable in-plane patterns. These suggest that the purpose of the emergency rescues is to improve the spatial stability of the whole structure and guarantee the construction safety of the

FIGURE 18: 1st~5th buckling eigenvalues calculated for different cases.

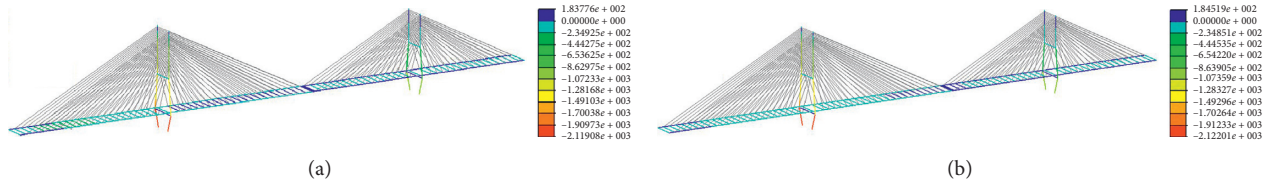
models for both repair scheme 1 and repair scheme 2, and the results are shown in Figures 20–23. As shown in Figure 20, the displacement responses calculated for the two repair cases are close, and they are also close to the displacement response calculated for the intact case (Figure 9(a)). After the repairs, the displacements for the main girder at the auxiliary piers are the same as those for the capping beam of the auxiliary piers. Similar situation holds true for the stress distributions on pylons and the main girder (see Figures 21 and 10(a)). These suggest that the mechanical states of the entire bridge are close to the ideal design state after the repairs, and ideal maintenances can be achieved for both repair schemes. However, after the repairs, the cable force distributions (Figure 22) are different from that for the intact case (Figure 11(a)), suggesting that cable force adjustments are required after the bearing repairs. According to Figure 23, after the repairs, the stress distributes uniformly on the main girder section; no stress concentration is observed, and the maximum von Mises equivalent stress is not greater than the material strength of C55 concrete. These suggest that the local strength failure can be avoided after the repairs.

FIGURE 21: Stress distributions on pylons and the main girder for the repair cases (unit: tonf/m²): (a) repair scheme 1 and (b) repair scheme 2.

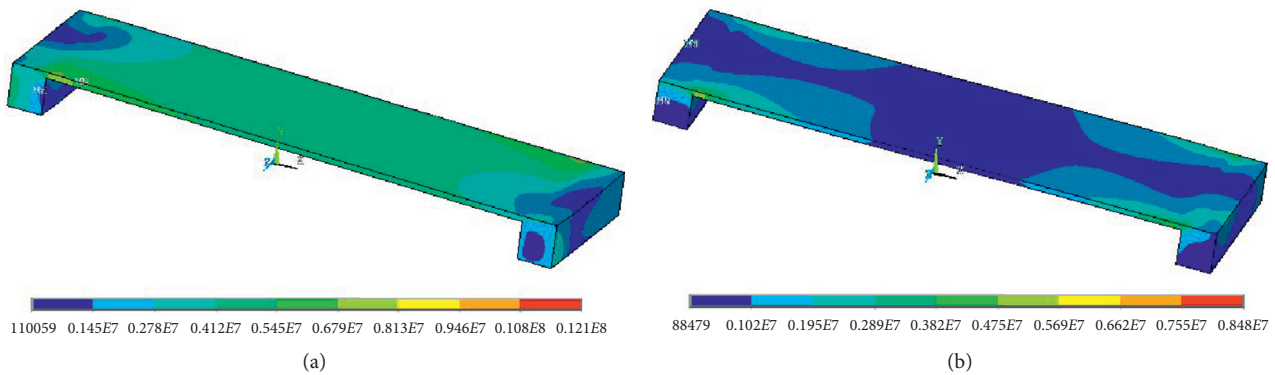
FIGURE 23: Von Mises equivalent stress distributions on the main girder section for the repair cases (unit: Pa): (a) repair scheme 1 and (b) repair scheme 2.

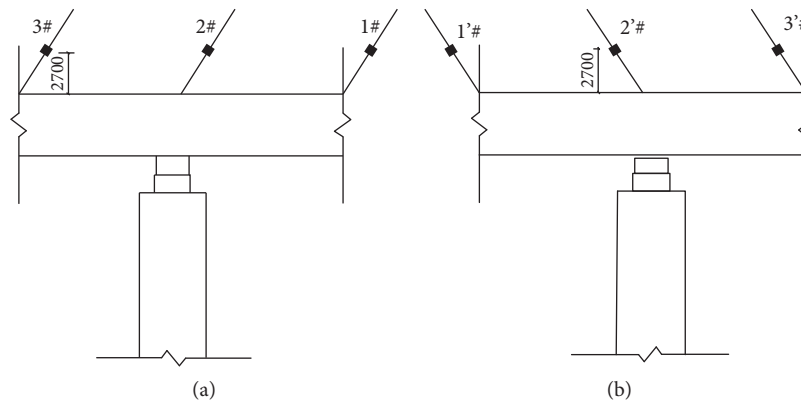
1.5. Repair Monitoring on the Location. According to Ref. [14], the forces in stayed cables measured on the cable-stayed bridges can be employed to calculate the real-time elevations of the main girders and detect the uncertain parameters of the structures. Therefore, different from the traditional monitoring practice of the beam bridges, the present repair monitoring of Poyanghu Cable-stayed Bridge not only measures the displacements of the main girder but the forces of the stayed cables as well. Special attention is focused on information extraction and utilization from the monitored forces of the stayed cables. As shown in Figure 24 and Table 1, the forces in six stayed cables above the auxiliary piers on both the upstream side (1#~3# cables) and the downstream side (1'#~3'# cables) are monitored during repair steps 1–3 by arranging one accelerometer on each of the six stayed cables.

FIGURE 24: Monitored stayed cables above auxiliary piers with accelerometers arranged (unit: mm): (a) upstream side and (b) downstream side.

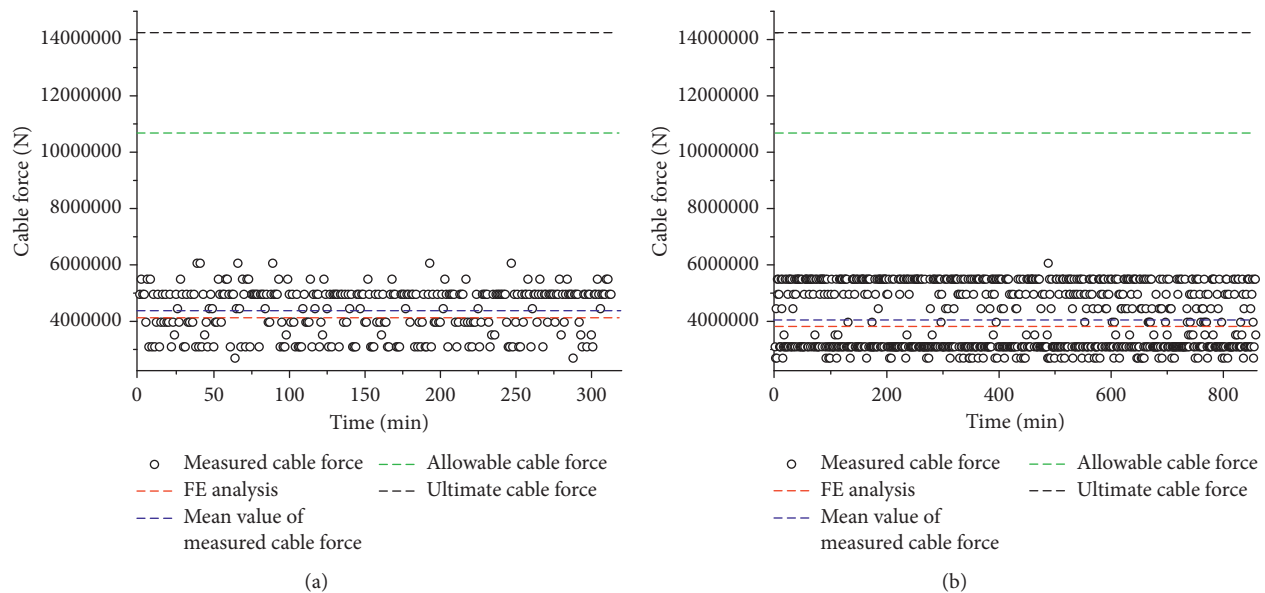
Using the Fourier transform and peak-picking method, the fundamental frequencies of the monitored stayed cables are identified from the one-min-long transverse acceleration samples measured continuously using the accelerometers arranged. Then, using the cable force formula, the continuous forces of the stayed cables are calculated from the fundamental frequencies. Figures 25(a) and 25(b) show two continuous force samples of the 1# stayed cable measured in repair steps 1 and 2, respectively. As can be seen in Figure 25, the measured force time-histories of the 1# stayed cable vary in small intervals, and they are much smaller than the allowable and the ultimate cable forces, suggesting that the mechanical states of the structure are stable and safe in different scenarios; the time-varying mean values of the measured cable forces calculated by using empirical mode decomposition are constants, suggesting that the measured cable forces do not have the gradual changing trends; the mean values of the measured cable forces are close to the FE analysis results (the relative errors between them are kept within $\pm 15\%$), suggesting that the safety of the structure during the repair process and the quality of repair are good. Similar situation holds true for 1# stayed cable in other repair steps or other cables in different scenarios.

FIGURE 25: Continuous cable force samples of the 1# stayed cable. (a) Sample measured on 18 September (repair step 1). (b) Sample measured on 25 September (repair step 2).
