## Review Article

# A Review of Precast Concrete Beam-to-Column Connections Subjected to Severe Fire Conditions

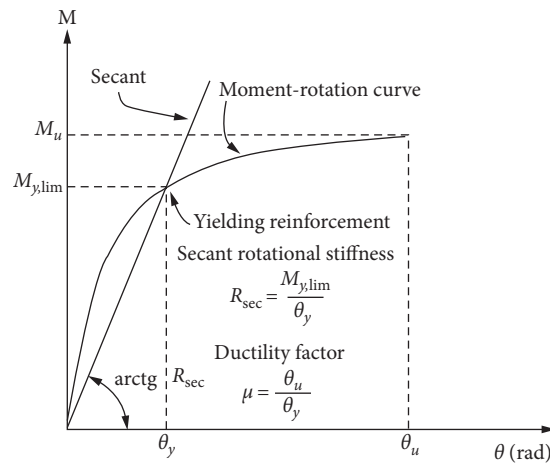
FIGURE 2: Simplified moment-rotation relationship [14].

However, the simplified moment-rotation relationship in Figure 2 was developed for practical applications and to obtain reliable results [14].  $M_{y,lim}$  is the yielding moment, and  $M_u$  is the flexural strength moment of the connection. Secant rotational stiffness ( $R_{sec}$ ) is used in a linear analysis that considers the nonlinearity response of the connection in the moment-rotation curve. Secant rotational stiffness is a safe approximation for representing the behaviour of connections in a global analysis of structural stability.

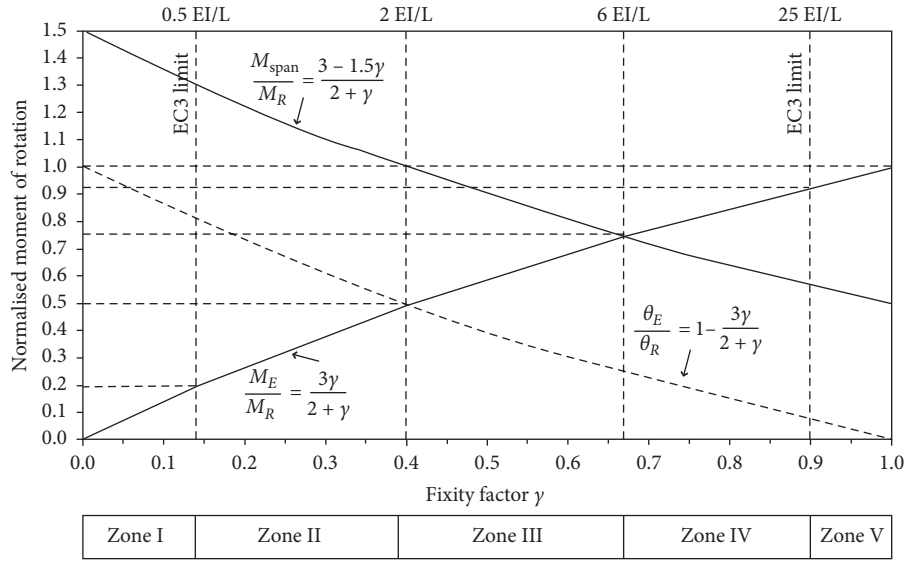
FIGURE 3: Connection classification system [11].

The second method for classifying semirigid connections uses the connection classification system shown in Figure 3 [11]. This system consists of five distinct zones. Zone I and V represents pinned connections and rigid connections, respectively. Zone II represents semirigid connections with low strength ( $0.14 < \gamma \leq 0.40$ ), Zone III represents semirigid connections with moderate strength ( $0.40 < \gamma \leq 0.67$ ), and Zone IV represents semirigid connections with high strength ( $0.67 < \gamma \leq 0.90$ ). The equation for Monforton's fixity factor [13] is given by
