## Research Article

# Experimental Behavior of the Curved Continuous Twin I-Girder Composite Bridge with a Precast Concrete Slab Subjected to Bending, Shear, and Torsion

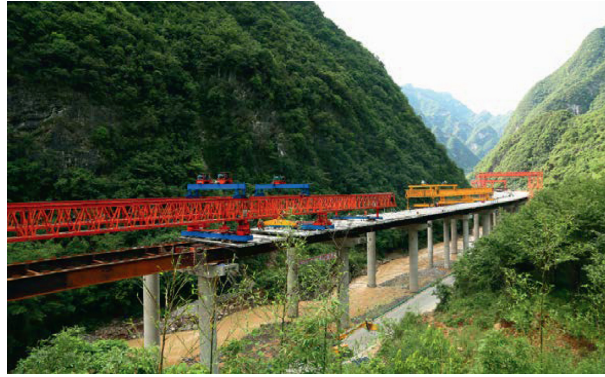
FIGURE 2: Prototype bridge.

**2.1. Model Design.** A prototype bridge (Figure 2), located in Shanxi province, China, was a curved continuous twin I-girder composite bridge with two spans ( $2 \times 35$  m) designed by current China highway standard specifications [32–34]. The radius of curvature of the centerline was 460 m. The height of the composite girder was 2.2 m. The width of the top concrete slab was 12.75 m. The width of the cantilever part of the top concrete slab was 3.025 m. The thickness of this cantilever part varied from 0.22 m at the free end to 0.4 m at the intersection over the steel web.

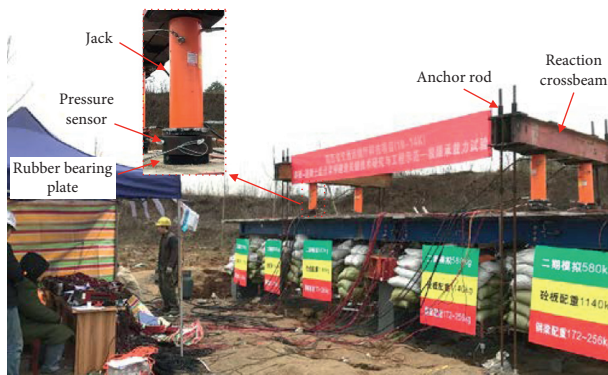
FIGURE 4: Overview of the test setup.

**2.4. Loading and Measurement Location.** Figure 4 shows the overview of the test setup. The test was carried out in the mixing station, near the prototype bridge. Because of the restriction of loading conditions, we had

to make a test setup. The self-developed test setup consisted of a ground anchor, six anchor rods, and two reaction crossbeams, as shown in Figure 4. The ground anchor is made of about 100 m<sup>3</sup> concrete. The diameter and length of the finished deformed bar used as an anchor rod were 32 mm and 7500 mm, respectively. Each reaction crossbeam was 3.2 m long and welded together by three 36b I-beams. The results of both calculation and experiment show that the deformation of the reaction crossbeam is negligible compared with that of the model during the loading.

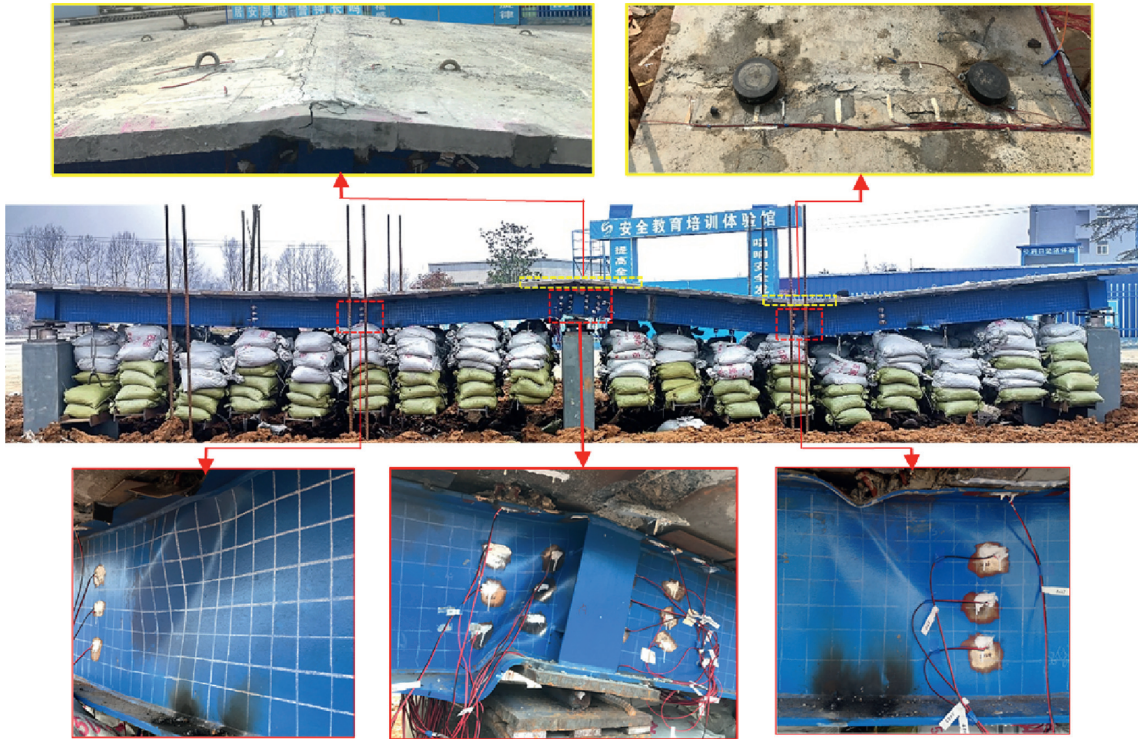
FIGURE 6: Failure mode of the model under the ultimate state (view of the internal girder).

Figure 6 shows the failure mode of the model under the ultimate state. Significant large deflection was recorded. The maximum crack width was up to 4 mm near the intermediate support section. The concrete slabs were crushed at the top of the concrete slab near the loading position. The webs of main girders were buckled locally at the loading position and intermediate support section, respectively. The whole bridge model presented an obvious “W” shape (Figure 6).

Finally, an obvious angle appeared at the intermediate support section, as shown in Figure 6. The major crack reached 4.5 mm wide. At that time, cracks propagated throughout the two precast slabs and cast-in-place joints on both sides of the intermediate support section. That is to say, the composite section within a range of  $\pm 11\% L$  from the intermediate support had become the cracked section. It is also indicated that it is reasonable and safe to presume the area within 15% of the span on both sides of the bearing in the negative moment as the cracking area in Eurocode 4.

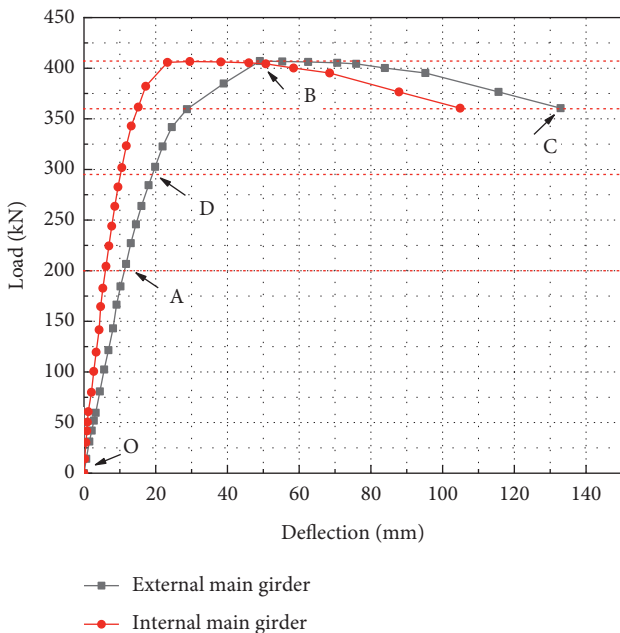
FIGURE 7: Load-deflection curves at the intermediate support section.

**3.2.1. Load-Deflection Relationship.** Figure 7 shows load-deflection curves at the loading position of the internal

girder and external girder, respectively. According to the curves in Figure 7, the load-deflection curves of the internal and external girders have similar changing law, which could be divided into three stages: elastic stage (O-A), elastic-plastic stage (A-B), and failure stage (B-C). The main conclusions are as follows:

(3) Failure stage: when the load reached 407 kN (about 13.6 times of the design load and the ultimate load  $P_u$ ), as shown in Figure 7, point “B,” the webs of both internal and external girders were buckled locally near the intermediate support section. A rotatable plastic hinge was formed at the intermediate support section. The change of the continuous beam structure system resulted in a redistribution of the internal force of the whole bridge model. Therefore, the deflection of the loaded section increased rapidly, a large area of the positive-moment steel beam yielded, and the concrete slab formed a crushing belt rapidly.

It was also found from Figure 7 that there were slight differences between the stiffness of the internal girder and that of the external girder. The deflection of the external girder was faster than that of the external one. Taking the applied load of 300 kN (about 10 times of the design load and about 0.72  $P_u$ ) as an example, the corresponding deflection of the external steel girder was 19.84 mm, while the corresponding deflection of the internal steel girder was only

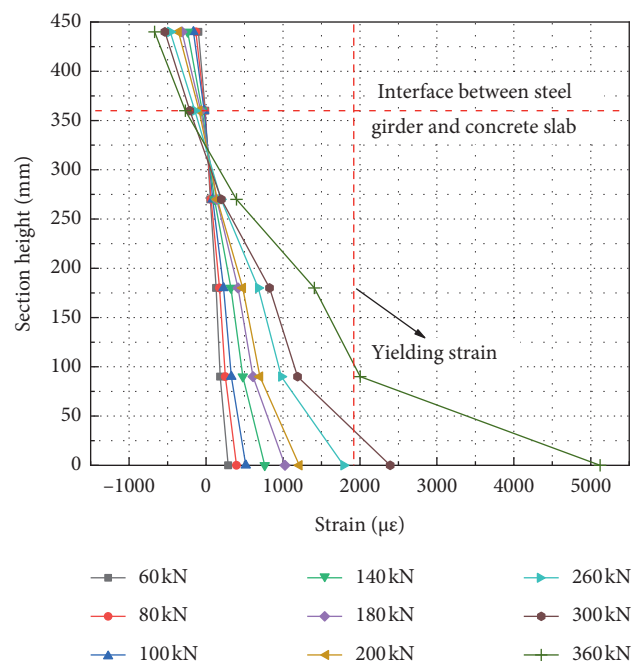
FIGURE 13: Strain distribution along the height of the section at the loading section (section B).

3.2.4. *Cross-Section Strain Distribution.* Take a loading section (section B) as an example, the distribution of the longitudinal normal strain increment along the height of the composite girder at different load steps is shown in Figure 13. At the early loading stage ( $\epsilon < \epsilon_y$ ), the strain increment points were linearly distributed along the

height of the composite girder, satisfying the assumption of the plane section. When the strain exceeds the yielding strain  $\epsilon_y$ , the points can no longer be connected by a single

straight line. It means the assumption of the plane section can no longer be valid. In addition, with the increase of loads, the bottom flange and web of the steel beam yielded gradually, and the neutral axis tended to move upward.

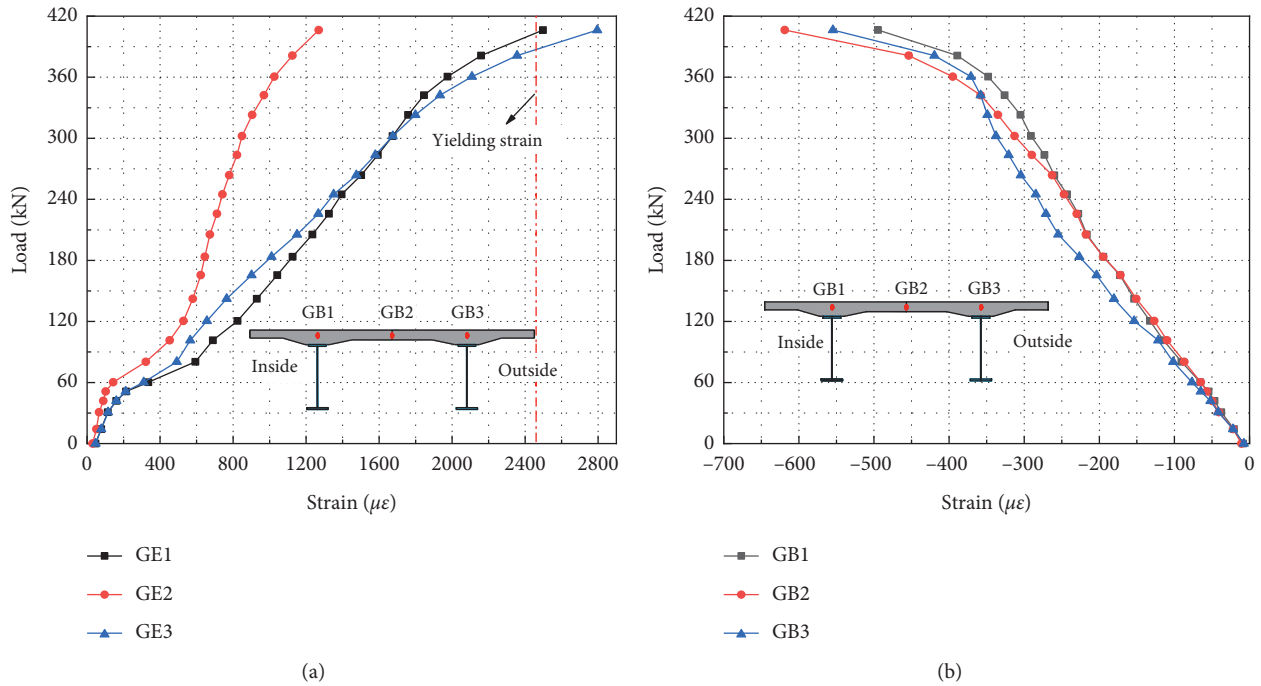
FIGURE 14: Load-strain curves of longitudinal reinforcement. (a) At the intermediate support section. (b) At the loading section.

**3.2.5. Strain of Longitudinal Reinforcement.** Figure 14 shows the relationships between the load and the longitudinal reinforcement strain at the intermediate support section and the loading section, respectively. According to the results of the material property test, the yielding strain of longitudinal reinforcement was  $2460 \mu\epsilon$ . As shown in Figure 14(a), the strain of reinforcement increased linearly with the increase of load in the initial loading stage (up to 50~60 kN). And then, the increase rate of longitudinal reinforcement strain increased suddenly, which was attributed to the gradual cracking of concrete. With the increase of crack width, the concrete at a crack lost tensile strength gradually, and the applied load was transferred to the longitudinal reinforcement. From then on, the longitudinal reinforcement strain increased steadily until longitudinal reinforcement yielding. The yielding load of the longitudinal reinforcement was about 390 kN.

It could be seen from Figure 14 that when the ultimate failure state was reached, the longitudinal reinforcement in the hogging moment region had reached yield, while the longitudinal reinforcement at the loading section was far less than the yield strength, as shown in Figure 14(b). When we calculated the flexural capacity according to the current China highway standard specifications (Specifications for Design and Construction of Highway Steel-Concrete Composite Bridge) [34], we considered the mechanical resistance of longitudinal rebars in the hogging zone, while we neglected the mechanical resistance of longitudinal rebars in the sagging zone. The test results showed that this method was reasonable.

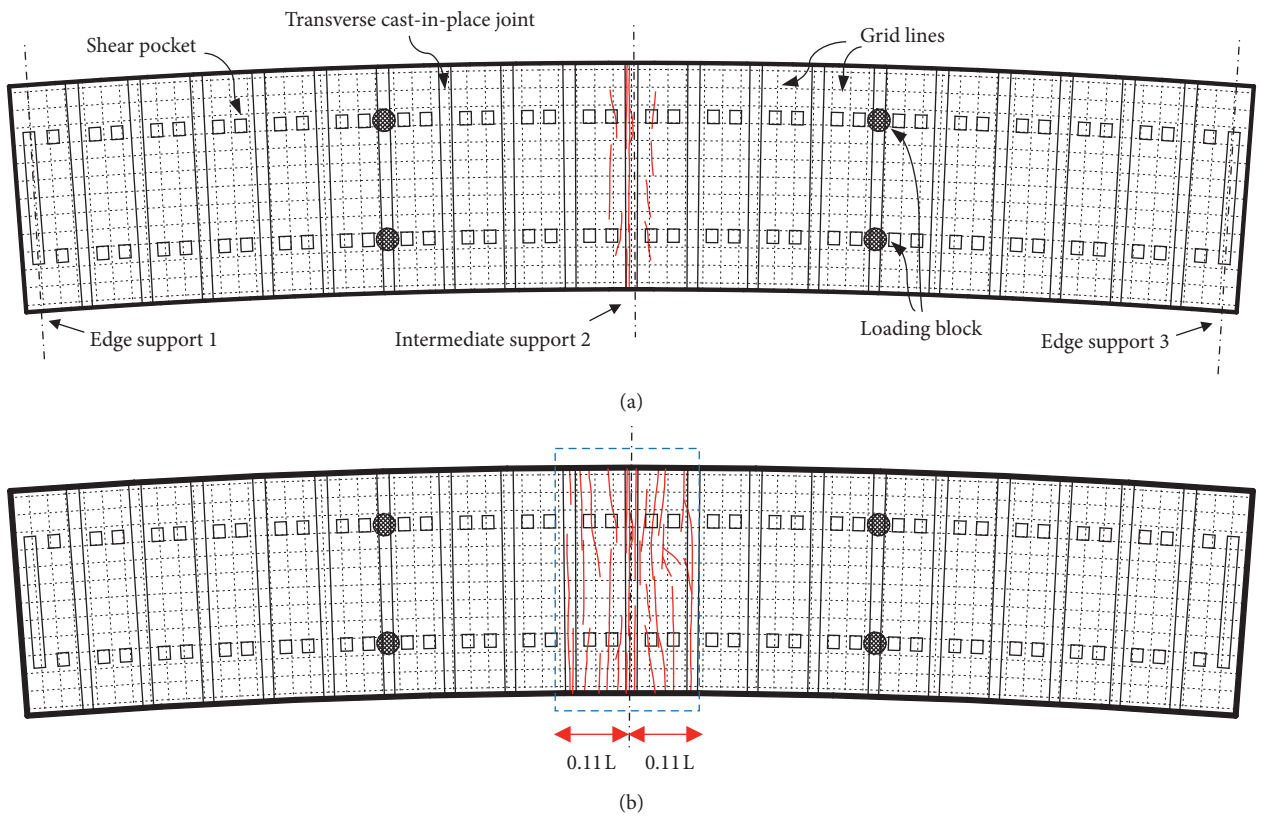
FIGURE 15: Schematic diagram of the concrete slab cracking process and distribution. (a) Cracking distribution under 140 kN loading force. (b) Cracking distribution under ultimate failure.

**3.2.6. Concrete Slab Cracking Distribution and Crack Width.** The schematic diagram of the concrete slab cracking process and distribution is shown in Figure 15. When the load was

about 60 kN, the first transverse crack (initial transverse crack) was detected through the naked eye at the edge of the transverse cast-in-place joint over the intermediate support, where the construction joint surfaces had weak points of cracking because of the different concrete age between precast slabs and cast-in-place joints. Thus, before casting in the transverse joints, the surfaces should be cleaned and be made rough using a water jet to increase bonding.

With the load increased gradually, the first crack became a major crack. It extended gradually from the outer flange of the concrete slab to the inner along the transverse direction of the bridge. Meanwhile, a few cracks also occurred at the shear pockets in the precast slab on both sides of the main crack. When the load is 140 kN (about 4.7 times of the design load and about 0.34 Pu), the major crack runs through the slab transverse direction, which causes the concrete of the intermediate support section to step out of work gradually. At that time, the width of the major crack was 0.15 mm, and twelve cracks had been observed on the concrete slab in the hogging moment region. From 140 kN to 360 kN, microcracks appeared and extended gradually. And when the load reached 200 kN (about 6.7 times of the design load and about 0.5 Pu), the width of the major crack was 0.25 mm. When the load reached about 360 kN (about 12 times of the design load and about 0.88 Pu), there had been about 20 transverse cracks in the negative moment region. The width of the major cracks was 0.35 mm. The cracks at the cast-in-place joints developed to 0.25 mm wide, and the other visible cracks were basically more than 0.1 mm wide. From then on, the number of cracks in the hogging moment region was not increased any more. When the load was close to 407 kN (Pu), both the width of the existing cracks and the deflection at the loading point increased rapidly. The stiffness of the intact continuous composite bridge model decreased drastically.
