Research Article

Restoration and Strengthening of Historical Buildings: The Example of Minceta Fortress in Dubrovnik

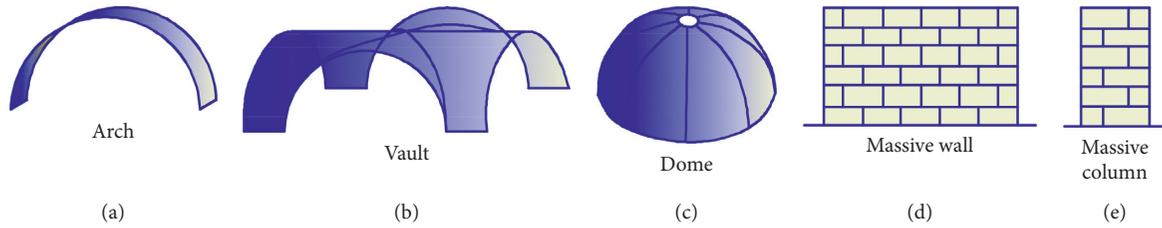
FIGURE 2: The schemes of preferred load-bearing systems of masonry structures. (a) Arch (b) Vault. (c) Dome. (d) Massive wall. (e) Massive column.

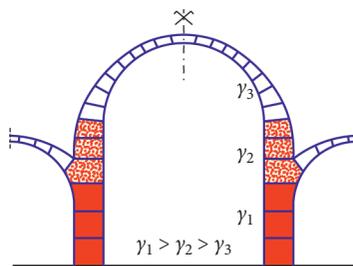
FIGURE 3: The scheme of favourable mass distribution (strength) and block size along height of historical building.

In order to reduce the seismic forces on buildings and the stresses in the soil below foundations, in many cases, the experienced builders use lightweight materials of lower strength in higher parts of the building and heavy materials with greater strength in lower parts. So the lower parts in many historical stone structures are made of high-quality stone blocks with larger volume weight and the taller parts (usually less loaded arches, vaults, and domes) of porous less resistant blocks with small volume weight (Figure 3). Because of the simplicity and faster construction, the size of stone blocks is regularly reduced through the height of the building. The use of stones with less volume weight in the arch structures was often motivated by the need for a simpler scaffold in their construction.

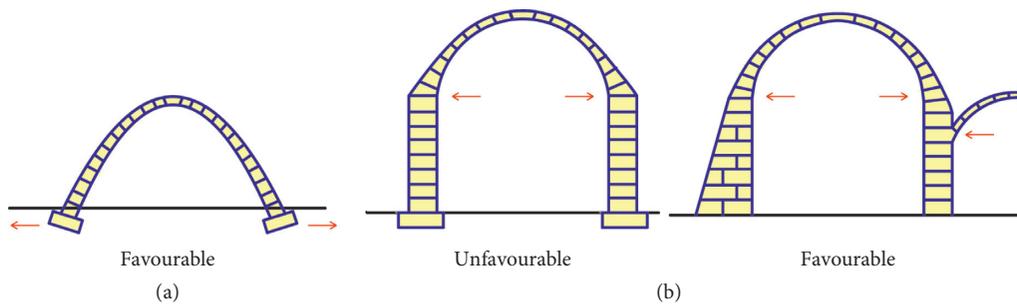
FIGURE 4: The schematic positions of supports of arch (vault, dome) along height of building. (a) Above the foundations. (b) At the top of the walls.

One of the basic structural characteristics of arches, vaults, and domes is the presence of the horizontal forces on supports. If the forces are at ground level and the soil has the adequate lateral bearing capacity with the limited lateral deformability, there will be no negative consequences on the building structure and they can be relatively easily transferred to the soil (Figure 4). If the soil is laterally deformable, it can cause shifting of the arch abutments and the appearance of cracks and damages in the arch structure. Particularly unfavourable is that the abutments of the arches, vaults, and domes are at a higher height above the ground, i.e., when being supported by high walls/columns. In this case, it is necessary that the peripheral supports of such arches are sufficiently massive (heavy) and rigid walls/columns which can transfer the horizontal forces to the soil without damage. In complex and tall stone structures, it is extremely important that the composition of the arches/vaults/domes with different spans and heights, combined with the stiffness/mass of walls and columns, be designed so that the compression forces dominate for the basic loads and smaller tension forces for earthquakes.

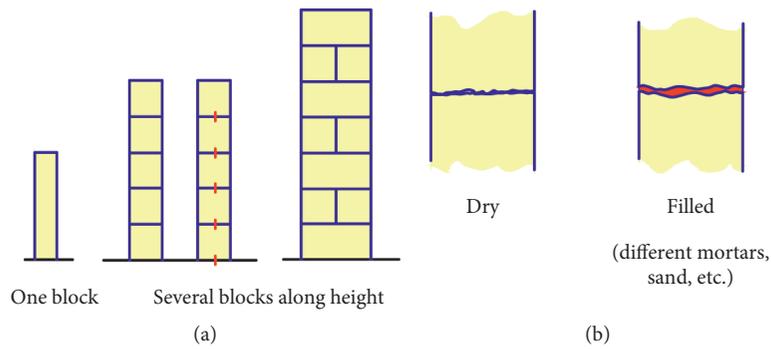
FIGURE 5: Some schemes of the stone columns and the types of joints. (a) The number and arrangement of blocks. (b) The joints.

The stone columns are often present in numerous historical masonry buildings, whether they are major structural or desirable aesthetic elements (Figure 5). Unfortunately, many such columns are damaged by earthquakes, due to material degradation over time, temperature changes, etc. Their restoration is usually complex and demanding. Short columns are often constructed from a massive block, and tall columns from several blocks (so-called multidrum columns). The behaviour and load-bearing capacity of multidrum columns depend on numerous factors [30, 31]. By increasing the number of blocks (joints) in the multidrum columns, the load-bearing capacity for static forces and impact earthquake forces decreases, thus increasing the seismic bearing capacity for earthquakes that generate large displacements and large energy. The rigid joints between stone blocks (filled with mortar, etc.), compared to soft joints (dry, filled with stone powder, etc.), enable greater load-bearing capacity of the multidrum stone column under static load and so-called impact earthquake, and lower load-bearing capacity in the case of earthquake with higher energy. The columns with the dowels between the stone blocks significantly increase the load-bearing capacity of multidrum columns under earthquake excitations, while the diameter and the length of the dowels, as well as the dowels material, and the diameter of the hole may have smaller or bigger effects on the bearing capacity of such columns.

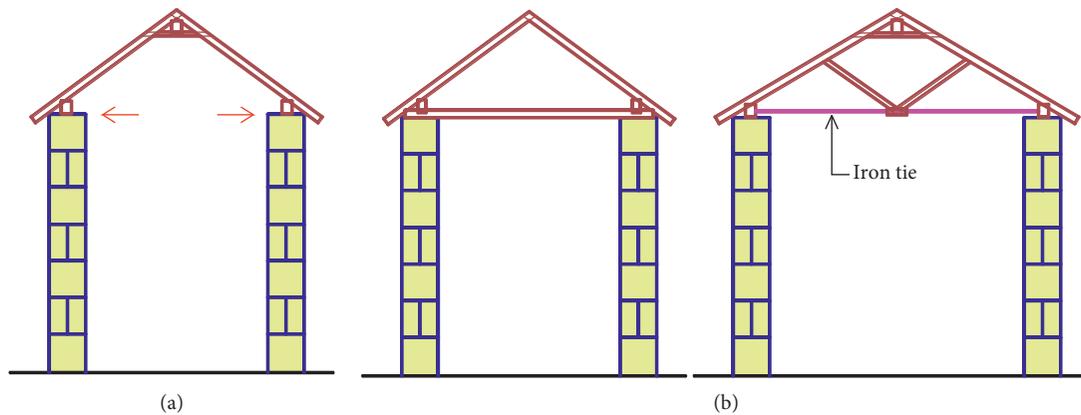
FIGURE 6: Some schemes of the wooden roofs of historical buildings. (a) Unfavourable. (b) Favourable.

Many historical buildings have a wooden roof structure (Figure 6). It is particularly desirable that its structure system does not transfer the horizontal forces to the substructure under dead and live loads. It is also desirable that the wooden structure be stiff in its plane and protected from moisture and pests.

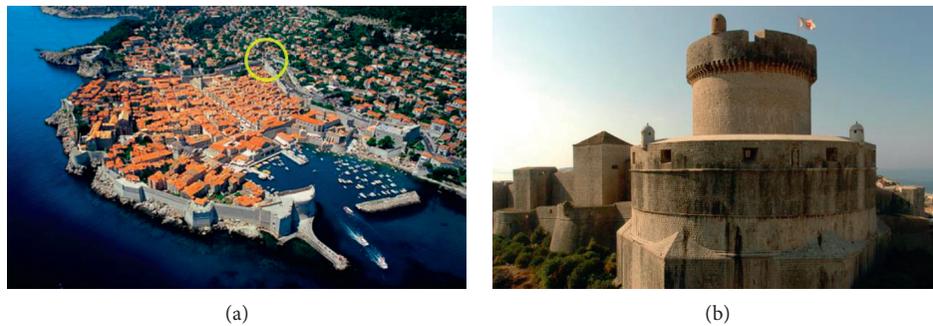
FIGURE 7: Dubrovnik and the Minceta fortress. (a) Dubrovnik, with the location of the Minceta fortress marked. (b) A view of the Minceta fortress from the north-west [32].

3.1.1. *Basic Data of the Fortress.* Dubrovnik is one of the UNESCO World Heritage Sites in Croatia. The Minceta fortress is a unique symbol of Dubrovnik being located in the north-western corner of famous city walls (Figure 7(a)). The top of the fortress is the highest and the most prominent part of the city walls (Figure 7(b)). With its position and size, it

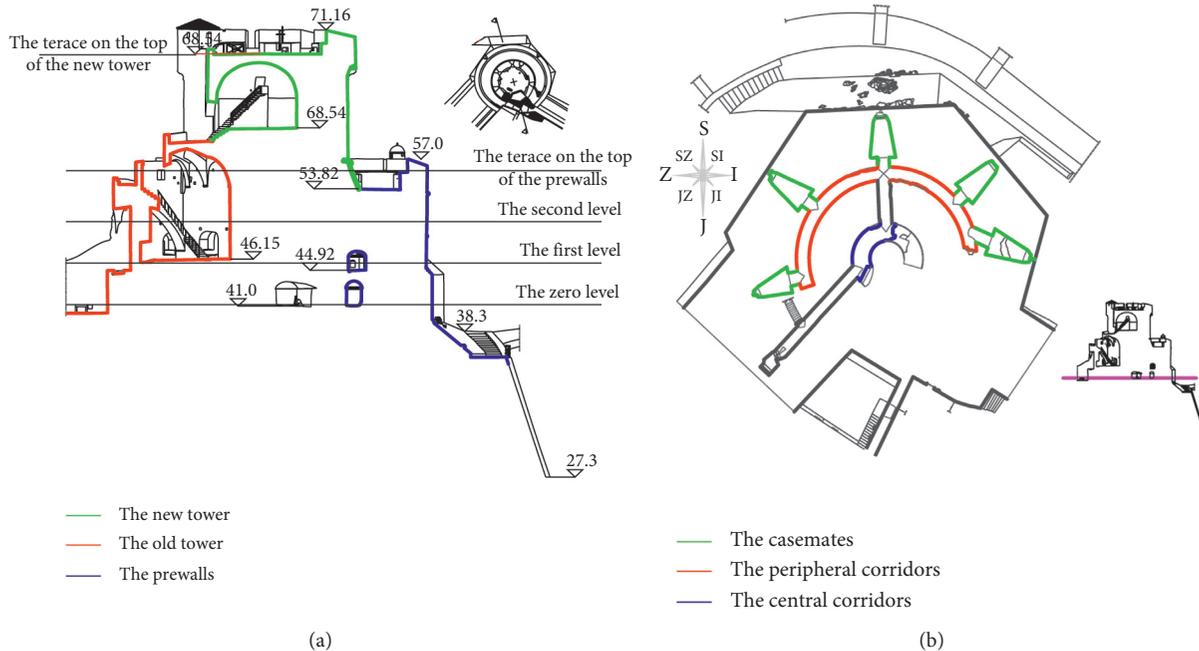
FIGURE 8: Vertical cross section (a) and floor plan at the zero level (b) of the Minceta fortress.

The vertical cross section through the fortress in the north-south direction is shown in Figure 8(a), and a floor plan at the zero level is presented in Figure 8(b). The main parts of the fortress are the old tower, the prewalls and the new tower. Only the interior of the old medieval tower, with an inside height of 12 m, and the south facade are still preserved. The prewalls were built in a circular form with an outside diameter of 35 m and a height of 16.3 m. The prewalls have three levels. The zero level has central and peripheral corridors and five radially placed casemates. The first level has a peripheral corridor and nine casemates. The second level is infilled with earth and stone. Above the second level,

there is the terrace surrounded by the prewalls, at a height of 3.4 m, and a thickness of 2.8 m, with nine openings for guns and the walkway.

The new tower rises from the middle of the prewalls, with a diameter of approximately 18 m and a height of 7.3 m. The bottom part of the tower is inclined, the central part is upright and the upper part protrudes outward as a cantilever. The domed atrium of the tower has a diameter of 8 m and a height of 7 m. The terrace at the top of the new tower is surrounded by a defensive wall with four holes for cannons and two guard houses.

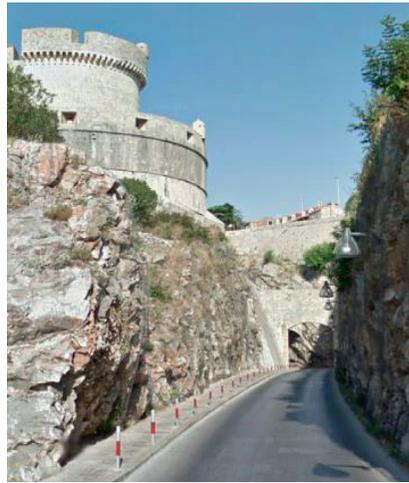
FIGURE 9: Some defects and damages of the fortress. (a) The deep cut on the northern side of the fortress. (b) Typical cracks in the vaults of the patrol corridors and casemates at the zero level. (c) The broken piece of the wall corner in the peripheral corridor at the zero level. (d) Typical cracks in the prewall around the gun opening above the terrace. (e) The marked cracks in the north-western facade of the fortress.

3.1.2. The Main Observed Defects and Damages of the Fortress. The rock layers below the fortress near the deep cut have an unfavourable slope inclination toward the road threatening the stability of the fortress (Figure 9(a)).

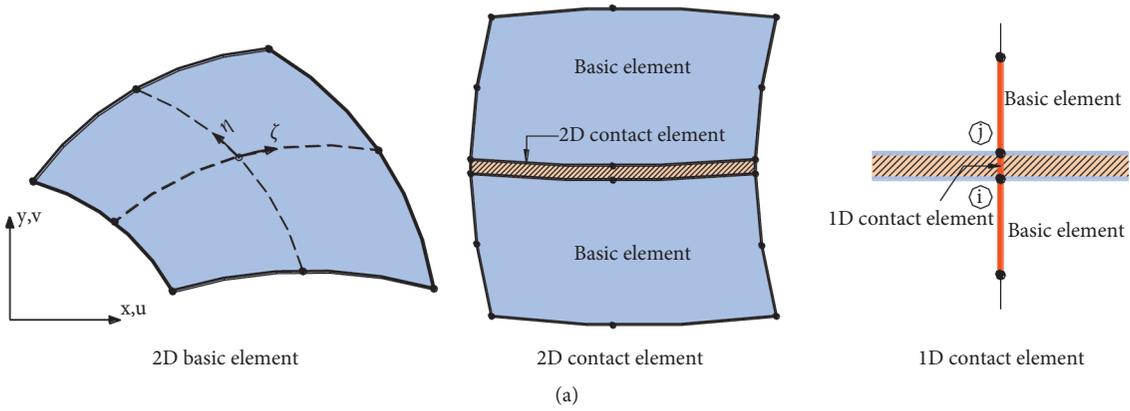
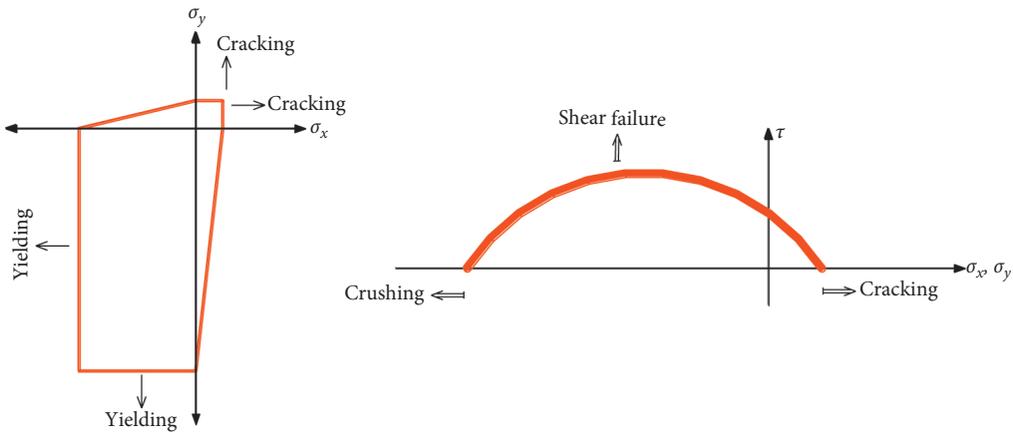
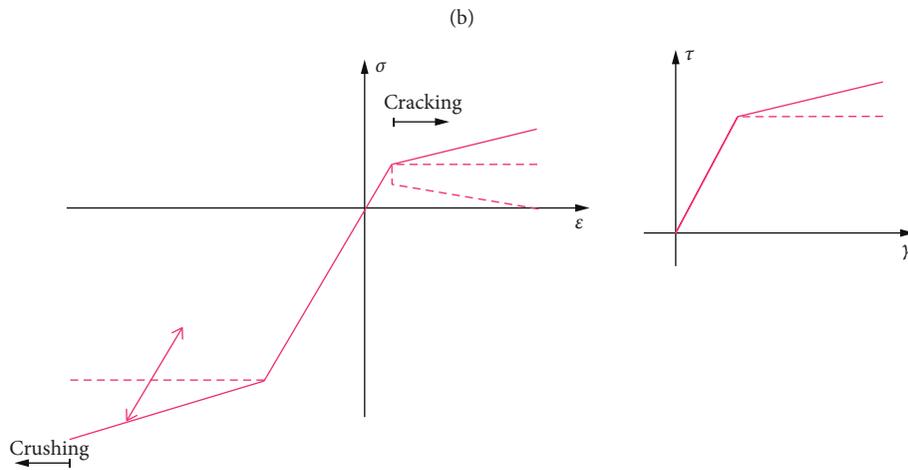
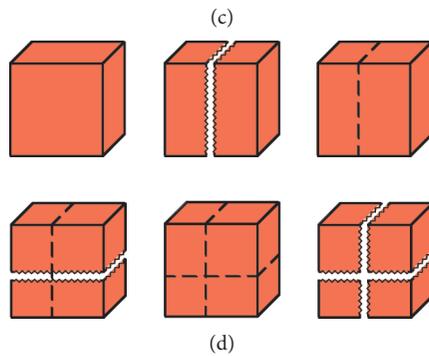
FIGURE 10: The graphical presentation of the adopted 2D nonlinear numerical model: (a) finite elements, (b) constitutive model for basic materials, (c) constitutive model for contact elements, (d) possible crack patterns [38].

The graphical presentation of the used nonlinear numerical model [38] is presented in Figure 10. The so-called macro model for the masonry and the rock was adopted. The cracks were modelled as smeared. The adopted discrete elements between the fortress and the rock can simulate the sinking, the uplift, and the sliding of the interface surface. The effect of the large displacements was also included. The dynamic equation was solved by an implicit Newmark algorithm. The adopted numerical model has been verified using experimental and numerical tests of other models [38] and can be considered reliable.

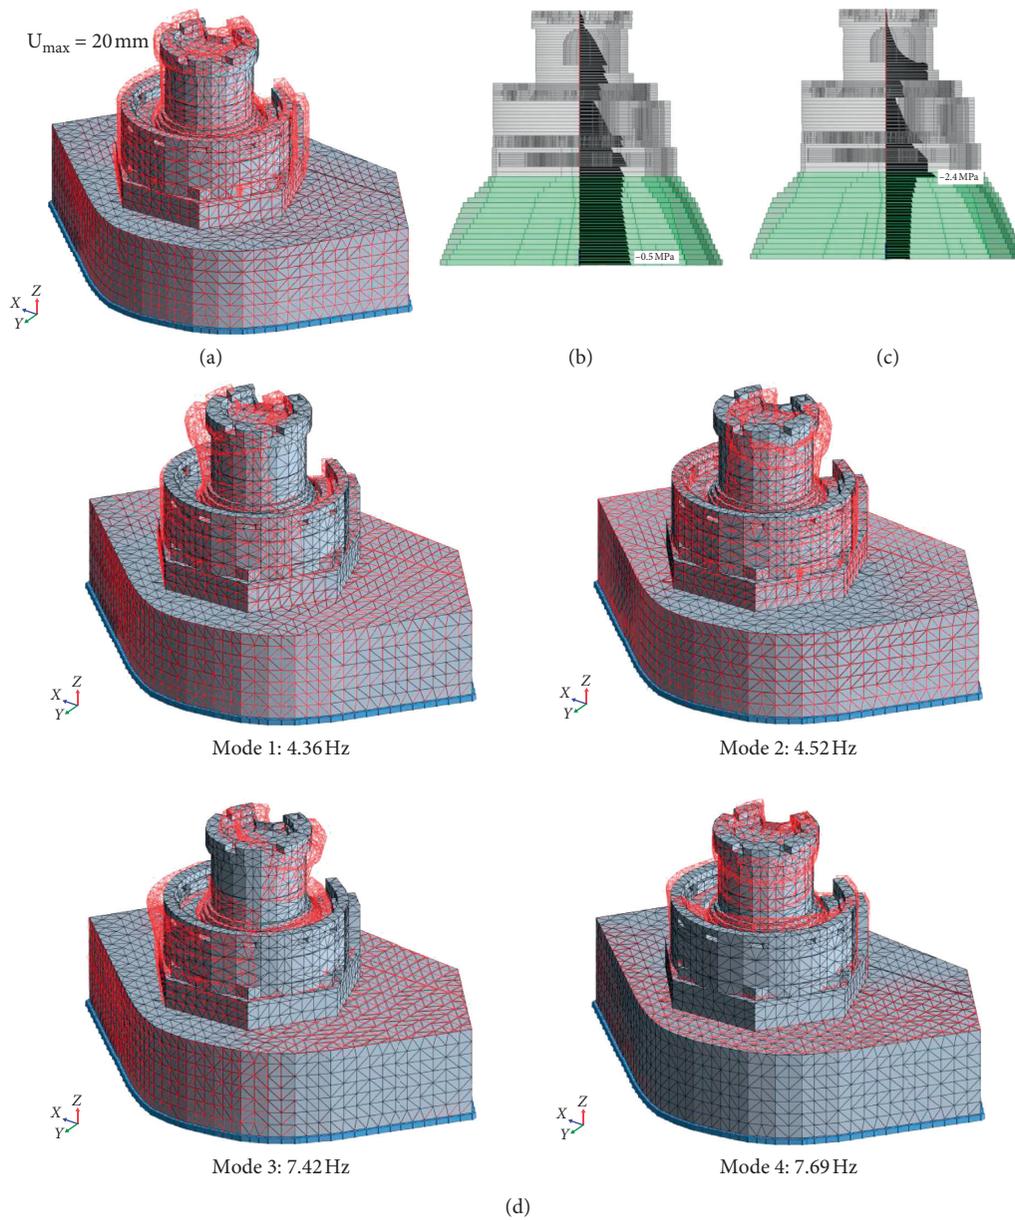
FIGURE 11: Some results of finite element analyses. (a) The displacements for the nonuniform temperature distribution of 10°C at the south side and 0°C at the north side. (b) The vertical stresses for the dead load (MPa). (c) The vertical stresses for the combination of the dead load and the earthquake forces for an acceleration of 0.3 g (MPa), equivalent static analysis. (d) The first four mode shapes and eigenvalues of the numerical model.

Only some results are presented in this paper: the displacement, compressive stresses, and tensile strains. The displacements for the nonuniform temperature distribution of 10 degrees Celsius at the south side and 0 degrees Celsius at the north side are shown in Figure 11(a). The vertical stresses for the dead load are shown in Figure 11(b), and the vertical stresses for the dead load and the earthquake accelerations of 0.3 g (equivalent static analysis) are shown in Figure 11(c). The first four mode shapes and eigenvalues of the numerical model are shown in Figure 11(d). Figure 11(b) shows that the average vertical compressive stresses from the dead load at the level of the bottom of the fortress (the top of the foundation rock) are relatively small and equal to 0.5 MPa. The stresses at the same position for a combination of dead load and earthquake forces of acceleration $a = 0.3$ g are 2.4 MPa (Figure 11(c)). Figure 11(d) shows that the frequency of oscillations for Model 1 is 4.36 Hz, i.e., $T_1 = 0.23$ s, so it can be specified that the fortress fits to the rigid masonry structures according to EN 1998 (EC 8), that generate the huge earthquake inertial forces.

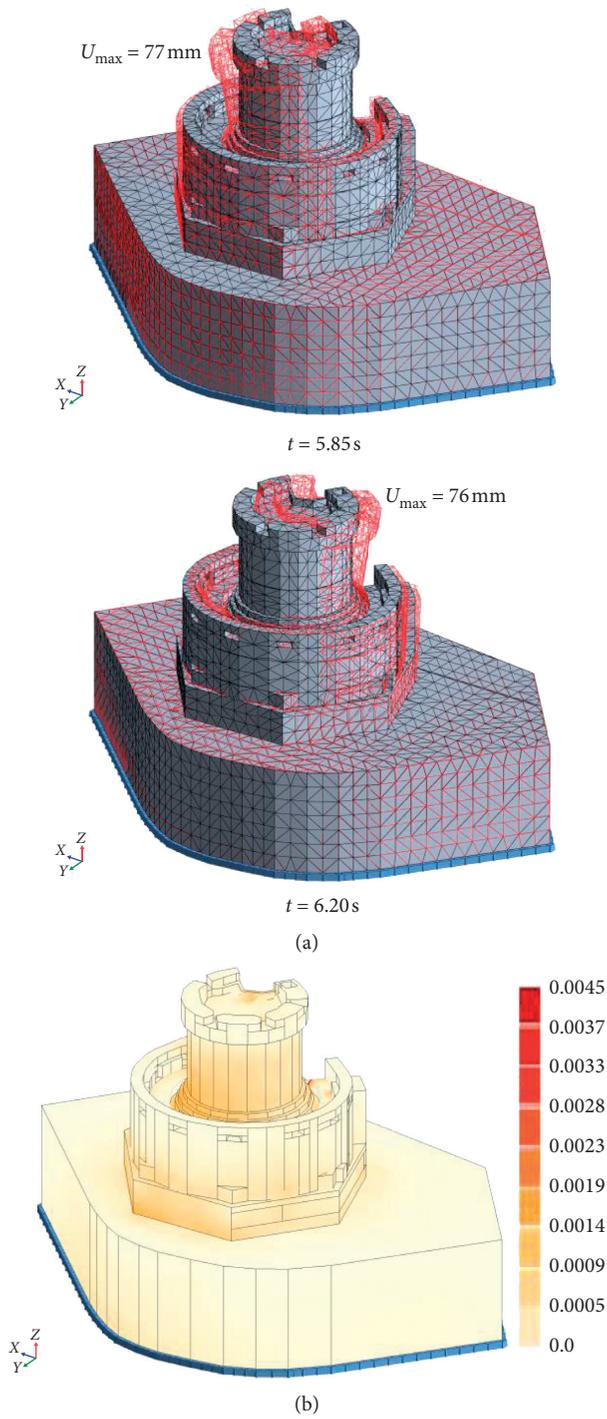
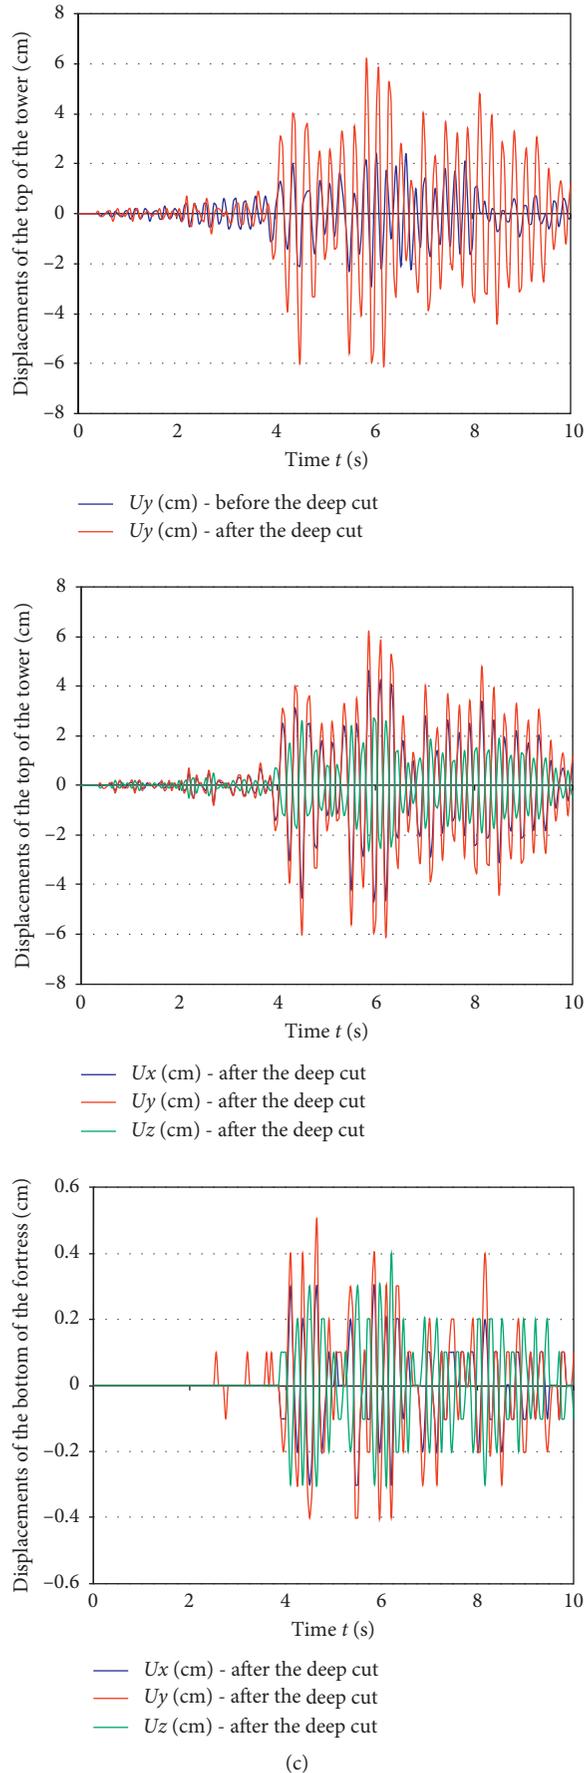
FIGURE 12: Some results for time history analysis under the Stone earthquake. (a) Some global displacements for the Stone earthquake at $t = 5.85$ s and $t = 6.20$ (s). (b) The principal tensile strains (cracking zones) at $t = 6.2$ s for the Stone earthquake, view from the north. (c) Some characteristic displacements of the north-western facade of the fortress over time for the Stone earthquake.

Some results for time history analysis under the Stone earthquake are presented in Figure 12. Figure 12(a) shows some global displacements at $t = 5.85$ s and $t = 6.20$ s. Figure 12(b) shows the principal tensile strains (cracking zones) at $t = 6.2$ s. Figure 12(c) shows some characteristic displacements at the top of the tower and bottom of the fortress over time before and after the excavation of the deep cut.

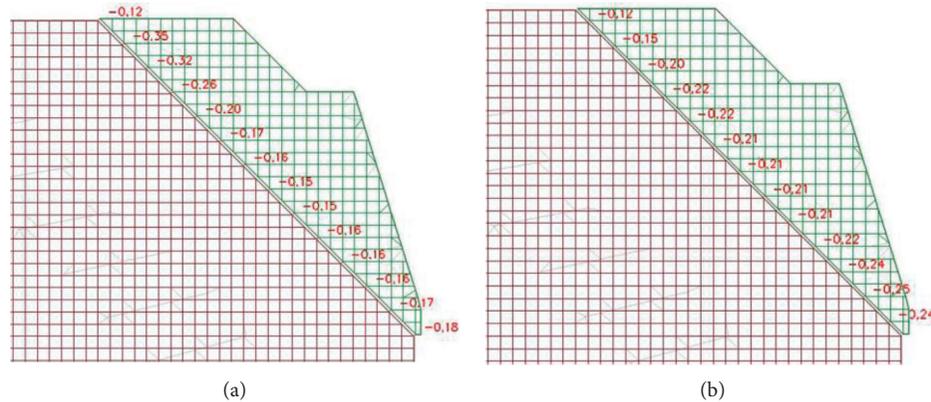
FIGURE 13: The stresses (MPa) in the assumed sliding surface of the rock for the dead load: (a) normal stresses, (b) shear stresses.

The stresses for the dead load in the assumed sliding surface of the rock below the fortress toward the deep cut are shown in Figure 13. Figure 13(a) shows that the normal

stresses perpendicular to the sliding surface are compressive, which is favourable; however, when they are relatively small, it is unfavourable. Figure 13(b) shows that the shear stresses

in-plane of the sliding surface are big, which is very unfavourable.

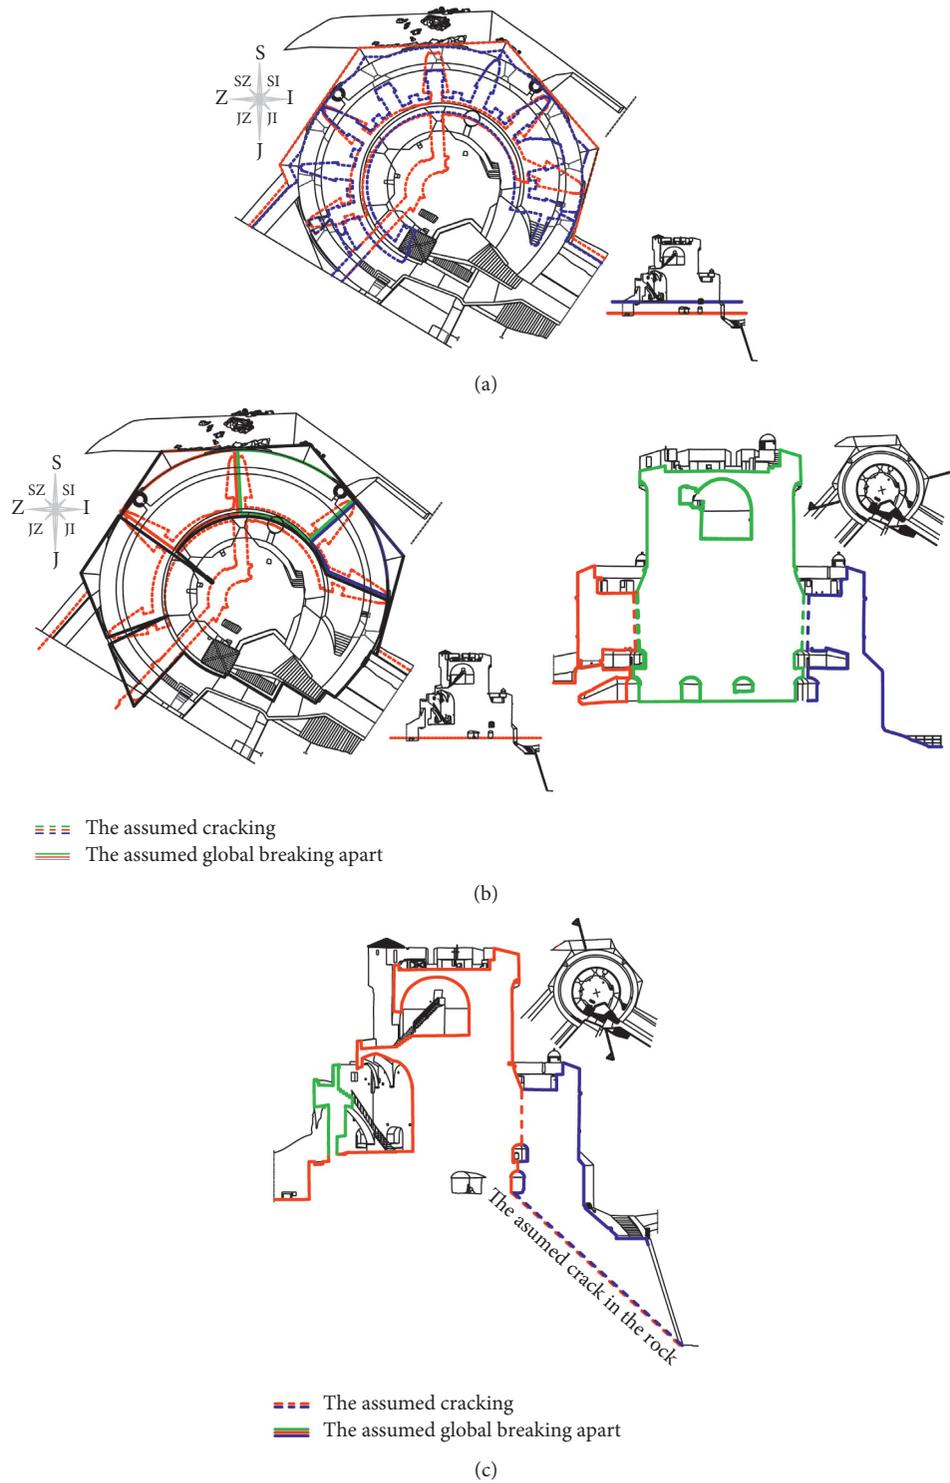
FIGURE 14: The assumed global cracking pattern, breaking apart, and sliding rock surface. (a) The overlapping of the corridors and casemates at the zero and first levels. (b) The assumed global breaking apart of the fortress. (c) The assumed sliding rock surface and the breaking apart of the prewalls.

The large horizontal cracks in the ceiling of the peripheral corridors at the zero level and the vertical crack over the entire northern facade likely indicate the breaking apart of the northern prewalls into the blocks. The assumed global breaking apart of the fortress is shown in Figure 14(b).

The fundamental rock below the fortress near the deep cut is cracked and adversely layered. At that location, the rock sliding surfaces are probably already formed. The assumed rock sliding surface and the breaking apart of the prewalls are shown in Figure 14(c).

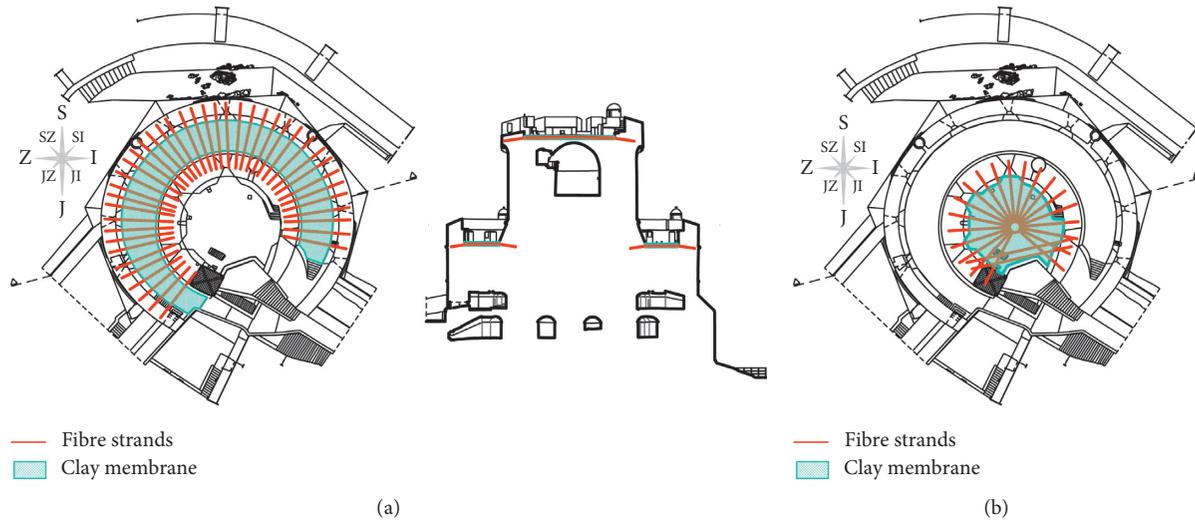
FIGURE 15: The position of the glass fibre strands for stiffening the tops of the fortress: (a) the terrace on top of the prewalls, (b) the terrace on top of the new tower.

- (i) Grouting of the cracks in the walls and vaults that are wider than approximately 2 mm.
- (ii) Jointing between the stone blocks along the cracks and in the locations of the worn joints using lime mortar.
- (iii) Stiffening of the south wall of the old tower by upgrading the southern boundary city wall.
- (iv) The construction of soft diaphragms for stiffening the fortress at the level of the open terraces on top of the prewalls and at the level of the terrace on the tower top, with the improvements of the system for precipitation water drainage. The position of the glass fibre strands that are anchored in the peripheral walls at the previously mentioned levels is shown in Figure 15.
