## Research Article

# Experimental Study on Stability Analysis of a Structure during Excavation beneath This Structure

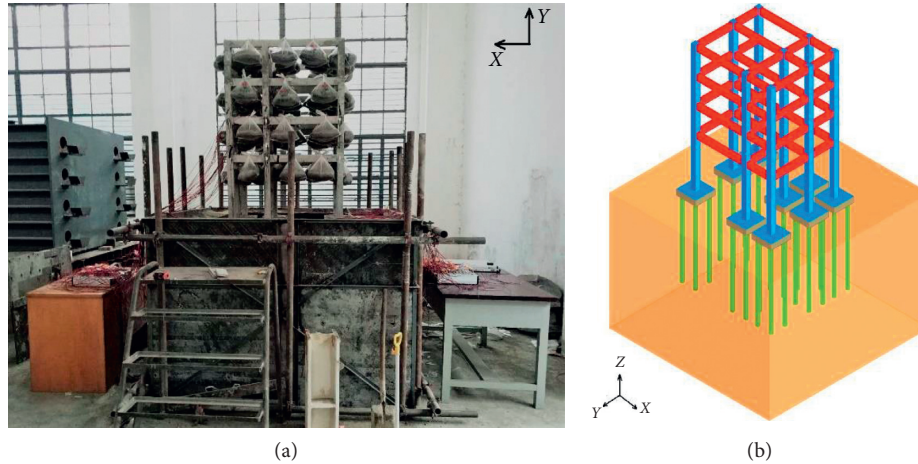
FIGURE 1: Model test.

Taking the difficulty and cost of the test into account, a small-scale model test was proposed to conduct the underpinning and excavation test, using the scale of 1:10, which is shown in Figure 1.

The whole small-scale physical model included two parts: an upper frame structure and a lower soil-micropile model.

The upper frame structure was cast in situ, and the model materials consisted of the fine wire and the particulate concrete. The structure model had 4 layers without floor and had a length of 1130 mm with a width of 980 mm. And the structure height above the foundation head was 1500 mm. The first layer was 600 mm high (including 100 mm embedding depth of foundation), and the second to the fourth layers were all 300 mm high. The section of each column was 50 × 50 mm, and the section size of each beam was 30 × 60 mm. The height of each spread footing was 60 mm, the section size was 230 × 230 mm, four holes were reserved for each independent footing, and the diameter of each hole was 32 mm. A load of 640 N was applied to each layer except the first layer to simulate the daily use of the building. Material parameters are shown in Table 1.

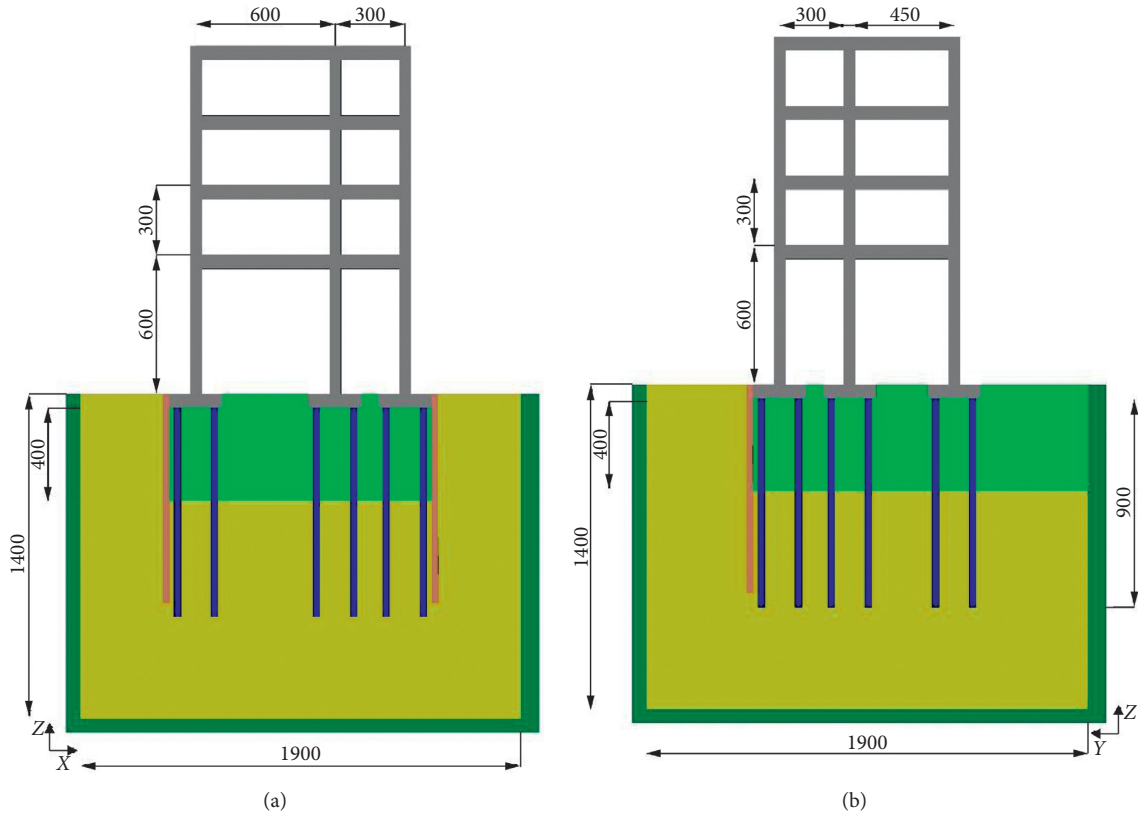
FIGURE 2: (a) Front view of model and (b) side view of model.

The model box was constructed of welded steel plates and fortified planks, which were polished and lubricated to decrease the boundary effect [23, 24]. At the same time, taking the width of settlement influenced zone into consideration, the model box was made of 1900 mm long and 1900 mm wide [25]. And based on the depth of settlement influenced zone, it was 1400 mm high (Chinese pile foundation code).

The support method was the three-sided diaphragm wall for support, without a diaphragm wall on excavation side. A crossbeam was placed at the top of the excavation side to ensure the stability of the original support system. The deflection of the diaphragm wall was not involved in this paper. However, there were some limits in diaphragm wall. Due to the special support structure and the close distance between the wall and the pile, the lateral movement of the diaphragm wall and the pile behavior affected by the lateral movement of the wall might not be ignored, which need to be improved in the future.

The size of model test is shown in Figure 2.

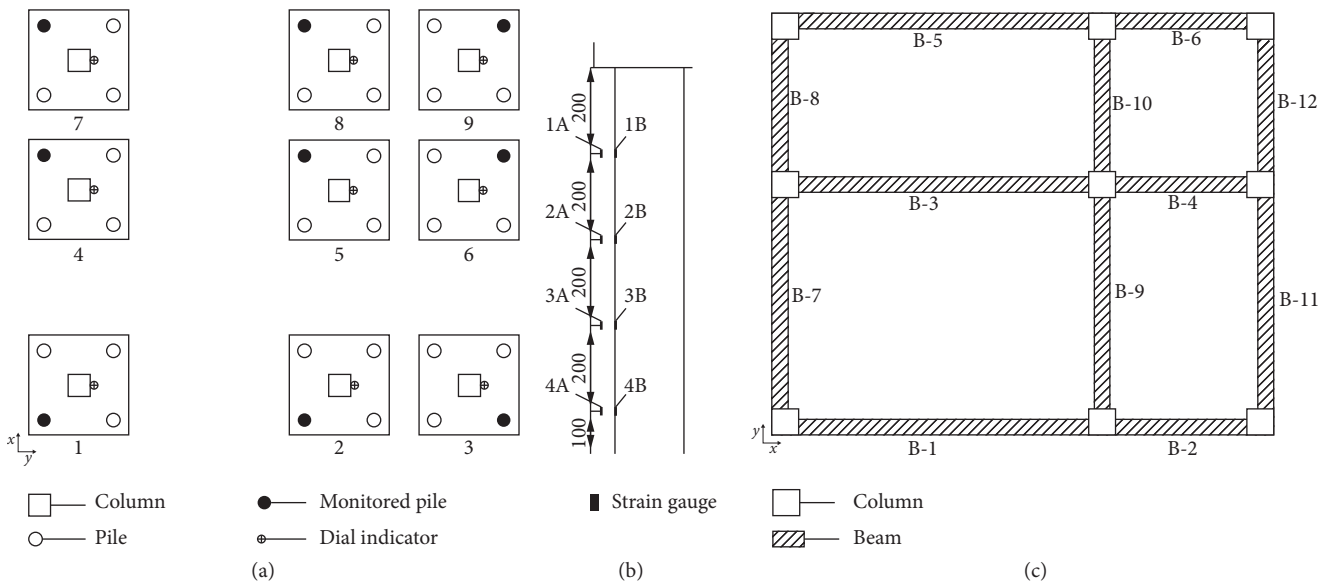
FIGURE 3: (a) Plan view of instrumentation setup, (b) strain gauges position layout of piles, and (c) number of beam layouts.

The monitoring system was consisted of strain gauges and dial indicator. Both the instrumentation setup and the number of piles, columns, and beams are shown in Figure 3. In particular, strain gauges of the beams were arranged at the midpoint of the bottom of each beam, and they were totally arranged at the first layer and the second layer of the structure. Similarly, strain gauges of the columns were arranged at midpoint of each column at the first layer.

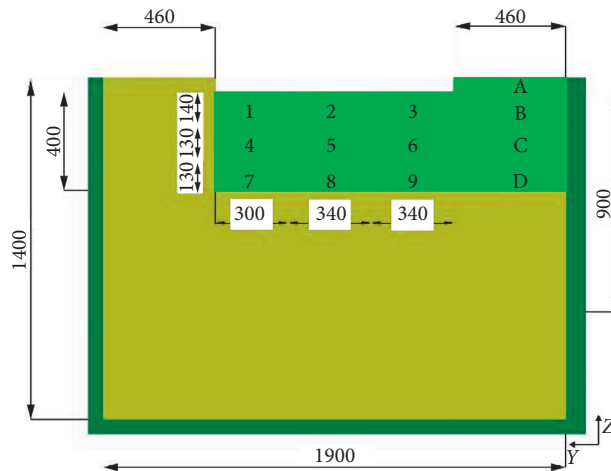
FIGURE 4: Number of excavation areas.

In particular, based on the trial request, the soil was excavated from one side instead of excavating from top to bottom. And soil was excavated by area in order except soil beneath spread footings, which was excavated in the end. The strain monitoring system started to work in Stage III, and it would continue to work for 138 hours. Finally, the excavation sequence is shown in Table 3, and the number of excavation areas is shown in Figure 4.

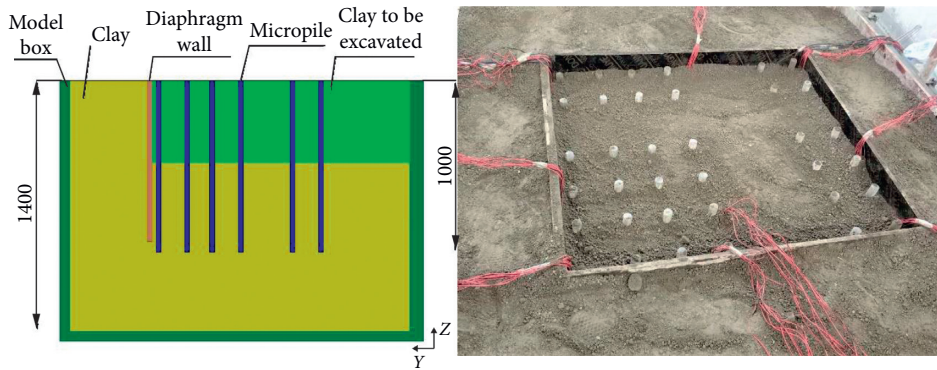
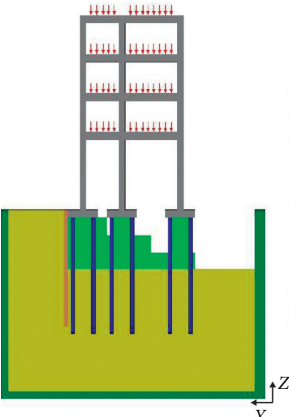
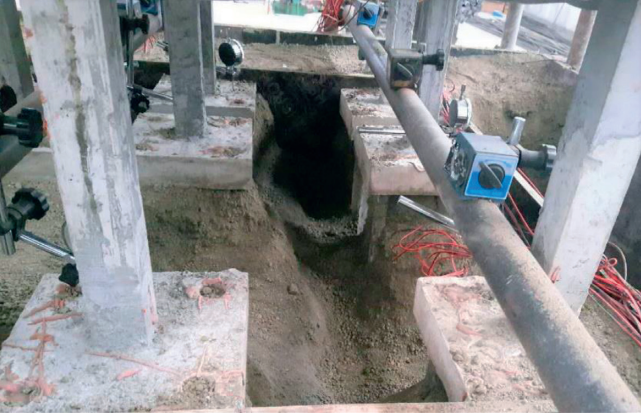
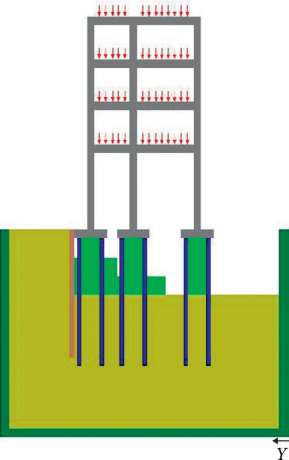
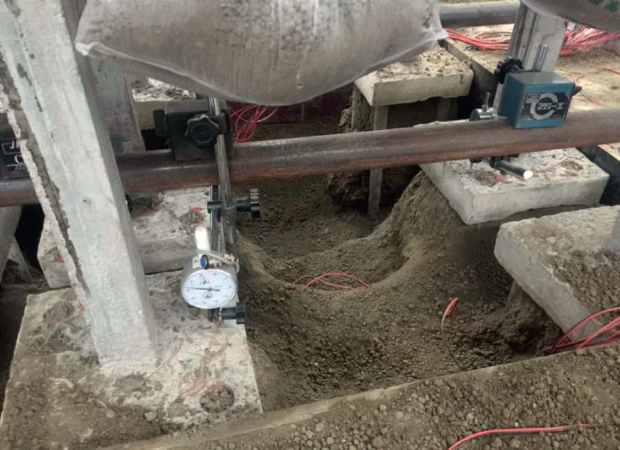
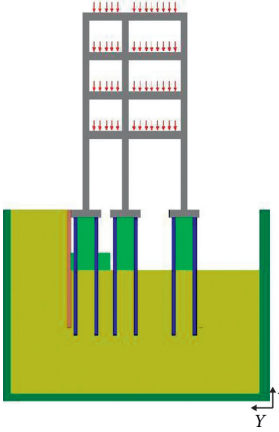
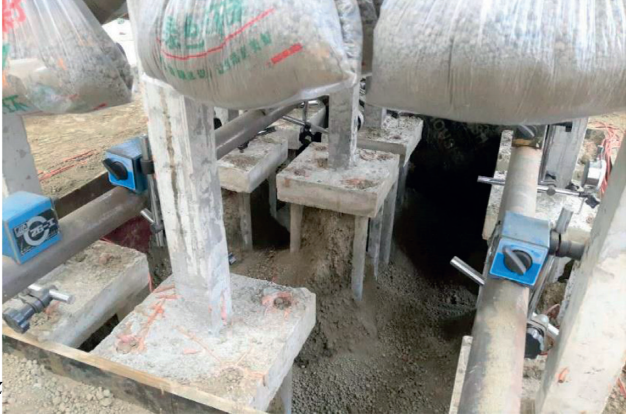
FIGURE 5: Model test setup.

The test steps shown in Figure 5 are as follows. (a) Step I: micropiles were preinstalled in the model box. Then, soil was filled into the model box, using tools to compact soil. (b) Step II: the small-scale RC frame structure was uplifted into the model box, ensuring that the four reserved holes of each spread footing were perfectly matched with the preinstalled micropiles. And a load of 640 N was applied on each layer except for the first layer. After the settlement of the structure tending to be stable, the spread footings and the micropiles were effective connected. (c) Step III: strain monitoring system started to work, and excavation of soil in Areas A and B was finished after 2 hours. (d) Step IV: soil in Areas 3 and C was excavated after 20 hours. (e) Step V: soil in Areas 2, 6, and D was dug away after 25 hours. (f)

Step VI: soil in Areas 1, 5, and 9 was excavated after 42 hours. (g) Step VII: soil in Areas 4 and 8 was dug away after 49 hours. (h) Step VIII: soil in Area 7 was excavated after 67 hours. Meanwhile, a little part of soil surrounding pile group was trimmed carefully because it is beyond the boundary of the spread footing. (i) Step IX: top half of the soil under the foundation was excavated after 73 hours. (j) Step X: rest of the soil under the foundation was dug away after 90 hours. (k) Step XI: the bottom of the excavation was clean and compacted after 114 hours. To ensure the accuracy of the test data, the monitoring data was continued to be obtained for 138 hours.

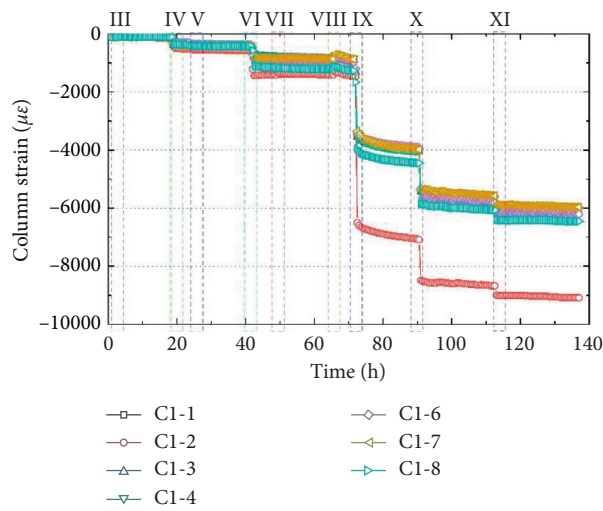
FIGURE 7: Strain changes of columns in the first layer.

Figure 7 showed strain changes of all columns during excavation except strain of C1-5, which was damaged during excavation. Based on monitoring strain data of columns, the following phenomena were discovered. (1) All strain values

of columns increased together after each stage. It illustrated that stresses of columns increased step by step and did not decrease after excavation. (2) Strain changes were the largest in Stage IX, because of the excavation under each spread

footing. And strain changes of columns were very sensitive to excavation of soil under the foundation, partly due to the stress redistribution of the structure and the method of excavation from one side. (3) Strain changes of columns

were larger in Stage VI, resulting from the excavation method and the stress redistribution of the structure. Finally, strain value of C1-2 was the largest during excavation, which need more attention in the future.

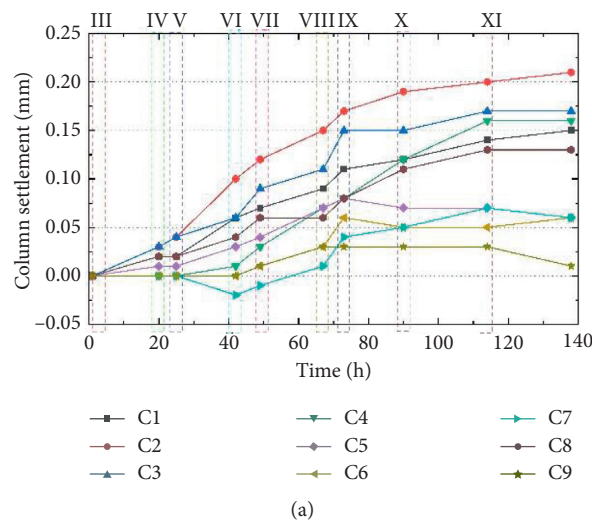
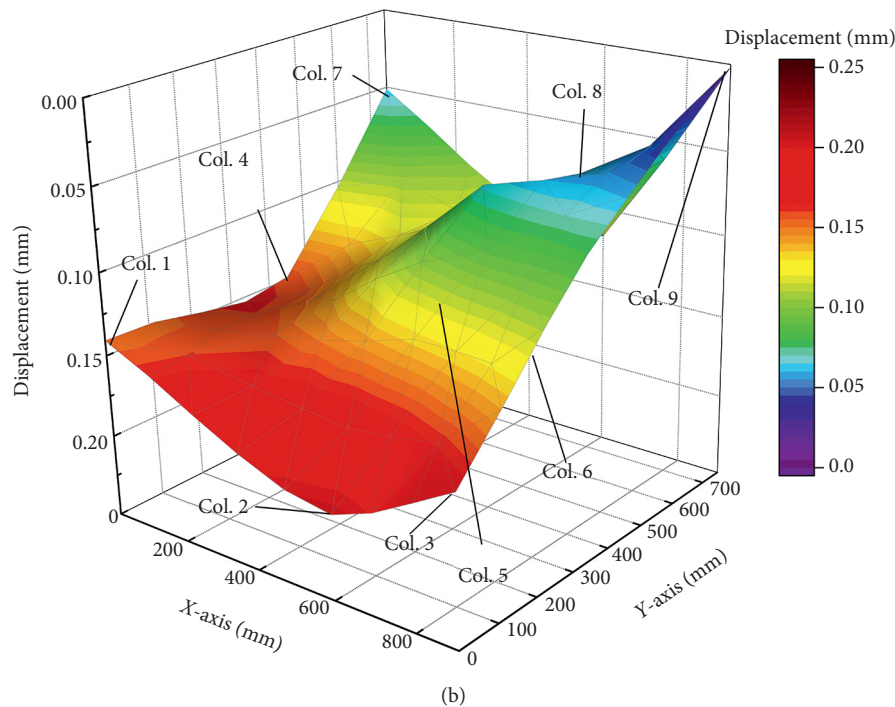
FIGURE 8: (a) Displacement of 9 columns and (b) 3D displacement of columns after 138 hours.

Figure 8 illustrated the displacement of 9 columns during excavation, and it should be noted that the positive value was settlement and the negative value was heave. In particular, C1 meant No. 1 column in the structure. The following rules were obtained from Figure 8(a). (1) Settlement of all columns was getting higher and higher during excavation. Only C7 experienced a little period of heave, partly due to stress unloading caused by excavation. Moreover, there were two reasons which caused the heave of C7. Firstly, the excavation from one side and the structure might tilt towards the excavation side. C1, C2, and C3 had higher settlement, but C7 and C9 had lower settlement. Secondly, based on FEM calculation, C7 had lower stress in the structure, resulting in the heave during excavation. C2 had the highest settlement during excavation, because C1-C2 had the highest value of strain during excavation. (2) In Stage IX, settlement increments of all columns were the maximum due to the largest strain changes of all columns in this stage.

Figure 8(b) showed the final settlement of columns in a three-dimension way. Obviously, the structure had settled more on excavation side. Secondly, it can be seen that the front area was lower and the back area was higher, and the shape was like a typical step. Besides, the middle area was lower, and areas on both sides were higher. Mainly because soil was excavated from one side, and stresses of columns in front and middle areas were much higher. Tan and Wang made the similar conclusion [26, 27]: during excavation, the

center portion of the excavation base would undergo much greater heave than the soils around the excavation perimeter.

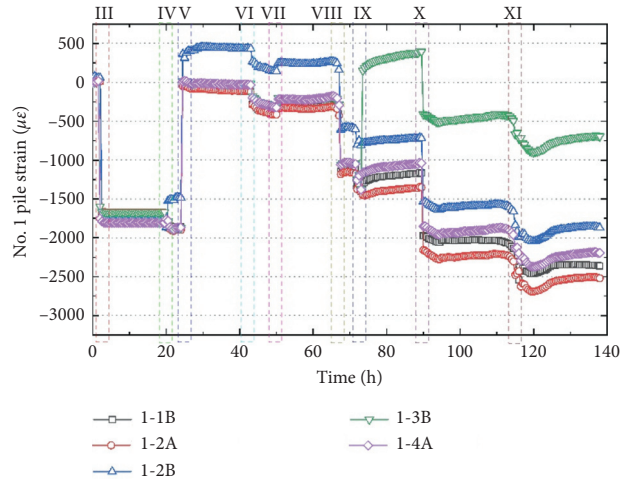
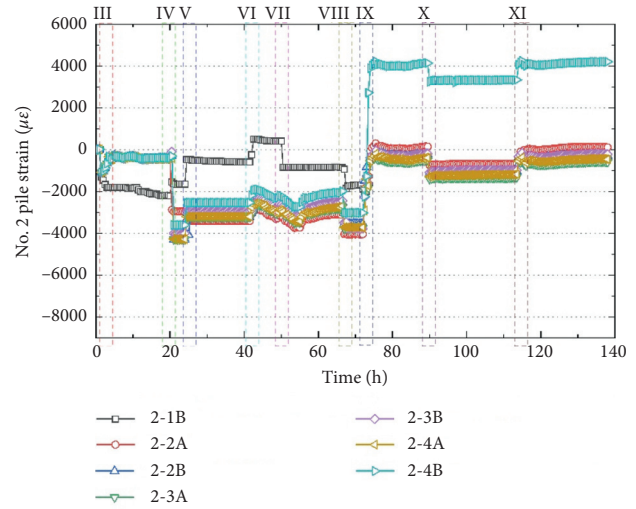
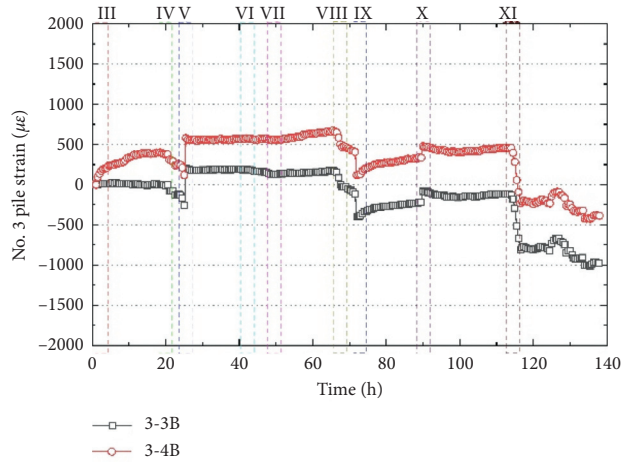
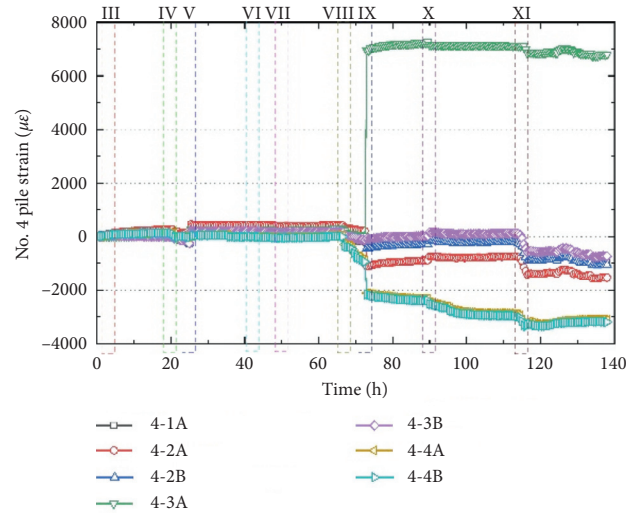
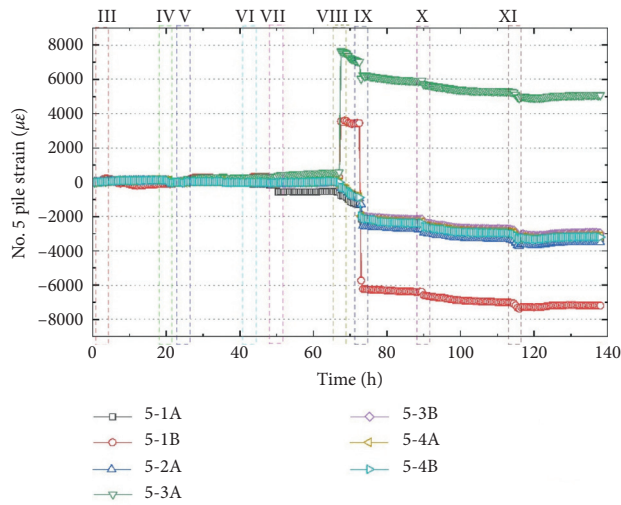
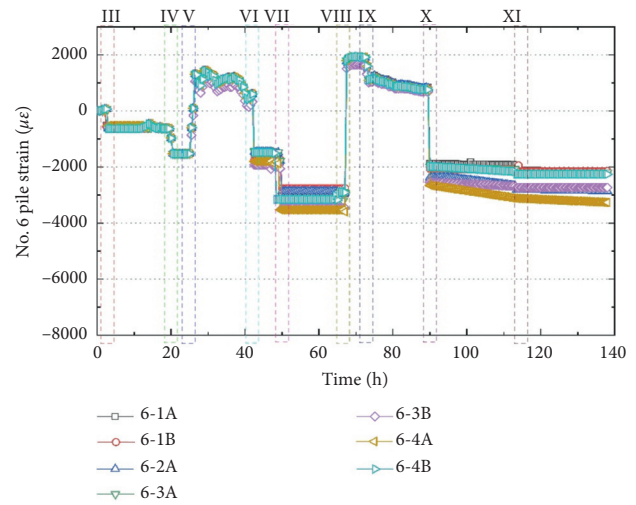
FIGURE 9: Strain changes of 9 piles.

A lot of strain gauges were chosen to monitor the strain change of piles during excavation, reducing the accidental factors such as strain gauge error and damage. In this paper, at the same depth, strain gauges facing the excavation side are called Side A, and the opposite was Side B. For example, 2-1A meant that a strain gauge was in Position 1 of No. 2 pile, facing the excavation side. And the plus sign indicated the axial tension, and the minus sign indicated the axial compression. However, some strain gauges of piles were damaged during excavation, and they only had part of data or did not appear in figures below. The strain change of piles was shown in Figure 9.

Figure 9 showed strain changes of underpinning piles during excavation, and it was continuously monitored for 138 hours, which reflected the change of strain accurately and in time. In analysis of the strain in all piles, there were some regular phenomena during excavation. (1) In general, each excavation caused strain fluctuations of piles, especially in Stage IX, resulting in a largest change of strain. The main reason was that the soil under the foundation was excavated, and stresses from foundations transferred to piles gradually. Meanwhile, columns had the largest changes of strain in this stage. (2) Generally, from Stage III to Stage VII, the fluctuation of strain caused by excavation was the lowest in the test because the soil beneath the foundation still sustained most stress from the upper structure in these stages. Furthermore, a little part of stresses from foundations had

already transferred to underpinning piles in Stage II, which were not monitored at first. However, No. 1 pile, No. 2 pile, and No.6 pile were exceptions. It might be related to the way of excavation from one side or related to error of strain. And it required more research in the future. (3) In Stage XI, strain of piles fluctuated without excavation, due to the factor of cleaning and compacting the soil.
