## Research Article

# Displacement Measurements and Numerical Analysis of Long-Term Rock Slope Deformation at Higashi-Shikagoe Limestone Quarry, Japan

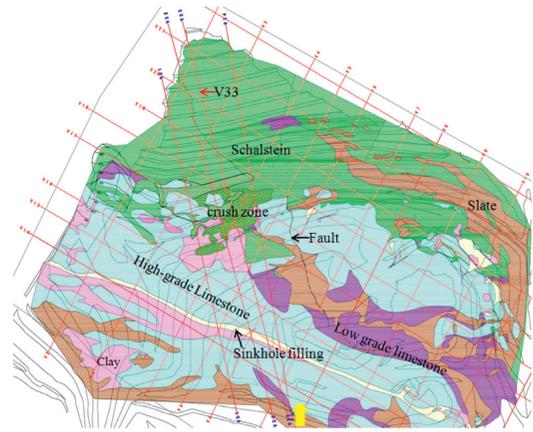
FIGURE 1: Geological map of the quarry. Yellow arrow shows the directional view of the rock slope's layout in Figure 2.

The Higashi-Shikagoe limestone quarry is a small-scale mine situated in Minami Furano, Central Hokkaido Prefecture, Japan. The site is approximately 400 m from artificial Lake Kanayama. The quarry has been in operation for more than 100 years and operated by Nittetsu Mining Co., Ltd. with an annual production of 200,000 tons. The rock mass at the quarry is predominantly composed of high-grade limestone and schalstein (Figure 1) of the pre-Cretaceous Hidaka Group. Although there are other types of rock such as low-grade limestone and slate, this altered with the main rock types. The limestone deposit lies irregularly and is lenticular with a N30°E strike, 680 m length, and 100–200 m thickness. The quarried limestone is mainly used in sugar production because of its grade. The major geological structure in the quarry is characterized as a right lateral faults, which strike and dip at N70°E-80°S and N70°E-75°N, respectively. The topographical layout of the rock slope as of July 2019 in Figure 2 is viewed from the direction indicated by the yellow arrow in Figure 1. The quarry has been developed by the bench cut method with a bench height of 10 m and overall slope angle of 42°. The working face is presently located at the 340 m level and the old working face at the northern side below the 340 m level has been used for backfilling. A massive rock slope of 130 m in height has been formed with the increasing excavation level, as sketched in Figure 2. A clay seam of approximately 70 m in thickness (elevation 440–370 m) occurs at the foot wall of the rock slope, as illustrated in Figure 2.

As seen in Figure 1, clay is mainly distributed on the left-hand side and centre of the quarry, which consequently exhibits significant strength reductions and deformability as a result of the clay's contact with water [29]. For simplicity, clay deterioration owing to water was modelled by reducing its Young's modulus. However, clay also shows other deterioration types, including plastic deformation, cracking, and breaking [48]. It is therefore noted that water induces slope displacement resulting from clay deterioration. For confirmation, rainfall time series were analysed and compared with the measured result, as shown in Figure 18. The comparison confirms that the distance tends to decrease with increasing rainfall accumulation rate. This relationship indirectly verifies that the clay deterioration is induced by water. It should be noted that clay deterioration can also be caused by other factors. Nicholson and Hencher [49] explained that clay deterioration includes the

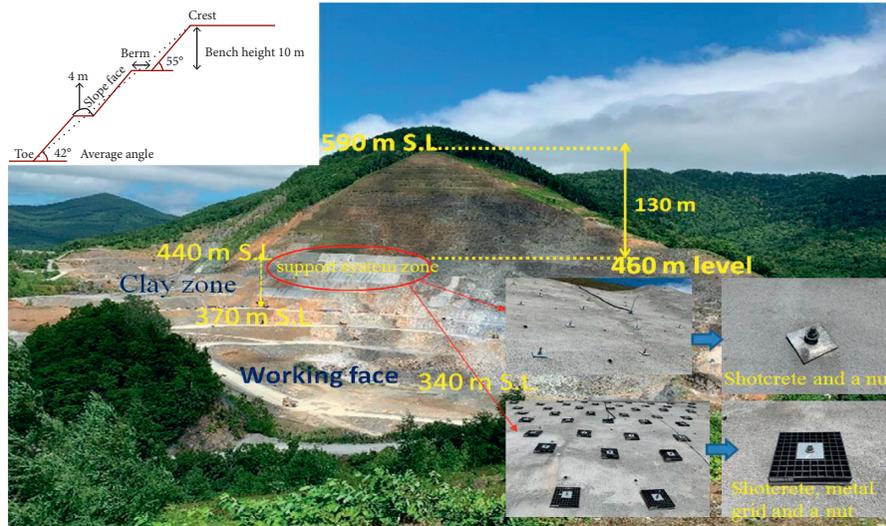
FIGURE 2: The layout of rock slope at the quarry (photo taken in the direction of yellow arrow shown in Figure 1). The support system zone is the area where rock bolts and shotcrete is installed to control the deformation.

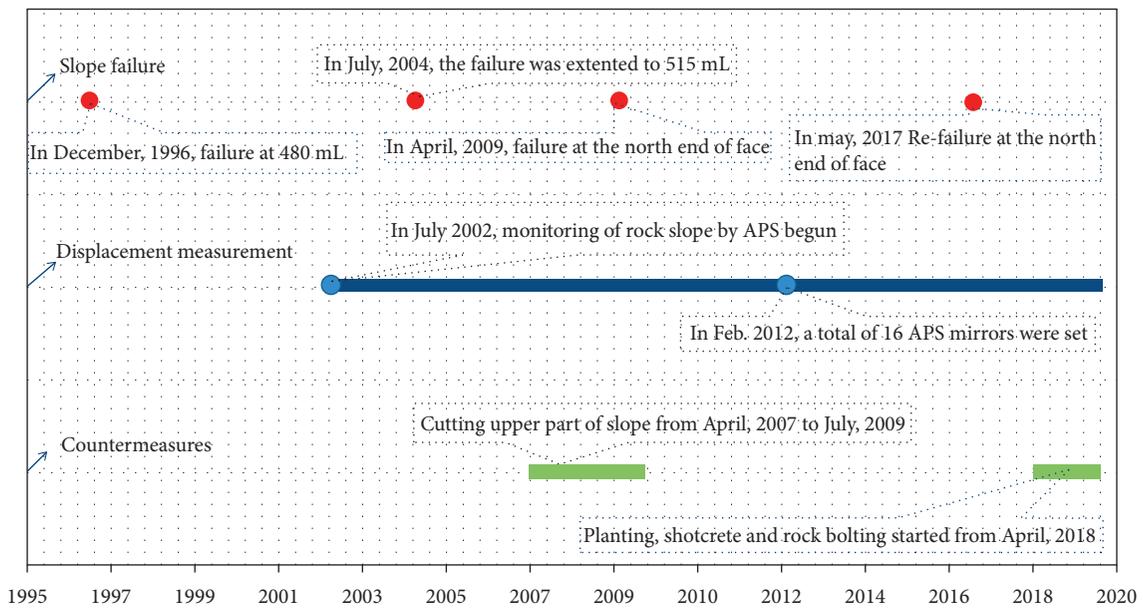
FIGURE 3: An illustration of events that have occurred at the quarry.

Figure 3 illustrates the series of events that occurred at the quarry from 1996 to 2020, including four slope failure incidents. The first massive slope failure occurred at the 480 m level in December 1996. The slope failure then extended to the 515 m level in July 2004 (Figure 4(a)). Failure later occurred in April 2009 at the north end of the face of the 2004 failure (Figure 4(b)) and then reoccurred in May 2017. However, mechanism of the slope failures was not discussed in this study as the evidence is not yet clear. More significantly, rock slope displacement was begun to be measured using an APS in July 2002 to monitor the rock stability behaviour by installing two mirrors at the 480 (ET480-1) and 500 m levels (ET500-1). To ensure rock slope stability, slope angle reduction and cutting measures were taken at the upper part of the slope from April 2007 until July 2009, as shown in Figure 5. In February 2012, 16 surface displacement monitoring points (mirrors) were set along the rock slope to monitor the deformation of the entire quarry, as shown in Figure 6. Countermeasures such as planting and support systems installation (shotcrete and rock bolts shown in Figure 2) have been undertaken since 2018.

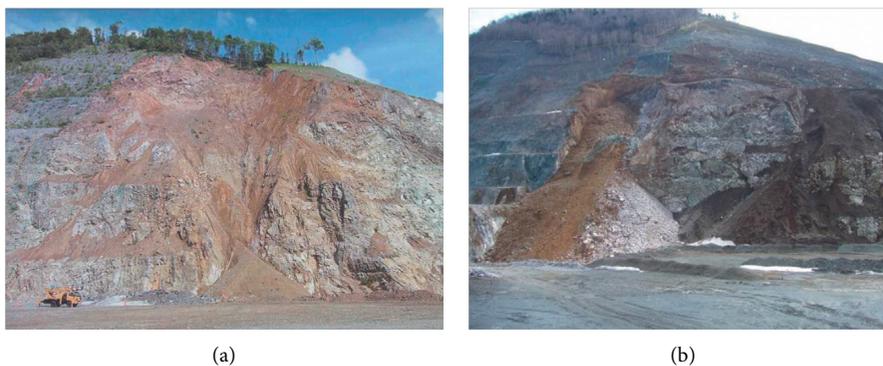
FIGURE 4: Slope failure that occurred at the quarry in (a) July 2004 and (b) April 2009.

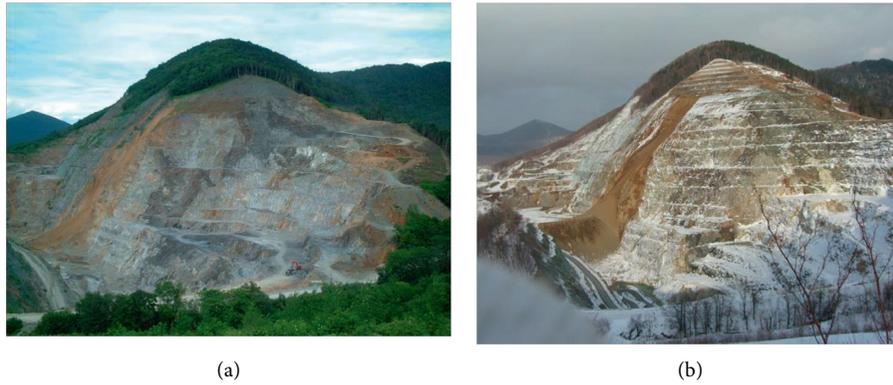
FIGURE 5: Layout of the rock slope (a) before and (b) after cutting upper part of the slope in July, 2004 and November, 2009.

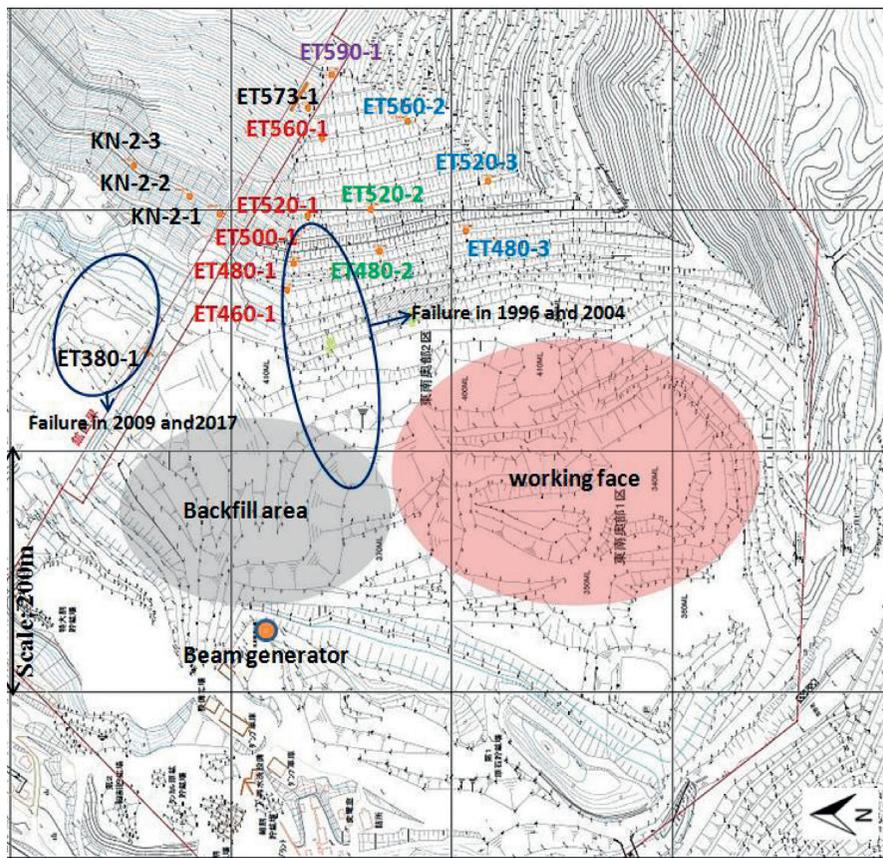
FIGURE 6: Map showing the APS at the quarry. The ET represents the mirror point locations of the automated polar system (APS) set on the rock slope. Each mirror point is represented with a number that indicates its level of elevation.

Excavation is expected to be one of the dominant causes of the slope displacement on the right-hand side of the quarry because the limestone on the pit floor of this area has been excavated since 2014 (Figure 6). Reduced distances will therefore occur if the regional horizontal stress at the Higashi-Shikago limestone quarry is sufficiently high. In this case, the effect of horizontal stress is expected to be greater than that of the gravity release. For example, Obara et al. [51] suggested that rock slope exhibits elastic extension by excavation, resulting in forward displacement of the rock slope at a horizontal stress to vertical stress ratio of 1.0. However, this ratio tends to increase with inverse depth and is therefore likely to be greater than 1.0 in open pit mines [52].

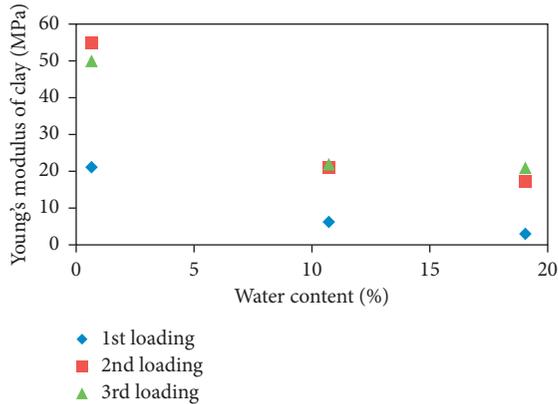
FIGURE 7: Young's modulus of the clay specimens at different water contents.

The relationship between Young’s modulus and water content of the clay specimens is shown in Figure 7. Young’s modulus is found to rapidly decrease with increasing water content from 21, 55, and 50 MPa in the first, second, and third load cycles, respectively, for water contents of approximately 1% to 3, 17, and 21 MPa for water contents of approximately 19%. These results demonstrate that Young’s modulus of clay in the quarry considerably decreases with increasing water content under both loose and consolidated conditions.

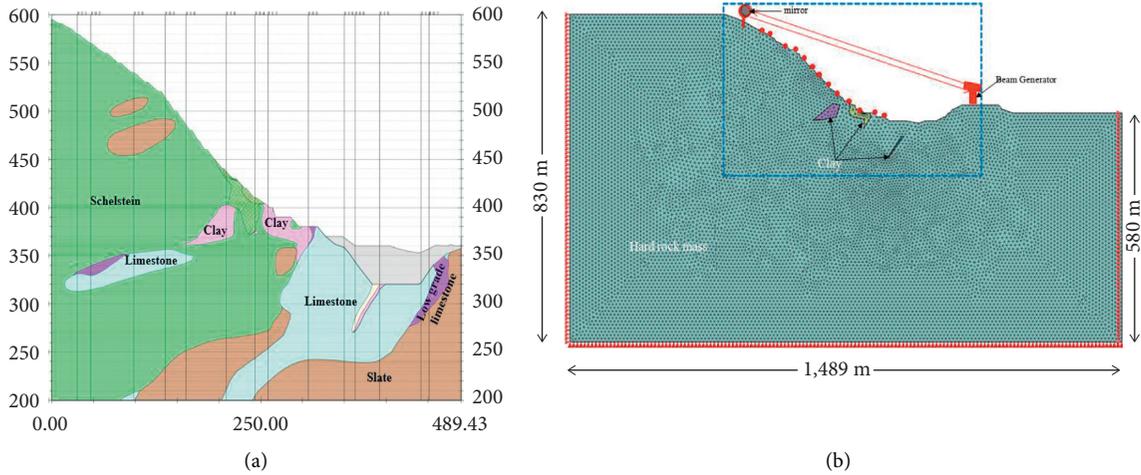
FIGURE 8: (a) Geological cross section along the line V33 in Figure 1 and (b) entire analytical model of the quarry. Simulated results of induced displacement in the blue rectangle are shown.

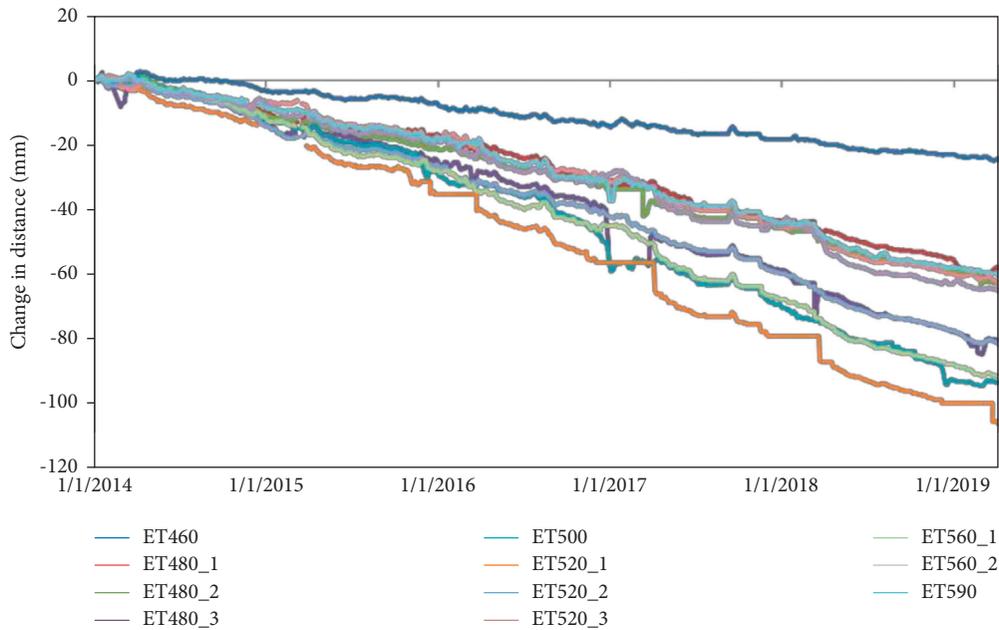
FIGURE 9: Change in distance with time for periods of five years, from 2014~2019.

As described in Section 4.1, the distance between the beam generator and each mirror gradually decreases with time (Figure 9). The reduced distance is greatest at the middle of the rock slope (elevation 520 m) in the left-hand side and centre of the quarry, but at the foot of the slope in the right-hand side of the quarry (Figure 10). The following deformation characteristics were estimated based on the numerical simulations, as discussed in Section 4.2. The lowered Young's modulus of the clay seam reduced the distance, and the maximum decrease is seen at the middle of the slope (Figure 12). The change in distance owing to excavation of the pit floor depends on the rock stress conditions (Figure 15). The distance increases under gravity force conditions and decreases under horizontal stress conditions. The magnitude of the distance reduction under horizontal stress conditions is greatest at the foot of the slope. As the shear sliding progressed in the rock slope owing to reduced rock mass strength, the distance decreased with the greatest magnitude at the foot of the slope (Figure 17). According to the above results, the possible causes of the continuous deformation of the rock slope at the Higashi-Shikagoe limestone quarry are deduced as follows. (a) The rock slope displacement at the left-hand side and centre of the quarry is caused by deterioration of the existing clay layer. (b) The rock slope displacement at the right-hand side is caused by floor excavation and/or shear sliding of the slope.

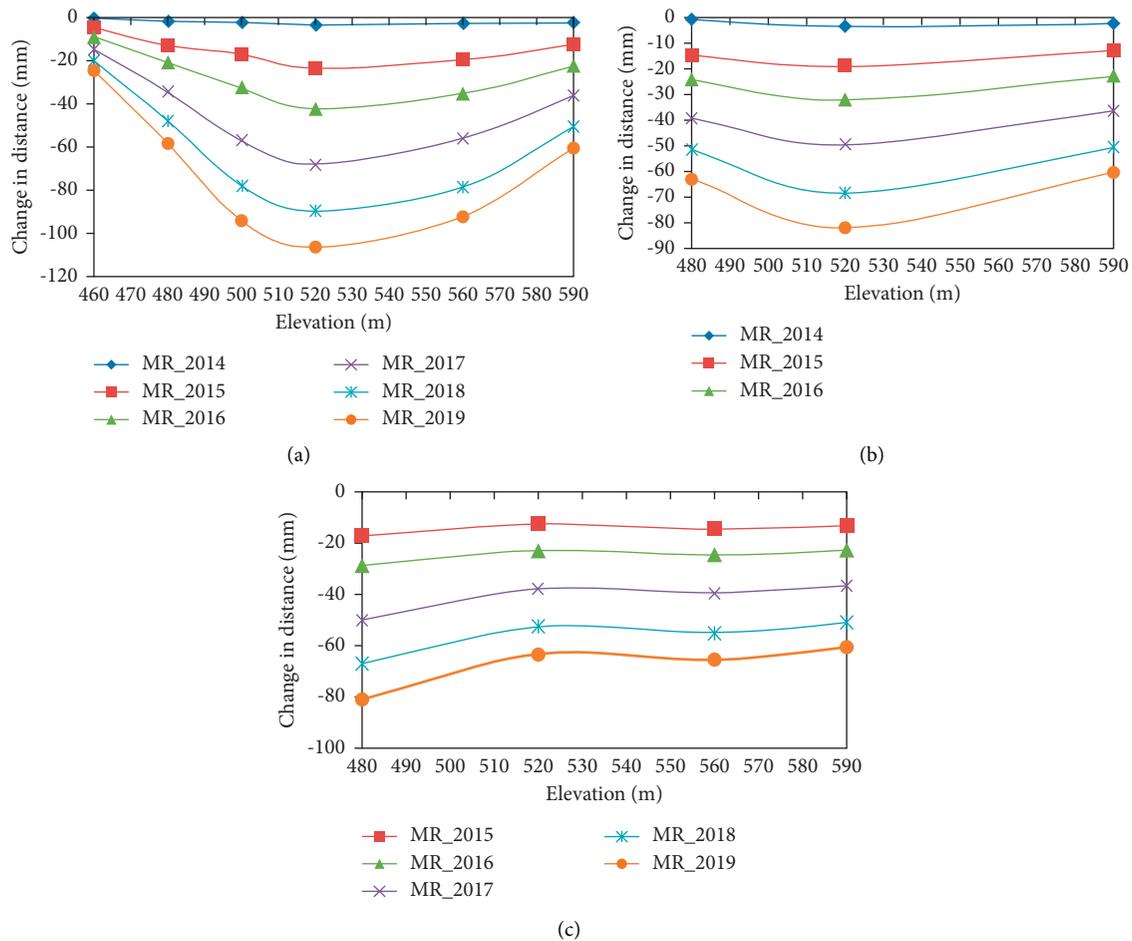
FIGURE 10: Relationship between change in distance from 2014 to 2019 and elevations at (a) the left-hand side, (b) centre, and (c) right-hand side of the quarry.

The relationship between the change in distance and elevation was analysed to better understand the rock slope deformation characteristics of the entire quarry by classifying the mirrors into three groups: north (i.e., left-hand side of the quarry: ET460-1, ET480-1, ET500-1, ET520-1, and ET560-1); central (central side of the quarry: ET480-2 and ET520-2); and south (right-hand side of the quarry: ET480-3, ET520-3, and ET560-2). ET590-1 is installed at the top of the slope and is common in all of the three groups. The mirrors are, respectively, indicated as red, green, blue, and purple in Figure 6. The correlation of each group (Figure 10) clearly shows that the greatest reductions of distance occurred in the middle (elevation: 520 m) of the rock slope (Figures 10(a) and 10(b)). In contrast, the decrease in distance reaches a maximum at the slope foot as shown in Figure 10(c). These results indicate that the factors that influence the slope deformation on the left-hand side and central part of the quarry are likely similar, but differ from those that influence the slope deformation on the right-hand side of the slope.

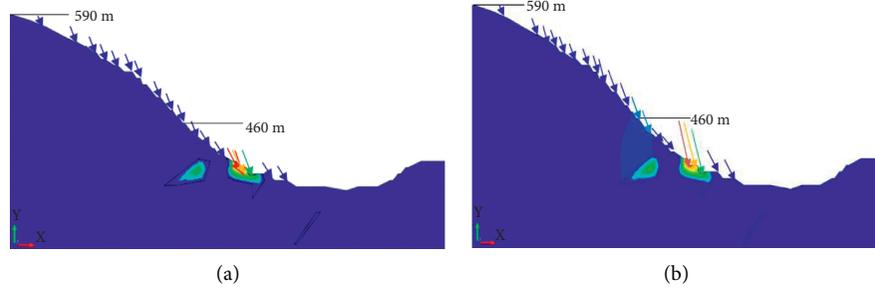
FIGURE 11: Total displacement vector at the surface of rock slope induced by reduction in Young’s modulus of clay, case\_a (a) and case\_b (b) in the blue dotted rectangle in Figure 8(b). The arrows indicate the direction of the displacement, whereas the length of the arrow is proportional to the magnitude of the displacement.

Case\_b; Table 2) were modelled following the simulation conditions described in Section 3.3. Based on the experimental results described in Section 3.2, Young's modulus of clay was set to 50 and 20 MPa in the initial stages and then assumed to deteriorate to 20 and 3 MPa, respectively, owing to increased water contact, whereas Young's modulus of the hard rock was set to 1 GPa (Table 2). The mechanical properties presented in Tables 1 and 2 were used. The relative displacements induced by the reduced Young's modulus of the clay were then calculated for each model by subtracting the displacement in the initial model from that in the deteriorated model. Figure 11 shows the displacement vectors at the surface of the rock slope in Case\_a (50 MPa  $\rightarrow$  20 MPa) and Case\_b (20 MPa  $\rightarrow$  3 MPa). Figure 12 depicts the change in distance at an elevation of 460–590 m calculated from the displacement vectors. The change in distances were normalised by the maximum value in case\_a and plotted relatively to the quarry elevations as shown in Figure 12. As seen in Figure 11, the displacement vectors show an overall trend of downslope displacement of the rock mass from the top to the toe of the rock slope surface in both cases. The maximum displacement was observed mostly within the clay zone near the foot of the

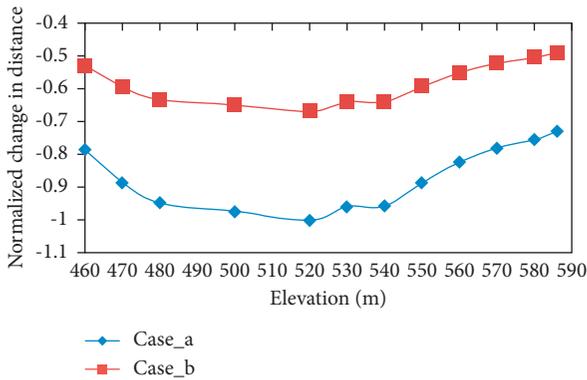
FIGURE 12: Normalized change in distance calculated from simulated results.

slope. In Figure 12, it can be seen that the distance decreased at all elevations between 460 and 590 m in both cases. The change in distance is considered to decrease because of a large displacement within the clay zone due to deterioration, which induces downslope displacement above the clay zone. It should be noted that the maximum decreasing rate of the distance was observed in the middle ( $\sim$ 520 m) of the rock slope in both cases although the maximum value in case\_a is greater than that in case\_b.

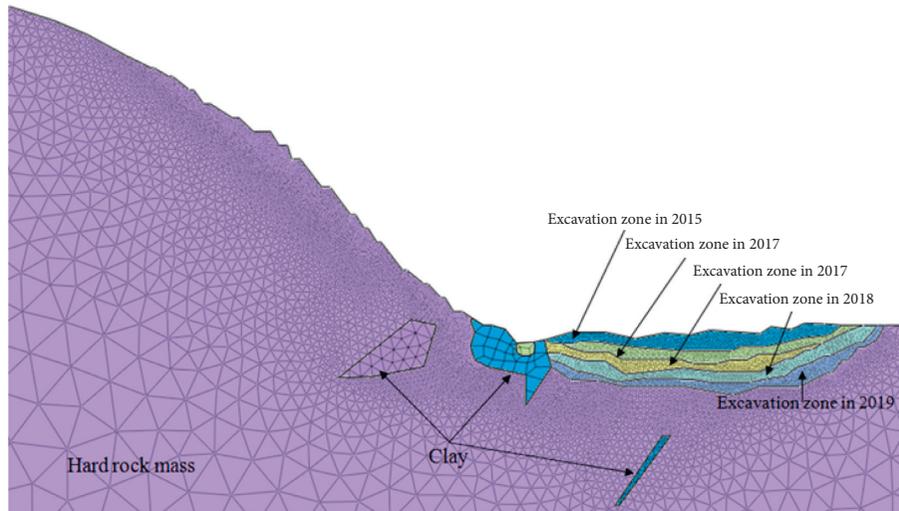
FIGURE 13: FEM meshes in terms of excavation yearly, in blue dotted rectangle in Figure 8(b).

In this section, numerical models for two stress conditions are established, and five cases are modelled in each set for the progressive excavation levels from 2015 to 2019. Excavation at the 400 m level was completed at the end of 2015 and resumed at the 360 m level in 2019. The basic configuration of the analytical models is the same as that discussed in Section 3.3 using the mechanical properties presented in Table 1. However, the geometry of the blue dotted rectangle in Figure 8(b) changed as the excavation progressed. Figure 13 shows the analytical models of the quarry in 2015–2019. Some of the boundary conditions are

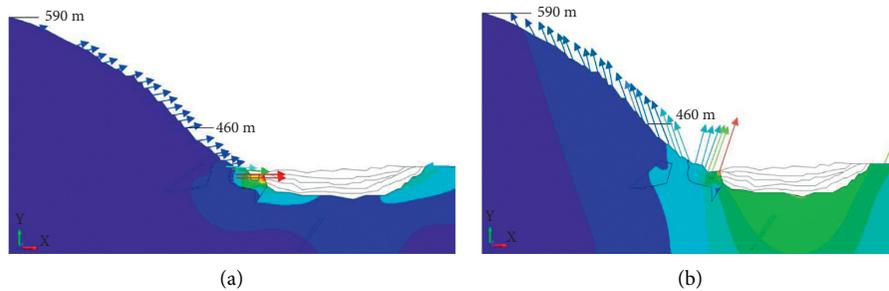
FIGURE 14: Examples of total displacement vector at the surface of rock slope induced by excavation due to (a) release of horizontal stress and (b) gravity in 2019 at the blue dotted rectangle in Figure 8(b). The arrows indicate the directions of the displacement, whereas the length of the arrow is proportional to the magnitude of the displacement.

Examples of the displacement vector at the surface of the rock slope and beam generator point induced by excavation are shown in Figure 14. The changes in distance calculated from the distribution of the surface displacement vectors along the slope and beam generator point are plotted relative to the quarry elevation between 460 and 590 m, as shown in Figure 15. The changes in distance were normalised by the maximum value in 2019. In Figure 14(a), the displacement vectors show the forward displacement of the rock mass from the top to the toe of the slope. It is clearly seen in Figure 15(a) that the distance decreased with similar tendencies along both the slope and at the beam generator point owing to the horizontal stress release as the rock floor was excavated likely because of the forward displacement of the rock mass. As expected, the displacement magnitude increased upon approaching the slope foot with the greatest displacement concentrated near the clay zone. The highest decreasing distance rate is also notably observed near the foot of the rock slope. The displacement vectors along the rock slope shown in Figure 14(b) indicate upward and leftward movement of the rock mass, whereas the vectors at the beam generator point show upward and rightward displacement owing to the gravity release when the rock floor of the pit was excavated. Figure 15(b) shows that the distance at elevation 590–460 m increased with progressive

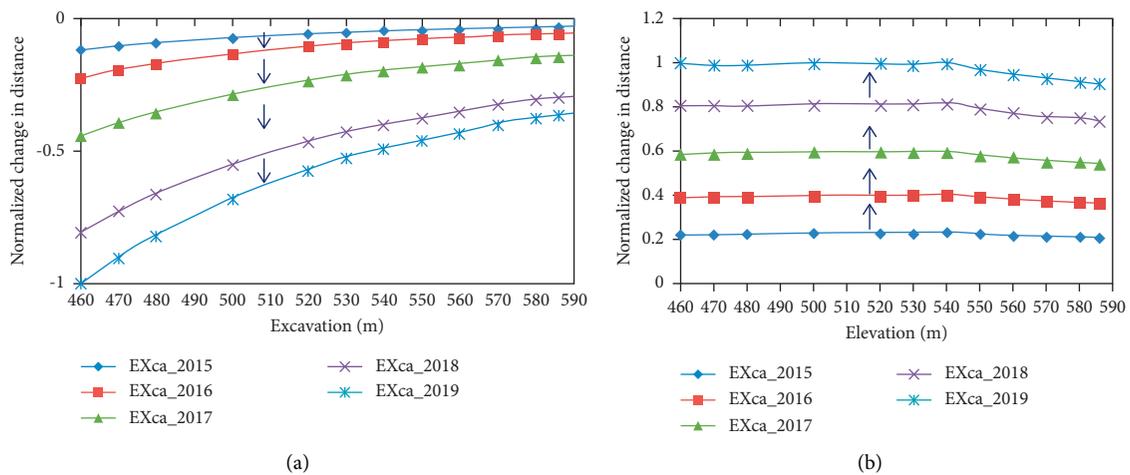
FIGURE 15: Normalized change in distance of the simulated results of displacement induced by (a) release of horizontal stress and (b) gravity.

yearly excavation owing to the leftward and rightward displacement of the rock mass along the slope and at the beam generator point. The maximum distance increase is observed near the foot of the rock slope, where the largest displacement magnitude is concentrated.

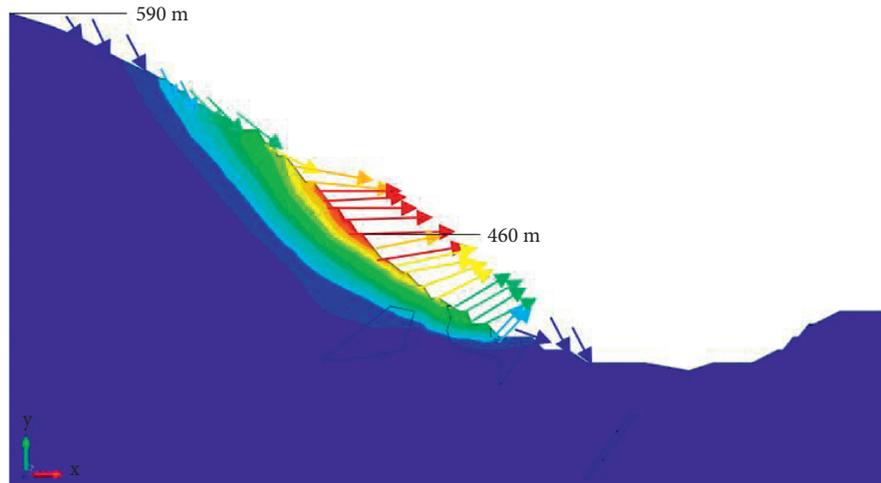
FIGURE 16: Displacement vector along the rock slope at  $\phi = 40^\circ$  in the blue dotted rectangle in Figure 8(b). The arrow indicates the direction of the displacement, whereas the length of the arrow is proportional to the magnitude of the displacement.

The surface displacement vector of the rock slope at  $\phi = 40^\circ$  is shown in Figure 16 with the shear strain distribution. The change in distance calculated from the surface displacement vectors is plotted against the quarry elevation

for comparison, as shown in Figure 17. The change in distance is normalised by the maximum value at  $\phi = 50^\circ$ . Figure 16 shows that the downslope movement of the rock mass occurred at the top of the rock slope. The slope clearly slid relatively downward from the top to the intense shear strain zone in the middle of the slope, resulting in massive forward displacement of the middle of the rock slope surface. The change in distance decreased as a result of the downslope movement along the slope and at the beam generator point. The maximum decreasing rate of the distance is shown at 460 m for both friction angles (Figure 17).

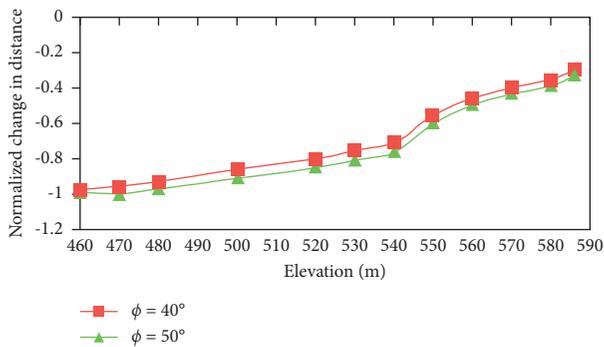
FIGURE 17: Normalized change in distance calculated from SSR simulation results.

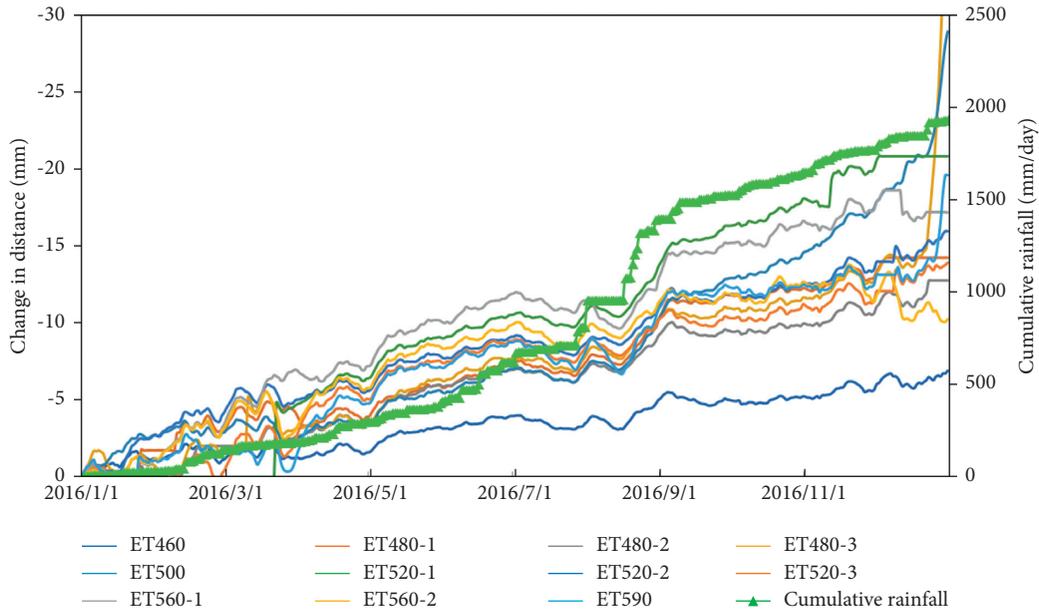
FIGURE 18: The comparison between cumulative rainfall and measured change in distance.

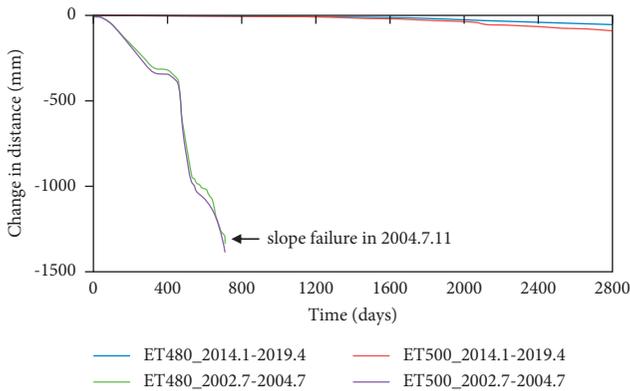
FIGURE 19: The change in distance from 2002.4 to 2004.7 and 2014.1 to 2019.4.

Figure 19 shows the change in distance at the 480–500 m level from the beginning of measurement (July 2002) until the second slope failure (July 2004). For comparison, the changes in distance at the same points between April 2014 and March 2019 are also shown. The decrease ratio of the distances from 2014 to 2019 is significantly smaller than that from 2002 to 2004. The total change of distance during the slope failure in July 2004 is closer to 1500 mm, whereas that from 2014 to 2019 is less than 50 mm. As seen in Figure 19, an apparent accelerating decrease is observed in the curves from 2002 to 2004. In contrast, the distance from 2014 to 2019 decreases at a nearly linear rate with no apparent acceleration (Figure 19), this was probably due to the effect of the undertaken countermeasures such cutting upper part of the slope, planting, and support systems installation (shotcrete and rock bolt). These results indicate that the risk of rock slope shear failure is presently low even though the distance decrease on the south side of the quarry is caused by shear movement of the slope. It can therefore be concluded that the slope is not unstable, even though continuous deformation is observed.
