Research Article

Grouting Technique for Gob-Side Entry Retaining in Deep Mines

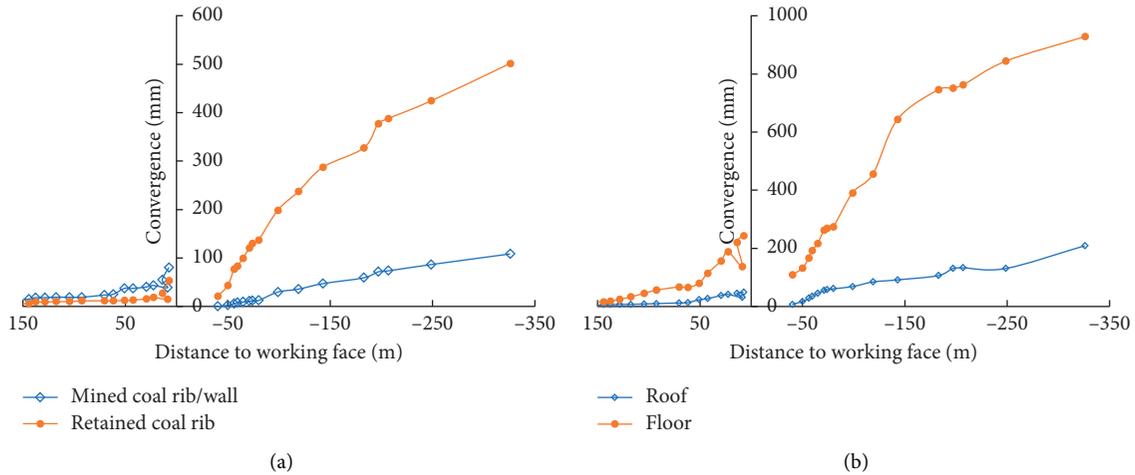
FIGURE 1: Surrounding rock convergence. (a) Rib/wall convergence. (b) Roof/floor convergence.

The surrounding rock deformation observation site is located in the tail roadway of 1252 (1) panel in the Panyidong Mine, which is retained after coal mining. The panel layout is 264 m wide by 1728 m long. The elevation of the panel is -823 – -738 m, and the ground elevation is $+21.5$ – $+22.1$ m. The average thickness of the coal seam is 2.3 m, and the dip angle is 3° – 9° . The main roof is medium-fine sandstone with a thickness of 0–11.0 m. The immediate roof is composed by mudstone, sandy mudstone, and 11–3 coal seam, with a thickness of 0–8.4 m. The surrounding rock deformation of retained roadway is shown in Figure 1. The surrounding rock deformation presents the following characteristics:

- (1) Roadway deformation presents a significant non-symmetrical feature, which is mainly caused by the retained coal rib deformation and the floor heave. The retained coal rib deformation accounts for 85% of the rib-to-rib convergence; and the floor heave accounts for 79% of the roof-to-floor convergence.

- (2) The roadway surrounding rock is in a state of high-speed deforming for a long time under the disturbance of the main roof rotation and subsiding, and it still shows a long-term rheological phenomenon after the main roof structure is stabilized. In deep mines, the retained roadway surrounding rock is loosened and broken under the influence of the mining-induced stress before and after the working face, and its bearing performance is significantly reduced. Surrounding rock has a strong rheological property, which has lower speed and sustained deformation. If proper reinforcement support is not adopted, the damaged area of the roadway will further increase, and even completely lose stability.

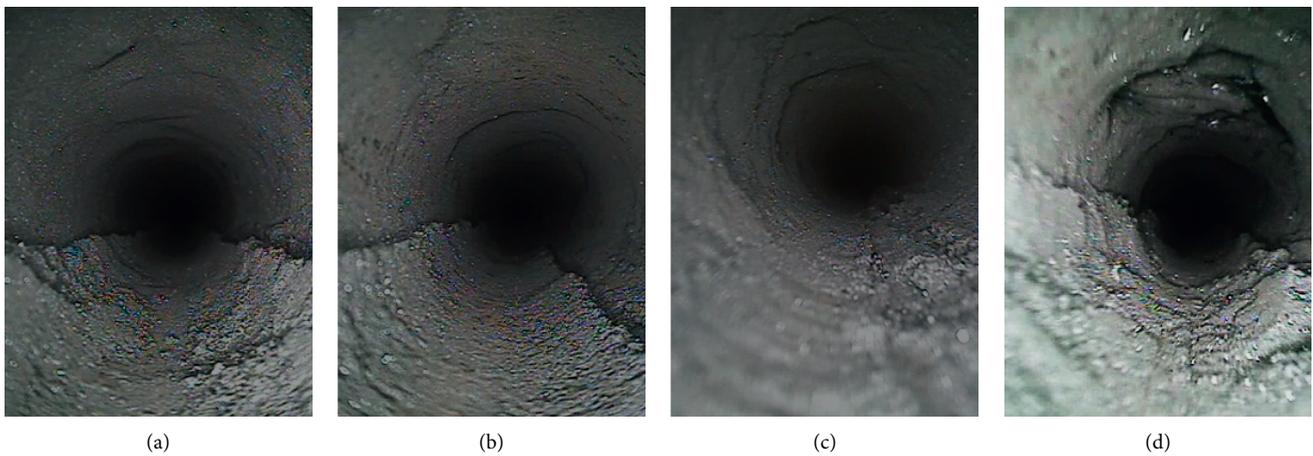
FIGURE 2: Typical cracks in borehole images. (a) Small crack. (b) Medium crack. (c) Large crack. (d) Broken zone.

face, holes with a depth of 6 m were drilled at the positions of 50 m, 30 m, 10 m, and 5 m in front of the working face, at the working face, and 10 m, 20 m, 40 m, 60 m, 100 m behind the working face along the coal seam inclination. In order to quantitatively describe the development of cracks in the holes, referring to other research results, coal bodies and cracks are divided into the following four categories [20]. Various kinds of typical cracks are shown in Figure 2.

- (a) *Small Crack.* The crack is original crack or newly developed with aperture less than 2 mm
- (b) *Medium Crack.* Affected by the mining-induced stress, the aperture of the cracks in the coal rib has increased to 2–5 mm
- (c) *Large Crack.* When the coal rib is relatively broken, multiple cracks are connected to each other and gradually expand, and the aperture reaches more than 5 mm
- (d) *Broken Zone.* Affected by mining-induced stress, a large number of cracks in the surrounding rock of the large-deformation roadway are interconnected with each other, and the range of the broken zone is greatly expanded

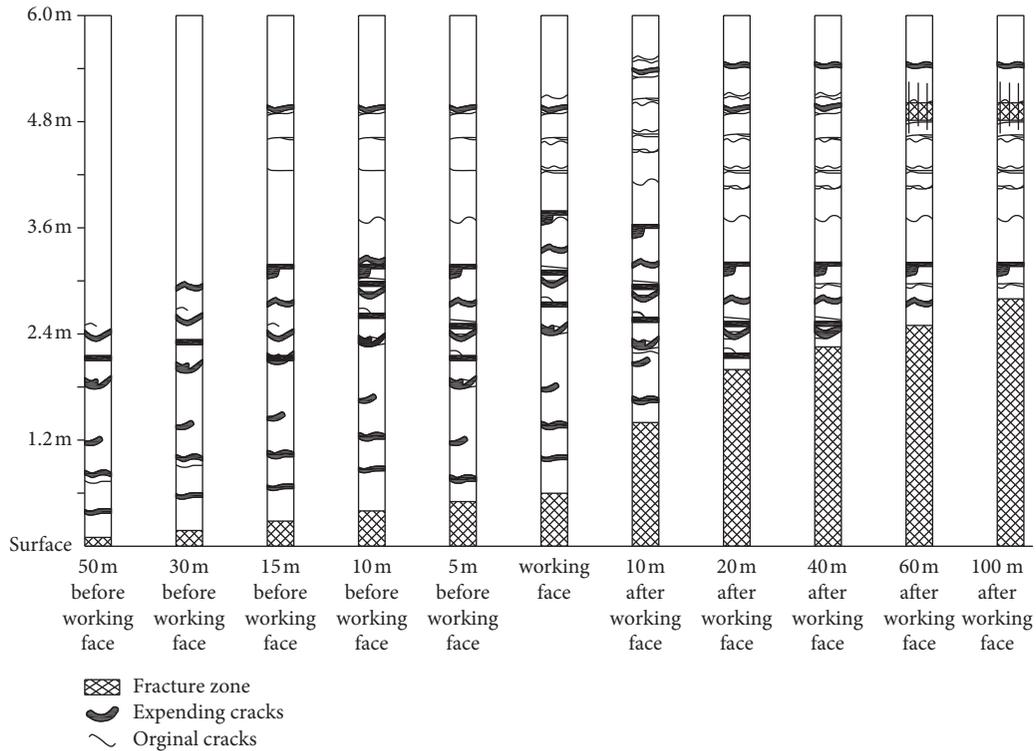
FIGURE 3: Sketch of cracks and fractures zones in retained coal rib around working face.

3.2. Development of the Cracks and Its Influence on Anchoring System. After the borescope was completed, the development of the cracks in the boreholes was sketched, and the result is shown in Figure 3. In order to facilitate statistics and analysis, every 500 mm width of the broken zone is equivalent to a small crack, a medium crack, and a large crack. Figure 4 shows the final statistical results of the cracks in the drilling hole. The development of cracks in the retained coal rib along with the working face is as follows:

- (1) Outside of the mining-induced stress area, the cracks in coal rib are generated within a depth of about 1 m from the surface. The causes of cracks are mostly the original small cracks, mining-induced stress caused by roadway excavation, and weathering of coal on the roadway surface.

- (2) With the advancement of the working face, the roadway surrounding rock fracture gradually penetrated into the coal body. Within the range of 0–30 m in front of the working face, the high mining-induced stress section, the cracks in coal rib are generated within a depth of about 0–2.8 m from the surface. The greatly fluctuating mining-induced stress caused a large number of new cracks in the retained coal rib and caused the original cracks to expand further. However, it is worth noting that because the roadway adopts the active strong bolting support method, and the main roof above the roadway has not broken or rotated and subsided, the range of the broken zone in coal rib has not been greatly expanded at this time.

- (3) In the 0–40 m mining-induced stress-affected section behind the working face, both the ranges of cracks and the width of the broken zones have increased

significantly, and the broken zone has also begun to appear inside the retained coal rib. After the main roof breaking, rotating, and subsiding, stress concentration occurs in the retained rib, which causes the shallow part of the coal rib to be crushed and squeezed out. At the same time, it also causes the weakening and failure of the bolting structure. At this time, the surrounding rock-supporting load-bearing structure is already in a postpeak failure state. The roadway surrounding rock needs strengthening supporting in time; otherwise, there will be slow and continuous plastic flow in the future.

- (4) Beyond 100 m behind the working face, retained coal rib cracks extend beyond 6 m depth. It is often found that the broken zone is in the deep part of the surrounding rock, and the cracks width is further increased. At this stage, the surrounding rock of the roadway has been in a loose and broken state, the anchoring force of the bolting system has been greatly attenuated or has been lost, and the roadway is in a state of plastic flow under low supporting force.

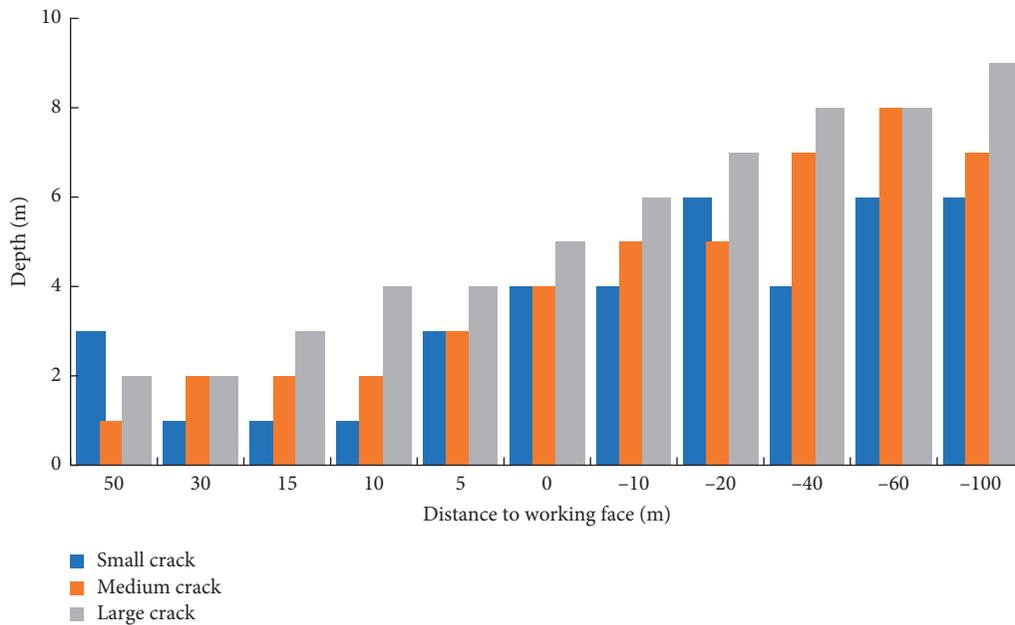
FIGURE 4: Statistical graph of cracks development in boreholes around working face.

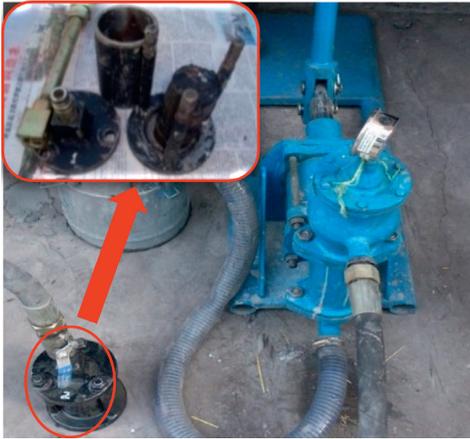
FIGURE 5: Pressure-bearing grouting device.

4.1. Experimental Device and Plan. The experiment was carried out on the MTS 815.03 testing machine and the self-made pressure-bearing grouting device. The self-made pressure-bearing grouting device can produce the fractured coal mass grouting geocomposite specimen by $\Phi 50 \text{ mm} \times 100 \text{ mm}$, as shown in Figure 5.

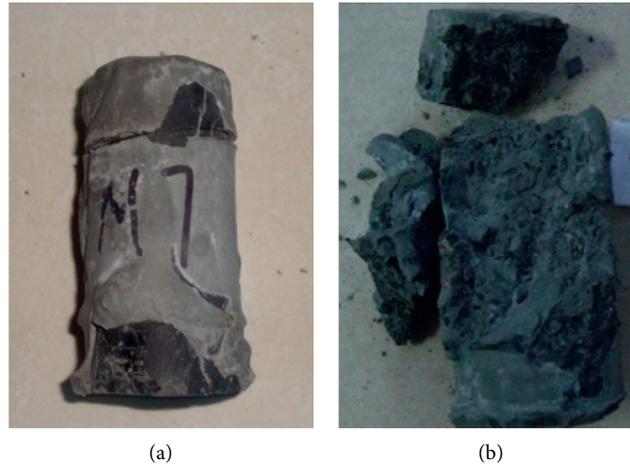
FIGURE 6: Grouting geocomposite specimen (a) and its broken pieces (b).

specimen to make them meet the experimental requirements, as shown in Figure 6.

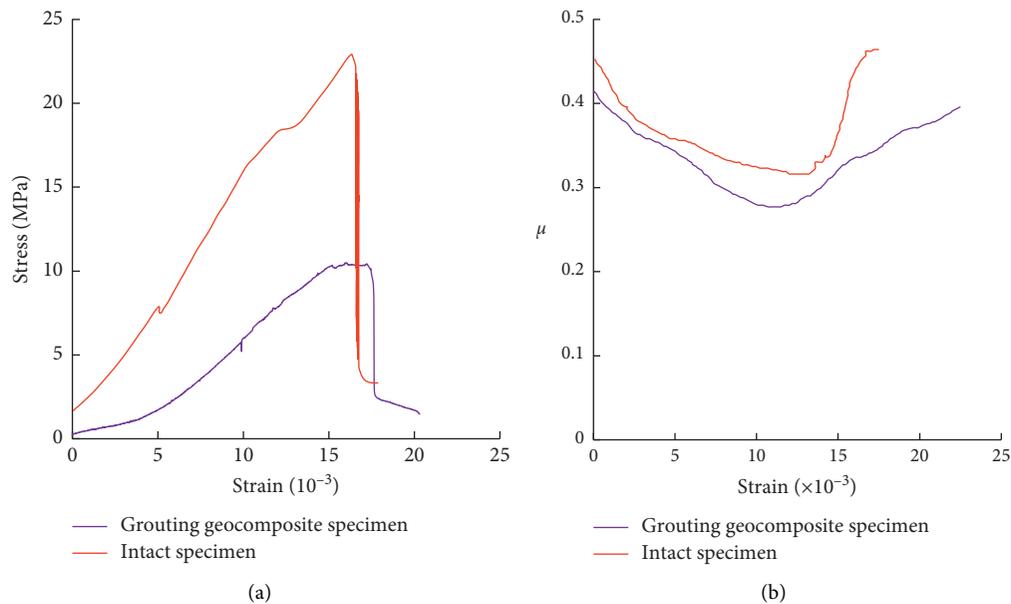
FIGURE 7: Mechanical properties of coal specimen before and after grouting. (a) Typical stress-strain curve. (b) Typical Poisson's ratio-strain curve.

4.2. Experiment Result and Data Analysis. The ratio of the grouting geocomposite specimen strength to the residual strength of the intact specimen is defined as the consolidation coefficient; the ratio of grouting geocomposite specimen strength to the compressive strength of the intact specimen is defined as the recovery coefficient. In this experiment, the mechanical properties of coal specimen with different P. O42.5 Portland cement water-cement ratios before and after grouting are obtained, as shown in Table 1. Figure 7 shows the stress-strain and Poisson's ratio-strain during the whole loading process of the grouting geocomposite specimen under the condition of 0.8 water-cement ratio. Analyzing the experimental results, we can get the following conclusions:

- (1) After grouting, the compressive strength of the grouting geocomposite specimen is significantly higher than the postpeak residual strength of the intake coal specimen, and it is partially restored compared to that of the intact coal specimen. When the water-cement ratio is 0.7, 0.8, and 1.0, the average consolidation coefficient and recovery coefficient of the grouting geocomposite specimen are 2.84, 2.55, and 1.24 and 35.33%, 31.43%, and 40.12%, respectively.

- (2) During the whole process from the beginning of the compression to the failure the grouting geocomposite specimen, there is no stress sudden decrease stress after failure of the specimen. It shows that the ductility of the fractured coal specimen increases after grouting, and it has stronger anti-deformation ability and plasticity.

- (3) After the specimen is fractured, the rock blocks slip and move along the fracture surface, the lateral deformation increases rapidly, and its Poisson's ratio μ increases rapidly. Poisson's ratio μ of the grouting geocomposite specimen is smaller than that of the intact specimen, which indicates that the broken

rock block can become a whole with coordinated bearing capacity, and its stability is improved after grouting.

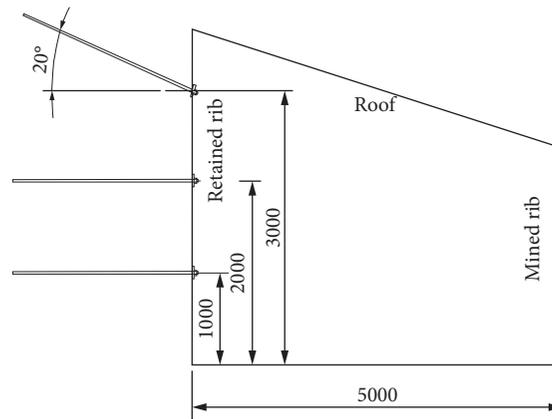
FIGURE 8: Grouting bolts layout.

6.2. Grouting and Supplementary Support in Retained Coal Rib. When the roadway was not affected by the mining-induced stress, a row of anchor cable beams was carried out along the roadway direction on the retained rib to control its rapid deformation during the mining. The distance between the anchor cable beam and the roadway floor was 2.5 m, and the diameter and length of the steel strand were 17.8 mm and 4300 mm, respectively. The drill hole was inclined upward by 40° . Quick-hardening sulphoaluminate cement was adopted for grouting cement, the compressive strength of which can reach 30 MPa in one day and 42.5 MPa in three days. Grouting was carried out 20–30 m in front of the working face with a water-cement ratio of 0.8. Three grouting bolts were arranged in each row in the retained rib, the length of the bolts is 2600 mm, and the distance between the bolts was 1.0–2.0 m. The hole sealing length of the grouting holes needs to be 1.0 m, and the grouting pressure was 1.0–1.5 MPa. The layout of grouting bolts is shown in Figure 8.

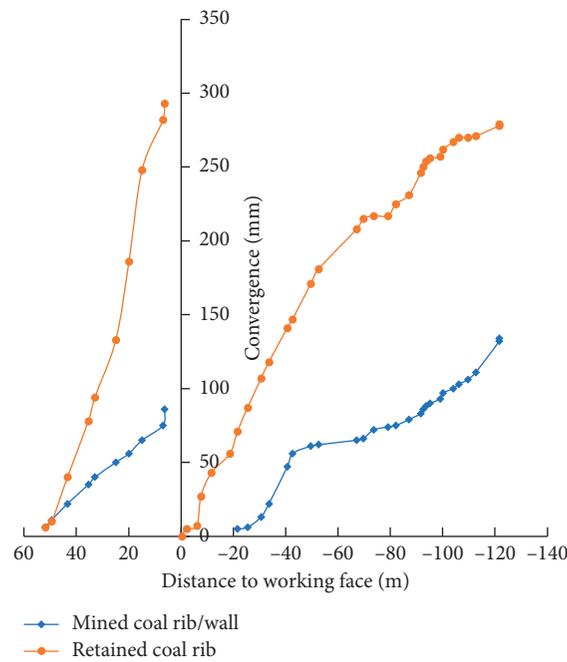
FIGURE 9: Curve of retained roadway ribs displacement.

6.3. Retained Roadway Deformation. Grouting and supplementary support in retained roadway have controlled the surrounding rock deformation, as shown in Figures 9 and 10. In front of the working face, the rib-to-rib convergence was only 300 mm, which provided a foundation for the stability of the retained roadway behind the working face. The retained roadway within the section of 0–40 m behind the working face was strongly affected by mining-induced stress. The influence of mining-induced stress in the section of 40–90 m behind the working face gradually weakened, and the deformation speed of the retained rib and wall began to slow down. Outside the section of 100 m behind the working face, the roof rotated and subsided to a stable state. At this time, the deformation speed of the retained roadway gradually decreased and entered a stable

period. After that, the deformation of the retained coal rib is less than 1 mm per day. Grouting and supplementary support kept the surrounding rock of the roadway intact, and the width and height of the roadway were about 3.6 m and 2.5 m respectively.

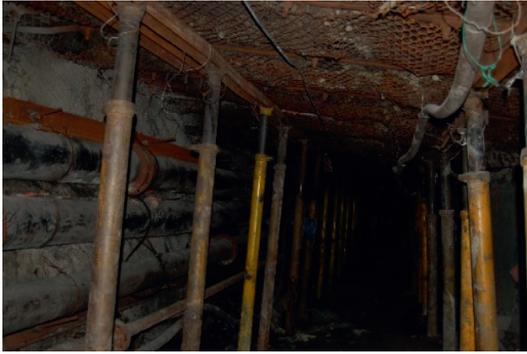
FIGURE 10: Roadway at 160 m after working face.
