# An Alternative Method for Long-Term Monitoring of Thai Historic Pagodas Based on Terrestrial Laser Scanning Data: A Case Study of Wat Krachee in Ayutthaya

*Department of Civil Engineering, Faculty of Engineering, King Mongkut's University of Technology Thonburi, Bangkok 10140, Thailand*

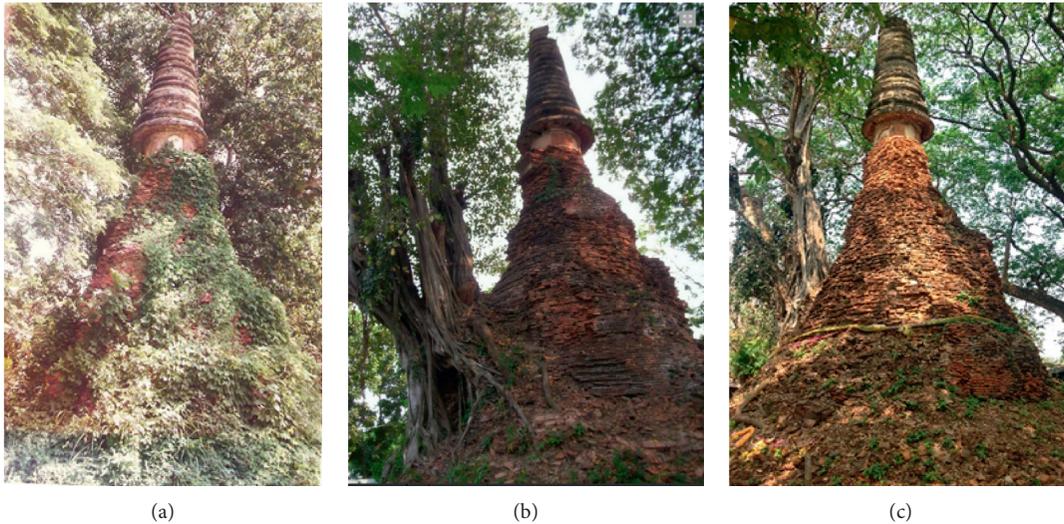
World Heritage Site in 1991. Figure 2 shows the differential environment of Wat Krachee at three points in time, namely, AD 1987, AD 2005, and AD 2018. It can be observed that the remaining shape of the pagoda is an inverted bell shape. Moreover, this temple has a dominant pagoda with two intertwined trees growing inside it and an entrance into the pagoda chamber, as shown in Figure 3. According to archaeological assumptions, the Wat Krachee pagoda was constructed in the middle period of Ayutthaya, in approximately AD 1550 (2093 BE), meaning that the Wat Krachee pagoda is almost 470 years old [19, 20]. At present, the material deterioration and the growth of the two intertwined trees may be affecting the stability of the Wat Krachee pagoda. In 2018, the Wat Krachee Conservation Project was started through cooperation with the Fine Arts Department of Thailand's Ministry of Culture and UNESCO Bangkok. This conservation project has brought together a multidisciplinary group of engineers, architects, materials scientists, archaeologists, arborists, craftspeople, and professionals from other related fields. Therefore, this study provides supporting information for the Wat Krachee Conservation Project.

FIGURE 2: Images of Wat Krachee pagoda at three points in time. (a) AD 1987 [24]. (b) AD 2005 [25]. (c) AD 2018.

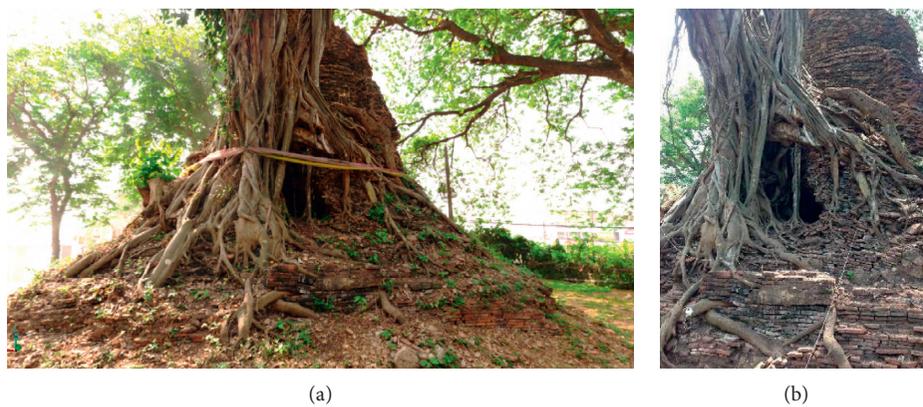
FIGURE 3: The two intertwined trees and the entrance to the chamber inside the pagoda.

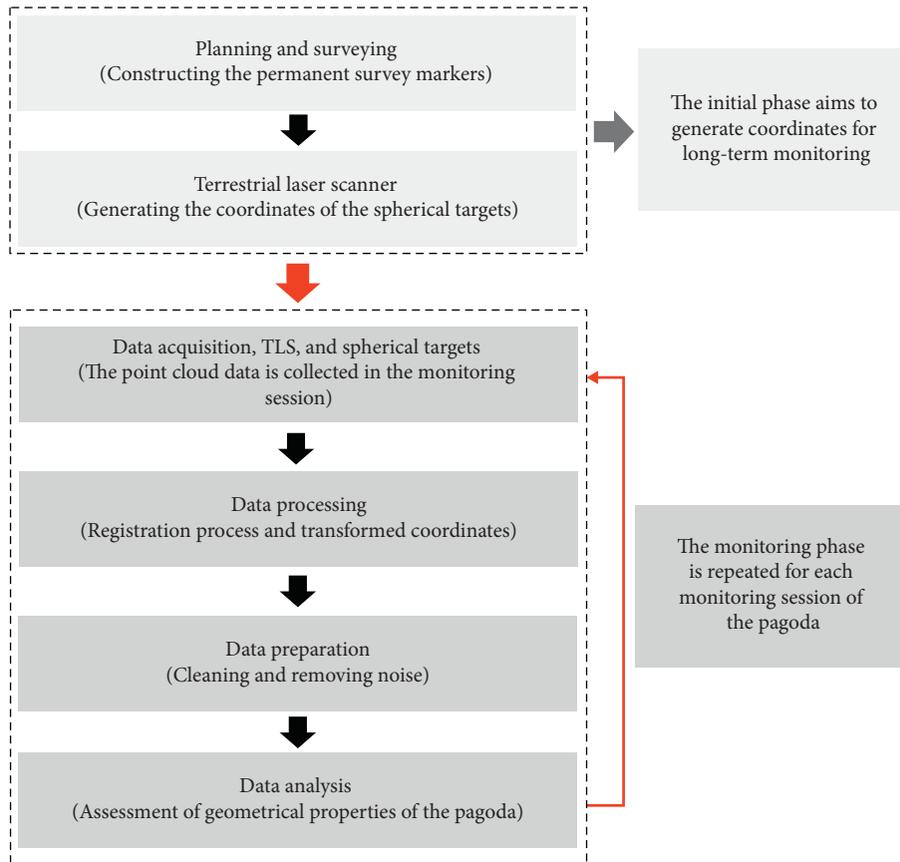
To alleviate the error from the target-less registration process, the present study proposes an alternative method for the long-term monitoring of pagodas in Thailand based on terrestrial laser scanning technology in combination with permanent survey markers. A flowchart of the monitoring procedure is presented in Figure 4. In the initial phase, the

planning and surveying were set up and the permanent survey markers were constructed to define the coordinate system for long-term monitoring. A terrestrial laser scanner was then used, together with spherical targets, to generate the initial coordinate system. The purpose of using the permanent survey markers was to reduce (or minimize) the error from the registration process by constraining the coordinate system of the monitoring period in three-dimensional space.

In the monitoring phase, the data acquisition of the pagoda was first carried out using TLS together with the initial coordinates and spherical targets. Then, the point cloud data were processed using FARO Scene software [27]. In this process, point cloud data were transformed into the control coordinates. Next, the preparation of the point cloud data involved cleaning and removing noise to reduce the amount of data. Then, the postprocessing results of the point cloud data were exported as an RCP file. In the last step, the data analysis procedure, the geometrical properties, the dimensions, the inclination direction, and several essential elements of the pagoda were investigated using Autodesk Revit software [2]. The monitoring phase was repeated for each monitoring session until the data analysis was complete.

FIGURE 4: Method for long-term monitoring of Thai historic pagoda.

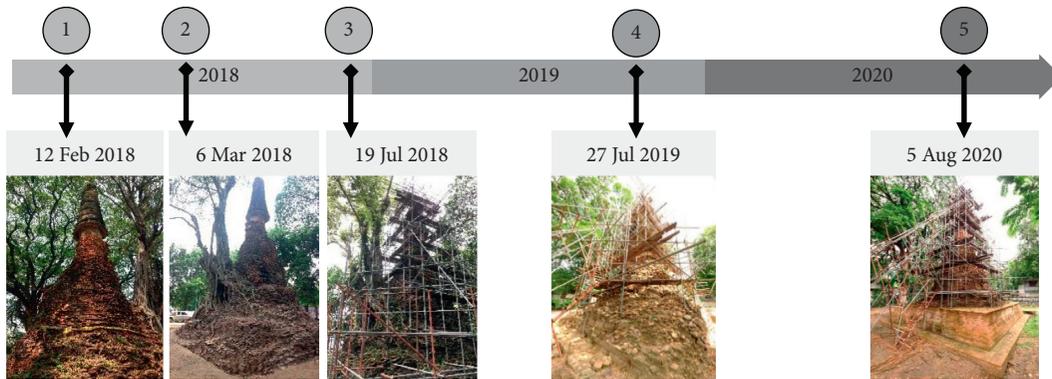
FIGURE 5: A schedule for the long-term monitoring of the Wat Krachee pagoda.

**3.1. Planning and Surveying.** Five sessions were completed as part of the long-term monitoring of the Wat Krachee pagoda, as shown in Figure 5. The operations were carried out in February 2018, March 2018, July 2018, July 2019, and August 2020.

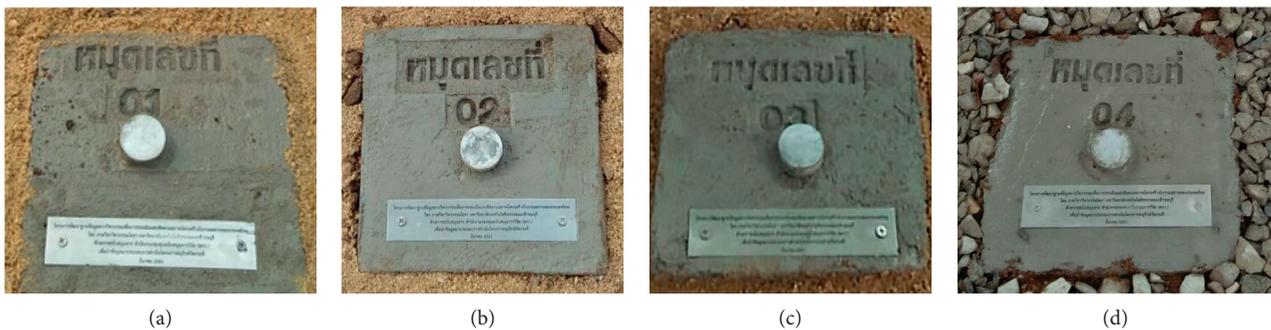
The surrounding area of the Wat Krachee is soft soil, which has the potential to subside due to the surveying. Therefore, it was necessary to create permanent survey markers to ensure a registration corresponding to the real-world coordinates, which should be kept in place for future reference. In this study, four permanent survey markers were constructed on-site for the sake of monitoring, as shown in Figure 6. These survey markers were made of reinforced concrete with a drill hole diameter of 0.1 meters and a depth below the surface of approximately 15–20 meters. In addition, a steel pin was attached to the survey markers to support the spherical targets.

FIGURE 6: The four survey markers for the long-term monitoring of the Wat Krachee pagoda.

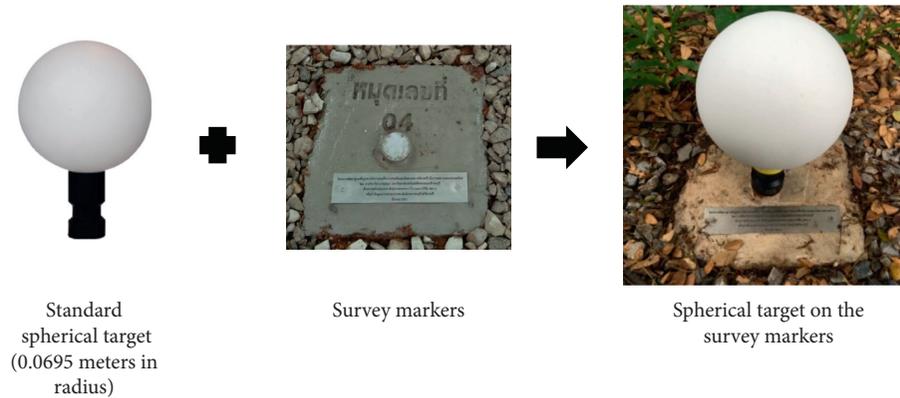
In the procedure for the creation of coordinates for the long-term monitoring of the pagoda, the essential equipment for defining the reference coordinates are standard spherical targets with a radius of 0.0695 meters. These spherical targets were installed on the survey markers, as shown in Figure 7. Then, TLS was used for collecting the coordinates of the four spherical targets. After that, the Scene software was used to automatically detect the spherical targets, as shown in Figure 8. The obtained coordinates ( $X$ ,  $Y$ ,  $Z$ ) were derived from the center points of the spherical targets. These coordinates, listed in Table 1, will be used as the reference coordinates for future monitoring.

FIGURE 7: The combination of standard spherical targets and survey markers.

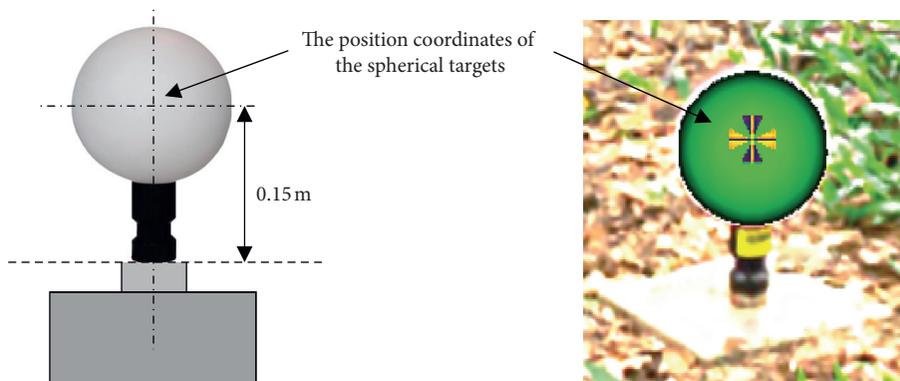
FIGURE 8: The position coordinates of the spherical targets on the survey markers.

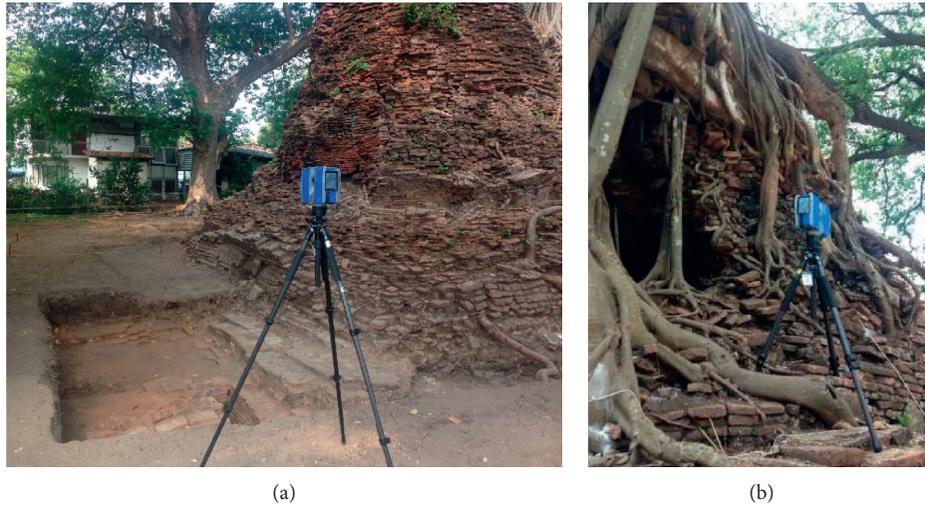
The TLS technology was applied to attain the 3D point cloud data of the Wat Krachee pagoda for each monitoring session, as displayed in Figure 9. Pueschel [28] noted that parameters such as scan resolution and scan speed had an influence on obtaining point cloud data. Therefore, for each monitoring session, these parameters were controlled using

FIGURE 9: Fieldwork at the Wat Krachee temple using a terrestrial laser scanner.

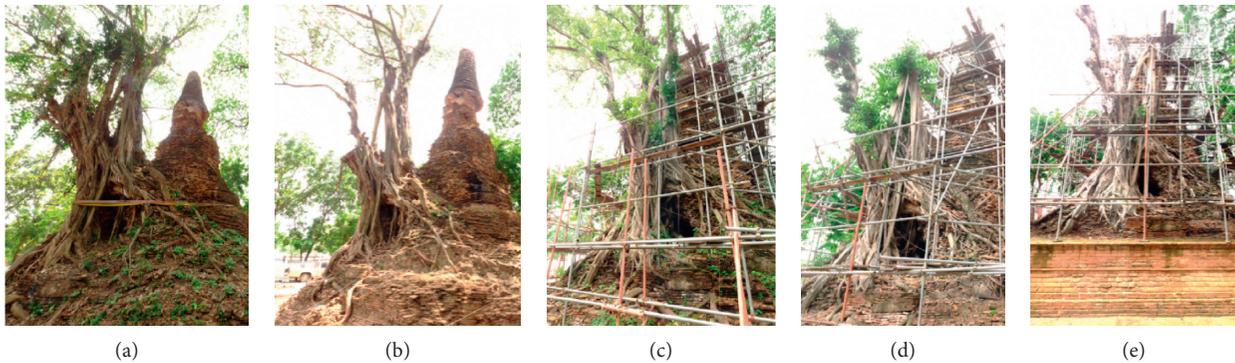
FIGURE 10: The surroundings of the Wat Krachee during the five monitoring sessions. (a) First survey. (b) Second survey. (c) Third survey. (d) Fourth survey. (e) Fifth survey.

months after the first survey, it was determined that tree trimming had slowed down the growth of the two intertwined trees, as shown in Figure 10(d). The scaffolding for preservation work was still attached to the pagoda. In this surveying session, thirteen stations of TLS were performed to gather the point cloud data. At this point, changes in the pagoda had been monitored for two years and six months from the first survey. In the fifth monitoring session, the Than Pra Thaksin section of the pagoda had been reconstructed based on archaeological assumptions, as shown in Figure 10(e). The other elements of the pagoda had not been restored. Therefore, the surveying teams carried out ten scan positions of the Wat Krachee pagoda surroundings.

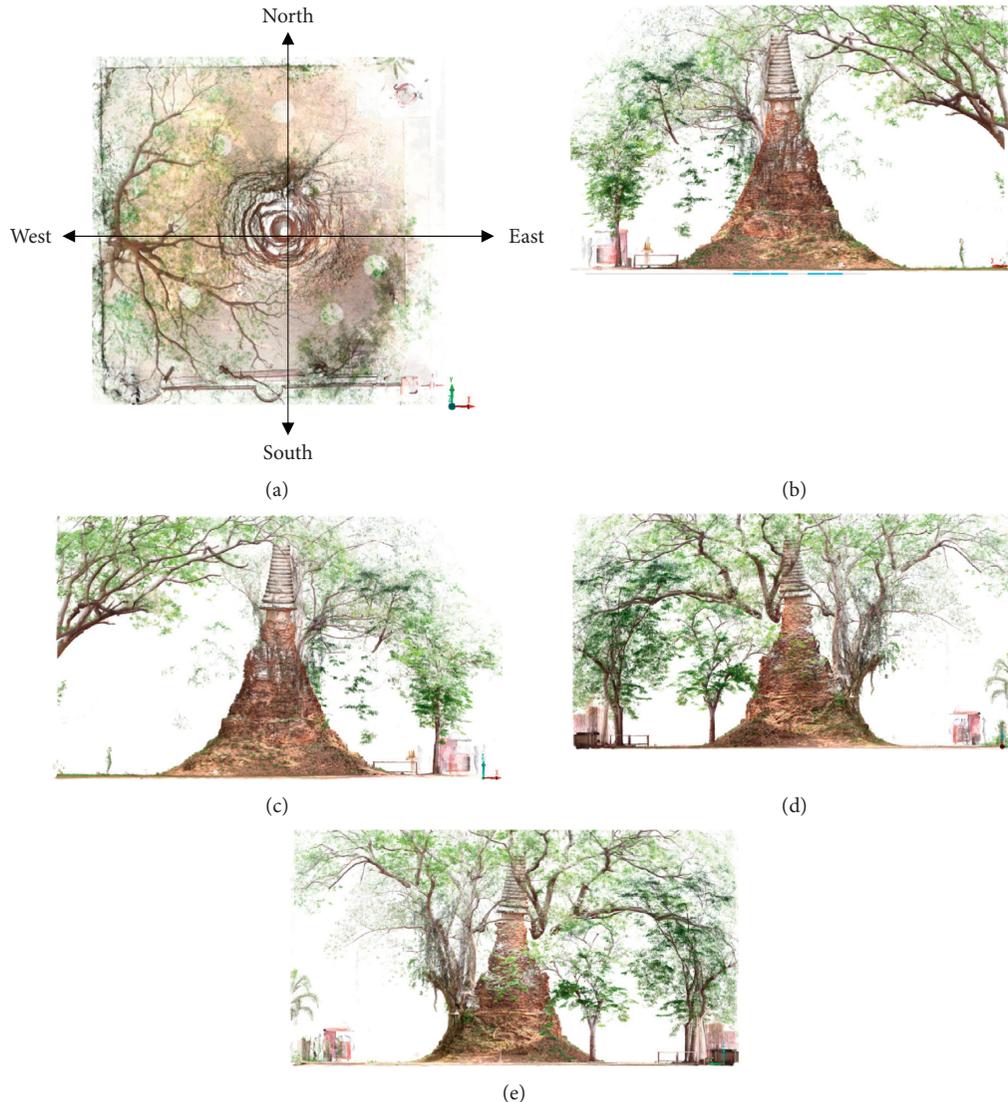
In the data preparation process before the point cloud analysis, it is necessary to clean the data obtained from the area surrounding the pagoda, such as scaffolding and unwanted objects. However, removing this point cloud data can only be done by filtering it out by hand, which takes a long time. The pagoda 3D models have been defined to conform to the realistic sites, as shown in Figure 11(a). The

FIGURE 11: Plan view and side views of the point clouds collected in the Wat Krachee. (a) Plan view of the Wat Krachee. (b) South view. (c) North view. (d) West view. (e) East view.

side views of the four directions of the pagoda are illustrated in Figures 11(b)–11(e). The 3D point cloud models from the five monitoring sessions after passing the data processing and data preparation stages are shown in Figure 12. Finally, each model's point cloud dataset was exported as an RCP file and then transferred to Autodesk Revit software for the point cloud analyzing process.

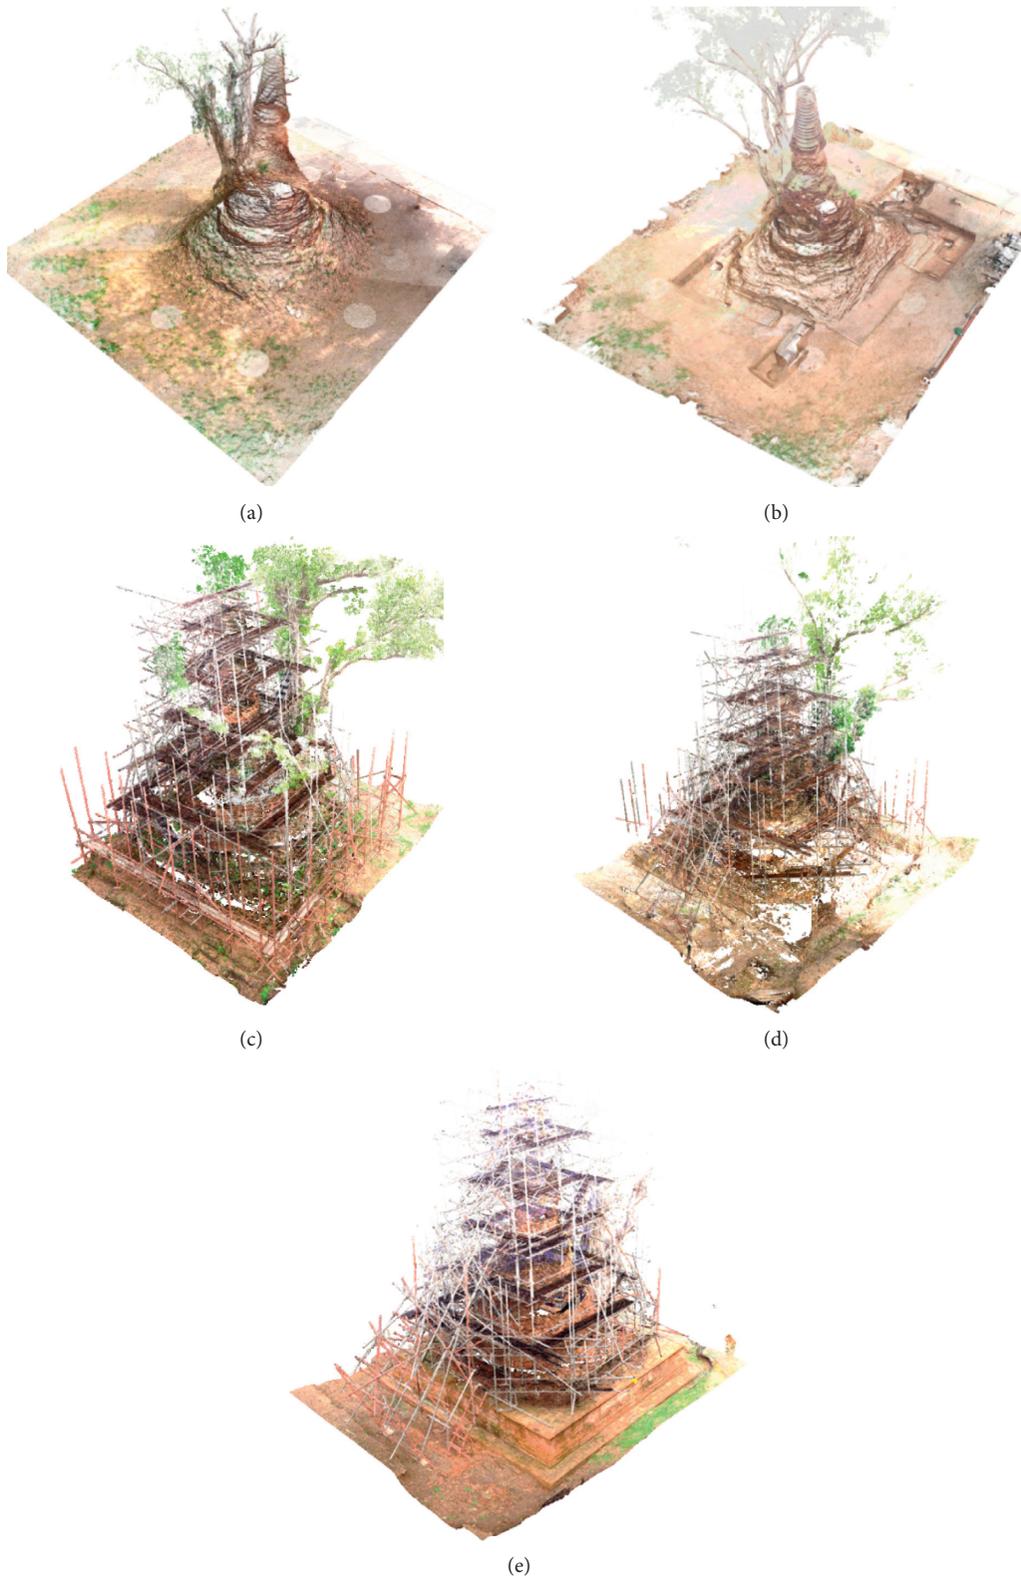
FIGURE 12: 3D point cloud models of the Wat Krachee from the five monitoring sessions. (a) February 12, 2018. (b) March 6, 2018. (c) July 19, 2018. (d) July 27, 2019. (e) August 5, 2020.

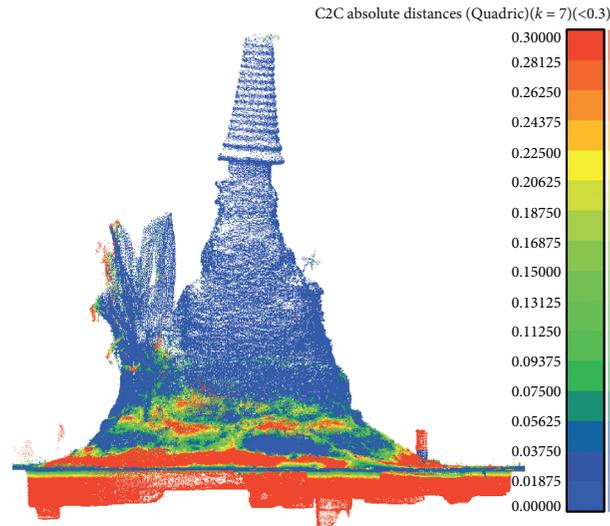
direction of the maximum inclination of the pagoda. The point cloud analysis of the Wat Krachee pagoda was investigated using tools in the Autodesk Revit software. The 3D point cloud models in the RCP file were inserted into the Autodesk Revit software. The point cloud dataset positioning was then selected using the origin-to-origin function so that the coordinate system was not changed. In this step, the pagoda dimensions and the change in the leaning angle for each monitoring session were assessed. Moreover, the effect of trimming the trees was investigated. A comparative analysis of the point cloud datasets was possible via CloudCompare software [7, 17]. The point cloud dataset for each monitoring session was compared with the first dataset before measuring the pagoda elements, as shown in Figure 13.

FIGURE 13: A comparative analysis between two datasets.

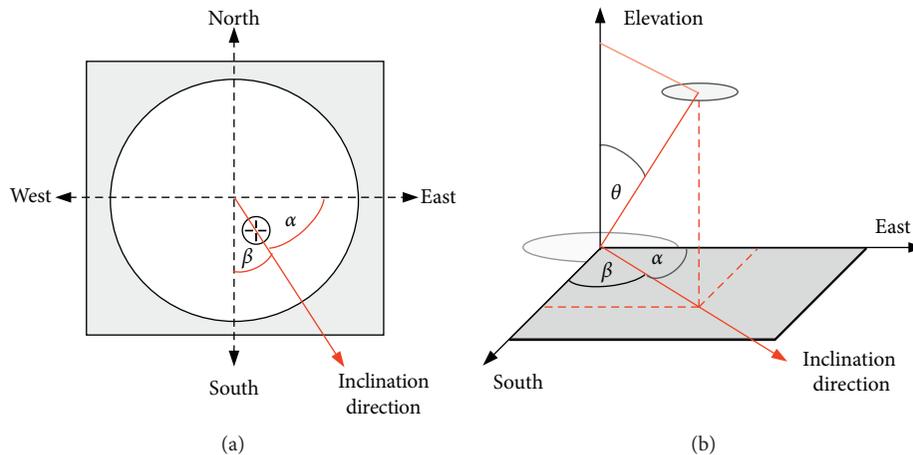
for ease of reference. Therefore, the beta ( $\beta$ ) angle was defined from the south axis and the alpha ( $\alpha$ ) angle was determined from the east axis as the inclination direction of

the pagoda, as shown in Figure 14(a). The pagoda leaning angle is defined as the zeta ( $\theta$ ) angle at the inclination direction plane, as shown in Figure 14(b).

FIGURE 14: Side elevation of the pagoda with the central axis and inclination direction. (a) Plan view. (b) 3D view.

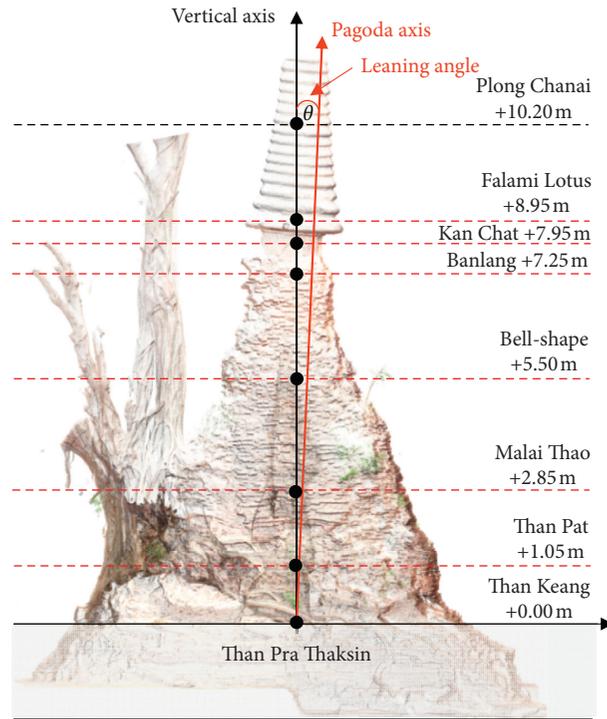
In the process of creating the geometry for the assessment of the pagoda, a level line for each component of the pagoda and a vertical axis were created, as shown in Figure 15. The Than Keang section of the pagoda was defined as a reference base for creating the vertical axis. The vertical line was generated based on the center of the Than Keang section. Afterward, a geometrical shape for each element of the pagoda was created using guidelines from the point cloud data. Then, the center of each geometric element was applied to find the pagoda inclination direction. The pagoda leaning angle could then be calculated by measuring the displacement differences between the center of each element's geometrical shape and the exact vertical line. This procedure will continue to be applied to assess the leaning angle for the long-term monitoring of the pagoda.

FIGURE 15: Section of the pagoda with the central axis and inclination direction.

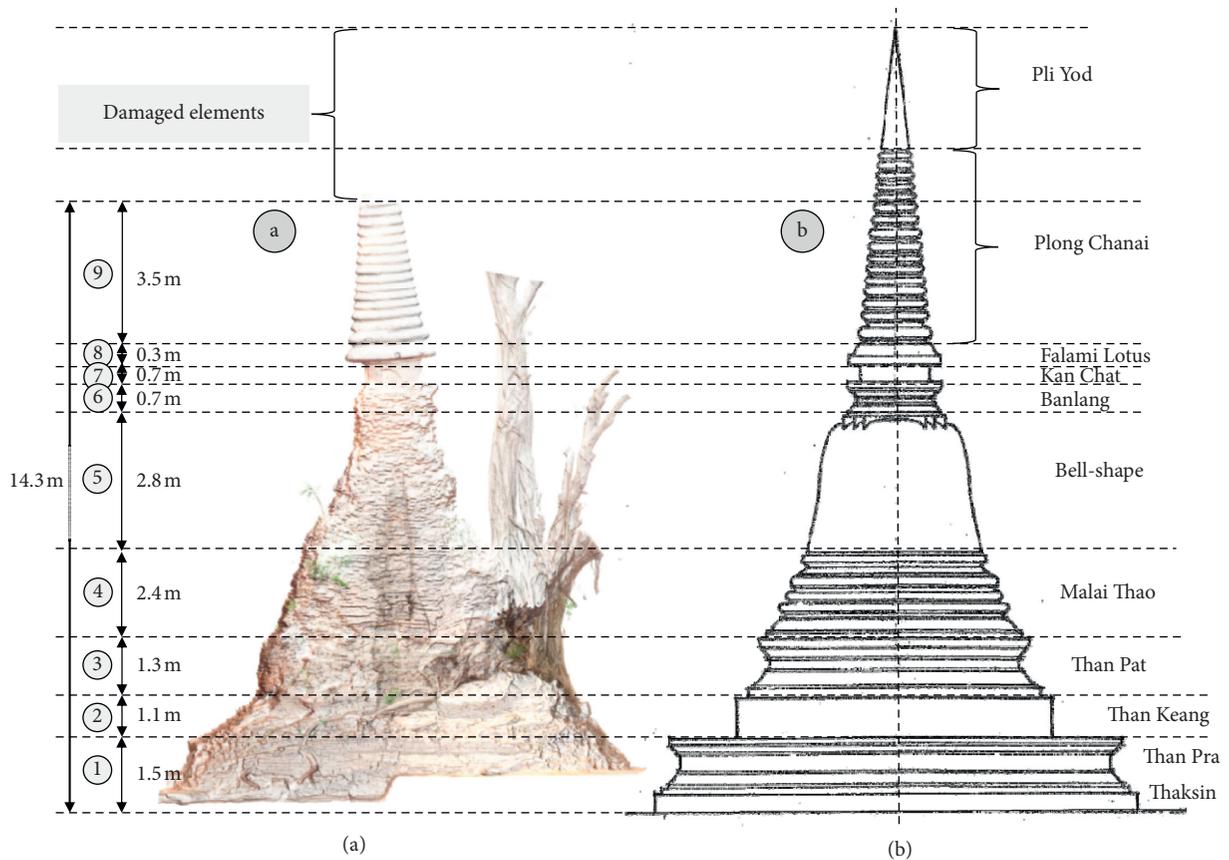
**4.1. Dimension Analysis.** The 3D point cloud models of the Wat Krachee pagoda for the first monitoring session are shown in Figure 16(a). According to a report by the Fine Arts Department [29], the assumption model for this temple pagoda is an inverted bell-shaped pagoda, which consists of the Than Pra Thaksin, Than Keang, Than Pat, Malai Thao, bell shape, Banlang, Kan Chat, Falami Lotus, Plong Chanai, and Pli Yod sections, as shown in Figure 16(b). A comparison between the bell-shaped pagoda elements based on the assumption model and the 3D point cloud models can be precisely matched for each pagoda element. It was observed

FIGURE 16: The comparison elements of the Wat Krachee pagoda. (a) 3D point cloud model. (b) Assumption model [29].

that the Pli Yod and some of the Plong Chanai sections were damaged compared to the assumption models. However, it was not clear when the damage occurred. Furthermore, the 3D point cloud models reported dimensions for each element based on the assumption model's pagoda elements.

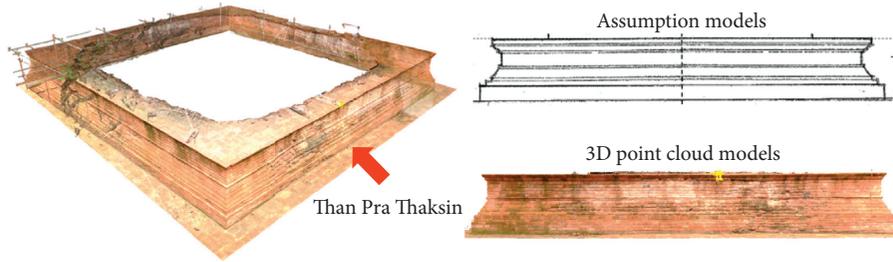
The dimensions of each element of the realistic bell-shaped pagoda can be measured in terms of height, base dimension, and geometrical shape, as presented in Table 3. These results reveal that the point cloud data are useful for the preservation of the pagoda to its original form. The obtained dimensions of each element of the pagoda were applied to the reconstruction phase. In 2020, the Than Pra Thaksin section of the pagoda was entirely reconstructed using assumption models as a square base, as shown in Figure 17, and the other elements are in the process of being renovated.

FIGURE 17: Addition of the Than Pra Thaksin section of the Wat Krachee pagoda.

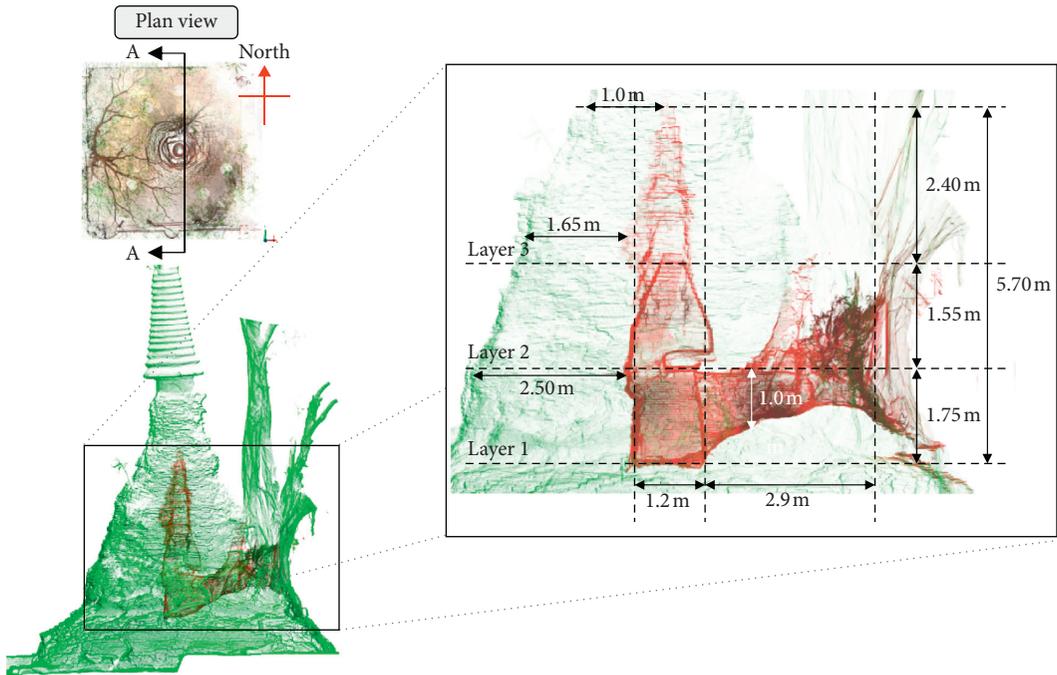
One of the essential elements of the pagoda is the complexity inside the chamber. After postprocessing, the 3D point cloud data were utilized to investigate the complicated shape of the chamber inside the pagoda. Figure 18 shows cross-section A–A in the west direction and the measured dimensions of the pagoda. The results revealed that the entrance of the chamber is adjacent to the trees, and the height of the cavity is an average of 1.0 m. The total length of the chamber from the access point to the last chamber has a horizontal distance of 4.1 m. The smallest thickness of the pagoda in the west direction is equal to 1.0 m in the upper part of the chamber. Figure 19 displays cross-section B–B in the south direction of the pagoda, representing the detailed measurement. The findings showed that the dimensions of the chamber in the first layer are  $1.2 \times 1.2$  m. There are three layers of the chamber inside the pagoda. The first layer has a height of 1.75 m, the second has a height of 1.55 m, and the third layer has a height of 2.4 m to the top layer of the chamber; thus, the total height of the chamber is 5.7 m. The smallest wall thickness is 0.5 m, located at 6.0 m above ground level. The horizontal and vertical lengths of the cavity opening were measured at 0.7 m and 1.2 m, respectively. This method collected the point cloud data inside and outside of the pagoda. Therefore, the thickness of the pagoda could be precisely assessed.

FIGURE 18: Section A-A in the west direction.

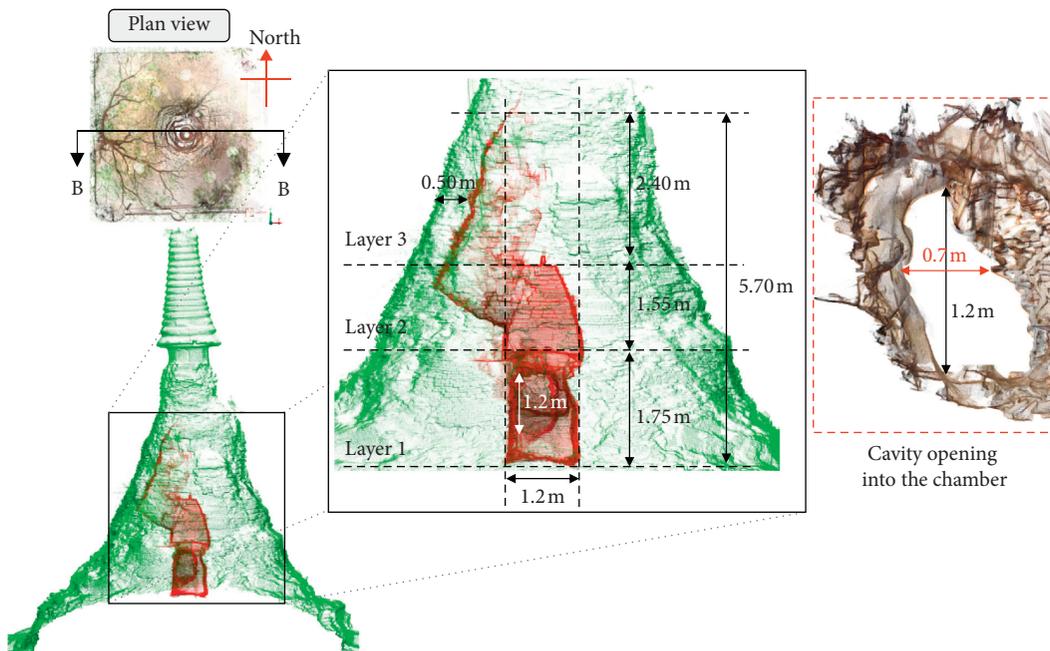
FIGURE 19: Section B-B in the south direction and a cavity opening into the chamber.

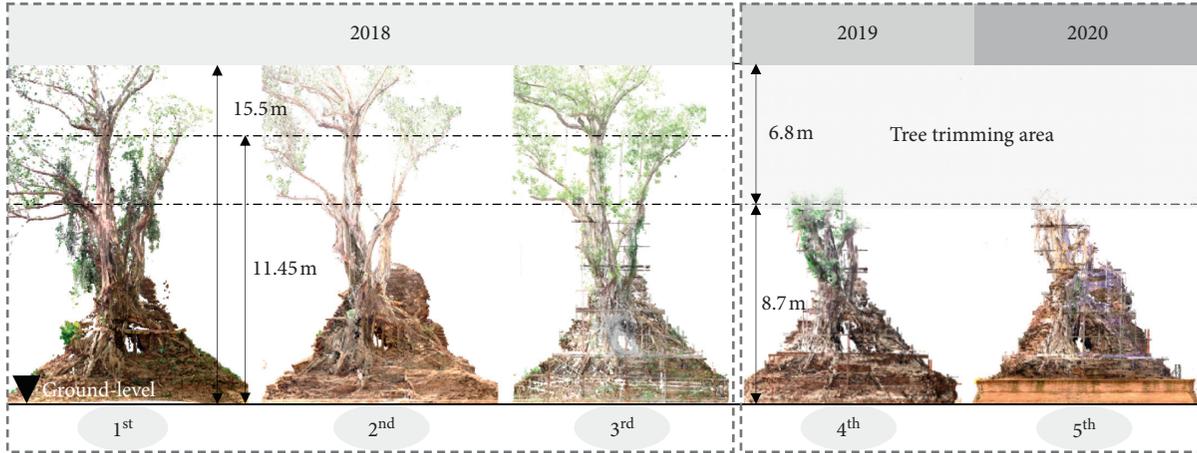
The highlight of the Wat Krachee pagoda is the two intertwined trees growing within it. The changes in the trees surrounding the pagoda at the time of each monitoring session are represented in Figure 20. In 2018, surveying and evaluation found that the height of the main tree trunk was approximately 11.45 m, and the total size of the tree was 15.5 m with respect to the ground level. During a multi-department meeting, it was agreed that the growth of the trees might affect the structural stability of the pagoda in the long term. Therefore, in 2019, arborists carried out tree trimming to slow down the growth. The height of the trimmed area was 6.8 m so that the main tree remained at the height of 8.7 m.

FIGURE 20: The changing of the trees surrounding the Wat Krachee.

Furthermore, a challenge of this project involved deciding whether to trim the trees or not. During a meeting, most of the individuals on the conservation project team agreed to recommend trimming the trees adjacent to the Wat Krachee pagoda. The results revealed that the tree trimming significantly decreased the leaning angle of the pagoda. For long-term monitoring, an equation was developed to predict the pagoda leaning angle for preservation and restoration planning. In addition, data from the terrestrial laser scanner were used to create a realistic drawing of the plan before the reconstruction phase. In 2020, this method was found to be beneficial to the conservation work of the pagoda, and the teams completely and successfully restored the pagoda's Than Pra Thaksin elements. Finally, the original forms of several Thai pagodas need to be preserved, and monitoring using a terrestrial laser scanner would be an efficient alternative method for this preservation work.

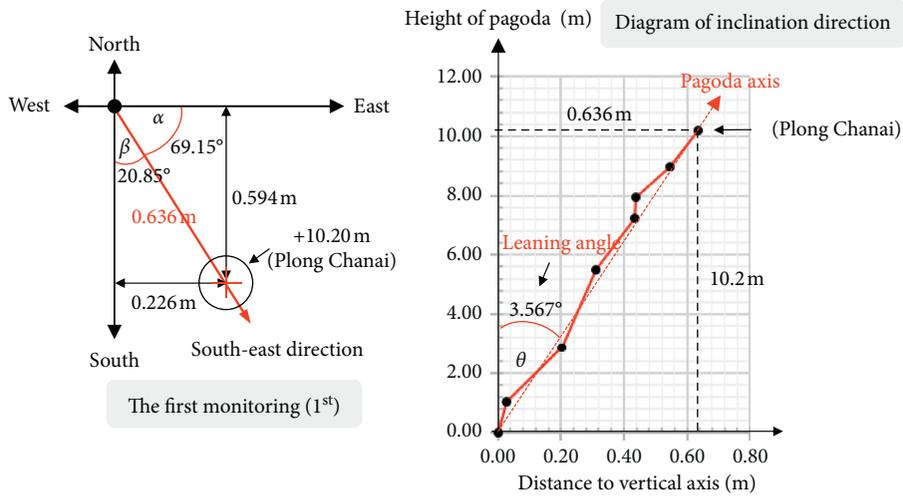
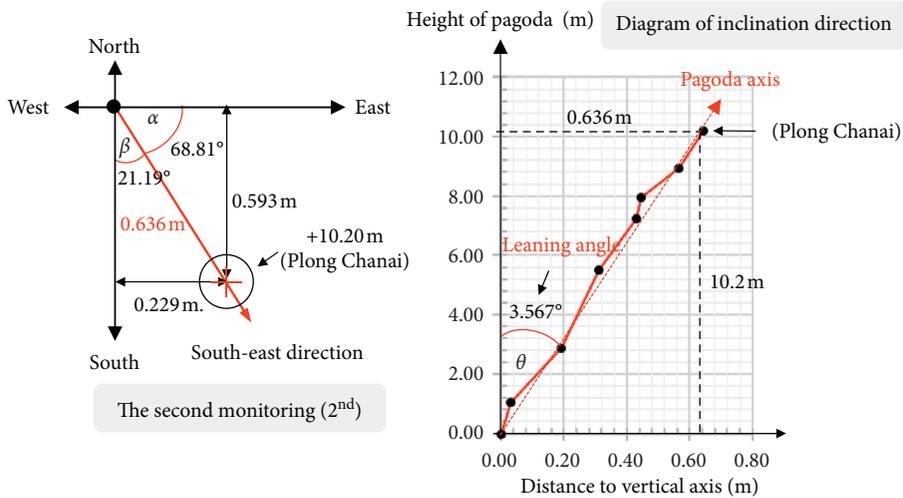
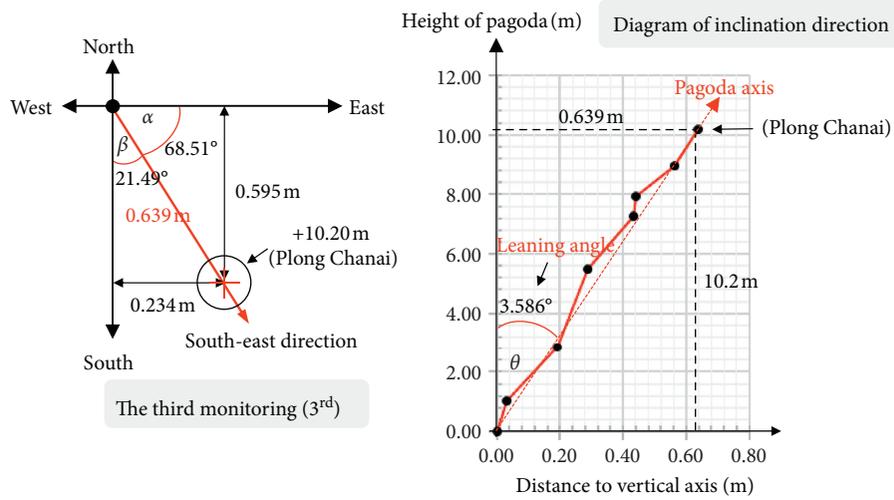
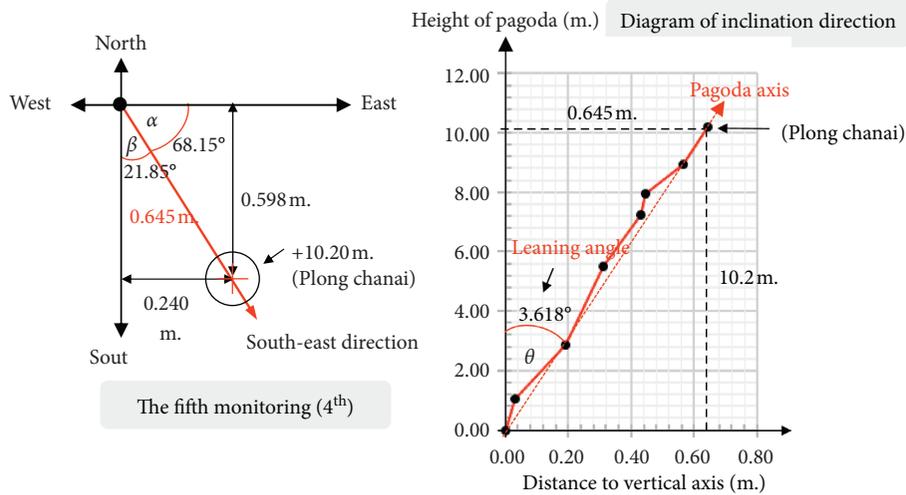
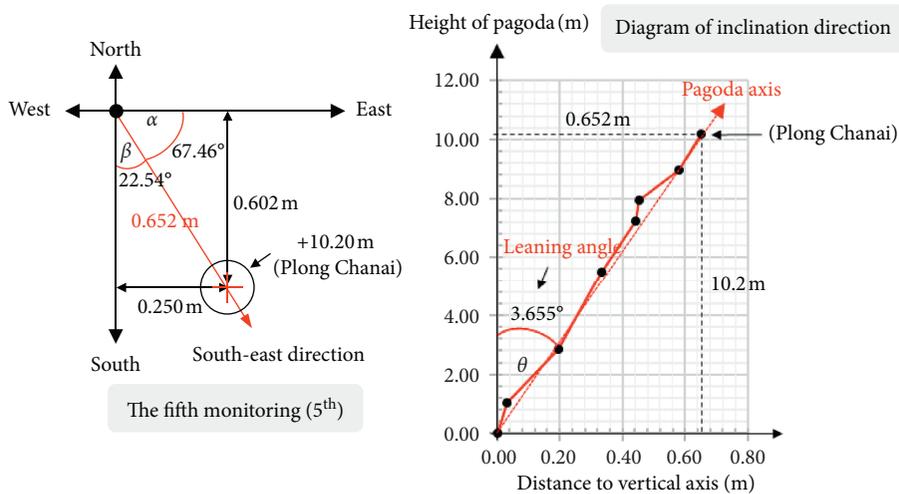
monitoring session revealed that the pagoda had leaned toward the southeast direction, in which the beta and alpha angles were 20.85 and 69.15 degrees, respectively. This inclination direction was applied to assess the distance from the vertical axis to the center of each element of the pagoda, as shown in Figure 21. The first monitoring session calculated that the maximum leaning angle of the pagoda was equal to 3.567 degrees. The second monitoring session of the pagoda found that the leaning angle had not changed significantly because the monitoring took place shortly after the first period, as represented in Figure 22. Four months later, the inclination direction and the horizontal displacement were determined, as displayed in Figure 23. From this monitoring, it was found that the leaning angle of the pagoda had increased by 0.019 degrees. Therefore, the leaning angle of the pagoda during the third monitoring session was equal to 3.586 degrees. Moreover, it was found that the beta angle had increased in the east direction when compared to the first monitoring. One year and six months after the first session, the assessment inclination direction and the leaning angle were determined, as shown in Figure 24. The results revealed that the leaning angle of the pagoda had become 3.618 degrees or an increase of 0.051 degrees from the first measurement. The beta angle continuously increased to 21.85 degrees. The results from the fifth monitoring session of the pagoda, two years and six months after the first one, are shown in Figure 25. The maximum distance of the vertical axis of 0.652 m was obtained on the Plong Chanai section of the pagoda, and the leaning angle was 3.655 degrees.

FIGURE 21: First monitoring session (February 2018).

FIGURE 22: Second monitoring session (March 2018).

FIGURE 23: Third monitoring session (July 2018).

FIGURE 24: Fourth monitoring session (July 2019).

FIGURE 25: Fifth monitoring session (August 2020).

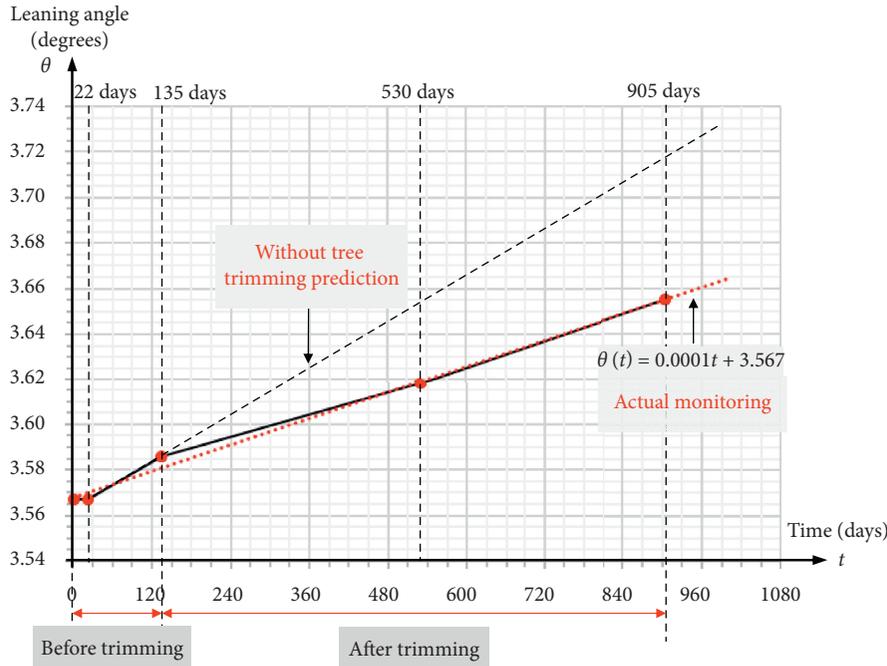
Furthermore, the assessment of the leaning angle for each monitoring session can generate the relationship between time and the leaning angle of the Wat Krachee pagoda, as shown in Figure 26. The results show that the leaning angle might have increased significantly if the recommendation to trim the trees had been ignored. Considering the actual monitoring, the results also indicate that time influences the leaning angle of the pagoda. However, a regression analysis was applied using the least-squares fit method with a linear trend line, as presented in equation (1). The result revealed that the slope ( $d\theta/dt$ ) and the coefficient of determination ( $R^2$ ) of this equation are 0.0001 and 0.99, respectively.

FIGURE 26: The relationship between time and the leaning angle of the Wat Krachee pagoda.

$$\theta(t) = 0.0001t + 3.567, \quad (1)$$

where  $\theta$  is the leaning angle of the pagoda in degrees and  $t$  is the time in days. Equation (1) was used to forecast the leaning angle of the pagoda with the initial leaning angle equal to 3.567 degrees, as measured in 2018. This equation can also predict the increase in the leaning angle for the structural stability assessment of the pagoda and restoration planning in the future. Moreover, the rate of increase in the leaning angle of the pagoda can be predicted using equation (2).
