Research Article

Geomechanical Model Experiment Study on Deformation and Failure Mechanism of the Mountain Tunnel in Layered Jointed Rock Mass

The Minxian tunnel is a key engineering of the Weiyuan-Wudu expressway that is excavated in layered jointed carbonaceous slate rock mass. During the construction process, the surrounding rocks of the tunnel encountered serious large deformations and failure, which brought about great difficulties to the safety and cost of the tunnel. In order to study the deformation and failure mechanism of the surrounding rocks, a physical model test was conducted, and integrated methods including strain gauges, a digital camera, and noncontact full-field digital imaging correlation technique were used to record the response information of the surrounding rocks. The evolution process of surrounding rocks failure was simulated successfully in the model test, and the deformation characteristics were basically consistent with the actual engineering. The modelling results show that concentrated stresses in the surrounding rocks were very uneven due to developed stratified and jointed rock mass structure. The maximum and minimum concentrated stresses appeared

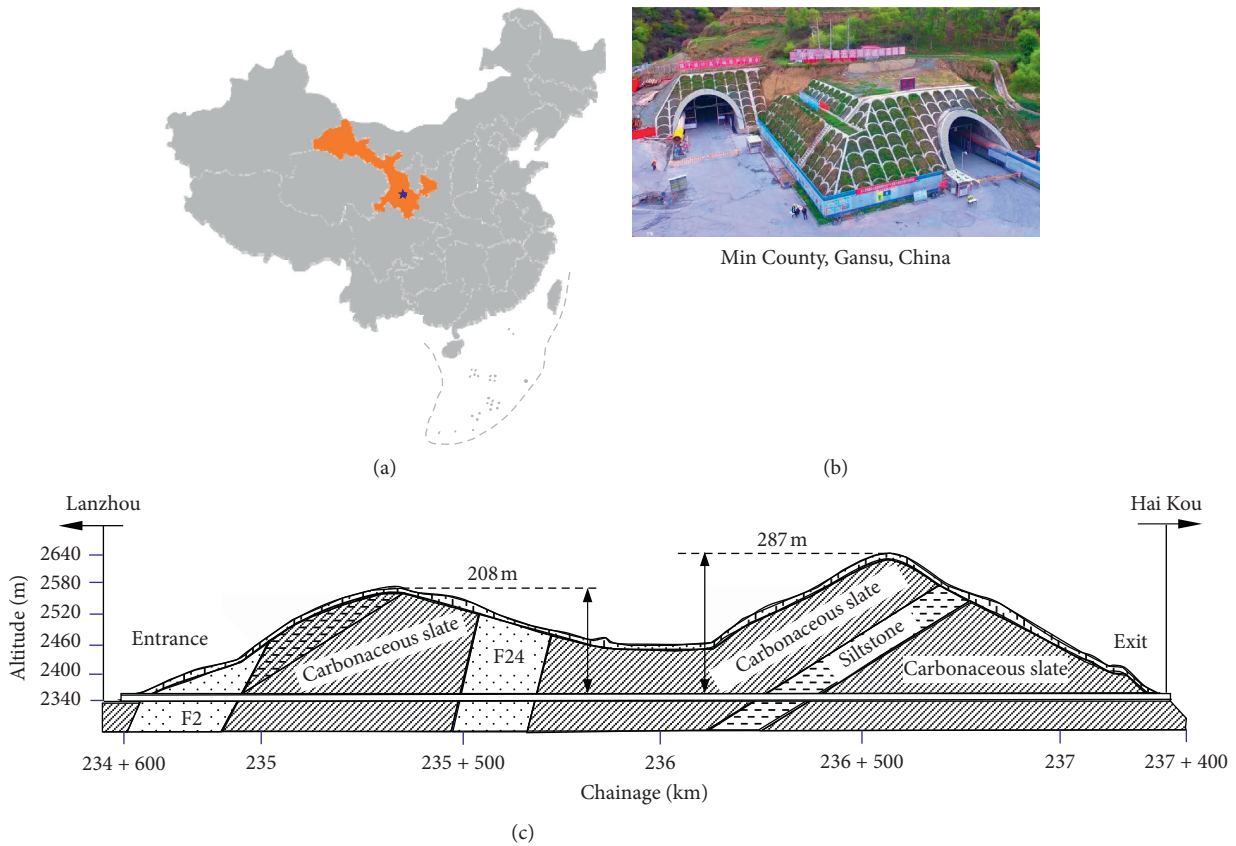
FIGURE 1: Profile of the Minxian tunnel.

2.1. Geological Conditions. The Minxian tunnel is located in Min county of Dingxi city in Gansu province, China (Figure 1(a)), and it is a dominant engineering of the Weiyuan-Wudu section of Lanzhou-Haikou expressway (G75). The tunnel is a twin-mountain tunnel with the length of 2800 m, and the minimum distance between left and right tunnels is 28 m appearing at the entrance and exit (Figure 1(b)). The maximum buried depth of the tunnel is 287 m (Figure 1(c)). The shape of cross section is horseshoe, and its area is about 110 m^2 . The three-bench tunnelling method with 4.8 m in length along longitudinal direction was adopted as the layout of the tunnel face. The surrounding rocks of the tunnel are mainly black, mud-altered residual texture and strongly or medium weathered carbonaceous slate and scattered intercalated siltstone (Figure 1(c)). Due to intense folding and complex tectonic motions in this area, the surrounding rocks are strongly or medium weathered and the foliations and joints of carbonaceous slate are very developed. According to the Standard for Engineering Classification of Rock Mass, the surrounding rocks of the tunnel are classified in grades V, the worst rock mass quality.

There are two large reverse faults (F2 and F24) filled with breccia, fault gouge, and crushed rock along the tunnelling direction (Figure 1(c)). The occurrence of F2 is $\text{NE}47^\circ\angle 60^\circ$, and the width of fracture zone is about 360 m; F24 is

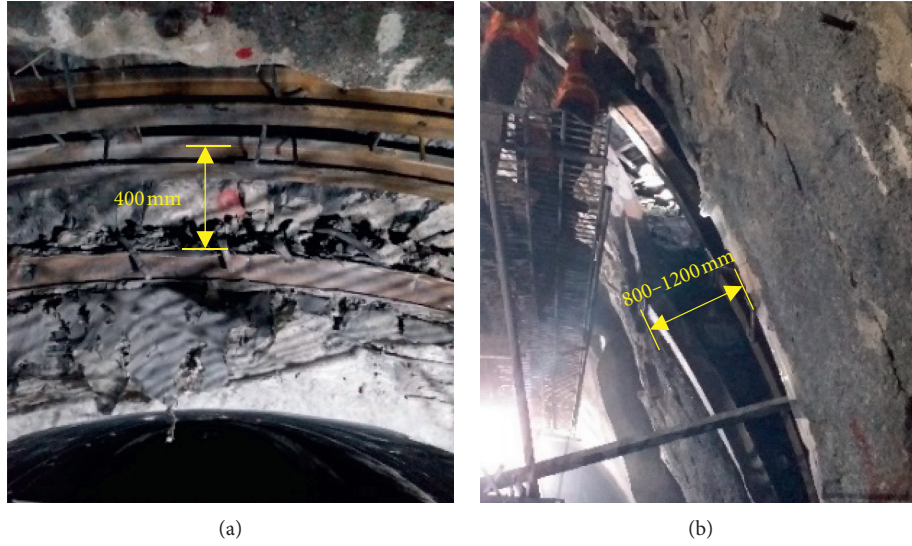
FIGURE 2: Large deformations of surrounding rocks.

rocks. However, with the increase of the buried depth, the deformations increased greatly and continuously. For example, when the heading face of right tunnel approached the drainage divide (mileage: 235 + 478 ~ 235 + 482 km), the maximum deformation of surrounding rock appeared at waist and the cumulative value reached 300 mm during seven days. With the deformation increasing, the sprayed concrete began to crack and steel frames deformed gradually. Two months later, the maximum crown settlement and deformation of sidewall reached 400 mm and 1200 mm, respectively (Figure 2). Then, the failed primary supports had to be removed and replaced.

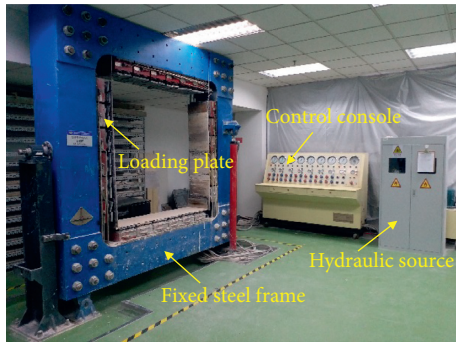
FIGURE 3: Physical model testing device.

3.1. Testing Machine. The biaxial loading geomechanical simulation apparatus (Figure 3), developed by State Key Laboratory for Geo-Mechanics and Deep Underground Engineering, consists of the frame system, the loading system, the pressure stabilizing system, and the control console. The sizes of testing machine (length × height × width) are 1600 mm × 1600 mm × 400 mm. The machine can be loaded from top, left, and right directions independently through eighteen hydraulic plates, and the maximum load of each plate is 5 MPa. The load stabilization is achieved through an intelligent hydraulic system, and the maintenance time can reach 300 hours.

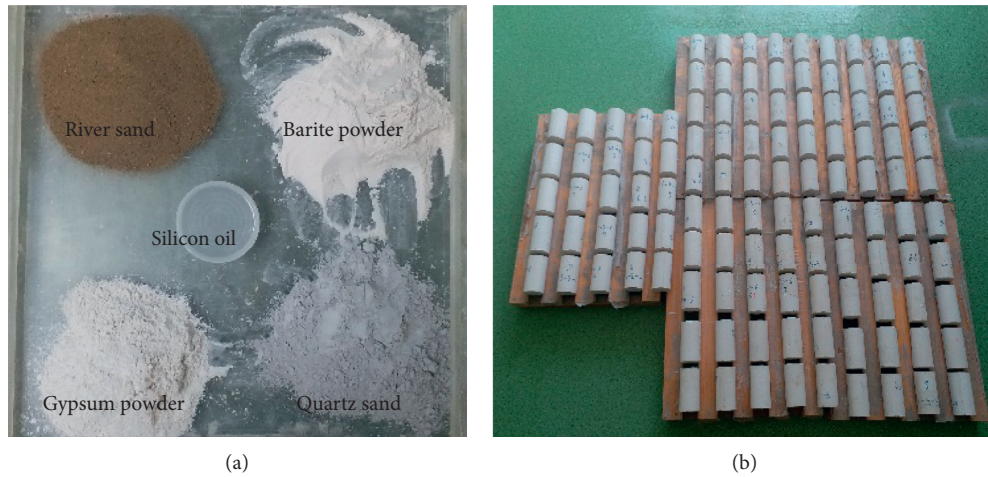
FIGURE 4: Similar materials. (a) Components of similar materials and (b) standard specimens of different proportions.

In order to obtain proper ratios of several materials, a number of standard specimens with different proportions were prepared (Figure 4(b)). Then, uniaxial compression, triaxial compression, and Brazilian tests were conducted in laboratory to measure their mechanical parameters. Finally, the applicable mass ratio was barite powder/river sand/quartz powder/gypsum powder/water/silicon oil = 1.00/0.28/0.20/0.52/0.48/0.04. The comparison of various parameters between target and actual similar materials was shown in Table 1, and general good agreements could be found.

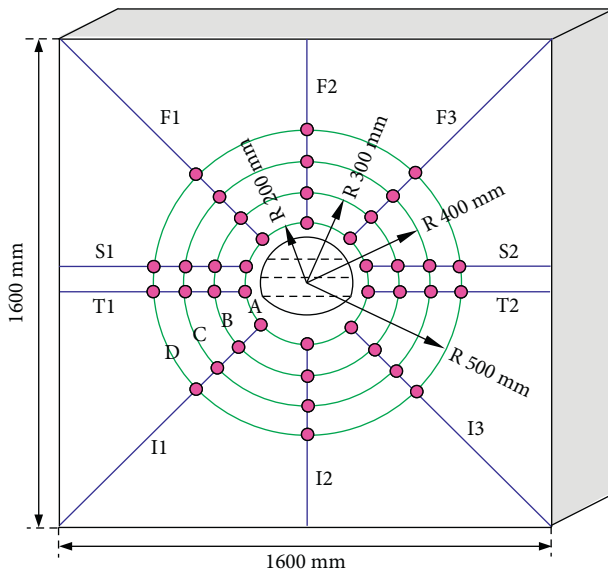
FIGURE 6: Layout of monitoring section ($y = 5$ cm) and points.

There were ten monitoring lines along the radial direction of the tunnel. Among them, three lines were set up, respectively, for the first bench and the inverted arc numbered as F1, F2, F3, I1, I2, and I3. F1 and I1 were located at 45 degrees to the left of the tunnel, and F3 and I3 were symmetrical with them about the center line of the tunnel. Two lines were set up, respectively, for the second and third benches marked as S1, S2, T1, and T2. Then, four monitoring rings labeled as A, B, C, and D were set up along the circumferential direction of the tunnel (Figure 6). Their radii were 200 mm, 300 mm, 400 mm, and 500 mm, respectively, corresponding to 2 m, 6 m, 10 m, and 14 m, respectively, from the tunnel free surface in real engineering. The intersection points of ten radial monitoring lines and four circumferential rings were determined as strain monitoring positions. For example, F2-B represented the monitoring point located at the position that was 45 degrees to the left of the tunnel and 300 mm from the tunnel surface. Finally,

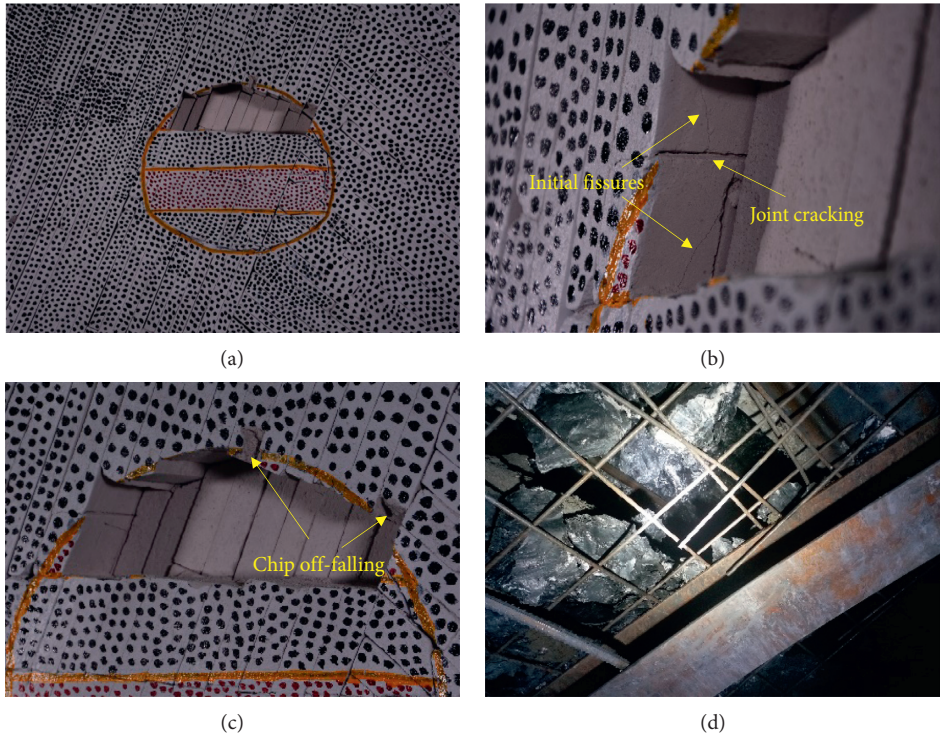
FIGURE 8: First excavation stage (E1 and E2) and deformations of surrounding rocks.

4.1.1. First Stage. After the completion of steps E1 and E2 (Figure 8(a)), the initial stress carried by the rock mass in the first bench transferred to the surrounding rocks, and the stress concentration occurred. Initial fissures and weak joints cracked under tensile stresses caused by bending deformation (Figure 8(b)). There was the phenomenon of chip off-falling at the vault and right shoulder due to the coalescence of local fissures (Figure 8(c)). Figure 8(d) shows chip off-falling of the surrounding rocks on the right shoulder in the tunnel field.

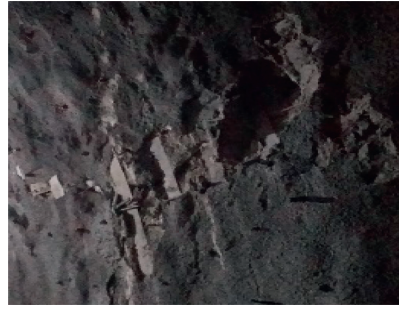
FIGURE 9: Second excavation stage (E3 and E4) and deformations of surrounding rocks.

4.1.2. Second Stage. In steps E3 and E4 (Figure 9(a)), the first and the second benches were both excavated. The area of exposed rock slab on left side of the tunnel increased, and its antibend performance declined. The thin rock layer on left side of the tunnel was similar to thin plate, and several rock layers were bent under concentrated stresses, which resulted in discontinuous deformation and separation due to different deformation stiffness between different rock strata (Figure 9(b)). The contact surface between the third bench and the bottom rock mass also cracked under horizontal compression stress due to the disappearance of limit caused by the overlying rock mass, which resulted in the slight floor heave (Figure 9(c)). Moreover, the effects of excavation unloading and stress redistribution were also significant. Local sidewall spalling and large-area cracking occurred on left side of the tunnel due to cracks expanding and coalescence under high concentrated stress (Figure 9(d)). Figure 9(e) shows large area damage on left side surface of the surrounding rocks in the tunnel field.

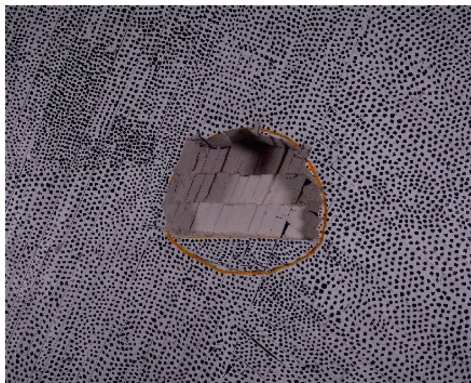
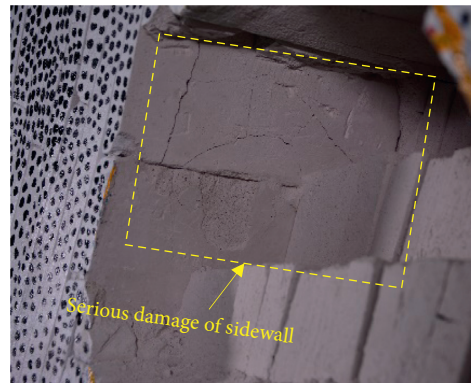
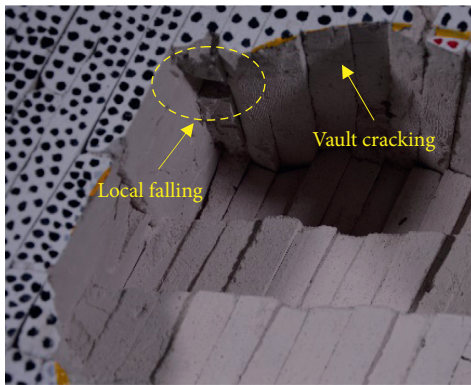
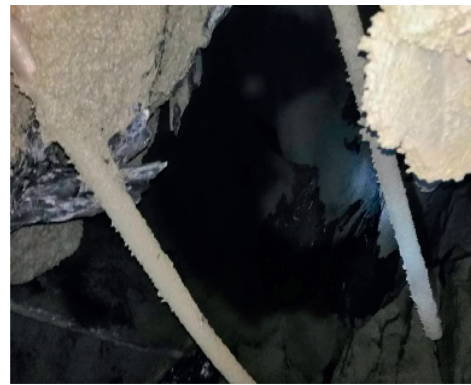
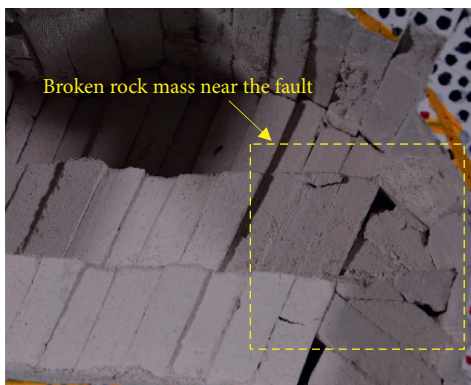
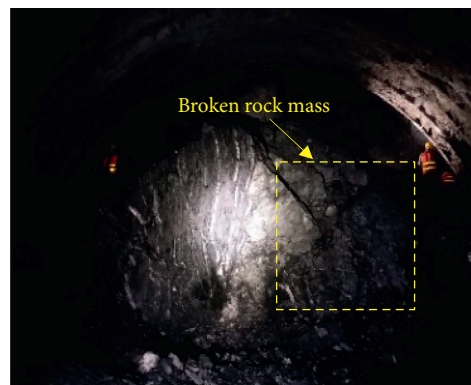
FIGURE 10: Third excavation stage (E5 and E6) and deformations of surrounding rocks.

4.1.3. Third Stage. During this stage (E5 and E6), the full cross section of the tunnel above the ground would be formed (Figure 10(a)). There was serious damage on left side of the tunnel such as a wide range of wall spalling and cracking (Figure 10(b)). The broken rock lump fell from left shoulder of the tunnel (Figure 10(c)). The rock mass near the fault was broken due to the mutual squeezing of angular unconformable rock strata (Figure 10(e)). Figure 10(d) and Figure 10(f) show the local collapse of surrounding rocks on left shoulder and broken rock mass near the fault in the tunnel field, respectively.

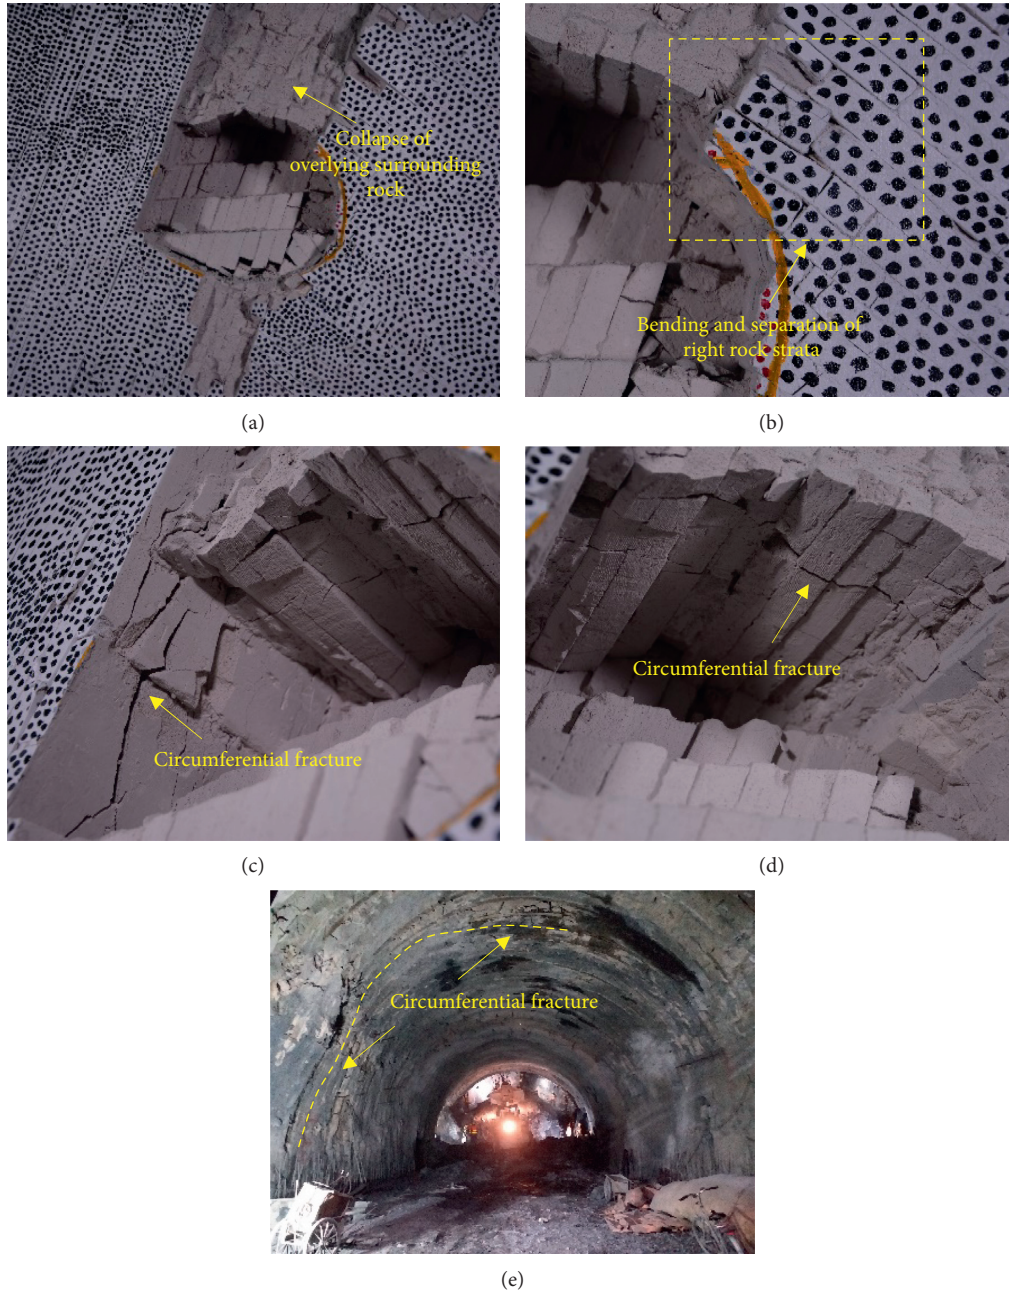
FIGURE 11: Excavation step E7 and deformations of surrounding rocks.

4.1.4. Fourth Stage. In step E7 of the fourth stage (Figure 11(a)), the full cross section of the tunnel was excavated, which included the first, second, and third benches and the inverted arc area, in which the maximum exposed area of the free surface was reached and the effect of stress redistribution was most significant. The exposed thin rock slabs on both sides of the tunnel were severely bent (Figure 11(b)). All free surfaces (left, top, and right) of the tunnel were seriously damaged, and there were several obvious circumferential fractures (Figures 11(c) and 11(d)). Figure 11(e) shows the actual large-scale circumferential fractures in the tunnel field. The overlying strata caved suddenly along the fault and foliation after some unstable rock blocks at the top of the tunnel dropping down (Figure 11(a)). It means that the tunnel failed totally in this step.

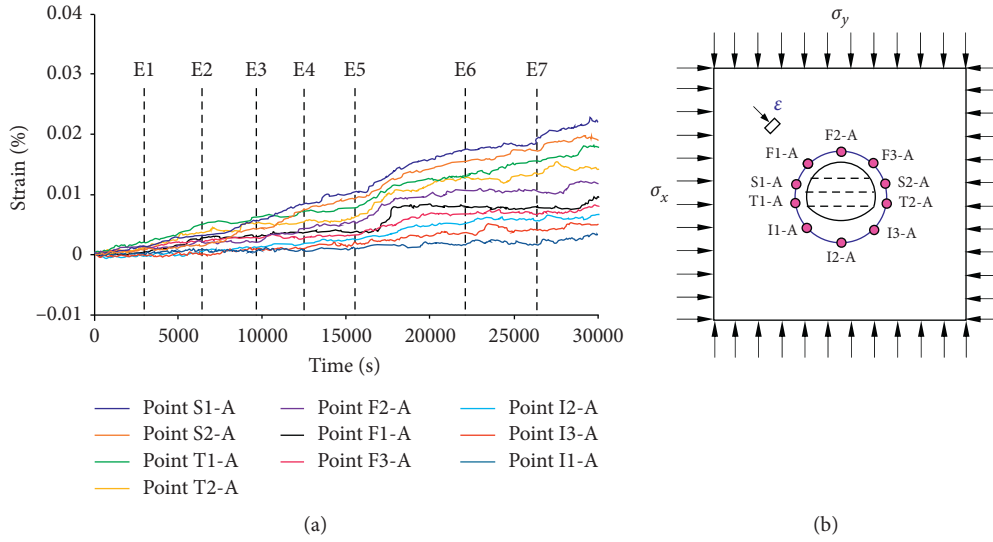
FIGURE 12: Evolution of surrounding rocks strains around the tunnel: (a) the curves of radial strain versus time and (b) taking the monitoring circle A around the tunnel as an example.

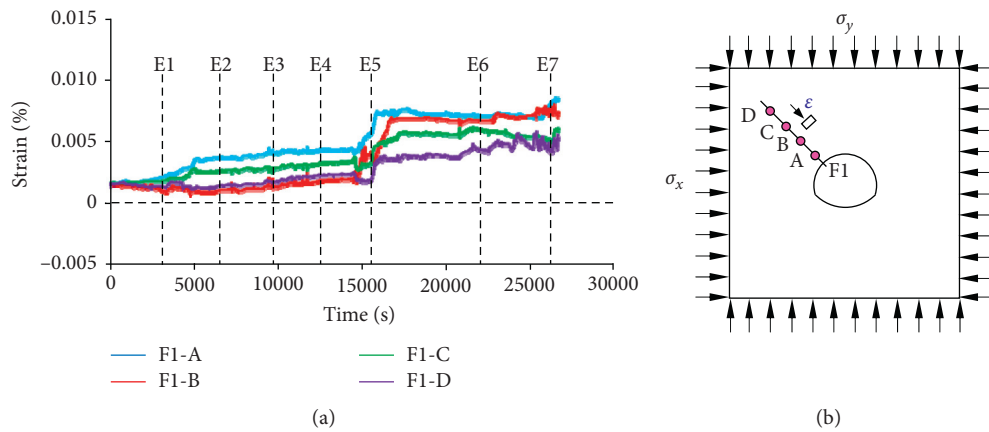
FIGURE 13: Evolution of surrounding rocks strains in different depths: (a) the curves of radial strain versus time and (b) taking the monitoring line F1 at left shoulder of the tunnel as an example.

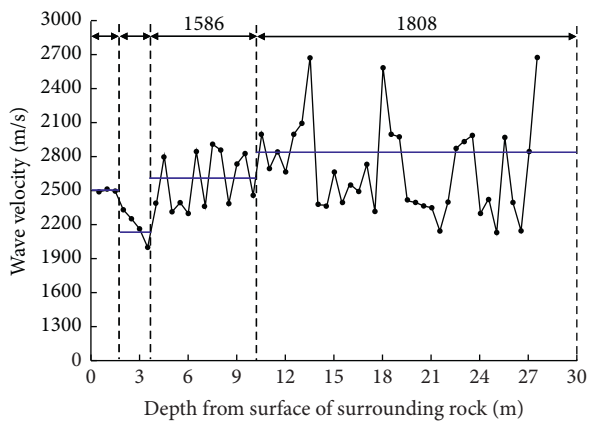
FIGURE 14: In situ measured result of acoustic wave testing at YK235 + 280 in the right tunnel.

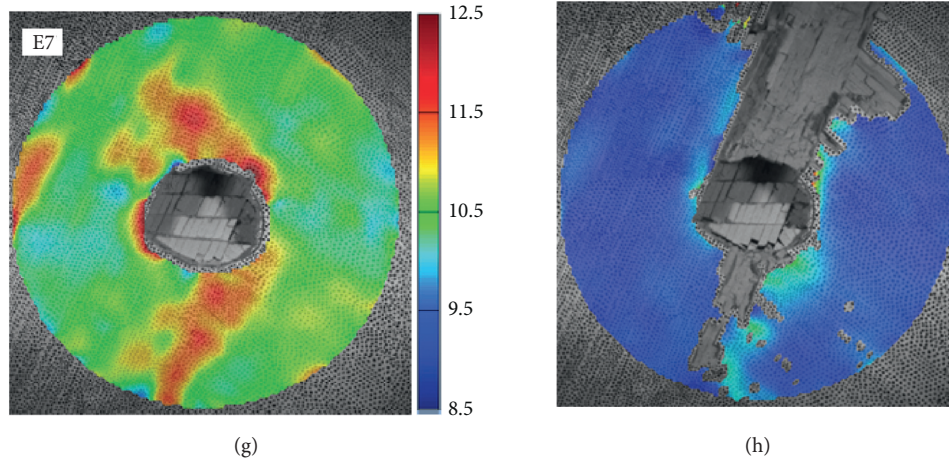
FIGURE 17: Evolution of displacement field around the tunnel by the DIC method (unit: mm).
