Research Article

Study on the Loess Immersion Test of Metro Line 2 in Xi'an, Shaanxi Province, China

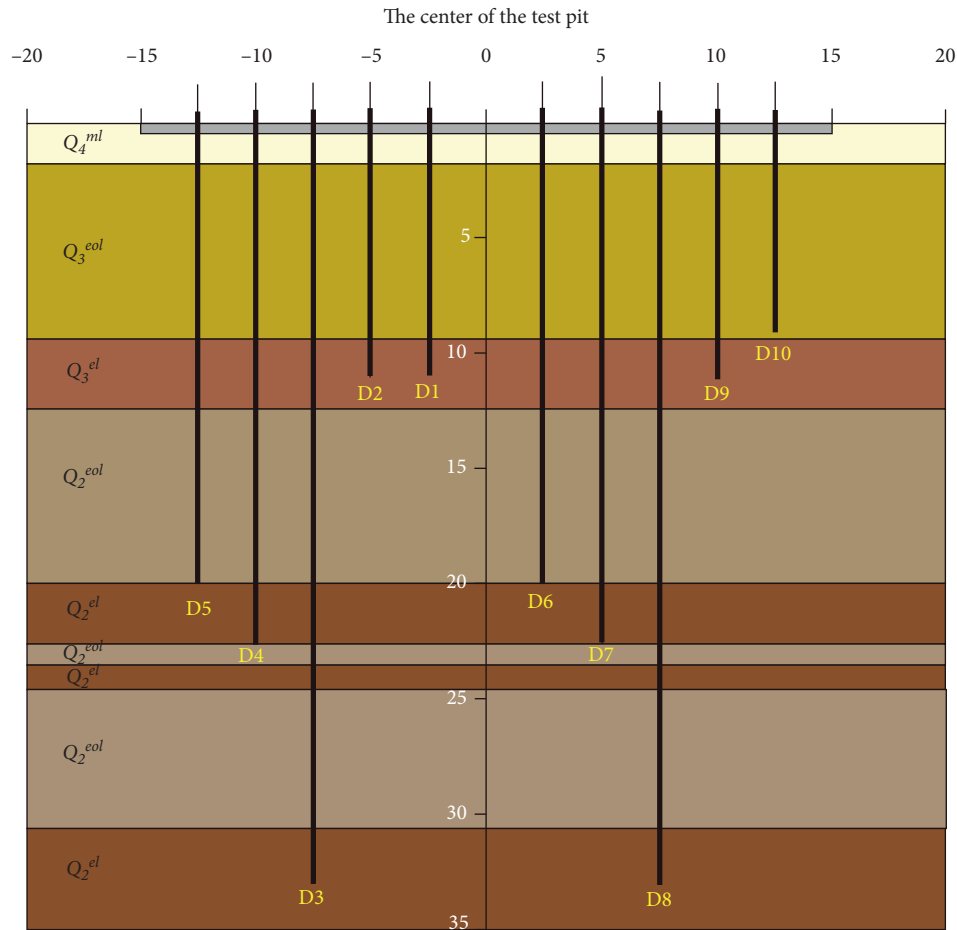
FIGURE 2: Geological profile of the test site (survey lines IV and V).

2.2. Soil Layers. The southern extension of Metro Line 2 of Xi'an crosses the primary and secondary terraces of the river and the Shenhe loess plateau, and collapsible loess is mainly found in the area from No. 3 waterworks Plant in Xi'an Chang'an District to Shenhe loess plateau. The soil layers of the site from top to bottom are as follows (Figure 2). The top soil layer is 4 m thick plain fill (Q_4^{ml}), which is yellow-brown, loose, highly compressible soil, and mainly treated loess soil, with a small amount of tile locally. And the upper part has about 0.30 m of asphalt concrete pavement. The next soil layer is 3.3–8.6 m thick wind-deposited new loess (Q_3^{eol}), which is yellow-brown, microporous, containing small amounts of snail fragments and calcareous mycelium, and continuously distributed on the surface of loess plateau. Furthermore, this soil layer is collapsible and hard to hard plastic above the water table. The third soil layer is 3–7.9 m thick eluvial paleosol (Q_3^{el}), which is reddish brown, dominated by clay particles, and containing a large number of calcareous mycelium and nodules, with developed macropores. And this soil layer has slight collapsibility with a continuous distribution in the loess zone. The fourth soil layer is 0.6–8.9 m thick aeolian old loess (Q_2^{eol}), which is yellowish brown, with needle-like pores, containing small number of calcareous nodules and scattered snail shells, and in a predominantly hard plastic state, locally plastic. The layer is continuously distributed in this region and is interlayered with the eluvial paleosol layer. The last layer is 0.6–4.2 m thick eluvial paleosol (Q_2^{el}), which is brown-red, with needle-like pores, agglomerate structure, locally nodule-rich, and mainly in a plastic state. This layer is continuously distributed in this region and interlayered with aeolian old loess.

The thickness of the collapsibility loess of the test site is 14.4 m, and the stratigraphic characteristics of the test site were consistent with the stratigraphy of the Shenhe loess plateau (collapsibility loess area), where the Metro Line 2 passes through. Therefore, the stratigraphic characteristics of the loess immersion test site are representative of the stratigraphy of the Metro Line 2's collapsibility loess area.

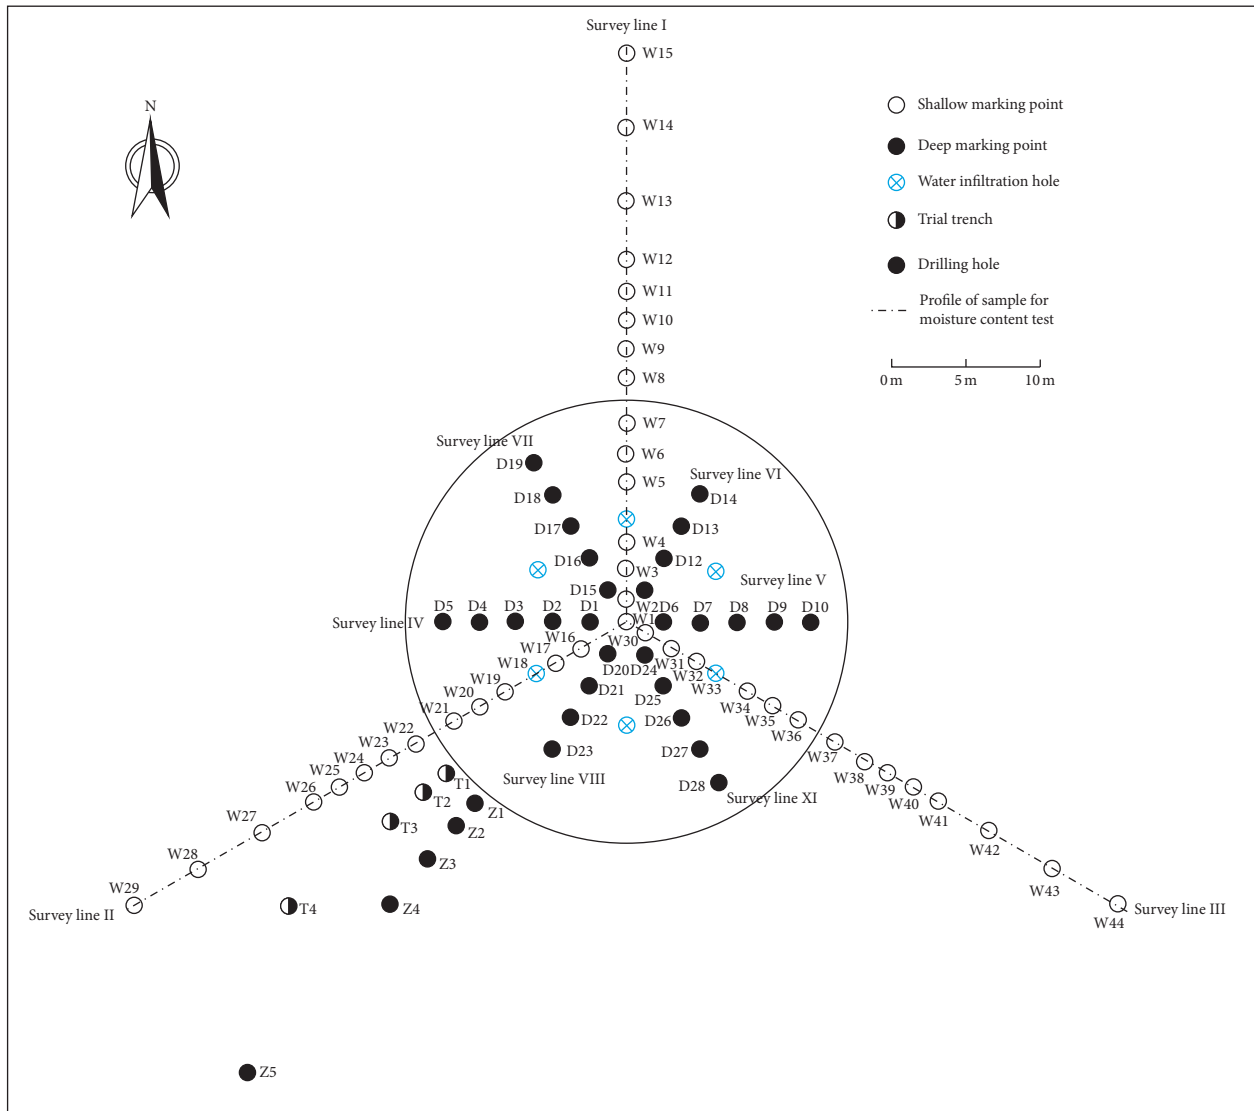
FIGURE 3: The layout of water immersion test.

Take the center of the test pit as the origin and arrange three survey lines radially in three directions to the edge of the pit, and the angle of the three lines is 120° (Table 1). Each survey line arranged 7 shallow markers inside the test pit, 8 shallow markers outside the pit, and 1 in the center of the test pit (Figure 3). The shallow marker was made of galvanized steel pipe and 25 mm in diameter. The markers inside the test pit were 2.5 m in length, those outside the test pit were 2.0 m in length, and the round steel plate is 15 cm in diameter and 0.3 cm thick at the base (Figure 4). The shallow pit at the base of the shallow markers was excavated by hand to a depth of 50 cm, with the surface layer of floating soil and cultivated soil removed, and tamped by light tapping.

Take the center of the test pit as the origin, and set survey lines I, II and III of the shallow marker on both sides at an angle of 30° as deep marker survey lines. There were six survey lines in total (Figure 3), and each survey line was 15 m

in length (Table 1). A total of 28 deep markers were laid out in the 6 survey lines, and there were 5 deep markers for survey lines IV, V, VII and IX, while 4 deep markers for survey lines VI and VIII. There were 3 groups of 6 deep markers in the new loess layer, with depths of 4.0 m, 6.5 m, and 9.4 m, and 2 deep markers in each depth (the same below). And there was 1 group of 2 deep markers in the paleosol layer, with a depth of 12.4 m, and 4 groups of 8 deep markers in the old loess layer, with depths of 14.0 m, 16.0 m, 18.0 m, and 20.0 m, respectively. Then, there were 6 groups of 6 deep markers in the interbedding layers of paleosol layer and old loess layer, with depths of 22.5 m, 23.5 m, 24.5 m, 28.0 m, 30.5 m, and 33.0 m. The deep marker (Figure 4) consisted of several mechanically connected galvanized pipes and a 60 mm diameter iron base plate welded vertically. And the location of the subbase reflects the subsidence of the soil beneath it. There is a fixed steel ruler on the exposed part of the pole for subsidence observation. The minimum scale of the steel ruler was 1.0 mm, and a PVC pipe was set outside of the marker to ensure that the subsidence plate can settle freely without the influence of soil friction, and the PVC pipe is exposed to the ground about 1 m, and the gap between the external PVC pipe and the

There were 4 exploratory wells (T1-T4) in the test pit to install moisture sensor, and the exploratory wells were 16 m, 18 m, 21 m, and 25 m away from the pit center (Figure 3). 19 soil moisture sensors (Figure 4) were installed in the exploratory wells (Table 2). The exploratory wells were excavated in advance, and the soil moisture sensors were buried in the side walls of the exploratory wells at a predetermined depth, and after the sensors worked normally, the exploratory wells were backfilled and tamped by layering. The moisture sensor is connected to the current acquisition card and transmits the signal wirelessly via data transfer unit (DTU) for real-time wireless transmission of moisture data.

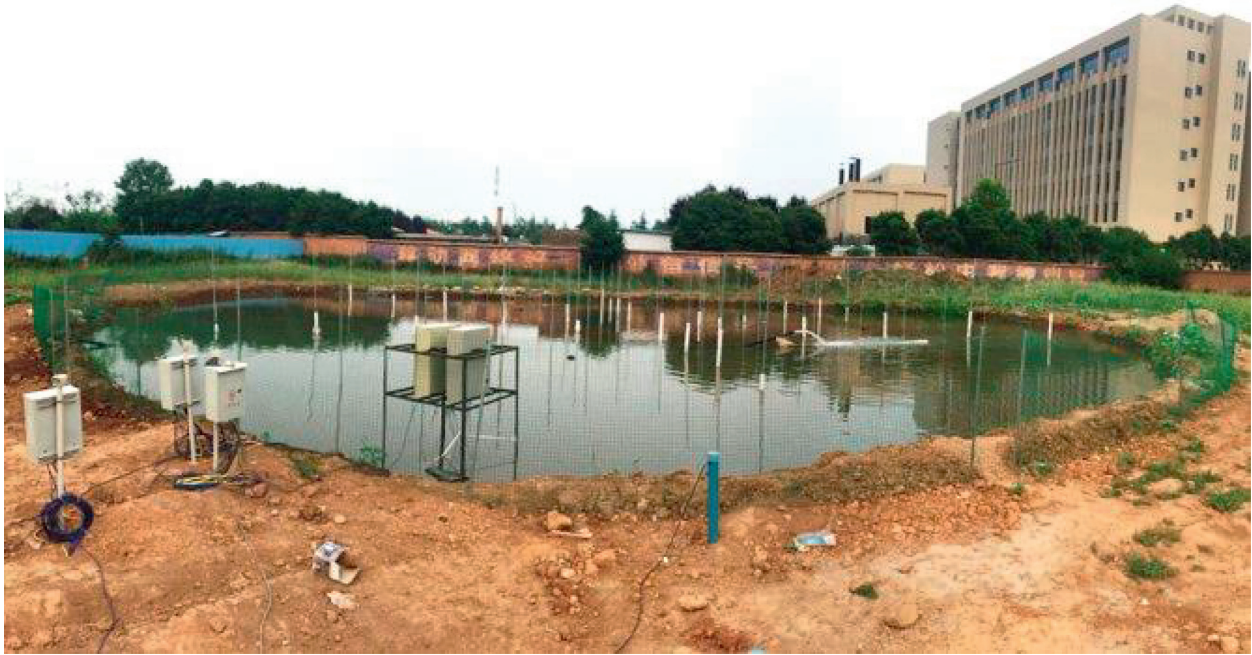
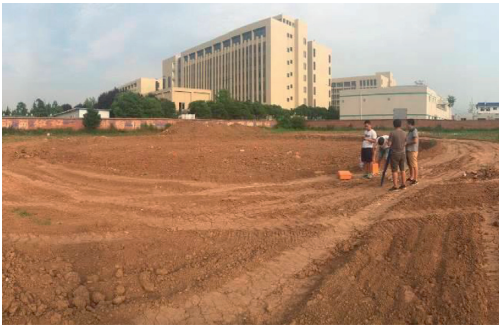
FIGURE 4: Site photos. (a) Overall view of the test pit. (b) Site leveling. (c) Shallow markers. (d) Deep markers. (e) Installation of the soil moisture sensor.

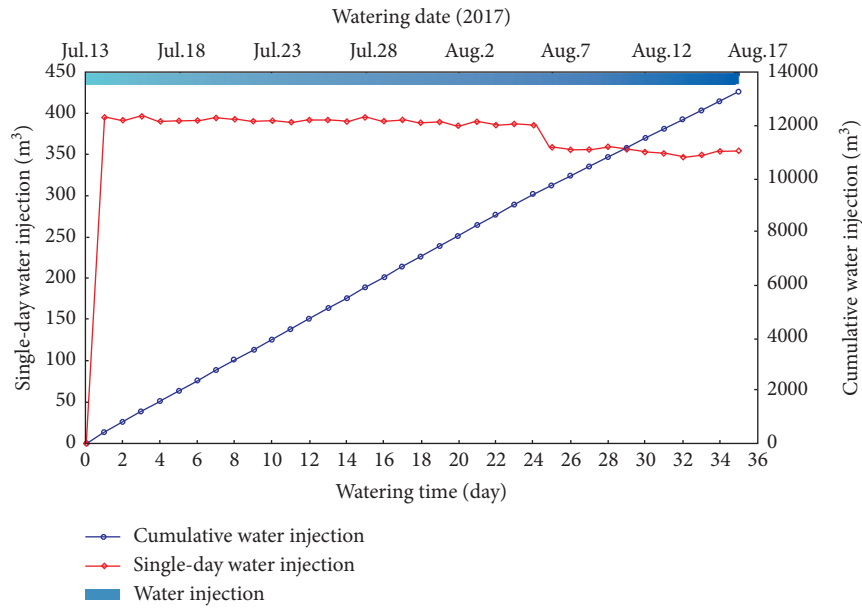
FIGURE 5: The relation between single-day water injection and cumulative water injection.

3.2. Water Injection Process. During the test, water injection was done through pump to keep the water level of the test pit maintained at around 40 cm. A ruler is set at the edge of the test pit to record the pit head, which is always kept at 40 cm during the water injection process. The test pit was injected for 35 days from July 13 to August 17, 2017, with a water injection of $13,255 \text{ m}^3$ and an average daily water injection of 378.7 m^3 . The relation between single-day water injection and cumulative water injection is shown in Figure 5. As can be seen from Figure 5, the water injection was large in the early stage, with an average daily water injection of $390.4 \text{ m}^3/\text{d}$ in the first 23 days. Since then, the water injection started to decrease, and the average daily water injection was stable at $353.4 \text{ m}^3/\text{d}$.

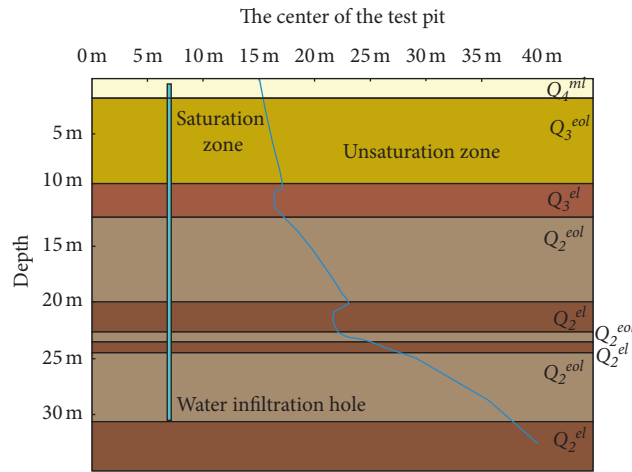
FIGURE 7: The scopes of the immersion area and saturated area of immersion test.

The scopes of immersion area and saturated area of immersion test can be obtained from previous monitoring data. As shown in Figure 7, the saturation range of the water after immersion resembles an inverted funnel, and the saturation range increases outwards in loess compared to old soils, because of the better permeability of loess than that of old soil. The influence of water at a depth of 30 m in the test pit is about 25 m from the edge of the pit, and the steepness of the infiltration line has been a matter of debate in the academic circles [35–41], as it tends to be slower for coarse-grained soils such as sandy soils and steeper for dense soils such as loess, clay, and old soils, because their vertical permeability coefficients are much higher than the horizontal permeability coefficients. The site's old soils have many layers and thicknesses, so they exhibit significantly larger vertical permeability coefficients, and for this reason, the steeper curve of the infiltration line at this site is normal.

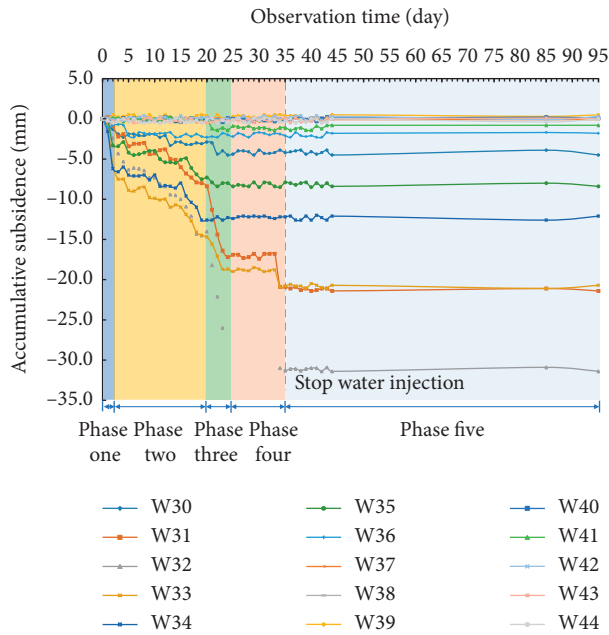
FIGURE 9: Typical accumulative surface subsidence curves (shallow markers of survey line III).

inside test pit was larger, and the maximum subsidence was 31.4 mm. As shown in Figure 9, the subsidence curves of survey line III can be divided into five stages.

- (1) Phase one is the initial stage (0 day-2 days). In the early stage of immersion, the soil surface was unsaturated, and water rapidly filled the soil pores and

infiltrated. Because there was a water infiltration hole between shallow marker W32 and W34 (it was like an artificially large fissure), large amounts of water infiltrated through the hole, and then it caused small subsidence at nearby monitoring points, while other monitoring points had no subsidence.

- (2) Phase two is the deformation stage (2 days–20 days). During this stage, the soil surface inside the test pit was saturated, but outside the test pit it was still unsaturated. As the water continued to infiltrate, the soil on both sides of the water infiltration hole was falling down by the force of erosion and water flow, and the water infiltration hole was gradually increasing, resulting in an obvious increase in subsidence nearby, and the subsidence of other shallow markers in the test pit away from the water infiltration hole was also slowly increasing due to the loess wetting deformation and collapsibility. But the subsidence of shallow markers outside the test pit was still near zero, because the vertical infiltration coefficient of loess is significantly larger than the horizontal infiltration coefficient, and the soil surface outside the test pit was not saturated for a short time.

- (3) Phase three is the rapid deformation stage (20 days–24 days). In this stage, the subsidence of shallow markers nearby the water infiltration hole had a sharp increase. This should be due to the continuous erosion of the water flow, which had led to the expansion of the water infiltration hole, and then the soil at the nearby shallow marker had been eroded causing rapid subsidence. Subsidence also continued to increase at shallow markers in the test pit away from the water infiltration hole. As the

- (4) Phase four is the stability stage (24 days–35 days). During this stage, the seepage was stable, the infiltration velocity decreased, and the subsidence and deformation of soil were stable. But subsidence of shallow markers nearby the water infiltration hole rose, the saturation of the loess layer is higher, and the interstitial pore fills a large amount of free liquid water, the water level remained almost constant during this time, the pore water pressure decreases, and the effective stress of the soil increases, resulting in consolidation subsidence.
- (5) Phase five is the stability stage (35 days–95 days). At this stage, after stopping water injection, the subsidence and deformation of soil also had smaller consolidation subsidence. Over time, however, the soil surface reached a new equilibrium, and the amount of subsidence is stabilized.

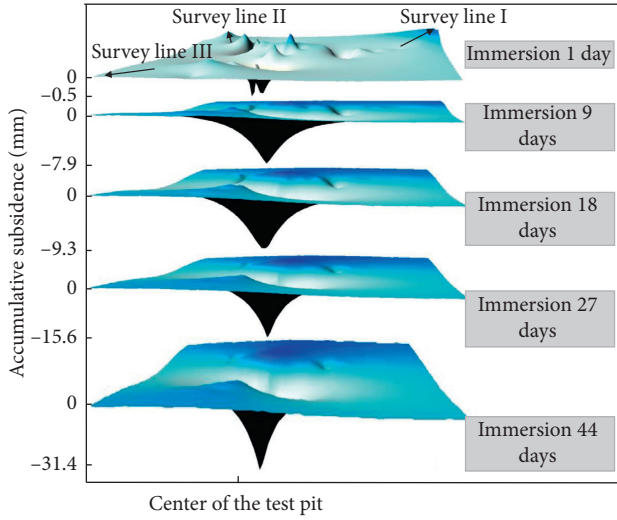
FIGURE 10: Accumulative surface subsidence curve of different immersion days.

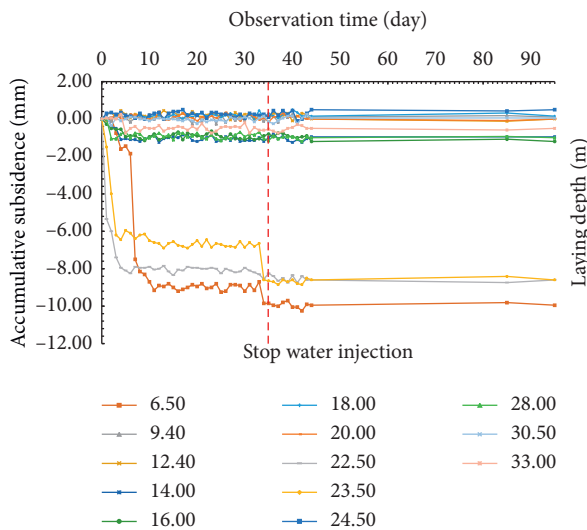
FIGURE 11: Accumulative surface subsidence curve of deep markers with different immersion days.

4.3. Analysis of Layered Subsidence and Deformation. According to the previous investigation data, the depth of subsidence of self-weight wet collapse is 30 m, so the monitoring depth range of this test is from 0 m to 33 m. Figure 11 shows the accumulative surface subsidence curve of deep markers with different immersion days. As shown in Figure 11, the collapsibility deformation of deep markers with buried depths 6.5, 22.5, and 23.5 m is larger, and the collapsibility deformation is -10 mm, -8.55 mm, and -8.85 mm, respectively. The collapsibility deformation of the rest of the deep markers is less than 2 mm. So, collapsibility deformation of deep markers in this immersion test is smaller. It may be related to the water infiltration holes; water infiltration holes and deep marker accelerate the water infiltration and make the deeper soil layer saturate earlier, and then the deeper soil layers result in wetting and deformation, but the middle layers are not saturated with water yet, so that making it difficult to reach the normal overlying pressure of the saturated layer.
